**REGISTER OF HAZARDOUS
MATERIALS REPORT
RESIDENCES IN NORTHERN PRECINCT
TALLAWARRA LANDS,
YALLAH BAY ROAD, YALLAH
NSW**

Report Date: 15 March 2011
Project Ref: ENAUWOLL04009AD

EXECUTIVE SUMMARY

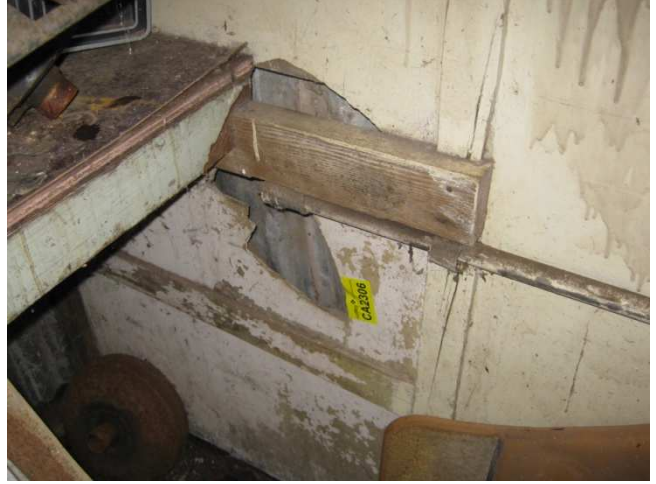
Photograph 2: 01 House, Internal: Car parts store, cement panels.

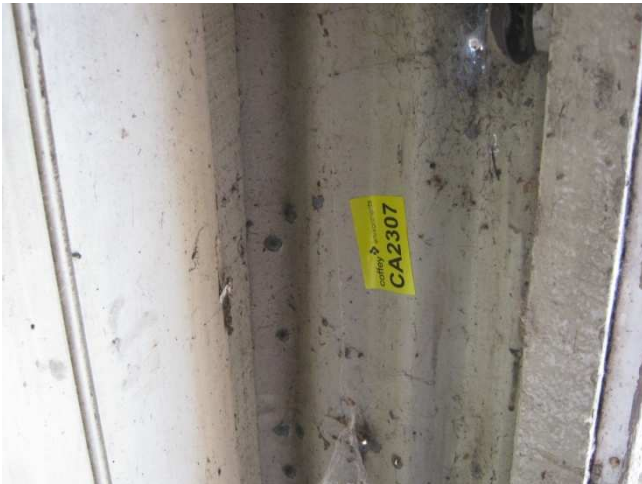
Photograph 3: 01 House, Internal: Car parts store, cream lead paint to walls.

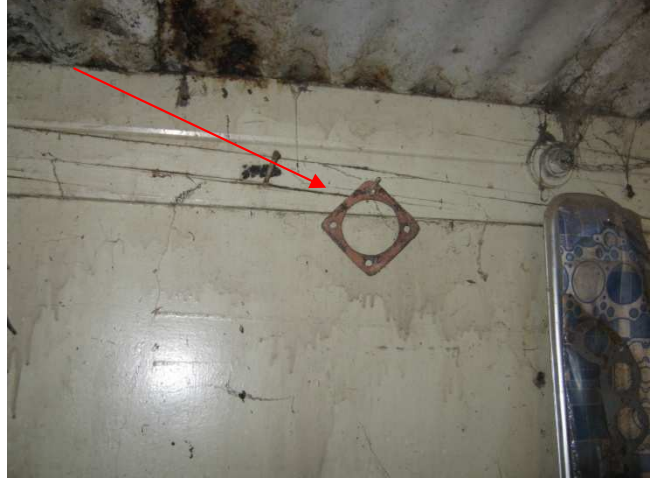
Photograph 4: 01 House, Internal: Car parts store, gasket.

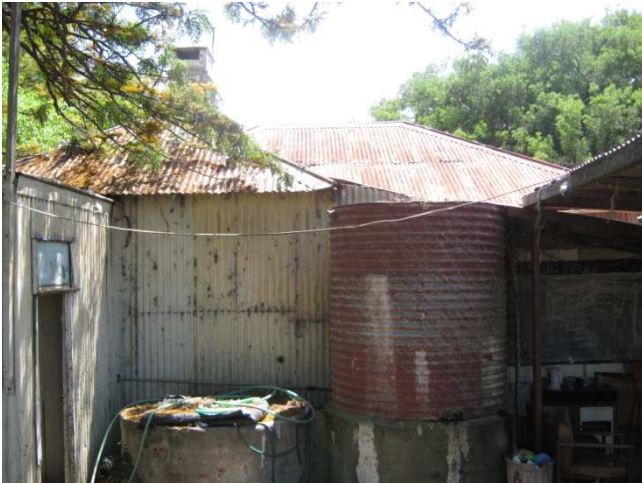
Photograph 5: 01 House, External: Red lead paint to tanks and roof, cream lead paint to walls.

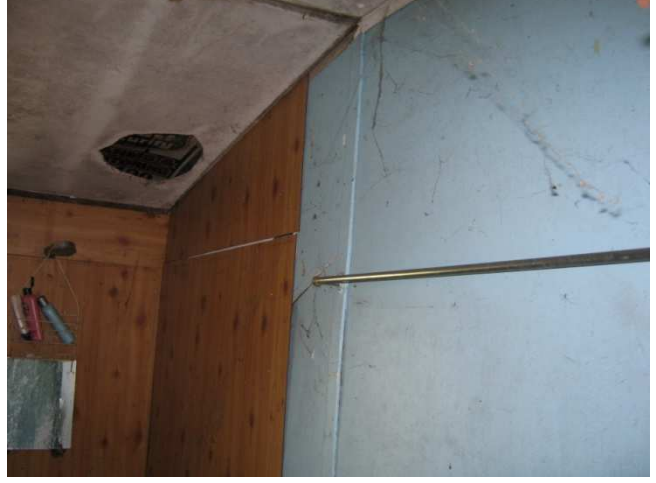
Photograph 6: 01 House, Internal: Cement panels to Bathroom.

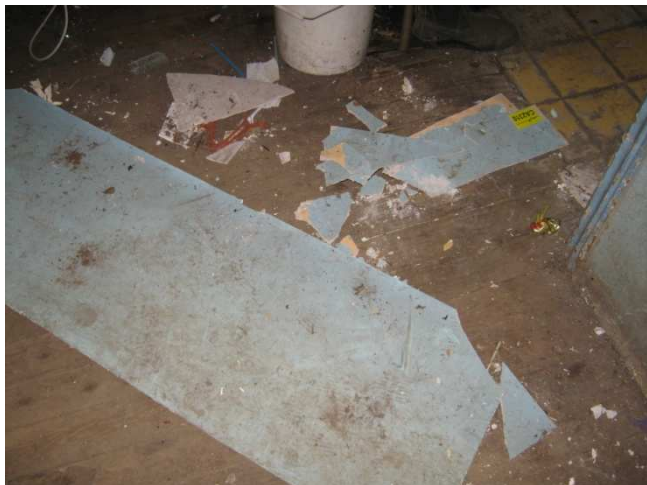
Photograph 7: 01 House, Internal: Cement panel debris to Bathroom. Note removed no longer present.

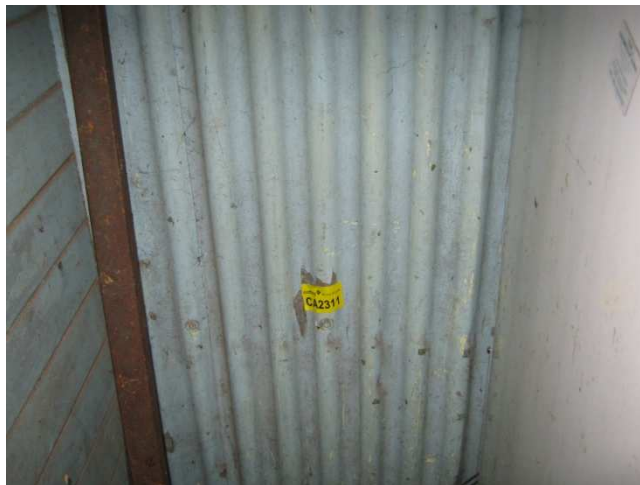
Photograph 8: 01 House, Internal: Corridor, blue lead paint to walls.

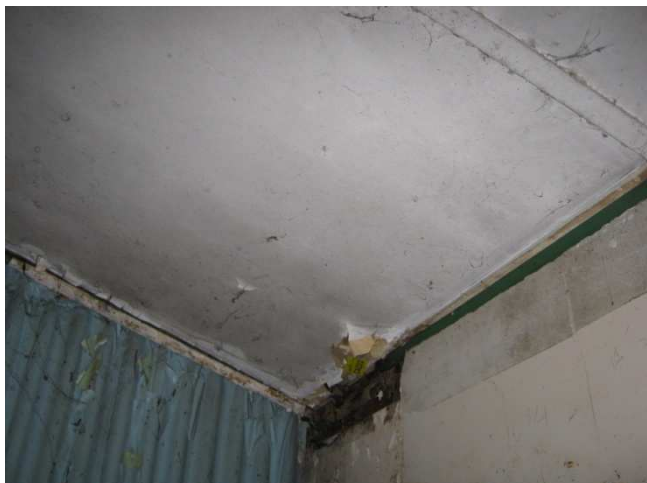
Photograph 9: 01 House, Internal: Cement panel ceiling to Corridor.

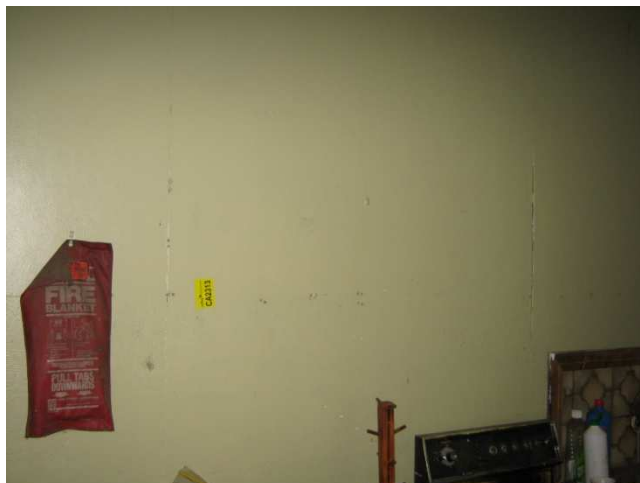
Photograph 10: 01 House, Internal: Cement panels to Kitchen wall.

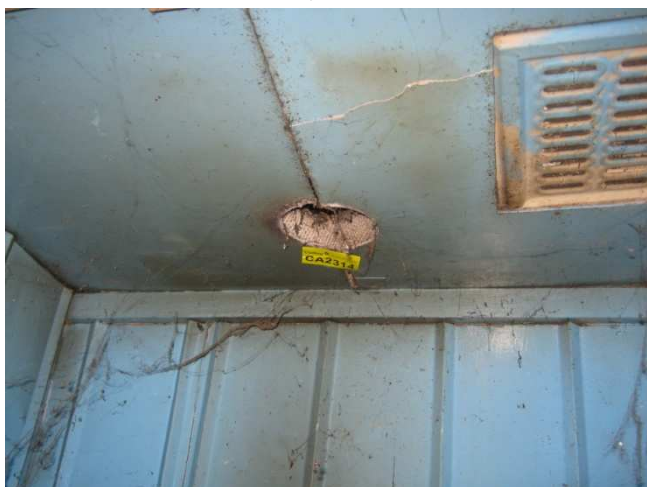
As CA2310	CH	11	Asbestos Cement Sheet	01 House: Internal: To chimney flue in Kitchen	N	1	1	A1	1 m ²	
CA2314	CH	11	Asbestos Textile	01 House: Internal: Cloth wrap to chimney flue in Kitchen	N	1	1	A1	<1 m ²	
CA2315	CH	12	Asbestos Cement Sheet	01 House: Internal: To ceiling in Kitchen	N	1	1	A1	12 m ²

Photograph 11: 01 House, Internal: Cement panels and cloth wrap to Kitchen chimney flue .

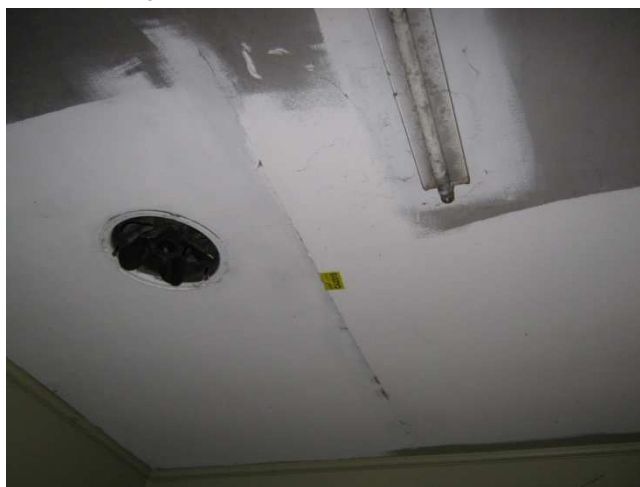
Photograph 12: 01 House, Internal: Cement panels to Kitchen ceiling.

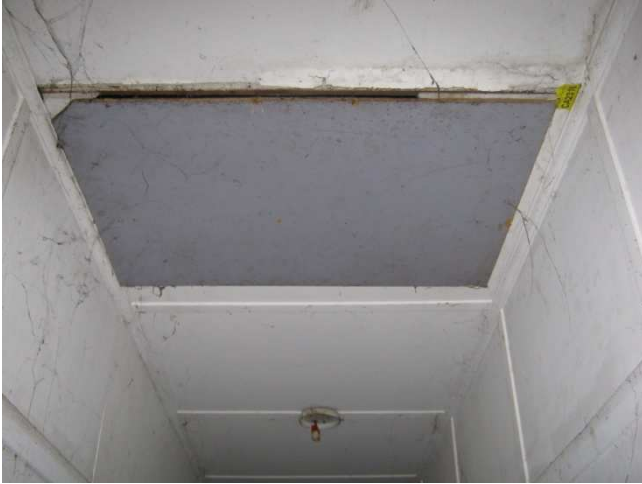
Sample No.	Results	Photo ID	Description	Location	Friable	Asbestos Type	Product Type	Action	Quantity (m, m ² , m ³)	Comments
CA2316	CH	13	Asbestos Cement Sheet	01 House: Internal: To ceiling of Corridor	N	1	1	A1	8 m ²	
As CA2310	CH	13	Asbestos Cement Sheet	01 House: Internal: To walls of Corridor	N	1	1	A1	24 m ²	Note: Lower wall panels are non-asbestos
As CA2309	CH	14	Asbestos Cement Sheet	01 House: Internal: To walls & ceiling of Bedroom 1	N	1	1	A1	48 m ²	Note: Some panels (~6 m ²) are non-asbestos
As CA2309	CH	15	Asbestos Cement Sheet	01 House: Internal: To walls & ceiling of Bedroom 2	N	1	1	A1	48 m ²	
As CA2309	CH	16	Asbestos Cement Sheet	01 House: Internal: To walls & ceiling of Office	N	1	1	A1	44 m ²	Note: Lower wall panels are non-asbestos
As CA2310	CH	17	Asbestos Cement Sheet	01 House: Internal: Over Sunroom door to external	N	1	1	A1	1.5 m ²	
Visual Obs	Presume CR	18	Zelemite Board	01 House: External: To fuse board under awning	N	3	1	A1	<1 m ²

Photograph 13: 01 House, Internal: Cement panels to Corridor ceiling & walls.

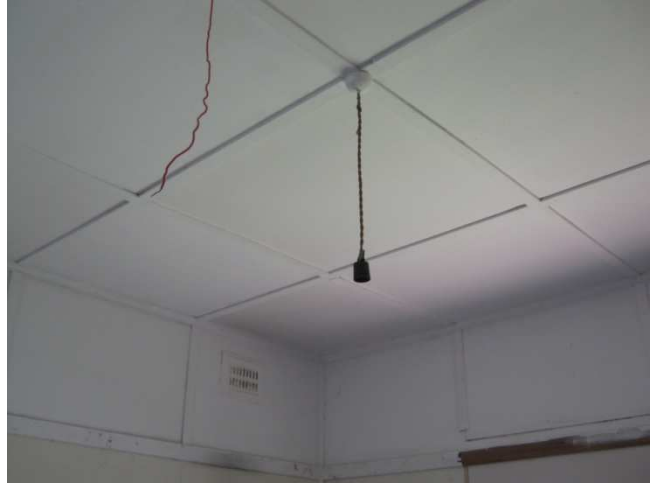
Photograph 14: 01 House, Internal: Cement panels to Bedroom 1 ceiling & walls.

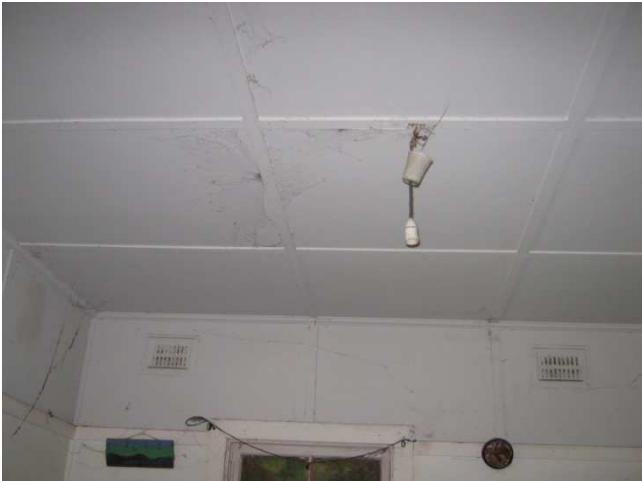
Photograph 15: 01 House, Internal: Cement panels to Bedroom 2 ceiling & walls.

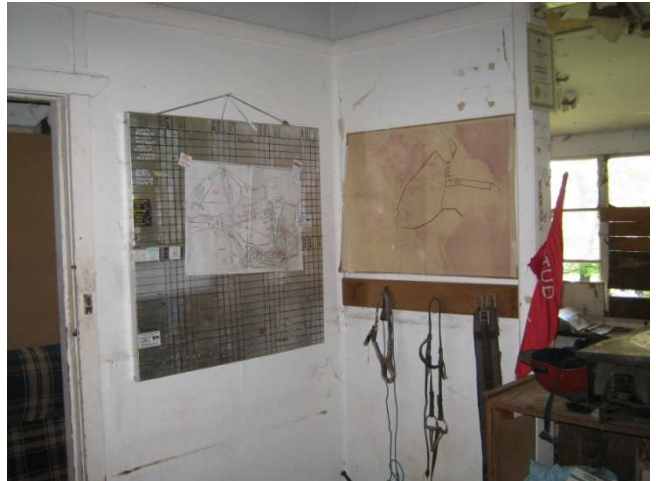
Photograph 16: 01 House, Internal: Cement panels to Office ceiling & walls.

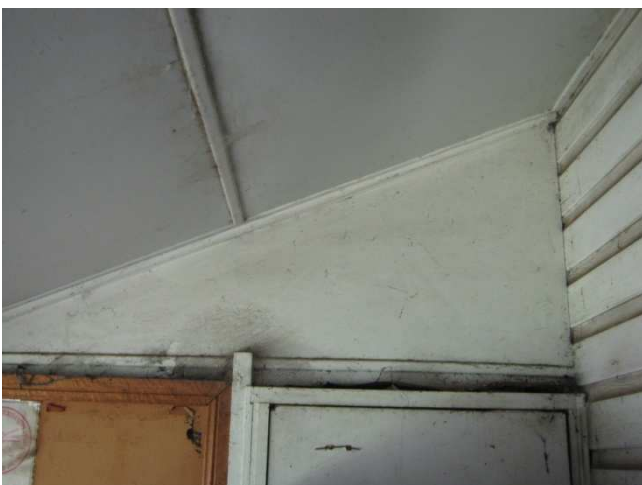
Photograph 17: 01 House, Internal: Cement panel to Sunroom above door.

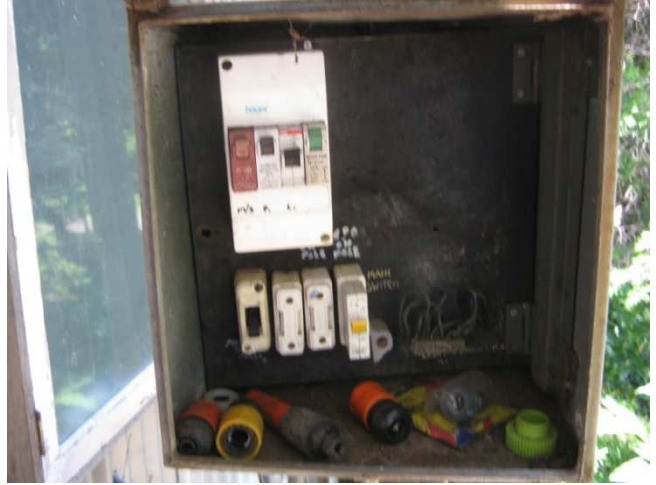
Photograph 18: 01 House, External: Zelemite panel to fuse board.

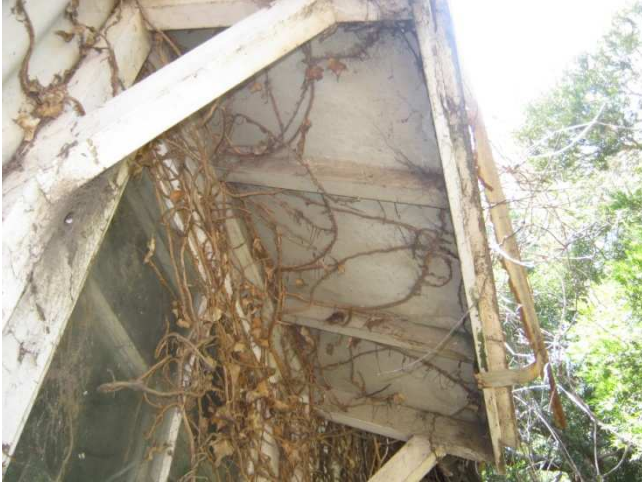
As CA2310	CH	19	Asbestos Cement Sheet	01 House: External: Canopies over windows	N	1	1	A1	3 x 1.5 m ²	Note: over three windows only.
As CA2310	CH	20	Asbestos Cement Sheet	01 House: External: Panels to door surrounds and below and over windows to Sunroom	N	1	1	A1	10 m ²	
As CA2310	CH	21	Asbestos Cement Debris	01 House: External: Cement sheet debris under and adjacent house	N	-	-	NIL	~4 m ²	Removed by P&D Environmental on 11/03/2011.
Visual Obs	Presume CR	22	Asbestos Cement Sheet	01 House: External: To gable end north	N	3	1	A1	4 m ²	
CA2320	CH,AM	23	Asbestos Cement Sheet	08 Toilet: Internal: To walls	N	1	1	A1	6 m ²	
CA2223	CH	25	Asbestos Cement Sheet	12 Stables: Internal: To ceiling in RHS areas	N	1	1	A1	32 m ²	Note: beading to panels is asbestos cement
As CA2223	CH	-	Asbestos Cement Sheet	12 Stables: Internal: To partition to far stores on RHS	N	1	1	A1	2 m ²

Photograph 19: 01 House, External: Cement panels over windows.

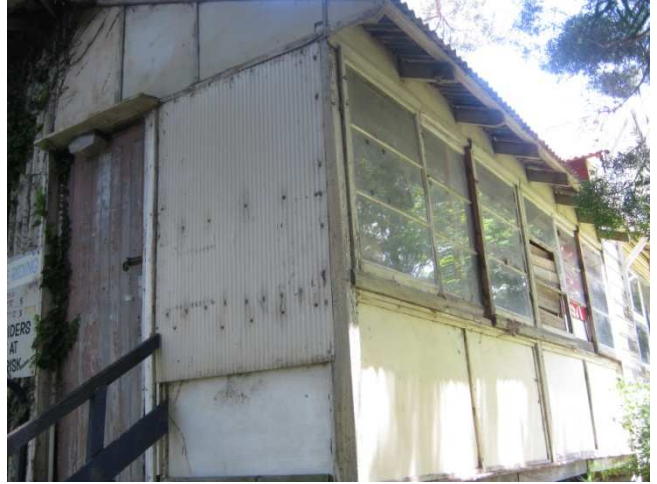
Photograph 20: 01 House, External: Cement panels above and below windows.

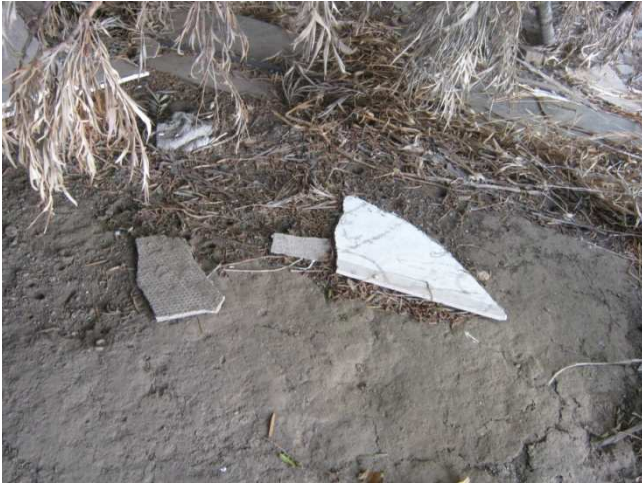
Photograph 21: 01 House, External: Cement panel debris under house. *Removed by P&D Environmental.*

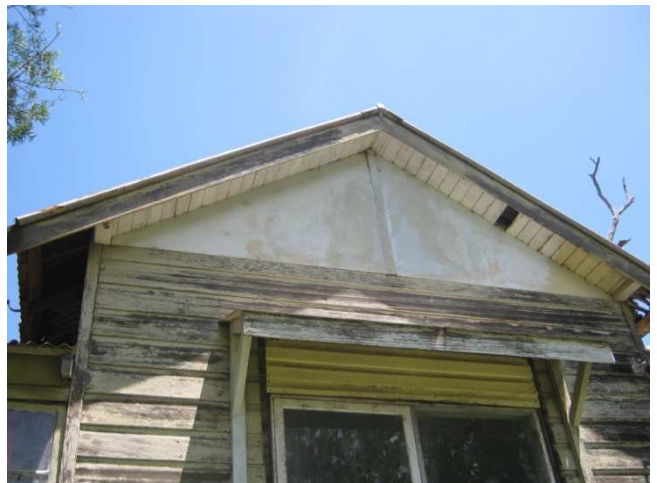
Photograph 22: 01 House, External: Cement panels to gable end.

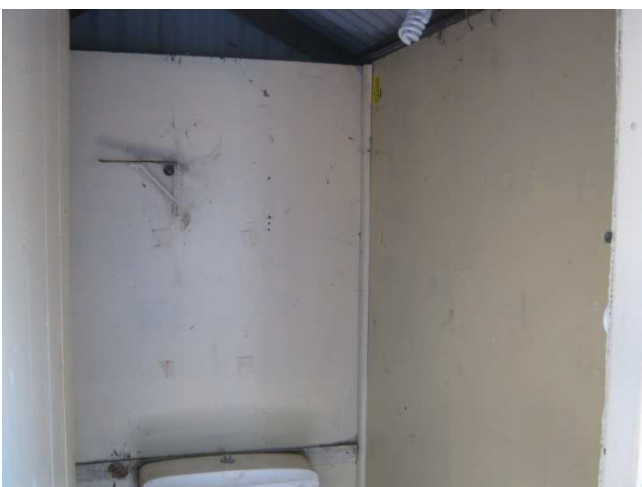
Photograph 23: 08 Toilet, Internal: Cement panels to walls.

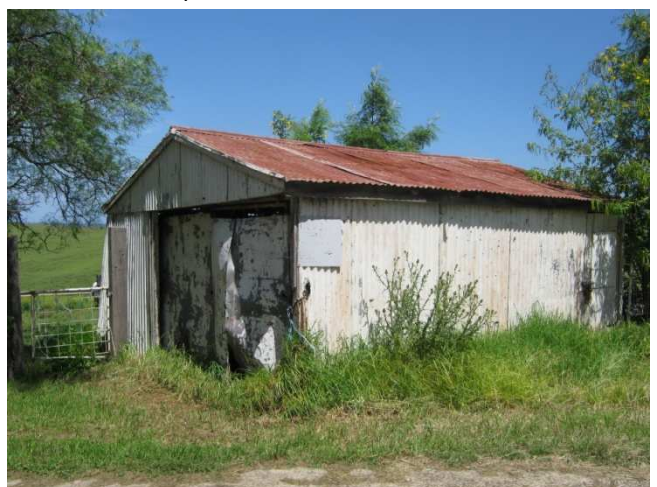
Pb	As CA2307	5.1%	-	Paint 'cream'	08 Toilet: Internal: To corrugated iron wall cladding	NA	A1	12 m ²	Poor condition – flaking prevalent throughout.
Pb	As CA2307	5.1%	24	Paint 'cream'	11 Garage: External: To corrugated iron wall cladding	NA	A1	50 m ²	Poor condition – flaking prevalent throughout.
Pb	As CA2308	9.3%	24	Paint 'red'	11 Garage: External: To corrugated iron roof	NA	A1	30 m ²	Poor condition – flaking prevalent throughout.
Pb	As CA2307	5.1%	29	Paint 'cream'	14 Tin Shed: External: To doors	NA	A1	4 m ²	Poor condition – flaking prevalent throughout.
Pb	As CA2307	5.1%	30	Paint 'cream'	15 Chicken Coop: External: To corrugated iron wall	NA	A1	3 m ²	Poor condition
Pb	As CA2308	9.3%	31	Paint 'red'	16 Weatherboard Shed: External: To corrugated iron wall and roof	NA	A1	14 m ²	Note: locked and no access internally.

Photograph 24: 11 Garage, External: Red lead paint to roof, cream lead paint to walls.

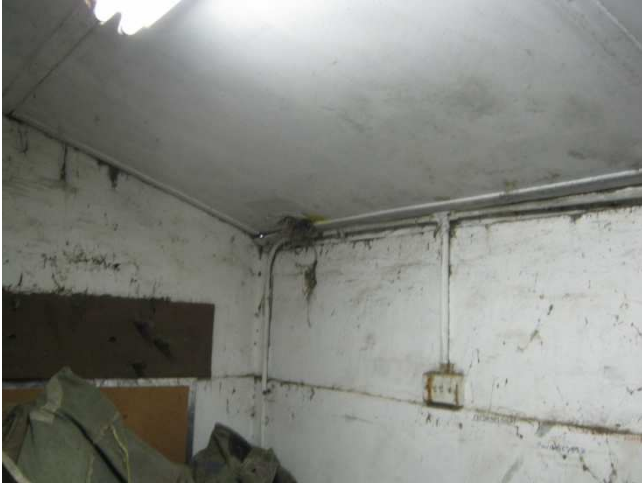
Photograph 25: 12 Stables, Internal: Cement panels to ceiling.

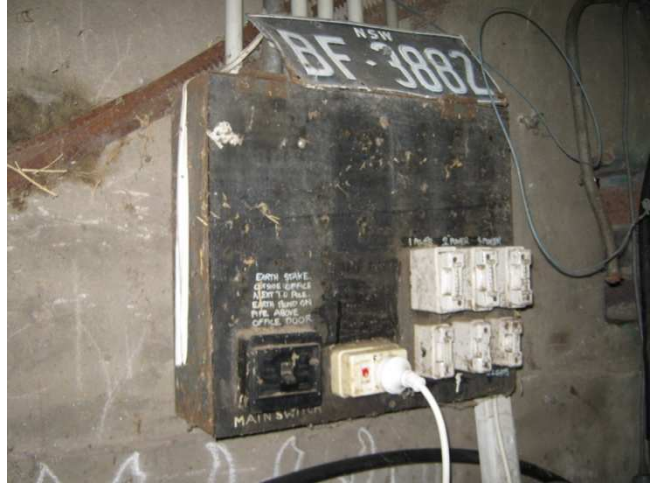
Sample No.	Results	Photo ID	Description	Location	Friable	Asbestos Type	Product Type	Action	Quantity (m, m ² , m ³)	Comments
Visual Obs	Presume CR	26	Zelemite Board	12 Stables: Internal: To fuse box on wall in middle stores	N	3	1	A1	<1 m ²	
Visual Obs	Presume CR	27	Zelemite Board	12 Stables: External: To fuse box on telegraph pole	N	3	1	A1	<1 m ²	
CA2223	CH	28	Asbestos Cement Sheet	13 Forge: Internal: To walls	N	1	1	A1	32 m ²	Note: some non-asbestos panels present.
Visual Obs	Presume CR	51	Asbestos Cement Sheet	01 House: External: Cement debris under Land Rover	N	-	-	NIL	2 m ²	Removed by P&D Environmental on 11/03/2011.
Visual Obs	Presume CR	52	Asbestos Cement Sheet	01 House: External: Cement panel to chimney stack	N	3	1	A1	1 m ²	
No Asbestos Detected (NAD)										
CA2318	NAD	-	Floor Tiles	01 House: Internal: Blue and white tiles to Sunroom	N	0	0	-	8 m ²	
CA2319	NAD	-	Tile adhesive	01 House: Internal: To blue and white tiles to Sunroom	N	0	0	-	2 m ²

Photograph 26: 12 Stables, Internal: Zelemite panel to fuse board.

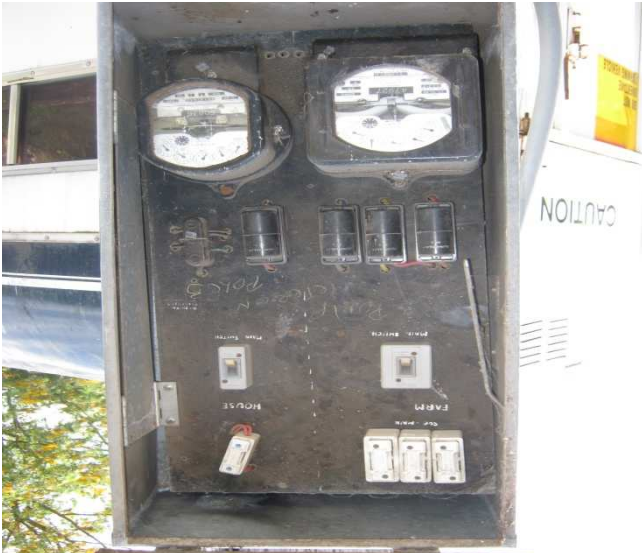
Photograph 27: 12 Stables, External: Zelemite panel to fuse board.

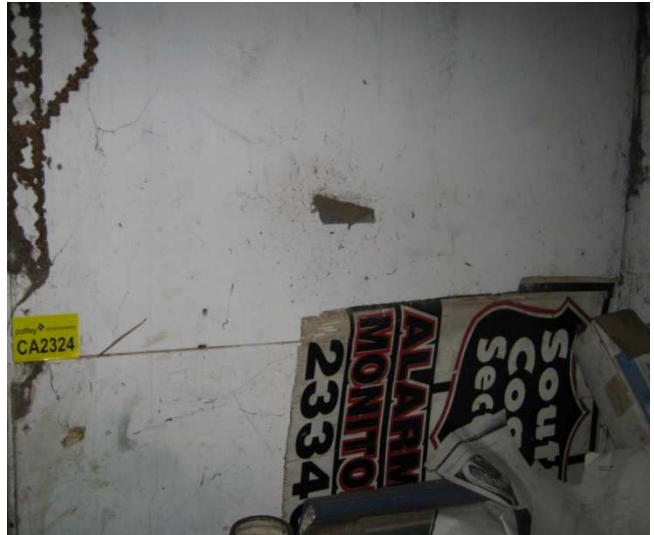
Photograph 38: 13 Tin Shed & Forge, Internal: Cement panels to walls.

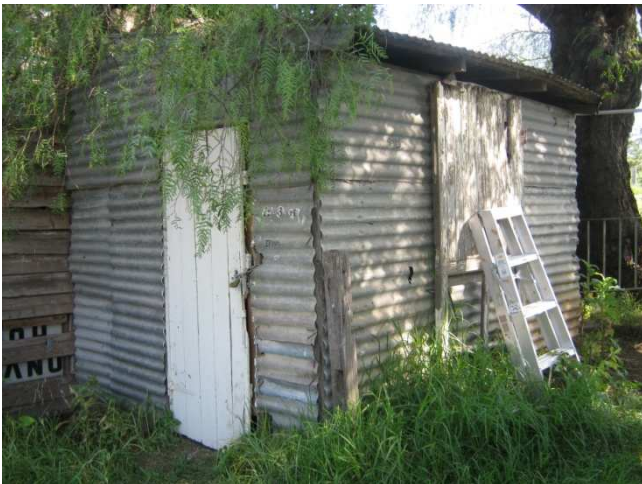
Photograph 29: 14 Tin Shed, External: Cream lead paint to doors & windows.

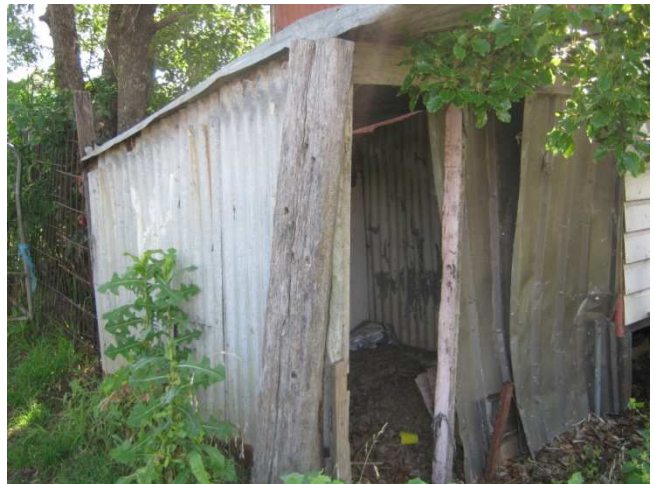
Photograph 30: 15 Chicken Coop, Internal: Cream lead paint to RHS wall.

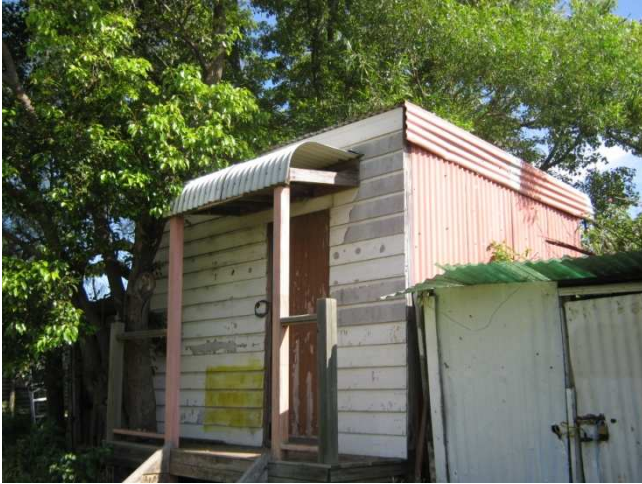
Photograph 31: 16 Shed, External: Red lead paint to roof & side. Locked no access.

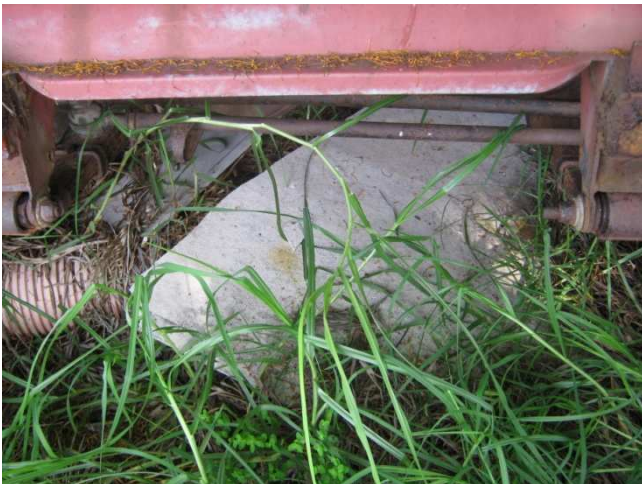
Photograph 51: External Cement debris under Land rover. *Removed by P&D Environmental.*

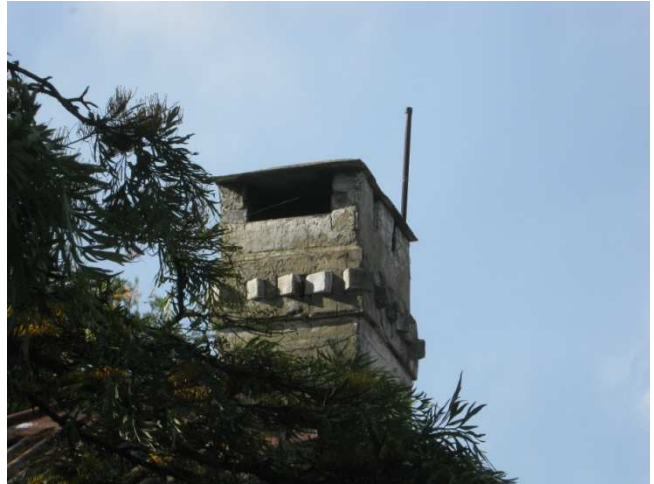
Photograph 52: External Cement panel to house chimney stack.
