# ARBORICULTURAL IMPACT REPORT

ROYAL FAR WEST  
CORNER WENTWORTH STREET AND SOUTH STEYNE  
MANLY NSW

28 MARCH 2011

PREPARED FOR ROYAL FAR WEST

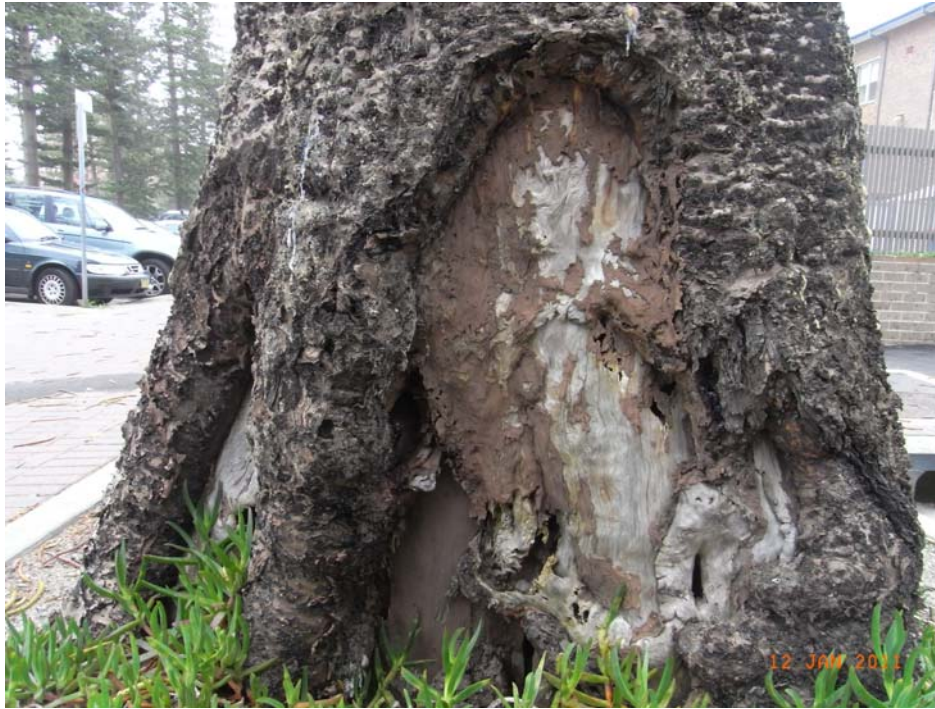
Tree number 1 is considered to be structurally suspect with a significant wound in the basal trunk on the north side with evidence of extensive decay and, possibly, past termite damage - further investigation and testing of this area is required to confirm the tree's structural integrity due to the high target value in the failure zone for the tree.

Photograph 1- Tree # 1 - Illustrating the significant wound in the basal trunk on the north side with evidence of extensive decay and, possibly, past termite damage.

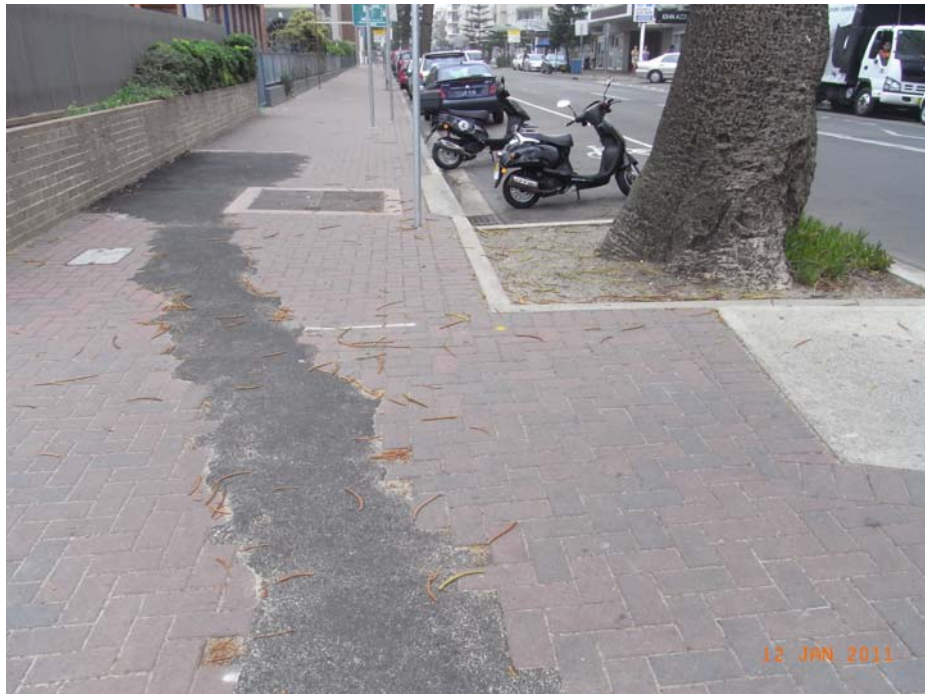
Photograph 2 - Tree # 1 - Illustrating the evidence of recent excavation in close proximity to the tree and within its identified structural root zone.

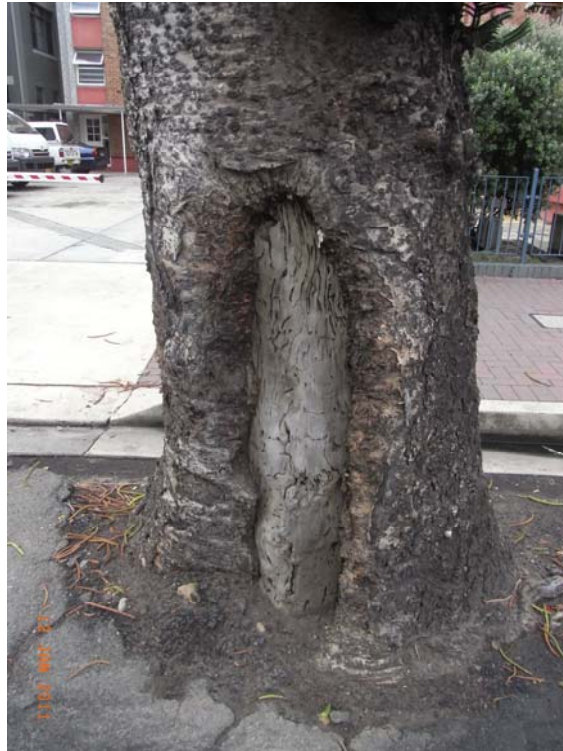
Photograph 3- Tree # 3 - Illustrating the past wounding of the basal trunk on the north side - sounding of this area indicated possible decay that requires further investigation.

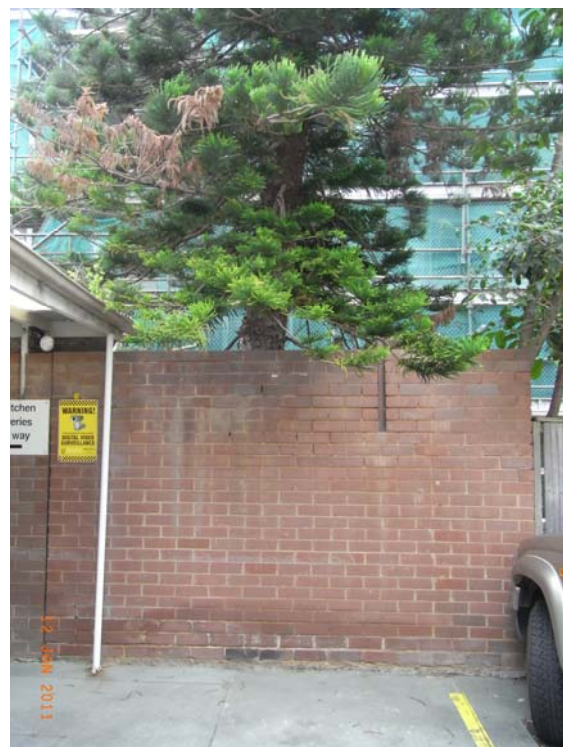
Photograph 4 - Tree # 6 - Illustrating masonry wall 2.3 metres in height adjacent to and within the tree's identified structural root zone.

6	<i>Araucaria heterophylla</i> (Norfolk Island Pine)	13	6	ca. 400	400	440	Good foliage condition	Mature	Single trunk	Upright trunk	Balanced canopy area	Lower limbs pruned in past to 2.5 metres	Appears stable	Sound branch attachment	Good health	Good vigour	<5%	No visual evidence of significant pest or disease	1 Long (> 40 years)	High landscape significance	1	Masonry wall at boundary 2.3 metres in height is adjacent to the tree and within its structural root zone it is probable the footing of the wall forms an important part of the tree's structural support.
