Report on
Preliminary Contamination Assessment

Proposed Train Support Facility
Woodlands Close, Hexham

Prepared for
QR National

Project 39798.06
November 2012

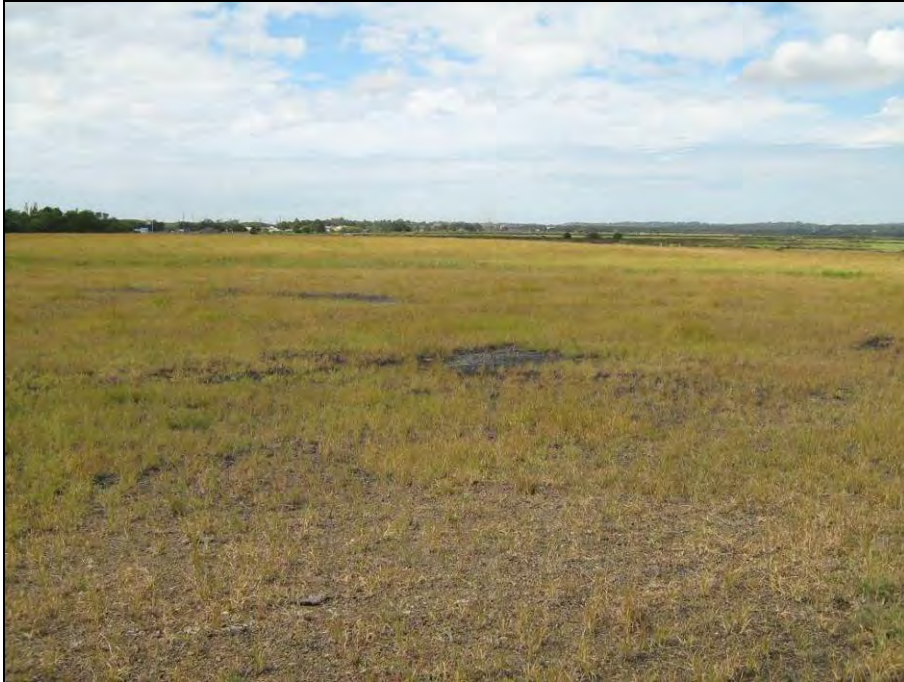
**Figure 1: Filled area in central-eastern portion of the greater Hexham site.
Coal reject and fines evident in the surface material (looking south)**

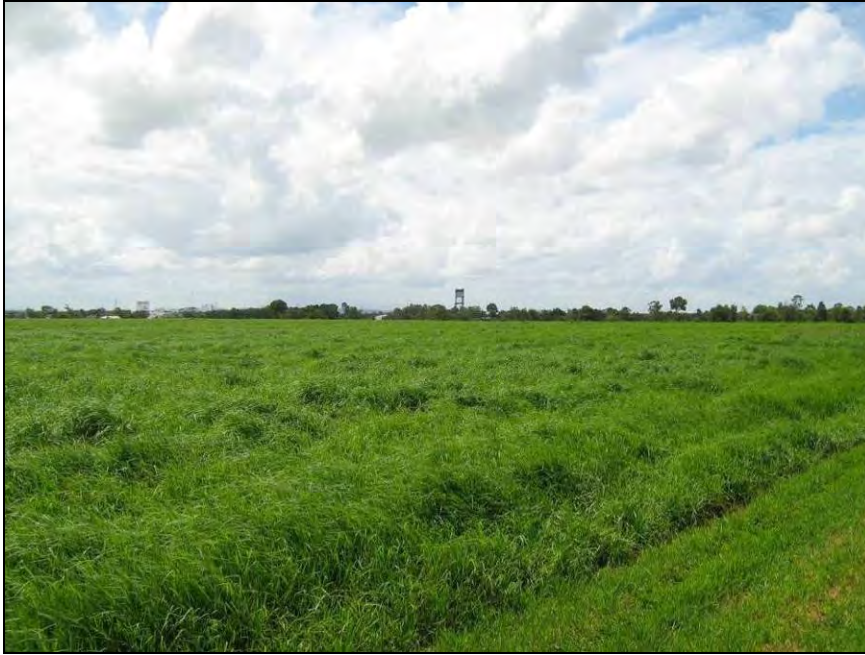
Figure 2: Densely vegetated grass on surface of stockpile, looking north-east

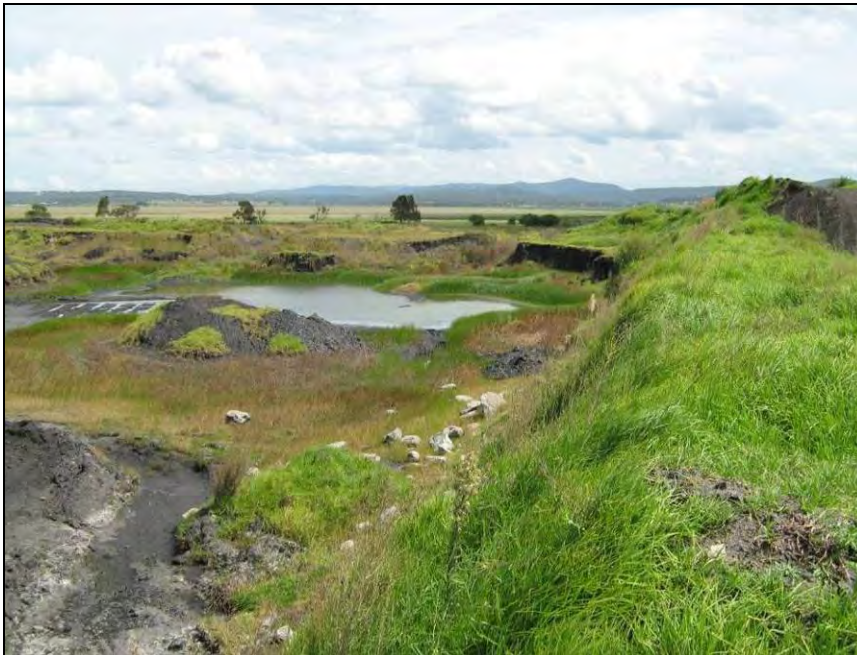
An excavation approximately 100 m by 150 m was present in the central portion of the stockpile. It is understood that the excavation was undertaken in about 2001-2002 as part of a trial to reclaim, dry and beneficially use the coal fines. The walls of the excavation were observed to range up to 8 m and comprised coal reject. Figure 3, below depicts the northern wall of the excavation vegetated with grass. Leached salts are evident in sporadic locations at the base of the excavation.

**Figure 3: Looking west along the northern wall of the excavation.
Leached salts are evident in sporadic locations at the base of the excavation**

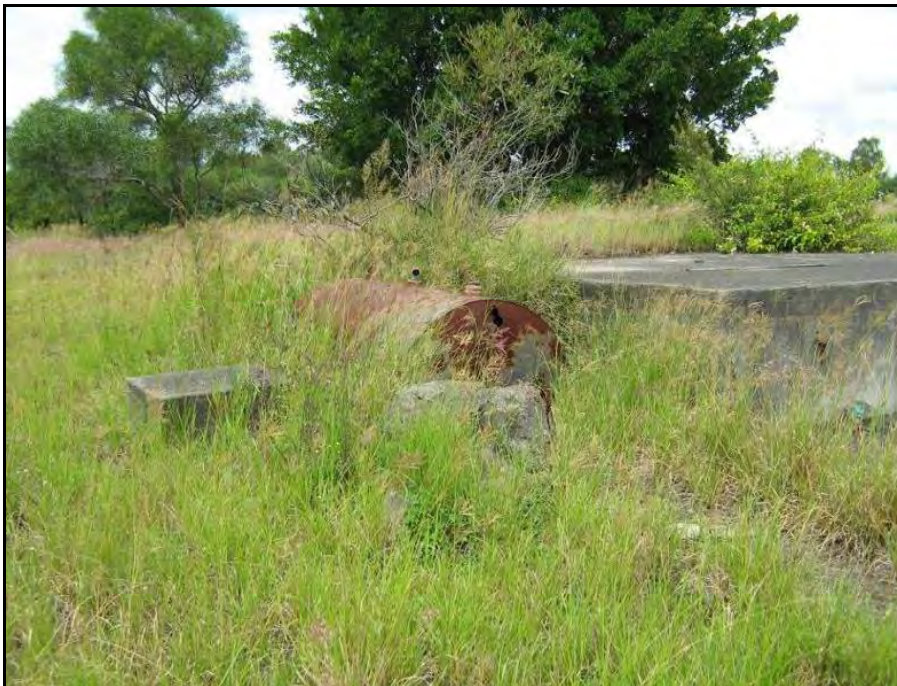
During the initial site inspection on the 18 March 2008, an abandoned former underground storage tank was located adjacent to a concrete platform (about Ch 174.8 km) (Figure 4). However, during field work (2 April 2008), DP observed that the tank had been removed from the site and residual tank contents were present on the ground surface. It is noted that Pit 128 was located at the footprint of the former tank.

Figure 4: Abandoned former Underground Storage Tank located adjacent to a concrete platform in the south-eastern portion of the site

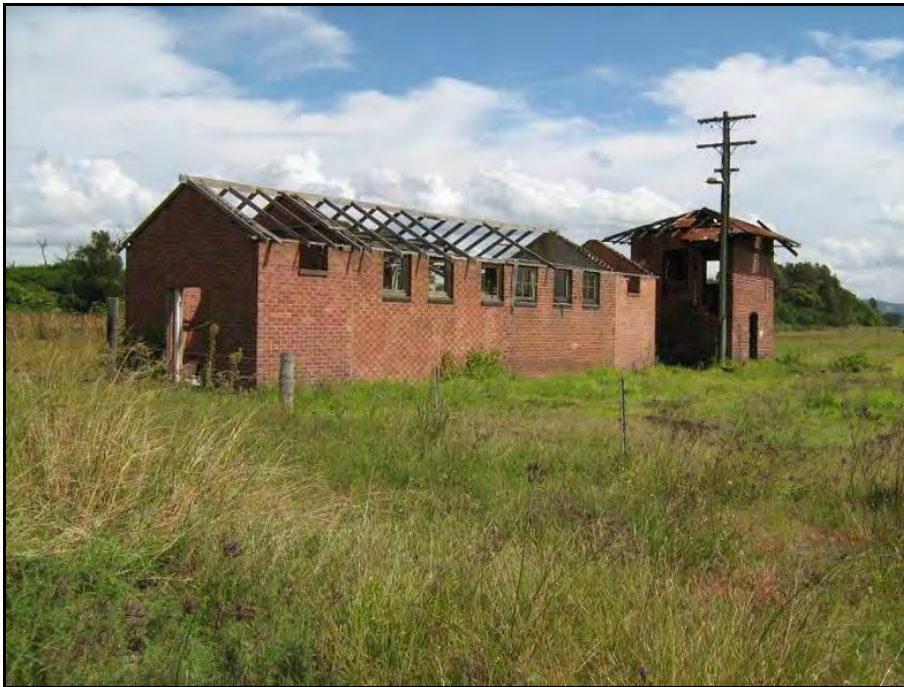
A derelict brick bathhouse and control cabin (signal box) remains on the site at approximately Ch 174.85 km. The buildings were constructed of brick. The roof of the bathhouse had been removed, whilst the roof of the control cabin was constructed of corrugated metal and was partially demolished (Figure 5). The walls of the control cabin are stained black, indicating fire damage. It is noted a previous report indicates that the cabin may have exploded (Ref 7). Fragments of fibre cement sheeting (possible containing asbestos) were observed on the floor of the bathhouse and control cabin. A small area to the west of the control cabin is bitumen sealed. A number of scattered stockpiles covered in thick vegetation were observed approximately 20 m to the north of the Bath house and also surrounding the former locomotive shed (Figure 6).

Figure 5: Bathhouse and Control Cabin located adjacent to the former Minmi-Hexham Railway

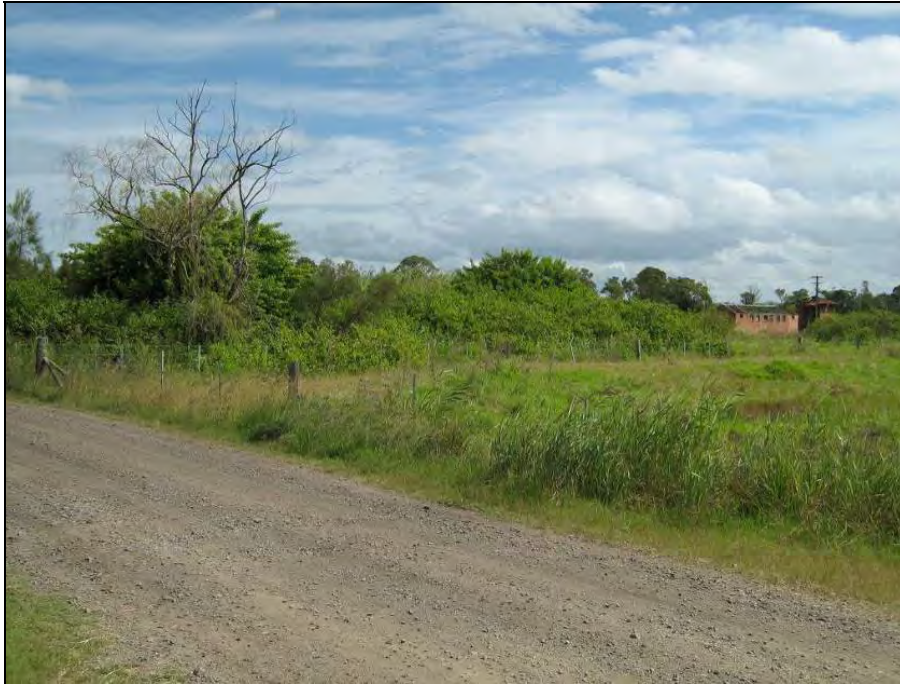
Figure 6: Stockpile covered in dense vegetation near concrete slab of Locomotive Shed, Bathhouse and Control Cabin in background (right)

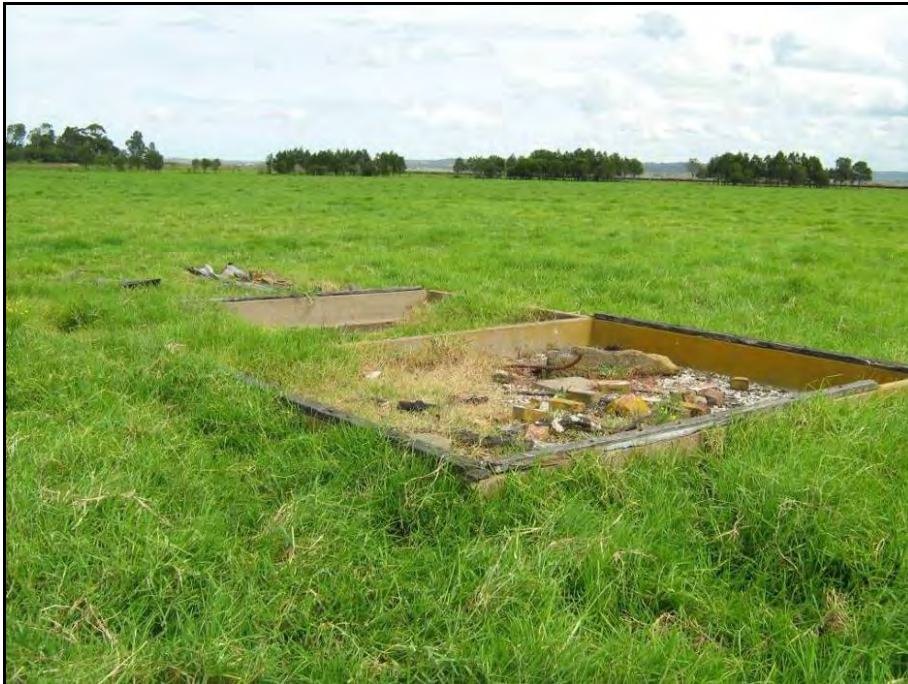
A concrete slab, with fragments of fibre cement sheeting was located to the south of the gravel access road in the central-western portion of Lot 113. It is understood that this building was a former baling shed (Figure 7).

Figure 7: Concrete slab of former baling shed, located within the effluent irrigated paddock vegetated with dense grass

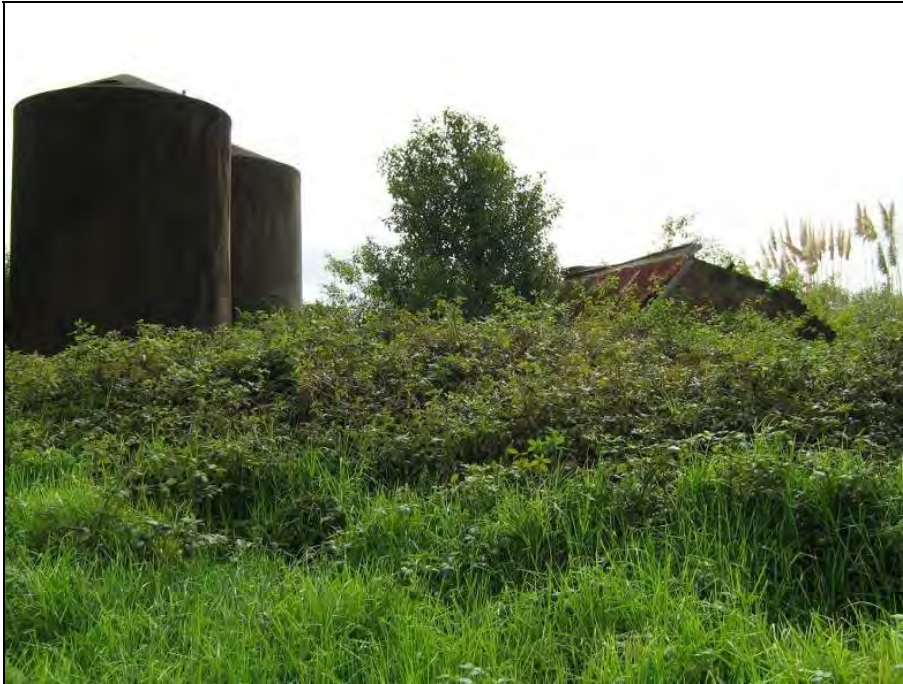
Figure 8: Two silos and derelict remains of buildings covered in dense weedy vegetation

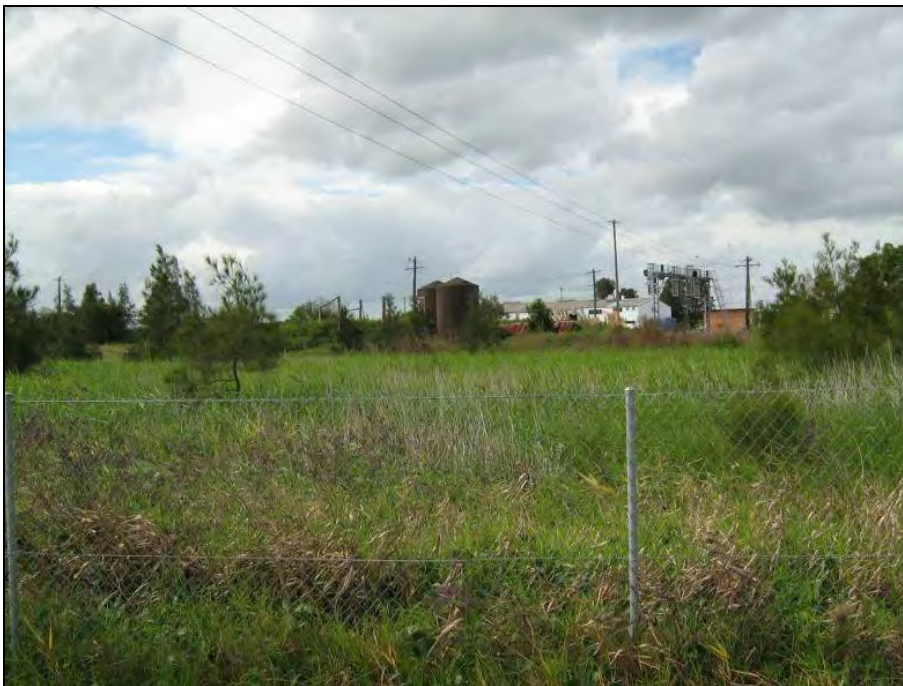
Figure 9: Southern low lying swampy portion of fenced ARTC area, looking north-west towards the silos

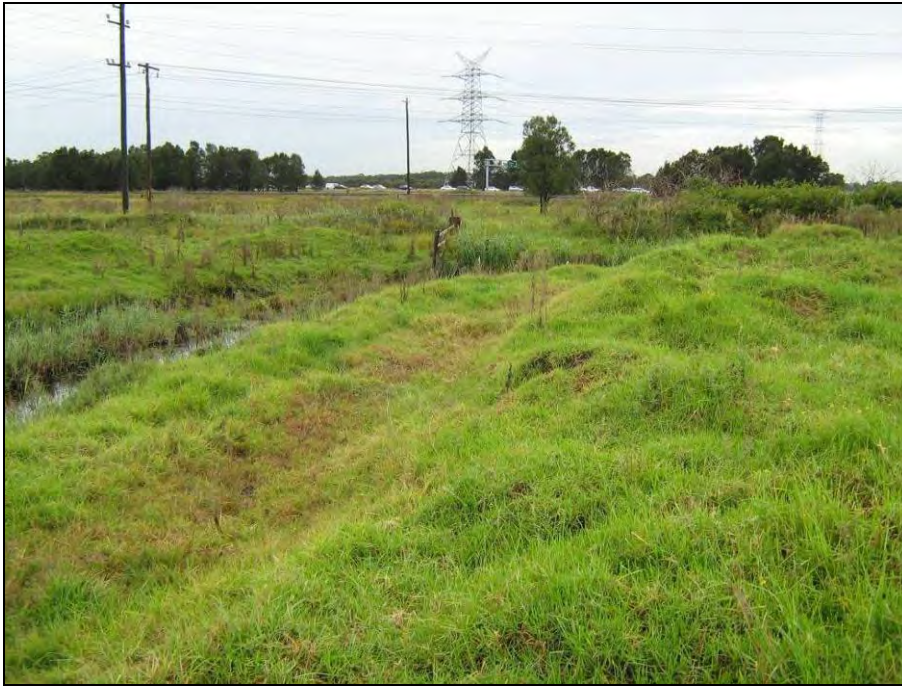
Figure 10: Scattered stockpiles on northern portion of elevated fill platform along bank of diverted drainage channel

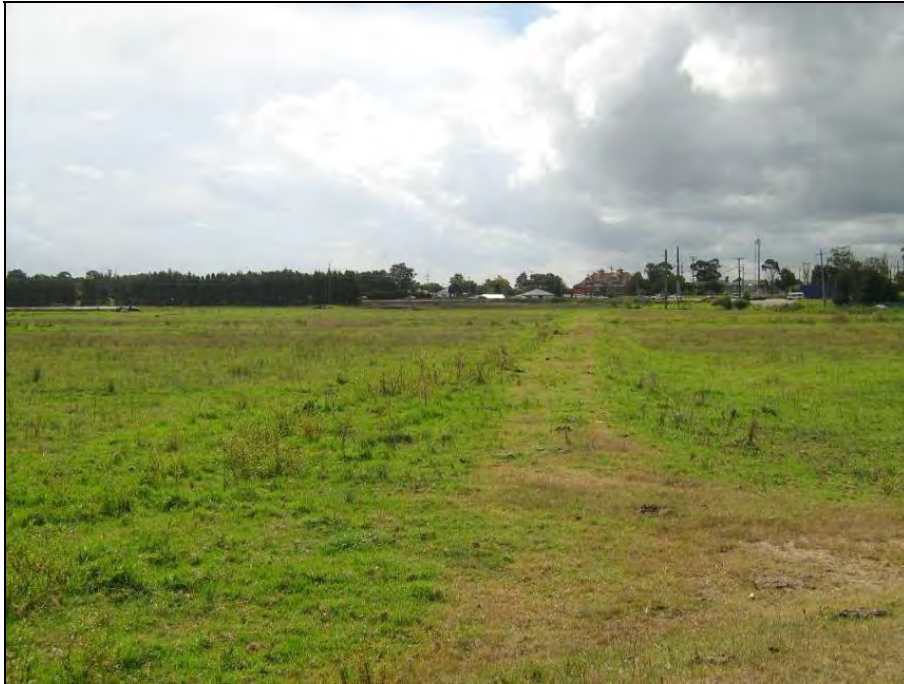
Figure 11: Elevated unpaved access road in northern portion of the site, looking north. Chichester pipeline to left

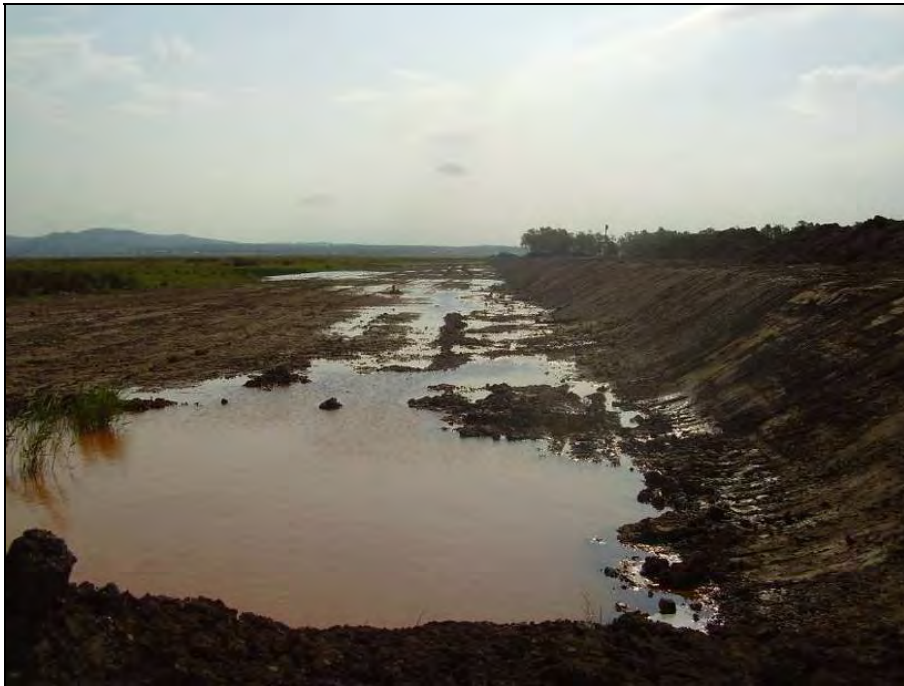
Figure 12: Ponded surface water within disturbed soil along alignment of HWC pipeline (looking west)

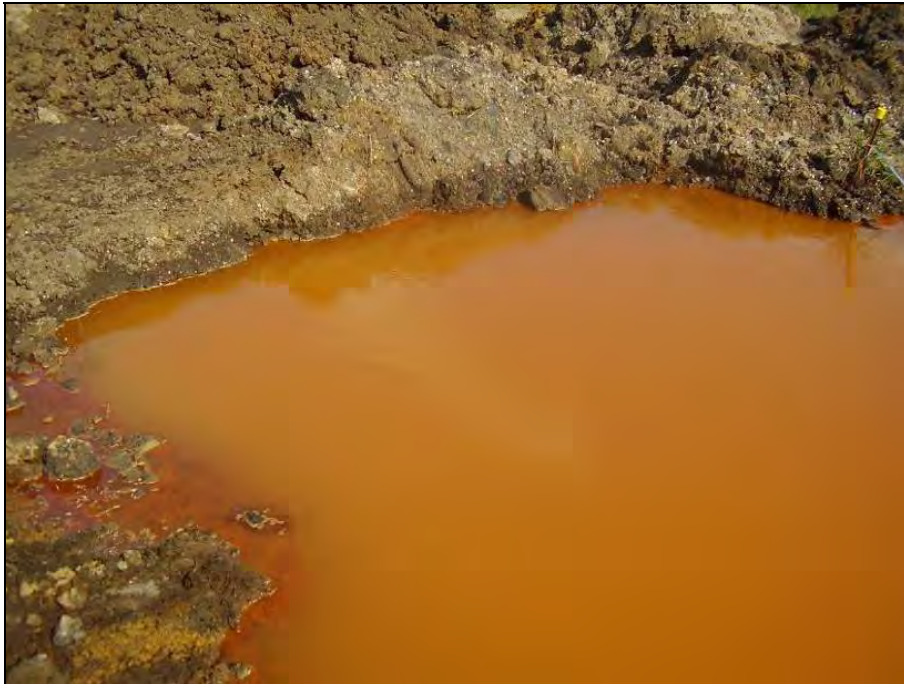
- The orange staining present within areas of surface water located south-west of the fenced compound associated with the Chichester pipeline upgrade has reduced in size, however has appeared to have migrated to the south;

Figure 13: Orange staining within ponded surface water adjacent to former balloon rail loop

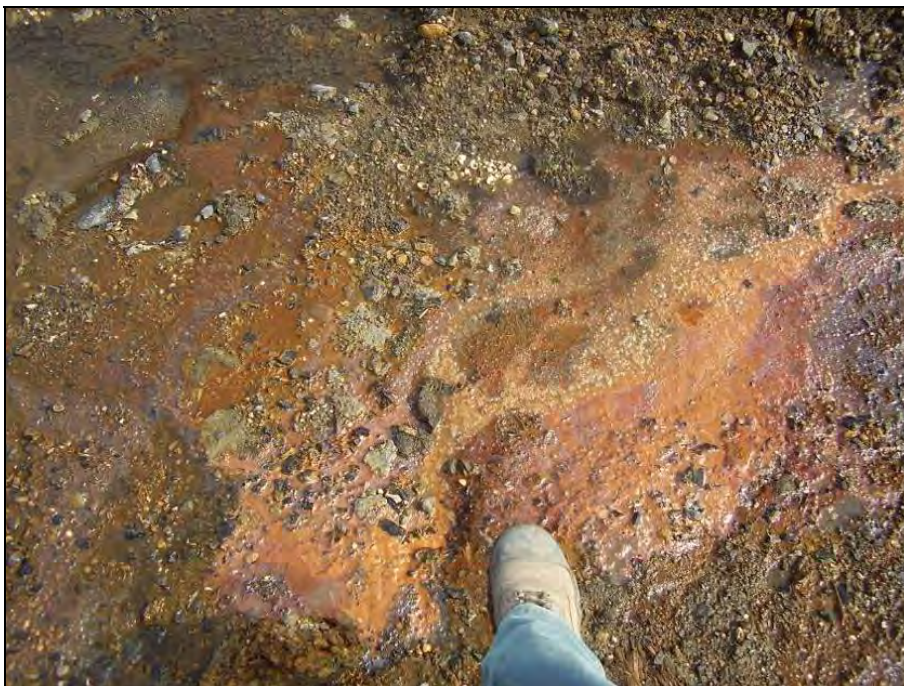
Figure 14: Orange staining of soil adjacent to former balloon rail loop

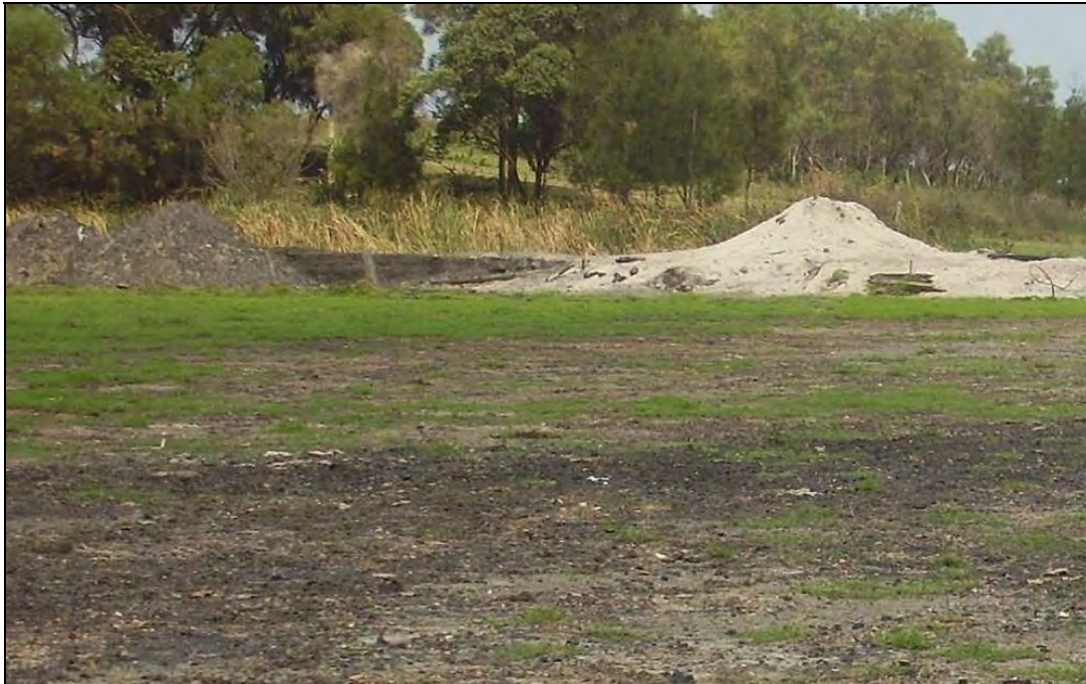
Another stockpile of material likely to have been excavated during the recent pipeline construction, as well as a stockpile of sand, were observed directly adjacent to the north western corner of the coal tailings stockpile (Figure 15). It should be noted that these stockpiles were located in the vicinity of the site boundary and could possibly be off-site. The stockpile of excavated material generally comprised dark grey clayey sandy gravel with some coal and siltstone gravel. The sand stockpile generally comprised light grey fine to medium grained sand possibly used to backfill trenches around the new pipeline.

Figure 15: Stockpiles adjacent to Chichester pipeline upgrade (looking south).
Note - this material has since been removed

A number of fill stockpiles dumped on-site which had previously been observed, where no longer present (i.e. only remnant surface impact evident). These include fill stockpiles shown in Figure 15 (Location on Drawing 2a).

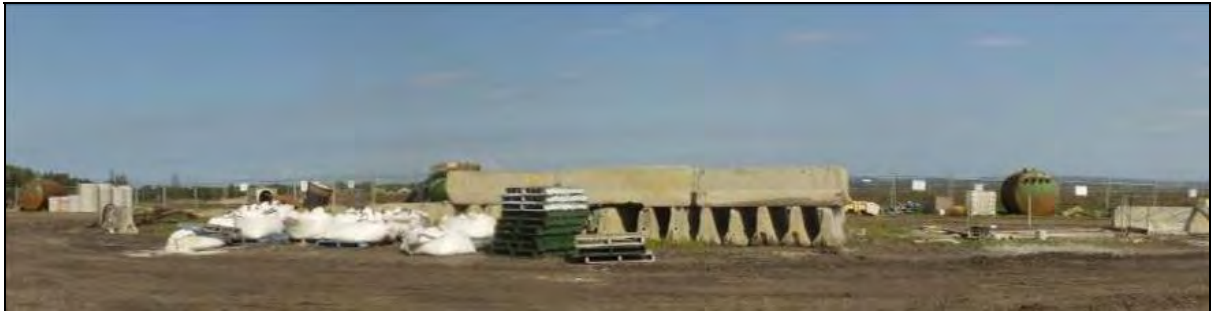
The Diona compound consisted of site offices, machinery and construction materials necessary for the HWC pipeline upgrade (Figure 16). Machinery and construction materials stored within the compound included excavators, polycarbonate concrete lined pipes, 1000 L water tanks, large water filtration tanks, shipping containers, concrete barriers and several 1 tonne bags of lime. Four separate stockpiles of materials were stored within the compound and were observed to comprise sand, coarse gravel/ballast and banded material thought to be lime. A large stockpile of torn garbage bags containing woodchips/straw was also observed in the northern portion of the compound.

Figure 16: Diona compound situated at the southern portion of the site (looking south to south west from the western section of the compound)

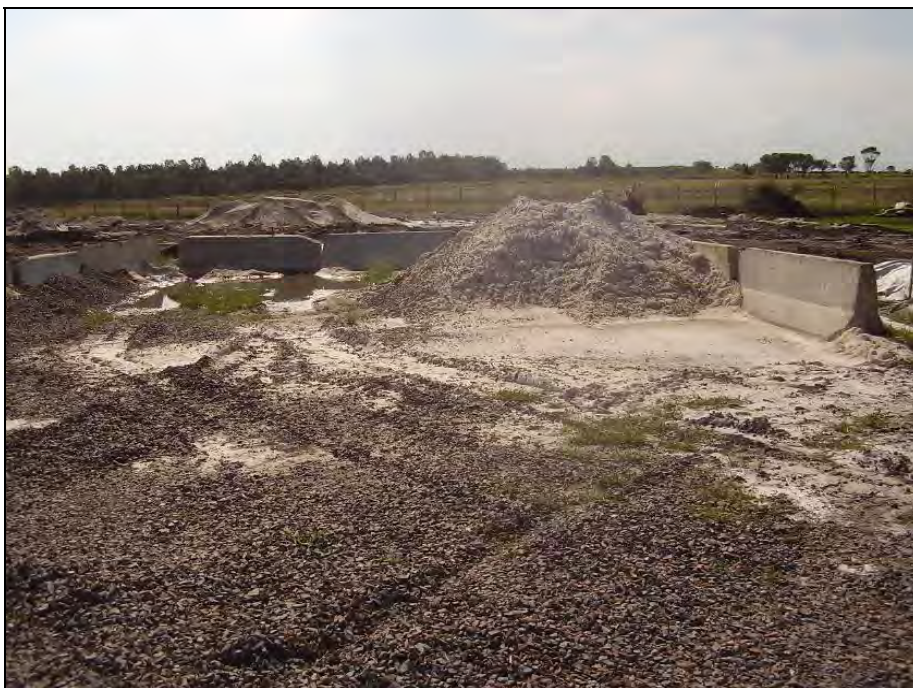
**Figure 17: Sand stockpile at the western section of the compound (looking north).
Note - this material has since been removed**

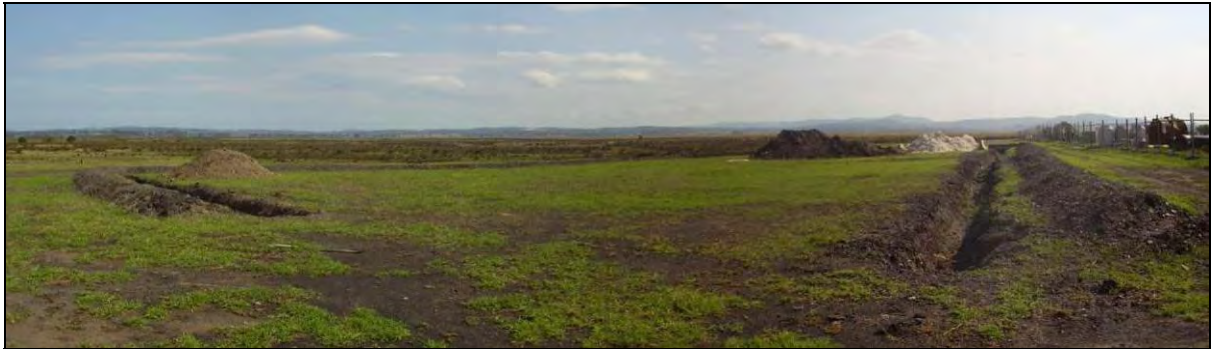
A trenched and bunded area, of approximately 1750m², has been constructed directly to the south of the fenced Diona compound. Trenching has been excavated to approximately 0.4 m and bunds were constructed from coal spoil material excavated from the trench (Figure 18).

Figure 18: Trench and bunded stockpile area directly adjacent to Diona compound (looking south west). Note - this material has since been removed.

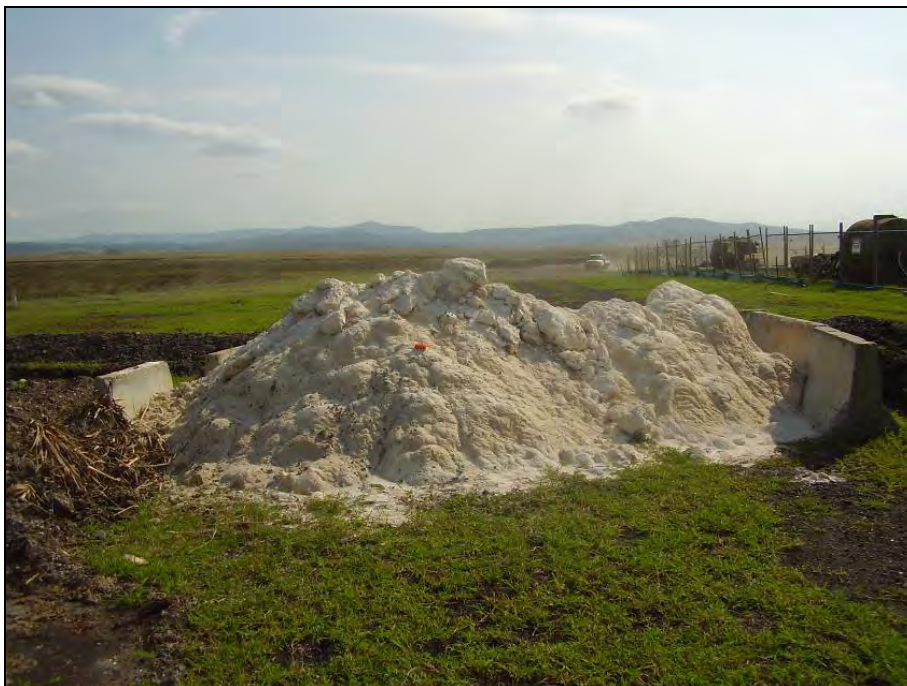
The lime stockpile was partially contained using concrete barriers (Figure 19). Employees of Diona indicated the area was used for the treatment of acid sulphate soils.

Figure 19: Stockpile of lime material within bunded area adjacent to Diona compound (looking west). Note - this material has since been removed

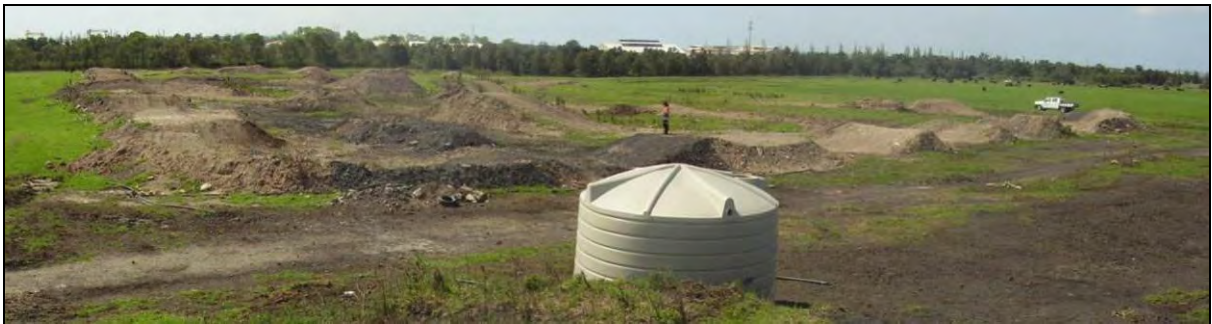
A water tank is located adjacent to the northern corner of the CWR excavation. A network of black polyethylene irrigation line runs from the water tank around the northern and western sides of the track and several hoses running to the middle of the track. Small areas of ponded surface water, up to 0.2 m deep, were observed at several locations within the bike track area.

Figure 20: Bike track constructed from filling material and associated water tank (looking south east from edge of CWR excavation)

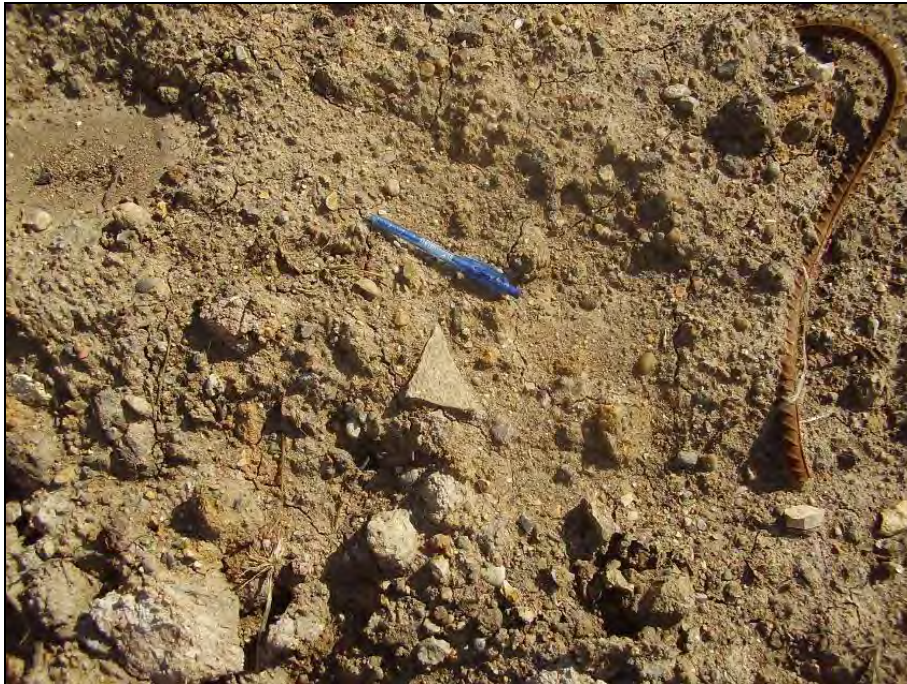
Imported filling used to construct the motocross track generally comprised light grey/brown clay filling with trace fibro sheet fragments at some locations (possibly containing bonded asbestos materials), tile, brick, plastic sheeting, concrete, timber, terracotta, metal and slag (Figure 21). Dark grey/black clayey sandy gravel with some coal and siltstone was also utilised in the construction of the ramps. This dark grey material is likely to have been excavated from the nearby CWR excavation area, as there is evidence of recently excavated material. It is noted that approximately 800 mm of cut is proposed through this area (refer to GHD Fig C0002, Appendix E)

Figure 21: Fibro fragment within soil in south western corner of bike track.
Note – fill materials within this area were subsequently levelled

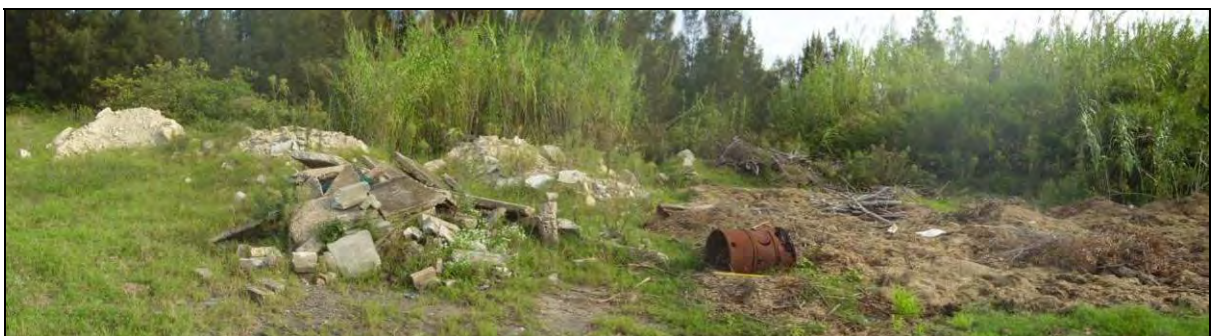
Stockpiles of dumped filling and deleterious material are located within Lot 12 DP 1075150, in the central portion of the greater Hexham site, approximately 70 m east of the Bathhouse (Figure 22). The dumped filling comprised light grey clayey sand (weathered sandstone), sandstone gravel, cobbles and boulders. The deleterious material included, bricks, concrete, terracotta pipe, sediment fencing, plastic sheeting, green waste and an empty 44 gallon drum.

Figure 22: Dumped material in the central portion of site, north-east of the Bathhouse / Control room (looking south)

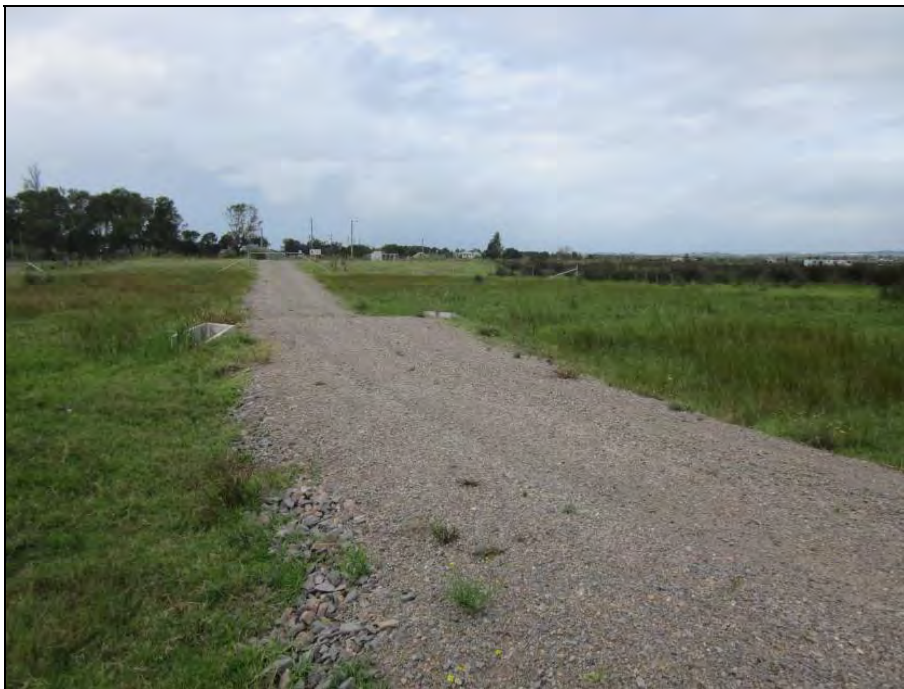
Gravel access tracks have been constructed along the new watermain pipeline routes, with former above ground pipework now removed. Fill materials used to construct the tracks were observed to comprise crushed rock/railway ballast (Figures 23, 24 and 25).

Figure 23: Gravel access track in south eastern portion of the greater Hexham site associated with the new watermain pipeline

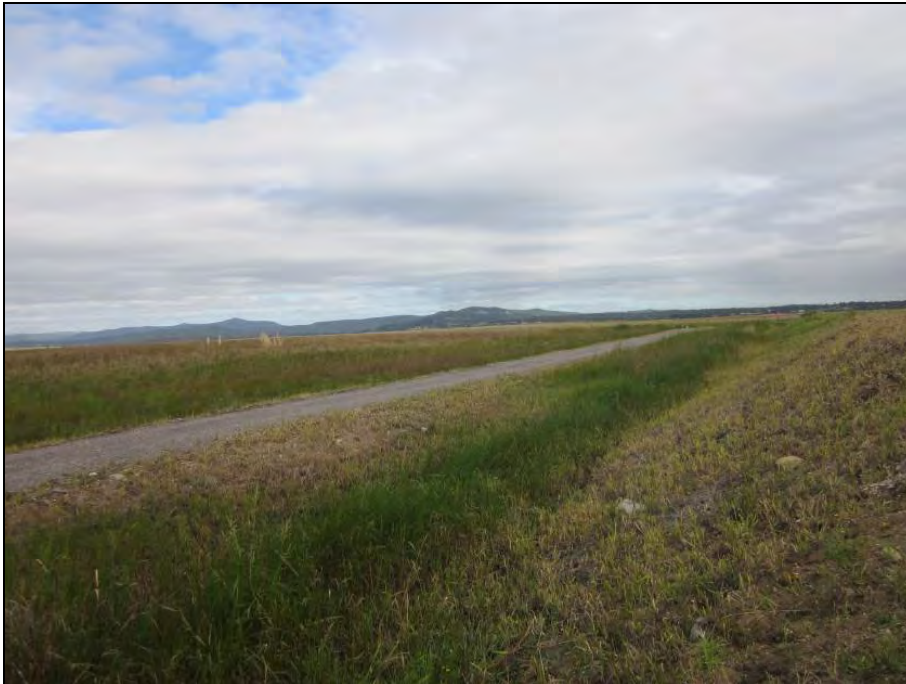
Figure 24: Gravel access track in southern portion of the greater Hexham site adjacent to new watermain pipeline

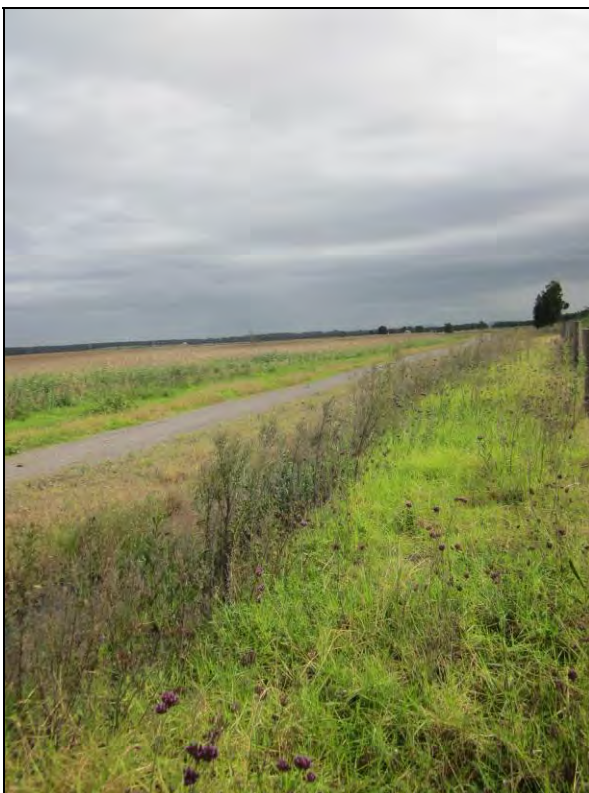
Figure 25: Gravel access track in south western portion of the greater Hexham site adjacent to new watermain pipeline

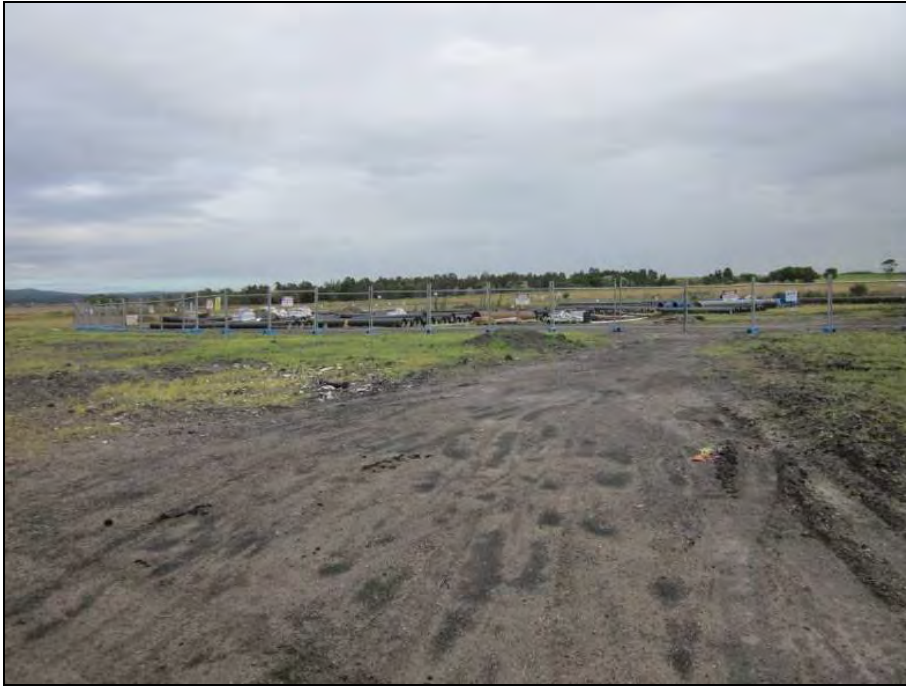
The Diona storage compound still remains, however, the area largely comprises stored piping and some machinery now (Figure 26). Stockpiles of lime outside the compound are no longer evident (Figure 18 and 19) and the ground surface in the area around the compound appears to have been graded (Figure 26).

Figure 26: Diona Compound looking north-west

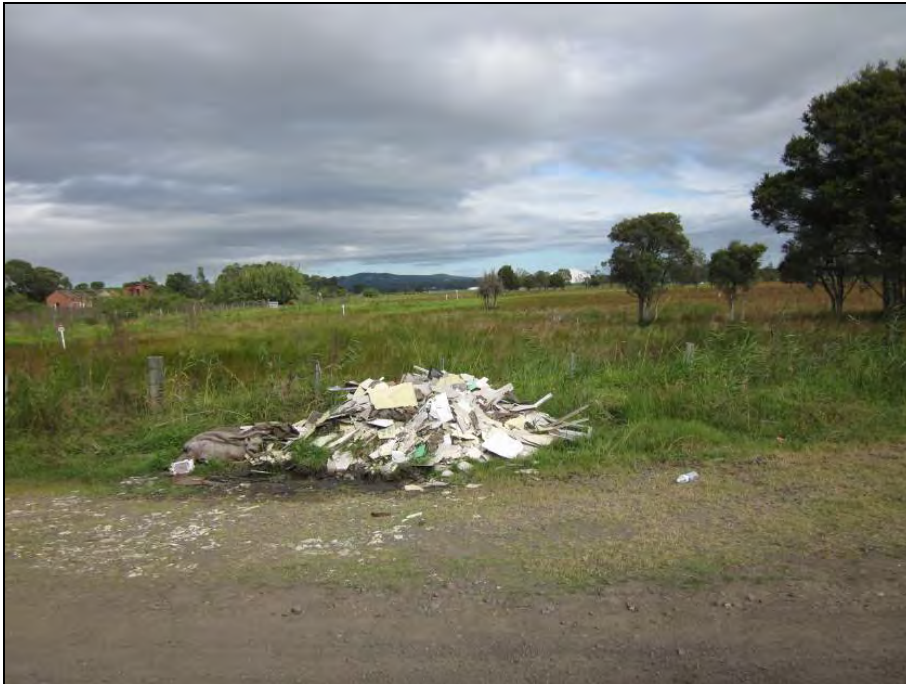
Additional areas comprising dumped general waste were observed in some areas including the former truck wash area in the central eastern portion of the greater Hexham site which comprised a mixture of household wastes. A new stockpile of demolition waste was also observed which included fibro sheeting (possibly containing asbestos) located adjacent to the main entrance road to the east of the WWTP (Figure 27). Near surface impact was also observed in the vicinity of the stockpile. It is understood that this stockpile was removed by a third party following the DP inspection.

Figure 27: Dumped demolition waste in central eastern portion of site

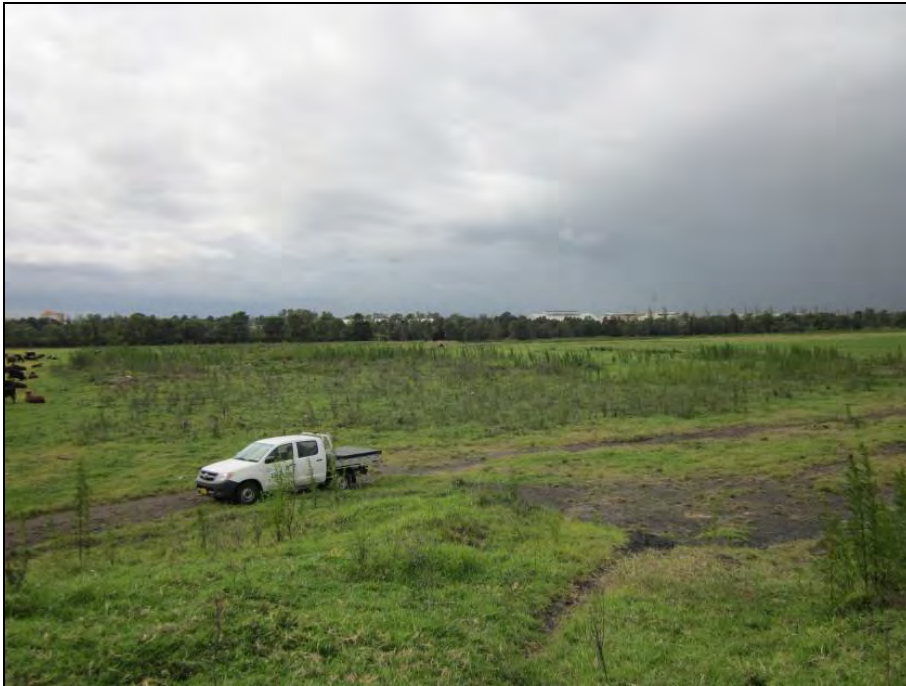
The stockpiled filling observed in 2011 which was utilised as a bike track (Figures 20 and 21) appears to have been levelled and spread (Figure 28), which was evidenced by the hummocky ground surface. Filling consistent with that initially observed within the bike track area was present at the surface where vegetation was absent.

Figure 28: Former Bike track looking south west from the CWR excavation area
