Remedial Action Plan
Identified Asbestos Contamination
Proposed Wet n' Wild Theme Park
Reservoir Rd, Prospect

Report Number 610.11873 R03

18 December 2012

Remedial Action Plan

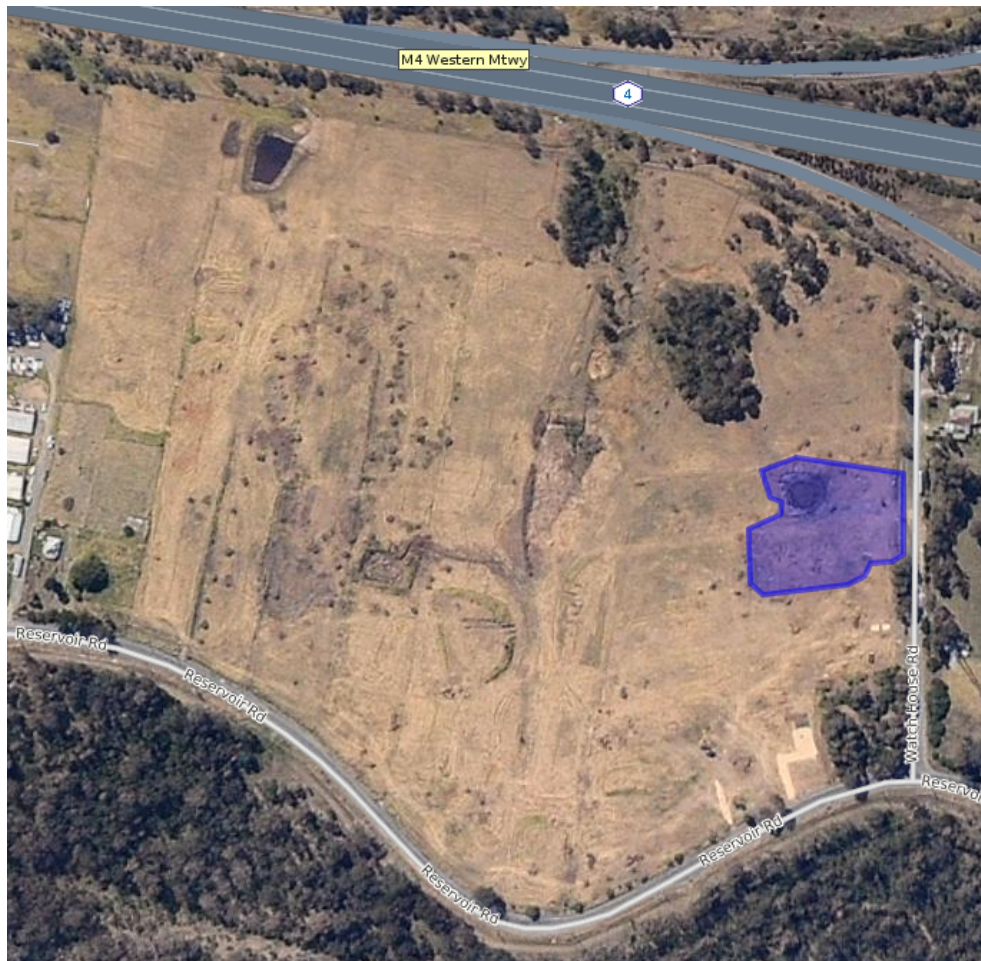
Figure 1 Contaminated Area Identified by ASET Adjacent to the Eastern Boundary

Following the observation of visible friable asbestos on the surface, ASET collected and analysed for asbestos, 401 surface soil samples on a grid pattern (grid spacing was reportedly 3-5m). The assessment found that the majority of the approximately 1Ha area is contaminated with friable (fibrous asbestos) and bonded asbestos.

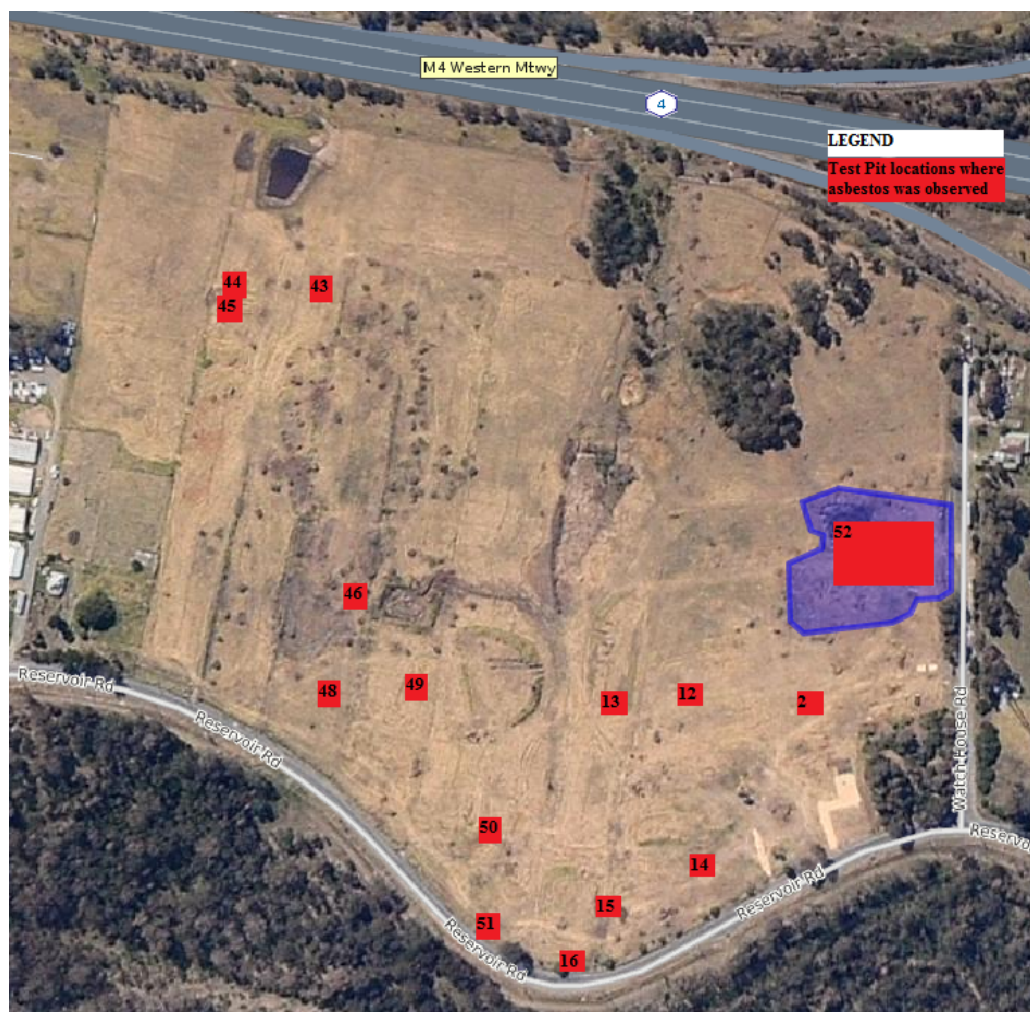
Figure 2 Visible ACM Observed by ASET Across The Site (ASET, 2012)

ASET observed 51 test pits excavated across the site for the presence of visible asbestos or asbestos containing materials (ACM). The pits were not excavated in any apparent grid pattern, and the rationale for the number of test pits and the test pit locations is unknown.

The results were reported in a letter report, which is attached in Appendix D. The ASET letter report indicated that visible ACM was observed in fifteen out of the 51 test pits excavated across the site. The locations where visible ACM was reported are shown in **Figure 2** below.

ASET also recommended further investigations to assess the extent of asbestos contamination, and the removal of identified friable asbestos as a priority, prior to removing the identified bonded asbestos.

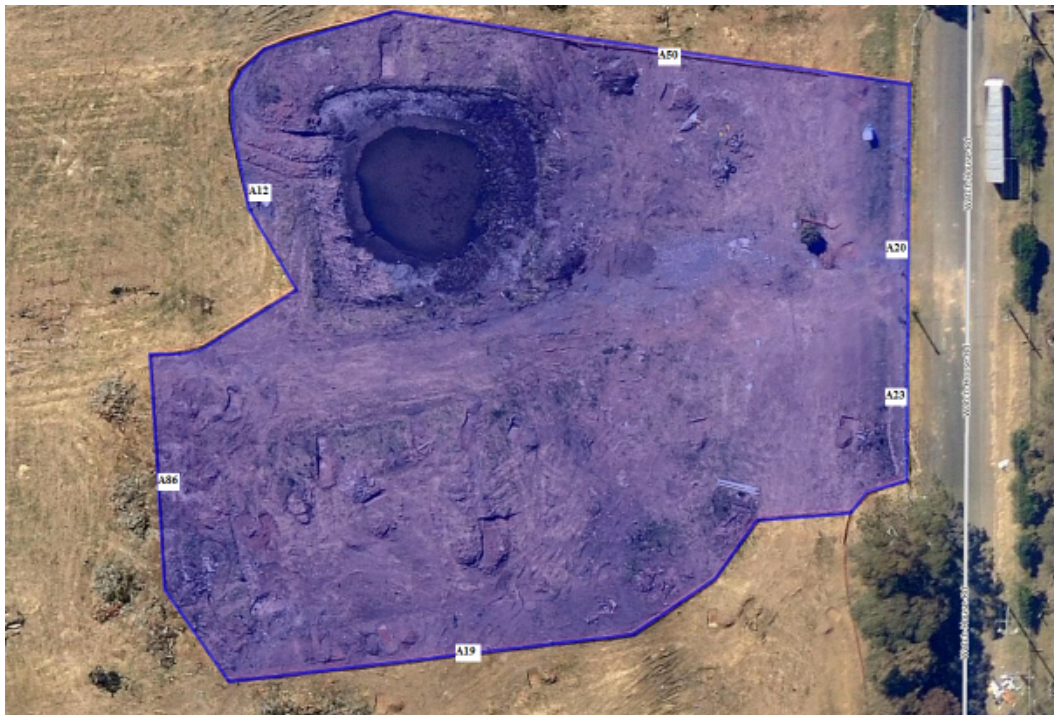
Figure 3 ASET's Air Monitoring Locations

The results of the air monitoring indicated that the fibre concentrations (total fibres – not necessarily asbestos only) were below the acceptable limits. The results are attached in Appendix E.

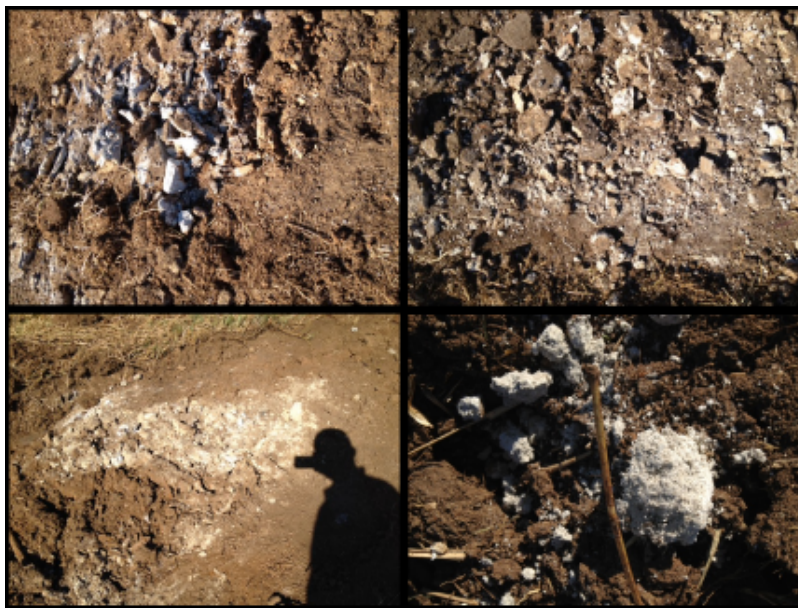
Figure 4 Form and Nature of Asbestos Identified Beneath the Grass

- **Figure 4** in Section 6.4.5 for photographs of this friable asbestos;
- Exploratory works by WEM found further friable asbestos contaminated areas, predominantly in the southern portion of the site. These areas were cordoned off and SLR Consulting was notified in accordance with the *Unexpected Finds Protocol* prepared for the site (SLR Consulting, 2012a). The *Unexpected Finds Protocol* is attached in Appendix G;

- **Figure 4** below for photographs of this friable asbestos.

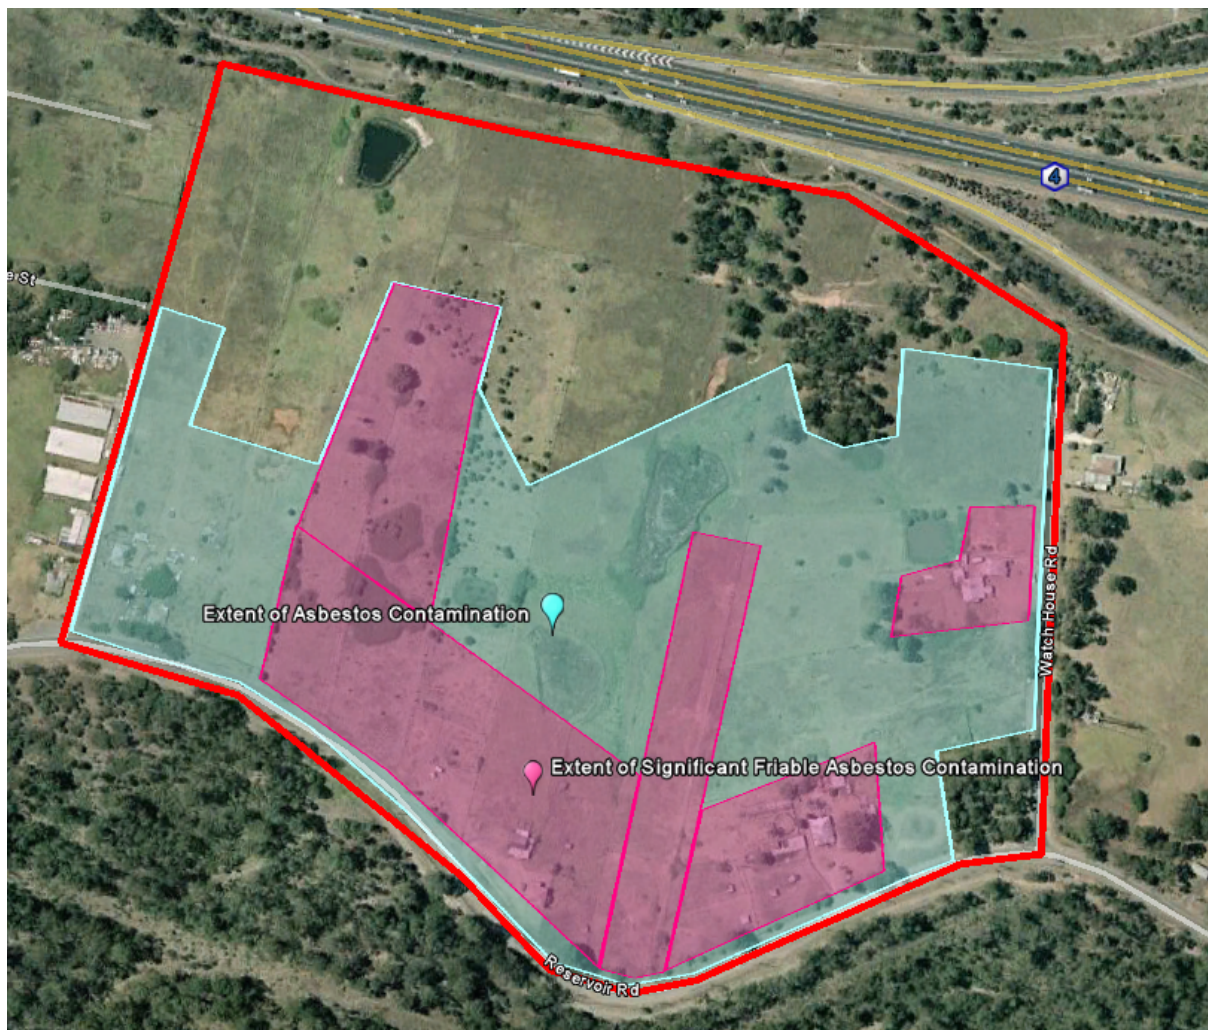
Figure 5 Identified Outer Extent of Patchy Asbestos Contamination

- Assessment and testing by ASET and SLR Consulting identified asbestos contamination present in isolated patches (typically 2m to 3m diameter) across a significant portion of the 25Ha site.. The lateral extent of contamination identified to date is shown on Figure 5 (in Section 6.4.5). Given that the contamination is generally present in isolated, small patches (less than 5m² each), it is impractical to map each such isolated patch of contamination that has been observed;

The areas where asbestos was identified were progressively mapped. The outer extent of identified patchy contamination (including that identified by ASET, SLR test pits, general observations and grass stripping exploratory works) is illustrated below on Figure 5.

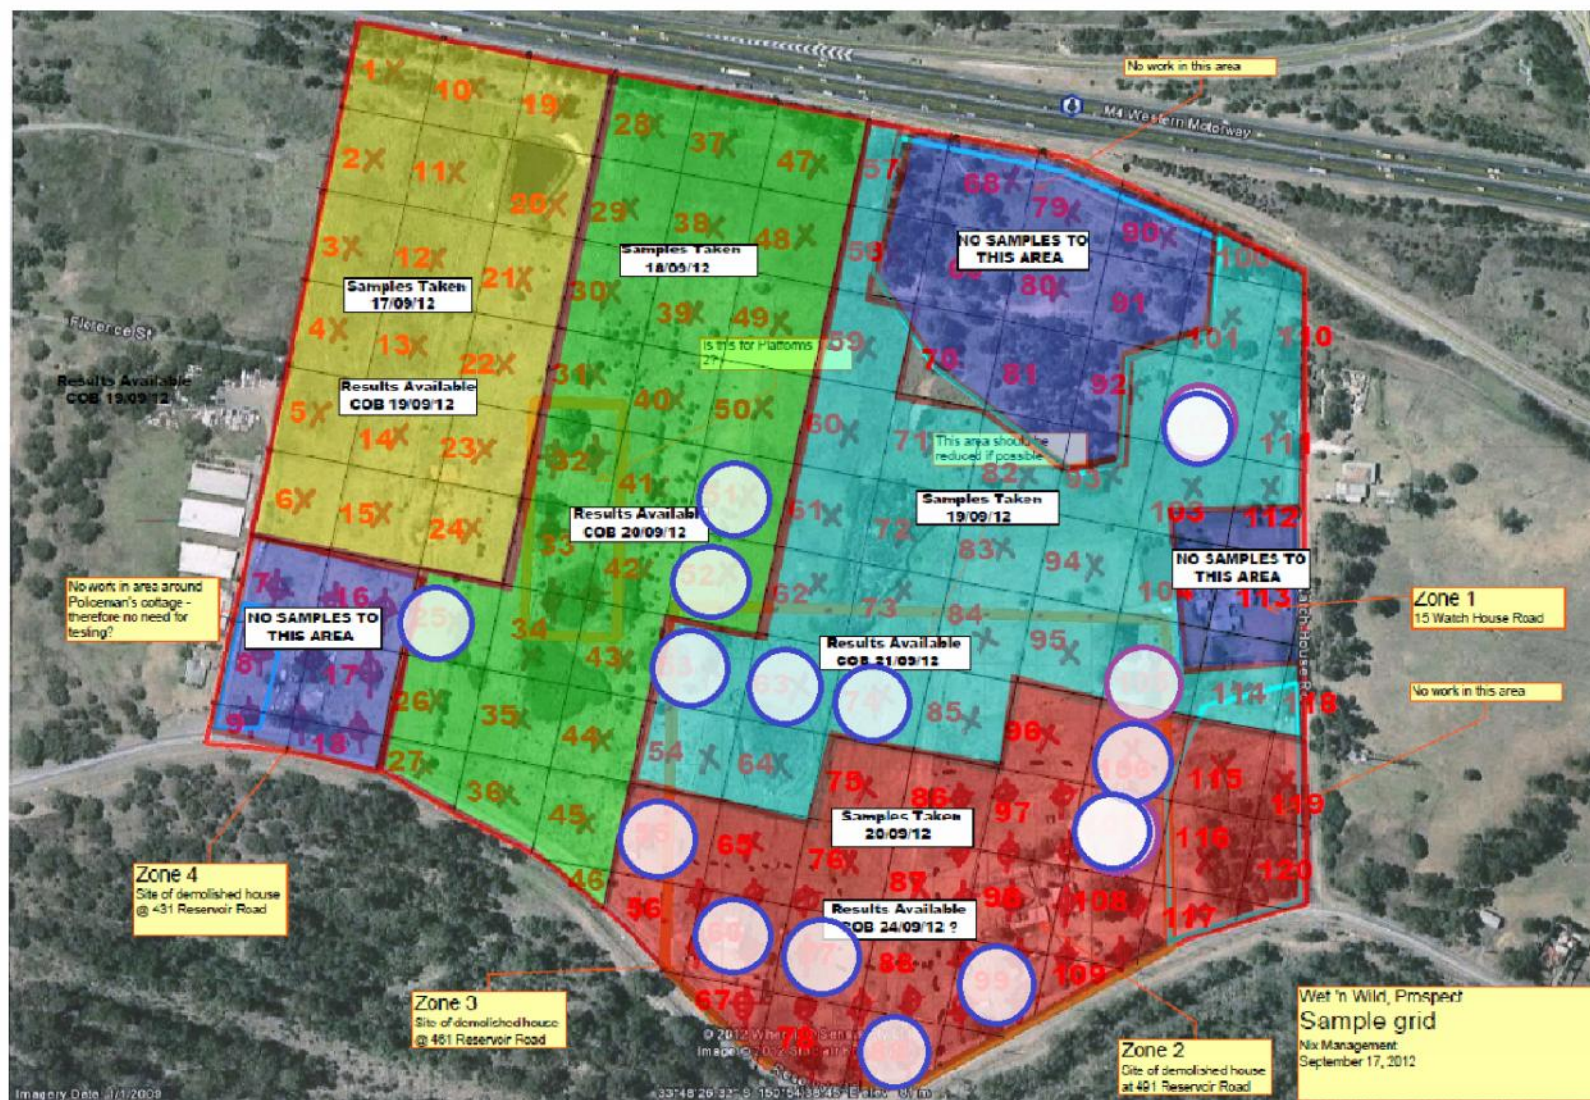
Asbestos Reported in SLR Test Pits

- 47 X Test Pit Locations on a 50m Grid
- 89 Test Pit Locations on a 30m Grid
- Colours indicate staging (dates) of the sampling work
- ACM Observed in test pit
- Asbestos detected in samples

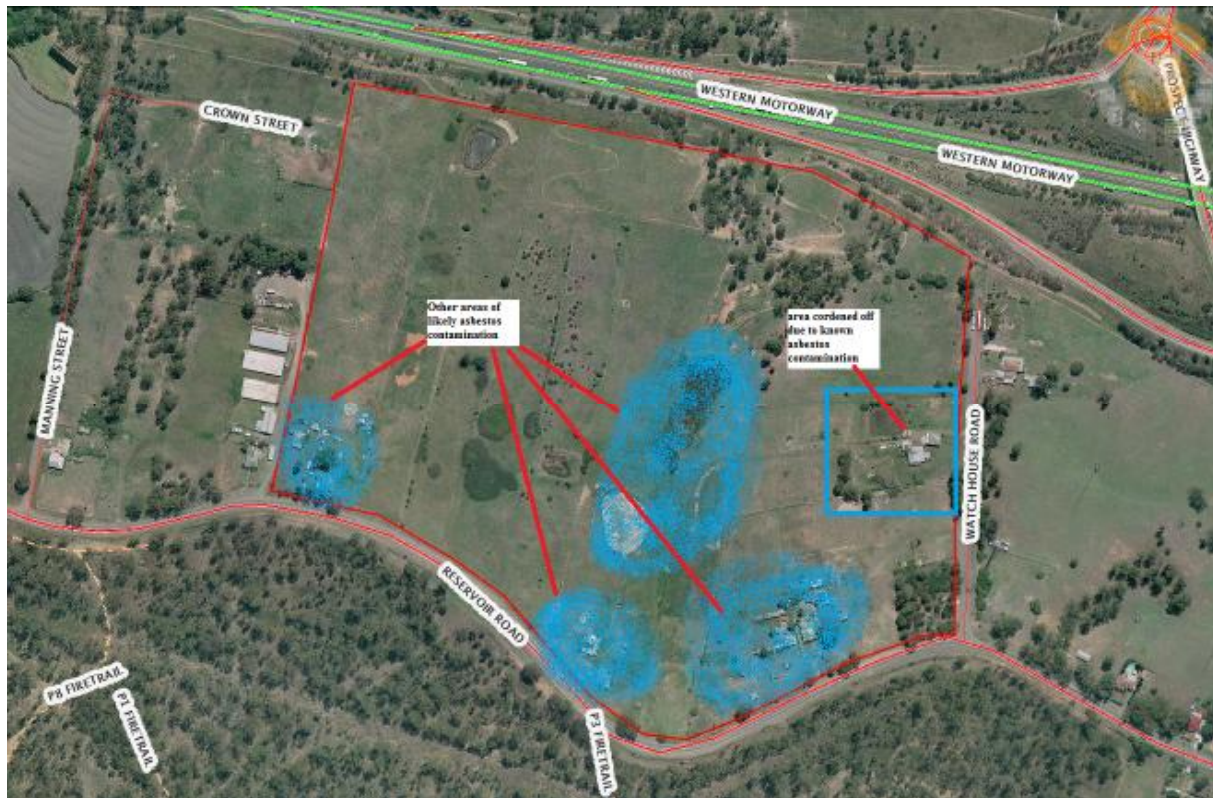
Figure 2 Areas of known and likely asbestos contamination

A number of areas have been cordoned off due to identified asbestos contamination. The main cordoned off area is shown on Figure 2 below.
