ARBORICULTURAL ASSESSMENT AND DEVELOPMENT IMPACT REPORT

FORMER RACHEL FORSTER HOSPITAL SITE
134-144 PITT STREET
REDFERN

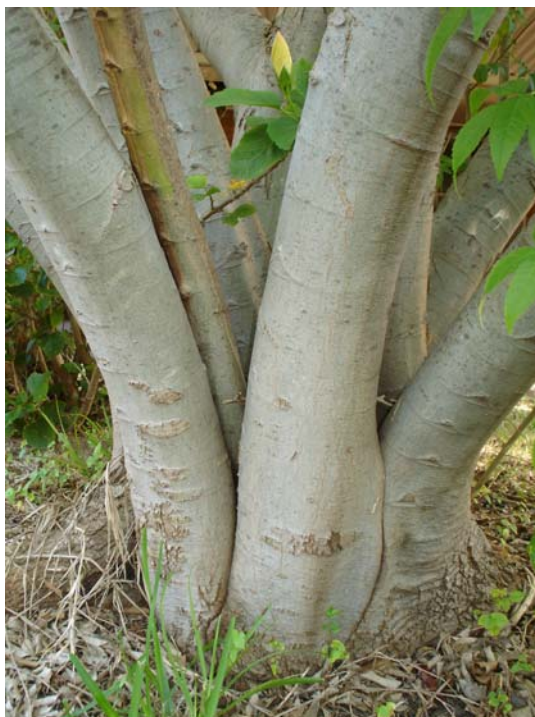
Tree No.	Genus, species and Common Name	Maturity and Dimensions	Health and vigour	Comments
1	<i>Celtis sinense</i> (Chinese Hackberry)	A mature, multi trunked specimen approximately 11 metres high with a canopy spread of 10 metres and DBH of 85 to 165mm	Good health, fair vigour	The tree displays signs of instability with multiple trunks from ground level and with evidence of poor attachment at the trunk junctions (included bark in junctions) - the junctions of the trunks are weak points in the tree's structure with increased risk of failure. Numerous structural roots from the tree are exposed in the vicinity of the trunk. Of moderate landscape significance.
2	<i>Ligustrum sinense</i> (Small-leaved Privet)	A mature, multi trunked specimen approximately 5 metres high with a canopy spread of 4 metres and DBH up to 50mm	Good health, fair vigour	The tree has been incorrectly pruned ('lopped') at 1.3 metres - the resulting regrowth is poorly attached with increased risk of failure. This species is an environmental weed - removal and replacement recommended. An environmental pest species.

Photograph 1: Tree # 1 – illustrating the multiple trunks from near ground level with evidence of poor attachment.

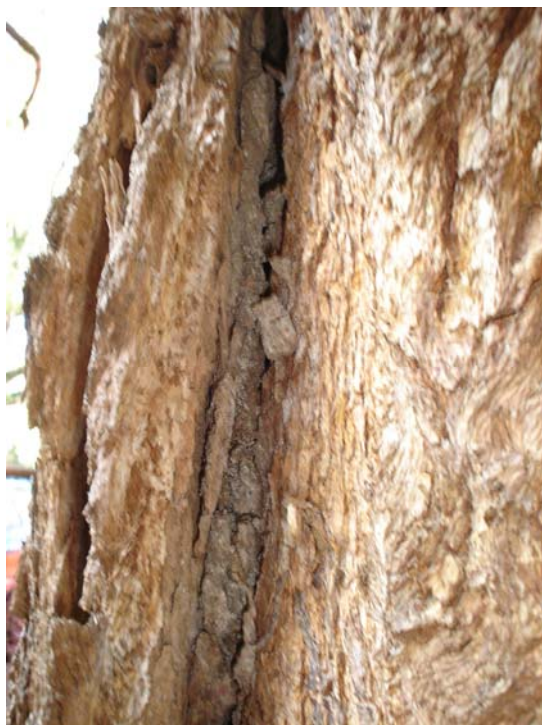
Tree No.	Genus, species and Common Name	Maturity and Dimensions	Health and vigour	Comments
3	<i>Lophostemon confertus</i> (Brushbox)	A mature, single trunked specimen approximately 18 metres high with a canopy spread of 11 metres and a DBH of 635mm (averaged from 580 x 740mm).	Good health, fair vigour	At the time of inspection the tree exhibited low to moderate levels of dieback. The tree displays signs of instability with 2 codominant trunks from 2.3 metres - while appearing sound at the time of inspection the junction of the trunks is a weak point in the tree's structure with increased risk of failure. In addition there is evidence of past termite activity in the tree with termite leads (mudding) in the tree's lower trunk bark - the presence of reaction wood in the lower trunk indicated there may be internal damage in the trunk, possibly from the past termite activity - it is recommended further testing such as Picus Sonic Tomograph® or Resistograph® testing be undertaken to provide an accurate assessment of the tree's structural integrity. This further testing should be undertaken at the project application stage. Of high Landscape significance.

Photograph 2: Tree # 3 – illustrating the termite leads/mudding in the lower trunk bark.

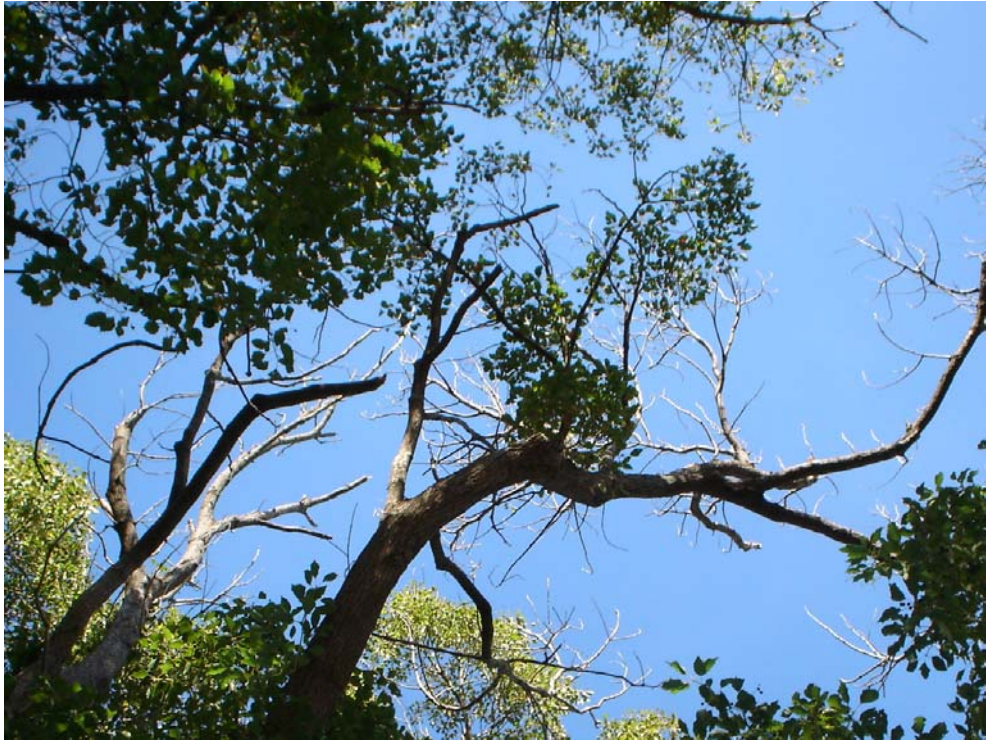
Photograph 3: Tree # 5 – Illustrating the very high levels of dieback in the upper canopy.

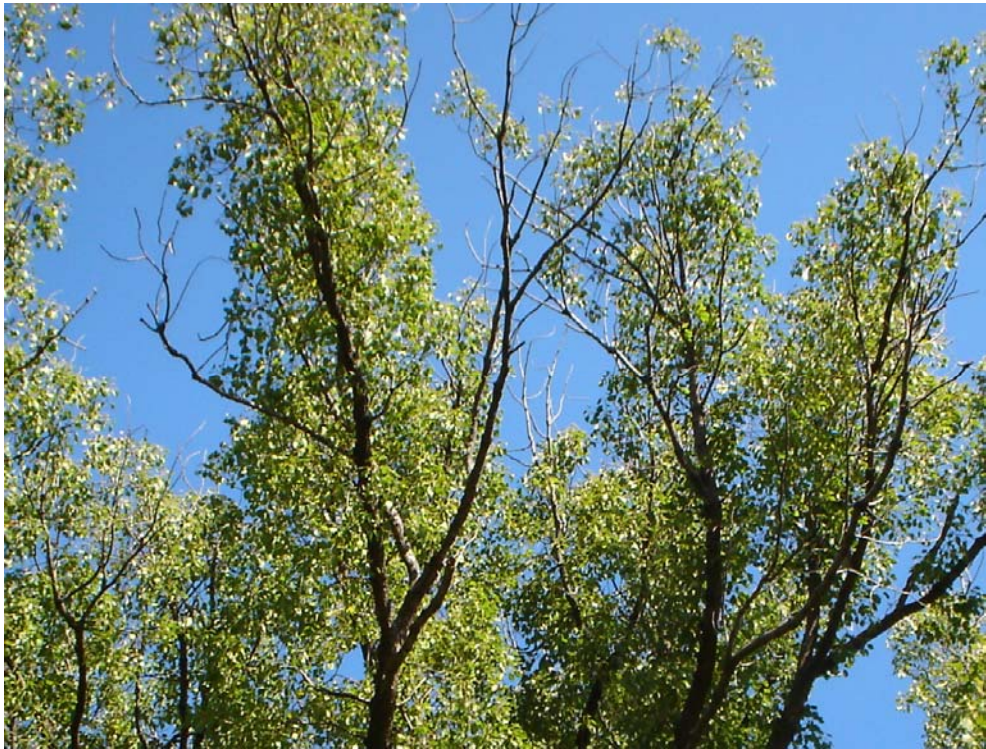
Tree No.	Genus, species and Common Name	Maturity and Dimensions	Health and vigour	Comments
6	<i>Cinnamomum camphora</i> (Camphor laurel)	An over mature, multi trunked specimen approximately 16 metres high with a canopy spread of 19 x 16 metres and DBH of 460, 540, 610, 670 and 850mm.	Moderate health, poor vigour	The tree displays signs of instability with multiple trunks from approx 1 metre and evidence of included bark in the junctions. There is a seedling <i>Ficus sp.</i> (Fig) and seedling <i>Exocarpos cupressiformis</i> (Native Cherry) growing in a trunk junction on the NE and SW sides at approx 1 metre indicative of deep inclusion. There is a hollow in a trunk at 3 metres on the western side that requires further investigation to determine structural integrity. At the time of inspection the tree exhibited high levels of dieback and very high levels of epicormic growth indicative of decline. The tree is in the initial stages of decline with a short predicted SULE (5 to 15 years). Significant in the landscape.

Photograph 4: Tree # 6 – illustrating the high levels of dieback and very high levels of epicormic growth.

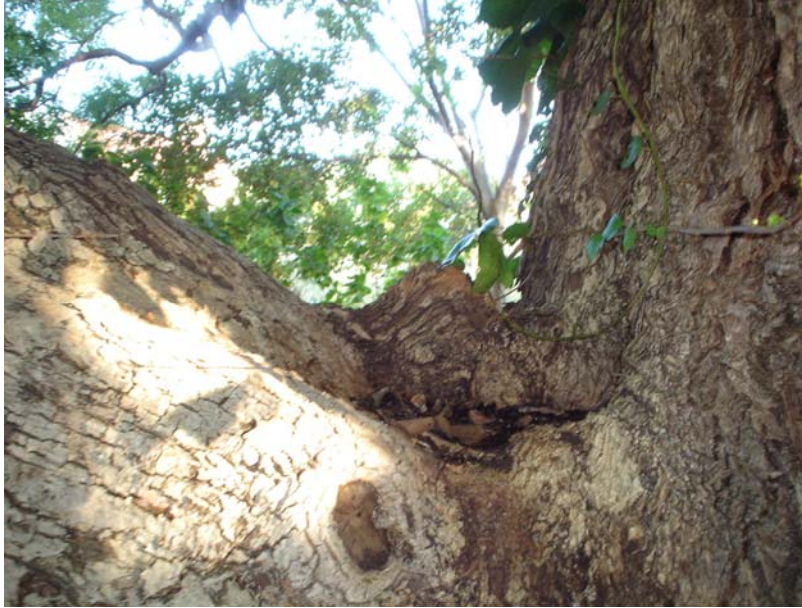
14	<i>Jacaranda mimosifolia</i> (Jacaranda)	A mature to over mature, single trunked specimen approximately 12 metres high with a canopy spread of 16 metres and a DBH of 890mm (averaged from 840 x 940mm).	Good health, fair vigour	The tree displays signs of instability with codominant trunks from 1.4 metres with potential for decay in an upward facing depression on the top side of the junction - while appearing sound at the time of inspection the junctions of the trunks is a weak point in the tree's structure with increased risk of failure - recommended the junction be monitored to check structural integrity if a future proposal was to provide for retention of this tree. Pruning stubs need to be investigated for potential decay. There is a split hazard beam at approx 8.5 metres on the south side of the canopy that requires removal. A number of self sown <i>Celtis sinense</i> growing in close proximity to the tree require removal. Of high Landscape significance to significant in the landscape.

Photograph 5: Tree # 14 – illustrating the crotch in the trunk junction at 1.4 metres on the north side with potential for decay.

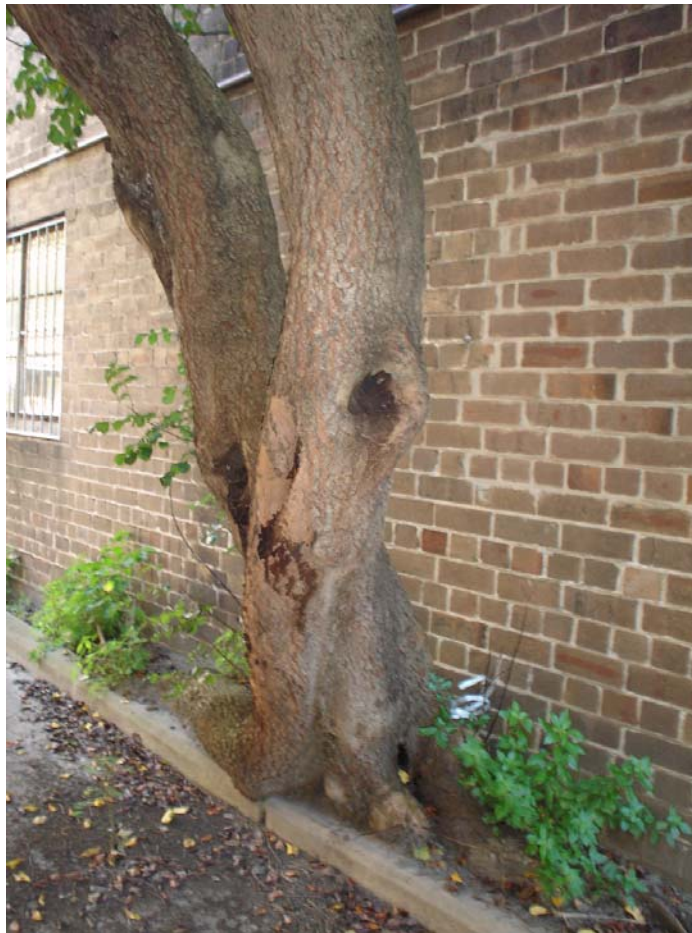
16	<i>Ceratonia siliqua</i> (Carob Tree)	The tree displays signs of instability due to its location - the tree is growing in a narrow planter area approx 260mm wide between the driveway on the site and the building on the adjoining property which will have limited its root development on the west side.

Photograph 6: Tree # 16 – illustrating the limited planter area in which the tree is growing.
