**Preliminary Contaminated Land Assessment
Sydney Heritage Fleet
Pyrmont, NSW 2009**

Report Number 610.10676-R4R0

16 December 2011

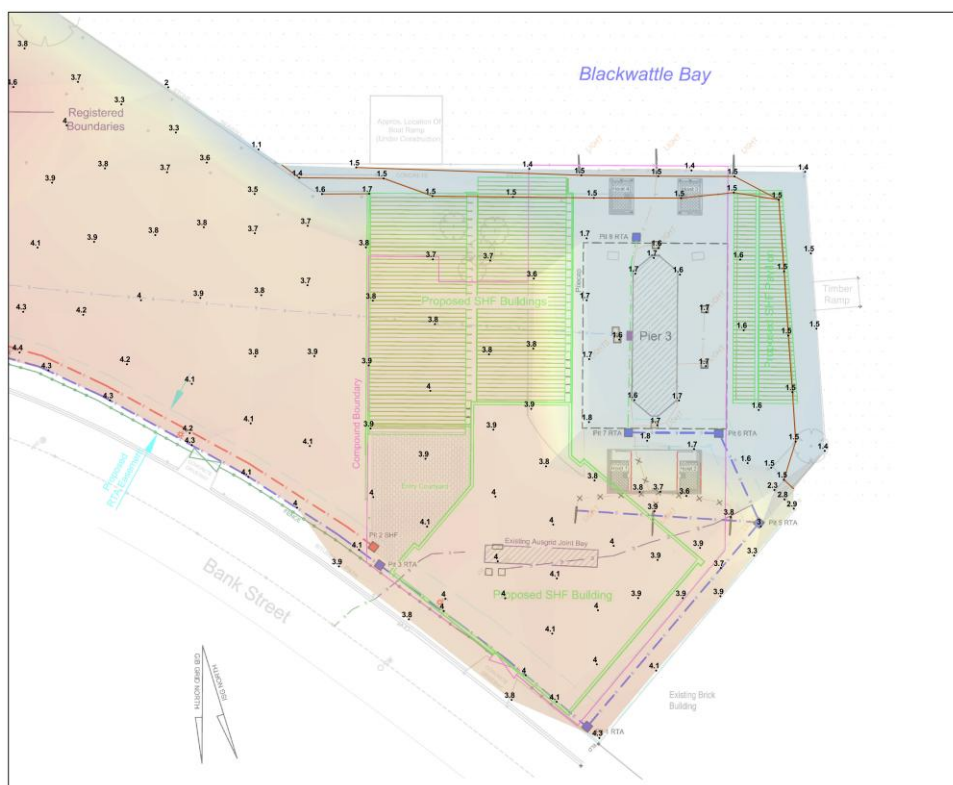
Figure 5 Site Topography

In the area of the site not disturbed by ongoing earthworks, the ground surfacing was seen to comprise sandy gravel. Inspection of the exposed soil materials in the new cut for the boat ramp, suggested that the fill in this area extended about 2m above the level of the new concrete wall. The fill exposed mainly comprised sandy gravel of sandstone, concrete and some brick with some cobbles of similar composition and was consistent with reprocessed demolition materials.
