# **DEVELOPMENT IMPACT ASSESSMENT REPORT**

## **PROPOSED COMMERCIAL DEVELOPMENT CRONULLA SUTHERLAND LEAGUES CLUB CAPTAIN COOK DRIVE, WOOLLOOWARE**

**January 2013**

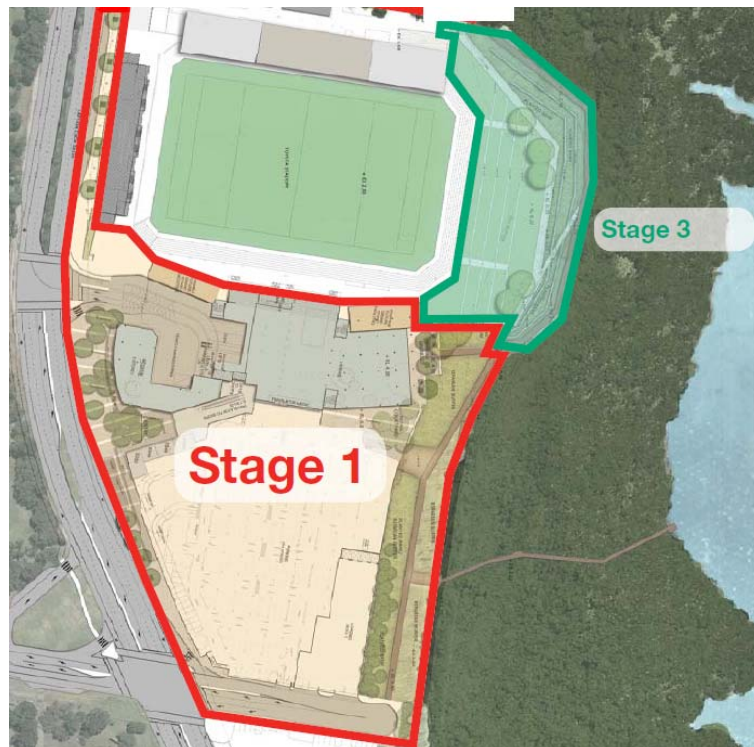
**Figure 1** – Showing the Stage 1 area of the proposed development.

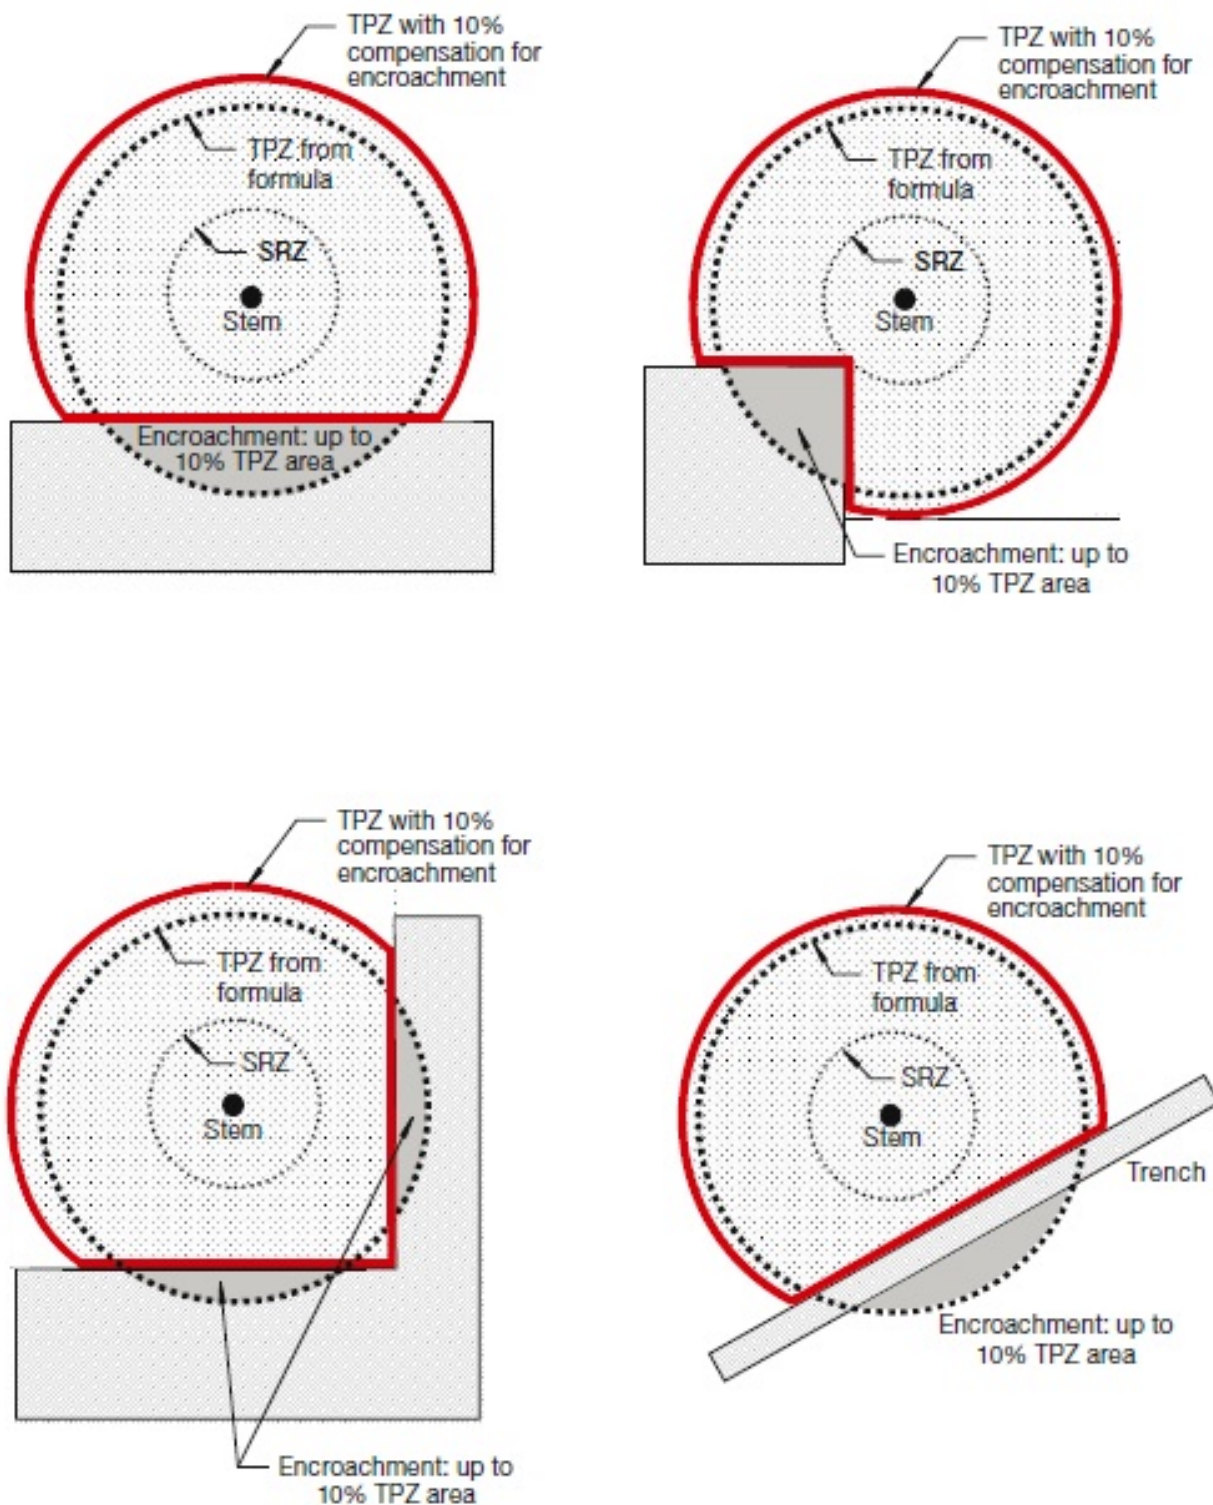
### APPENDIX 3 – ACCEPTABLE INCURSIONS TO THE TREE PROTECTION ZONE (TPZ)

NOTE: Less than 10% TPZ area and outside SRZ. Any loss of TPZ compensated for elsewhere.
