**Appendix H – Register of Asbestos Materials
Coffey Environments**

**Register of Asbestos Materials
Report
Caritas/ O'Brien Project
Cnr Forbes St and Burton St
DARLINGHURST NSW 2010**

Report Date: 23.8.06
Project Reference: ENVISYDN00113AA

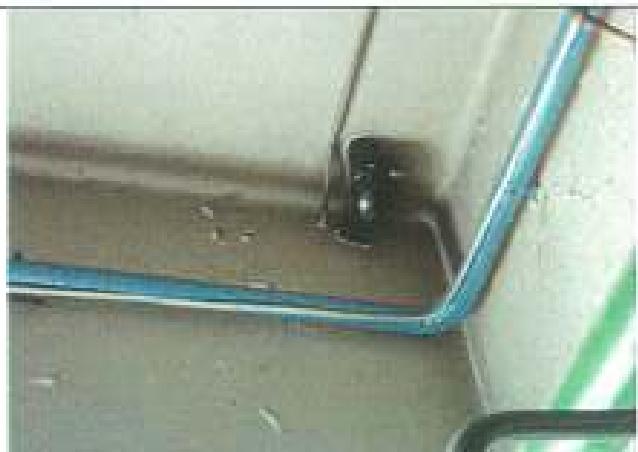
Photograph 1: Lagged pipes, Basement Plant Room Outpatients Building

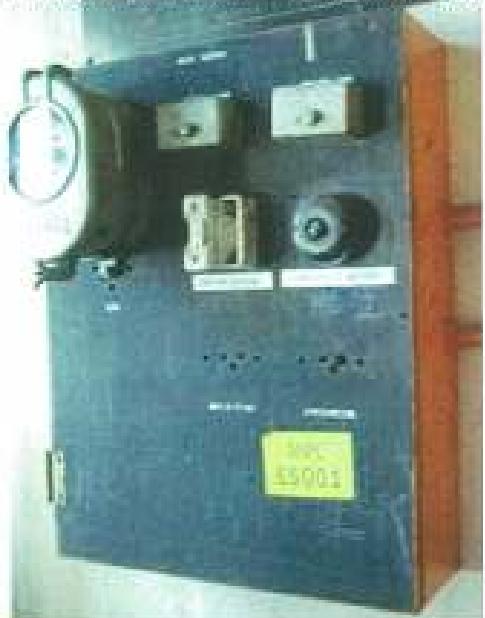
Photograph 2: Electrical switchboard backing, Plant Room, Outpatients Building

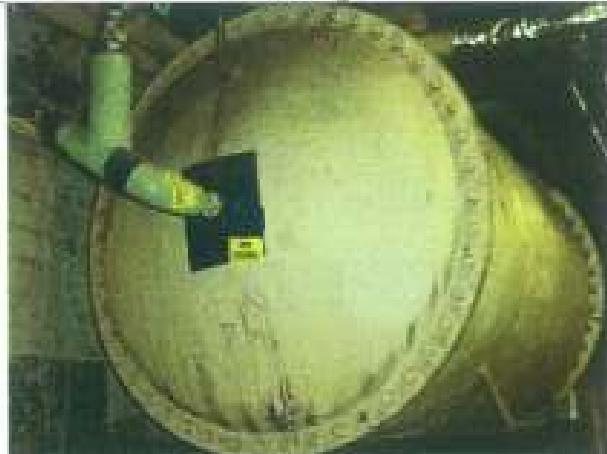
Photograph 3: Storage Container, Basement Plant Room, Outpatients Building

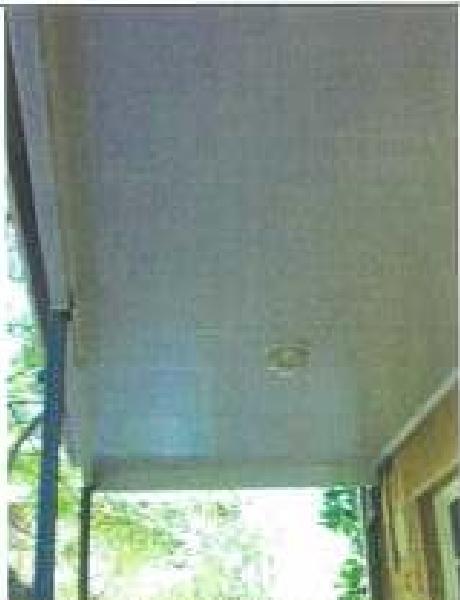
Photograph 4: Veranda Ceiling, Outpatients Building

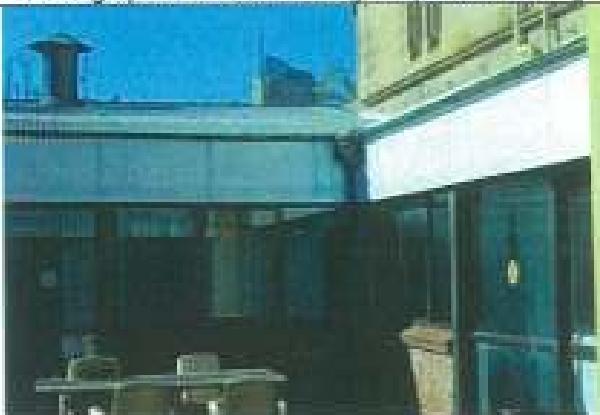
Photograph 5: Cement sheeting on external wall/ Fascia, Courtyard, Outpatients Building

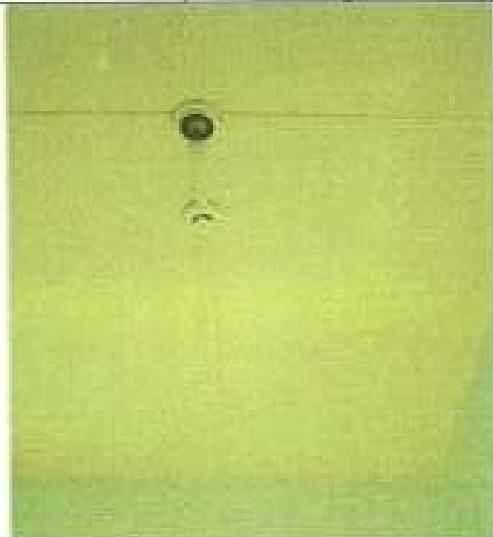
Photograph 6: Ceiling of Toilet, Outpatients Building

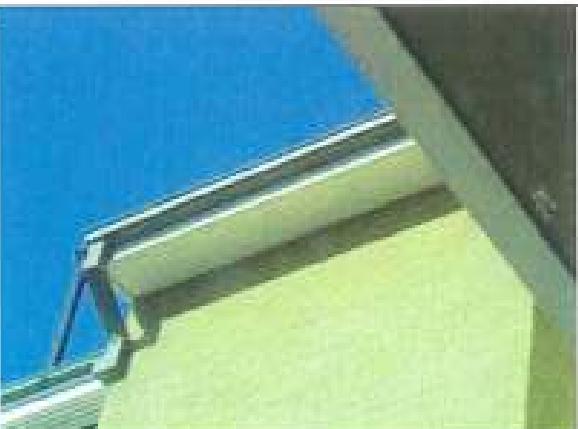
Photograph 7: Fibrocement sheeting, eaves, Outpatients Building

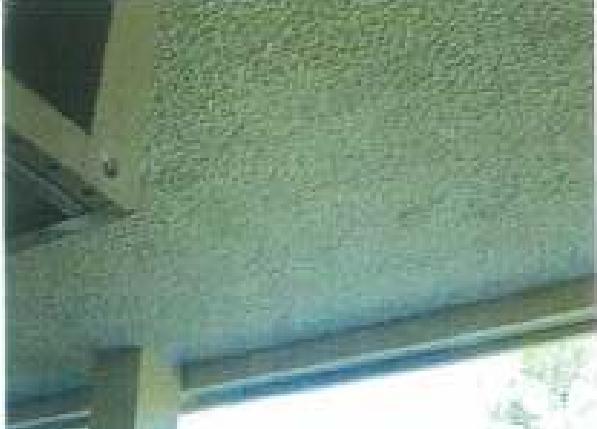
Attention is drawn to the sprayed insulating material on the second floor veranda ceiling of the inpatients building which is friable and assumed to contain asbestos. Not all sprayed insulating material contains asbestos. Coffey recommend the material be sampled and analysed for asbestos fibres. The building material should be managed as an asbestos containing material until sampling and analysis is undertaken.

Photograph 8: Sprayed insulating material, second floor veranda ceiling, Inpatients Building

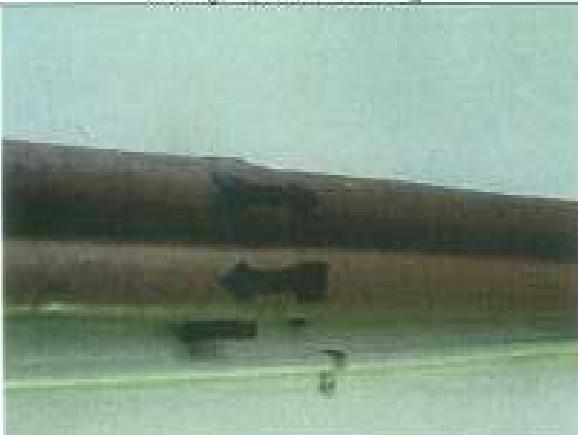
Photograph 9: Lagged pipes, Basement Service Tunnels Plant Pump Room, Inpatients Building.
