## St Vincent's Hospital, Caritas Site Ancillary Report

- Perimeter Walls and Fencing
- Rear Ablutions and Storage Block
- Old Kitchen Facility

299 Forbes Street, Darlinghurst

Considerations on Particular Heritage Items:  
To be read in context with Heritage Impact  
Statement for the same Site

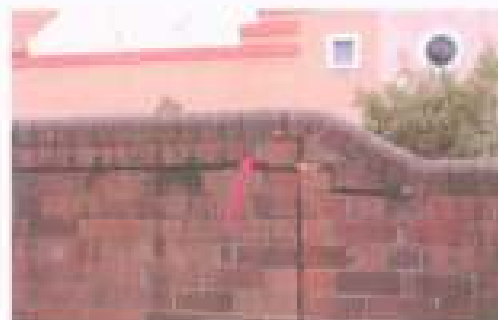
Figure 18:  
The state of repair on the perimeter wall is at some points quite poor and sections built on the support further additions over time.  
(Source: Graham Brooks & Associates, July 2006)

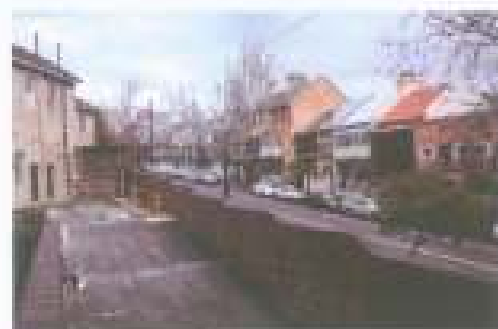
Figure 21:  
View of the Bourke Street (rear) of the brick wall from inside the property. Note the up-lamp. It appears that there has been substantial fill along the portion of the property.  
(Source: Graham Brooks & Associates, July 2006)

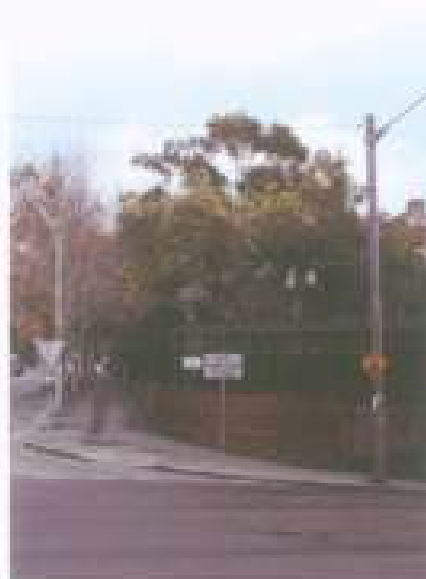
Figure 27:  
View at the intersection of Burton and Forbes Streets. It would appear that the older fencing foundations were demolished to make way for the portion of the site in the mid-1990s.  
(Source: Graham Brooks & Associates, July 2008)

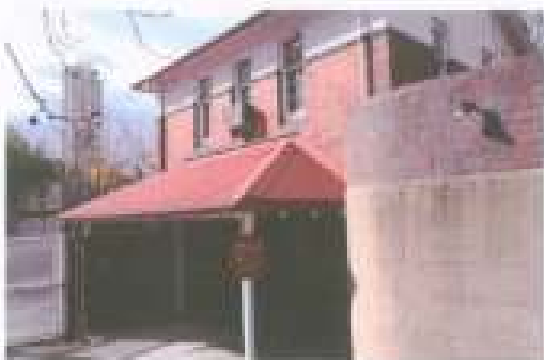
Figure 53:  
View of the west facade and adjacent existing wall and compound. The building would have originally been freestanding at this level unencumbered by the southwest wall and retaining walls.  
(Source: Graham Brooks & Associates, July 2006)

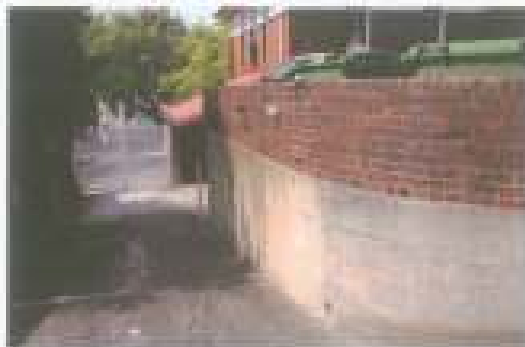
**Figure 60**  
The alleyway down to Butler Street, looking north, with the retaining wall to the right. The wall is in poor condition  
(Source: Graham Brooks & Associates, July 2006)

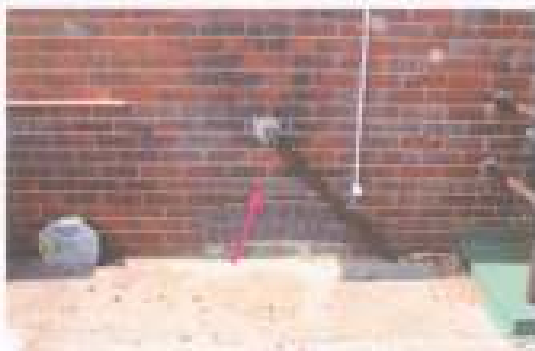
**Figure 61**  
Example of the way in which land 1000 has covered most of the south side of the first floor of the old kitchen facility. Future workers are indicated by the arrow  
(Source: Graham Brooks & Associates, July 2006)
