**GEOTECHNICAL ASSESSMENT**

**PROPOSED MIXED USE DEVELOPMENT**

**KIRRAWEE BRICK PIT SITE  
566-594 PRINCES HIGHWAY KIRRAWEE**

**Date: October 2010**

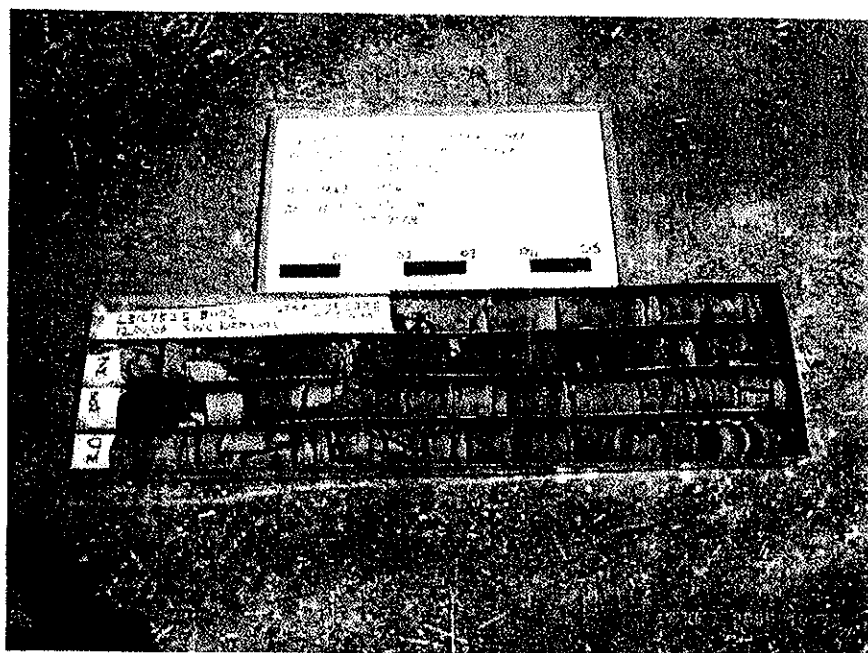
BH2: 6.4 - 10.0 m

METHOD RUN	TESTING	WEATHERING	STRENGTH	RQD (%)	DEFECT SPACING (mm)	DEPTH (m)	DEFECT DESCRIPTION	GRAPHIC LOG	DESCRIPTION OF STRATA	GEOLOGICAL DESCRIPTION
Augering 6.4						0			Terminate augering at @ 6.4m, start coring	
Coring 100% CR 100% CR 100% CR 100% CR 100% CR 100% CR 100% CR 100% CR 100% CR 100% CR		XW				6.56-6.89	JN 10-50° St, S, Clay 1mm, Rf 20mm		SHALE: Extremely Low-Very Low strength, Extremely weathered-Distinctly weathered dark brownish grey, thinly laminated, poorly developed to massive bedding, fractured, occasional siltstone laminations	SHALE
		DW				6.89-7.00	2x BP 0° Pl, S-Sr, Rf & Clay 1-7mm			
		XW				7.00-7.11	3x BP 0° Pl, Sr, KL<1mm			
		DW				7.11-7.12	4x BP 0-10° Pl, Sr, Clay 5mm

7.80-7.87	7x BP 0-10° Pl, S-Sr, Rf & Clay 70mm			
						7.87-8.00	3x Drill breaks		SHALE: Very Low-Low strength, Distinctly weathered, dark grey, thinly laminated, poorly developed bedding, fragmented to fractured	SHALE

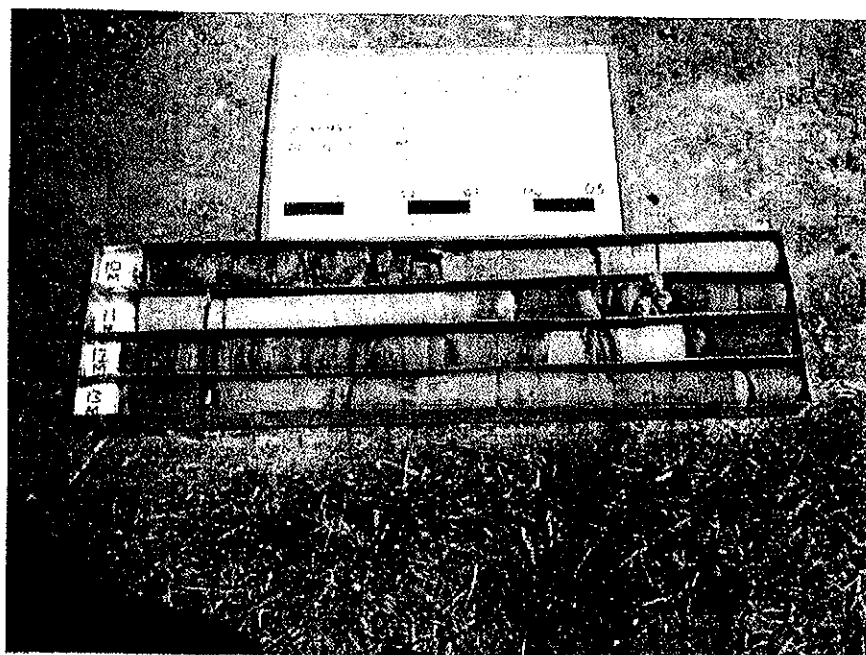
BH2: 10.0 - 14.0 m

8.96-9.30	JN 80° Pl-Wa, S, KL<1mm			
						9.30-9.31	11x DI fractures 0° Pl, S, KL<1mm			
						9.31-9.53	3x BP 0-10° Pl-Ir, S-Sr, Rf & Clay 5-40mm		SILTSTONE: Low strength, Distinctly weathered, light to mid grey, poorly developed to massive bedding, slightly fractured, grading into Sandstone with depth	SILTSTONE

9.53-9.65	JN 65° Pl, S, KL<1mm			
						9.65-9.74	JN 65° Pl, S, KL<1mm			
						9.74-9.81	JN 75° Ir, Sr, KL<1mm			
						9.81-9.89	5° DI fractures 0-5°, Pl, S, KL<1mm

9.89-9.91	5° DI fractures 0-90°, Ir, Sr, R Clay 70mm			
						9.91-9.99	JN 0-20° Pl-St, Sr, Rf 12mm			
						9.99-10.00	2° DI fractures 0-5°, Pl, S, KL<1mm

10.00-10.48	Fz 0-90°, Ir, Sr-R, Rf 480mm			
						10.48-10.70	BP 0° Pl, S, R Clay 20mm			
						10.70-11.00	4° DI fractures 0-5°, Pl-Wa, S, KL<1mm

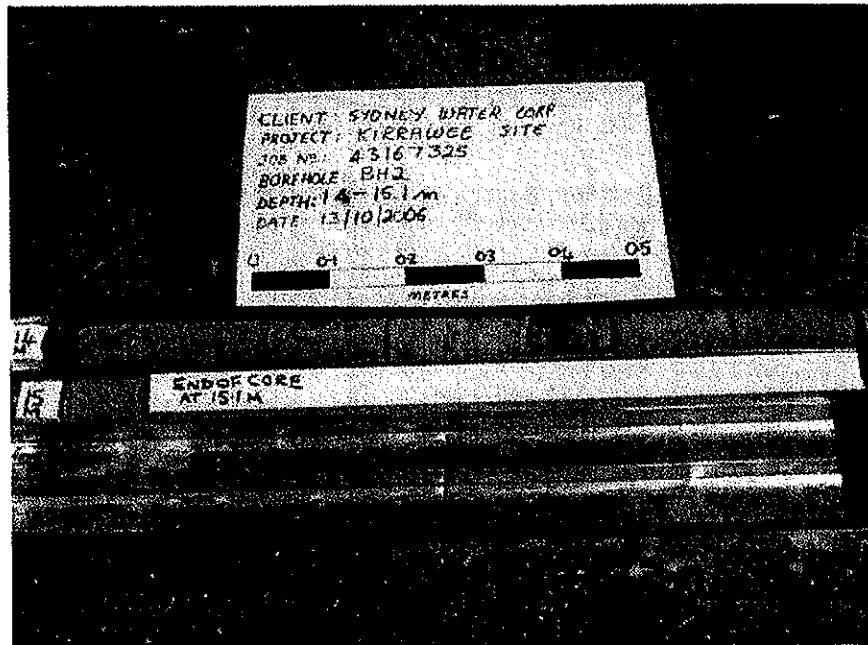
BH2: 14.0 15.1 m

METHOD	TESTING	WEATHERING	STRENGTH	RQD (%)	DEFECT SPACING (mm)	DEPTH (m)	DEFECT DESCRIPTION	GRAPHIC LOG	DESCRIPTION OF STRATA	GEOLOGICAL DESCRIPTION
Corelog	100% CR	100% CR	100% CR	100% CR	100% CR	11	11.00-11.41 4° DI fractures 0-5°, PI, S, KL <1mm			SANDSTONE
						12	BP 0° PI, Sr, R Clay 15mm JN 25° PI, Sr, KL <1mm 11.72-11.83 Cz, Ir, S-Sr, Rf 120mm BP 10° PI, S-Sr, R Clay 1mm 12.00-12.16 7° DI fractures 0-10°, PI, Wa S-Sr, KL <1mm		RL 85.35 SANDSTONE: Low-Medium strength, Distinctly weathered, grey, thinly laminated, poorly to well developed bedding, fine to medium grained, fractured to slightly fractured, with occasional Extremely Low, Extremely weathered bands, increasing grain size with depth	SANDSTONE
						13	12.48-13.00 2° DI fractures 0-7°, PI, S-Sr, KL <1mm 13.00-14.00 4° DI fractures 0-5°, PI, S-Sr, KL <1mm 13.11- 13.15 Dz 0°, PI, Sr, R Sand 40mm 13.32-13.35 Dz 5°, PI, Sr, R Sand 30mm		SANDSTONE: Low-Medium strength, Distinctly weathered-Slightly weathered, light gray, laminated to thinly laminated, massive bedding, medium grained, fractured to slightly fractured	SANDSTONE

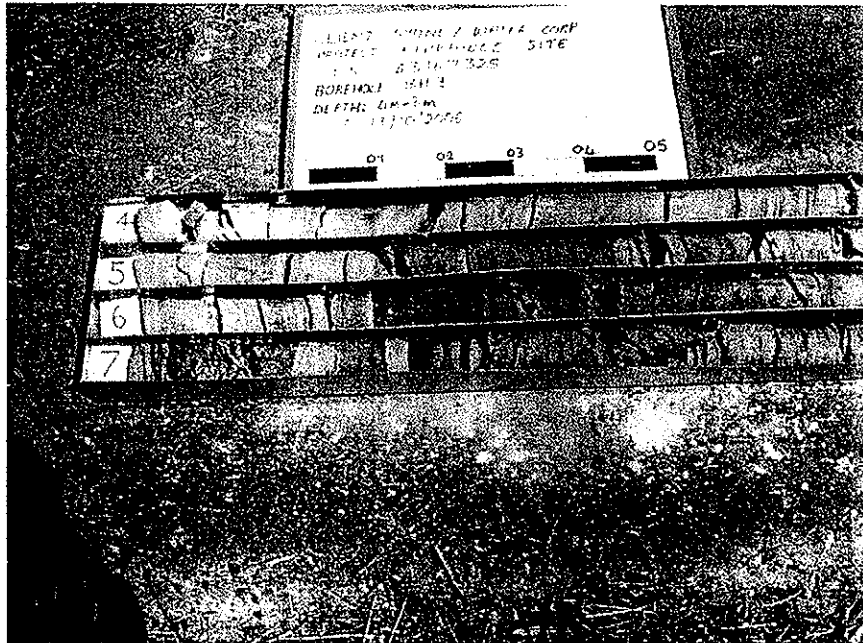
BH3: 4.0 – 8.0 m

METHOD	TESTING	WEATHERING	STRENGTH	RQD (%)	DEFECT SPACING (mm)	DEPTH (m)	DEFECT DESCRIPTION	GRAPHIC LOG	DESCRIPTION OF STRATA	GEOLOGICAL DESCRIPTION
Augering			EL VL M H EH	25 50 75	0-25 25-50 50-100 100-150 150-200 200-300	3				
4						4	4.07-4.1 2x BP 5° Pl, S, KL<1mm 4.14-4.43 2x BP 10° Pl-Ir, Sr, KL<1mm		Terminate augering at @ 4.0m, start coring	
		DW				5	4.80-4.94 2x BP 15° Pl-Ir, S-Sr, KL<1mm JN 90-95° Pl, S, KL<1mm		SHALE: Extremely Low to Very Low strength, Extremely weathered to Distinctly weathered, dark grey, poorly developed bedding	SHALE
		XW DW				6	DI fracture BP 10-20° Pl, Sr, KL<1mm JN 50° Ir, Sr, KL<1mm & BP 20° Pl, Sr, KL<1mm 5.35-5.72 3x BP 15° Pl, Sr, KL<1mm BP 15° Pl, Sr, Rf JN 50° Pl-Ir, Sr, KL<1mm 5.83-5.94 2x BP 15° Pl, S, KL<1mm JN 75° Ir, Sr, KL<1mm BP 20° Ir, Sr, KL<1mm 6.22-6.25 2x BP 15° Pl-Ir, Sr, KL<1mm JN 55° Pl, S, KL<1mm 6.60-6.66 2x BP 20° Pl-Ir, Sr, KL<1mm JN 40° Pl, S, KL<1mm		SHALE: Very Low- Low strength, Extremely weathered-Distinctly weathered, dark brown and grey/brown, thinly laminated, poorly to well developed bedding, fractured to highly fractured, with occasional Extremely Low strength, Extremely weathered bands CLAY: high plasticity, grey to dark grey with some rock fragments SHALE: Very Low- Low strength, Extremely weathered-Distinctly weathered, grey, poorly developed fabric, fractured to highly fractured, with occasional Very Low strength, Extremely weathered bands	SHALE CH SHALE

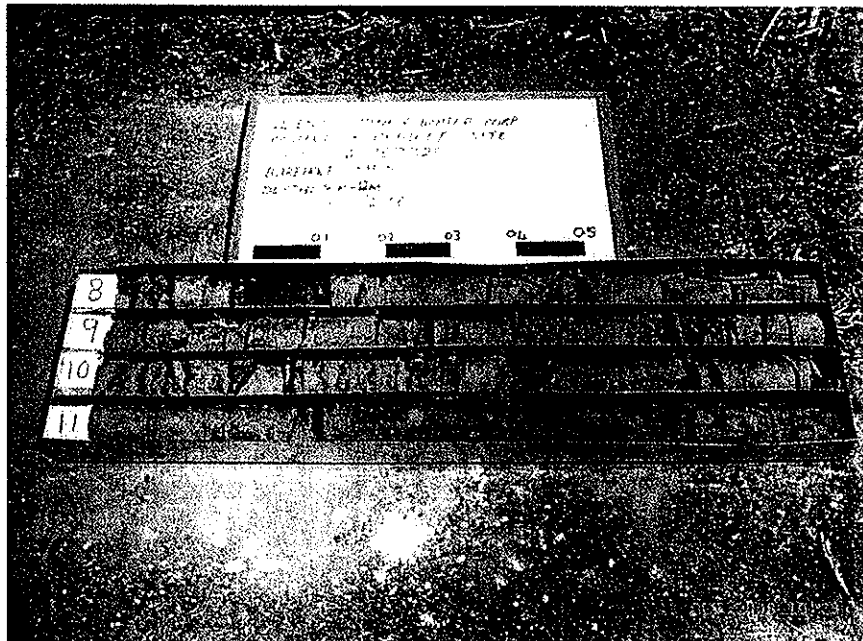
BH3: 8.0 – 12.0 m

METHOD	TESTING	WEATHERING	STRENGTH	RQD (%)	DEFECT SPACING (mm)	DEPTH (m)	DEFECT DESCRIPTION	GRAPHIC LOG	DESCRIPTION OF STRATA	GEOLOGICAL DESCRIPTION
RUN										
100% CR		SW				8	JN 50° Pl, S, KL<1mm BP 15° Pl, S, KL<1mm BP 20° Pl, S, KL<1mm  JN 45-50° Ir, Sr, KL<1mm 8.38-8.53 2x BP 5-10° Pl, S, KL<1mm JN 30° Pl, S, Rf 110mm JN 60° Pl, Sr, Rf to previous JN JN 85-90° Pl, S, KL<1mm BP 10° Pl-Wa, S, KL<1mm JN 60° Pl, S, KL<1mm		SHALE: Very Low- Low strength, Distinctly weathered-Slightly weathered, dark grey, brown, poorly developed fabric, fractured to highly fractured, with trace rock clay seams

9.97		DW				9	9.05-9.63 5x BP 10° Pl-Ir, S-Sr, KL<1mm JN 30° St, Sr-R, KL<1mm 9.17-9.94 5x BP 5° Plr, S, KL<1mm 9.47-9.59 Dz, R Clay 120mm  9.75-9.85 Cz 5°, Ir, R, 100mm			SHALE
						10	JN 50° Pl, Sr, Rf 10.04-10.12 5x BP 5° Pl, S-Sr, KL<1mm JN 30° Pl, S-Sr, KL<1mm JN 50° Pl, S-Sr, R Clay 20mm 10.24-10.35 6x BP 5° Pl-Ir, Sr, KL<1mm 10.35-10.39 Dz, R Clay 30mm 10.40-10.49 4x BP 5° Pl-Ir, S-Sr, KL<1mm 10.62-10.63 Dz, R Clay 10mm JN 55° Pl, S, Rf 30mm JN 50° Pl, S, KL<1mm 3x BP 0° Pl, S, KL<1mm		SHALE: Medium strength, Slightly weathered, dark grey, slightly fractured	
100% CR		SW				11	11.27-11.30 BP 5-10° Pl-Ir, S-Sr, KL<1mm BP 10° Pl, S-Sr, KL<1mm  JN 30° Pl-Wa, S-Sr, KL<1mm BP 15° Pl, S, KL<1mm JN 25° Pl-Ir, Sr, KL<1mm JN 80° Ir-St, Sr, KL<1mm BP 10° Ir, Sr-R, KL<1mm 12.10-12.19 Cz 20°, Ir, R, 90mm BP 15° Pl-Ir, Sr, KL<1mm		SHALE as above becoming Medium to High strength	SHALE

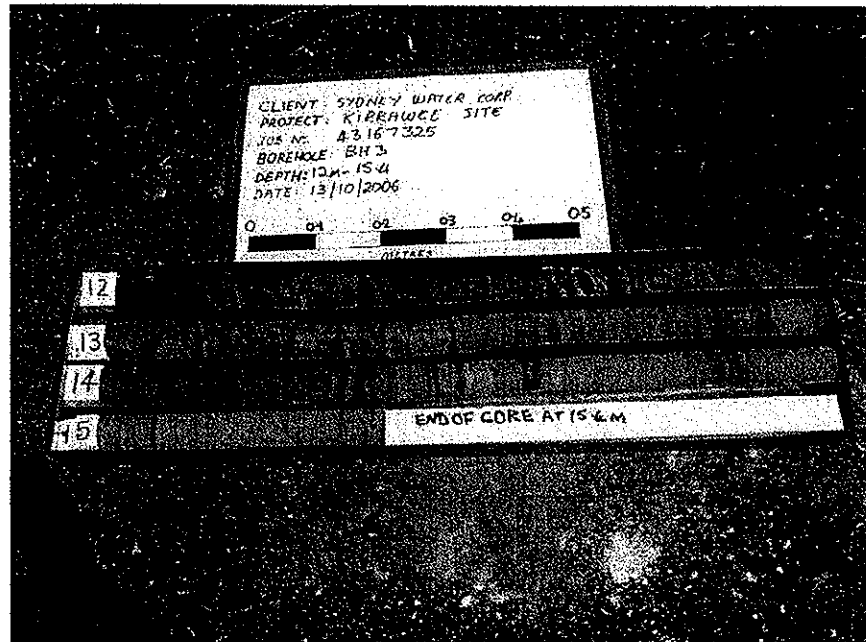
BH3: 12.0 – 15.4 m

12.35						12	12.62-12.67 Dz, R Clay 50mm			
						13	BP 15° Pl-Ir, Sr, drillers break JN 15° Pl, S, KL<1mm JN 10-15° Ir, Sr, KL<1mm BP 5° Ir, Sr-R, KL<1mm BP 25° Ir, R, KL<1mm BP 10° Plr, S, KL<1mm  BP 5° Pl-Ir, Sr, KL<1mm		SANDSTONE: High strength, Slightly weathered, light grey, yellow/brown, with shale interbeds, fine to medium grained, fractured to slightly fractured	SANDSTONE

METHOD	RUN	TESTING	WEATHERING	STRENGTH			RQD (%)	DEFECT SPACING (mm)	DEPTH (m)	DEFECT DESCRIPTION	GRAPHIC LOG	DESCRIPTION OF STRATA	GEOLOGICAL DESCRIPTION
				EL	M	BF							
Coring	100% CR	PL 14.32m D=2.51 A=1.22	SW						14	BP 5° PI-Ir, Sr, KL<1mm DI fracture BP 5° PI-Ir, Sr, KL<1mm		As above with shale interbeds, grey	SANDSTONE
		PL 14.8m D=2.30 A=2.87							15	BP 0° PI, S, KL<1mm 15.00-15.08 3x DI fractures 5° PI-Ir, Sr, KL<1mm		SANDSTONE: High strength, slightly weathered, yellow/brown, massive bedding, fine to medium grained, with trace bedding, slightly fractured	
									16			End of borehole @ 15.4m	
									17				
									18				
									19

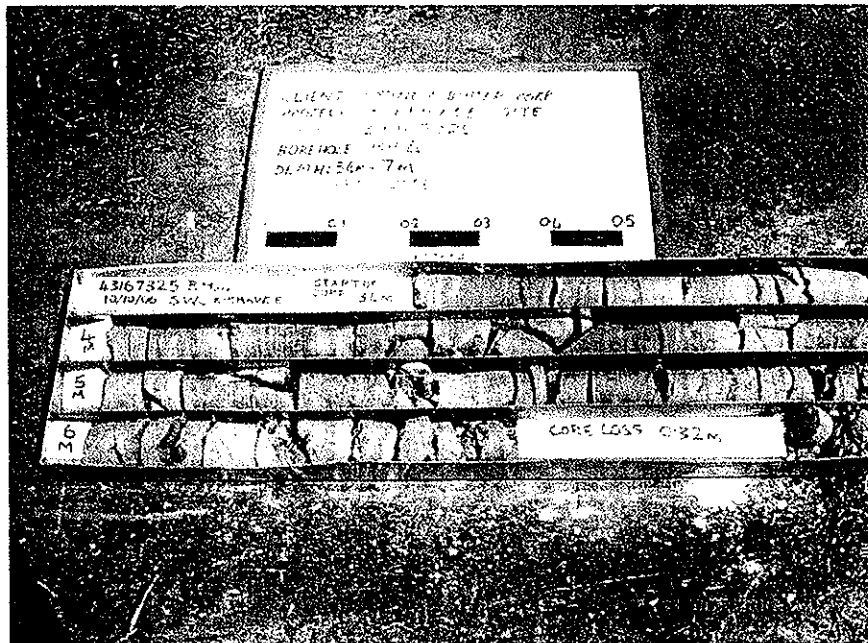
BH4: 3.4 – 7.0 m

METHOD RUN	TESTING	WEATHERING	STRENGTH	RQD (%)	DEFECT SPACING (mm)	DEPTH (m)	DEFECT DESCRIPTION	GRAPHIC LOG	DESCRIPTION OF STRATA	GEOLOGICAL DESCRIPTION
100% CR	6.35	XW	RS	75	6	6.24-6.28 Cz 0-90°, Ir, S-R, Rf 40mm BP 0° Pl-Wa, Sr-R, KL <1mm		SHALE as above	SHALE: Extremely Low strength, Extremely weathered, grey and dark grey, thinly laminated, poorly developed, fragmented to fractured with ironstaining in bedding planes	SHALE

6.52-6.84m	Core Loss		Core loss 6.52-6.84m	
		XW			7	6.84-7.05 Fz 0-90°, Ir, S-R, with Rf & Clay 210mm			SHALE as above	
						7.14-7.31 BP 0° Pl, Sr-R, Rf & Clay 1-3mm BP 0° Pl, Sr-R, Rf & Clay 50mm			SHALE: Very Low-Low strength, Extremely weathered-Distinctly weathered, dark grey, thinly laminated, well developed bedding, fractured with some Extremely Low strength, Extremely W bands

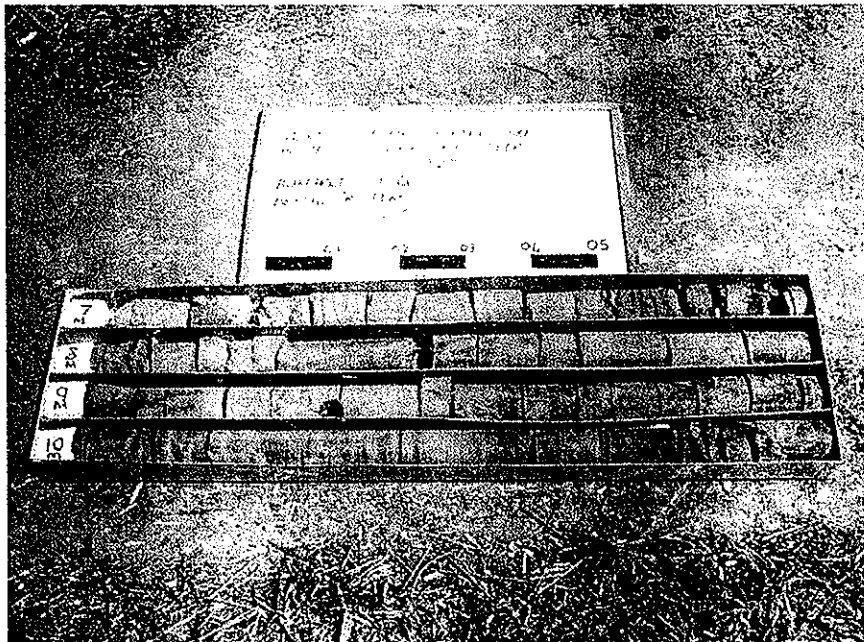
BH4: 7.0 – 11.0 m

7.33-7.45 3x BP 0-3° Pl-Wa, S-Sr, KL <1mm				
						BP 3° Pl-Wa, Sr-R, Rf & Clay 10mm BP 0° Pl, Sr, Rf & Clay 5mm BP 3° Pl-Wa, tight, KL <1mm 7.74-7.88 3x BP 0° Pl, Sr-R, Rf & Clay 3-10mm				
		DW			8	7.93-7.97 Cz 0-90°, Ir, S-R, Rf 40mm 7.98-8.00 2x BP 10° Pl, S, KL <1mm 8.00-8.03 Fz 0-90°, Ir, S-R, Rf 30mm 8.06-8.10 Cz 0-90°, Ir, R, Rf 40mm 8.16-8.23 3x BP 0° Pl, S, KL <1mm 8.23-9.6 8x BP 0-3° Pl, S-Sr, KL <1mm some with iron veneer 8.26 - 8.45 2x BP 15° Pl, S, KL <1mm			SHALE: Medium strength, Slightly weathered, dark grey, thinly laminated, well developed bedding, fracturing along bedding planes, with occasional siltstone bands	SHALE
		SW				8.78-9.13 3x DI fractures 0° Pl-St, S, KL <1mm				
81% CR	9.25				9	9.25-9.35 2x Drillers breaks Pl-Ir, Sr, KL <1mm 9.45-9.6 2x BP 0° Pl, S-Sr, KL <1mm JN 80° Pl, Sr, KL <1mm

12.25		DW				9.86-9.83	4x DI fractures PI, S-Sr, KL<1mm		SHALE as above: Medium strength, slightly weathered, dark grey, thinly laminated, well developed bedding, fracturing along bedding planes, with occasional siltstone bands	SHALE
							BP 0° PI, S, KL <1mm

9.89-10.02	3x DI fractures PI, S-Sr, KL<1mm			
							10.19-10.57	4x DI fractures PI, S, KL<1mm			
							BP 0° PI-Ir, S, Rf 4mm				
							10.7-10.89	3x DI fractures PI, S, KL<1mm

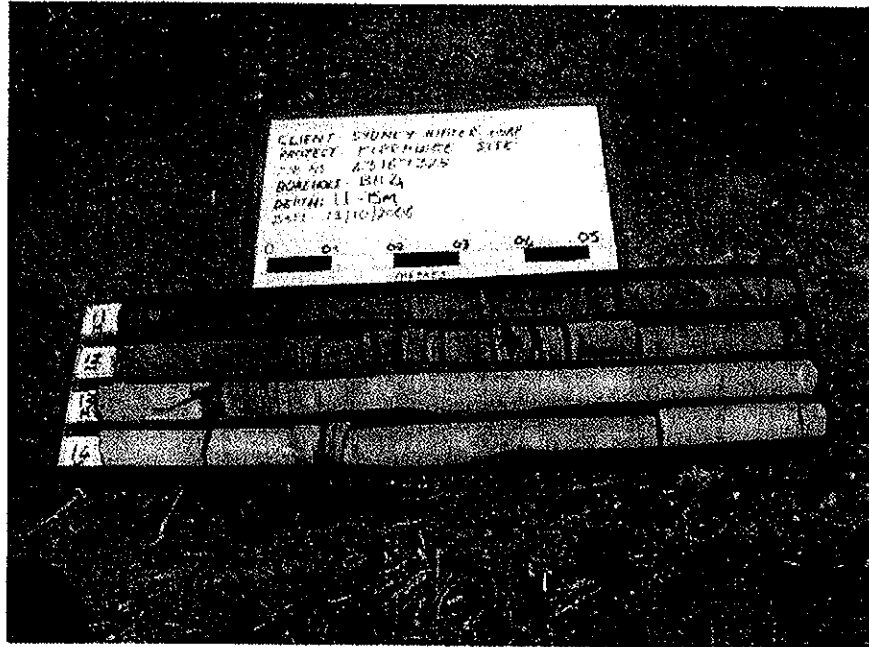
BH4: 11.0 – 15.0 m

10.79-10.84	Fz 0° PI, Sr, Rf 50mm			
							JN 60° Cu, Sr, KL<1mm				
							10.89-11.74	5x DI fractures 0° PI-Ir, S, KL <1mm			
							11.23-11.74	3x DI fractures PI-Ir, S, KL<1mm			
							12-12.47	4x BP 0° PI, S-Sr, KL <1mm		SILTSTONE: Medium to High strength, Distinctly weathered, light brown and grey, thinly laminated, poorly developed bedding, fractured to slightly fractured	SILTSTONE
			DW				12.25-12.75	6x DI fractures 0-7° PI, S-Sr, KL <1mm		As above beginning to grade into Sandstone, becoming Medium to High Strength	
							JN 80° Cu, tight, KL<1mm

12.52-12.57	Fz 0-90° PI-Ir, Sr-R, Rf 50mm			
			SW				12.65-12.95	BP 0-3° PI, Sr-R, KL <1mm		RL 83.27m	
							BP 0-7° PI-Ir, Sr, Rf 7mm				
			DW				BP 0° PI, Sr-R, R Clay 10mm			SANDSTONE: Medium to High strength, Distinctly weathered-Slightly weathered, light grey/brown to light brown, faintly bedded, fine to medium grained, slightly fractured to fractured, with poorly developed siderite cross bedding and lamination & occasional laminite bands and trace carbonaceous wisps	SANDSTONE
							JN 90° PI-Wa, R, KL<1mm				
							JN 0° PI, Sr-R, R Clay & Rf 30mm

METHOD	TESTING	WEATHERING	STRENGTH	RQD (%)	DEFECT SPACING (mm)	DEPTH (m)	DEFECT DESCRIPTION	GRAPHIC LOG	DESCRIPTION OF STRATA	GEOLOGICAL DESCRIPTION
Run		SW	EL-VL L-M H-VH BK	25 50 75	0-10 10-50 50-100 100-200 200-300 300-500					
100% CR	PL 14.33m D=230 A=1.82					13	13.26-13.3 2x BP 5° PI, Sr, R & R Clay 2-3mm		SANDSTONE as above: Medium to High strength, Distinctly weathered-Slightly weathered, light grey/brown to light brown, fine to medium grained, slightly fractured to fractured, with poorly developed siltitic cross bedding and laminations & occasional laminite bands and trace carbonaceous wisps	SANDSTONE
						14	14.15-14.78 4x BP 0-5° PI-Wa, S-Sr, KL <1mm  BP 0° PI, S-Sr, Clay 4mm			
						15			End of borehole @ 15m	
						16
