Hazardous Materials Survey

UrbanGrowth NSW

Sewage Treatment Plant Former Defence Ingleburn Site Campbelltown Road Edmondson Park, NSW 2174

29 November 2013 JBS&G 43008-56110 (Rev 1) 43008-56110

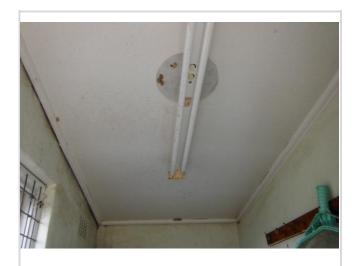
Photograph 3:

FCS panels to store room ceiling, eastern portion Building 1

Contains asbestos

A Class A or Class B licensed asbestos removalist shall be engaged to remove all non-friable asbestos materials outlined in the Hazardous Materials Register, included as **Appendix 1**.

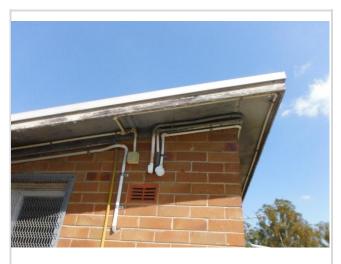
Photograph 4:

FCS to external eaves surrounding Building 1

Contains asbestos

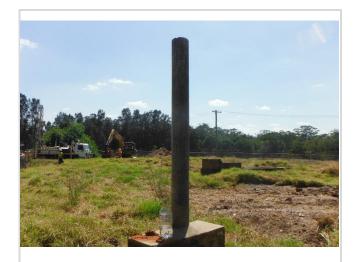
Photograph 5:

Moulded AC pipe to BBQ flue, north of Building 1

Contains asbestos

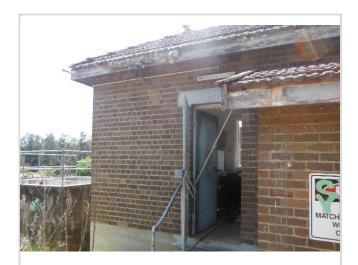
Photograph 7:
Blue paint to door, Building 2
Contains lead in paint >1%

Lead based paints identified in Hazardous Materials Register (**Appendix 1**) should be managed in accordance with the Australian Standard (AS) *4361.2 Guide to Lead Paint Management; Part 2 Residential and Commercial Buildings*. If peeling or deteriorated they should be removed under controlled conditions by an experienced contractor prior to demolition. Stable lead based paints adhered to building fabric can be removed as general solid waste provided care is taken to minimise any potential for paint flakes to be dispersed onto ground surfaces.

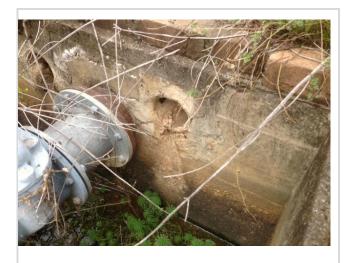
Photograph 10:

Gaskets to the pipework within pit adjacent front entrance, Building 3.

Noted to be either metallic or rubber. A sample of the metallic type gasket had no asbestos detected.

The small pipes within the wall were also inspected and noted to be metal.

No access was available to the bottom of the pit due to the water hazard.

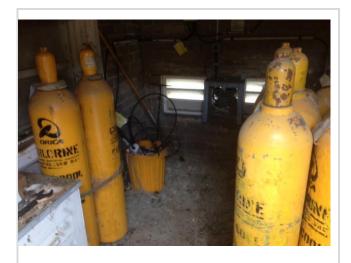
Photograph 11:

Although outside of the scope of our investigations a number of gas cylinders marked 'chlorine' and painted yellow were identified inside Building 3. Chlorine gas is a corrosive gas (*i.e.* a gas that, in contact with living tissue causes destruction of the tissue by chemical action) and as such should be handled and disposed of appropriately.

Chlorine gas bottles within Building 3.

The gas cylinders marked 'chlorine' and painted yellow inside building 3 should be removed prior to demolition by a suitably trained person and taken to a facility licensed to accept them.
