**Patterson Britton
& Partners Pty Ltd**

19 July 2007

RESERVOIR 1, POTTS HILL – STRUCTURAL INTEGRITY AND FORM

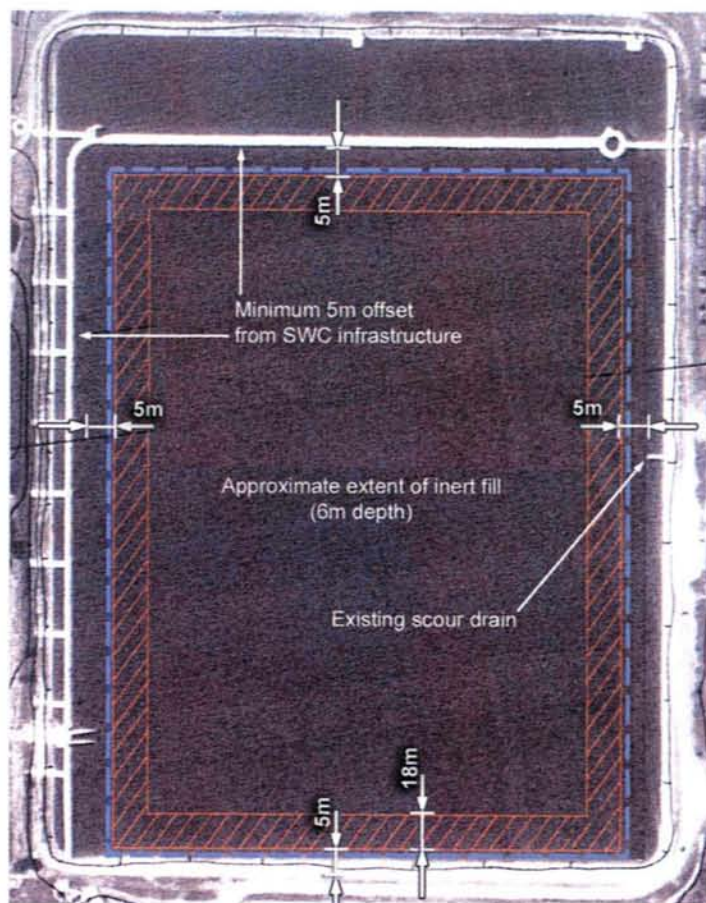
FIGURE 1

FILL OPTION 1

Batters around fill at 1 in 3

Wall /bunding to control surface run-off

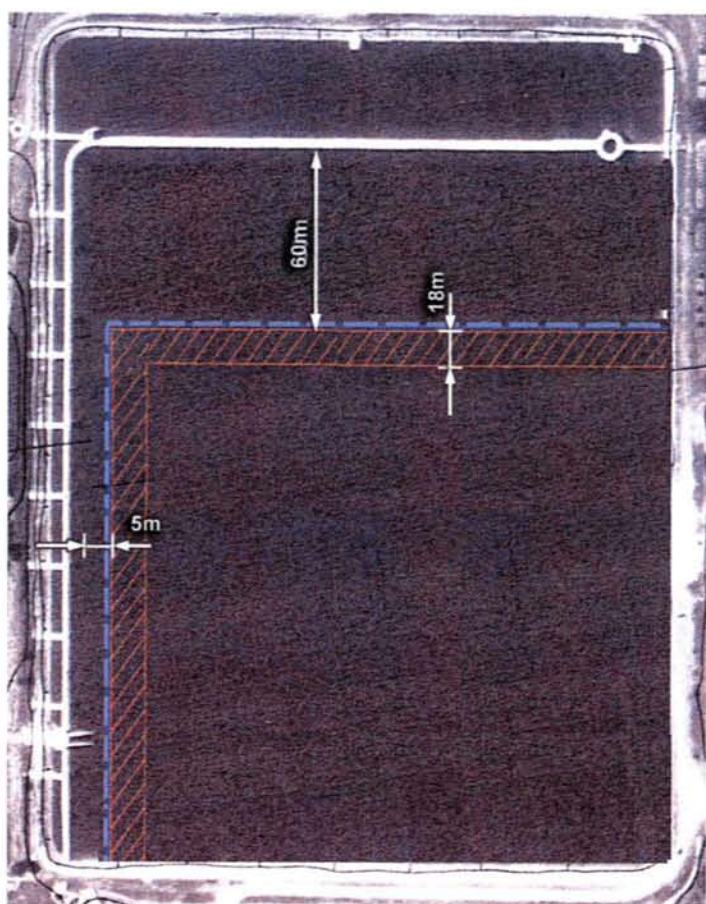
FIGURE 2

FILL OPTION 2
