PRELIMINARY CONTAMINATION ASSESSMENT

**BEVIAN ROAD CONCEPT APPLICATION
BEVIAN ROAD, ROSEDALE**

Prepared for
MARSIM

**PROJECT 38045E
OCTOBER 2007**

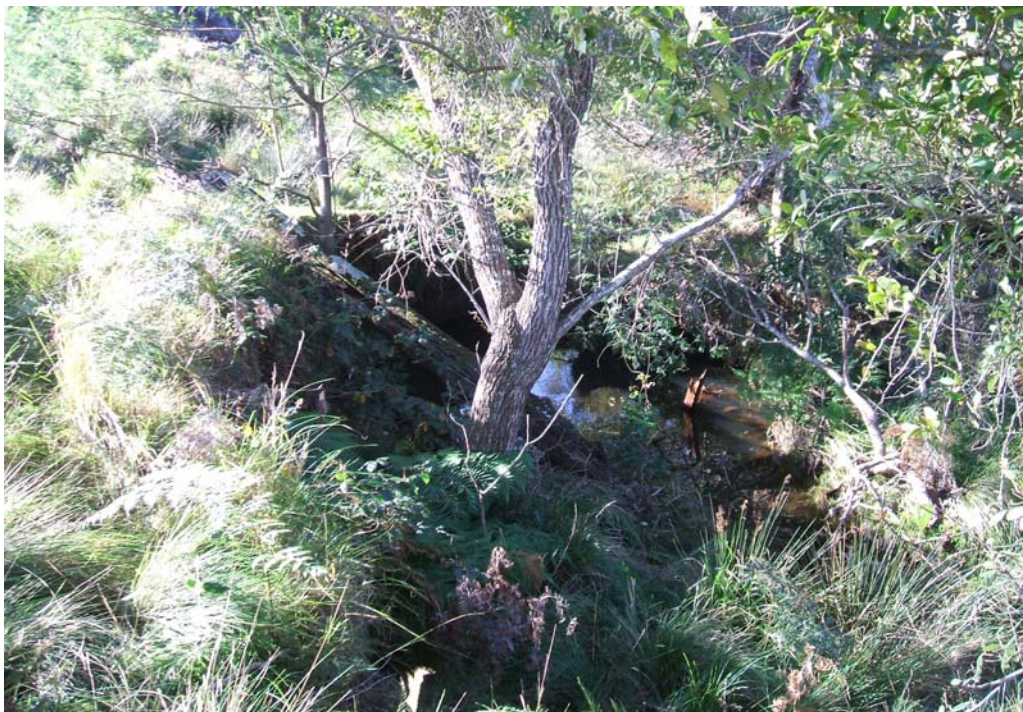
Photo 2: PAEC 4 - incised creek, no filling

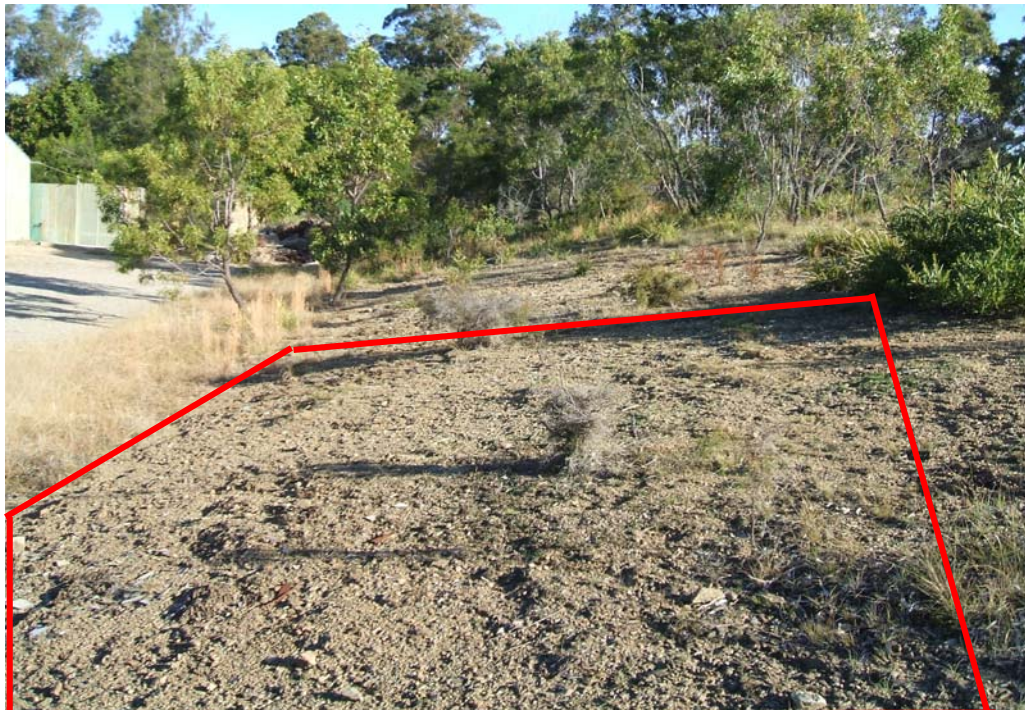
Photo 3: Asbestos scatter

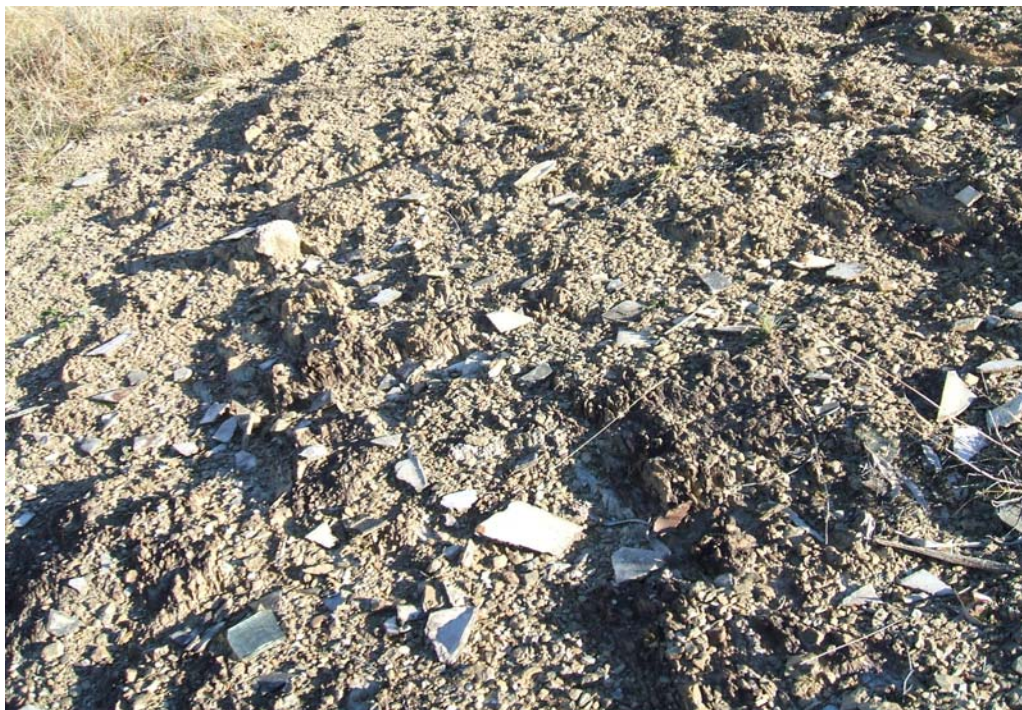
Photo 4: Asbestos scatter (close up)

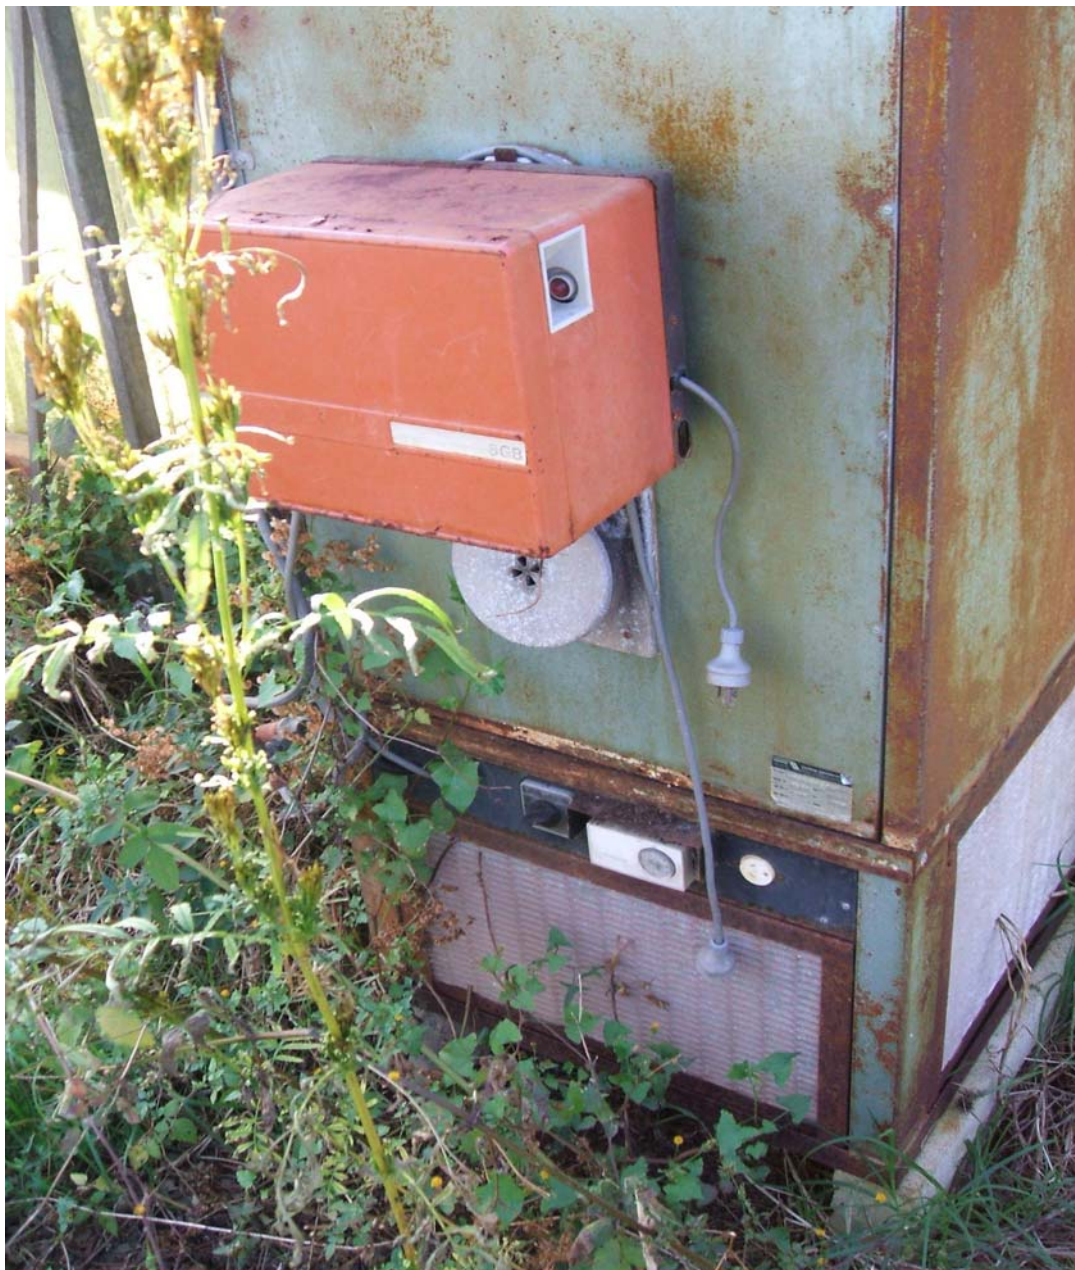
Pump removed – Pipes galvanised and poly pipe, no AC. ASTs – appear to be used for heating oil for heaters in glasshouse. Some minor leakage.

Photo 5: PAEC 15 - oil heater in nursery

AEC1 Above Ground Storage Tanks	Hydrocarbon contaminated material will require delineation, excavation, waste classification and off site removal. Depending on the extent of contamination, soils may require excavation to underlying bedrock and a groundwater monitoring and remediation program may be necessary. Following the successful removal of the tanks, validation of the excavation and confirmation of off site disposal of excavated material the site would be deemed suitable for residential use.
AEC2 Old Cheese Factory	<p>If the hazardous building material assessment confirms the existence of the hazardous building materials on site, the hazardous material would require removal by an appropriately licensed contractor and the factory restored using non hazardous material. A Clearance Certificate by an Occupational Hygienist must be provided post refurbishment,</p> <p>Further to this, soils surrounding the building will require investigation and any lead, asbestos or other contamination identified would require delineation. The delineated area would require excavation and material disposed of to an off site location. The resultant excavation would require validation. Following successful validation of the site, the site would be suitable for residential use.</p>

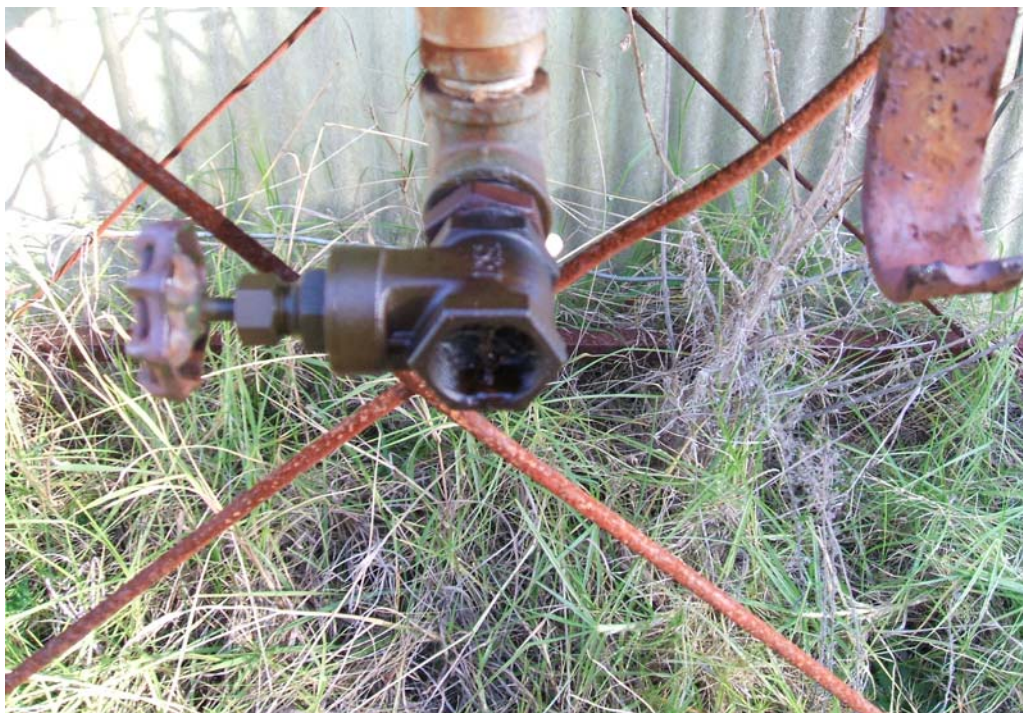
Photo 6: leaking heating oil

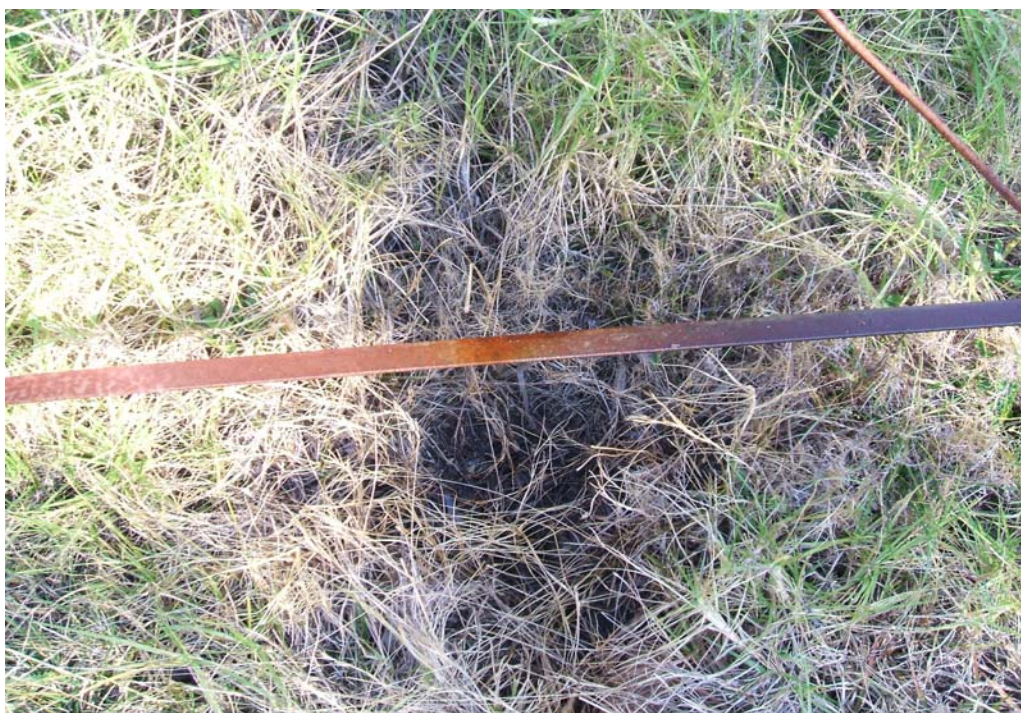
Photo 7: leaking heating oil and distressed vegetation

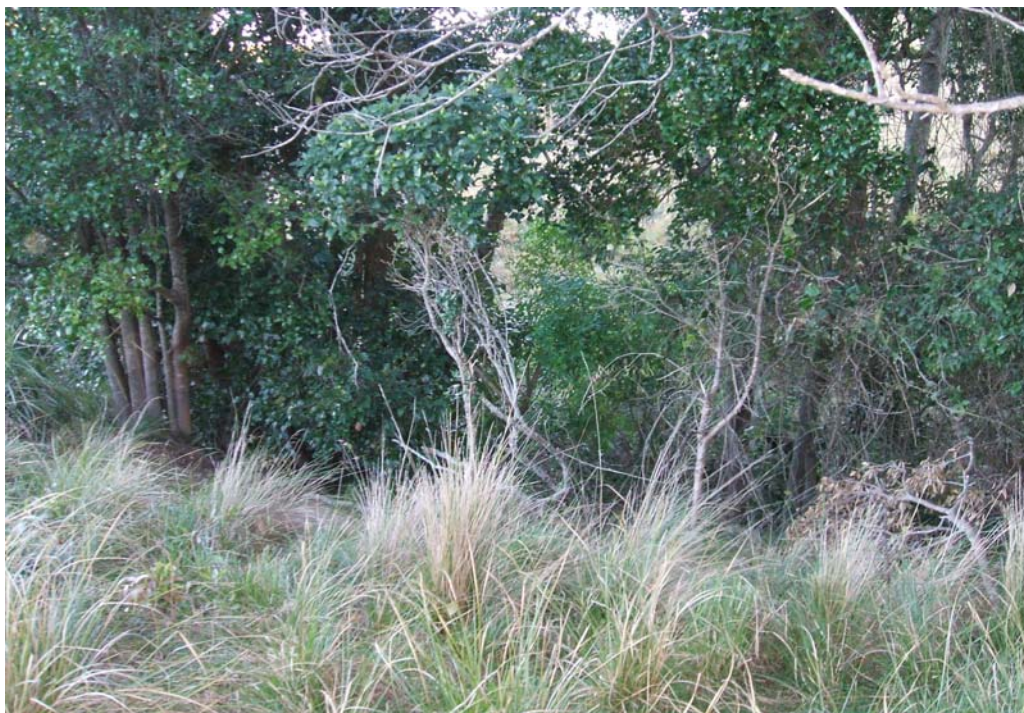
Photo 8: PAEC 10 - incised gully, no filling

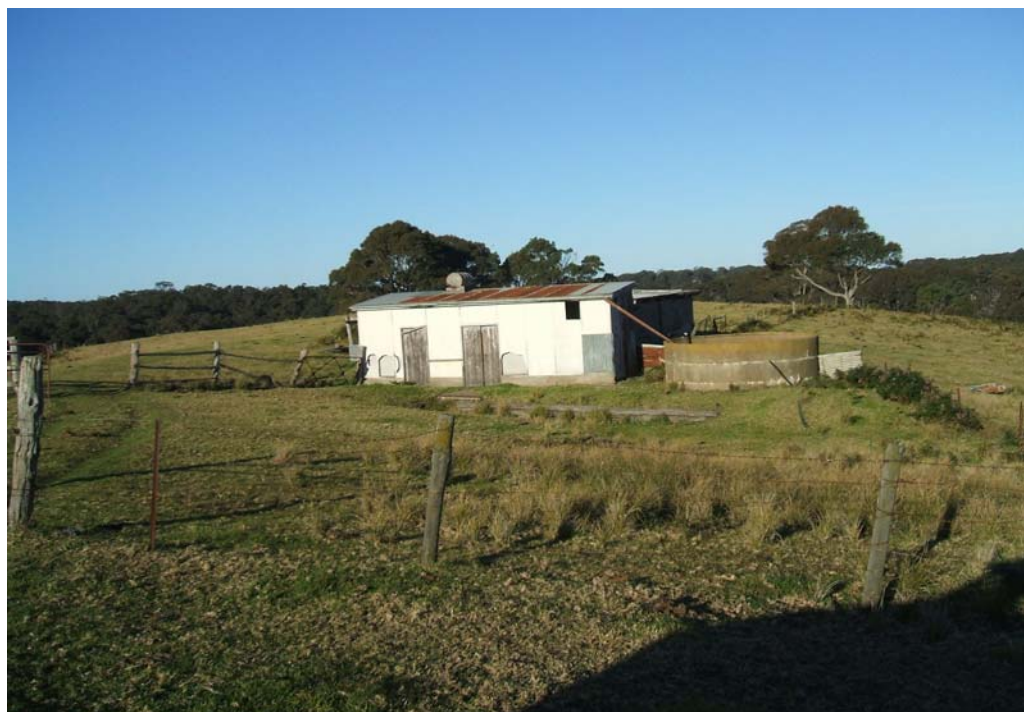
Photo 9: PAEC 13 - old dairy

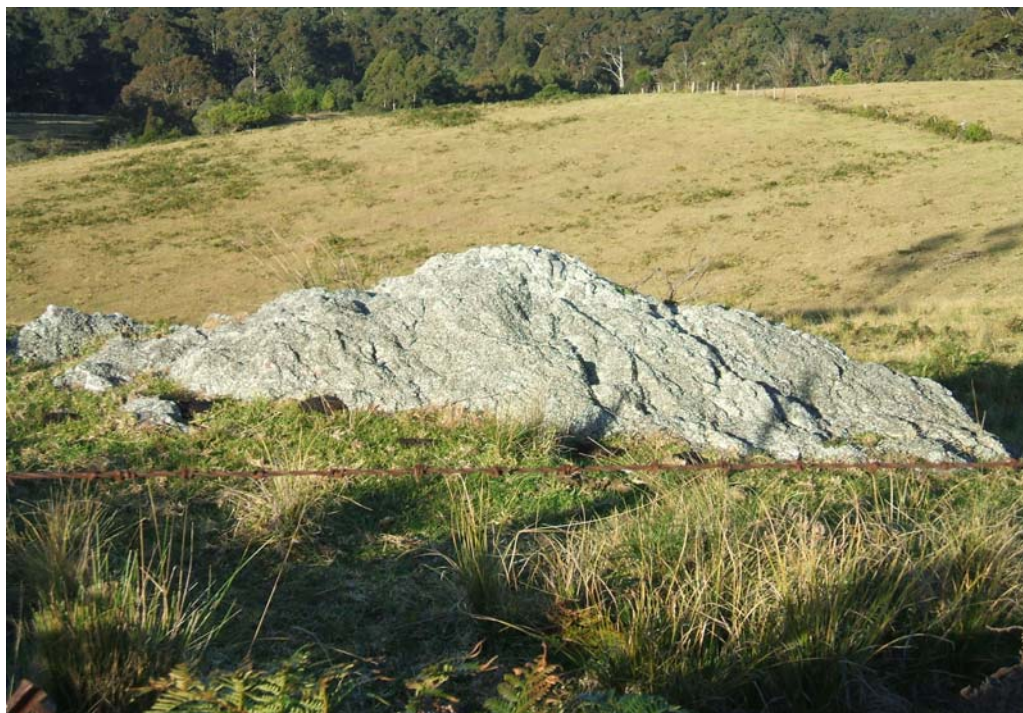
Photo 10: PAEC 11 - rock outcrop

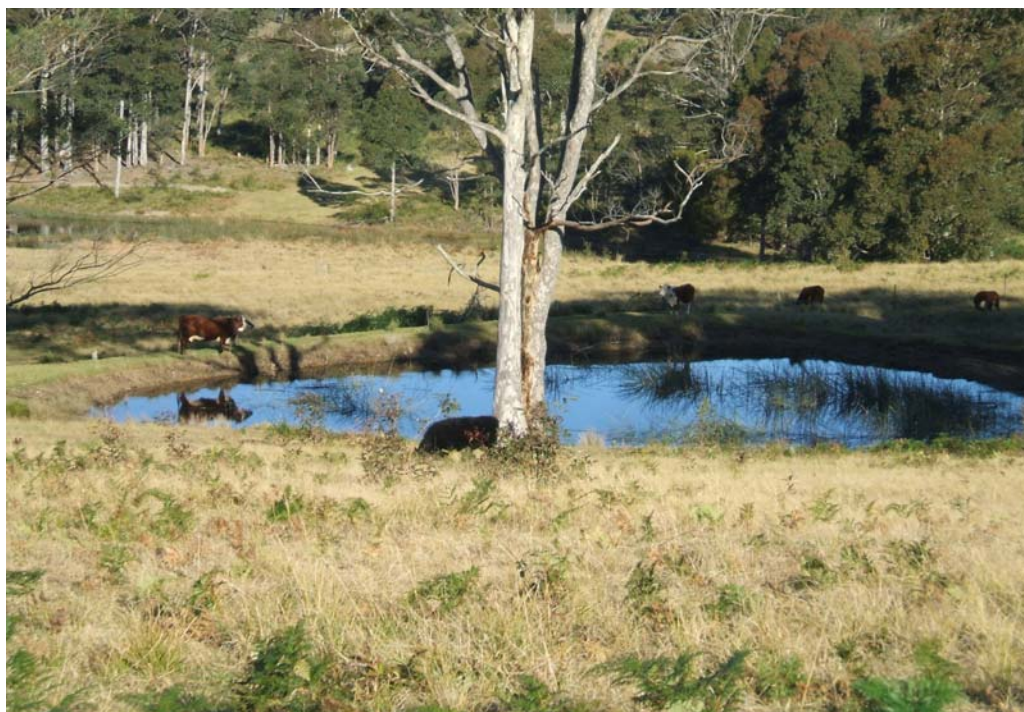
Photo 11: PAEC 16 - farm dam
