PRELIMINARY SITE ASSESSMENT

LOT 219 DP 755218, COORANBONG

PROPOSED REZONING FROM RURAL TO URBAN

Project 39229

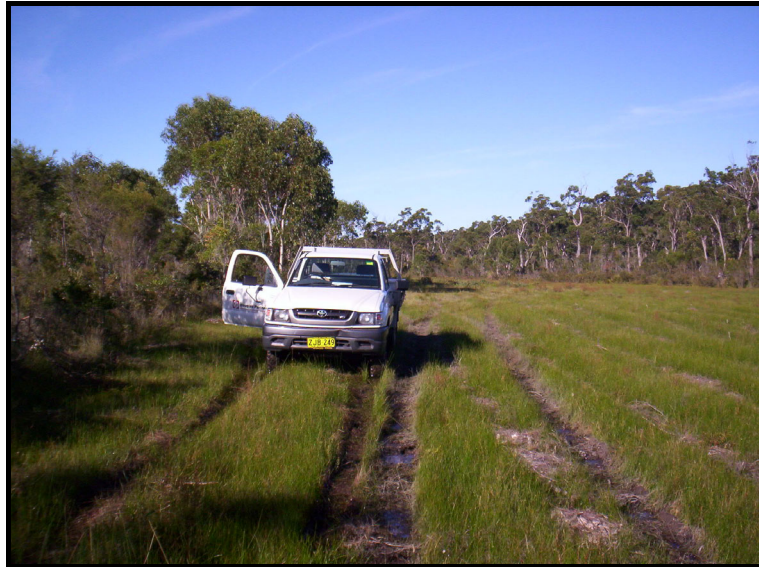
Site soils on the upper hill slopes were generally dry, however within and adjacent to the central gully, wet soils were observed at the surface (Photo 1). Wet surface soils were observed to be

approximately 100 m to 200 m wide within the gully alignment and also extended over the lower slopes to the east of the gully, as shown on Drawing 1, Appendix A.

Photo 1 – Wet soils on lower slopes near gully

Soft / saturated soils were observed within the main gully alignment and on lower site slopes. Should development be proposed within the area currently occupied by the main gully alignment or within the area identified as being soft/wet (see Drawing 1, Appendix A), appropriate drainage control, and engineering design will be required to facilitate development.

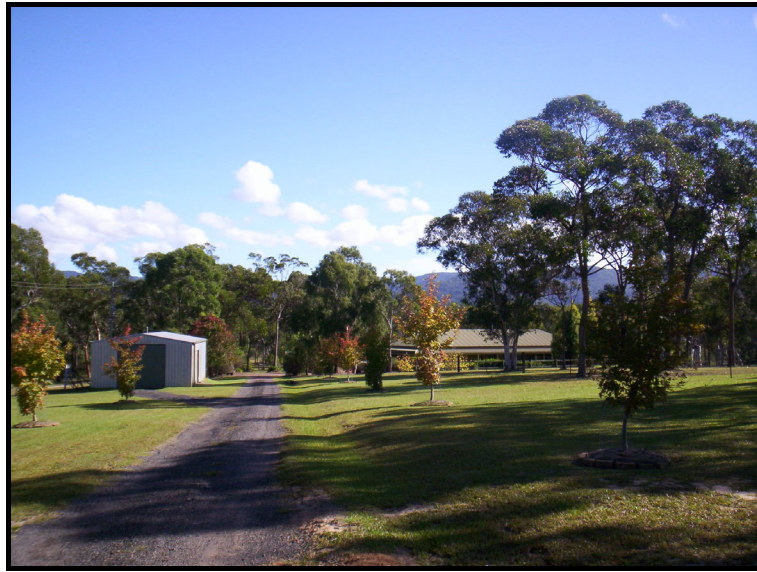
There is little development over the site. Within the southern corner of the site is a single storey brick dwelling with metal roof and an associated metal clad shed with gravel floor (Photo 2).

Photo 2 – House and shed in the southern corner of the site

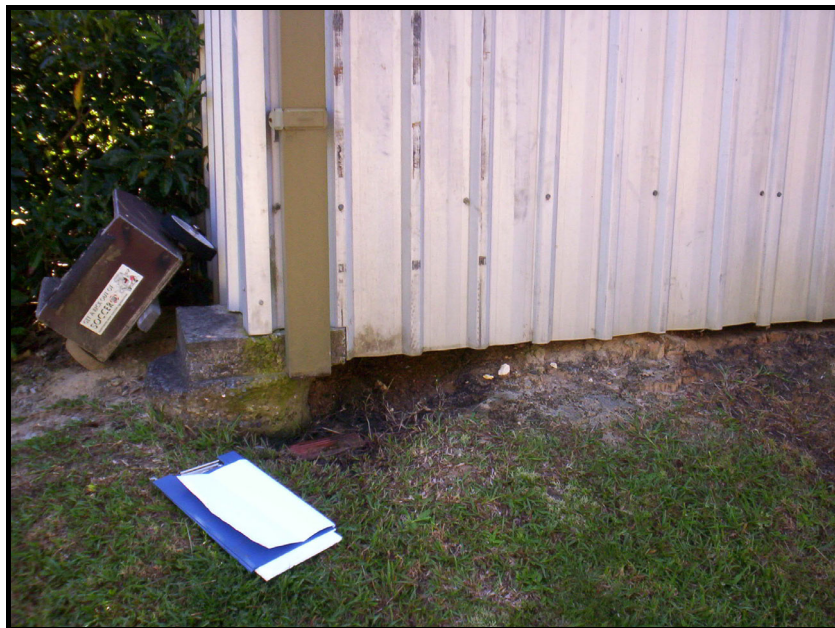
A gravel driveway was present from the boundary fence leading to the shed and house. Minor hydrocarbon staining was observed at one corner of the shed (Photo 3).

Photo 3 – Minor hydrocarbon staining near shed

- minor hydrocarbon and heavy metal impact within and in the vicinity of the shed near the dwelling where surface staining was observed;
- minor hydrocarbon and heavy metal impact in the vicinity of fence posts treated with waste oil;
- possible nutrient and heavy metal impact within the domestic effluent disposal area;
- localised near surface impact on soils around the perimeter of the dwelling due to minor herbicide / pesticide use;
- surficial filling from unknown origin associated with the driveway.

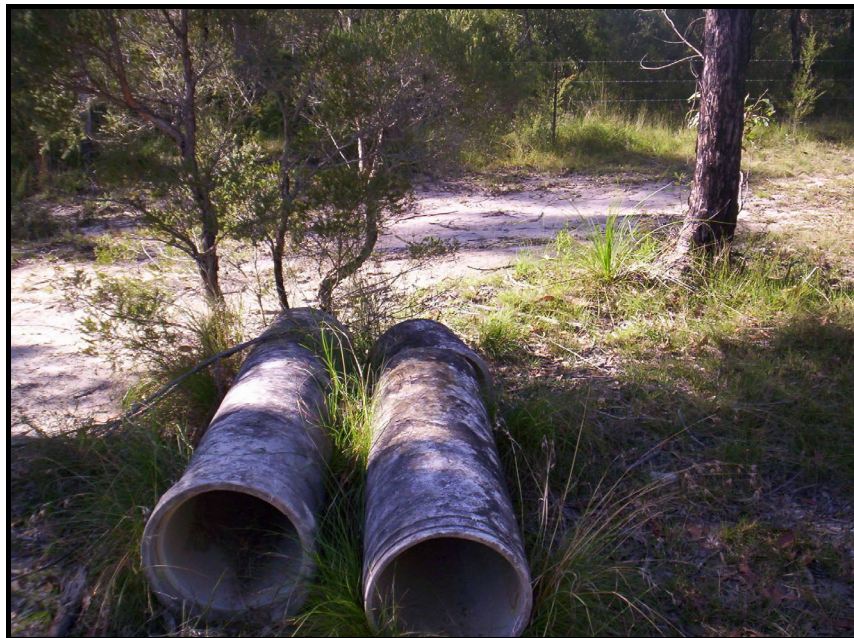
Two fibre cement pipes, 300 mm diameter and about 3 m in length (Photo 4) were observed adjacent to the eastern boundary of the site. The approximate location of the pipes is shown on Drawing 1, Appendix A.

Photo 4 – Fibre cement pipes

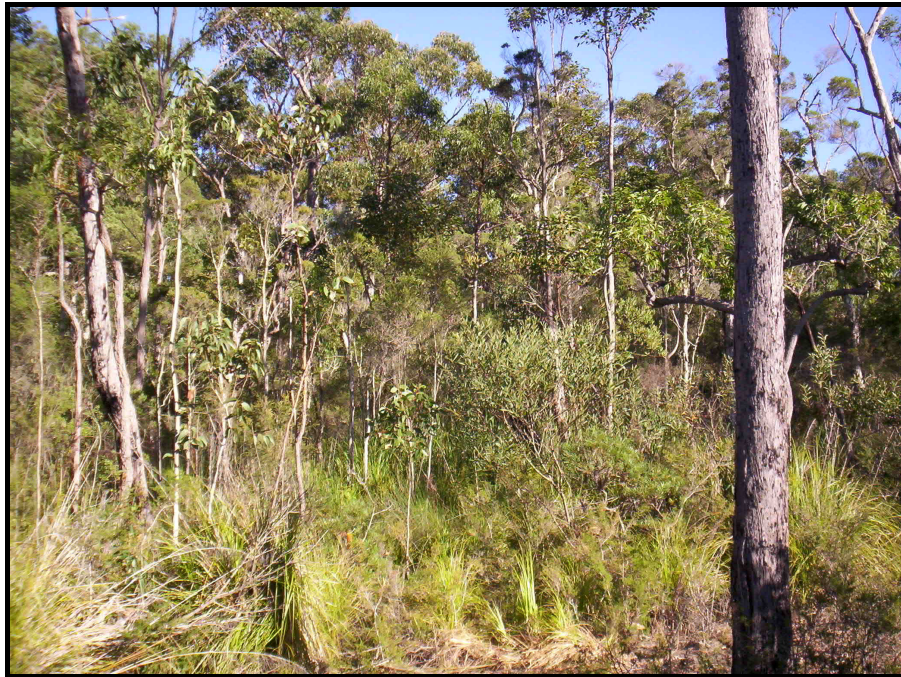
Vegetation over the site was observed to range from very dense swamp forest (Photo 5) to cleared pasture land (Photo 6).

Photo 5 – Very dense vegetation within main gully

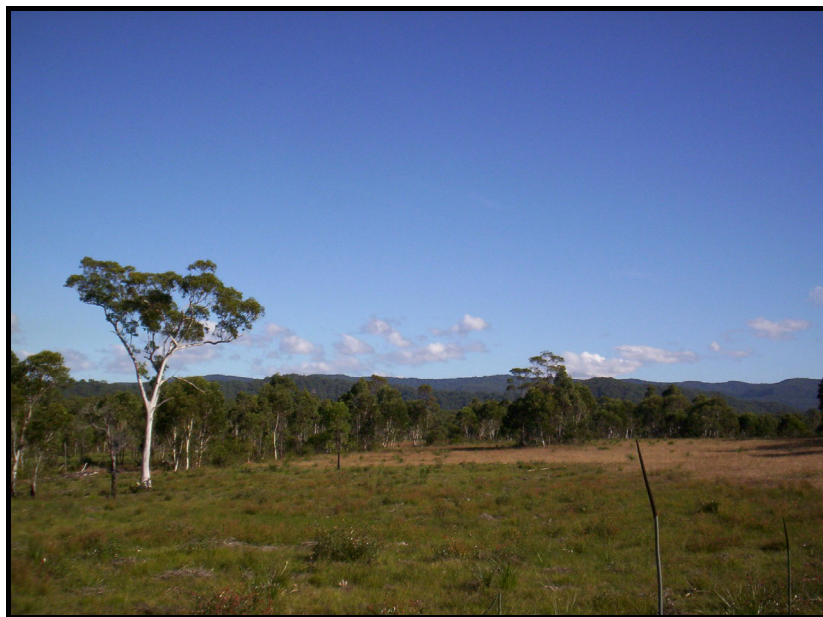
Photo 6 – Typical vegetation within cleared areas

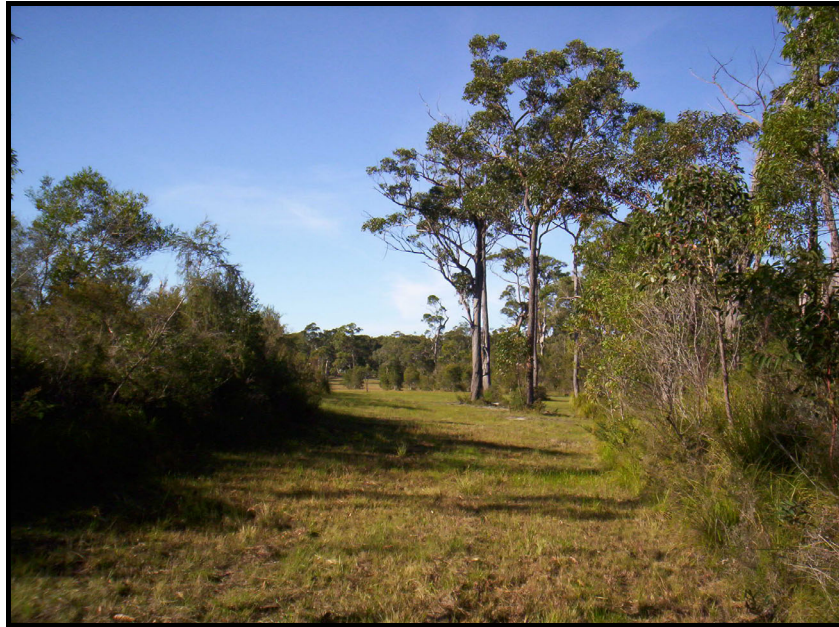
vegetation was placed in windrows along approximate contours of the site, which now also contain semi-mature trees (Photo 7).

Photo 7 – Clearing along site contour

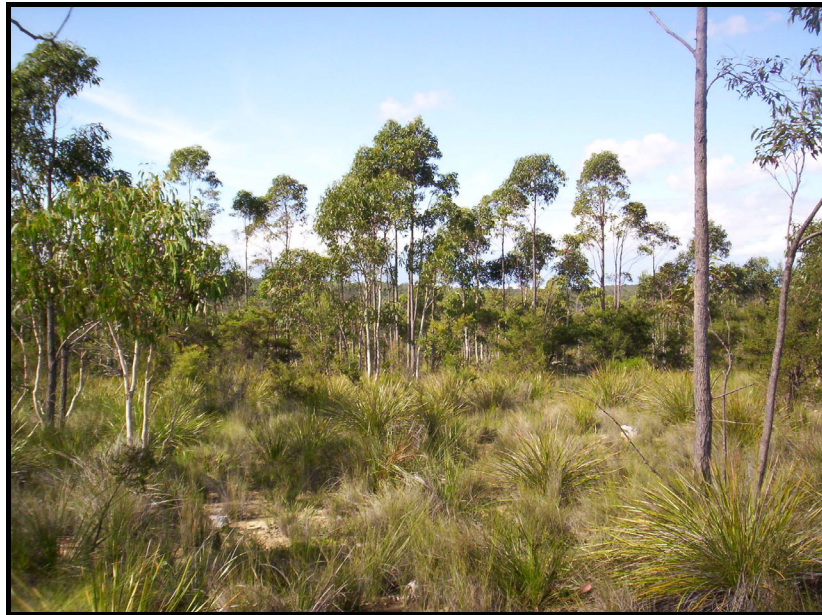
Vegetation on the western portion of the site generally comprises regrowth from past clearing activities. The regrowth comprises moderately dense shrubs and grasses with occasional semi mature to mature trees (Photo 8). Clearing along contour lines, similar to the eastern portion of the site are also present.

Photo 8 – Typical vegetation on the western portion of the site
