Hazardous Materials Survey Report

77-89 Eveleigh Street, Redfern NSW

EI Report No.: E23309 AB_Rev1

Date: 7 April 2017

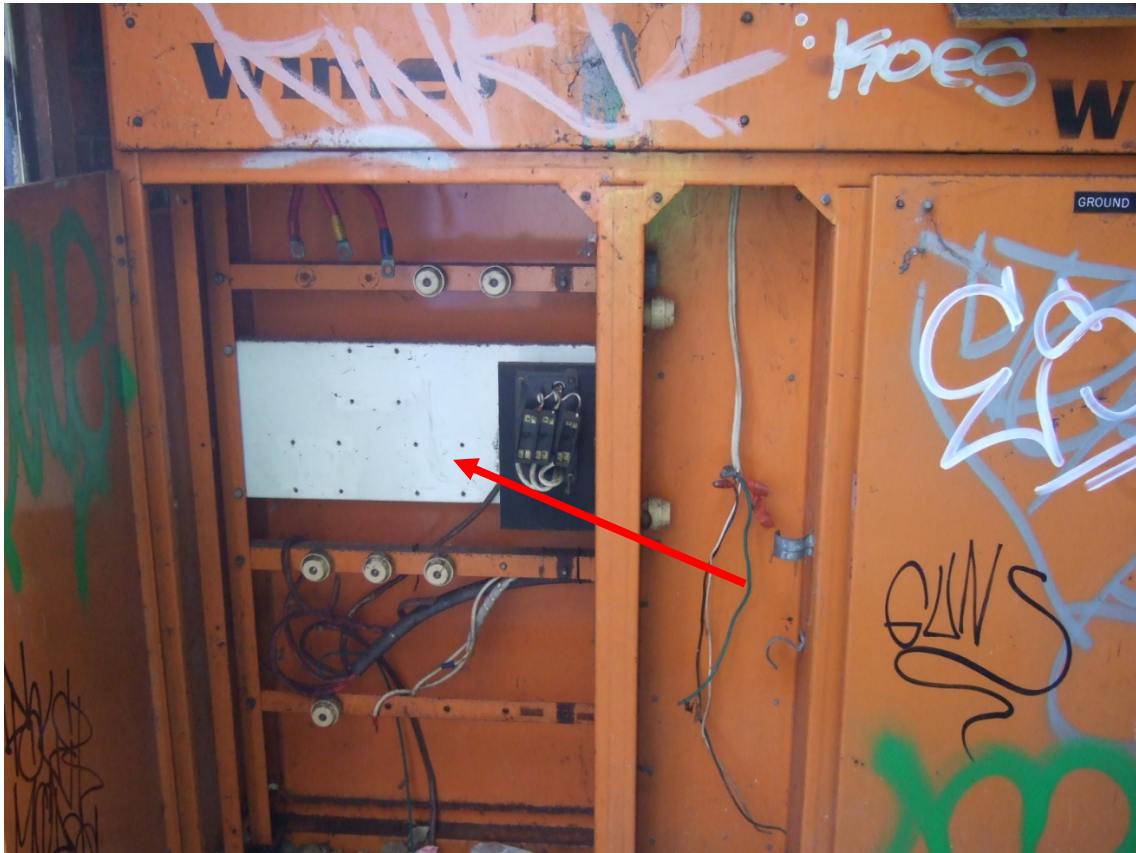
Photograph 1

Property	Location	Sample Description
77-89 Eveleigh Street	External, western electrical switch cabinet	Electrical backing board

Location: 78-89 Eveleigh Street

The red arrow points to the flat asbestos cement sheeting on backing board

Asbestos materials should be removed prior to the commencement of any renovation or demolition works that may cause their disturbance. The removal of these materials is to be done in accordance with the requirements of the SafeWork NSW approved code of practice "How to Safely Remove Asbestos" and requires a minimum Class B licenced asbestos removal contractor.
