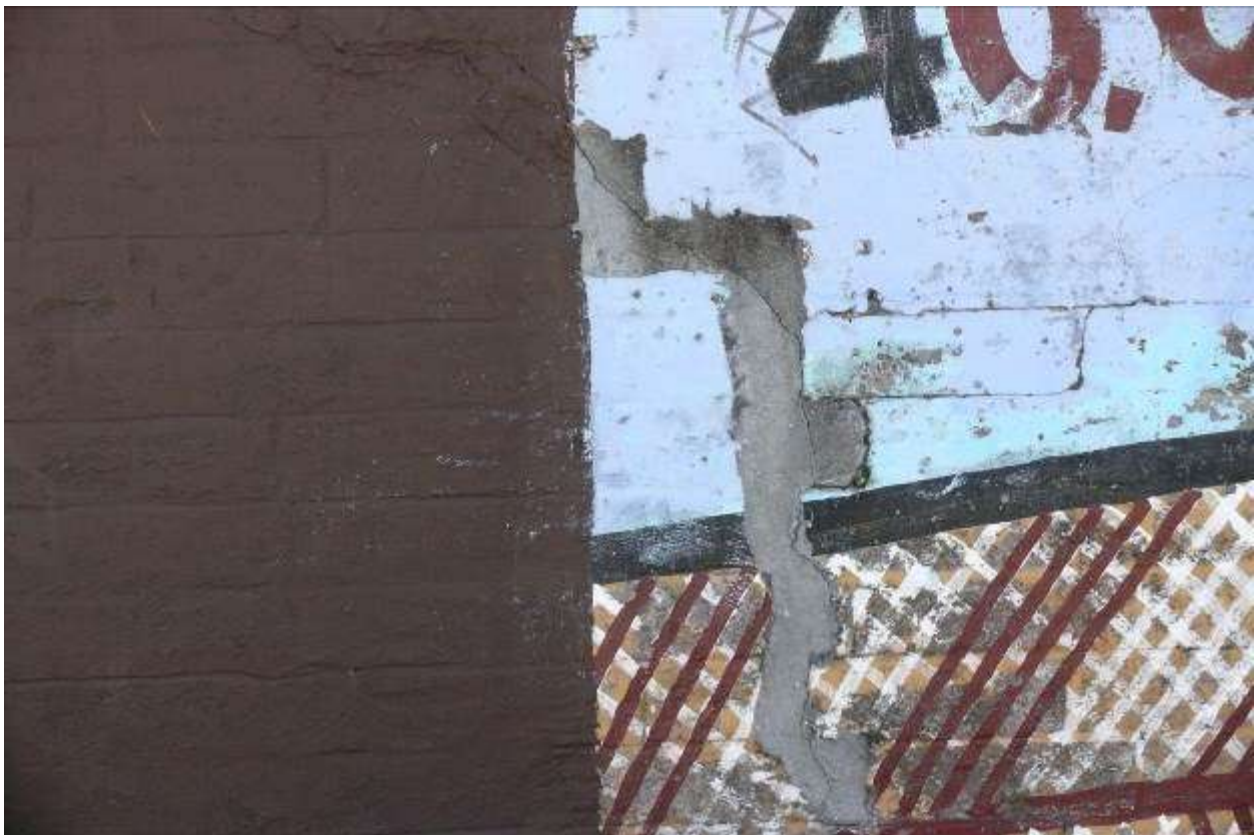
Figure 21 – Crack propagation through boundary wall observed from Lawson Street Overpass Bridge

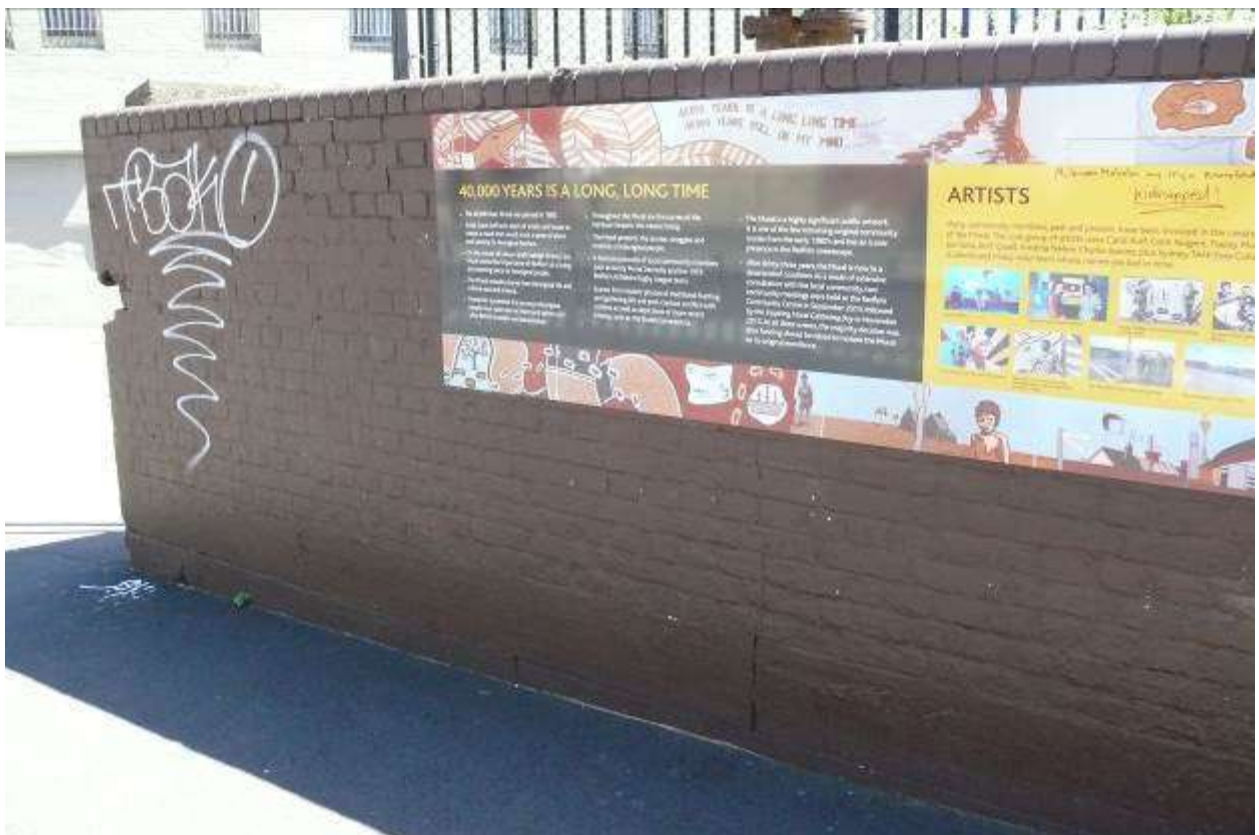
Figure 25 – Loss of material and evidence of patchwork through boundary wall observed from Lawson Street Overpass Bridge

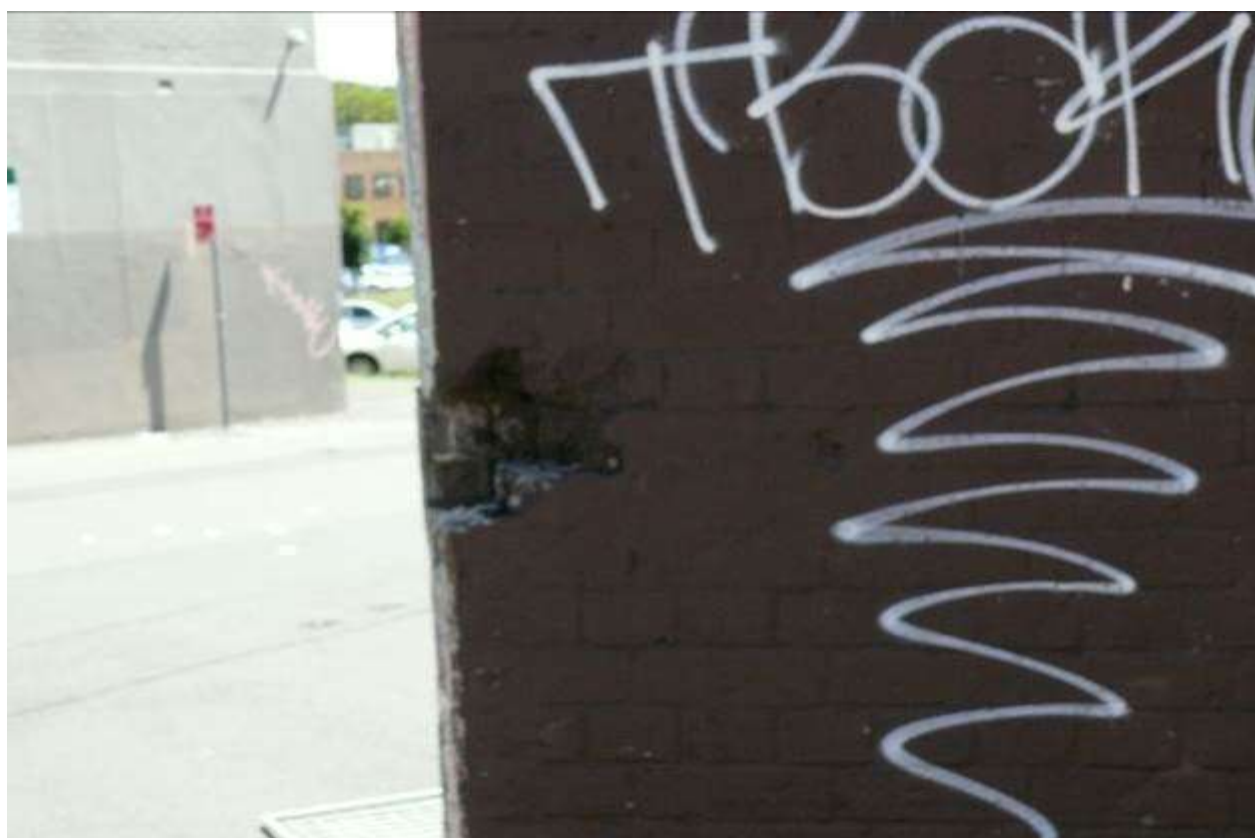
Figure 27 – Crack propagation through boundary wall observed from Lawson Street Overpass Bridge

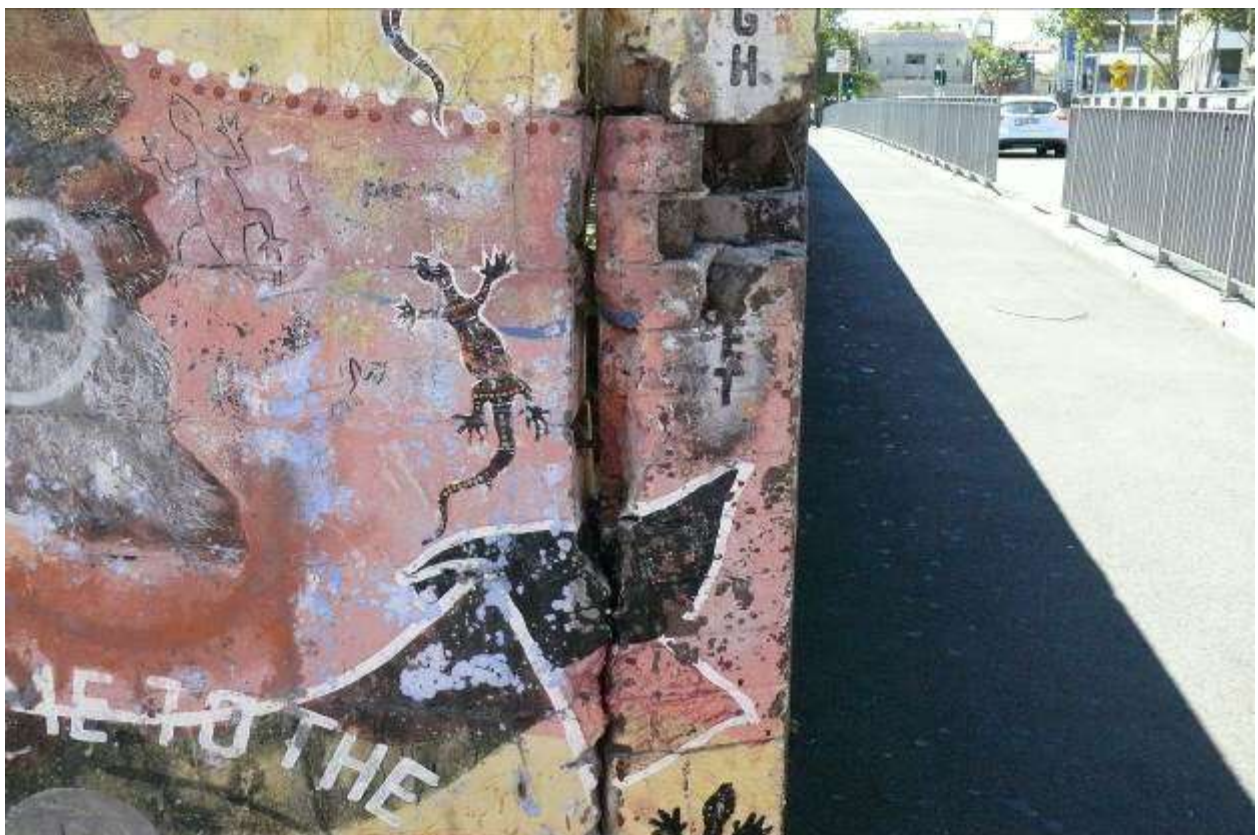
Figure 31 – Crack propagation, separation and loss of material through boundary wall observed from Lawson Street Overpass Bridge

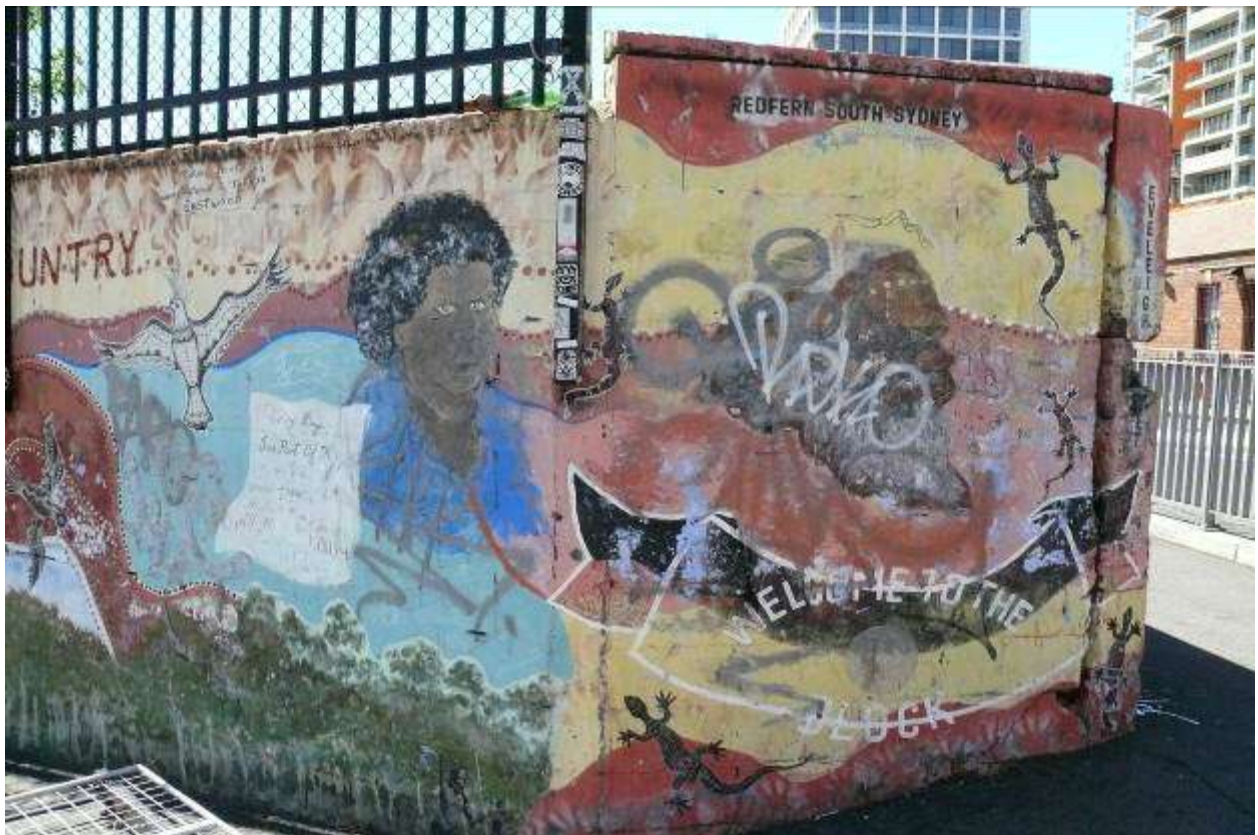
Figure 33 – Crack propagation, separation and loss of material through boundary wall observed from Lawson Street Overpass Bridge

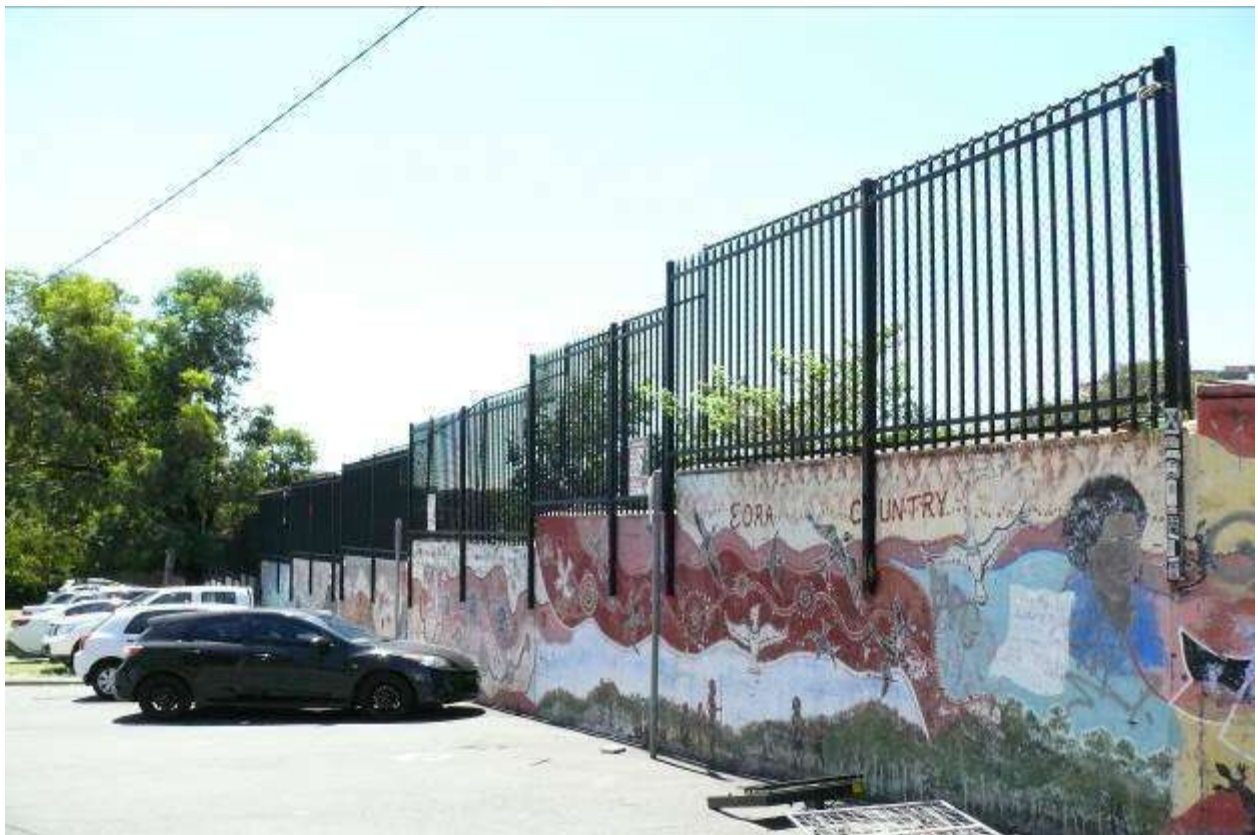
Figure 35 – Crack propagation, separation and loss of material through boundary wall observed from Lawson Street Overpass Bridge

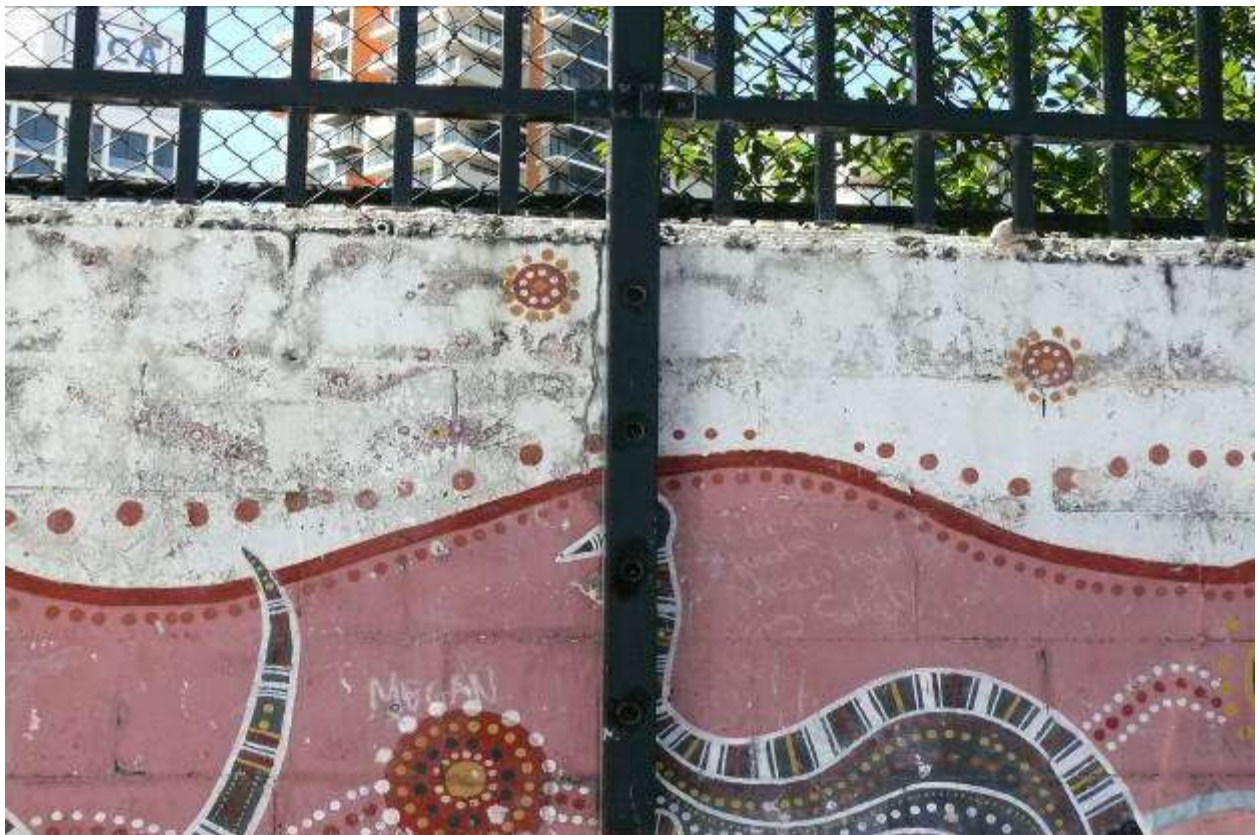
Figure 43 – Crack propagation through boundary wall observed from Eveleigh Street

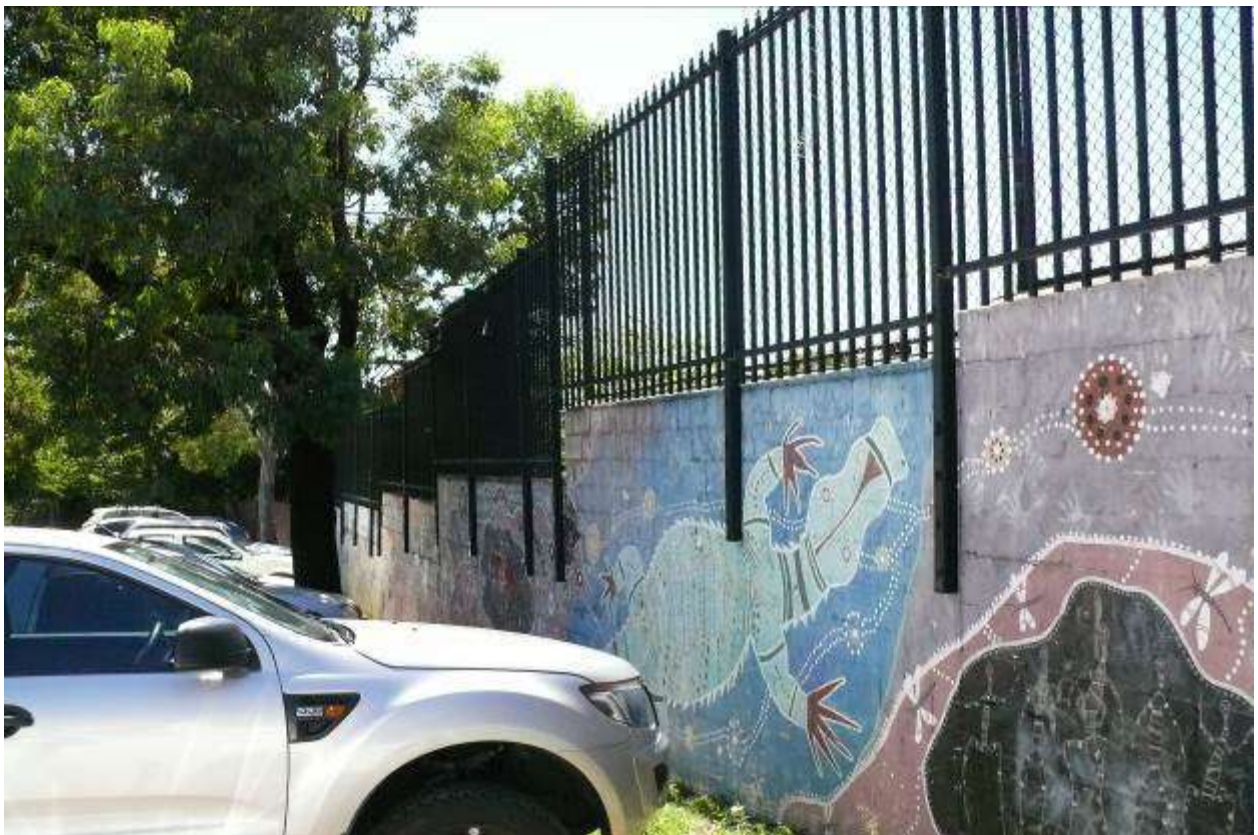
Figure 53 – Crack propagation through boundary wall observed from Eveleigh Street

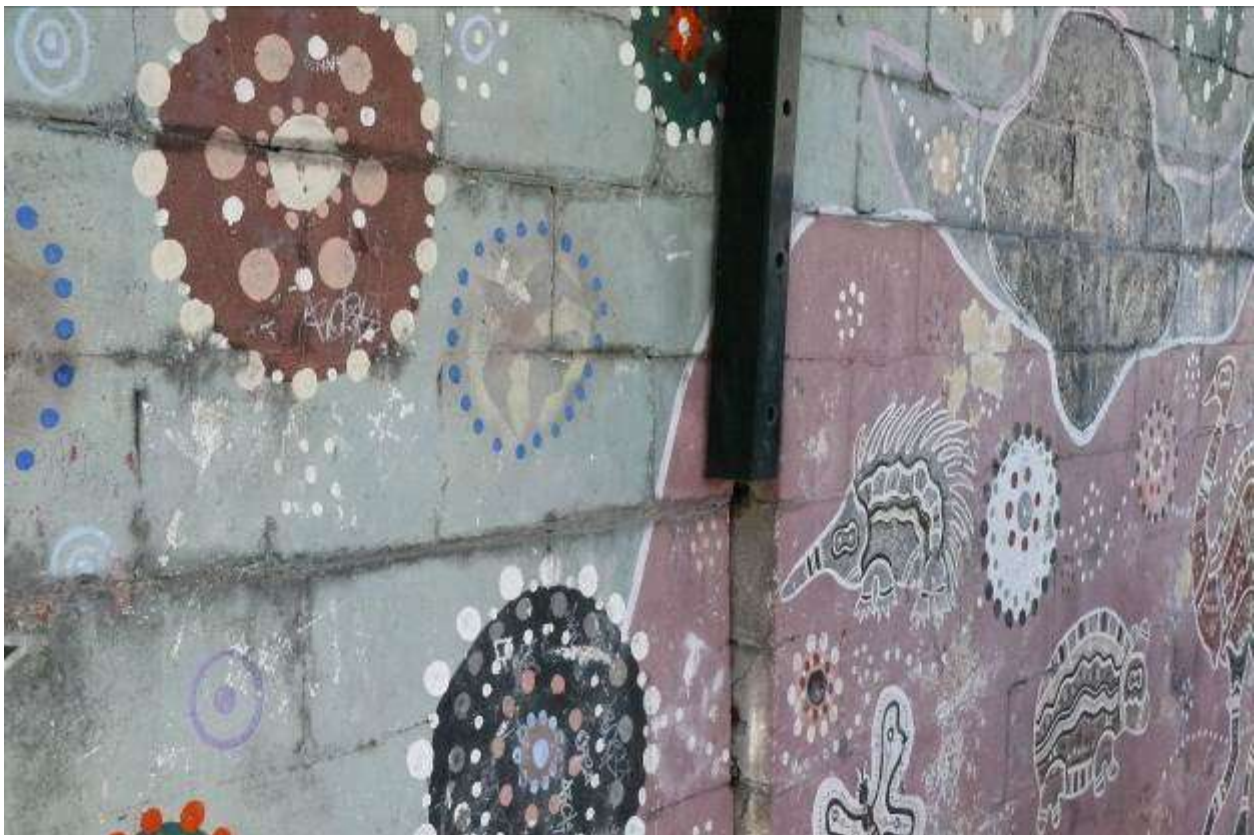
Figure 63 – Crack propagation and separation through boundary wall observed from Eveleigh Street

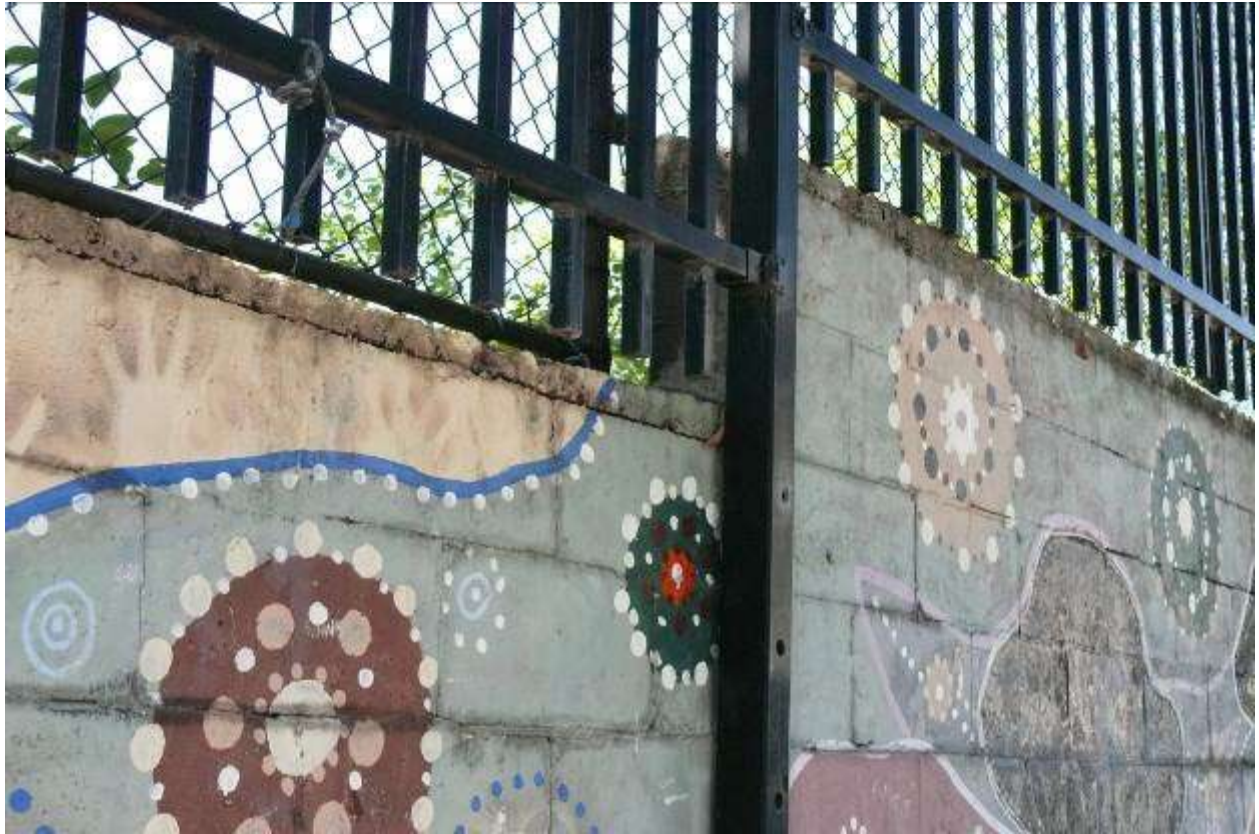
Figure 64 – Crack propagation and separation through boundary wall observed from Eveleigh Street

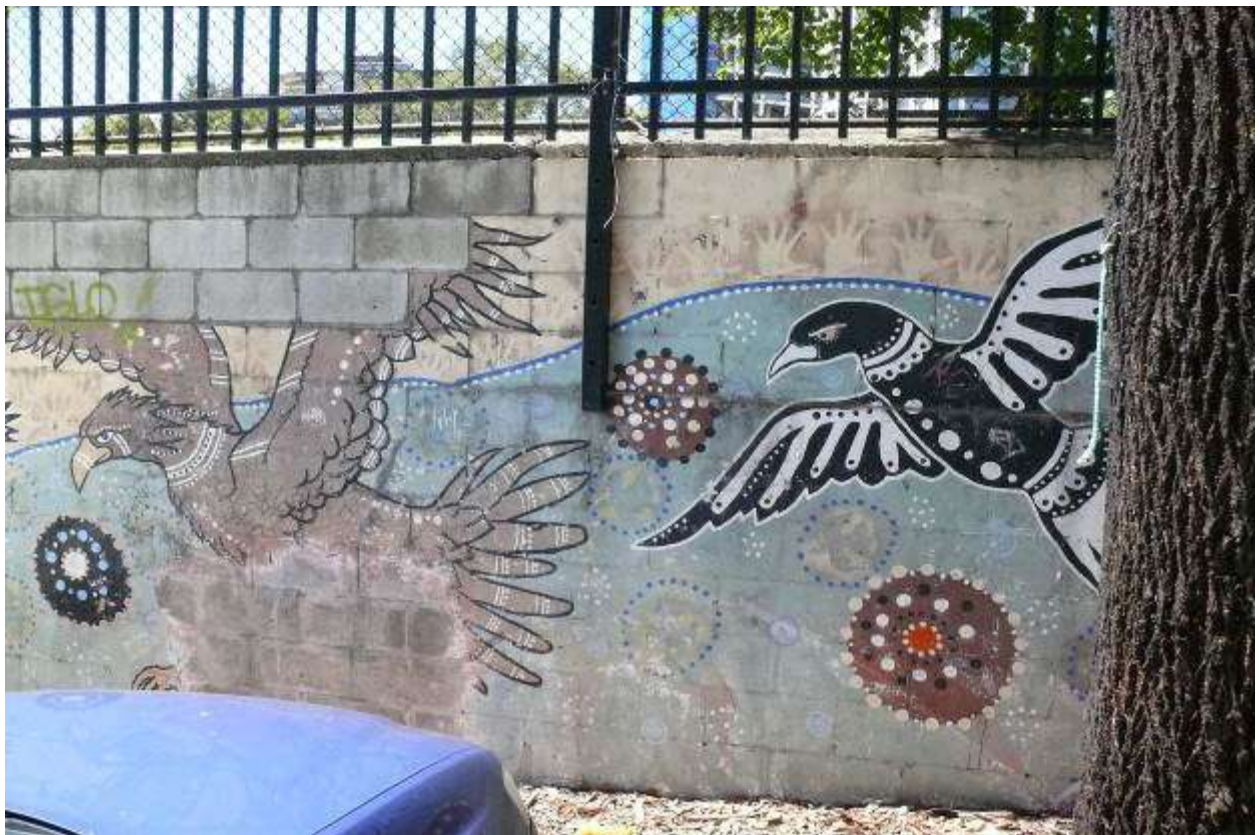
Figure 65 – Crack propagation through boundary wall observed from Eveleigh Street

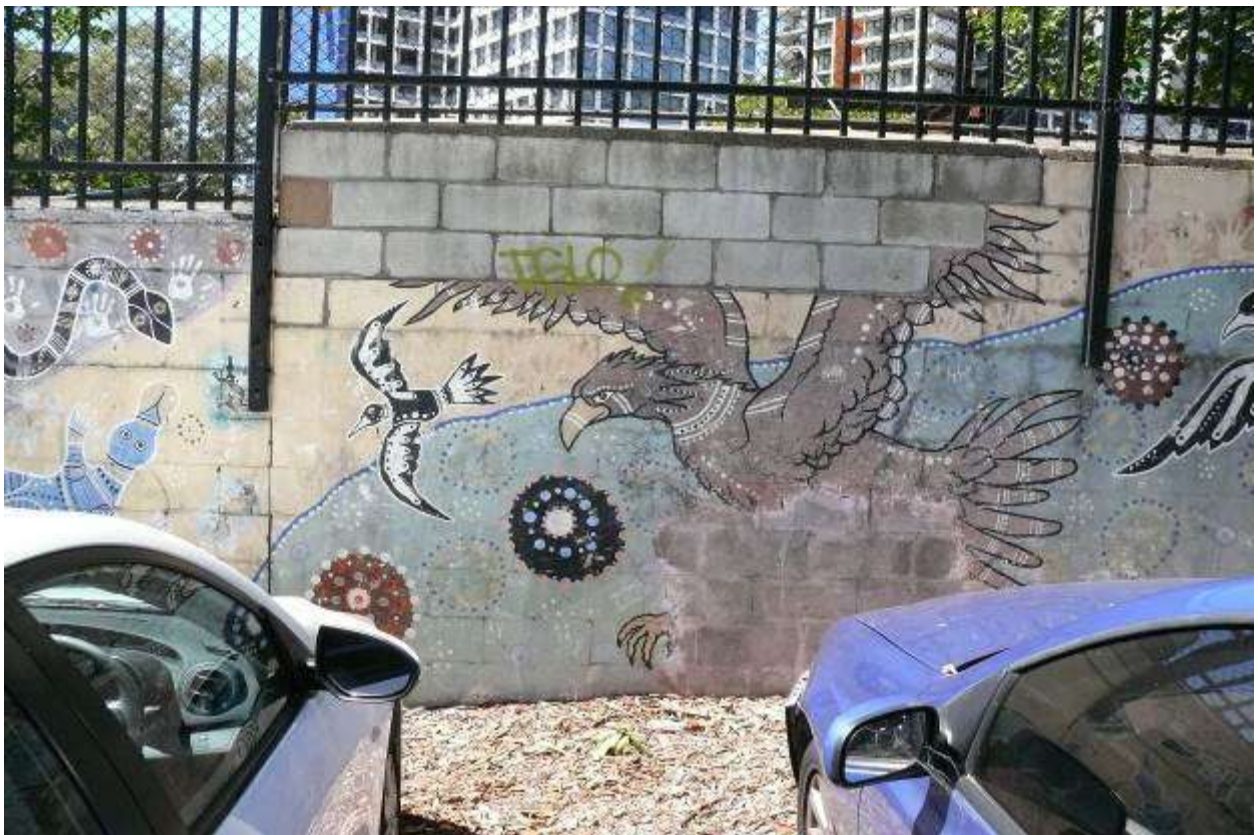
Figure 67 – Crack propagation through boundary wall observed from Eveleigh Street

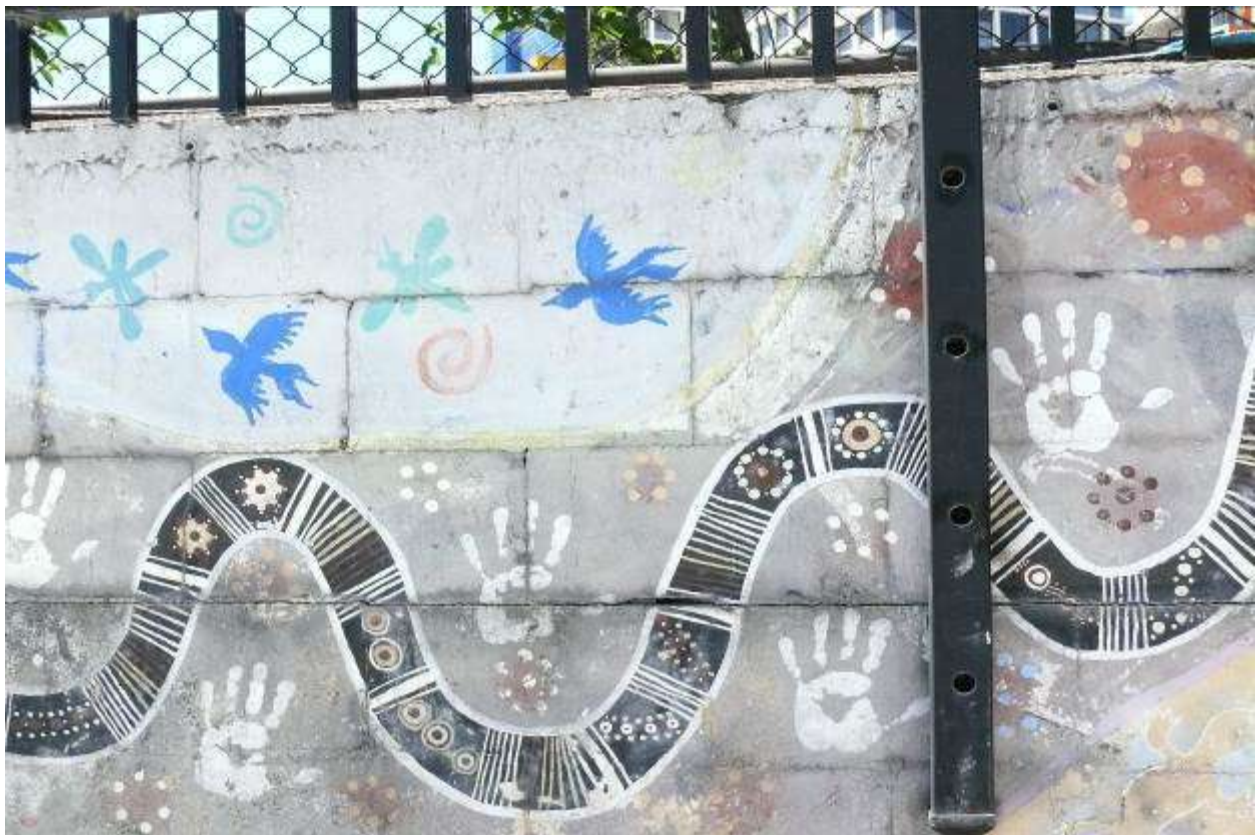
Figure 71 – Crack propagation through boundary wall observed from Eveleigh Street

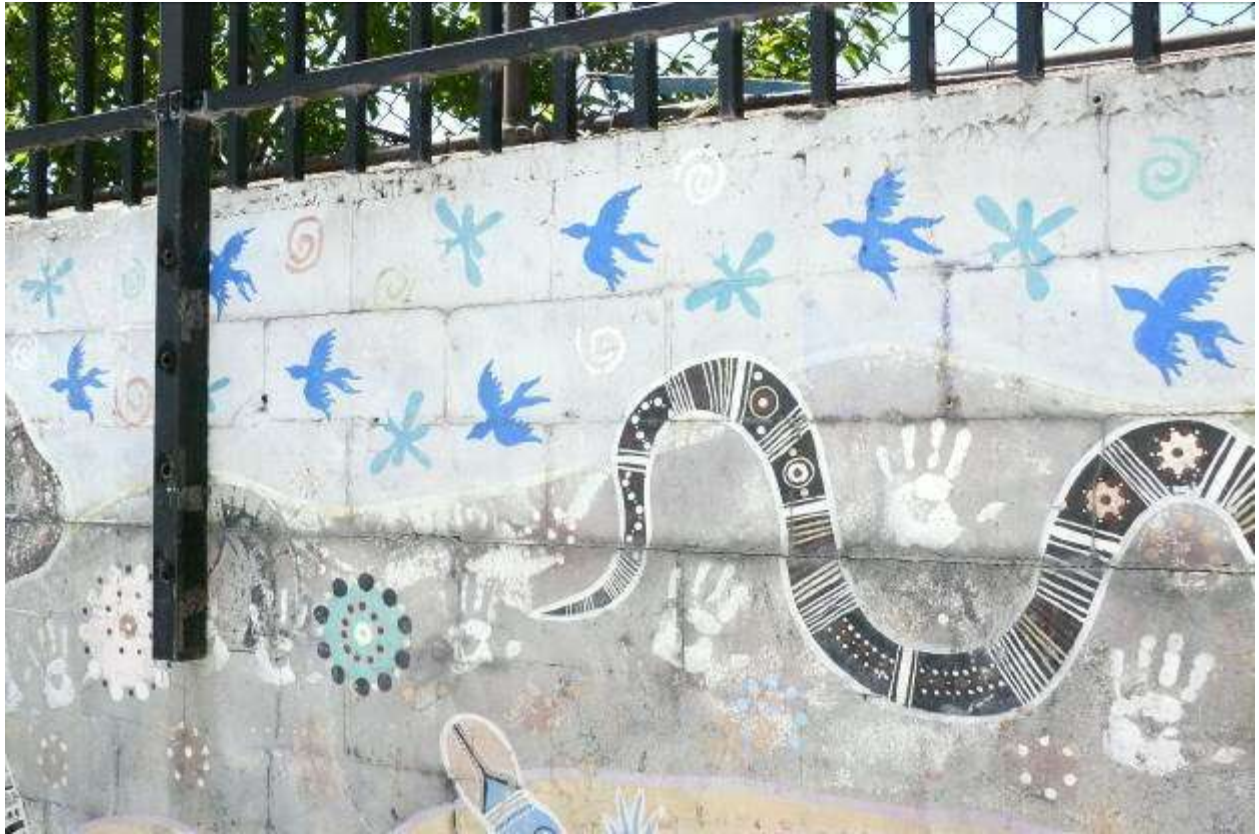
Figure 72 – Crack propagation through boundary wall observed from Eveleigh Street

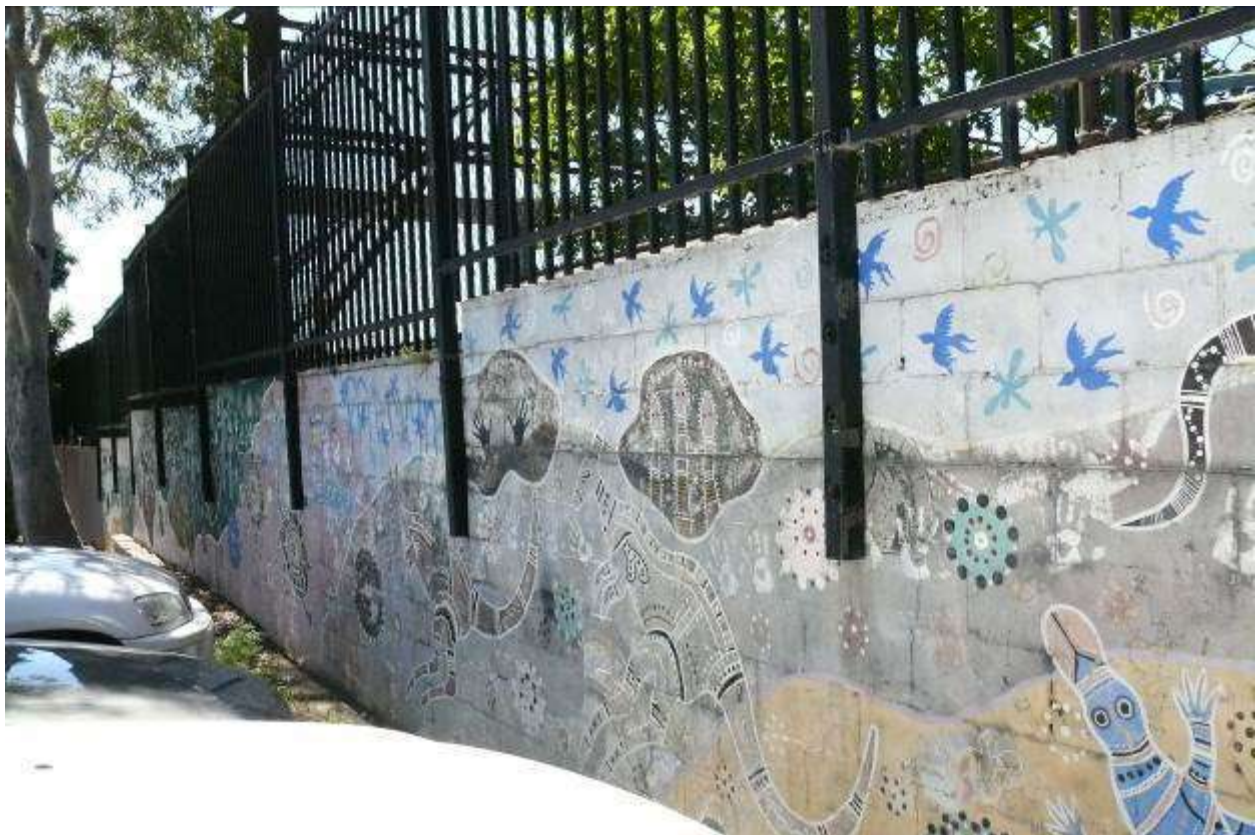
Figure 73 – Crack propagation through boundary wall observed from Eveleigh Street

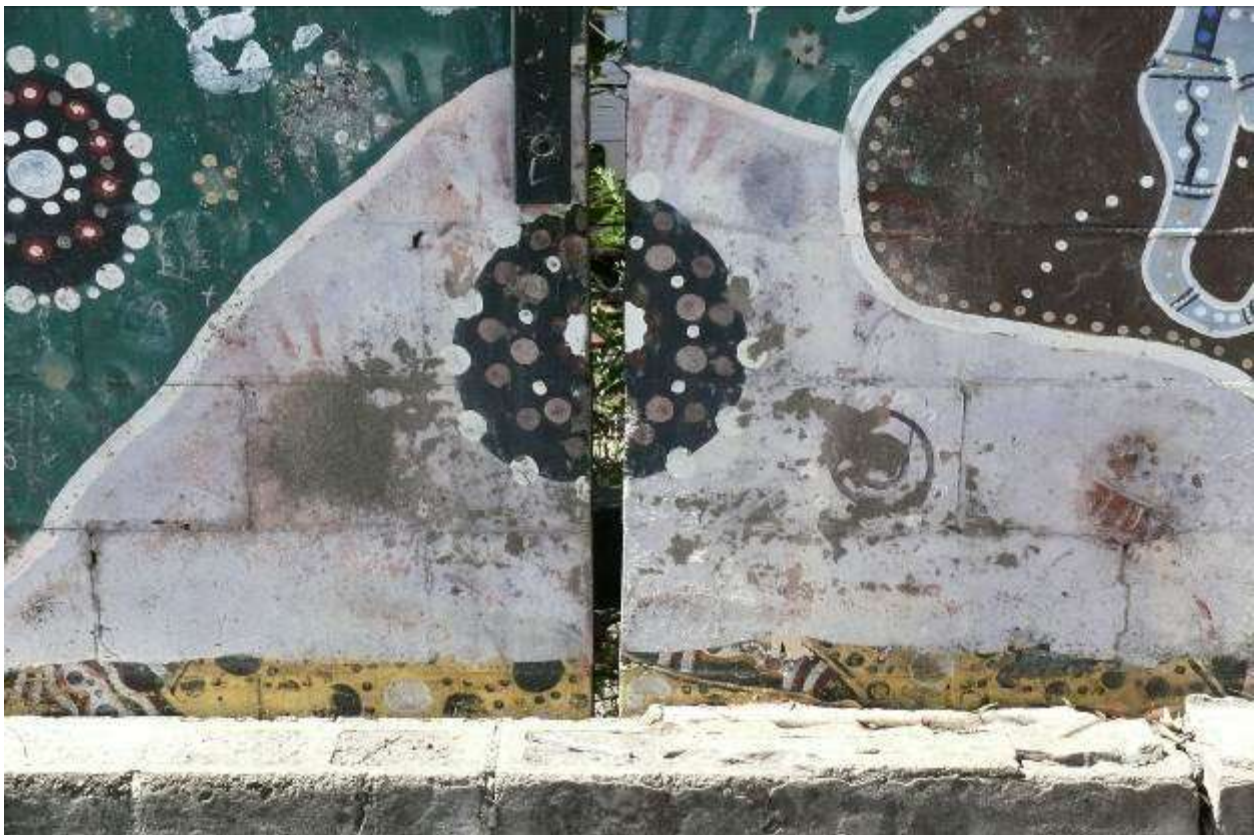
Figure 87 – Crack propagation and separation through boundary wall observed from Eveleigh Street

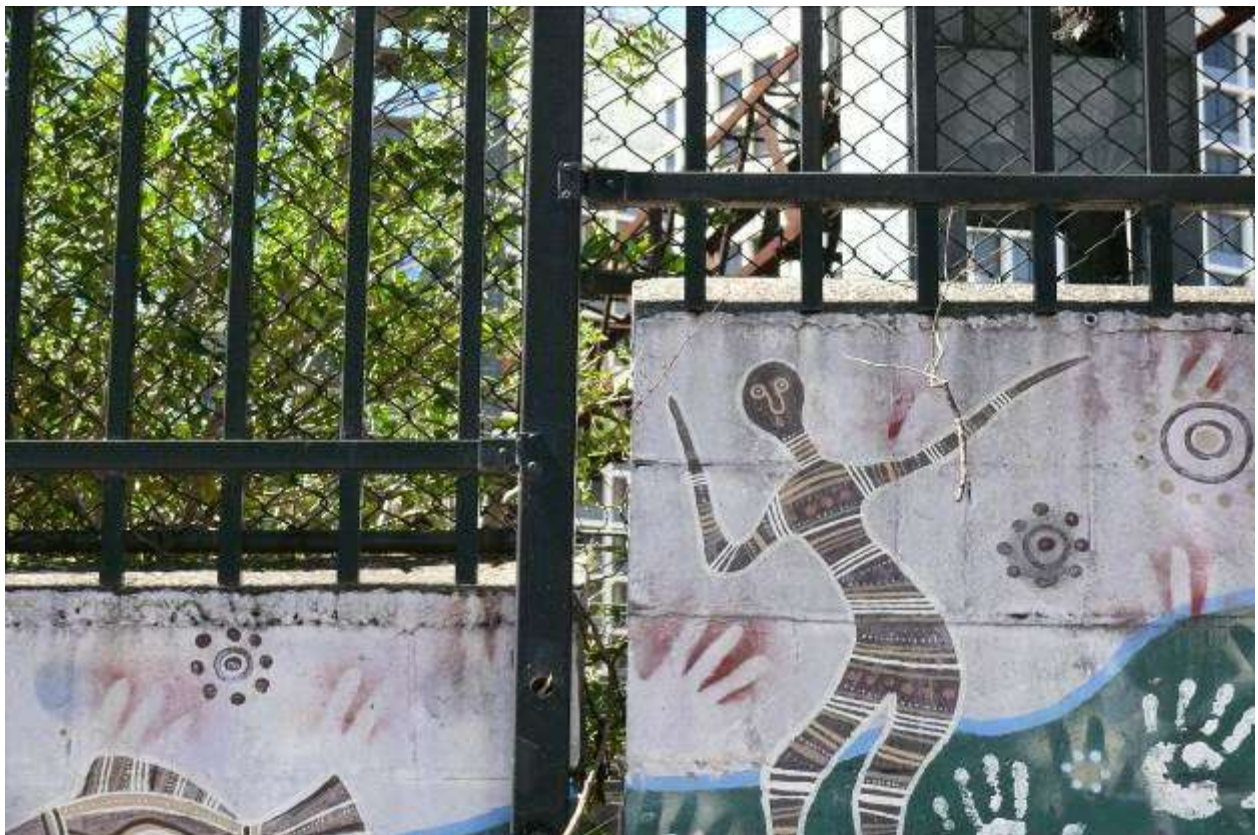
Figure 89 – Crack propagation and separation through boundary wall observed from Eveleigh Street

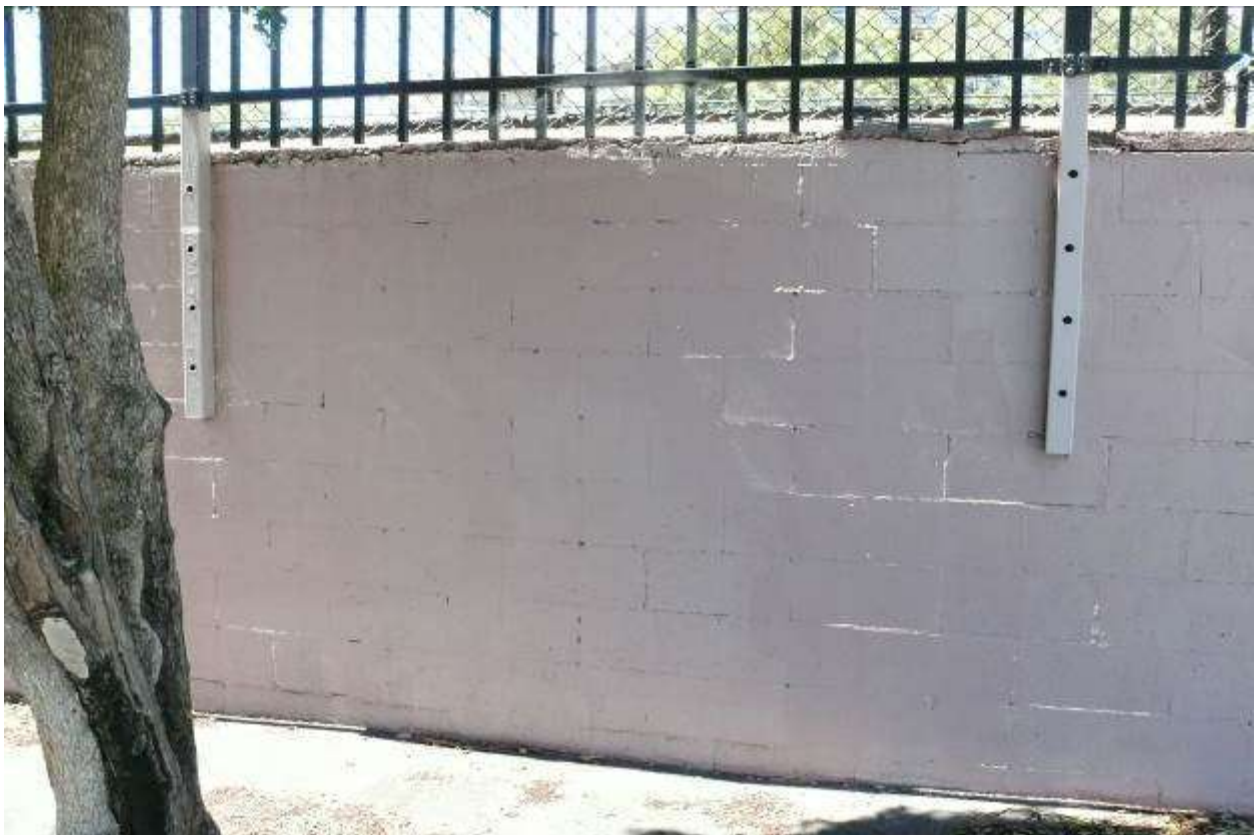
Figure 95 – Crack propagation and loss of material through boundary wall observed from Eveleigh Street

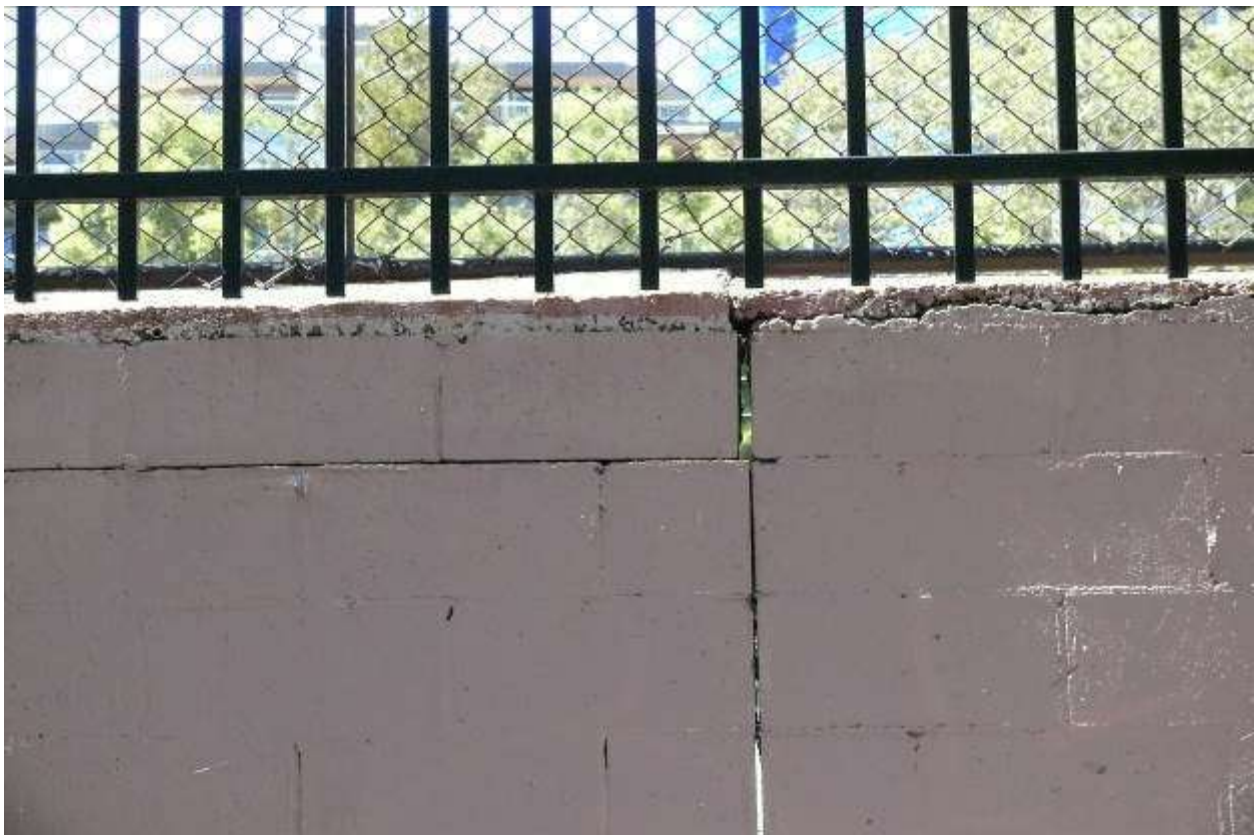
Figure 99 – Crack propagation and separation through boundary wall observed from Eveleigh Street

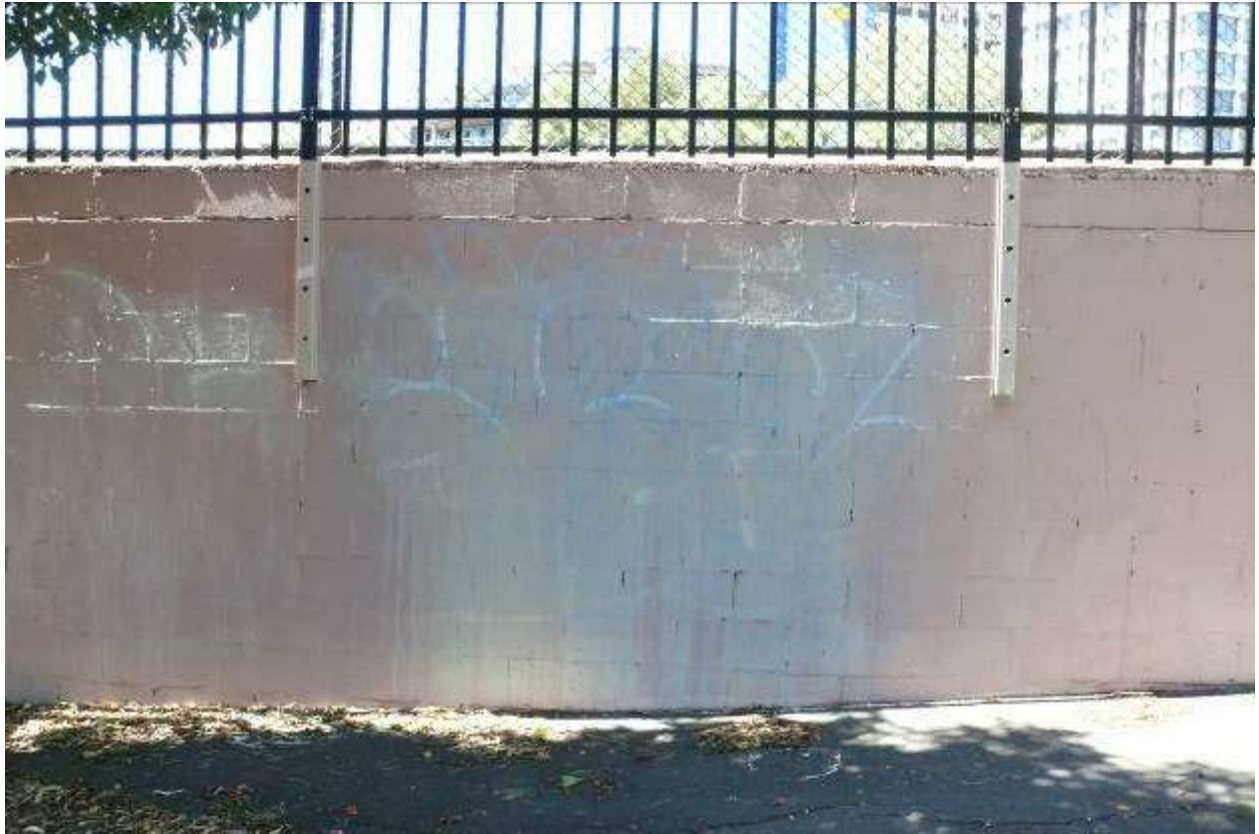
Figure 100 – Crack propagation and separation through boundary wall observed from Eveleigh Street

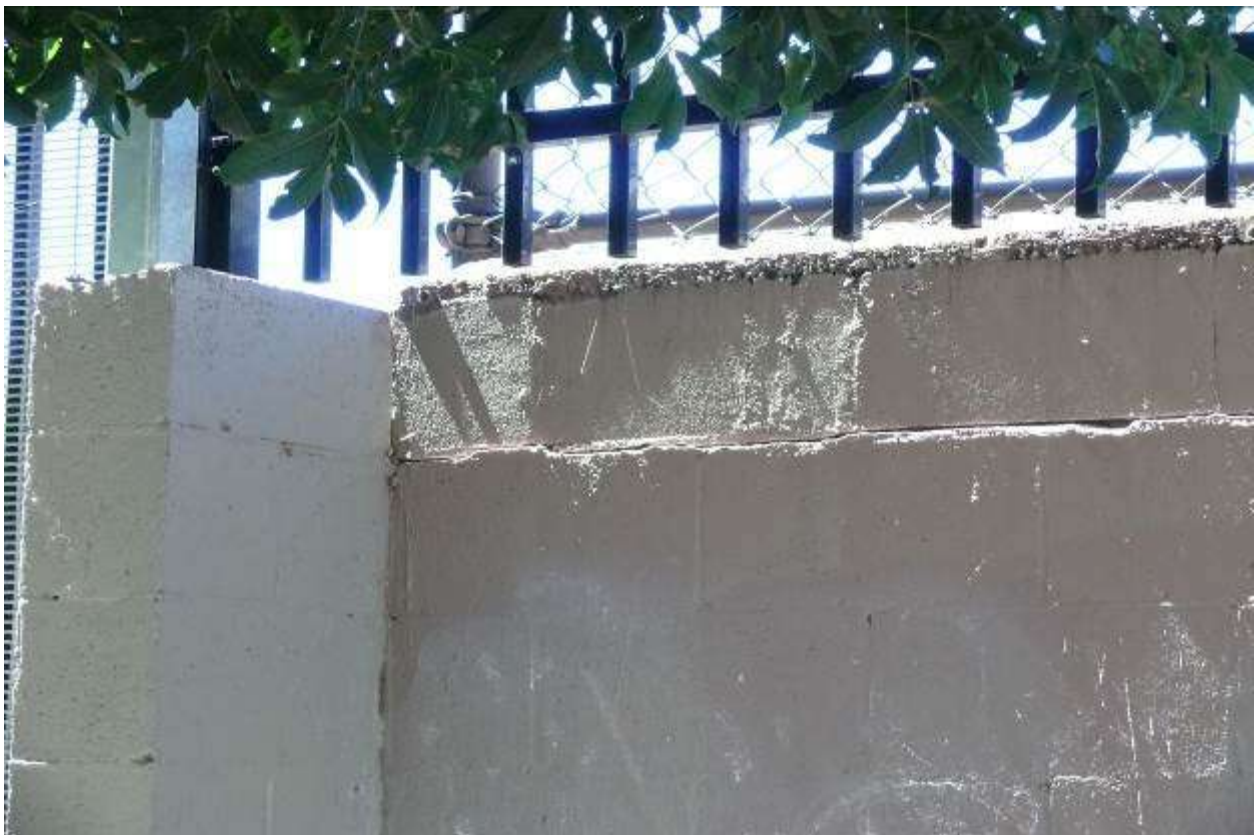
Figure 103 – Crack propagation through boundary wall observed from Eveleigh Street
