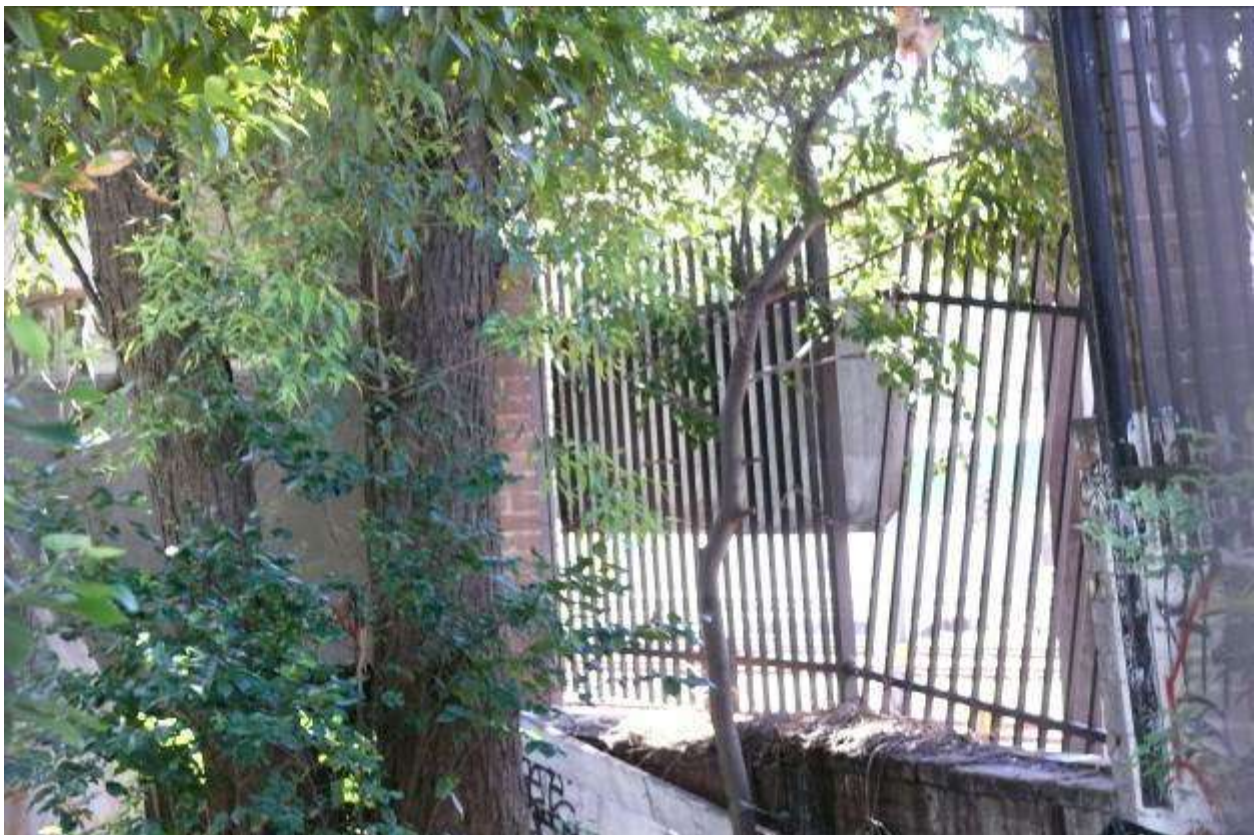
Figure 115 – Physical damage to boundary fence observed from Eveleigh Street

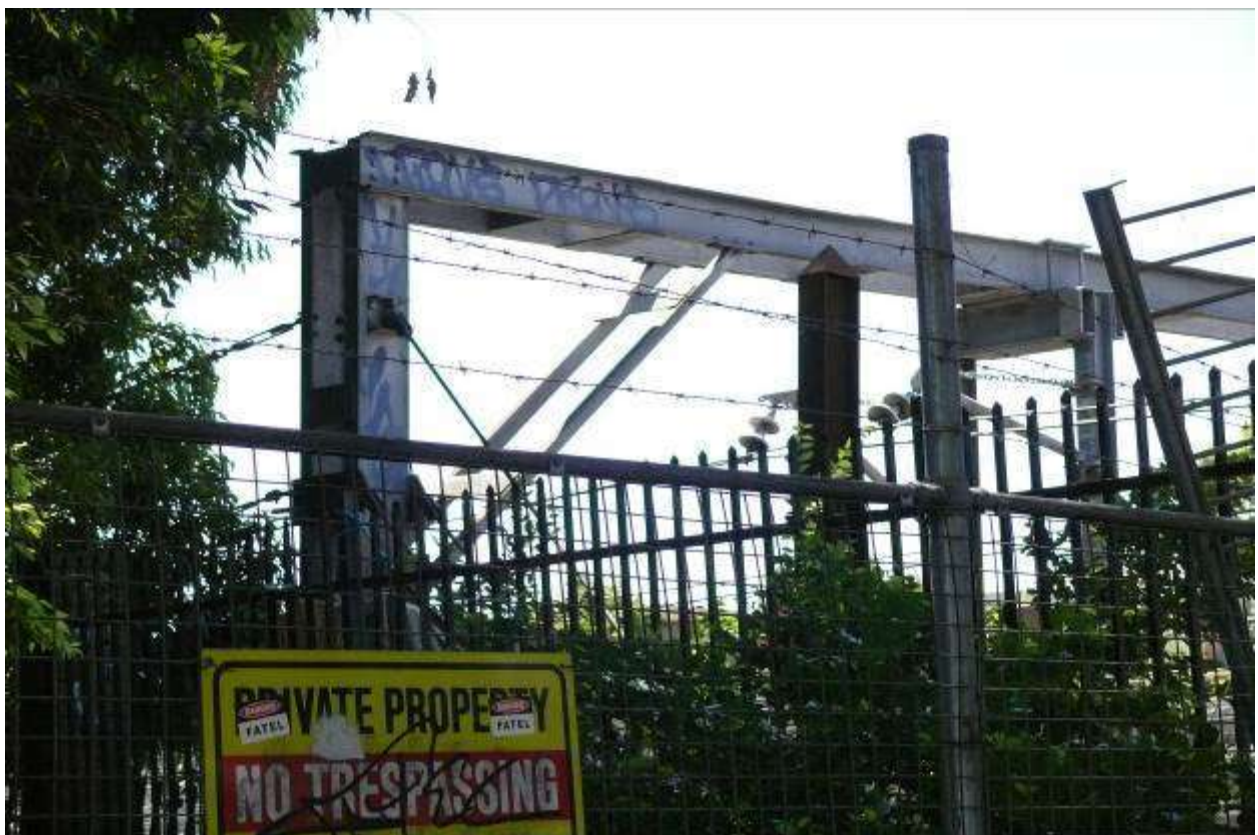
Figure 117 – Physical damage to boundary fence observed from Eveleigh Street
