Re: Dilapidation Report for Property
No: Pemulwuy Project - Redfern NSW 2016

Job: 170037.0
Date: MAY 2017

SUMMARY

This report serves as a record of the condition of the RailCorp infrastructure assets of the "Metro Illawarra & South Coast" line, which is adjacent to the subject site, prior to the commencement of any works proposed at: Pemulwuy Project - Redfern NSW 2016.

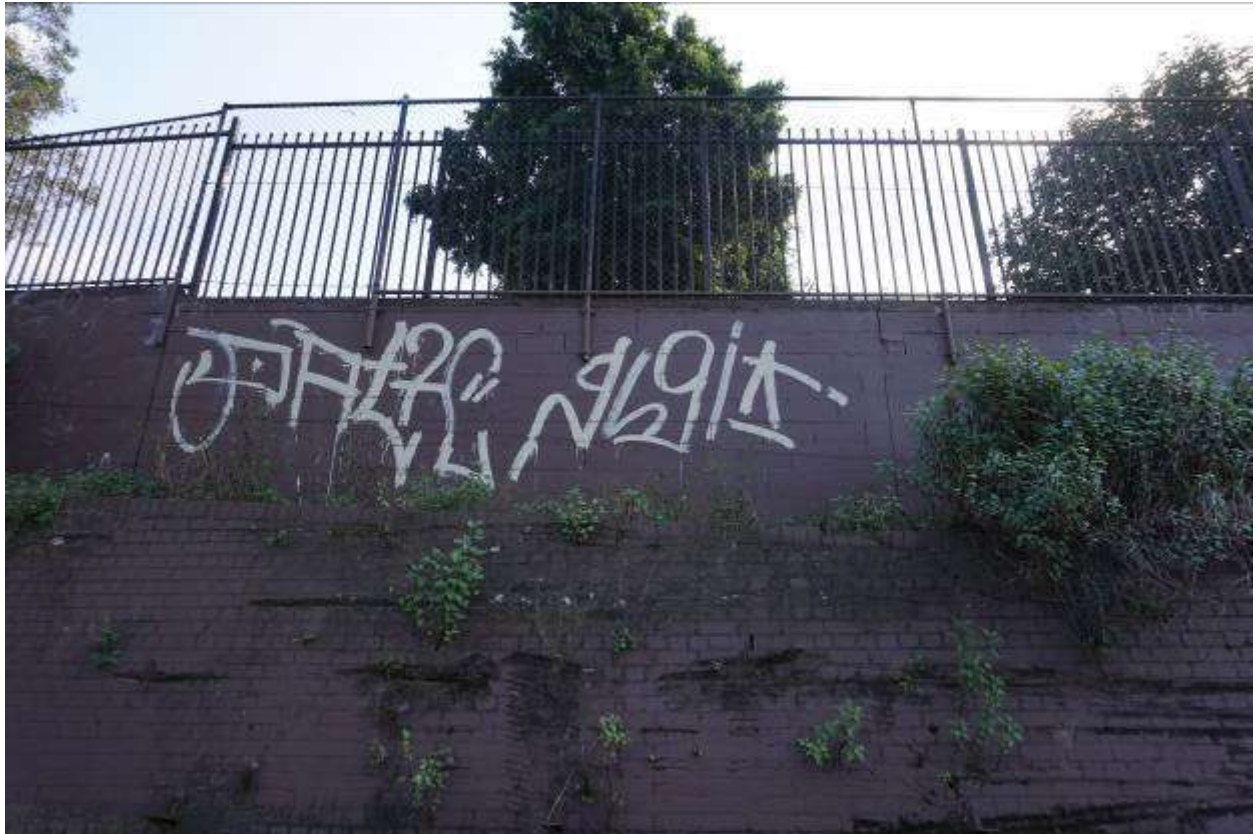
Figure 171 – General condition of RailCorp boundary wall and fence observed from Railway Corridor

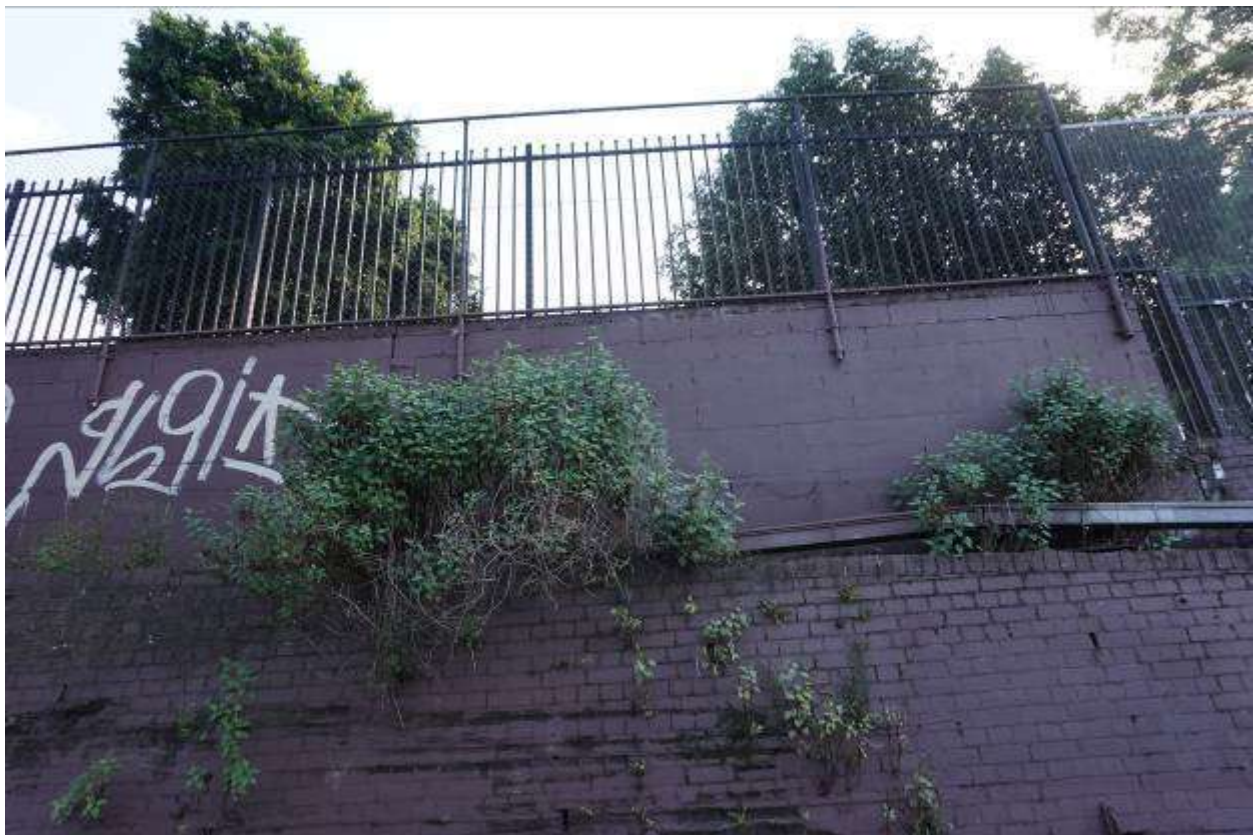
Figure 172 – General condition of RailCorp boundary wall and fence observed from Railway Corridor

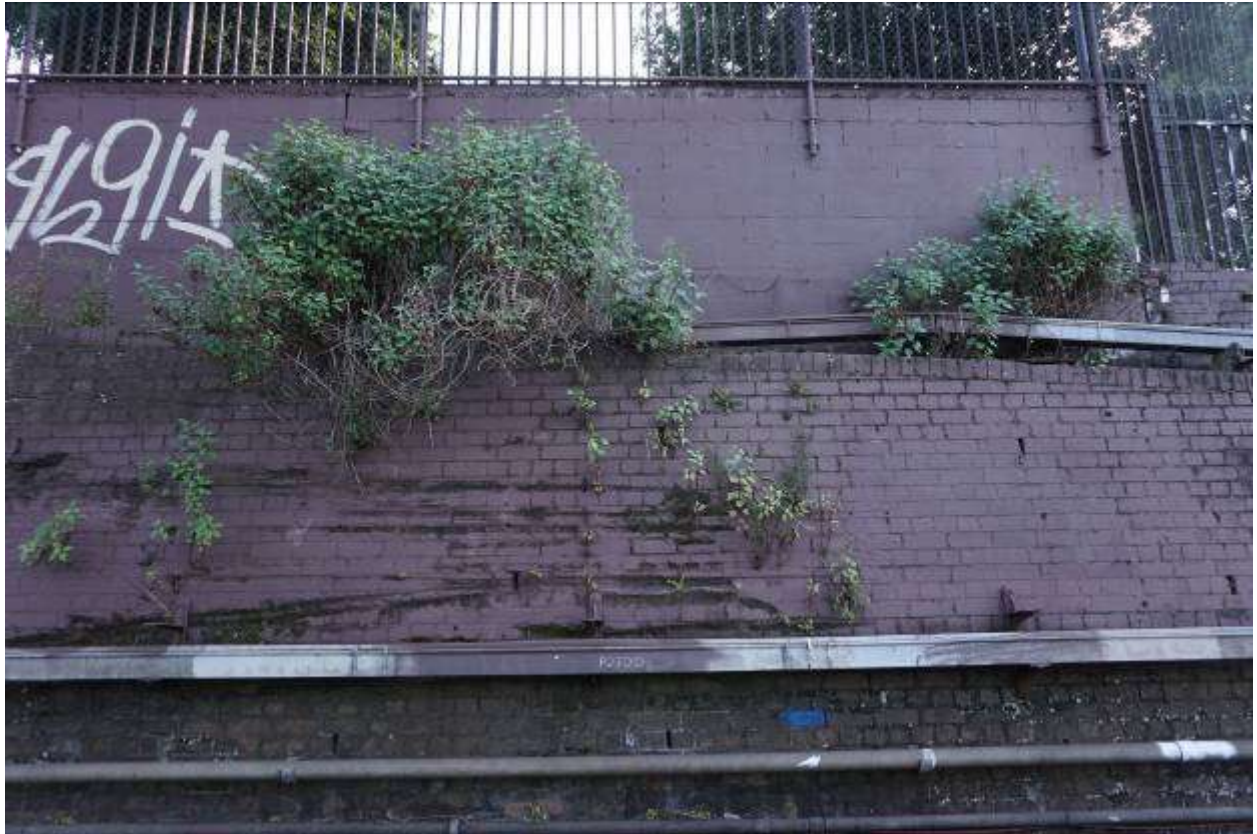
Figure 173 – General condition of RailCorp boundary wall observed from Railway Corridor

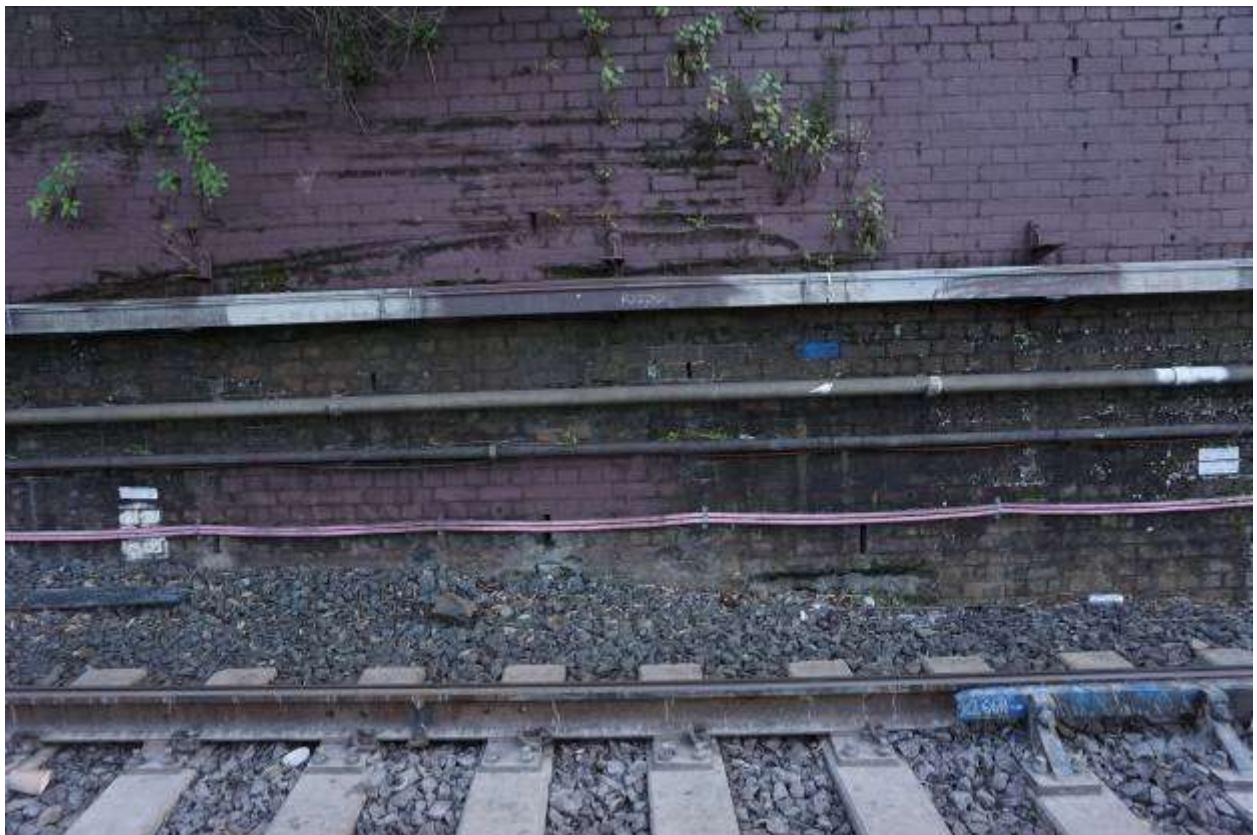
Figure 174 – General condition of RailCorp boundary wall observed from Railway Corridor

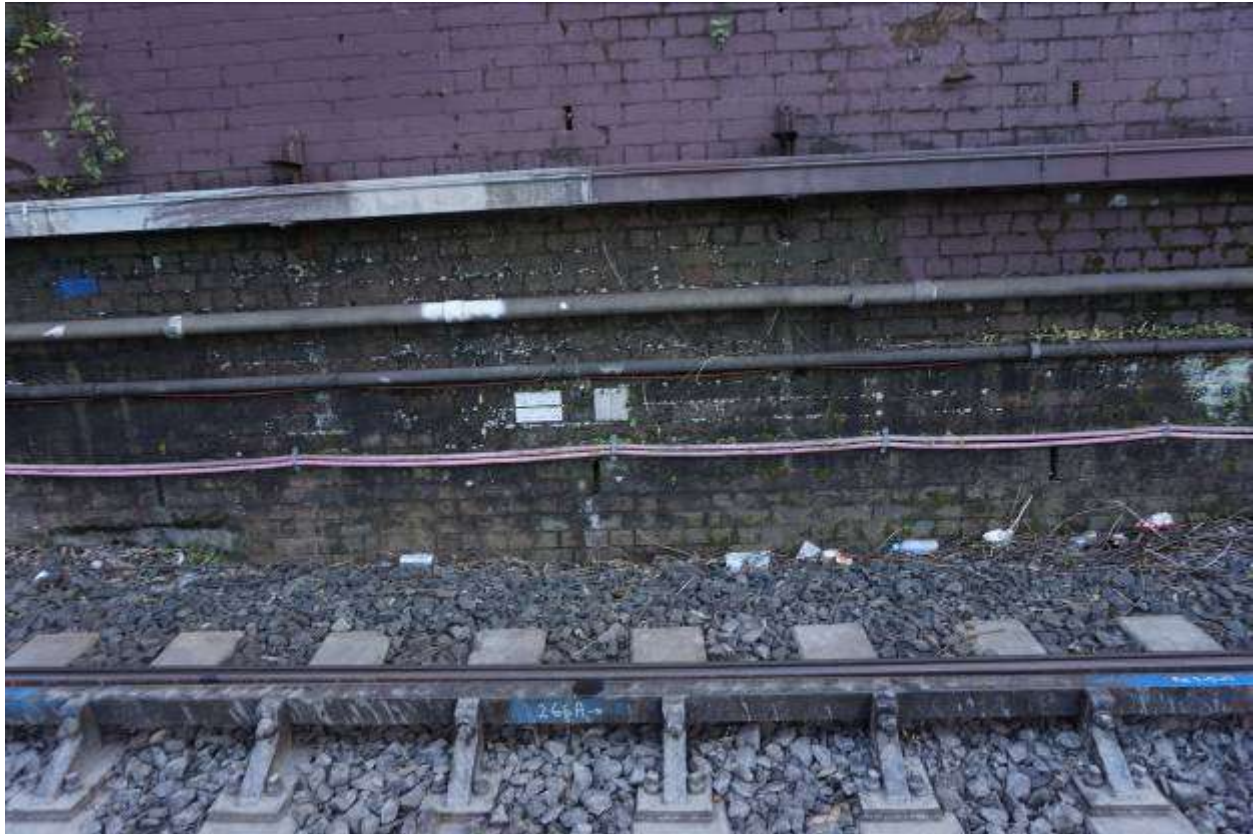
Figure 175 – General condition of RailCorp boundary wall observed from Railway Corridor

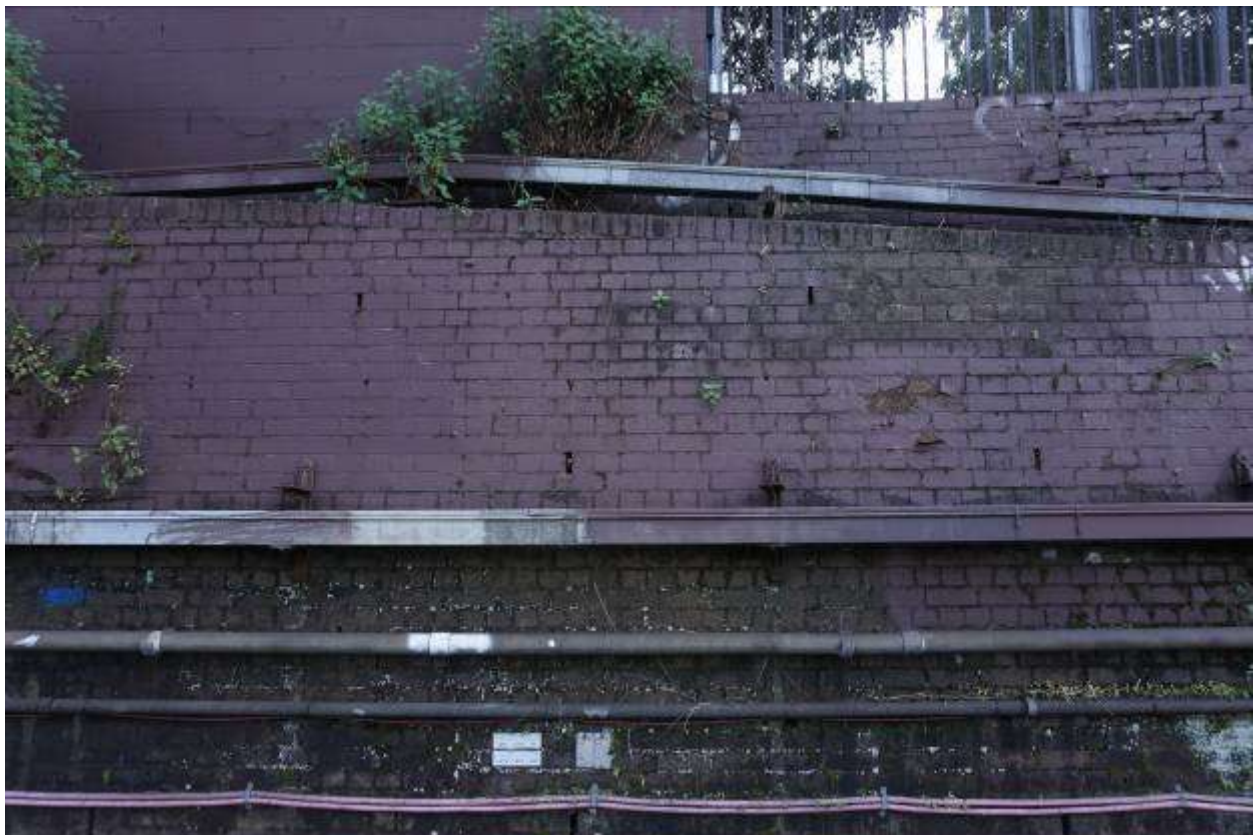
Figure 176 – General condition of RailCorp boundary wall observed from Railway Corridor

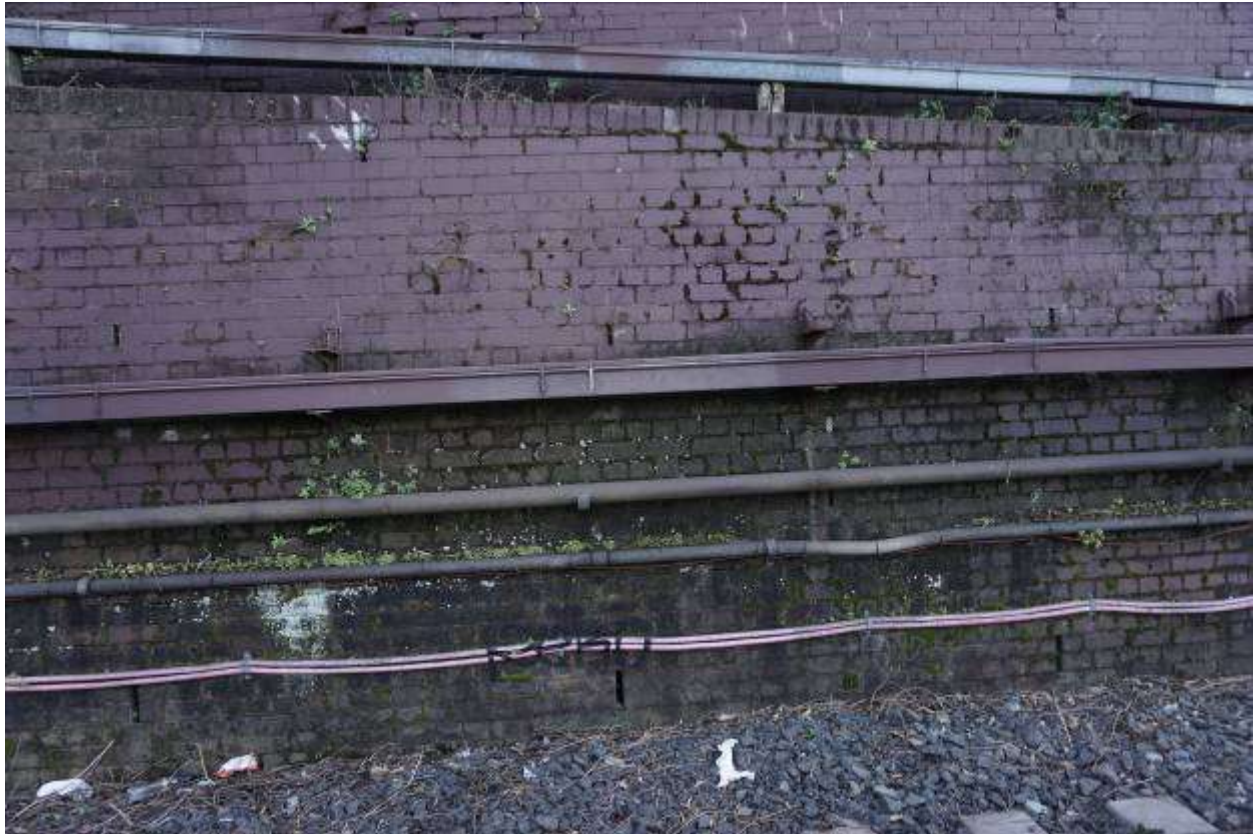
Figure 179 – General condition of RailCorp boundary wall observed from Railway Corridor

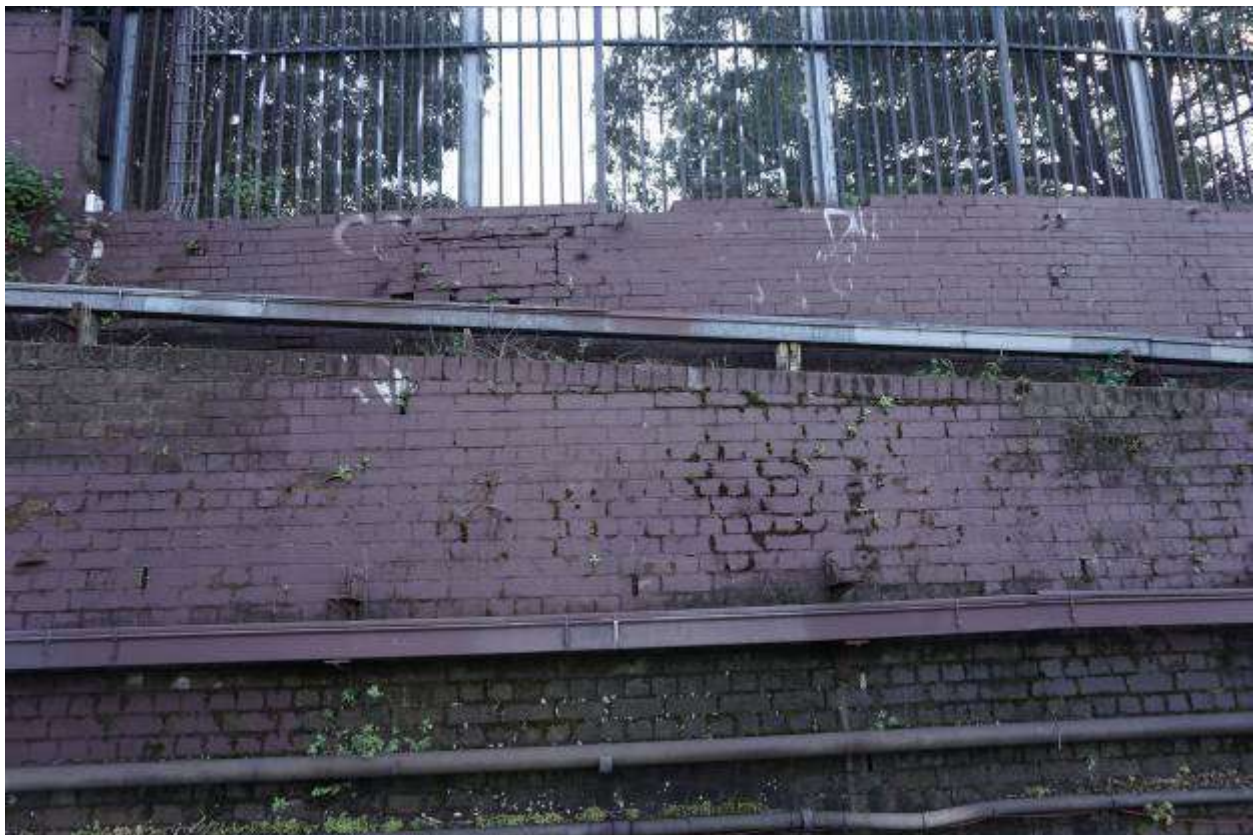
Figure 180 – General condition of RailCorp boundary wall observed from Railway Corridor

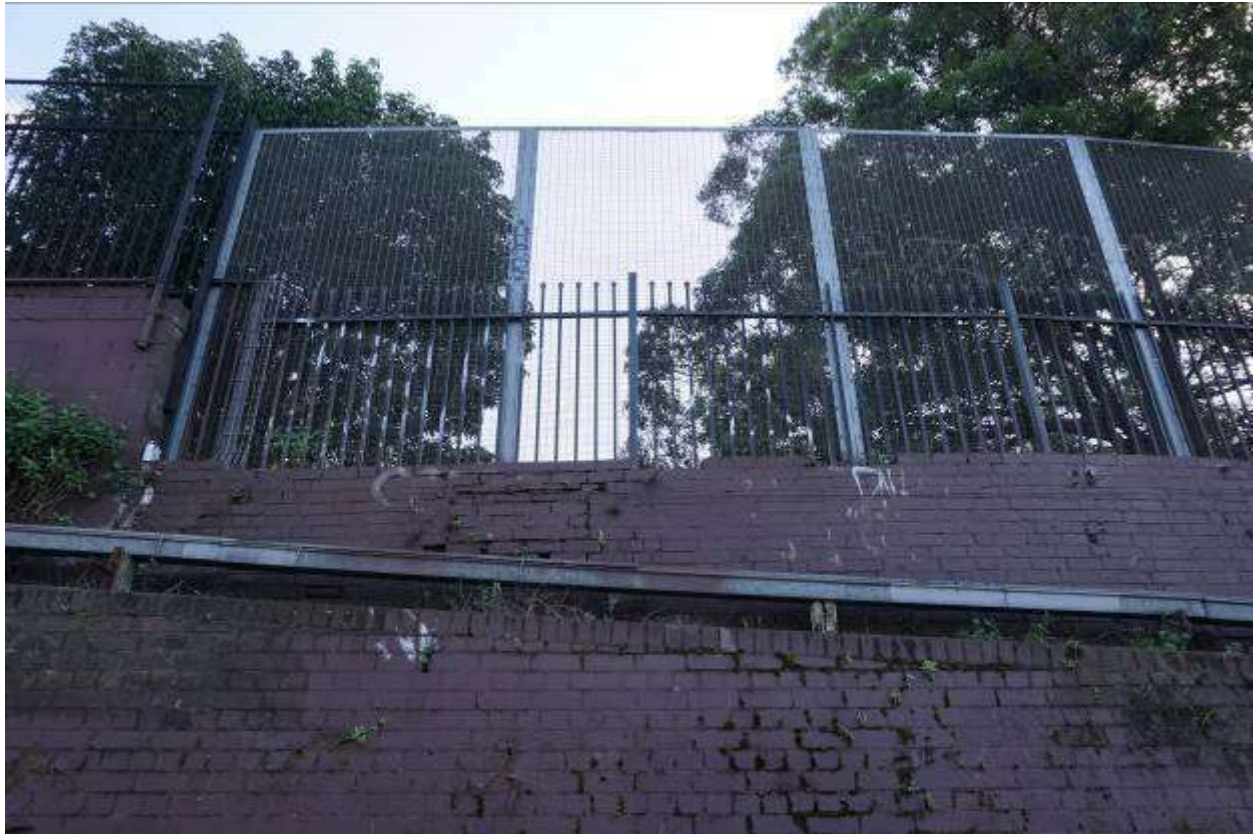
Figure 181 – General condition of RailCorp boundary wall and fence observed from Railway Corridor

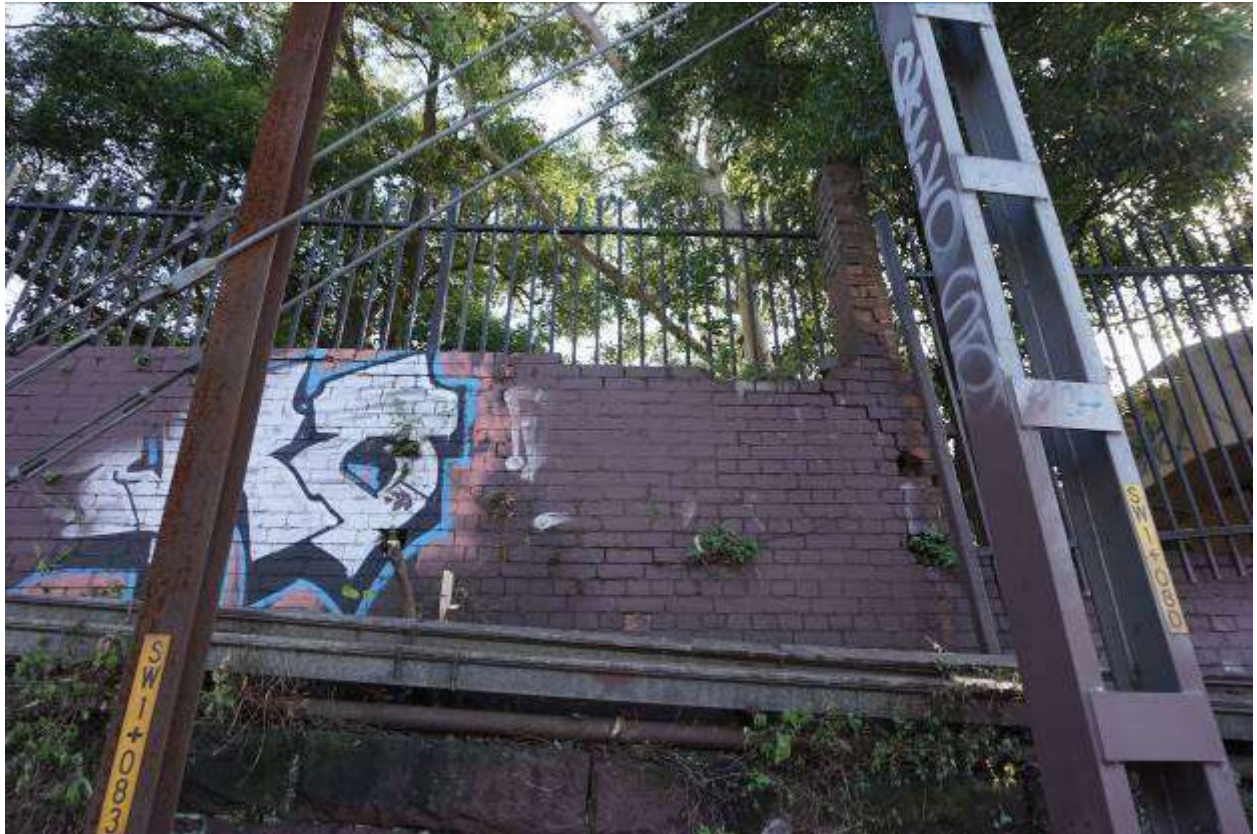
Figure 191 – Crack propagation through RailCorp boundary wall and fence observed from Railway Corridor

The boundary walls along Eveleigh Street was also inspected and it was determined to be in reasonable to poor condition with various cases of cracking, separation and material loss noted throughout the wall. Some cases of physical damage was also observed through the boundary fence along this street.

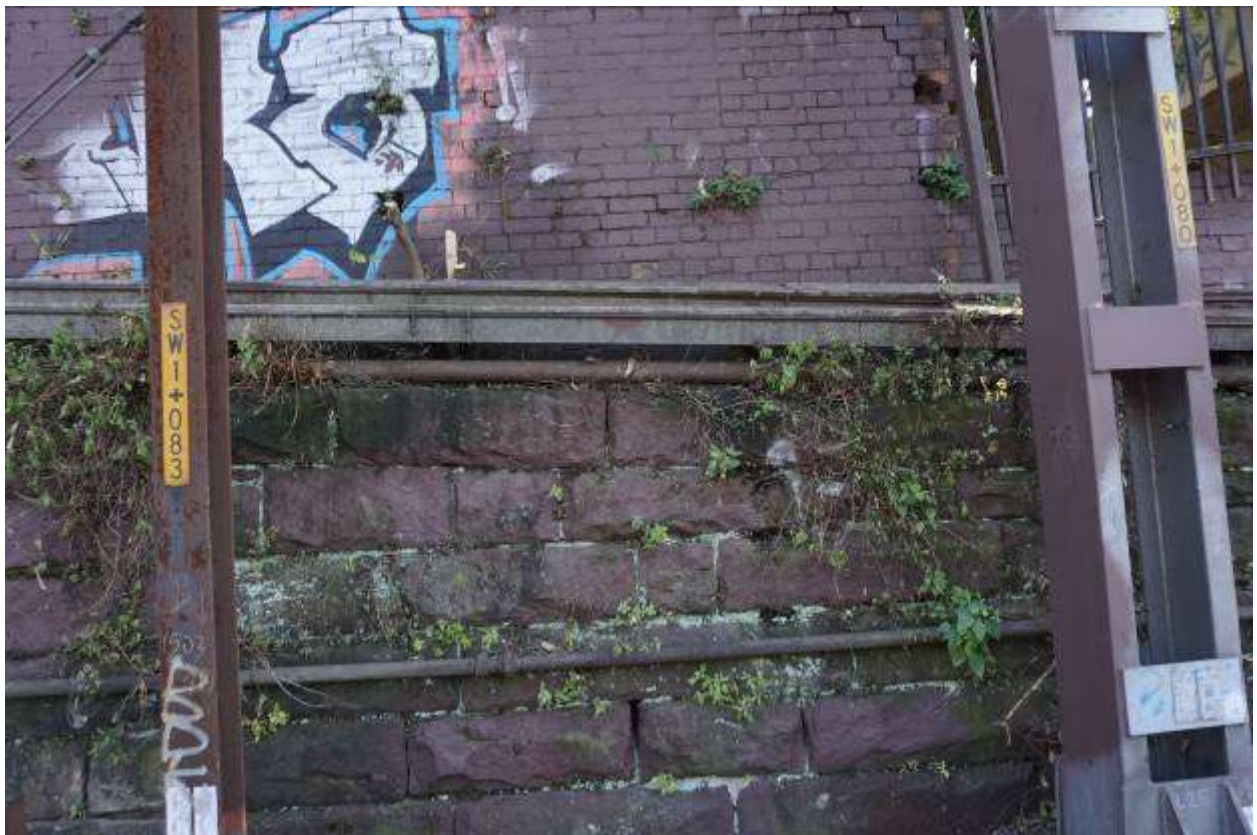
Figure 192 – Crack propagation through RailCorp boundary wall observed from Railway Corridor

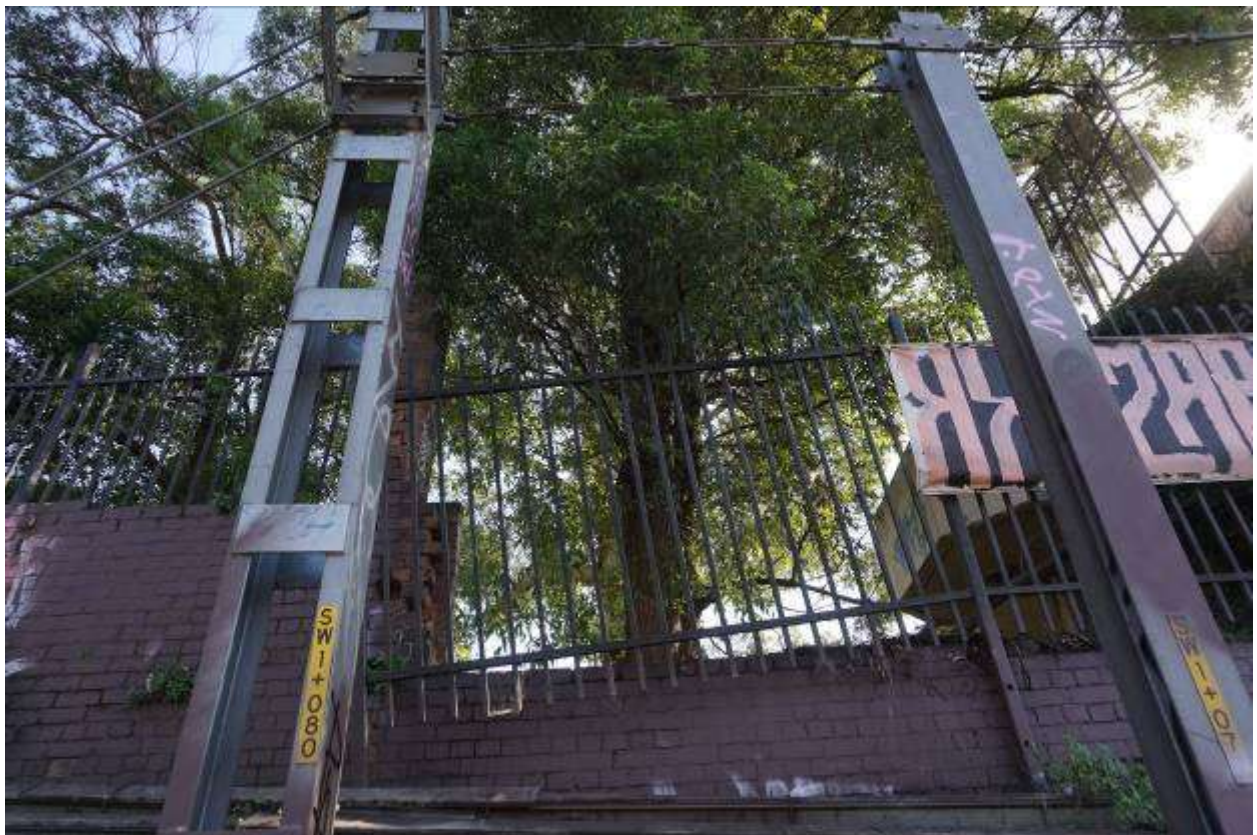
Figure 196 – Physical damage through RailCorp boundary fence observed from Railway Corridor

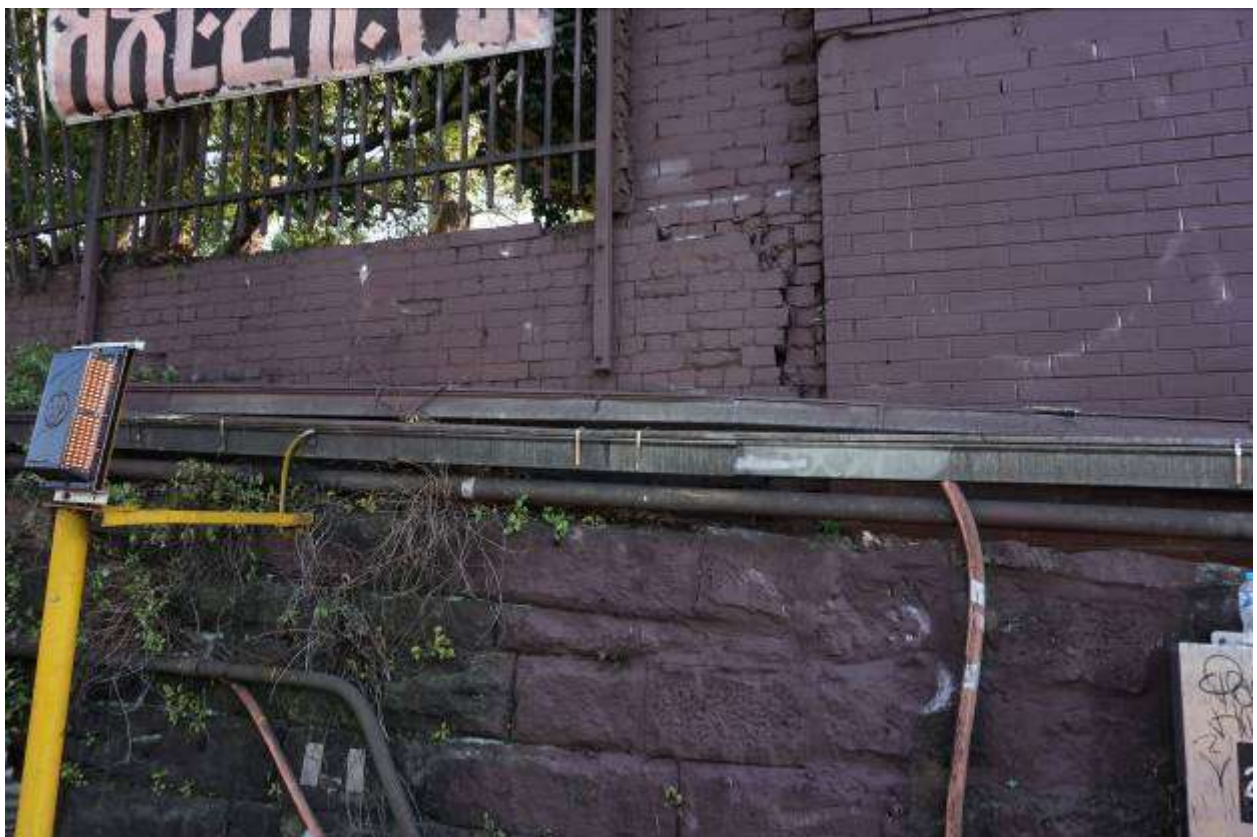
Figure 198 – Crack propagation and loss of material through RailCorp boundary wall observed from Railway Corridor

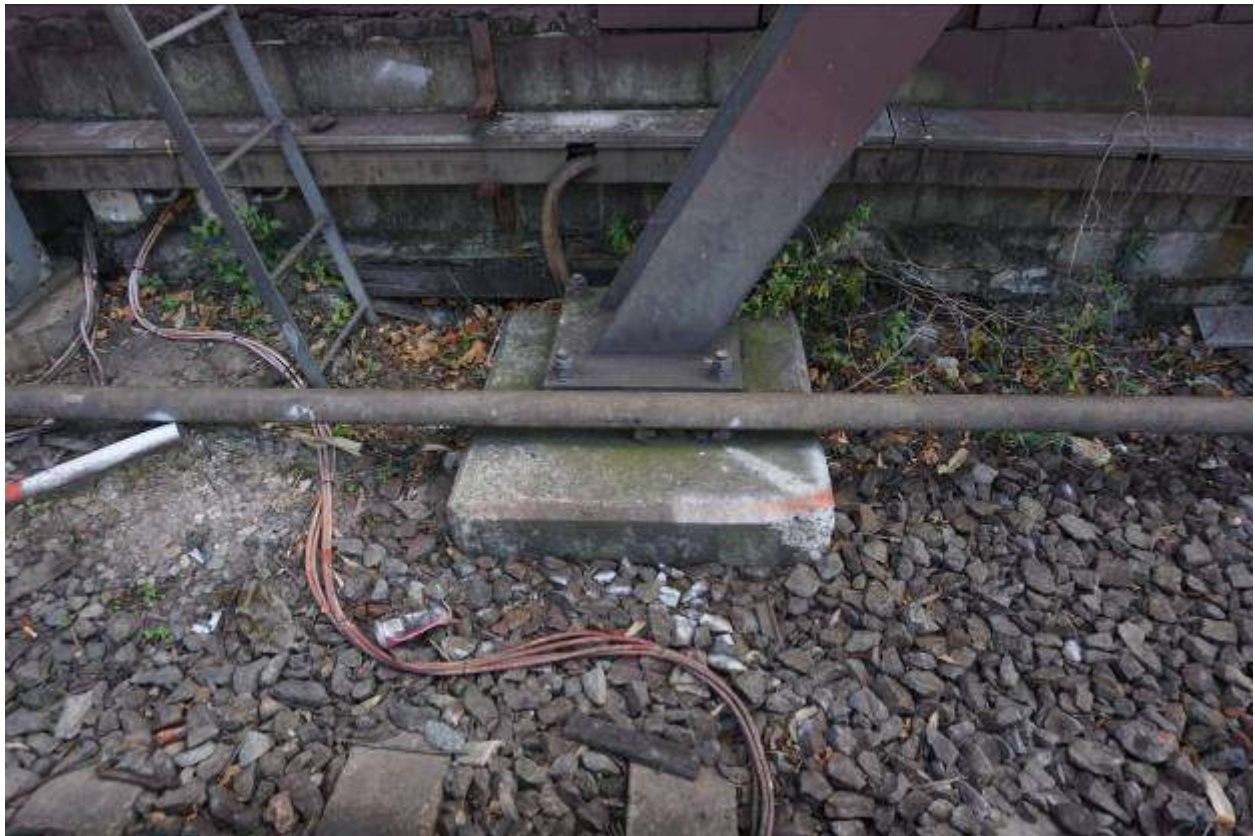
Figure 237 – General condition of concrete footing observed from Railway Corridor

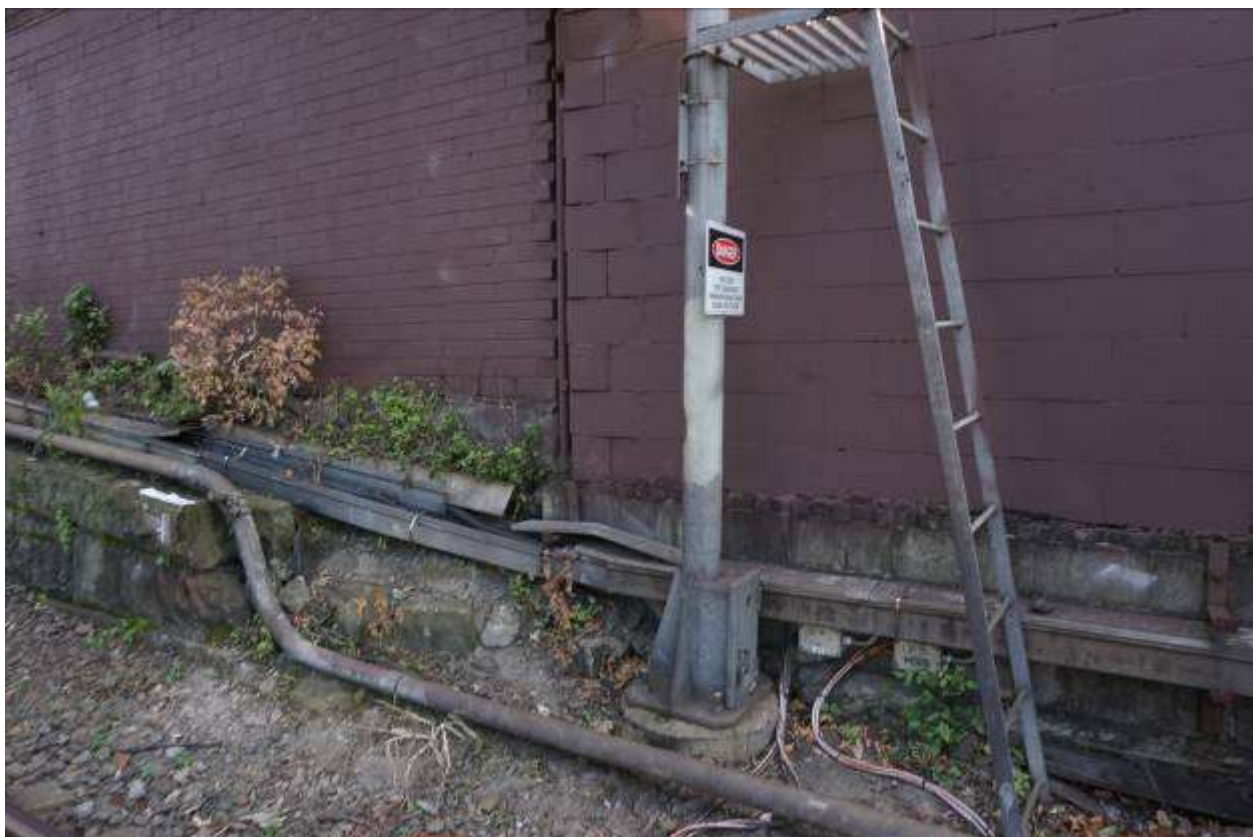
Figure 238 – General condition of RailCorp traffic signal observed from Railway Corridor

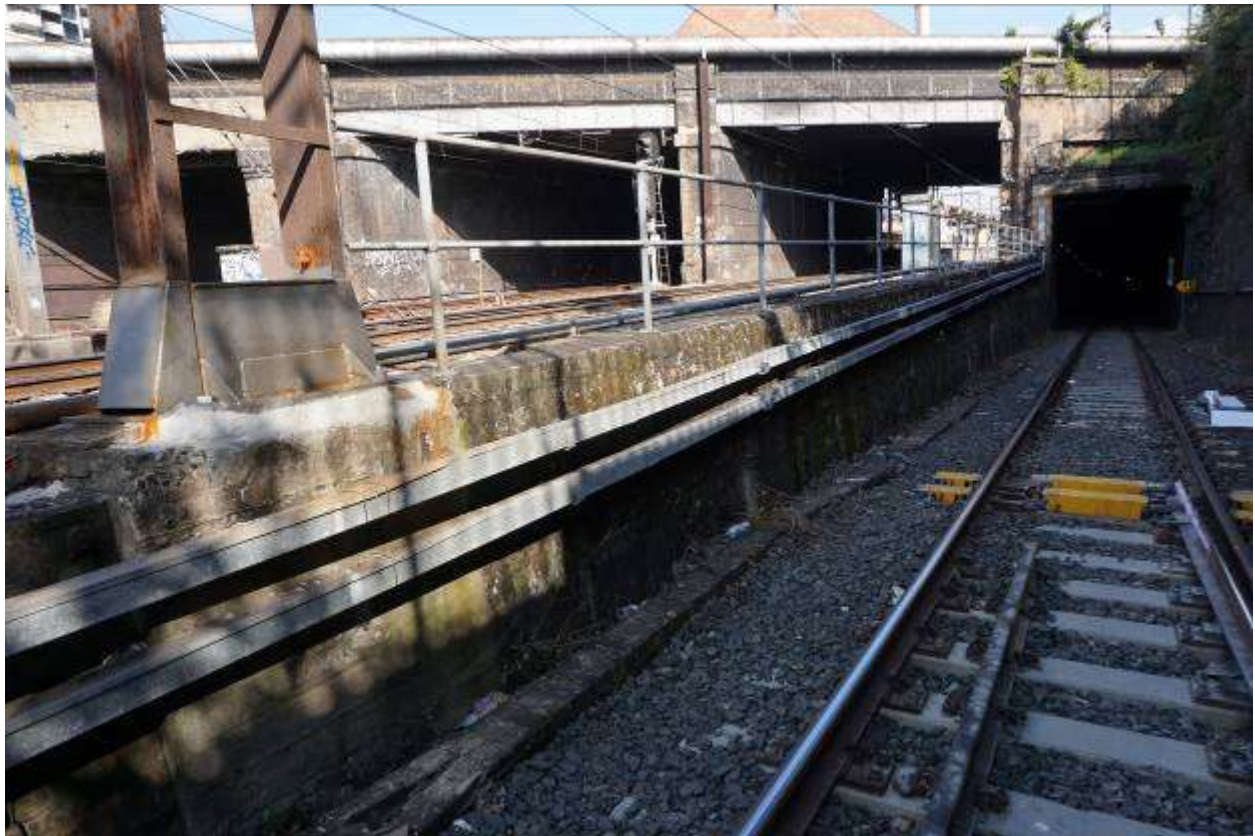
Figure 287 – General condition of RailCorp signal troughing observed from Railway Corridor

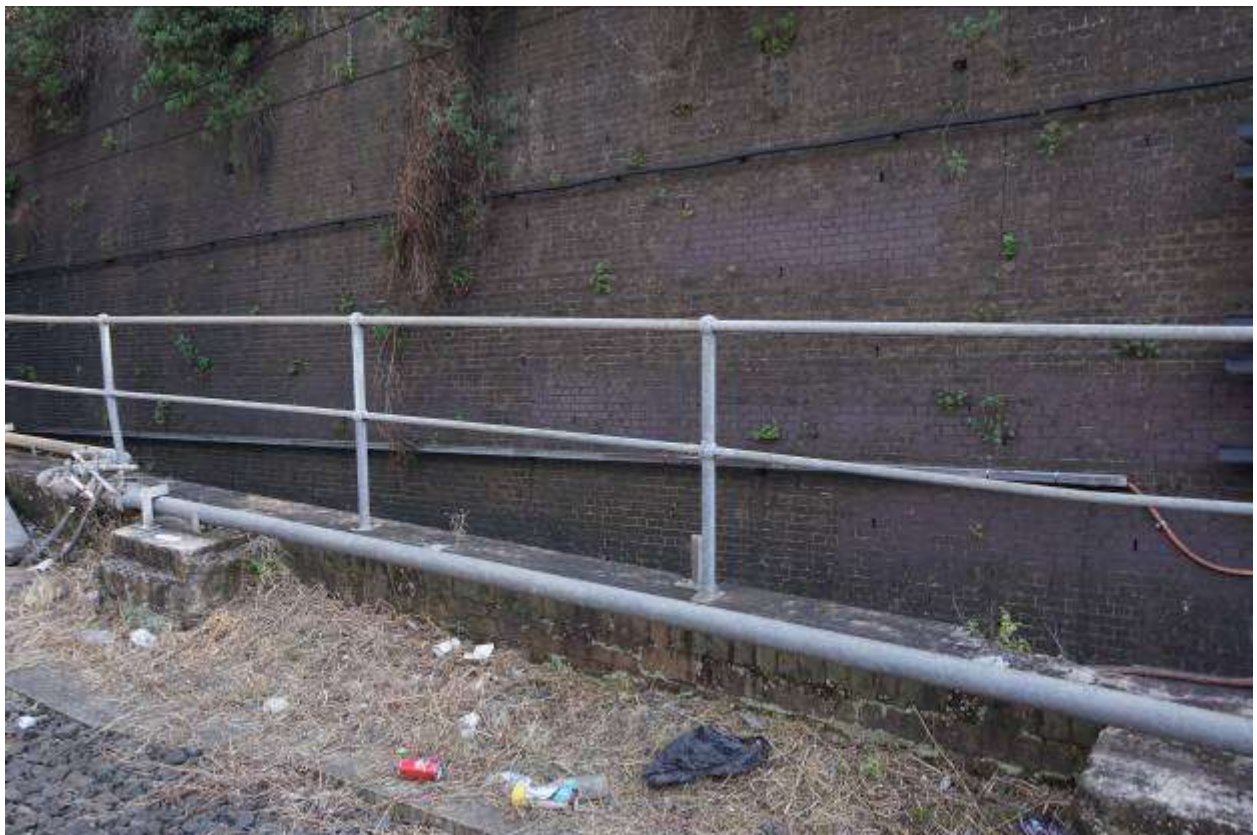
Figure 300 – General condition of railway boundary fence observed from Railway Corridor
