Structural Condition Report ATECO BUILDING – VALAD TEMPE SITE

for Valad Property Group

10 JULY 2008

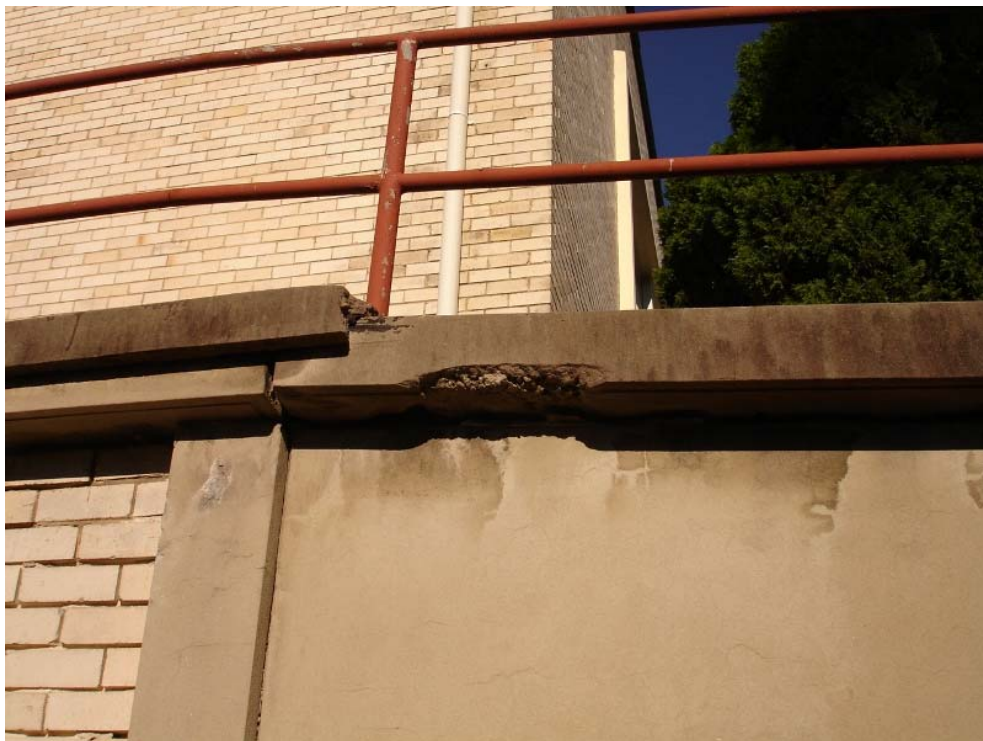
Photograph 10. Damage to Walkway, North Elevation

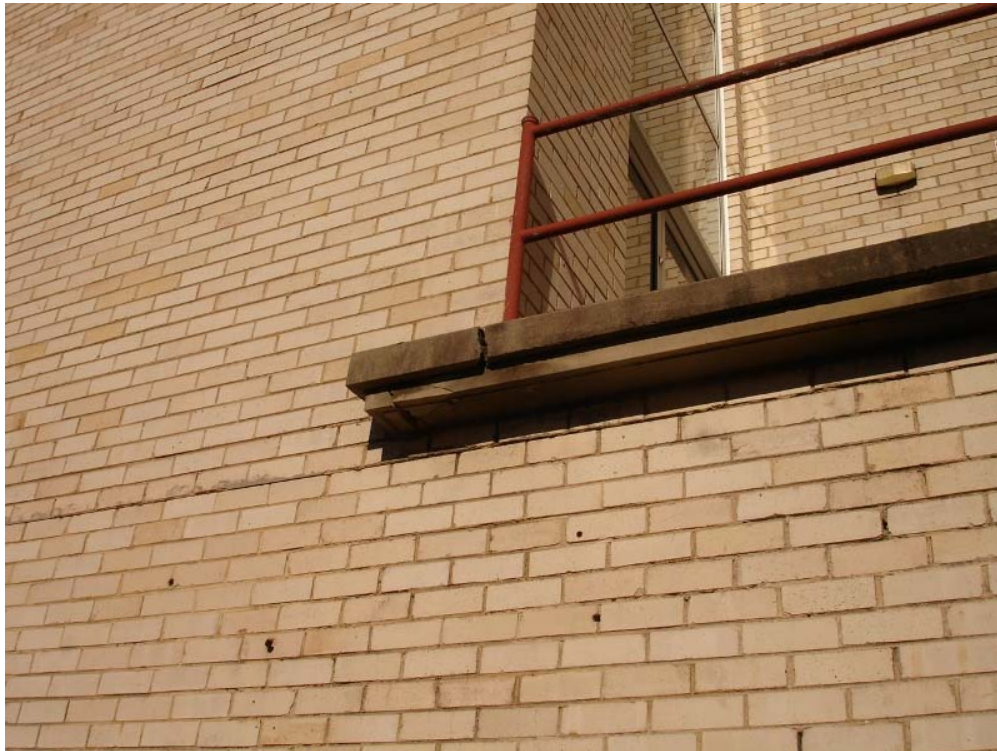
Photograph 11. Damage to Walkway, North Elevation

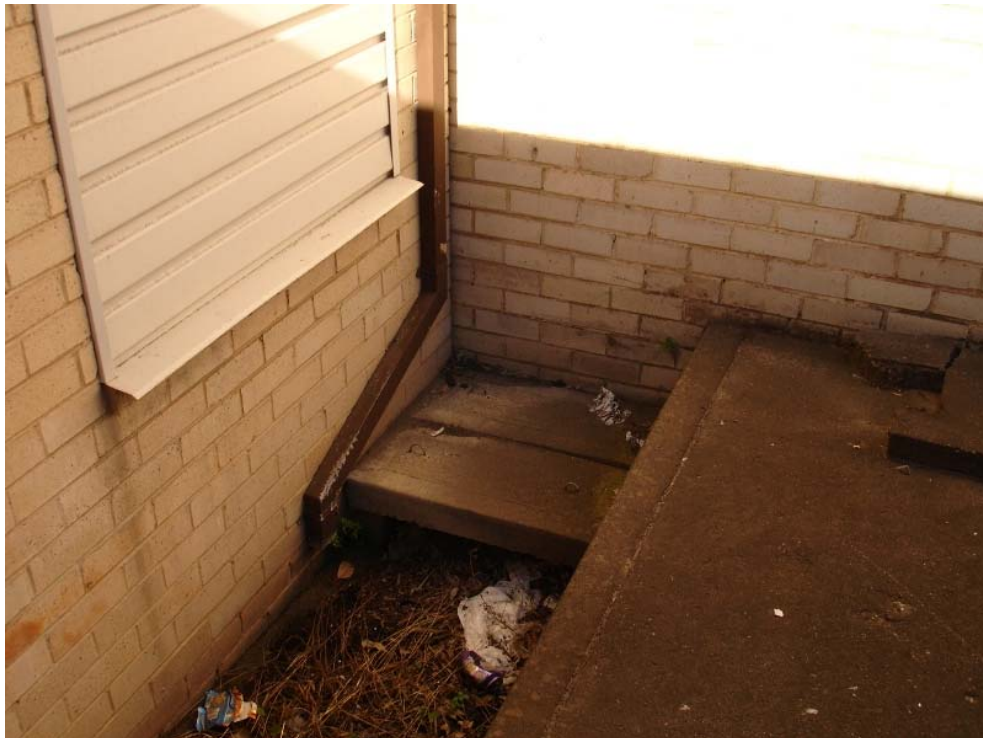
Photograph 12. Drainage Problems, North Elevation

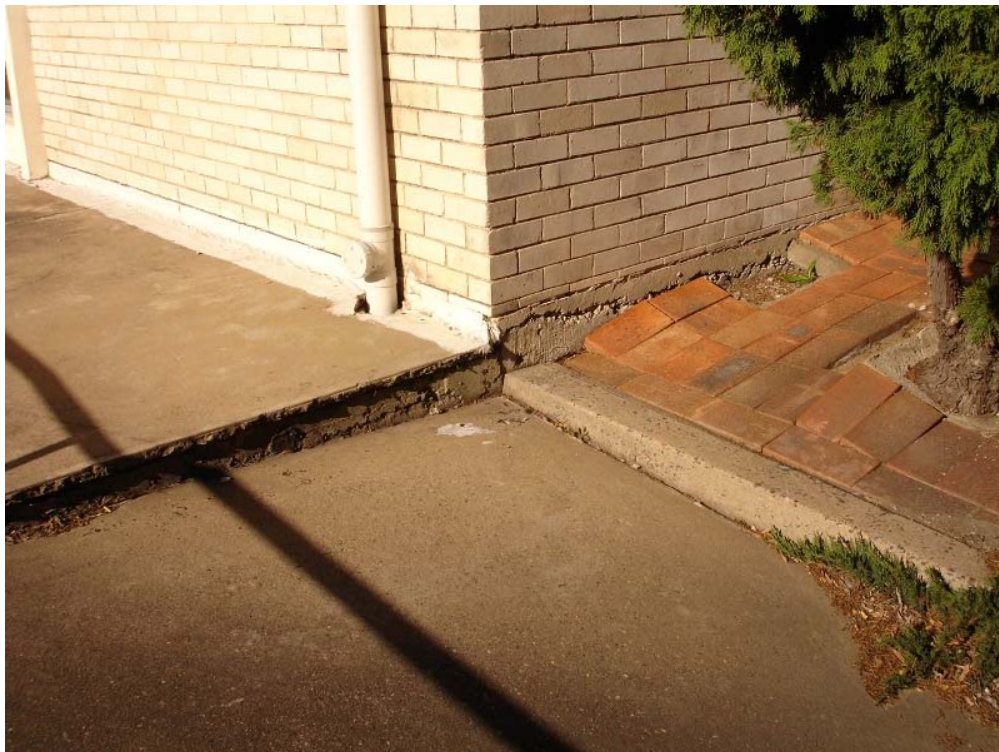
- Evidence of water ingress was noted on the retaining walls to the ground floor slab.
- The existing on grade pavements to the front of the building show evidence of cracking, settlement and rutting. Longterm consideration to replacing this pavement should be considered.

Photograph 14. Settlement of external pavement

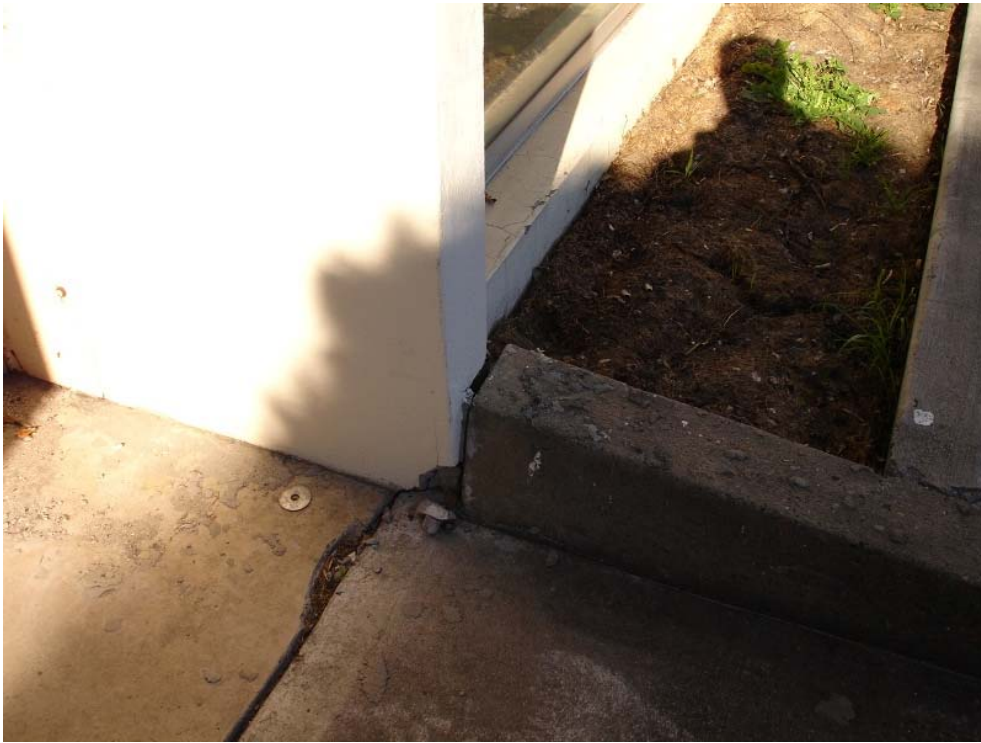
Photograph 15. Separation of concrete planter

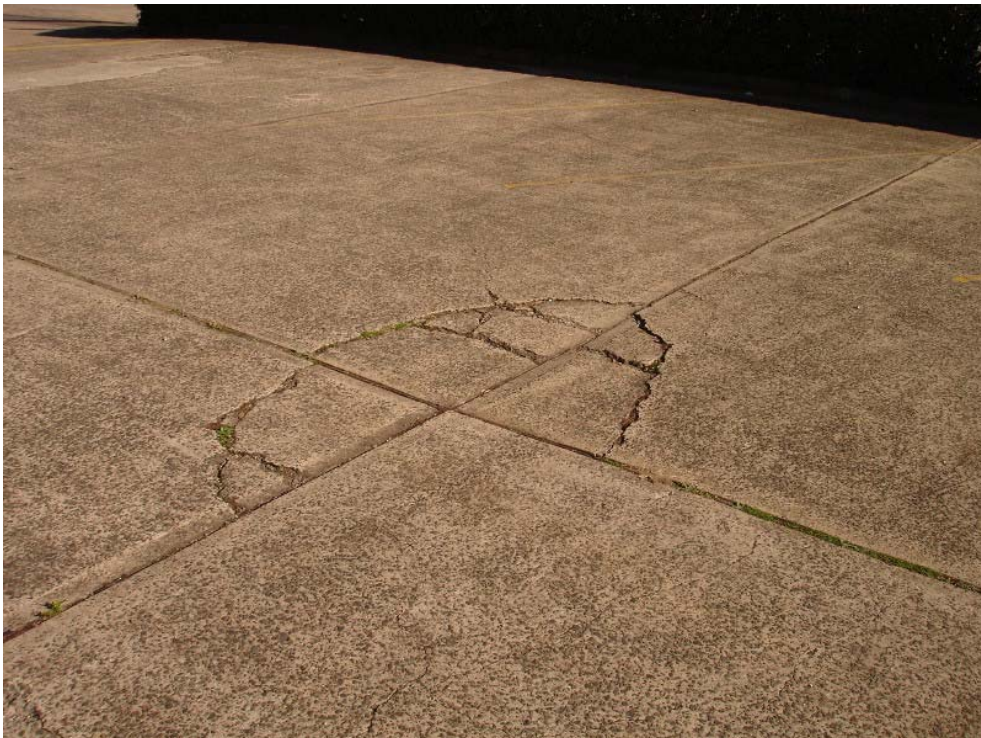
Photograph 16. Settlement and cracking of external pavement

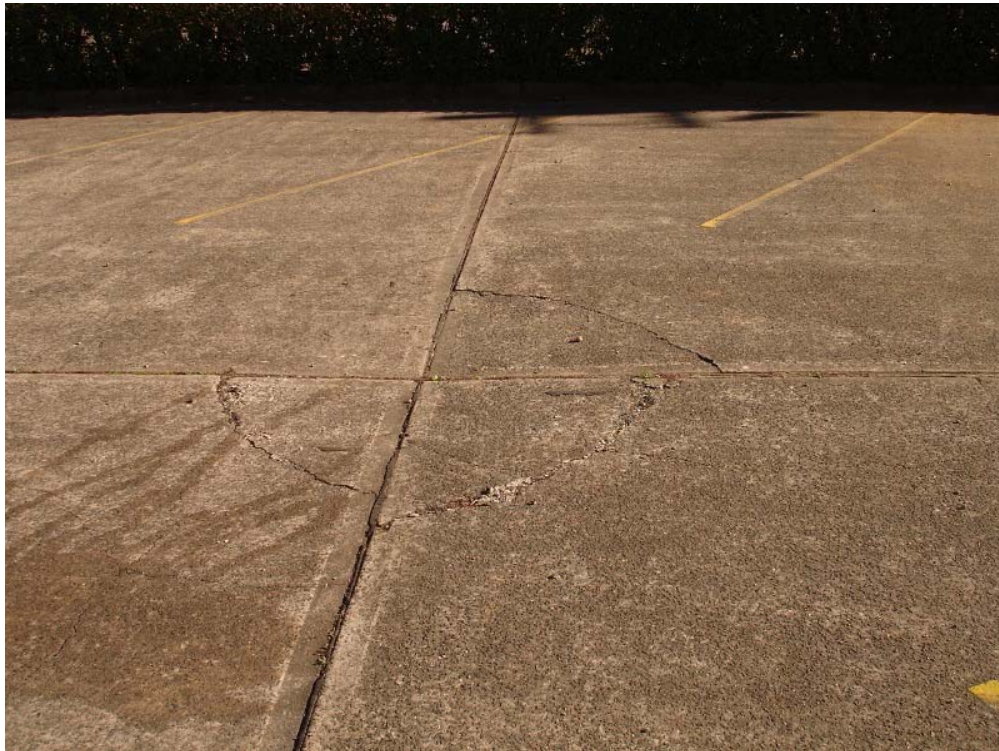
Photograph 17. Settlement and cracking of external pavement

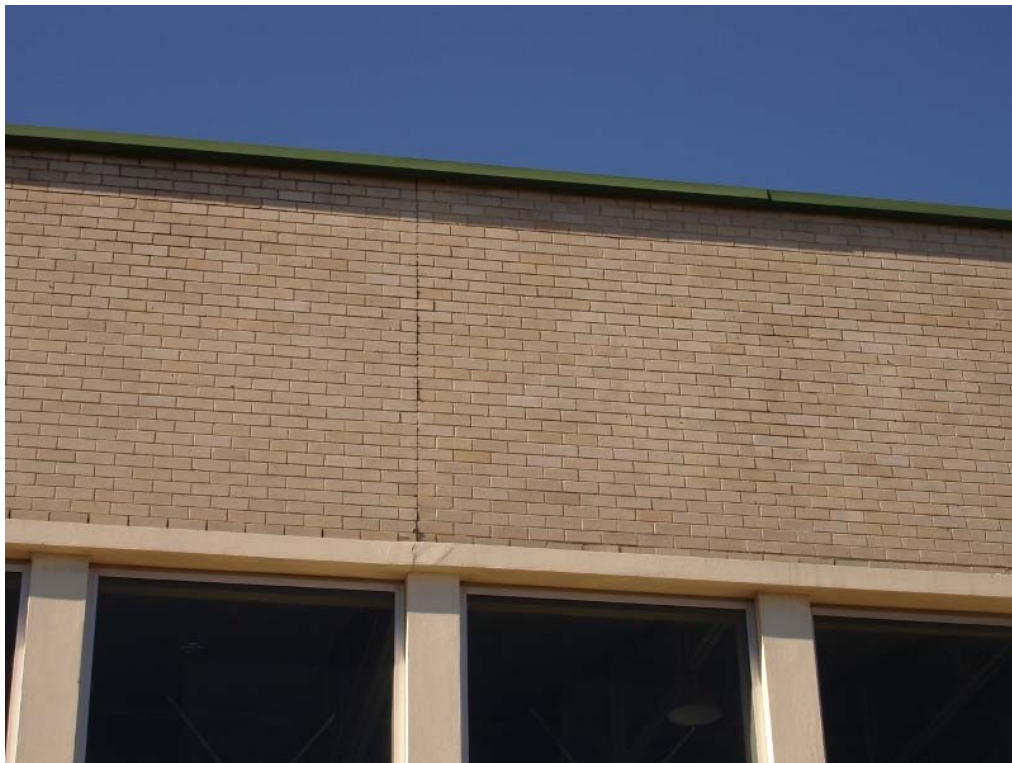
Photograph 18. Drummy render and cracking masonry at building joint, West Elevation

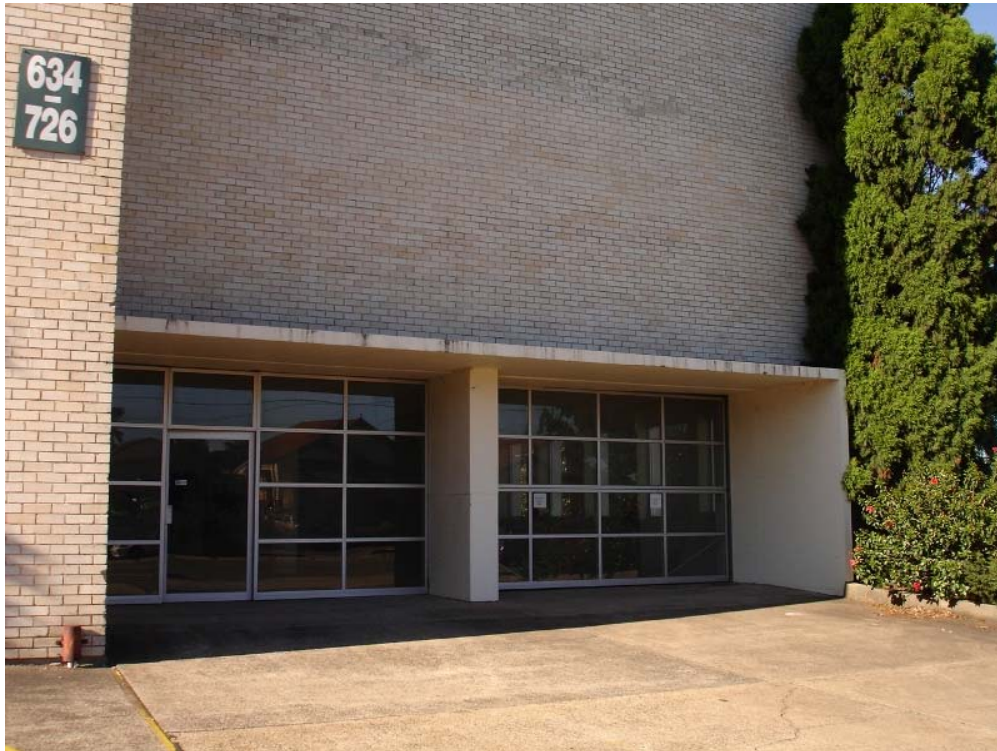
Photograph 19. Water Staining, Main Entry, West Elevation

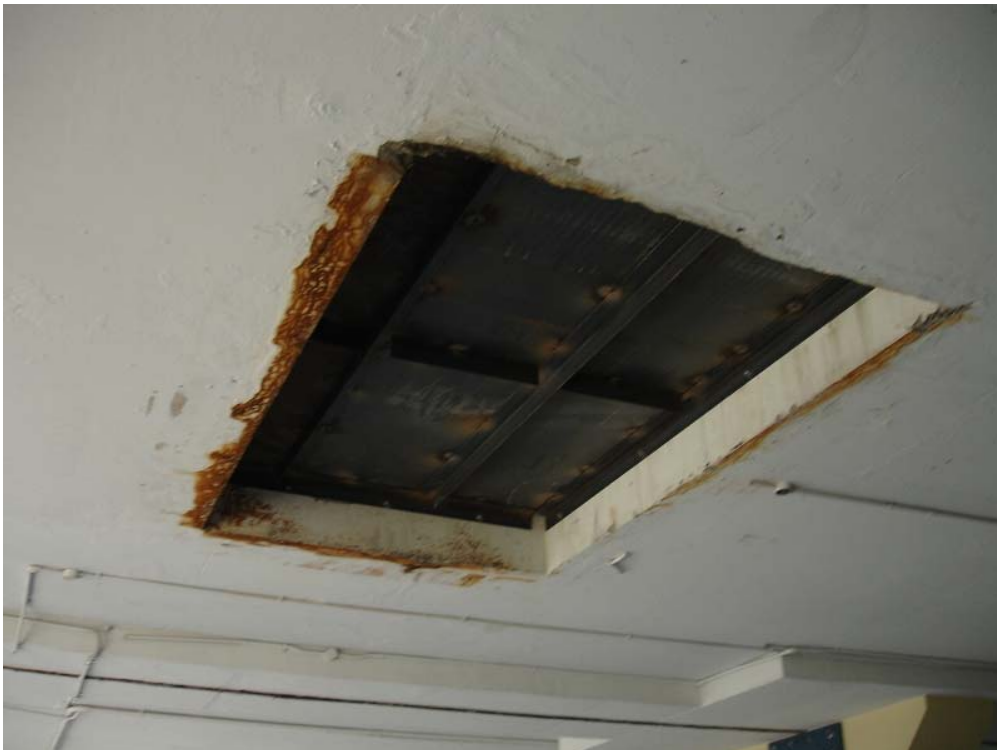
Photograph 22. Penetration Level 1 soffit

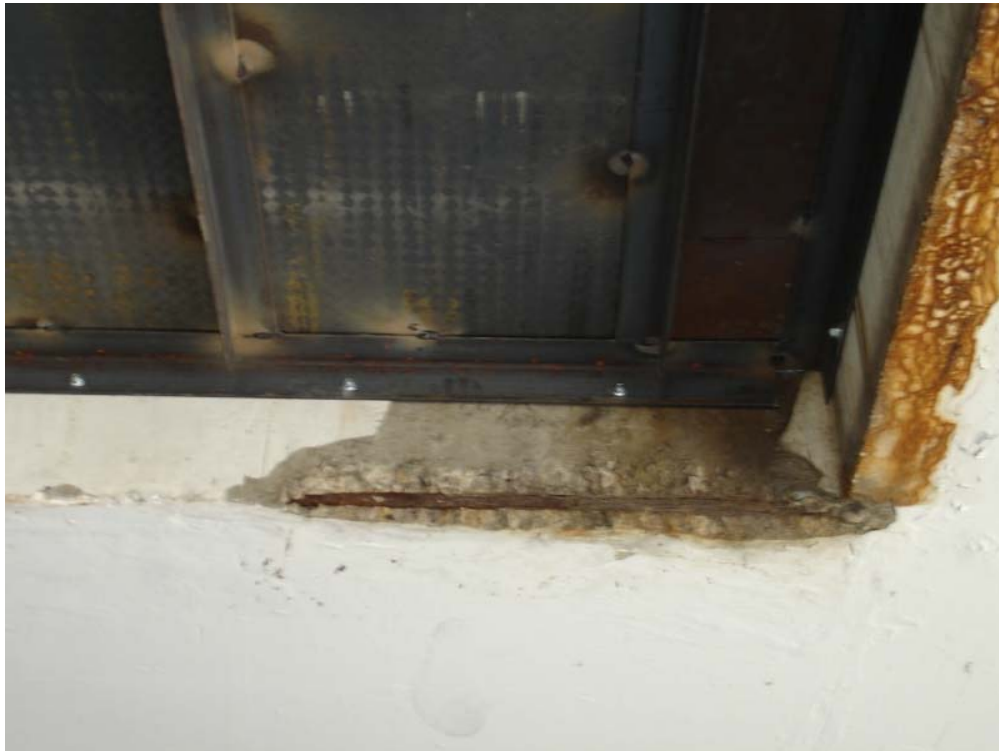
Photograph 23. Corroded Reinforcing Level 1 soffit

- Corrosion to the soffit of the level 1 slab. Drummy concrete is to be scabbled back to a solid substrate, bars are to power wire brush cleaned and then be primed with Nitoprime Zincrich. The concrete should be patched with Renderoc HB40, or a similar concrete repair system.

- Repair of corroded reinforcement to the soffit of the level 1 slab.
- Repairs to the truss bearing plates.

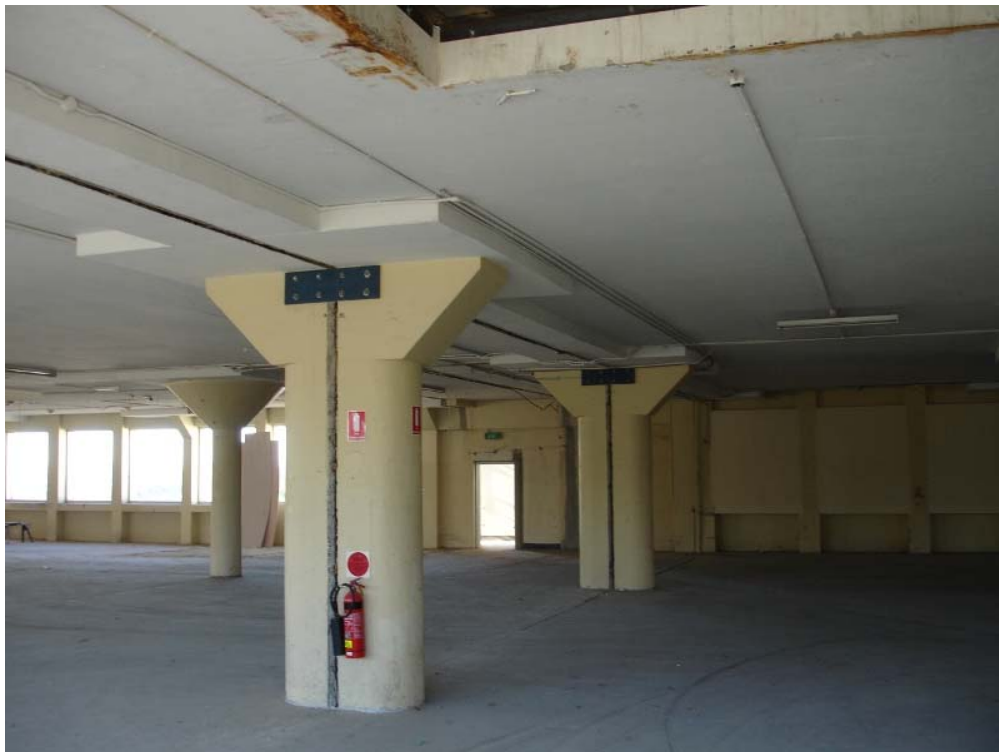
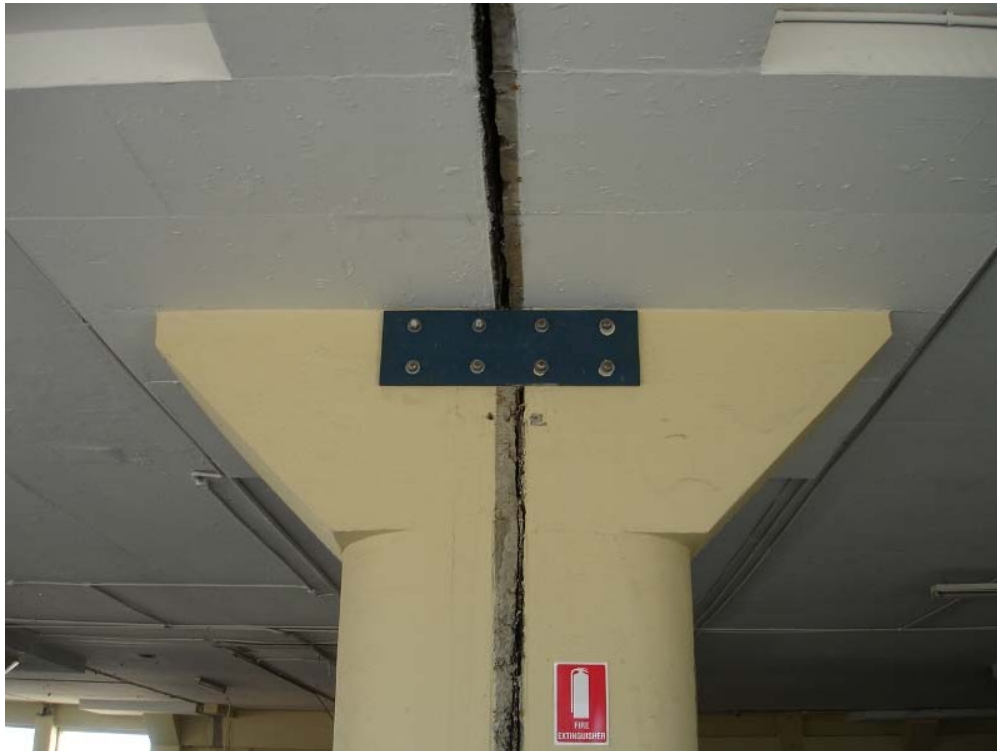
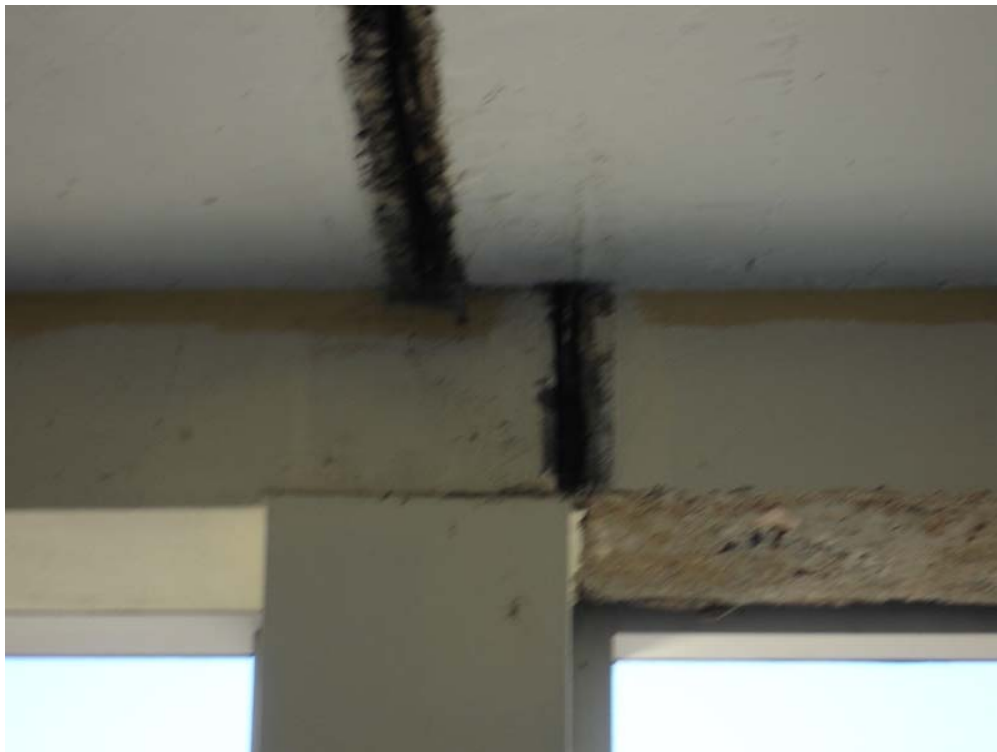
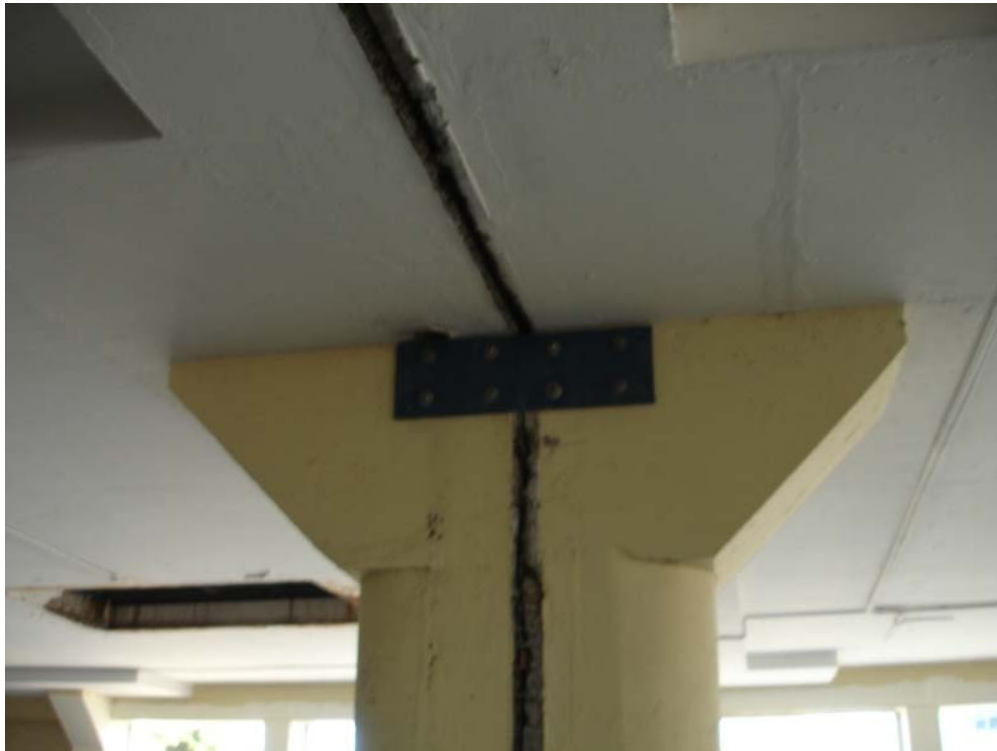
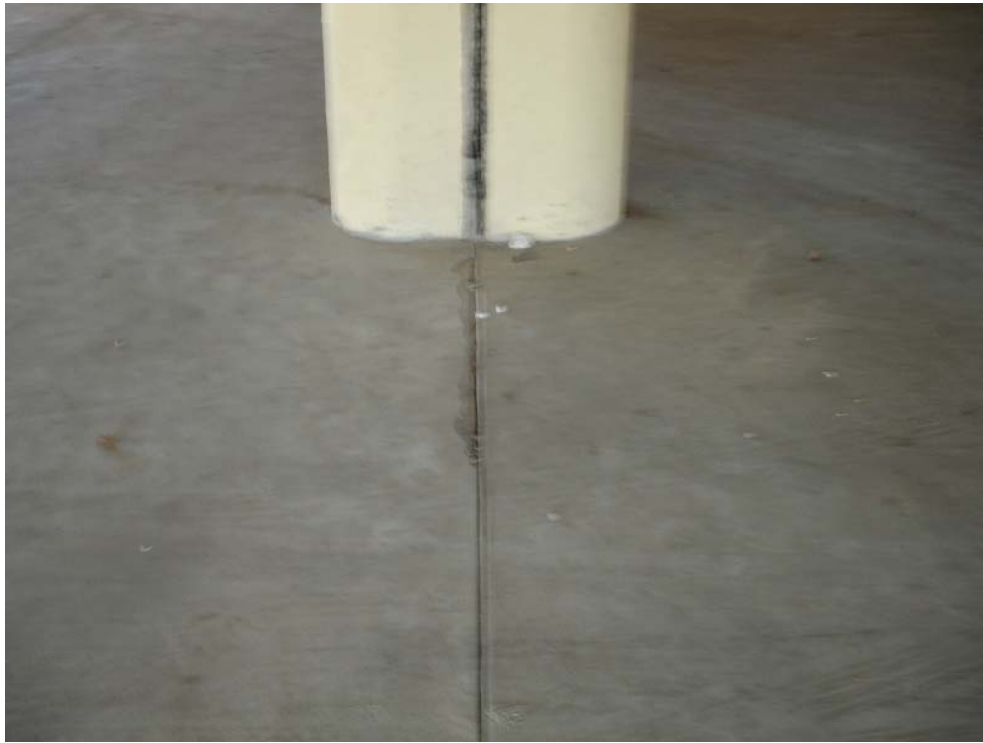
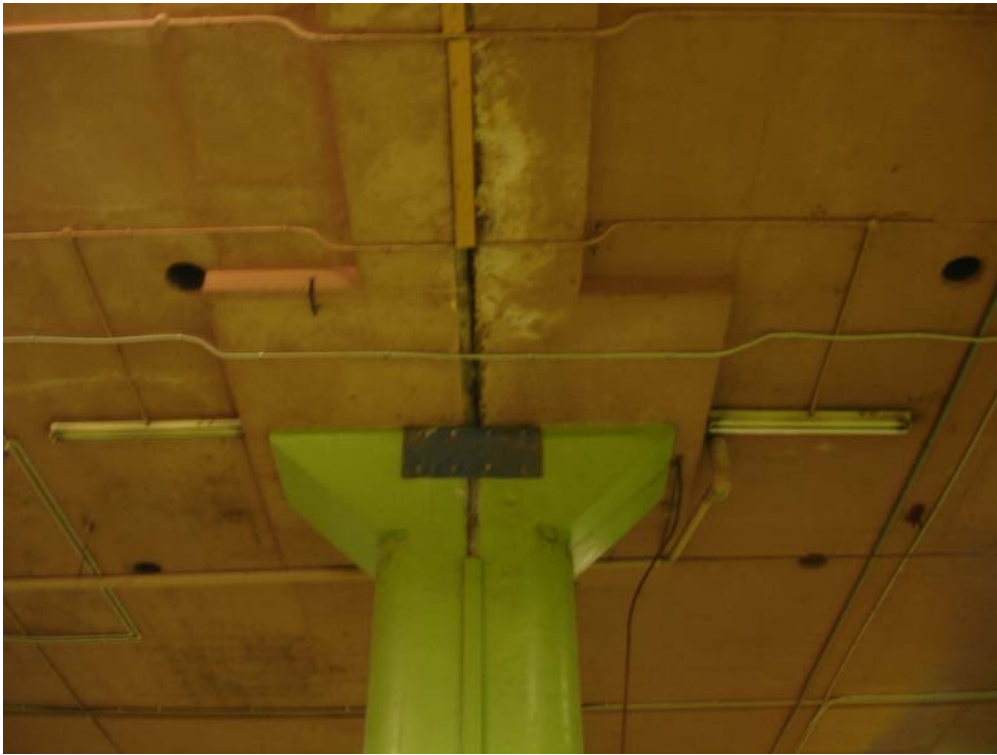
There was evidence of pre-existing problems at the building construction joint. Long-term shrinkage and building movements have caused the joint to separate approximately 20mm. Concrete columns on each side of the joint have been stitched together with steel plates. The stitching has been carried out to minimise distress in the twin steel column supporting the roof. This column currently bridges the building joint.

Photograph 24. Upper Ground Building Joint

- Separation of the building joint has occurred. Any upgrade to the building should consider installing an appropriate coverplate to the joint such as a Latham expansion joint.

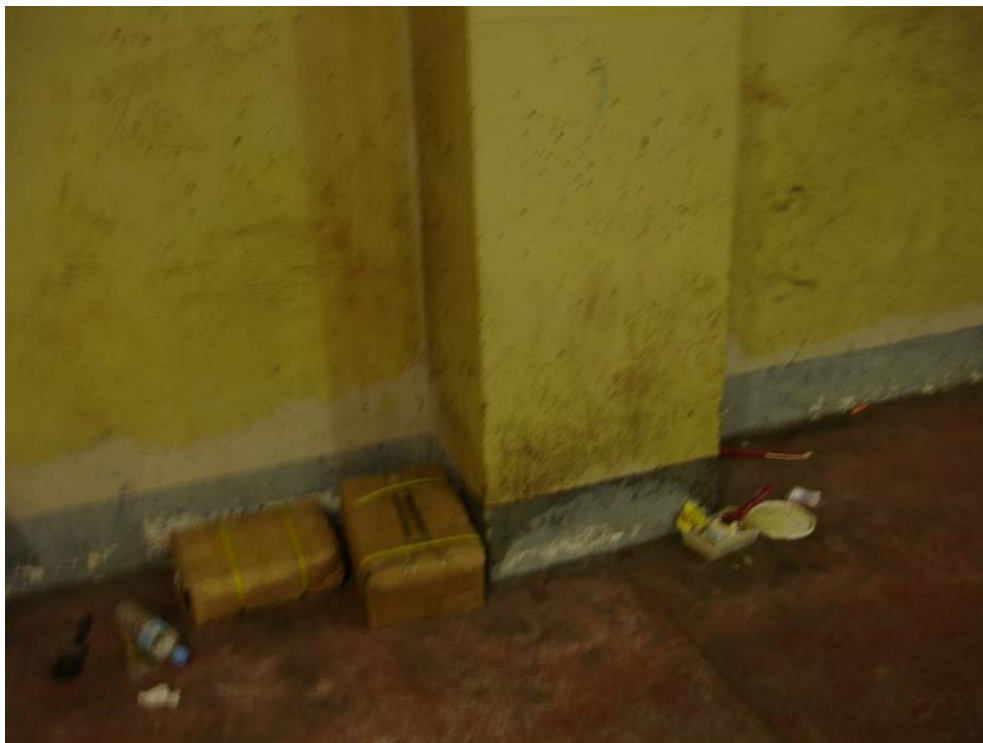
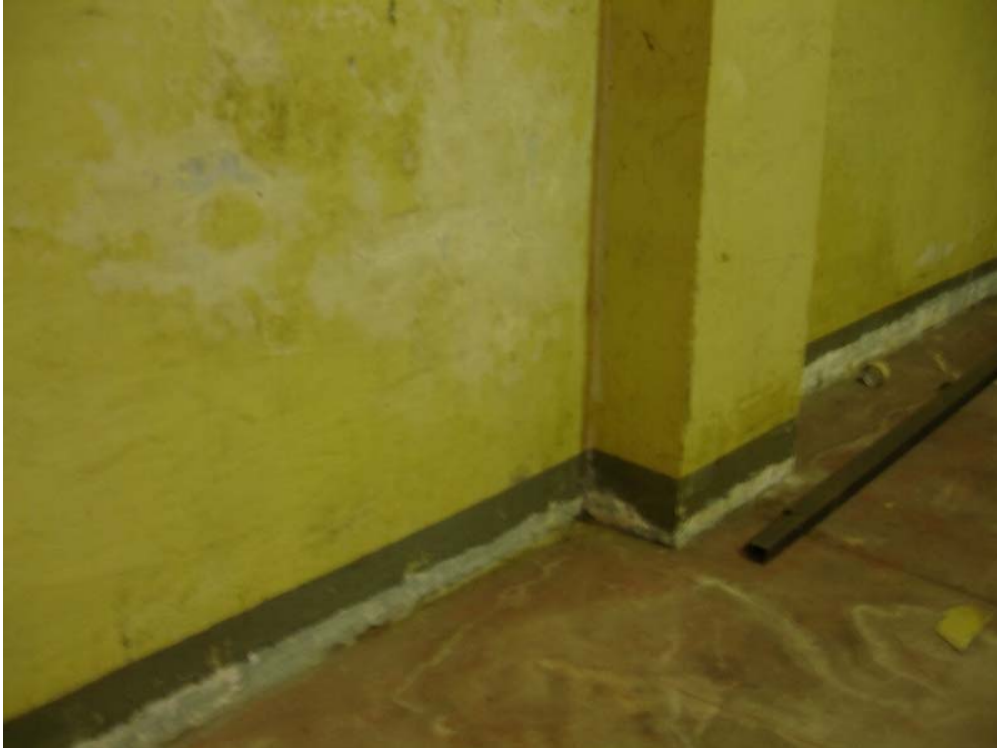
Water stains in isolated areas of the floor adjacent the western wall of the Ground floor was noted during the inspection. A small dish drain or hob and secondary wall will contain the minimal amount of water that currently penetrates through the retaining wall.

Photograph 30. Water Ingress Ground Floor, West Elevation

Other work such as the replacement of the external pavements, installation of hobs to control water ingress are of a aesthetic nature and can be undertaken depending on the required future use of the building.

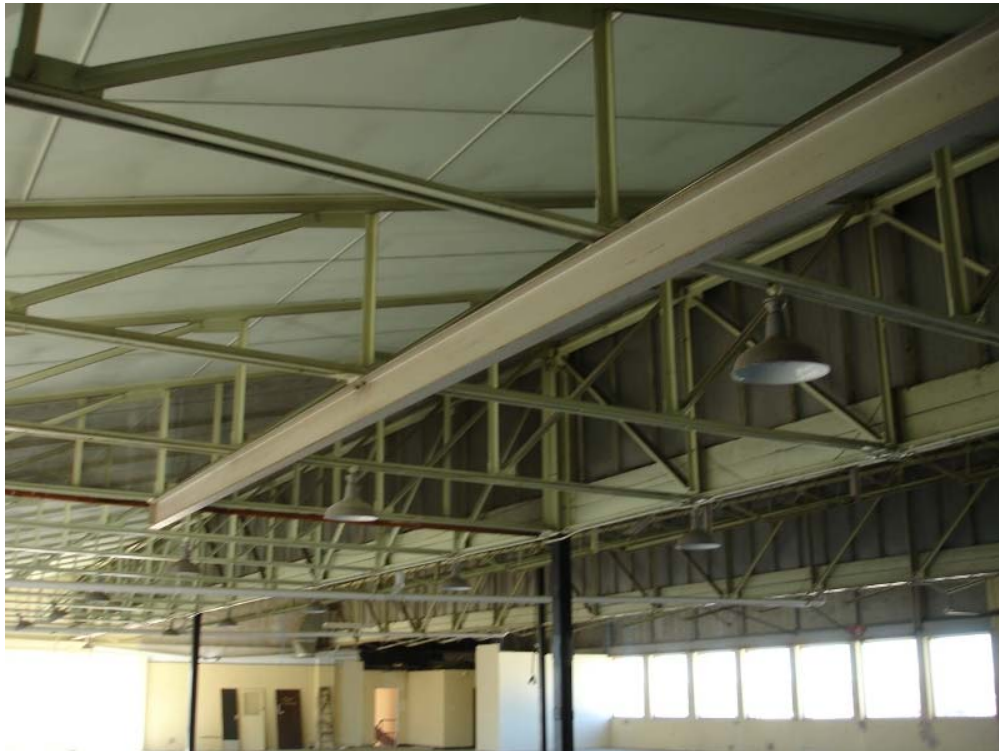
It was noted that the bottom chord of the truss currently does not have any lateral restraints. Originally the roof of the building may have been clad in Fibre Cement sheeting which may have been heavy enough to negate the wind uplift forces and the requirements for bracing the truss bottom chord.

Photograph 41. Roof layout, no restraint to truss bottom chord

Prior to occupation the design of the existing roof trusses should be checked to confirm that they have sufficient capacity under the effects of wind uplift.

- Design check of the existing roof truss to confirm its adequacy under the wind load pressures in accordance with AS1170.2.
- Exposing of the truss bearing plates to determine appropriate rectification details.
- Detailed checks for fire rating requirements during the design phase.
- Removal of select sample areas to the face brick façade to check the condition of the existing wall ties.

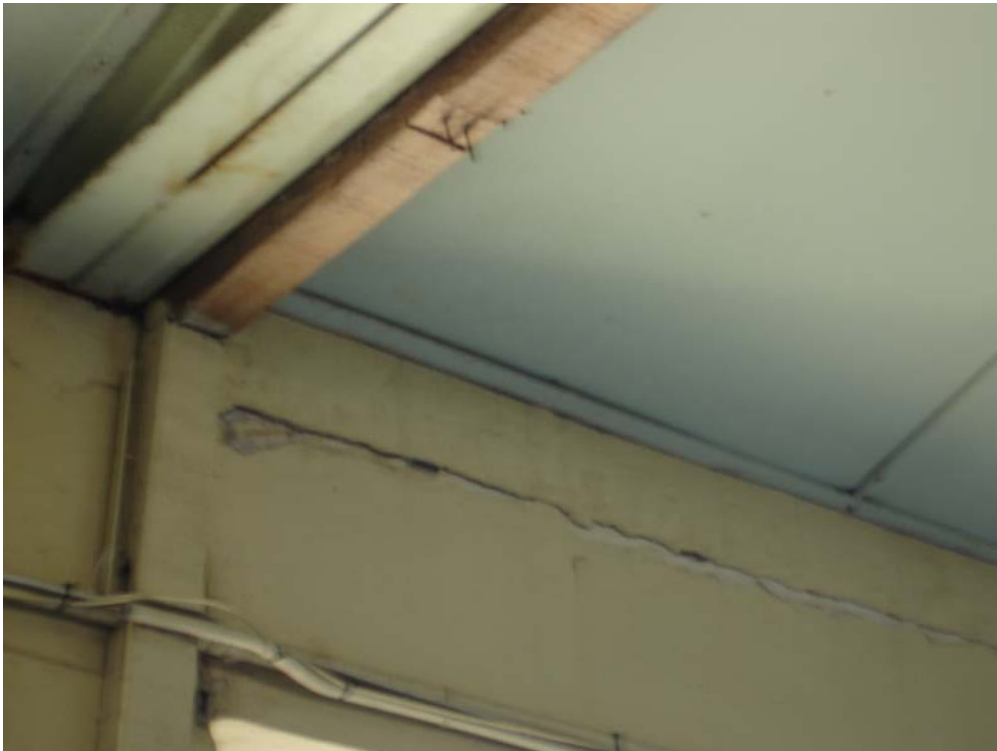
Photograph 43. Cracking masonry at roof level

- Localised cracking to face masonry to the external facades. Masonry needs to be removed and new masonry installed. This is not urgent but will require repairs in the medium term.

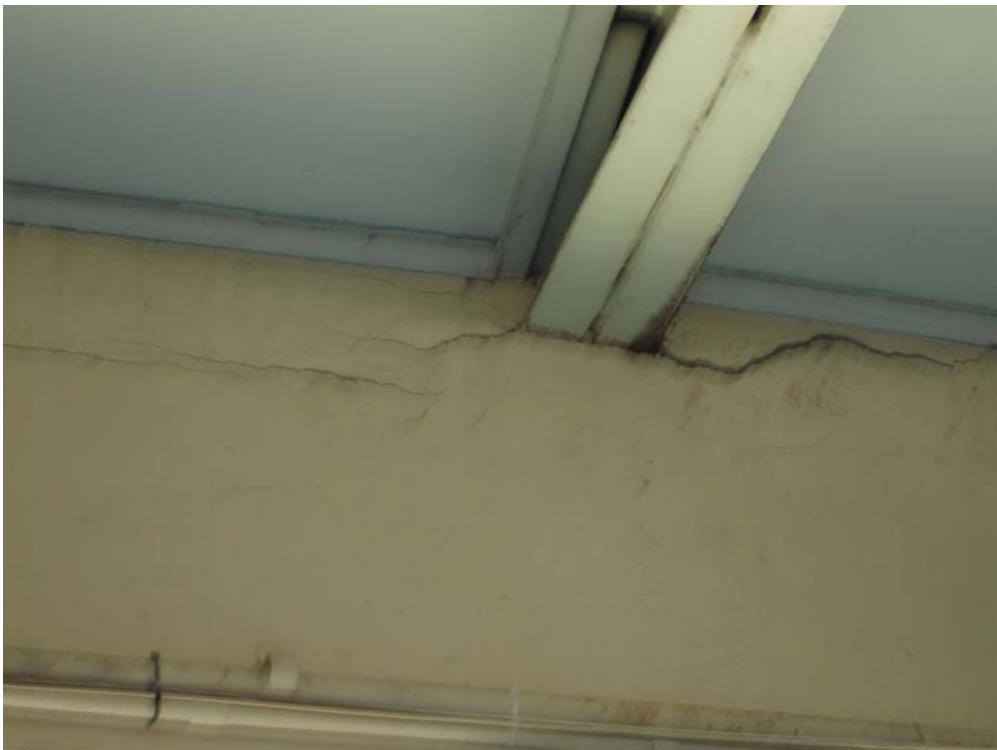
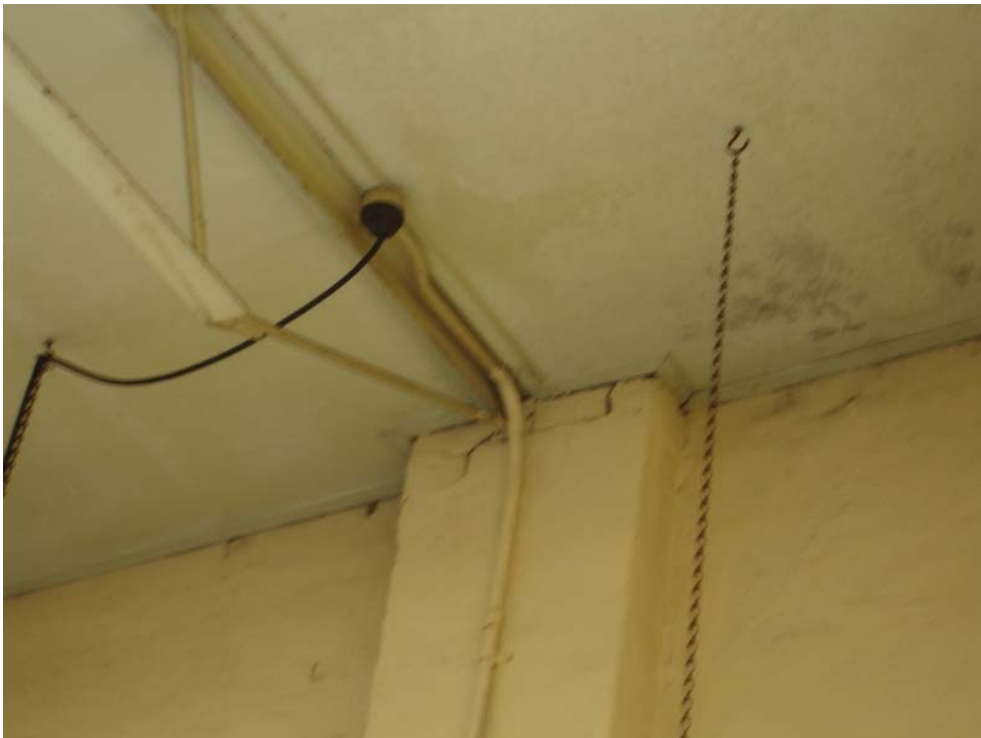
- The bearing plates of the roof trusses are showing evidence of corrosion which is in turn causing separation in the masonry bed joints. The bearing plates are required to be exposed in 3 separate locations so that an inspection can take place and appropriate rectification determined. It is expected that some repairs will be required during construction/fitout works.

Photograph 44. Typical corrosion to truss bearing plate, cracking masonry

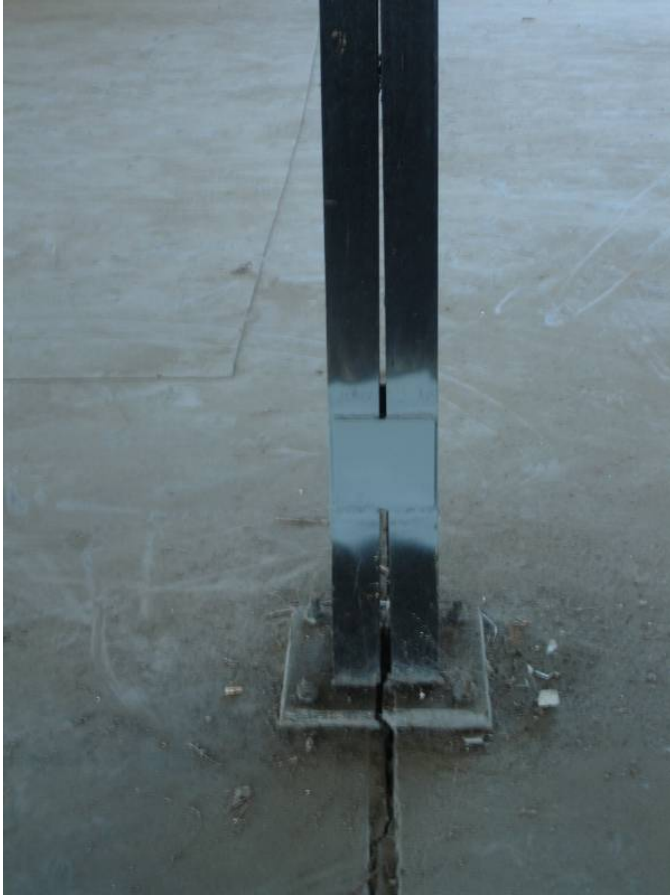
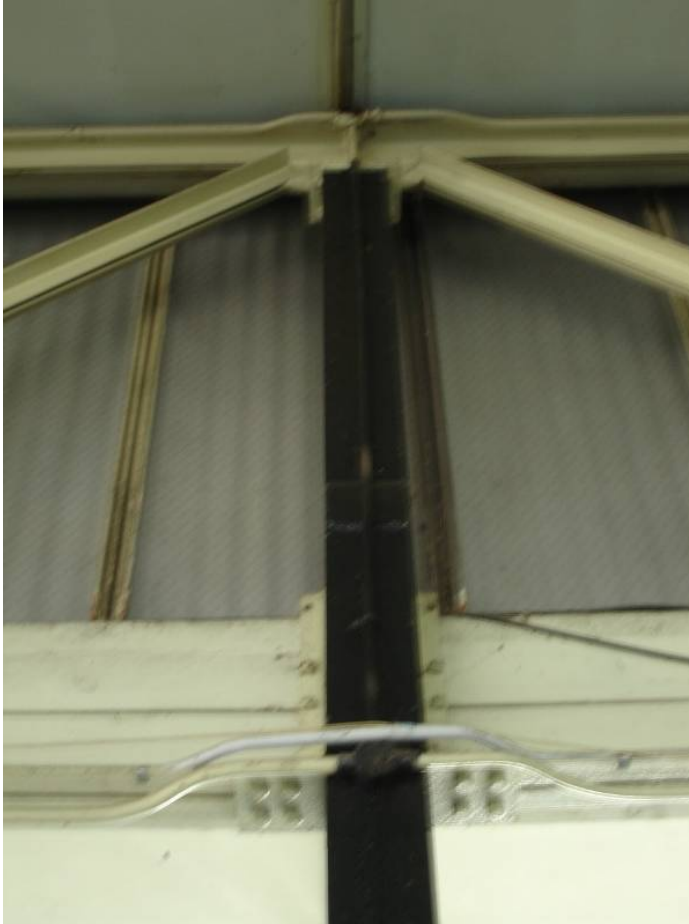
Photograph 45. Column built across building joint, previous repairs have occurred

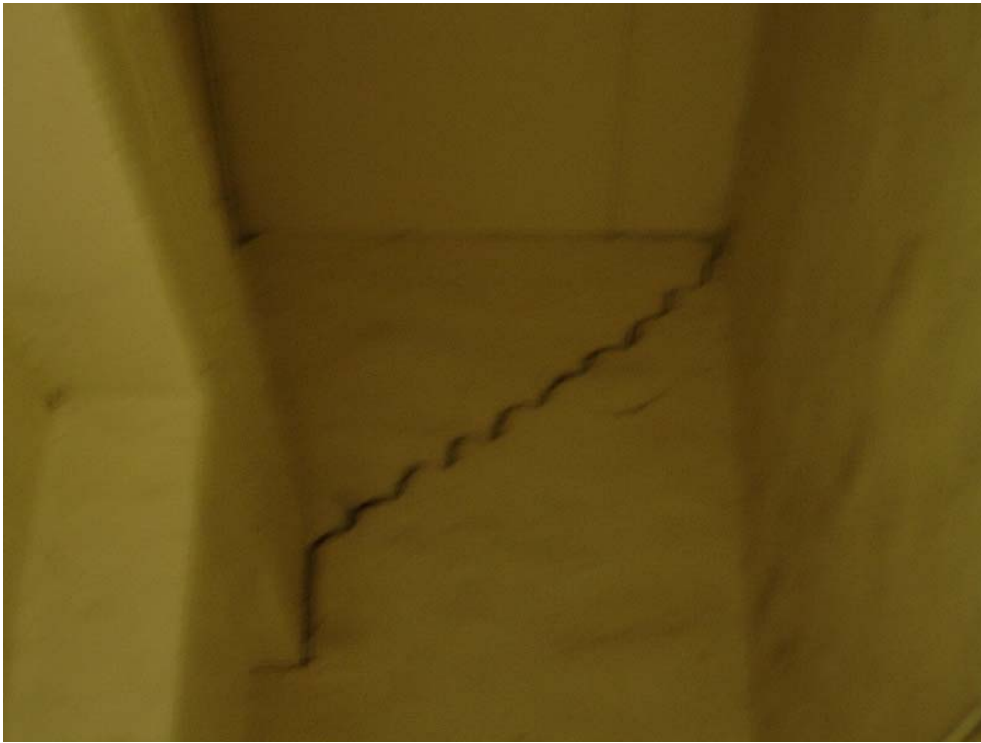
Photograph 47. Cracking masonry in stairwell
