***MINE SUBSIDENCE RISK ASSESSMENT***

***PROPOSED RESIDENTIAL DEVELOPMENT***

***MINMI AND LINK ROAD***

***Project 39663D***

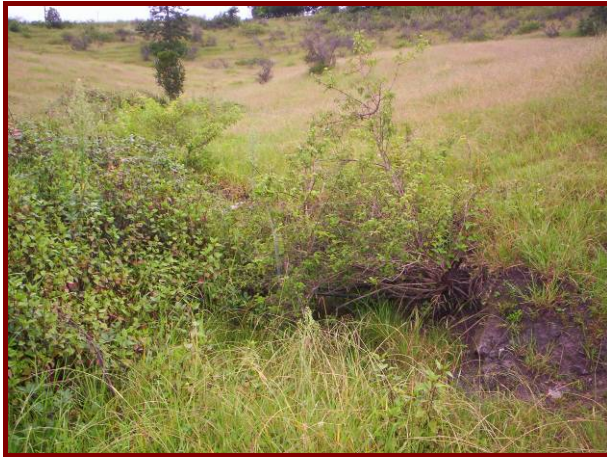
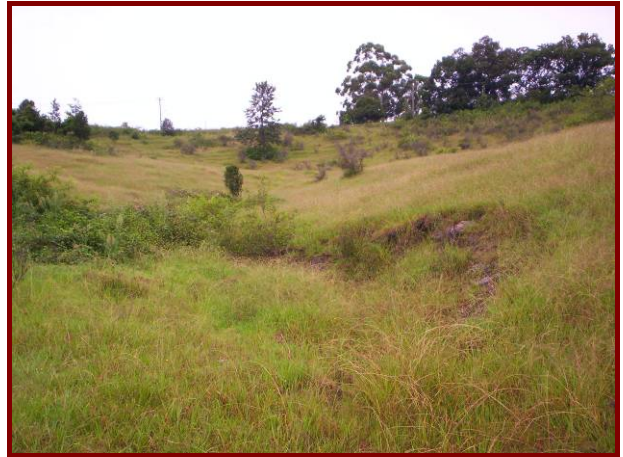
**Pothole P1**

Number	Description	Comments
P1	Located in gully in Minmi West. Area had been clearly filled for a diameter of about 20 m. Small pothole about 2 m diameter was observed to be reforming near centre	Mapping indicates that the pothole is located over an intersection of the Wallsend Borehole Colliery workings in the Young Wallsend Seam at about 16 m depth
P2	Formed in creek bed shortly after June 2007 floods. Water from creek flowed into workings. Was repaired with concrete plug	Borehole Seam workings at shallow depth < 10 m present
P3	Probable pothole in gully, filled with waste material	Underlain by Pit A, B, C workings at about 10 m depth
P4	Possible pothole located on side of road in area of channelled runoff	Underlain by Brown Colliery Borehole Seam workings at about 18 m depth
P5	Reported pothole by Lenny Grant. No evidence of pothole at surface	Underlain by Young Wallsend Seam at about 10 m depth. No workings are mapped. Extensive line drilling at 1 m centres around reported pothole locations indicated no voids. Unlikely to be workings present apart from possible very localised tunnel

It is noted that for the confirmed potholes P1 – P4, each was located in a creek, gully or area of high water flows and each was underlain by mapped mine workings at less than 20 m depth of cover. P1 – P8 are shown in the following photographs.

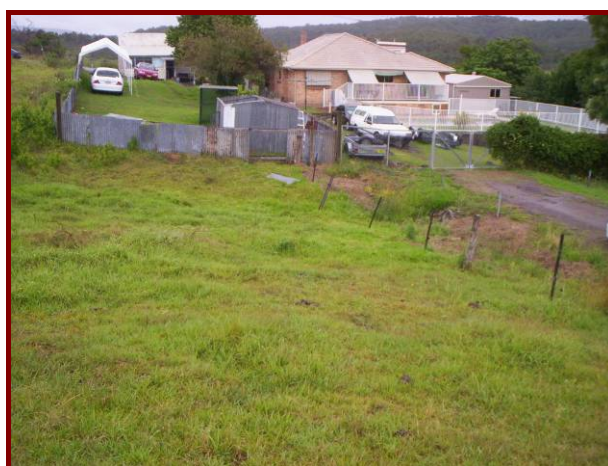
**Reported Location of Pothole P5 - No Void Found**

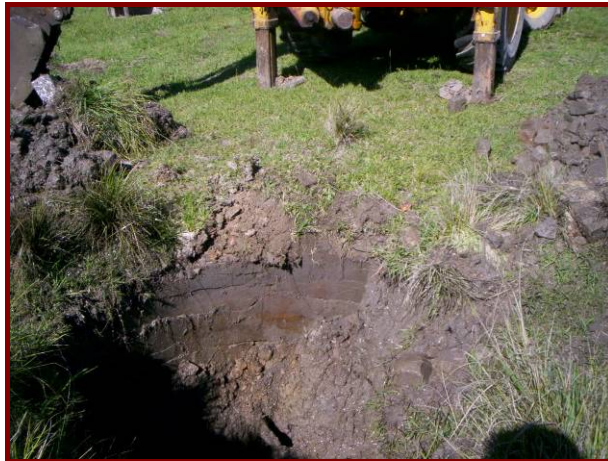
- He recalled filling two potholes in a paddock to the west of Minmi Pub in the 1960s. He physically located both, and both showed signs of surface slumping. (Both possible potholes were subsequently excavated and were found to actually be brick lined cisterns which had been filled with soil , bricks and sheet metal. Both were water filled. (See Section 5 for details).

**Brick Cistern at Reported Location of Pothole P7**

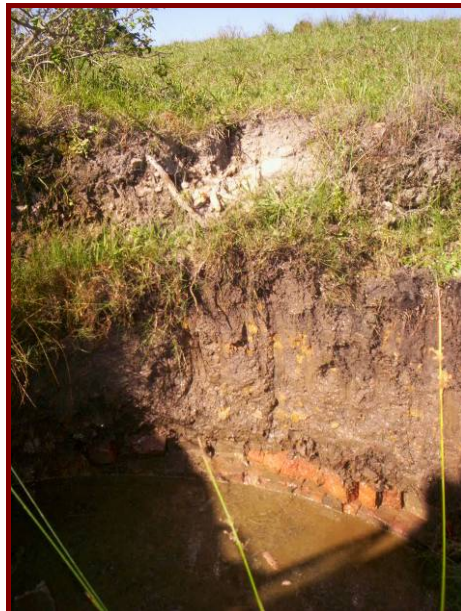
**Brick Cistern at Reported Location of Pothole P6**

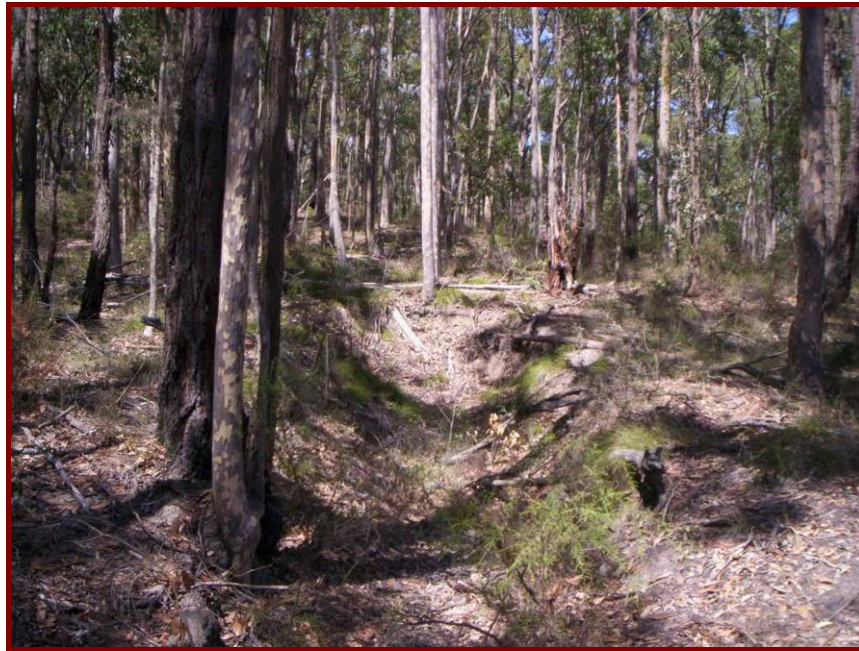
Individual potholes P8 are not shown on Drawing 3; they are numerous and extensive throughout area PR4 in Minmi East (Drawing 3).

**Extensive Potholing in Far Eastern Area P8**

Extensive pothole subsidence was also observed at shallow workings of the Cooperative Colliery on a parcel of land on the far eastern part of the site near Fletcher, Area PR 4 in Minmi East. The depth of cover where potholes are occurring is probably less than about 10 m depth, although this has not been confirmed by drilling.

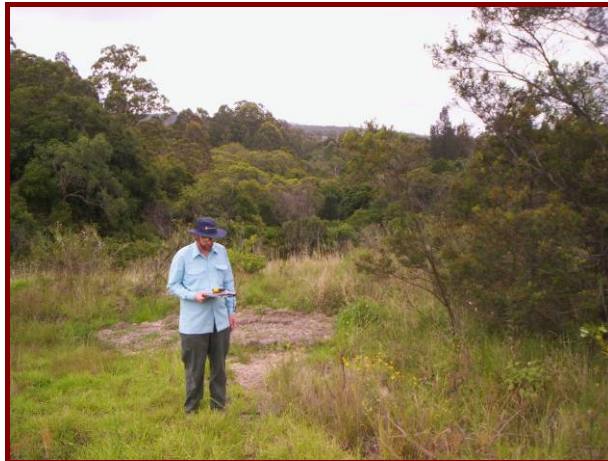
- Tailings were pumped into the Borehole Seam workings;
- Most shafts on site has been filled and capped, however some could not be found as follows:
  - No 4 Entry (B4 on Drawing 3) was never found and assumed to have been filled over;
  - No 2 entry (B4) and the nearby unlabelled entry (B10) were removed by open cut operations;
  - The Purple Hill shaft and ABC entry were never found;

**Approximate Location of Browns No 4 Tunnel Entry (B4)**

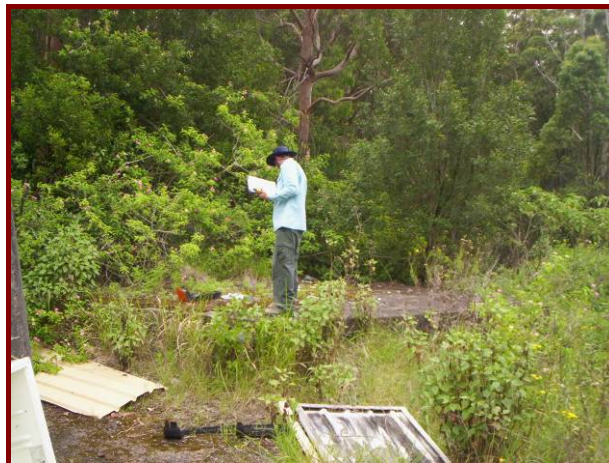
**Concrete Capping on Shaft Near Dam**

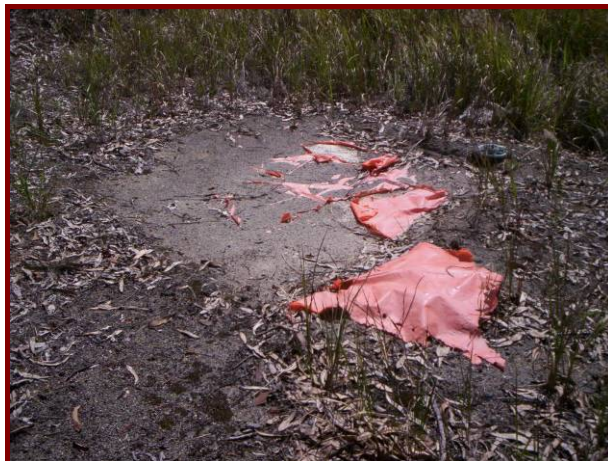
**Capped Shaft No 4**

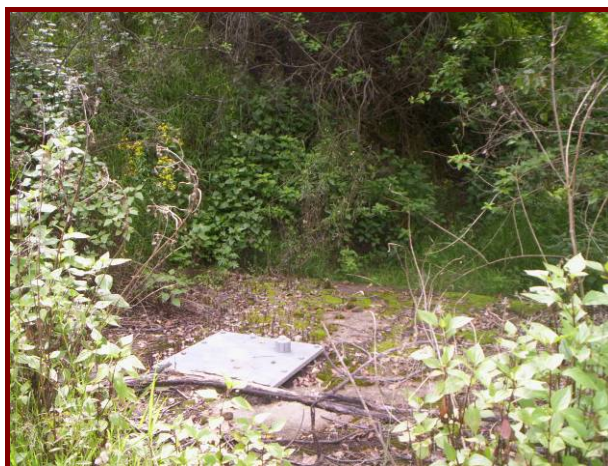
**Capping on Shaft No 12**

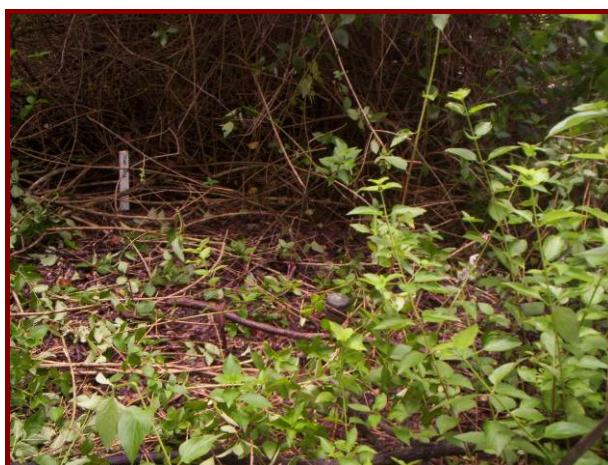
**Capping on Shaft No 14**
