Barton Street, Barangaroo

Road Safety Audit

Detailed Design Stage

JN21019_Report01 Rev02 - JMT Barton

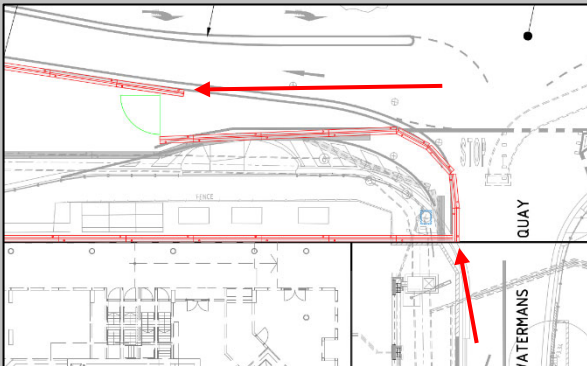
Item	Safety Hazard Finding	Frequency	Severity	Level of Risk	Project Manager Response
1. Hoarding/Barrier Terminals	<p>There are hoarding/barrier terminals in the clearzone of the travel lane.</p> <p>There is a risk that an errant vehicle may impact the blunt end of a hoarding/terminal resulting in injury to vehicle occupants.</p>

Occasional	Serious	High	<p>This has been addressed with adjustment to hording to include taper and separation from Hickson Road travel lane as per the recommendation of the Road Safety Audit, as indicated below</p>

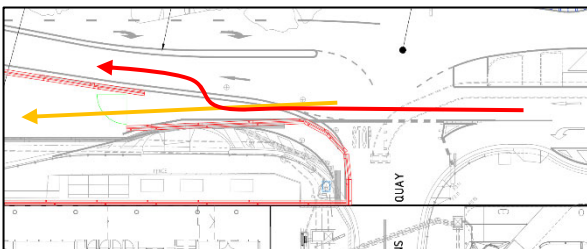
2. Following Vehicles	<p>There is a construction access in line with the through carriageway.</p> <p>There is a risk that a motorist may follow a construction vehicle into the access point before undertaking sudden manoeuvres to enter back into the travel lane resulting in sideswipe collisions.</p>

Improbable	Minor	Low	<p>This will be managed through clear signage and traffic control.</p>

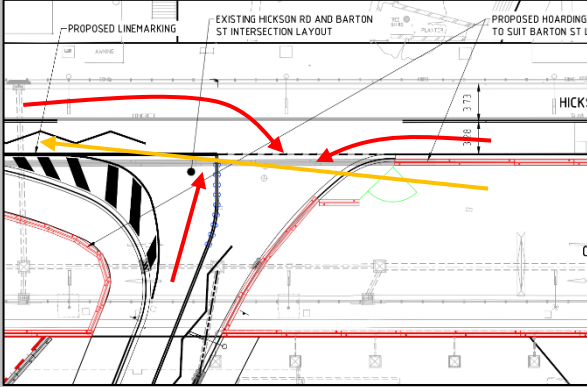
Item	Safety Hazard Finding	Frequency	Severity	Level of Risk	Project Manager Response
3. Vehicle Exit	<p>There is a construction exit at the kerb return of an intersection.</p> <p>There is a risk that a motorist (northbound, southbound, eastbound, or turning) may not sight an exiting construction vehicle resulting in side impact or sideswipe collisions.</p>

Probable	Minor	High	Traffic controller at this location to ensure vehicles exit safely. Construction vehicles will only be instructed to depart the gate by traffic controllers when there is no oncoming traffic on Barton Street and is safe to do so.

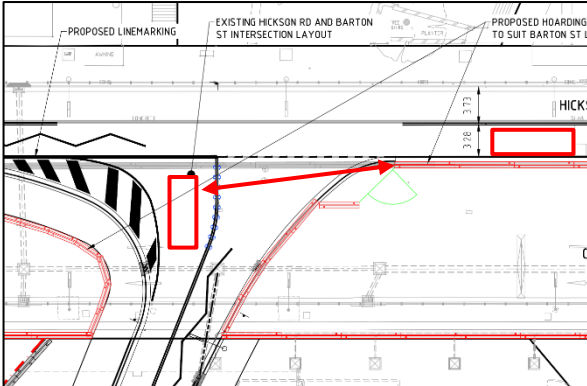
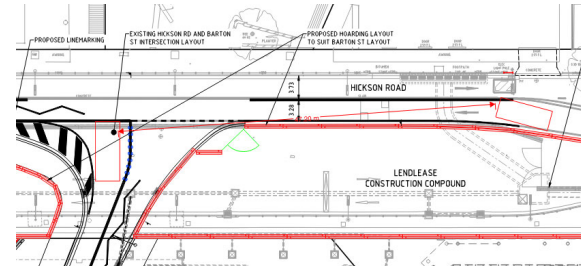
4. Sight Distance	<p>There is hoarding restricting the sight distance between a northbound motorist on Hickson Road and a motorist exiting Barton Street.</p> <p>There is a risk that motorists may not have sufficient sight distance to avoid a collision between turning vehicles resulting in side impact or rear end collisions.</p>

Probable	Minor	High	Driver behaviour will be on high alert with the presence of traffic controller, construction hoarding and signage. Advanced warning signage will be included to address sight line. The sight line to the intersection is beyond the hoarding line and deemed acceptable.

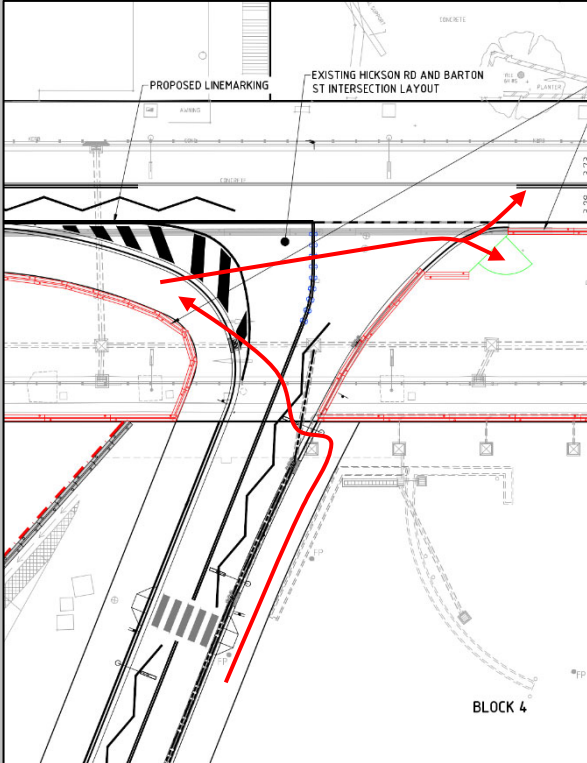
Item	Safety Hazard Finding	Frequency	Severity	Level of Risk	Project Manager Response
5. Pedestrian Access	<p>There is pedestrian access proposed beyond the pedestrian crossing point, with no safe pedestrian route provided.</p> <p>There is a risk that a pedestrian may continue past the pedestrian crossing and enter the travel lanes resulting in a pedestrian-vehicle collision.</p> <p>There is a risk that a pedestrian may continue south along Hickson Road entering the construction access or walking around the proposed hoarding on Hickson Road resulting in a pedestrian-vehicle collision.</p>

Occasional	Serious	High	<p>Pedestrian barriers to be in-place to prohibit pedestrian movements at this location in line with the recommendation of the Road Safety Audit, as indicated below</p>

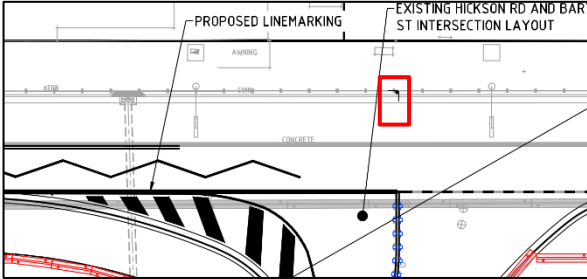
Item	Safety Hazard Finding	Frequency	Severity	Level of Risk	Project Manager Response
6. Street Signage	<p>There is a sign proposed on the eastern extent of the intersection that hangs into the travel lane.</p> <p>There is a risk that a vehicle may impact overhanging signage resulting in vehicle damage.</p> <p>There is a risk that a motorist may swerve to avoid a sign resulting in head on collisions with oncoming vehicles.</p>

Occasional	Limited	Low	Noted as a low risk. Deemed acceptable.

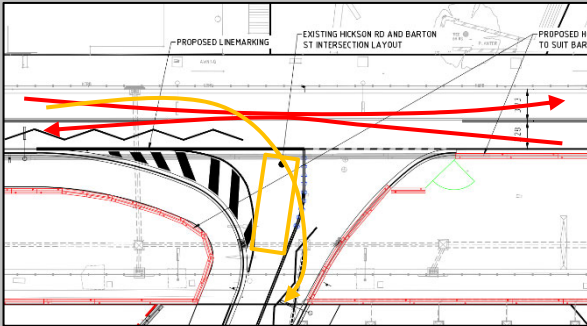
7. Centre Linemarking	<p>There is a long section on Hickson Road with no centreline provided.</p> <p>There is a risk that insufficient centre line delineation may reduce lane discipline resulting in sideswipe or head on collisions.</p> <p>There is a risk that vehicles turning right onto Barton Street may clash with holding vehicles off Barton Street.</p>

Improbable	Limited	Low	Noted as a low risk. Deemed acceptable.

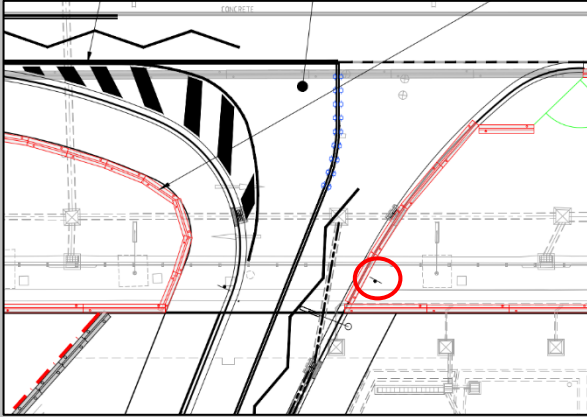
9. Signage	There is no signage provided on the plans. There are signposts shown but it is unclear to the audit team of the proposed sign face. In particular, there is no intersection priority signage shown in close proximity to the intersection hold line, and there is a sign shown inside of the hoarding. No further assessment has been carried out.	Note			This will be managed through clear signage.
