Report on
Desktop Study for Contamination

Proposed Commercial Tower
Westfield Parramatta, 175 Church Street, Parramatta

Prepared for
Scentre Group Ltd

Project 99750.01
October 2020

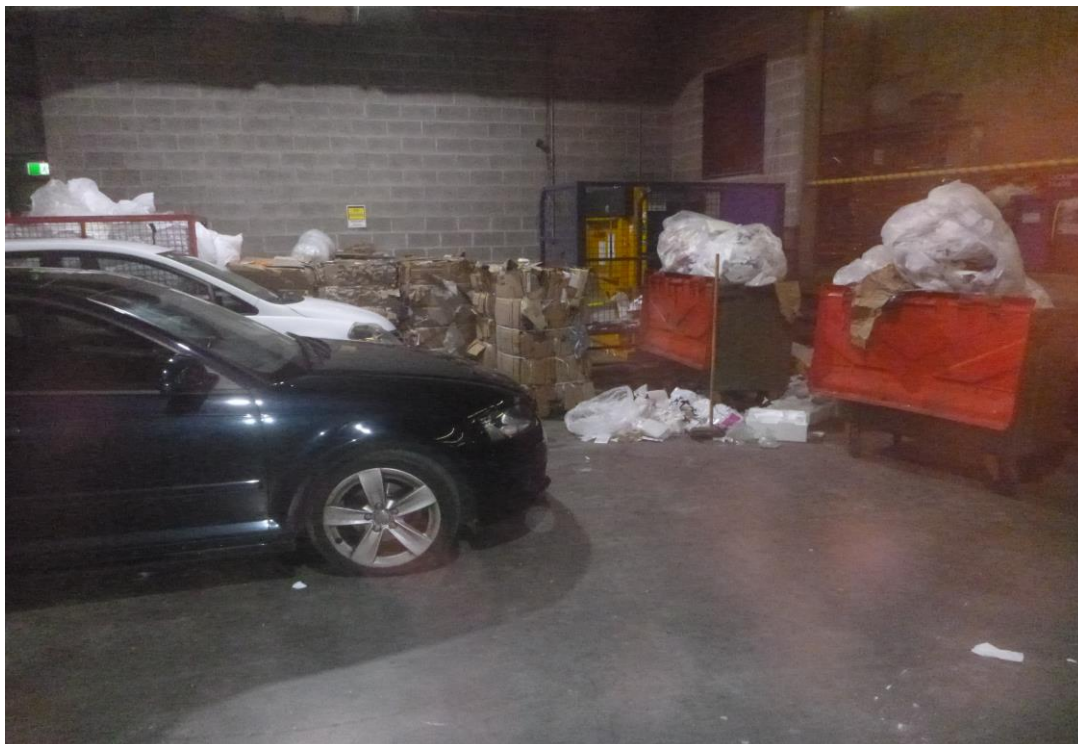
- The south-western part of the site is part of a loading dock (accessible via Marsden Street). Waste compactors and numerous skip bins were present in this area (Photographs 1 and 2, Appendix B). An electrical substation was located at the rear of the loading dock (Photograph 3, Appendix B);

Photograph 1 - Skip bins and waste at loading dock

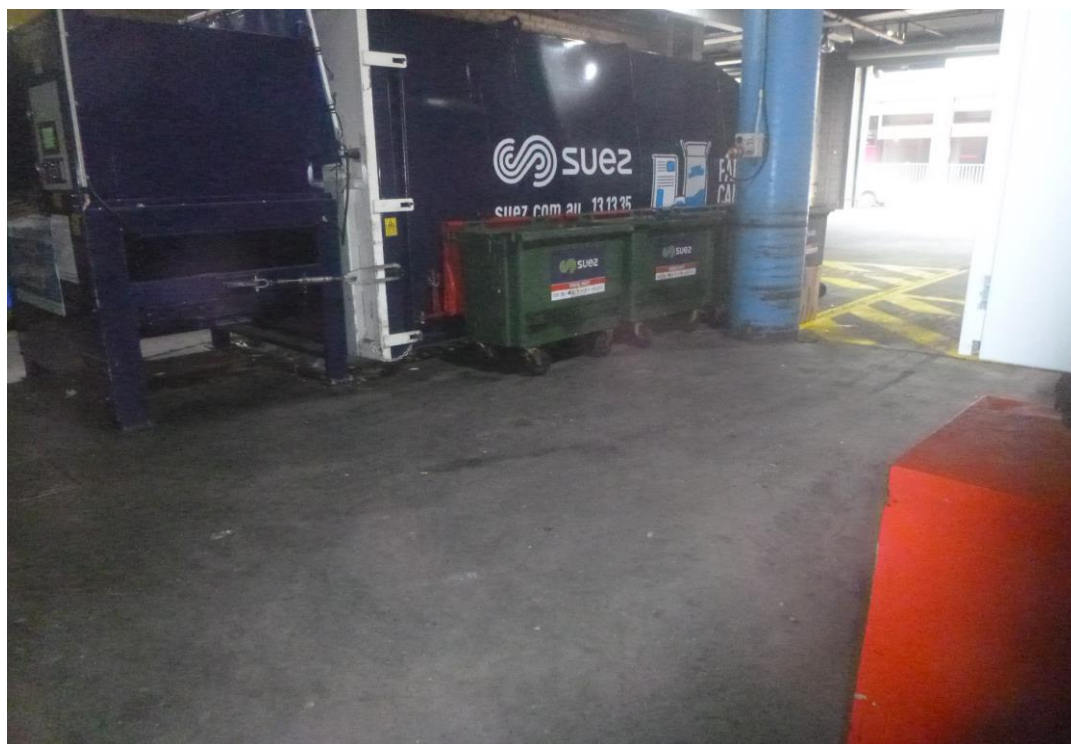
Photograph 2 - Waste compactor and skip bins at loading dock

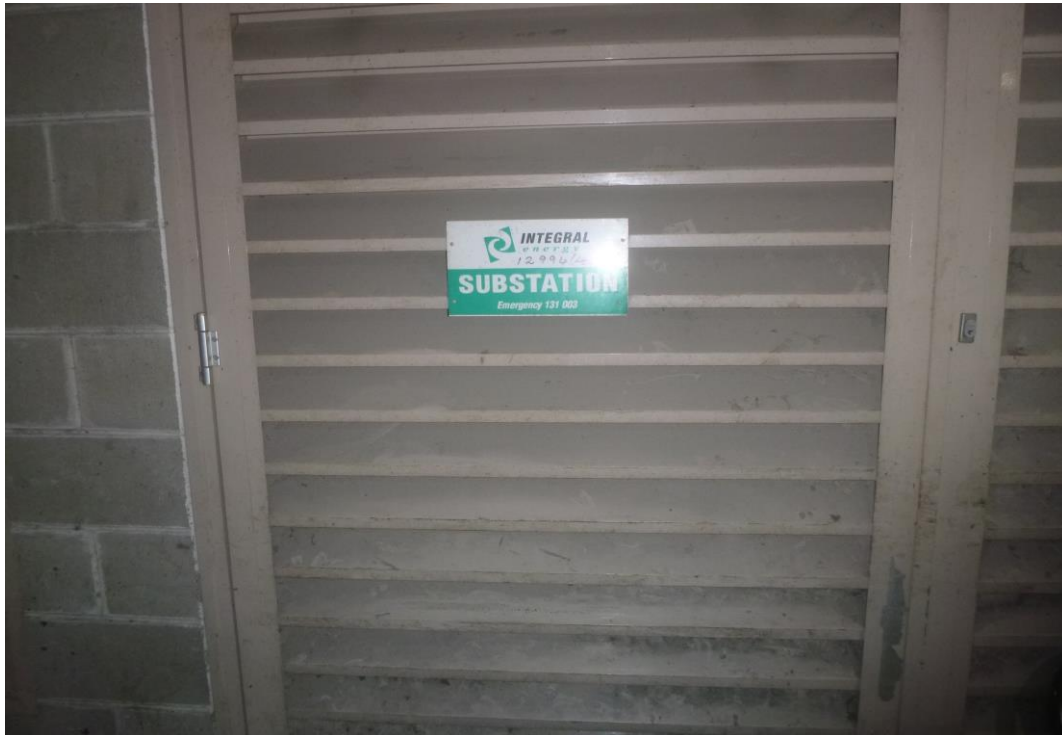
Photograph 3 - Door to sustation at rear of loading dock

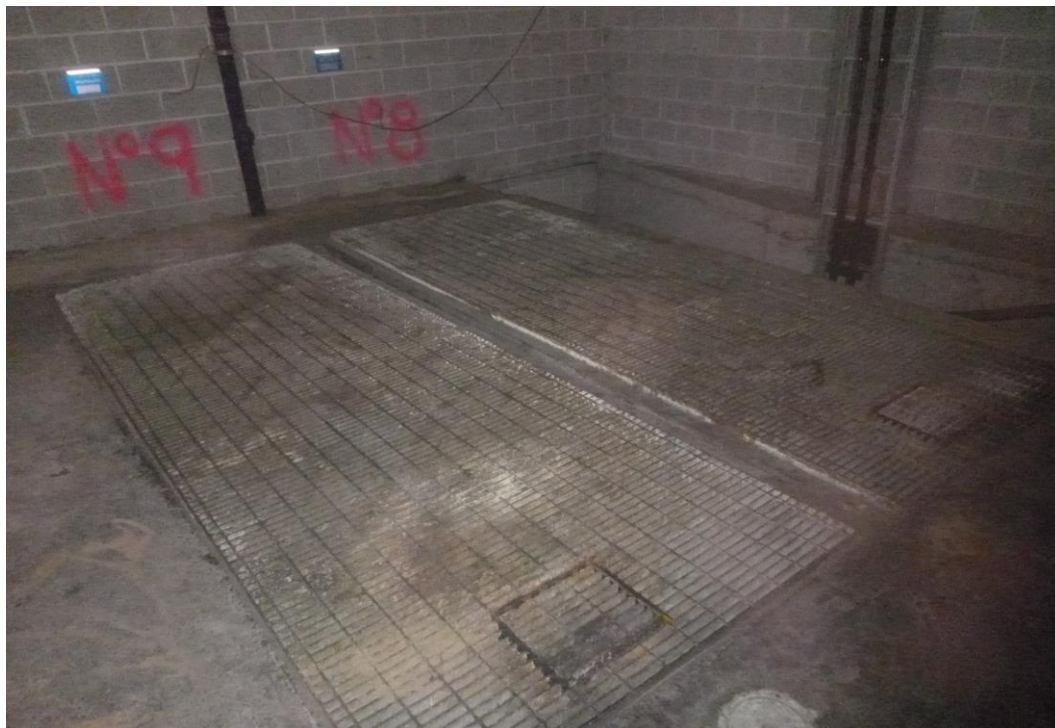
- To the east of the loading dock were some below-ground and above-ground grease traps which were accessible from the loading dock (Photographs 4 and 5, Appendix B and shown on Drawing 1, Appendix A);

Photograph 4 - Below ground grease traps

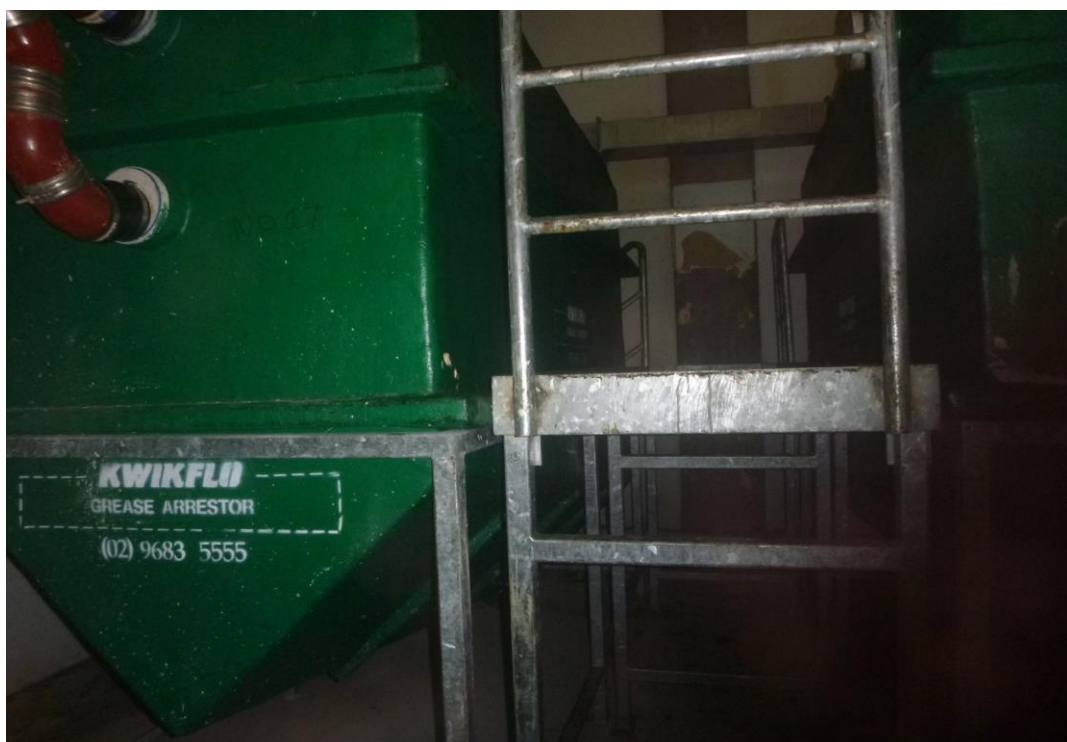
Photograph 5 - Above ground grease traps

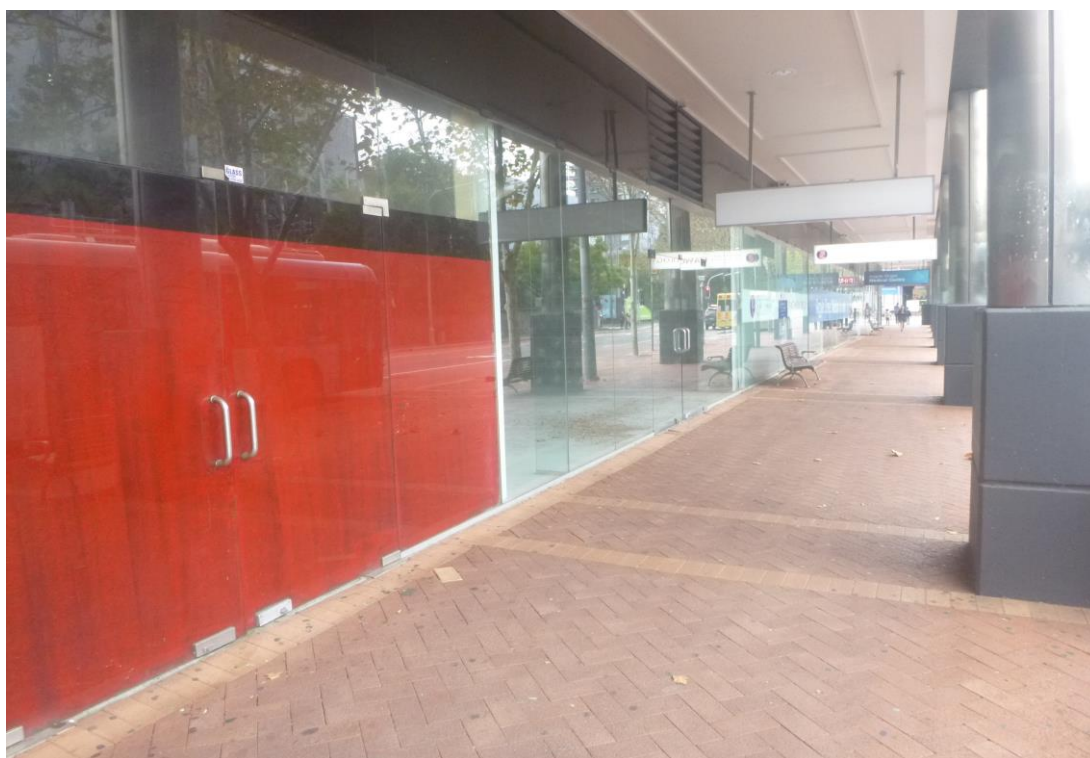
- Lifts and a fire escape corridor were at the eastern site boundary;
- A below ground fire escape corridor is present at the western part of the site;
- 'Shops' fronting Argyle Street were tenanted by a dentist, a pharmacy, a medical centre and a pathology clinic. There were two untenanted shops, one of which was used for storage of Christmas decorations for the mall (Photograph 6, Appendix B);

Photograph 6 - Front of site (Argyle Street)

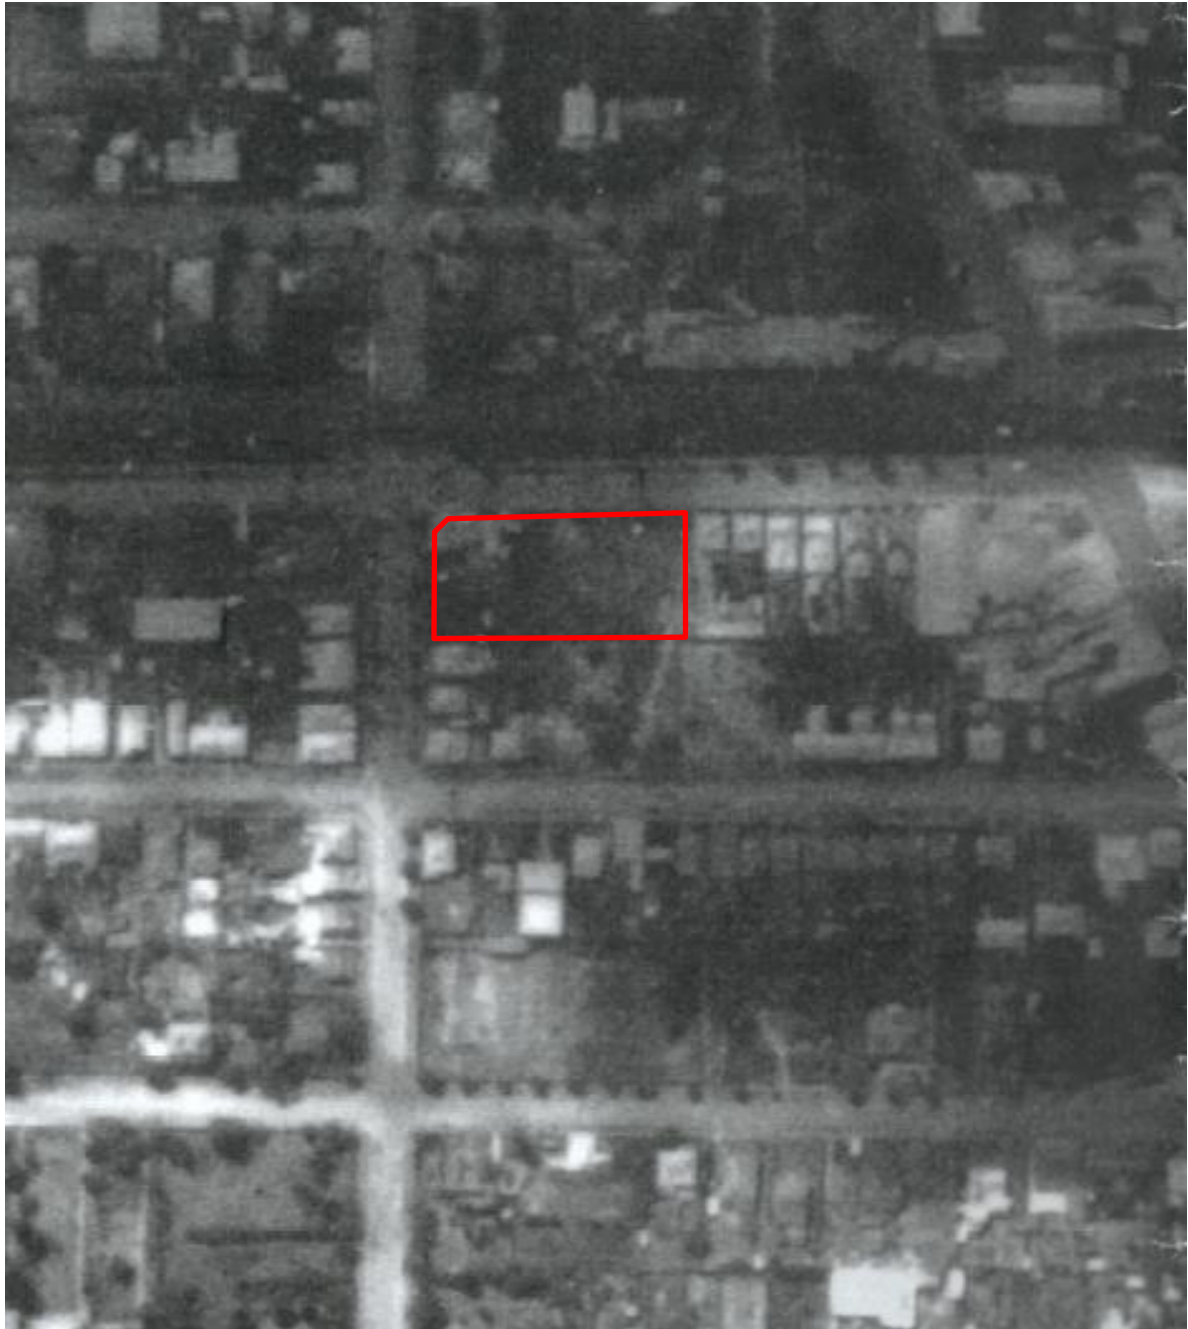
Douglas Partners Geotechnics Environment Groundwater	1928 Aerial Photograph	PROJECT: 99750.01
		PLATE No: C1
	Proposed Commercial Tower	REV: 0
	Westfield Parramatta	DATE: 16-Jul-20
	CLIENT: Scentre Group Ltd

The 1928 and 1943 images show that the site was largely vacant with a small commercial (possibly also residential) building at the north-west corner. The rail corridor was present to the north and nearby surrounding properties to the east, south and west appear to have been used for residential purposes.

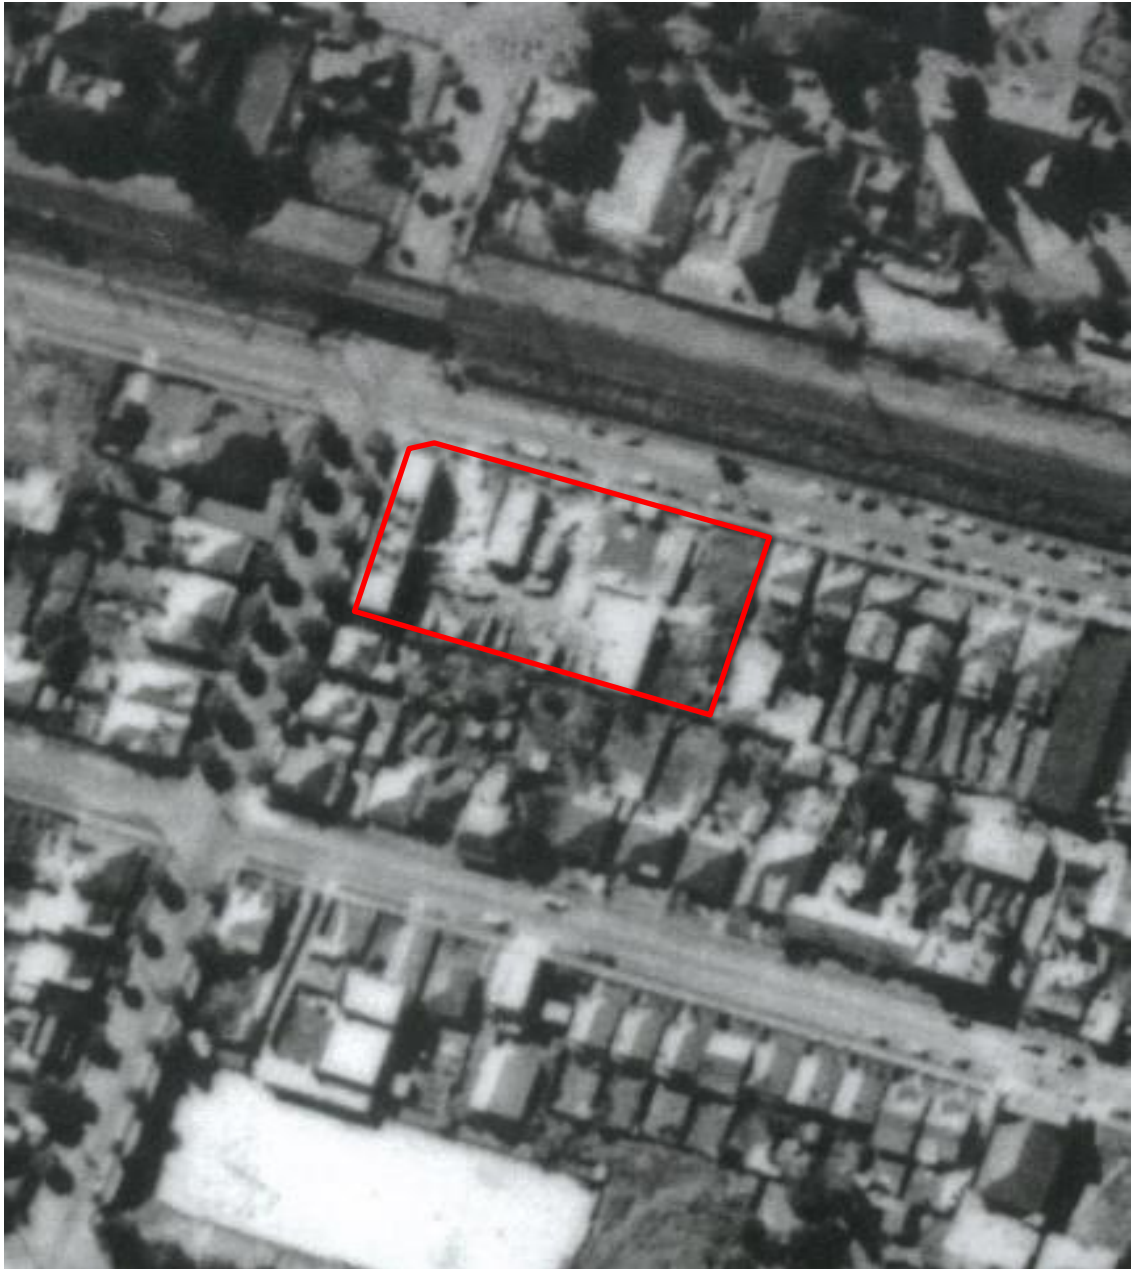
1951 Aerial Photograph
Proposed Commercial Tower
Westfield Parramatta

The 1951 image shows that the site was subject to construction activities. The building at the north-west corner, present in 1943, had been removed. Neighbouring properties appear to have been used for residential purposes.

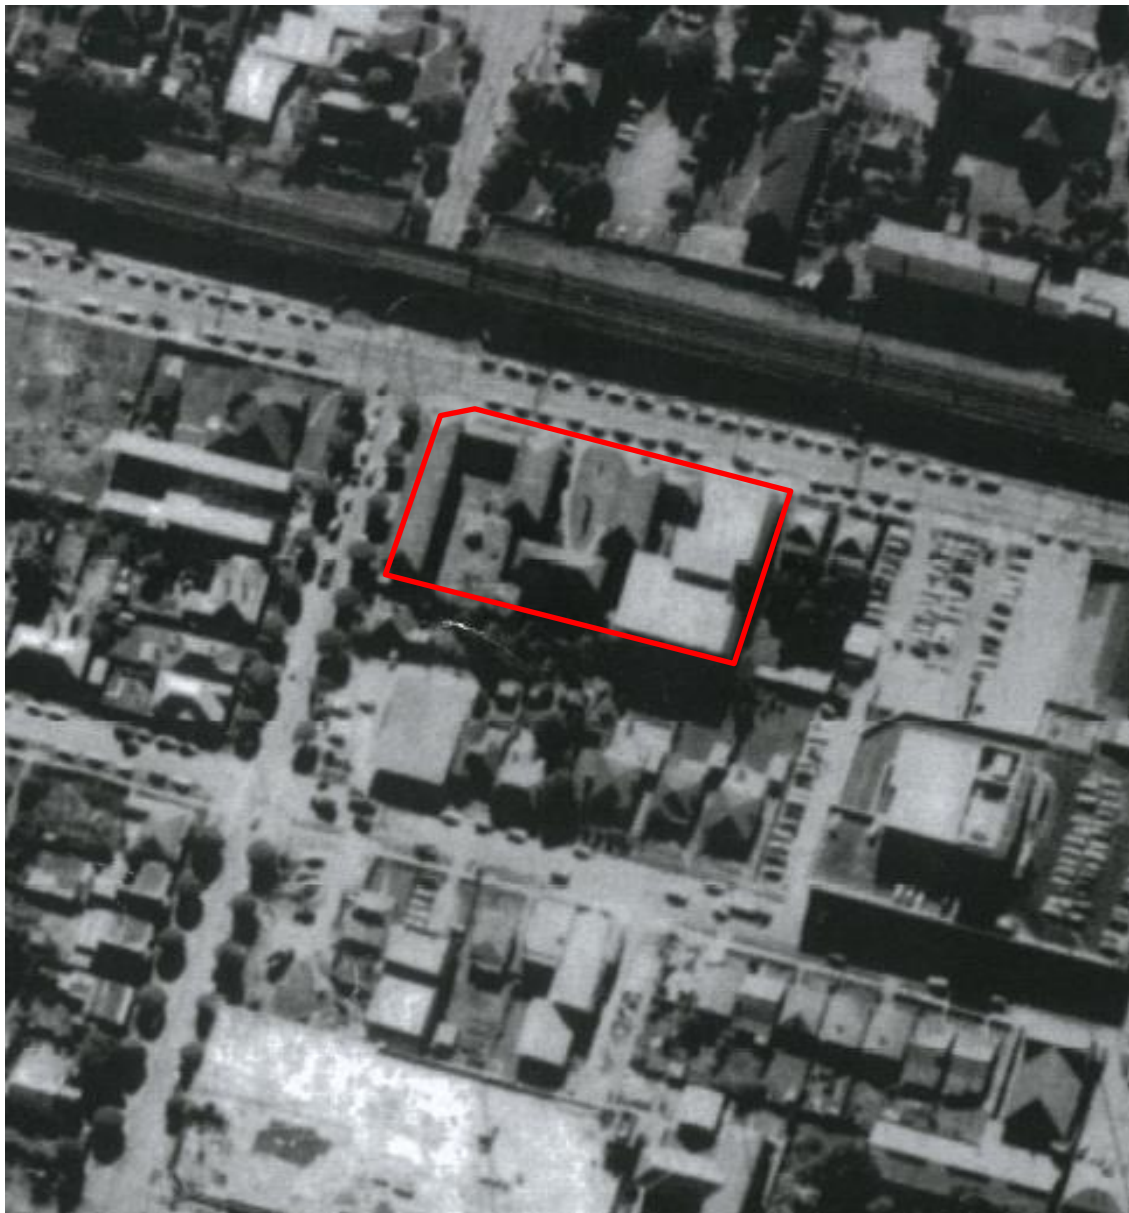
1961 Aerial Photograph
Proposed Commercial Tower
Westfield Parramatta

The 1961 image shows that the site comprised numerous buildings, presumably used for commercial purposes. Some of the nearby land appears to have transitioned from residential to commercial use since 1951.

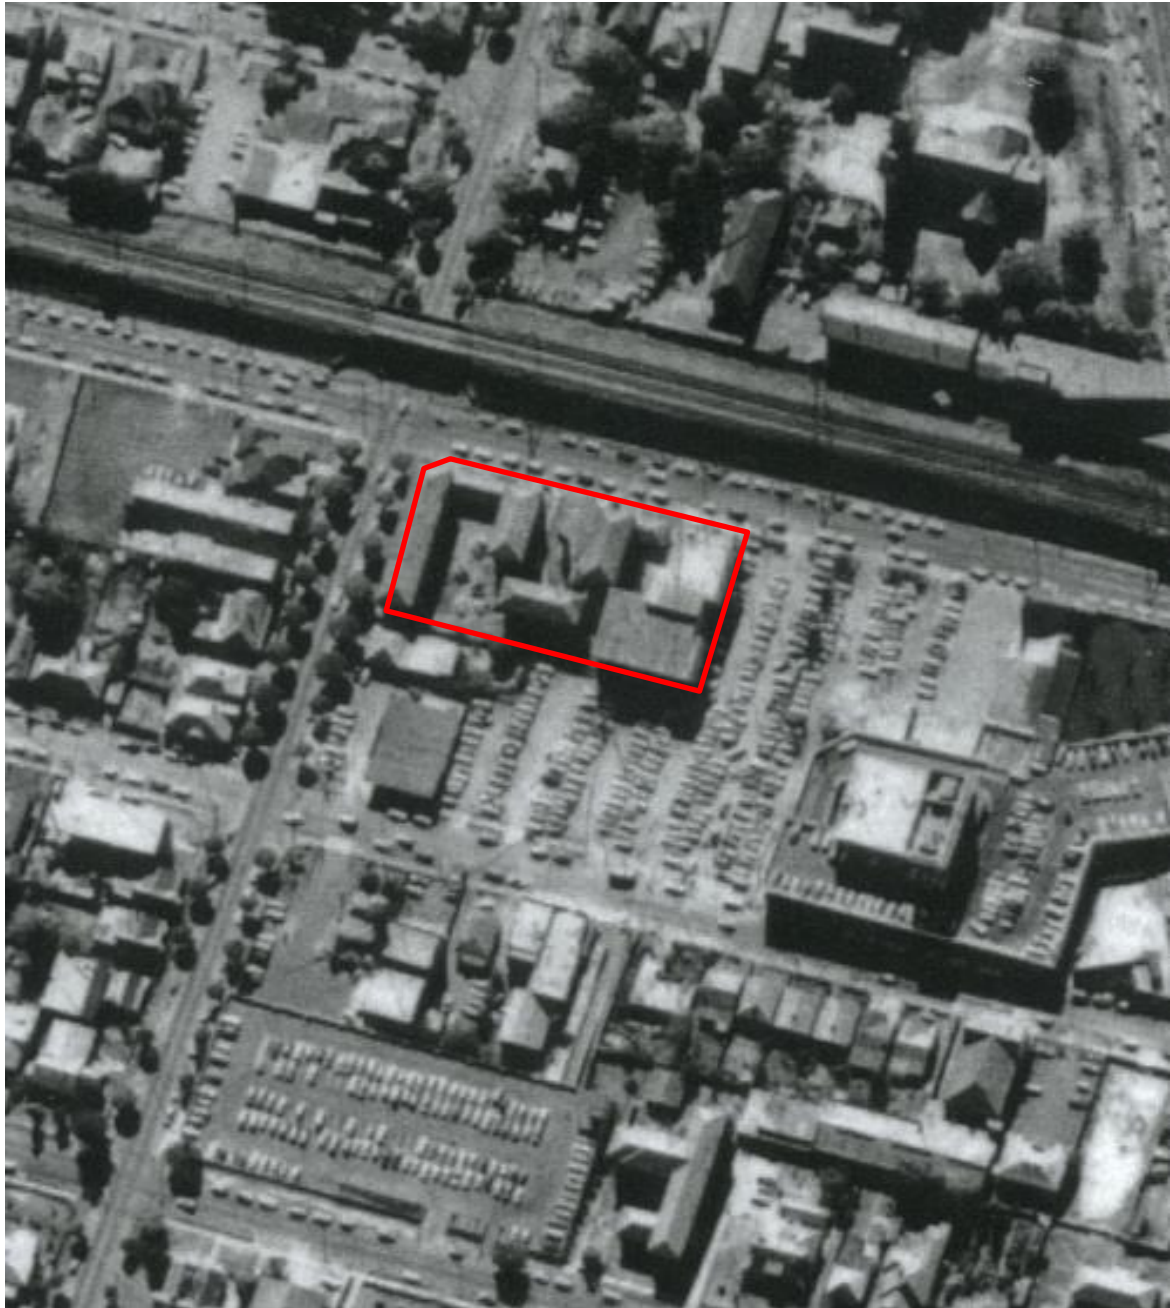
1970 Aerial Photograph
Proposed Commercial Tower
Westfield Parramatta

The 1970 image shows that the site had remained relatively unchanged since 1961, however, houses at the neighbouring properties to the east and south had been removed and replaced by a ground level car park.
