ROYAL FAR WEST - MANLY

14-22 WENTWORTH STREET &

19-21 SOUTH STEYNE, MANLY NSW

ARBORICULTURAL IMPACT ASSESSMENT REPORT

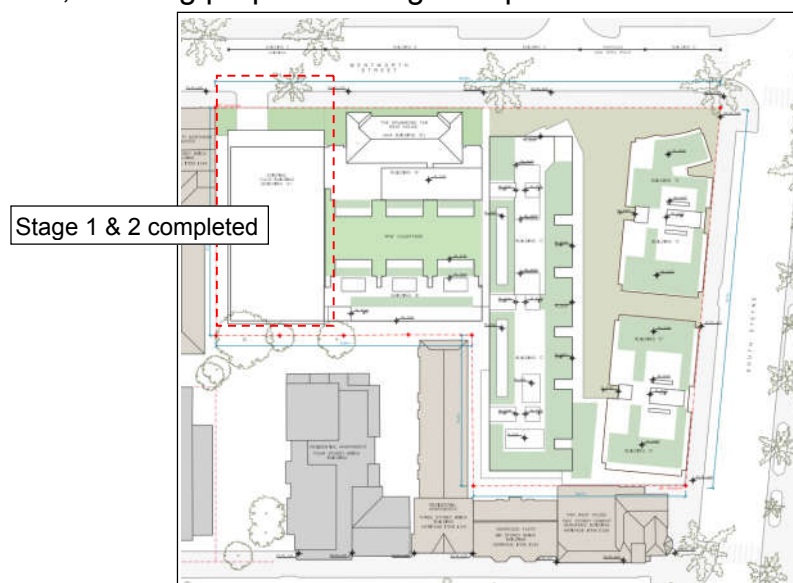
Figure 1, showing proposed design footprint

1.2.1 The development proposal consists of additions and alterations to Drummond House with deep soil excavation for basement levels to facilitate construction. The works which include upper level multi use facilities are located within notional tree protection zone setbacks.
