**REPORT
on
PHASE 1 CONTAMINATION ASSESSMENT**

**PROPOSED REDEVELOPMENT
WAHROONGA ESTATE**

**Prepared for
JOHNSON PROPERTY GROUP and
AUSTRALASIAN CONFERENCE ASSOCIATION**

**Project 45569.01
November 2008**

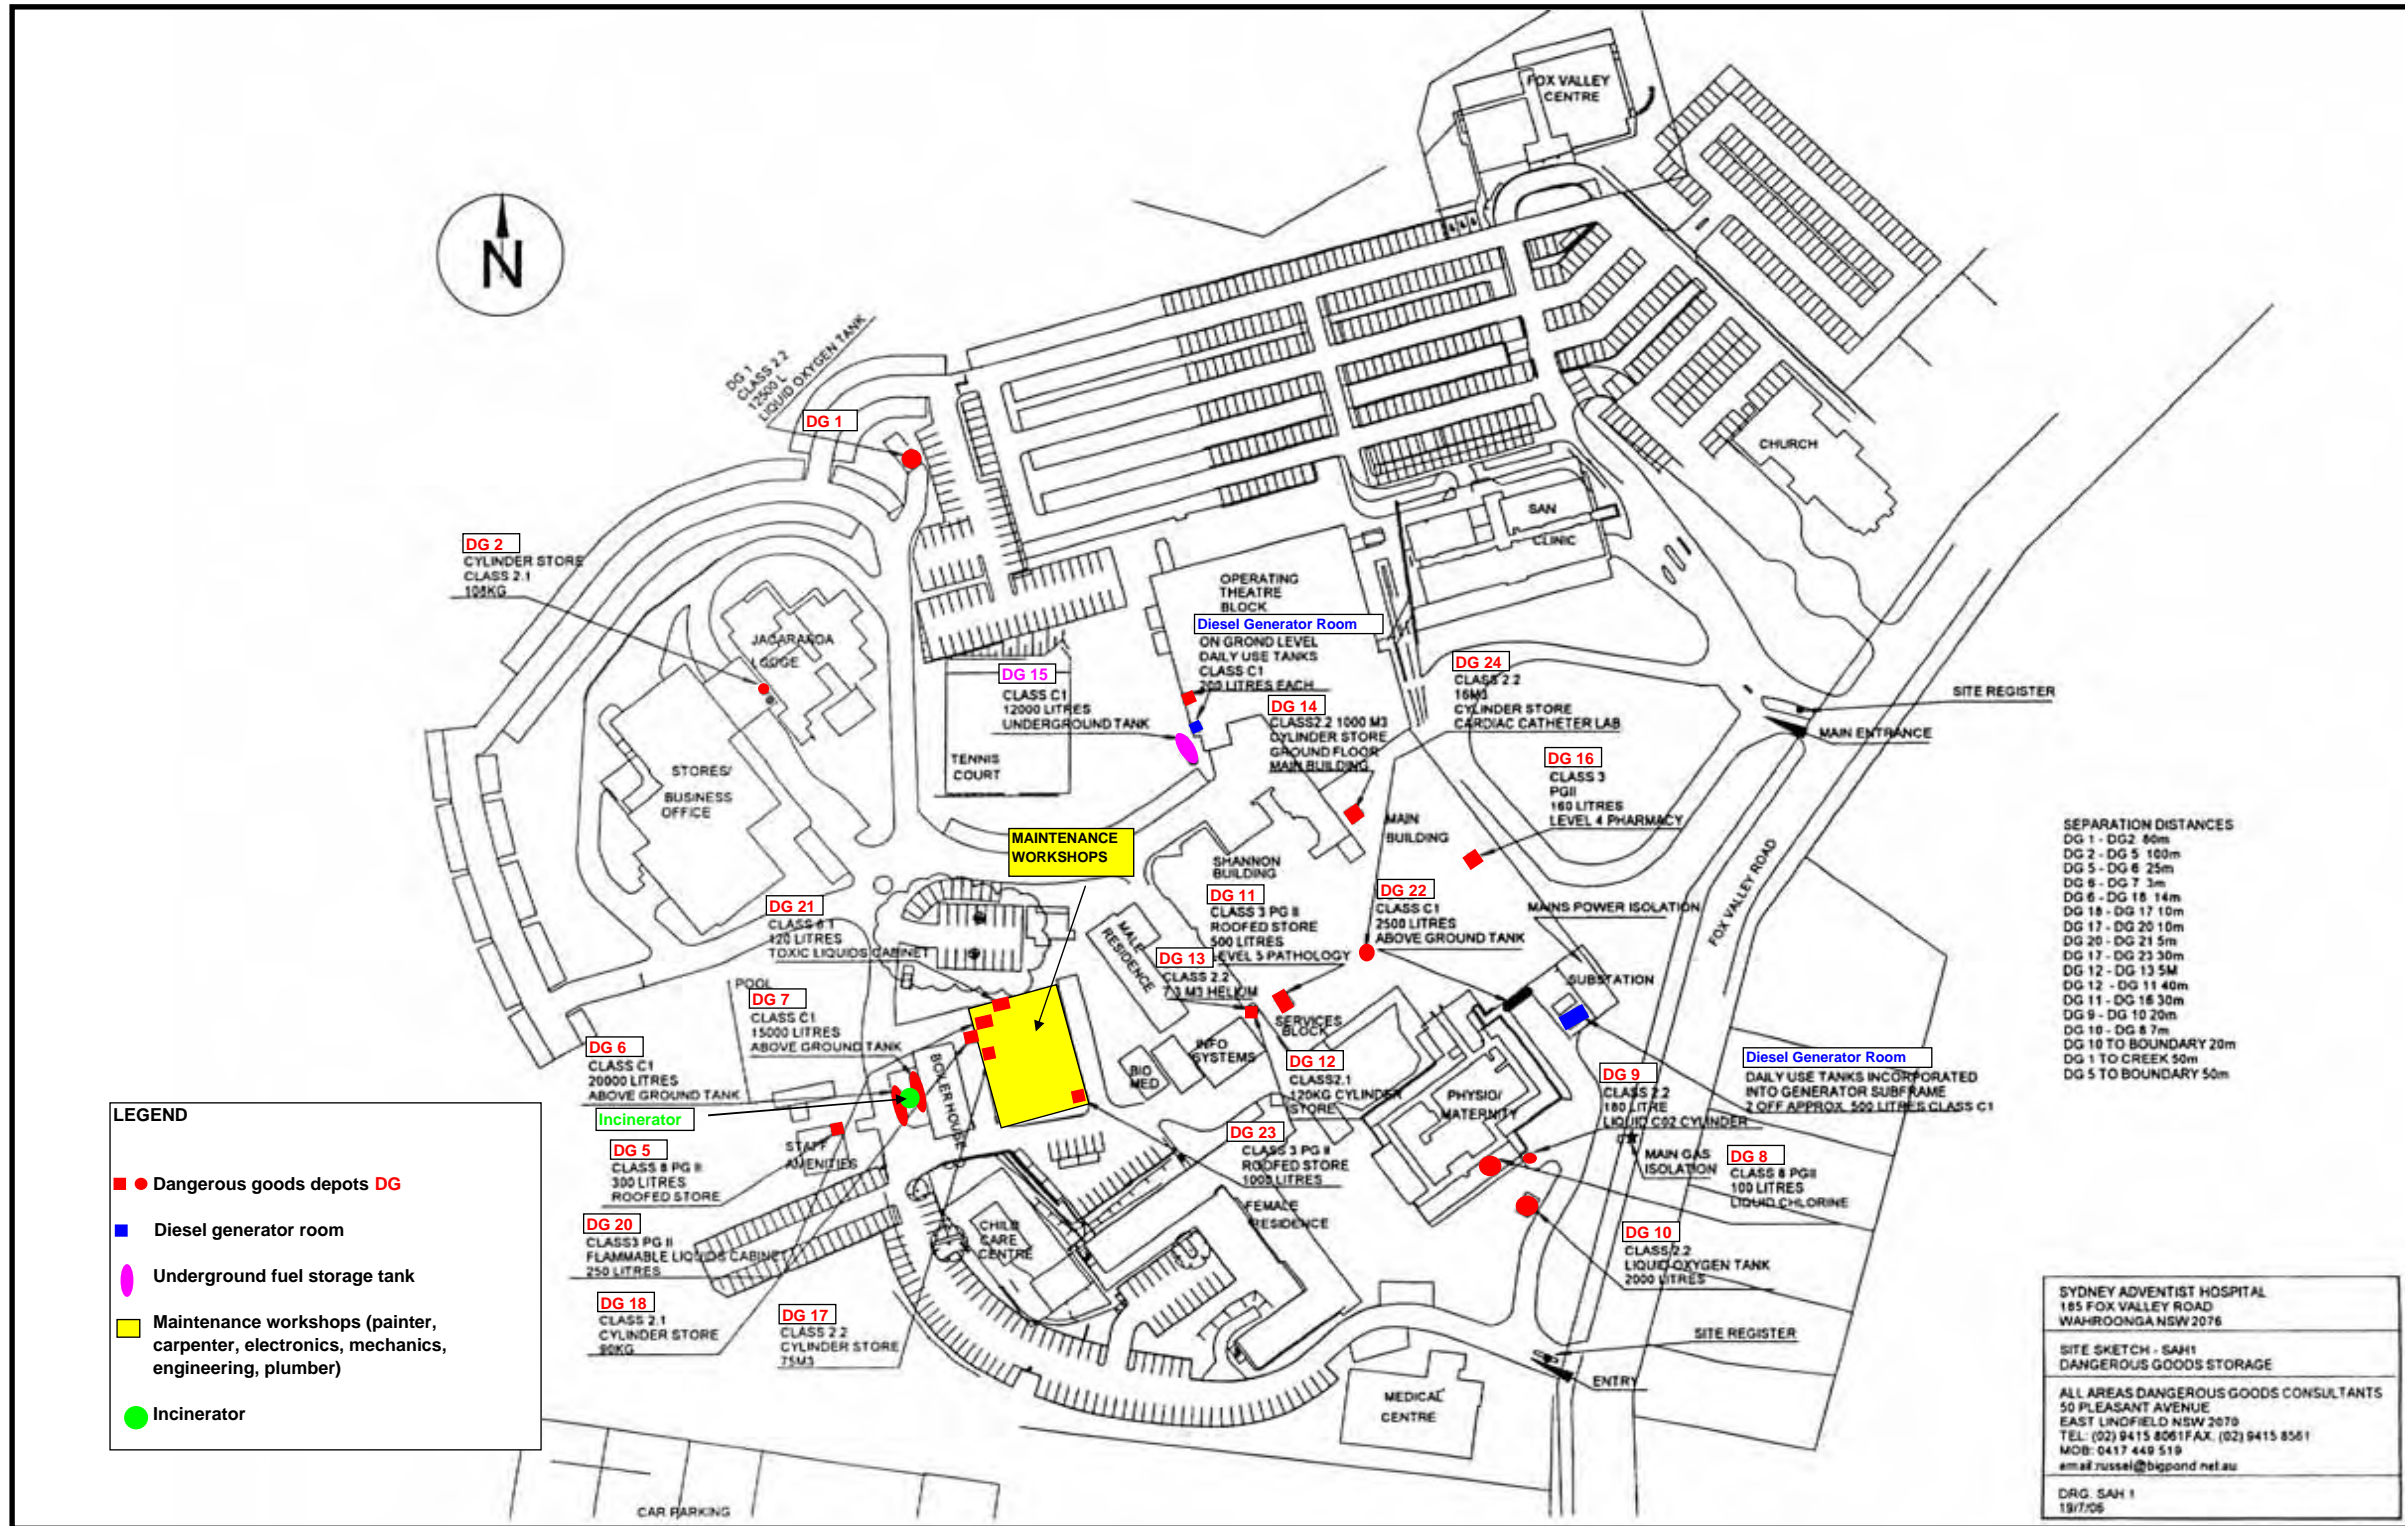
Drawing
 3

In the Hospital precinct there are a number of workshops near the incinerator block and there are a number of licensed Dangerous Goods Depots in the workshops. These are mainly small packaged goods depots which are small, steel cabinets with the appropriate signage. A typical small package depot and gas depot are shown in Photos 4-5, Plate C5, Appendix C and the location of the workshops and depots are shown in Drawing 3, Appendix A.

An underground fuel storage tank (UST) was noted where shown on Drawing 3, Appendix A, as Depot 15. Nearby was an inspection pit to access the top of the tank. There was no bowser near the fill point. The dangerous goods register indicates that the UST contains diesel (possibly installed circa 1995, refer to WorkCover records Appendix D).

With respect to the potential to impact soil and groundwater, the underground storages are the most important (depot 15) followed by the above-ground storages of hydrocarbons such as diesel and heating oil (depots 1, 6, 7, 9, 10, 22) and roofed stores (depots 5, 8, 11, 23). Gas storage depots will not impact the soil and groundwater. Pesticides are noted to be stored in depot 21. A similar pesticide store was also evident in the basement of one building east of Fox Valley Road (Centre for Health and Fitness Studies). This latter depot was observed to have suffered some leakage onto the concrete floor.

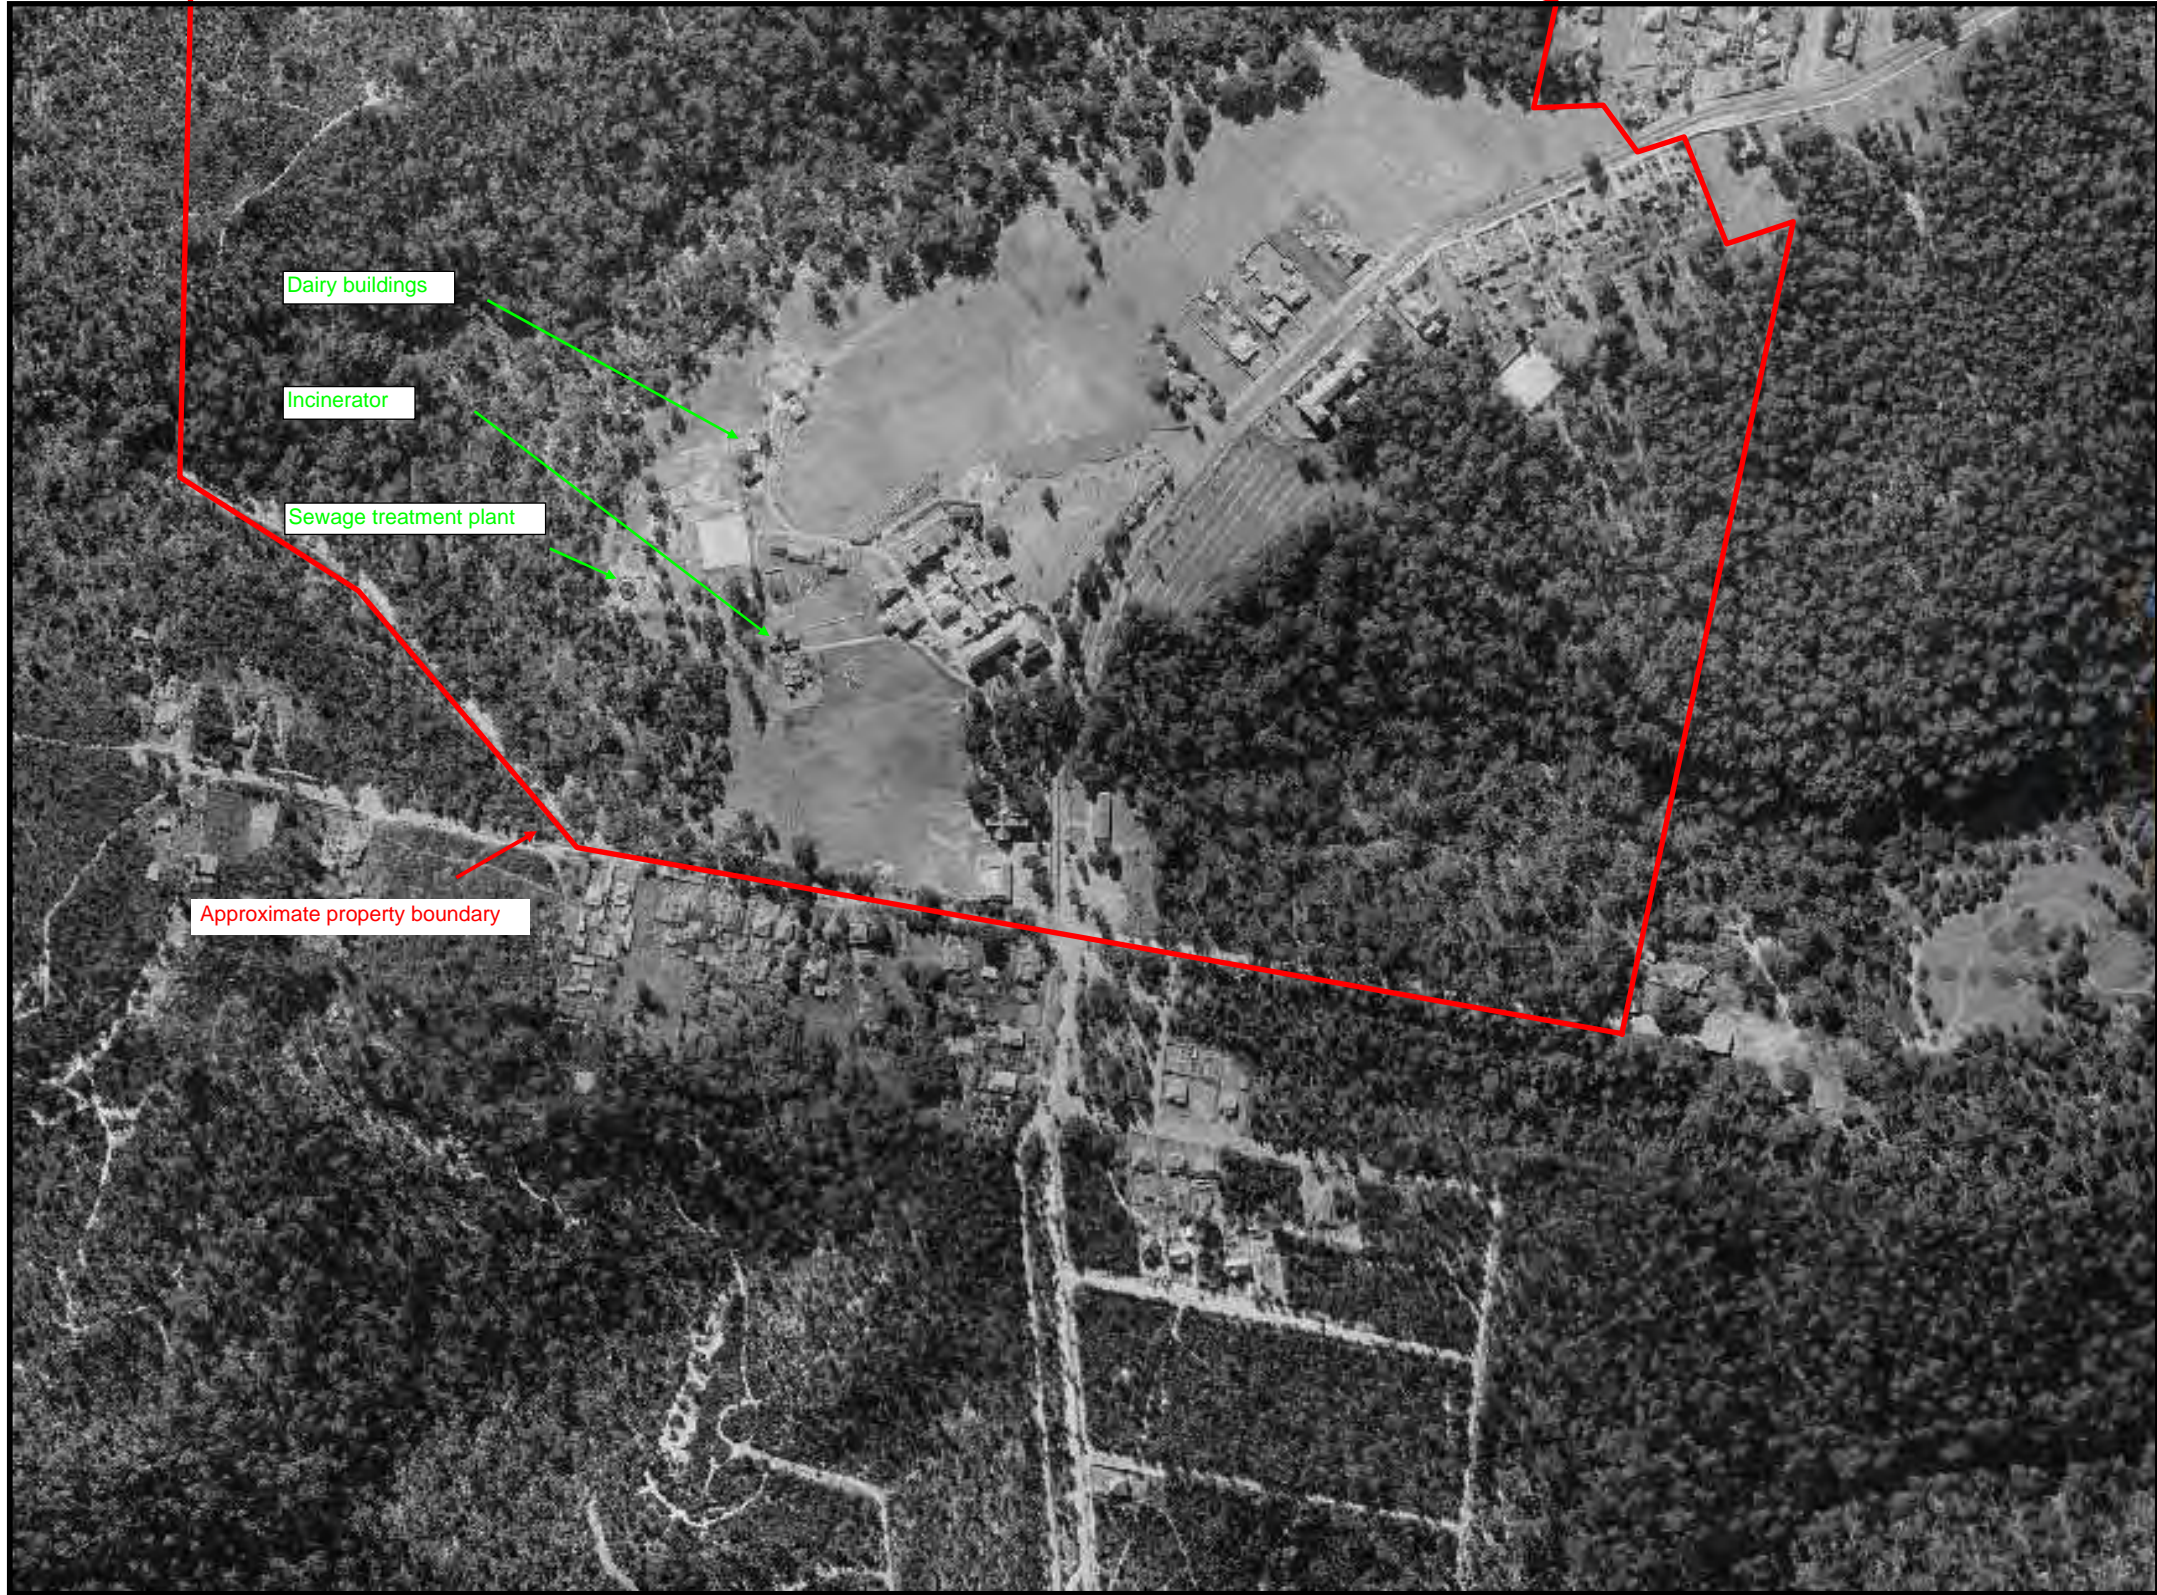
Plate
B 1

The photograph shows the hospital, much smaller than today, surrounded by large areas of cleared land. To the west of the hospital and on the edge of the cleared land, adjacent to the bushland, is a circular structure. This may be the sewage treatment plant that was discussed with the Works Coordinator (refer to Section 3.8). We understand from the heritage consultant to the project (Australian Museum Business Services) that there was also an incinerator located at the site (as shown on Plate B1). The buildings to the north of the incinerator are probably a farmhouse and dairy also noted in the same discussion with the Works Coordinator. The pale coloured feature to the east of the treatment plant may be an associated pond, however, there is a similar feature, both in colour and shape, on the eastern side of Fox Valley Road in the north-east of the photograph which is considered unlikely to be pond. In this case, these features cannot be identified with certainty.

An apparent cultivated plot of land is noted on the eastern side of Fox Valley Road, broadly opposite the Hospital. The other development of note is the housing on both sides of Fox Valley Road at the northern end of the site. There is little or no on-site housing along the site boundaries fronting the Comenarra Parkway, Mt Pleasant Avenue or Waratah Way (the latter two had not yet been constructed). The Comenarra Parkway appears to be a gravel road and is a cul-de-sac.

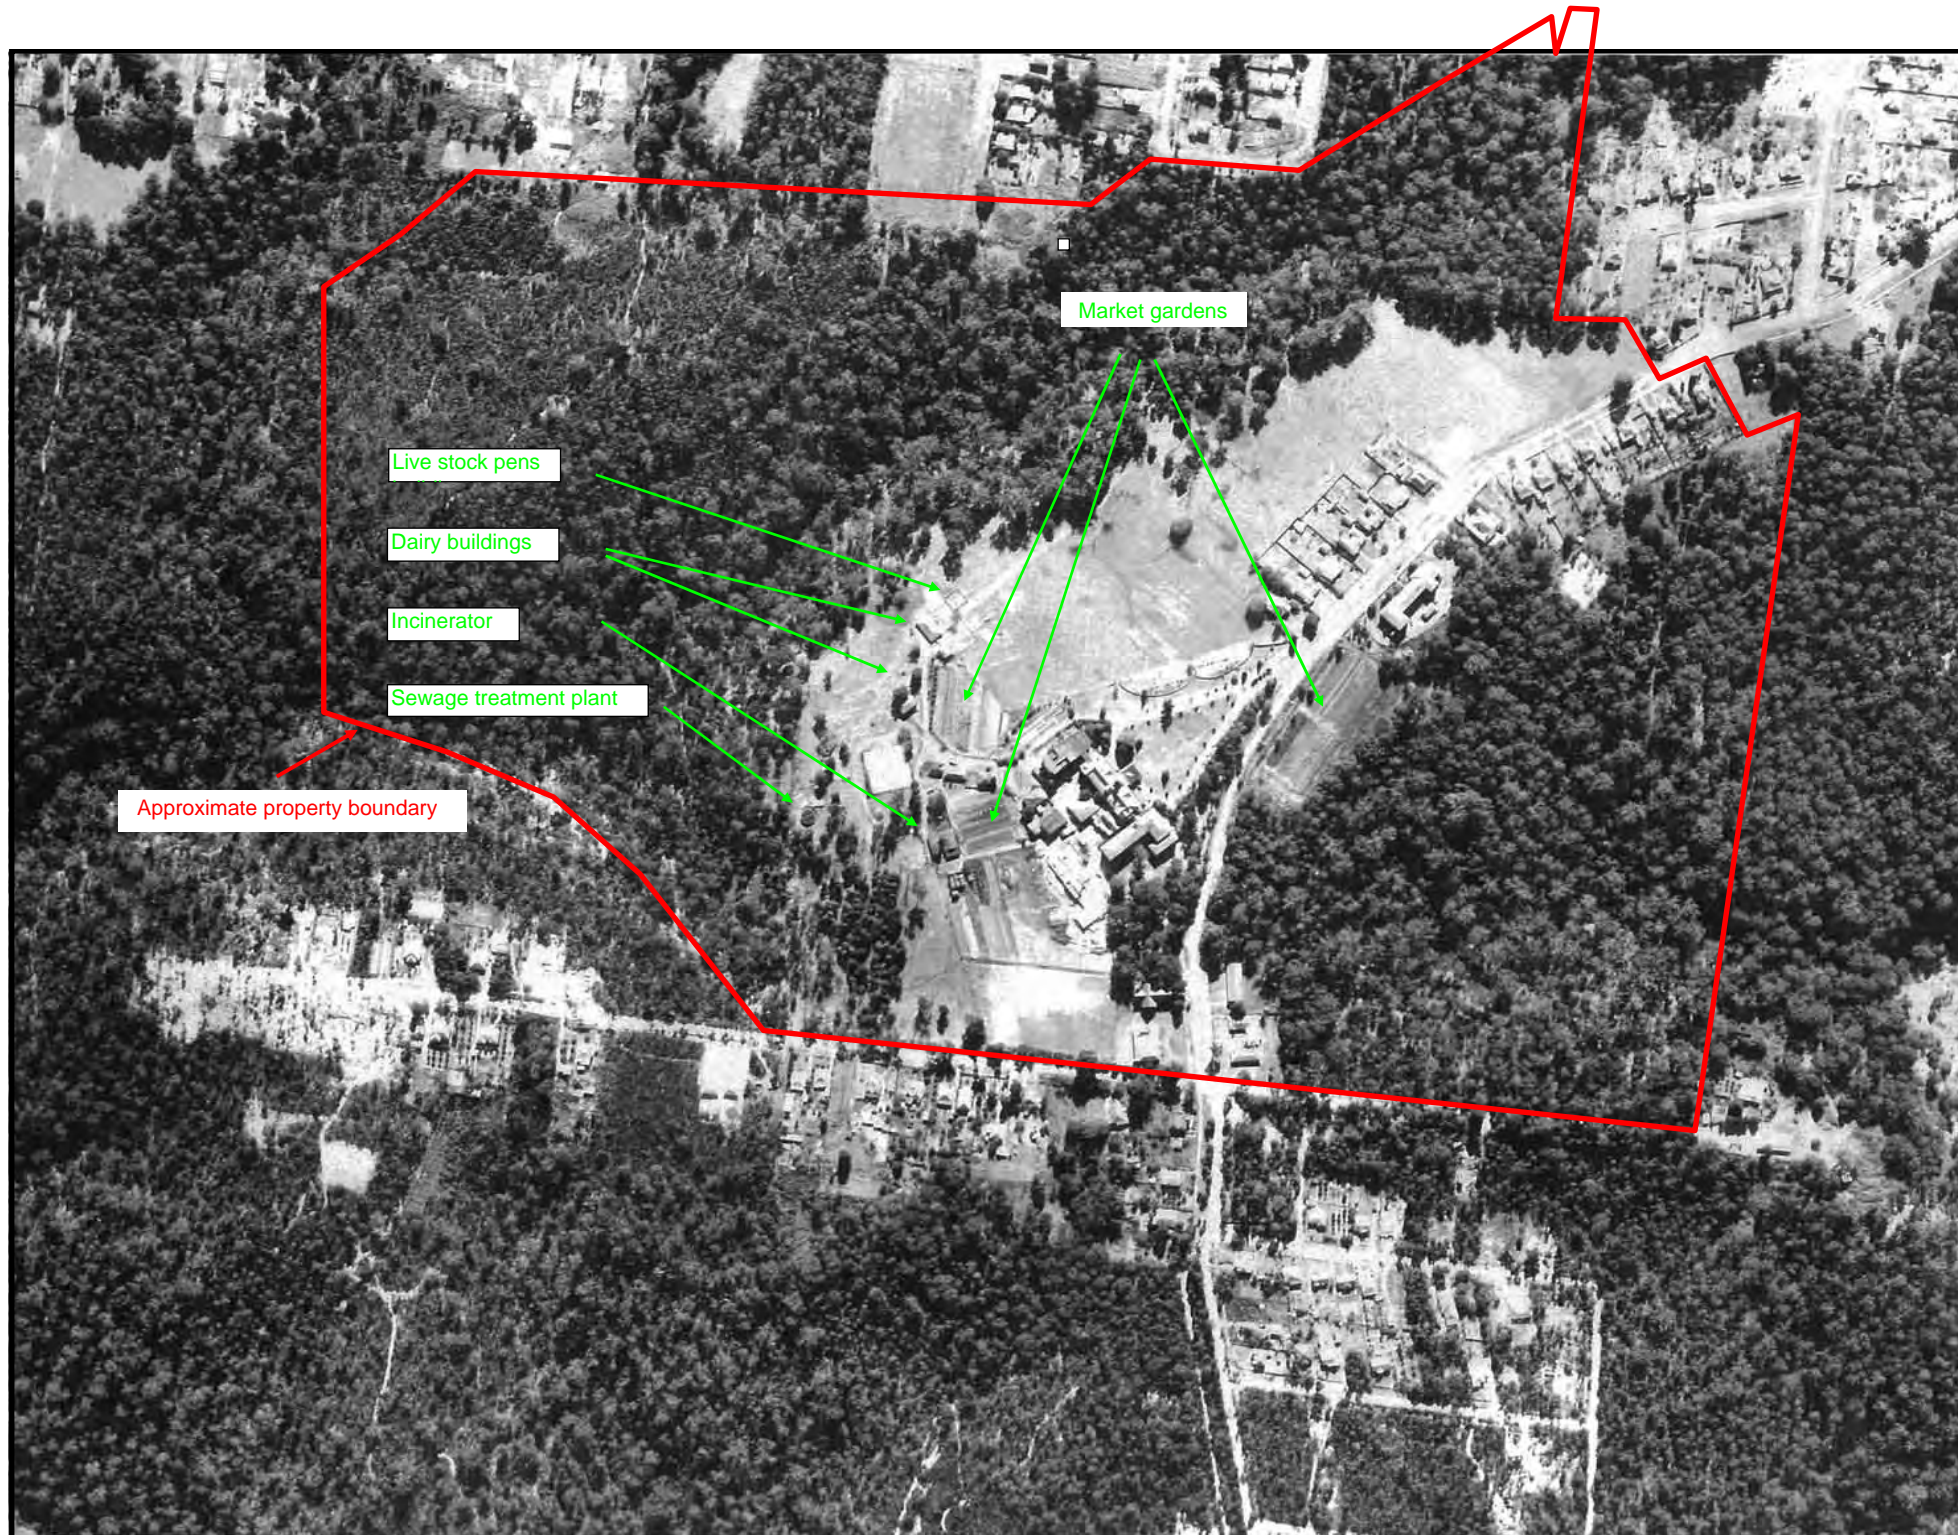
Plate
B 2

There has been an expansion of the hospital. The treatment plant, dairy and incinerator buildings are still existing. There appears to be small areas of cultivation to the west of the hospital buildings, possibly including orchards. Historical photographs supplied by the Australian Museum Services showed significant orchards present in a photograph dated 1921. The cultivation looks typically like market gardens (possibly for hospital consumption?) and this is confirmed by the historical photograph in Plate F1, Appendix F. Similar cultivation can also be seen in two large Lots on the eastern side of Fox Valley Road (at the same location of the cultivated plot noted in Plate B2) which is also confirmed by the historical photograph in Plate F2, Appendix F. Housing development can be seen to be increasing in the surrounding suburbs although there are only small increases in housing along Fox Valley Road. Possible livestock (dairy cows?) are evident in the northern end of the cleared land. Plate F3, Appendix F, shows the cows in this area. Further photographic evidence (Australian Museum Services) indicates the dairy herd was there from as early as 1921 until at least 1964.

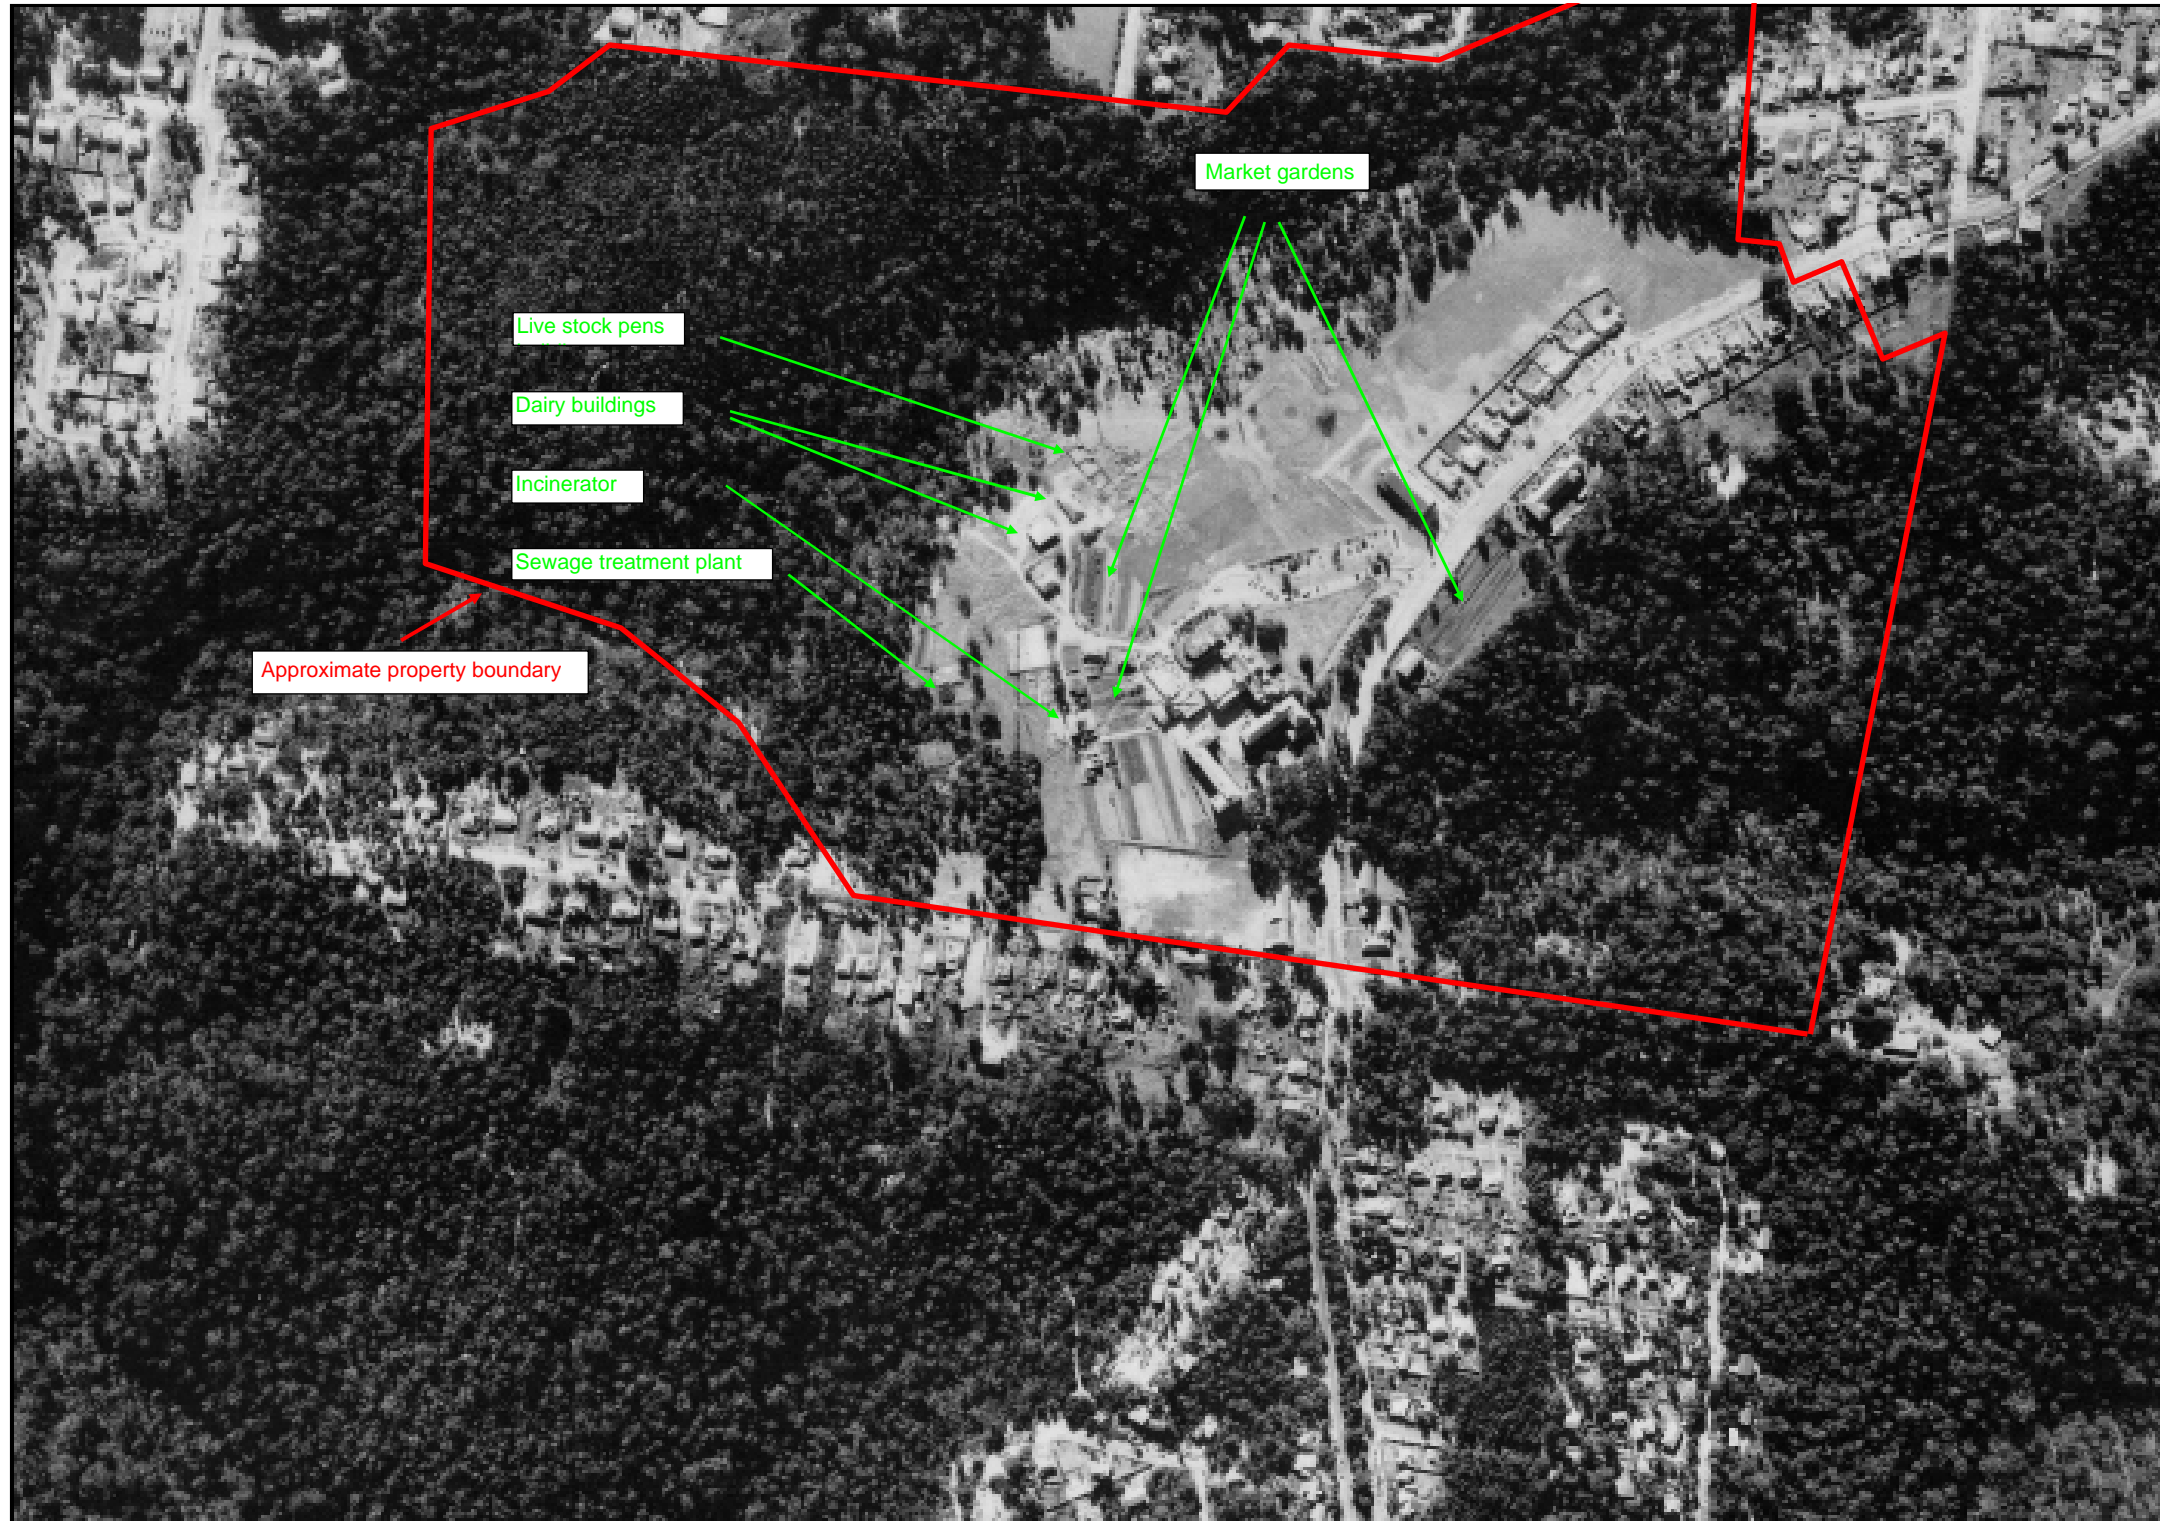
The hospital had not expanded very much since 1951. The treatment plant, dairy and incinerator buildings are still present. There are indications that the cultivation had expanded to the north of the hospital with a small number of fields or allotments evident. Housing had marginally increased along Fox Valley Road and Comenarra Parkway. Mt Pleasant Avenue and Waratah Way were not yet constructed. Livestock and livestock pens are evident north of the hospital and are probably related to dairy cows.
