2 June 2008

Our Reference: Winton-080521-POWMRI-asbestos survey

ASBESTOS MATERIALS SURVEY

PRINCE OF WALES MEDICAL RESEARCH INSTITUTE RANDWICK, NSW

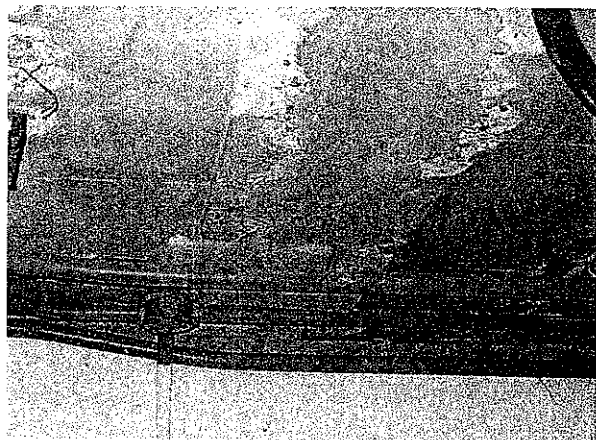
A fibre-cement packer approximately 15 cm x 15cm in dimension was found adhered to the underside of the soffit at the base of the stairs outside the Electrical Switch Room, in which amosite and chrysotile asbestos was detected; refer to Sample No.1, Photo Nos. 1 & 2. Another packer, suspected to contain asbestos was found in the soffit adjacent the south wall above air-conditioning unit in the Electrical Switch Room.

Photo 1: Villa No. 2 Basement, A/C packing

- Pickford & Rhyder Consulting recommend that all ACM found during the survey should be removed by NSW WorkCover Authority licensed asbestos contractors *prior* to, or as part of any refurbishment project.

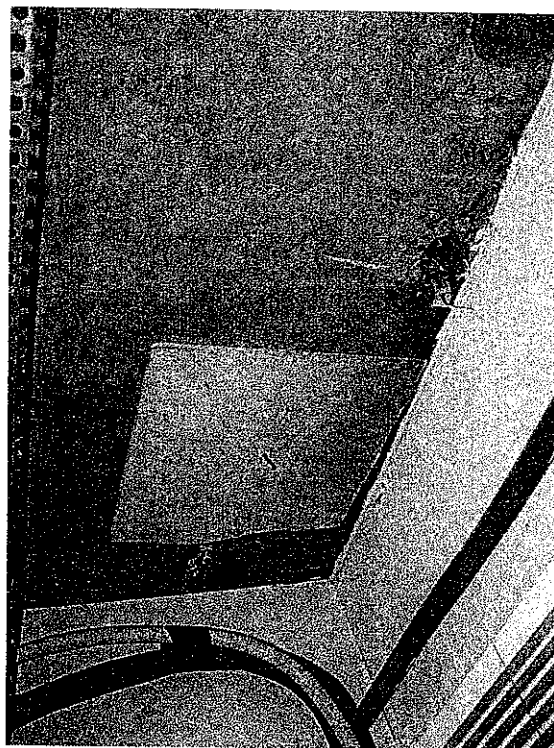
Photo 2: Villa No. 2 Basement, A/C packing

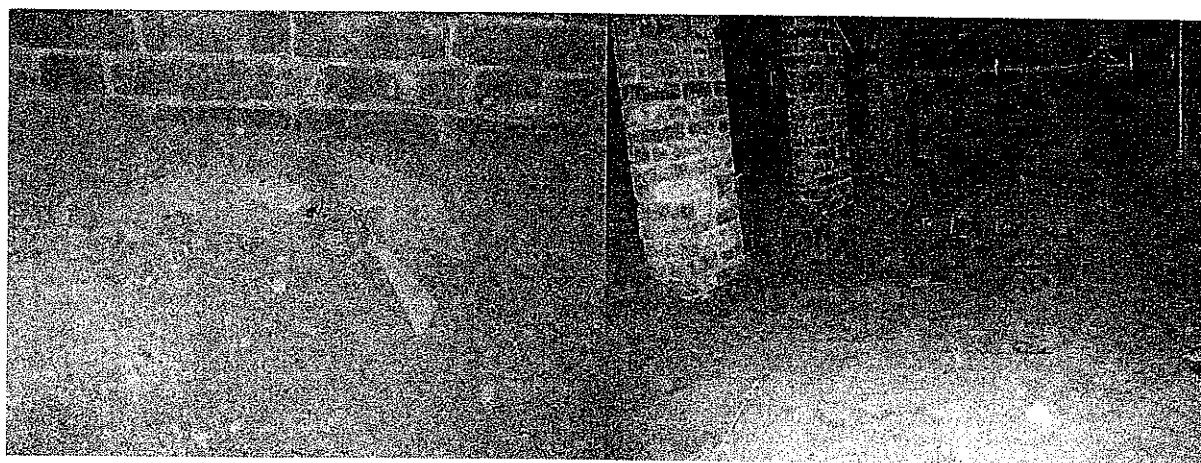
During the walkthrough of the service tunnels, there was some building debris consisting of brick, pipe, mortar and general refuse in the soil fill material. *A minor amount of fibre-cement fragments⁴ was found scattered throughout the underfloor spaces partially buried and on the surface of the soil fill, refer to Photo No.4.* The fragments are more than likely remains of pre-construction concrete formwork. The fragments are similar to those fragments identified in the soil fill in the Ground Floor Basement of Villa No.2 and therefore suspected to contain asbestos.

During the walkthrough of the service tunnels, there was building debris consisting of brick, pipe, mortar and general refuse in the soil fill material. A minor amount of fibre-cement fragments⁴ was found scattered throughout the underfloor spaces partially buried and on the surface of the soil fill. The fragments are more than likely remains of pre-construction concrete formwork. *A sample of a fibre-cement fragment was taken from the south service tunnel underfloor area, in which chrysotile asbestos was detected; refer to Sample No.4, Photo No.3.*

Photo 3: Villa No.2 Basement, A/C in soil fills

Photo 4: Villa No. 1 Basement, General Debris
in soil fill material

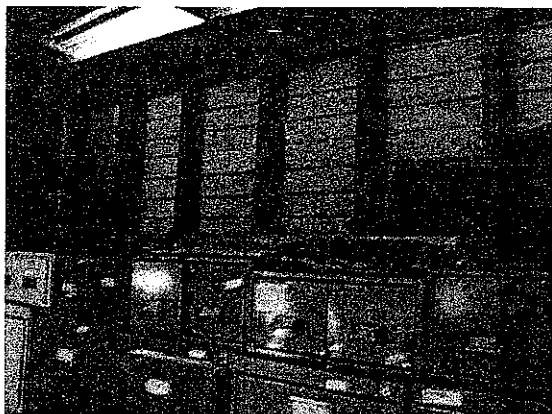
A sample was taken of the fibre-cement wall cladding, in which amosite and chrysotile asbestos was detected; refer to Sample No. 5, Photo No.s 5 & 6.

Photo 5: Tank Room No.2 A/C wall cladding

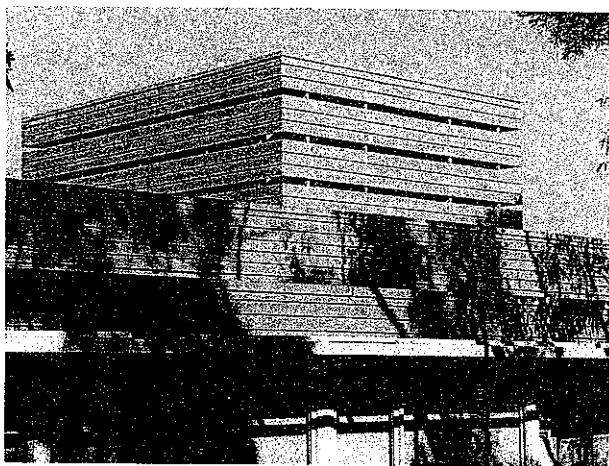
Photo 6: Tank Room No.2 A/C wall cladding under timber facade

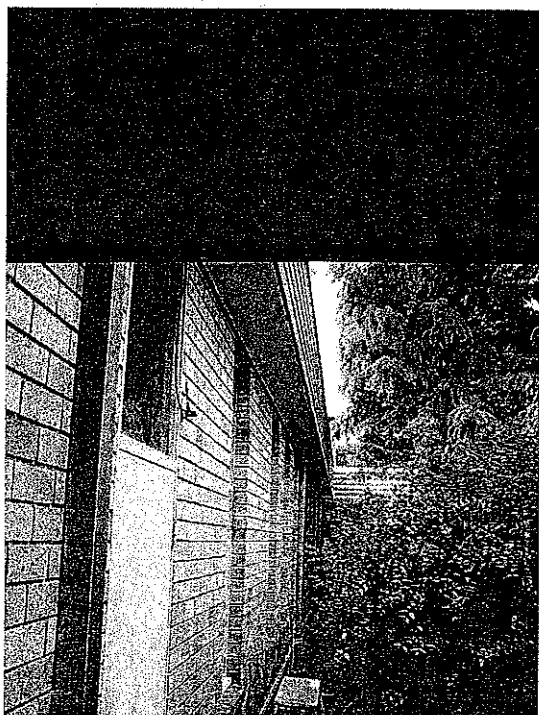
A sample was taken from the fibre-cement eave located on the north wall of the internal courtyard, in which amosite and chrysotile asbestos detected, refer to sample No. 12, Photo No. 7.

Asbestos-cement was found in the eave in the internal courtyard, refer to Sample No. 12, Photo No. 7. The eave is also present on the east and north wall (above north annexe) of the building, refer to Photo No 10.

Photo 7: Courtyard No. 2, A/C eave

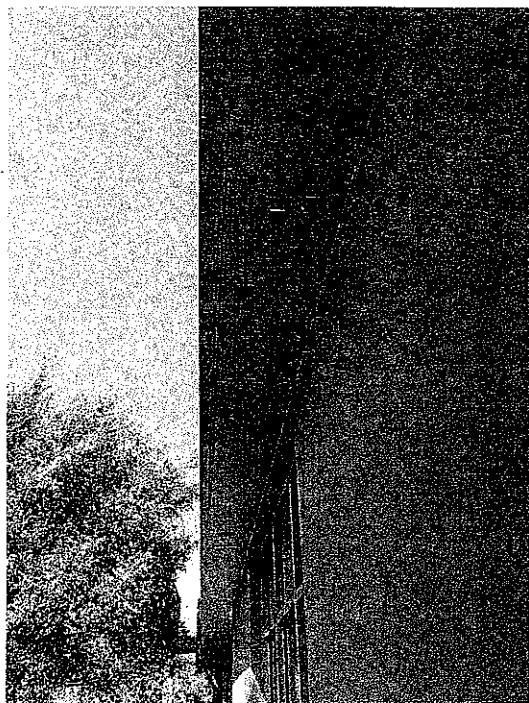
A sample was taken of the fibre-cement eave, south of the main entry (adjacent Symbion Imaging Centre), in which amosite and chrysotile asbestos was detected; refer to Sample No. 9, Photo No. 9. Therefore, the external eave on this building contains asbestos.

Photo 9: Main entry, A/C eave

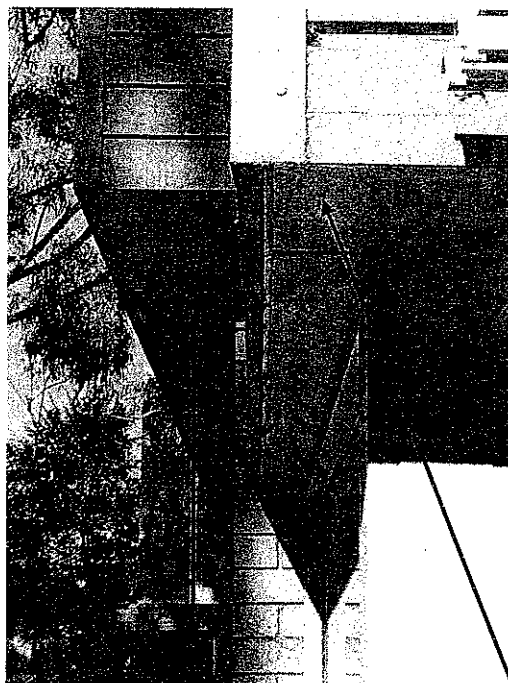
Photo 10: East A/C eave, *Note: eave extends above annexe along north wall.*
North annexe eave is non-asbestos

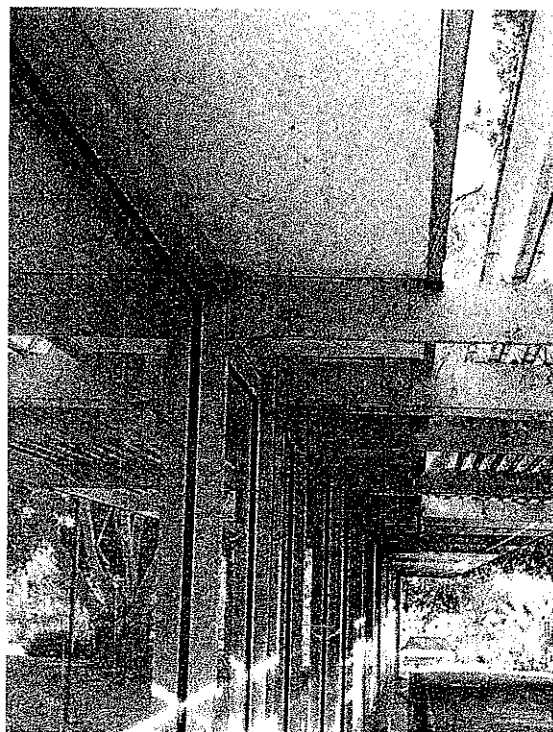
A sample was taken of the fibre-cement eave lining from the north annexe (addition to Villa No.2), in which no asbestos was detected, refer to Sample No. 14, Photo No. 11.

Photo 11: North annexe eave (non-asbestos)
