Tillegra Dam

Planning and Environmental Assessment

Roads and Other
Infrastructure

WORKING
PAPER

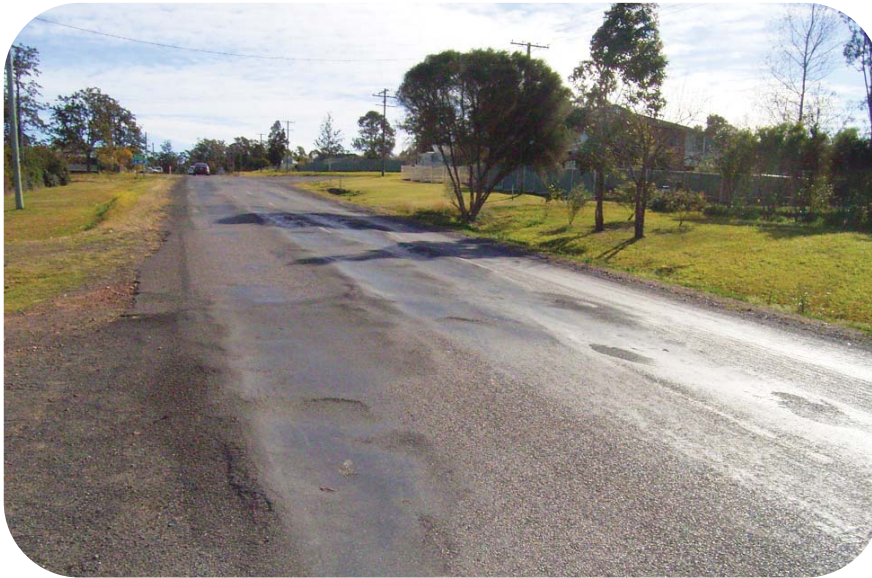
PHOTO B1

Surface deformations such as shoving and rutting along Clarence Town Road.

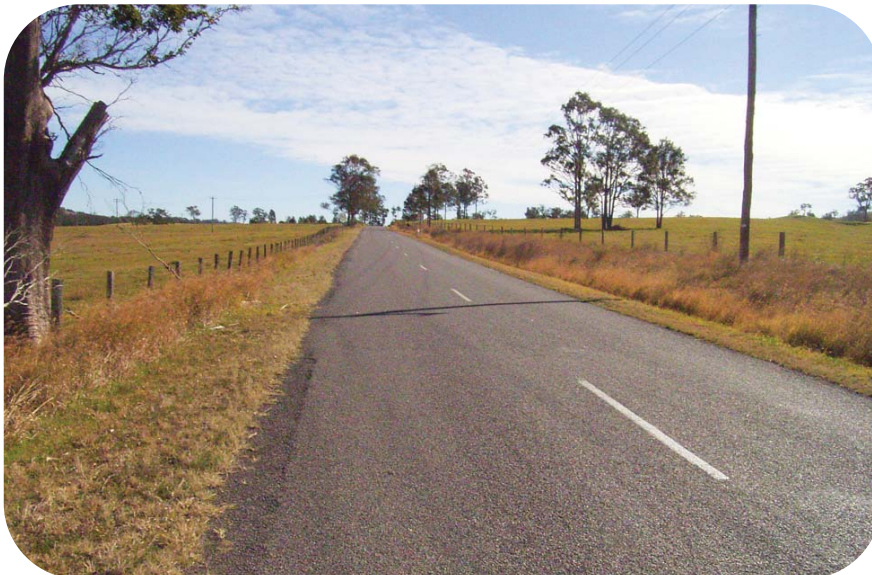
PHOTO B2

The road surface condition between Clarence Town and Wirragulla is in reasonable condition. There are no visual signs of pavement failure along this section of roadway.

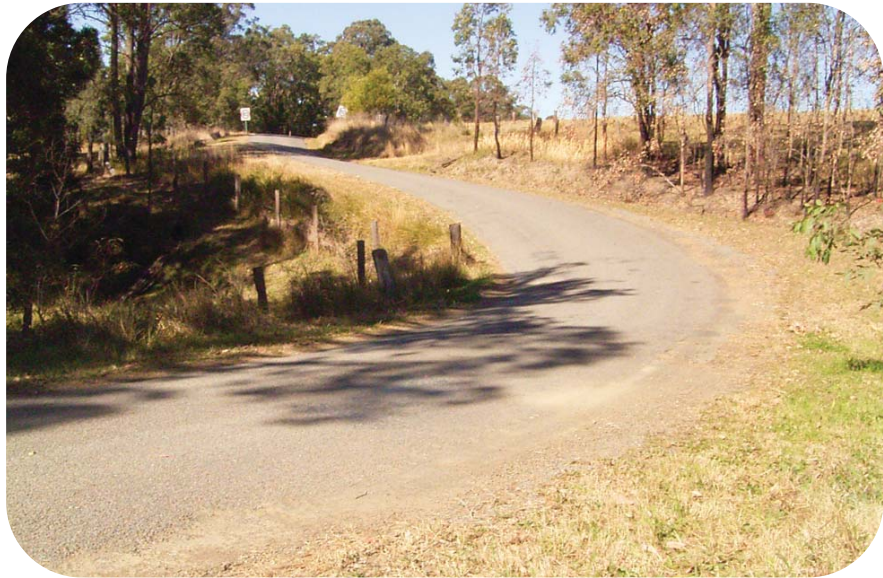
PHOTO B5
Edge patching undertaken
along Salisbury Road.

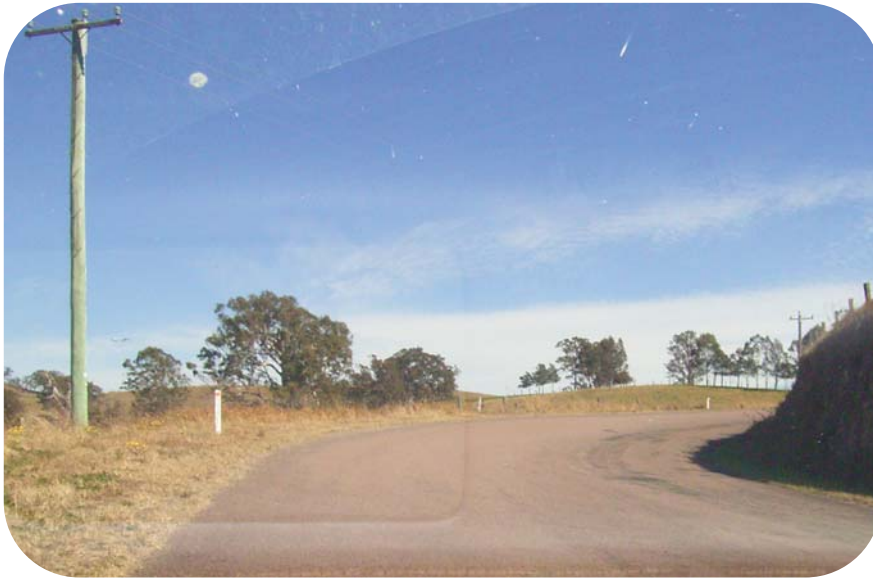
**PHOTO B7**

Sections of Salisbury Road where there is limited sight distance in both directions. On the inside of the curve it can be seen that the pavement has failed.

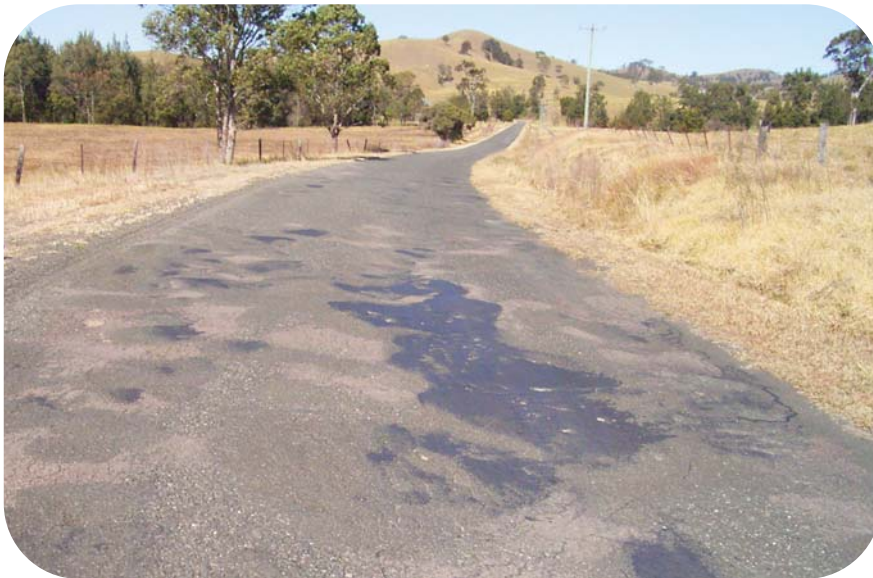
**PHOTO B8**

Sections of Salisbury Road which have been patched after pot holes have occurred. This is a temporary measure to a pavement which has failed.

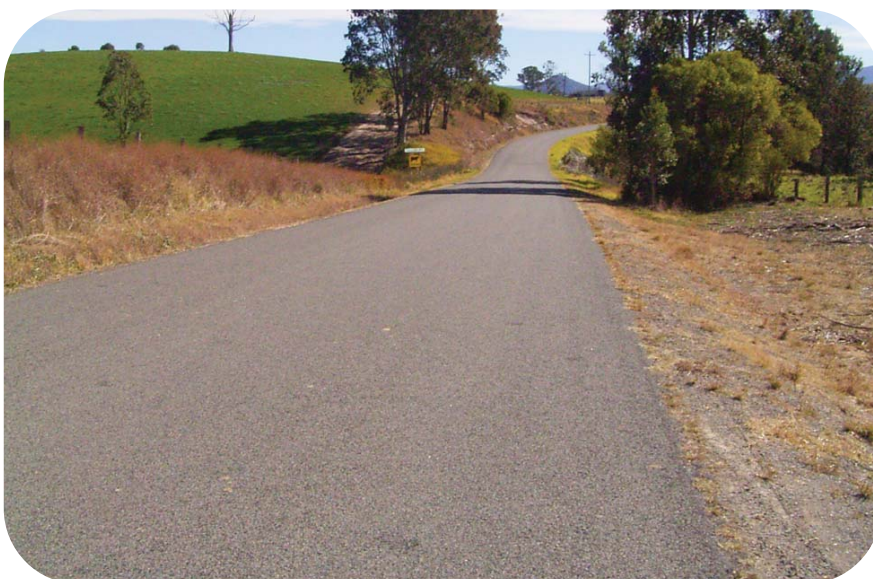
**PHOTO B9**

Salisbury Road with no line marking delineation.

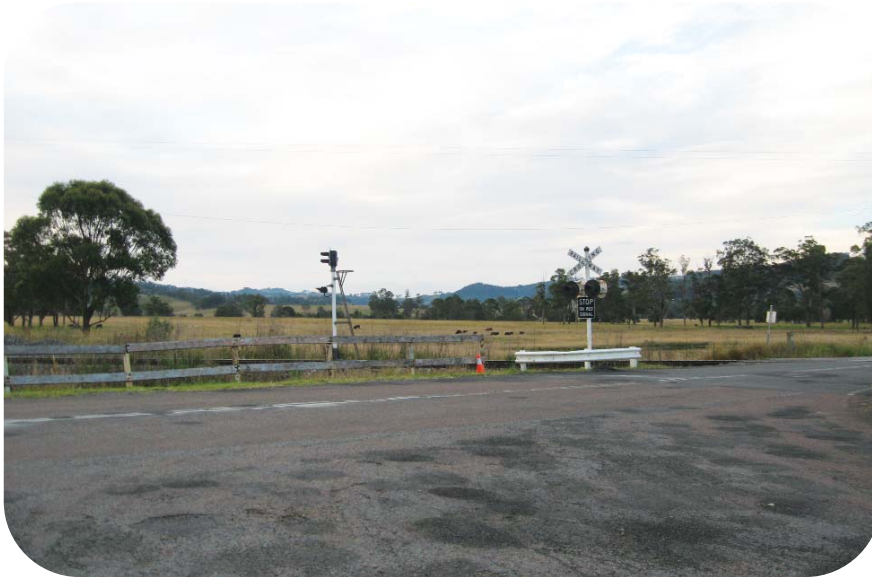
PHOTO C1
Intersection of Wallarobba
Brookfield Road and Dungog
Road.

- the intersection of Wallarobba Brookfield Road with Dungog Road contains significant pavement defects. The close proximity of the intersection to the rail level crossing contributes to the increased hazardous nature of the deficiency (Photo C1).
- the section between Sandy Creek Road and Hilldale Road contains steep inclines and declines with continuous and severe pavement defects, and steep unprotected embankments (Photo C2).

- there are pavement deformations and faded line marking at the intersection of Wallarobba Brookfield Road with Dungog Road
- the section between Sandy Creek Road and Hilldale Road along Dungog Road contains severe pavement defects that continue throughout the undulating terrain. The steep embankments along this section include old fencing where there are no guard barriers. The lack of signs to indicate the winding nature of the road contributes to the overall deficiency along the route.
- the intersection of Horns Crossing Road with Dungog Road consist of a narrow rail overpass, faded line marking, damaged signs in conjunction with inadequate guard barriers and incorrectly installed curve alignment markers (Photo C17)
- the bridge over Martins Creek on Dungog Road consists of old wooden fencing with no guard rail protection for the steep embankments on the southern approach (Photo C18).

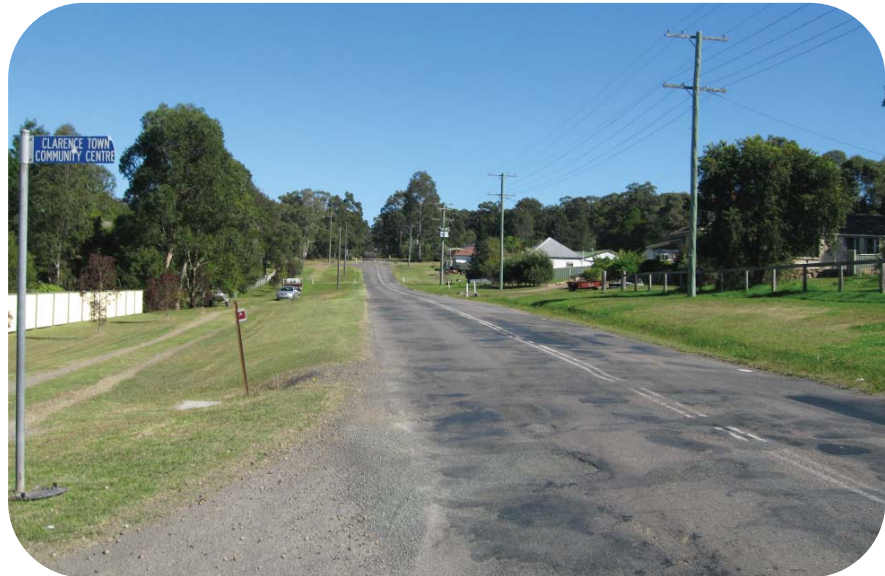
PHOTO C5
Salisbury Road, north of
Tillegra Bridge.

- directly north of Tillegra Bridge, the pavement along Salisbury Road becomes extremely narrow. It is also damaged with unprotected embankments (Photo C5).

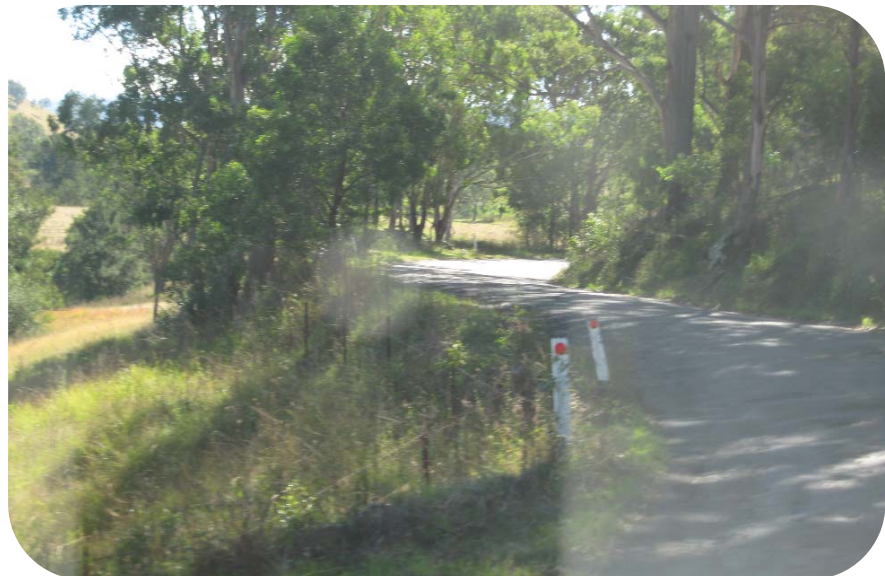
PHOTO C6
Clarence Town Road/Dungog
Road intersection, looking
south on Clarence Town Road.

- substantial rutting at all approaches to the intersection (Photo C6)
- no line marking is provided at the Dungog Road approach
- line marking is faded along the acceleration lane on Clarence Town Road
- the guard rail on the south western corner of the junction, after the concrete bridge, is damaged and is located too close to the roadway
- the sight distance to the right turning vehicles is limited due to the crest which is located north of the intersection on Clarence Town Road (Photo C19)
- no right turn bay is provided on the northern approach of the Clarence Town Road
- no lighting is provided for this intersection.

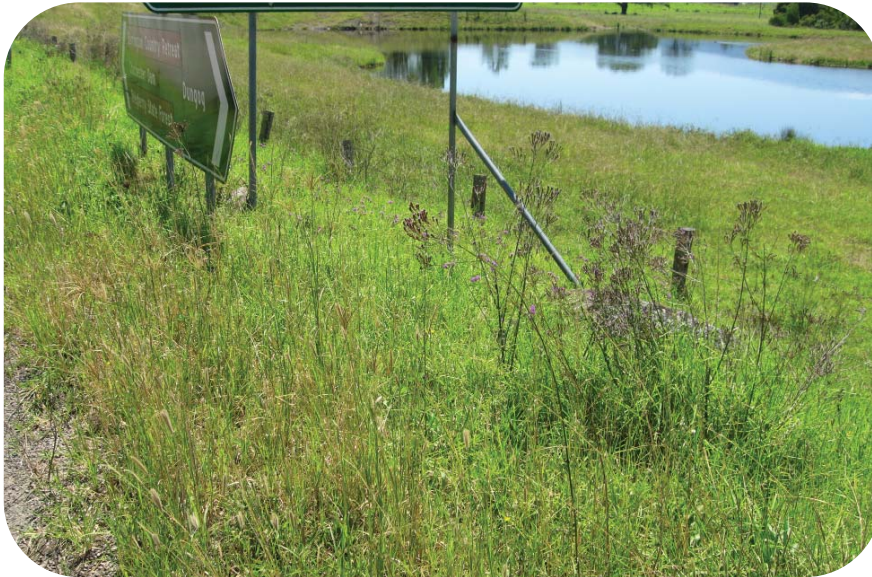
PHOTO C7

Shoulder drop off on eastern side of Chichester Dam Road/Salisbury Road intersection.

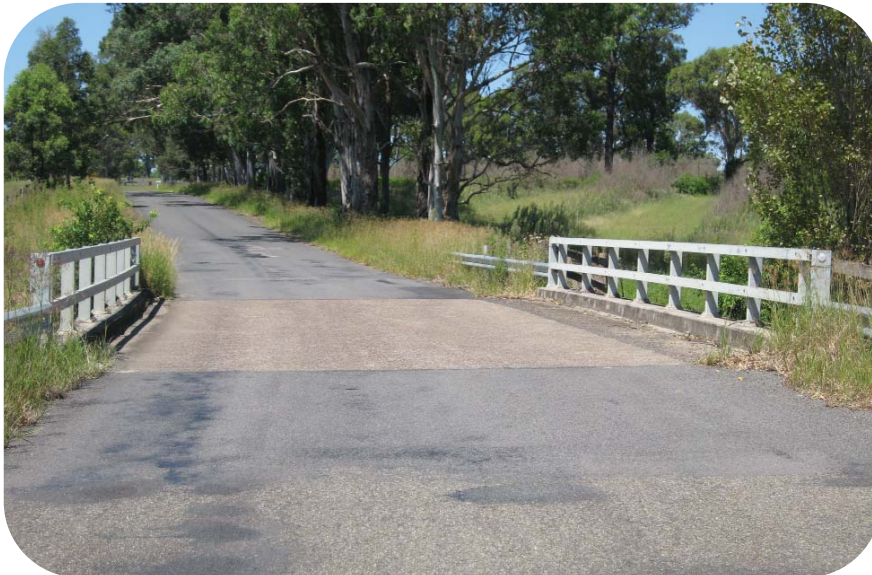
PHOTO C8

- most bridges along this road section are narrow and/or have substandard widths. Some of the narrow bridge signs are either missing or faded (Photo C8).

Narrow bridge width on Chichester Dam Road, southbound.

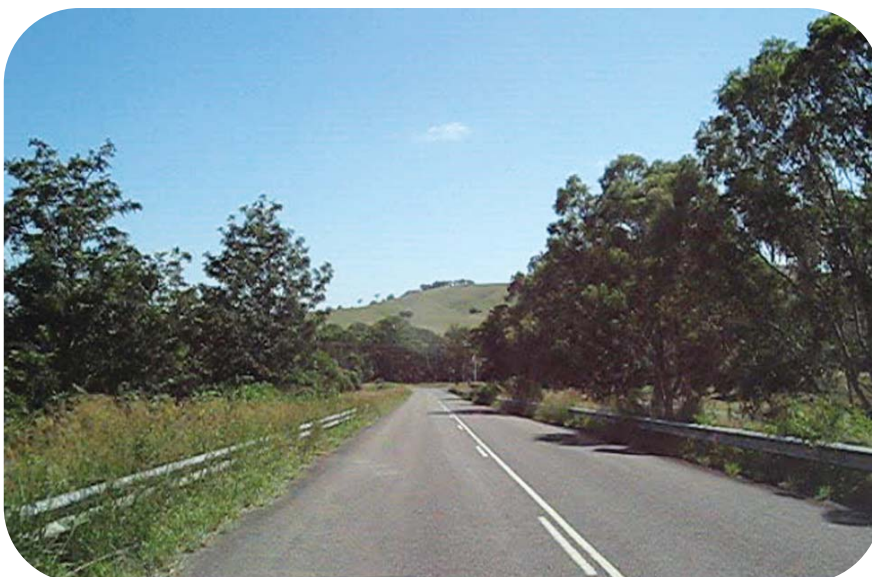
PHOTO C9

Unsafe overtaking northbound on Clarence Town Road, 100 m north of intersection with Dungog Road.

PHOTO C10

Unsafe overtaking southbound on Clarence Town Road, 200 m north of intersection with Dungog Road.

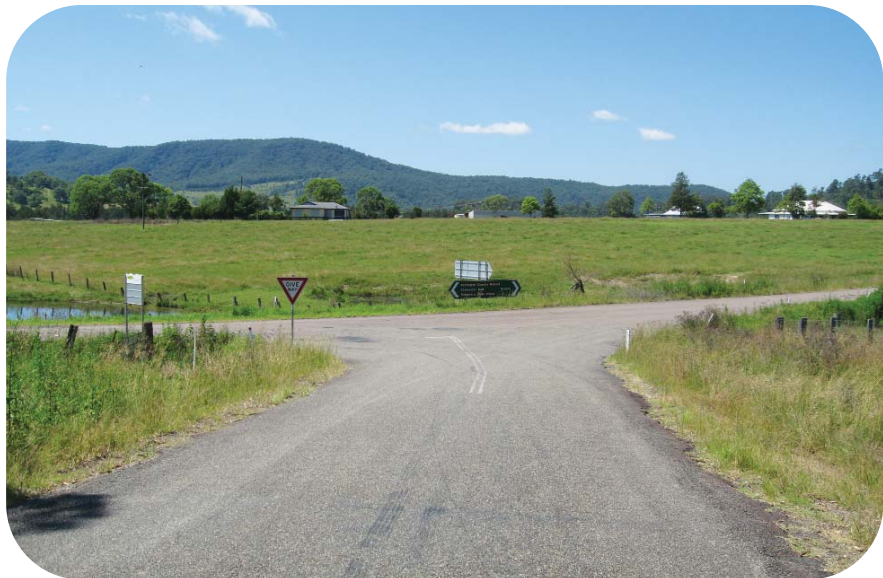
PHOTO C12

Overgrown vegetation in road verge on Salisbury Road, eastbound.

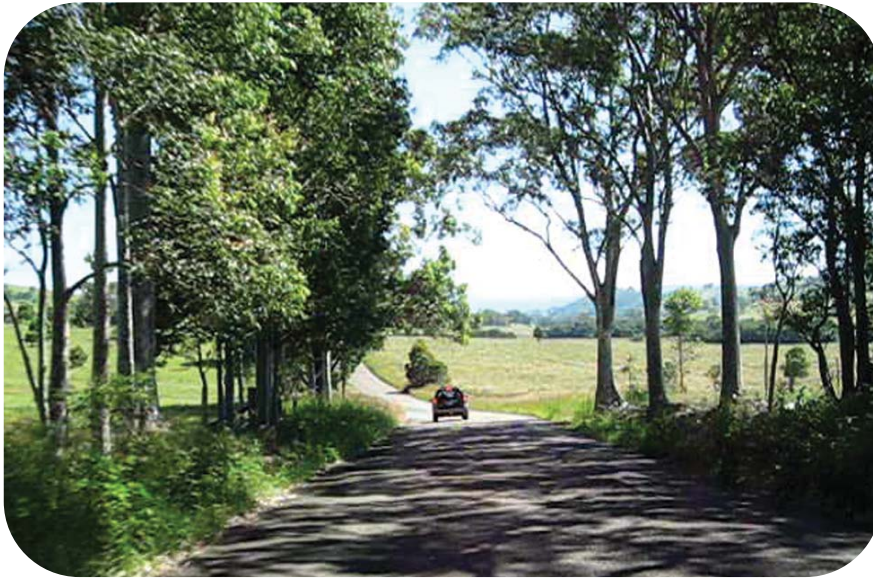
PHOTO C13

- roadside objects such as trees are located within the clear zone (Photo C13)
- guide posts are missing at several locations. The existing guide posts along the road are obscured by overgrown vegetation. The delineation is expected to be poor during night time with inadequate/missing guide posts and the lack of line marking along the road.

Trees located within clear zone, Chichester Dam Road.

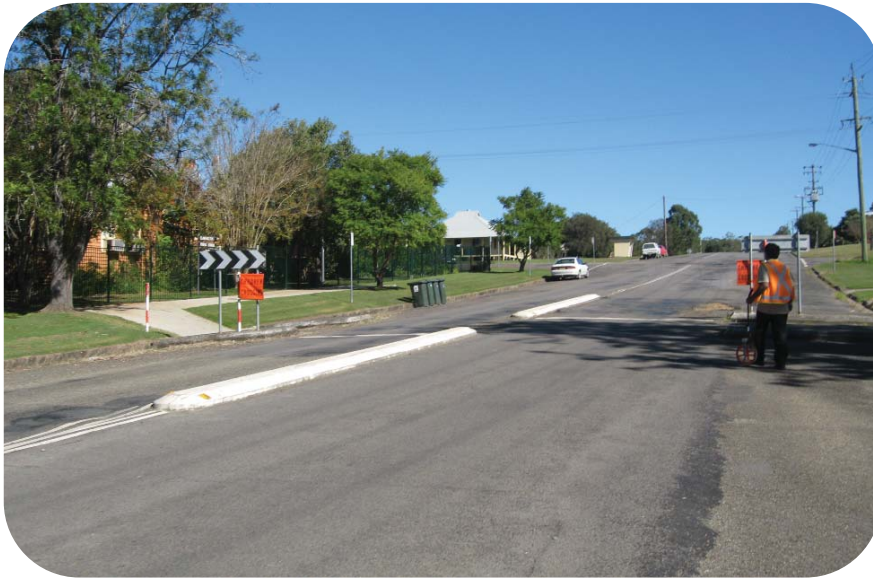
PHOTO C14

Substandard pedestrian crossing at Clarence Town Public School.

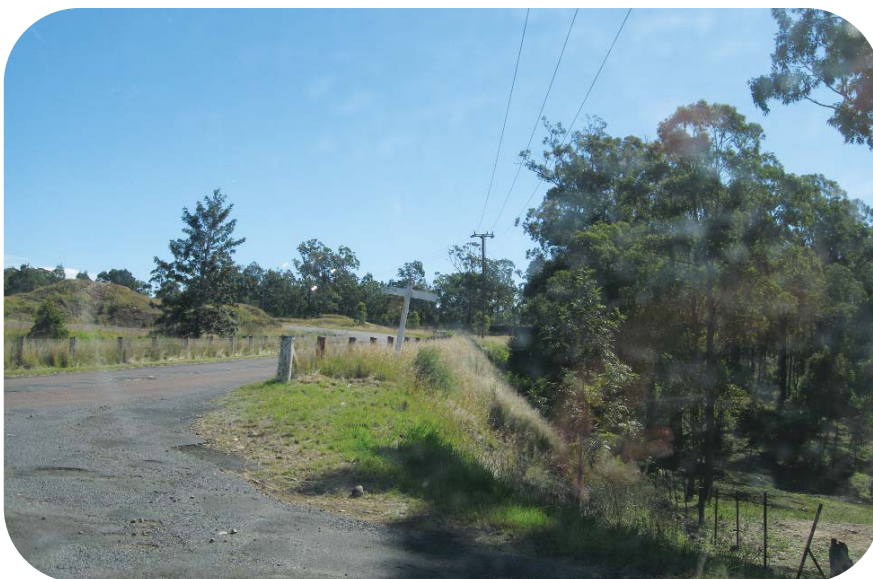
PHOTO C15

Embankment north of Earl Street on Clarence Town Road, Clarence Town.

PHOTO C16

Unprotected embankment on Clarence Town Road at Carmichaels Creek, northbound.

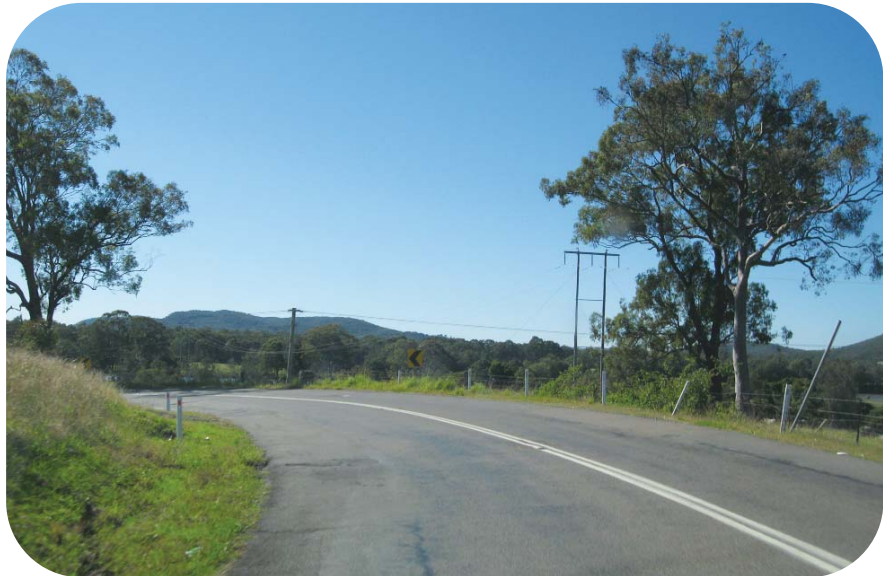
PHOTO C17

Incorrect use of curve alignment markers on Dungog Road, approaching Horns Crossing Road intersection.

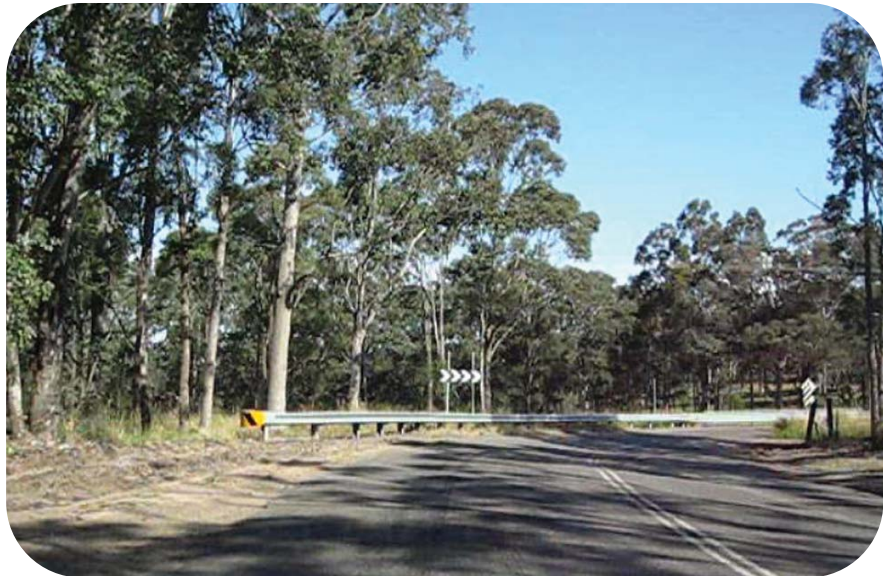
PHOTO C18

No guard rail protection on western approach of Martins Creek Bridge on Dungog Road.

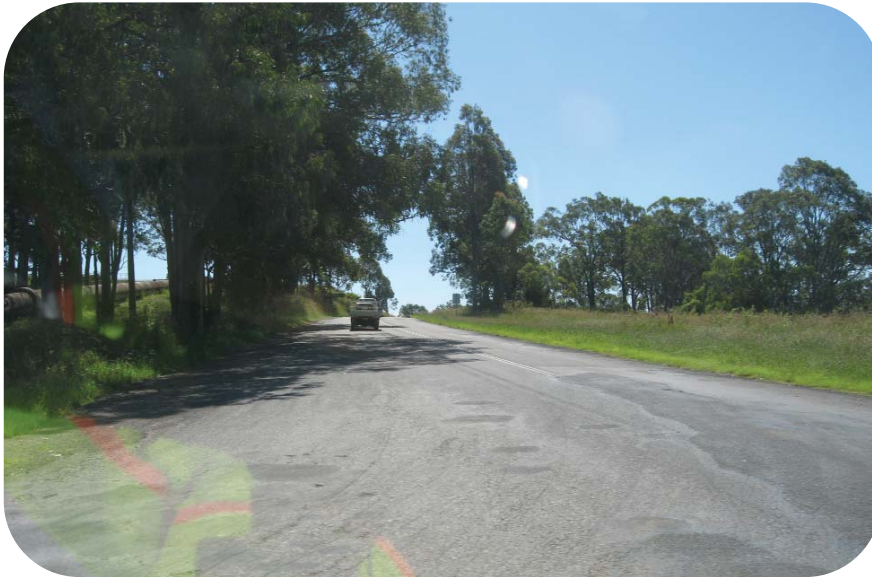
PHOTO C19

Inadequate safe intersection sight distance southbound from Dungog Road.

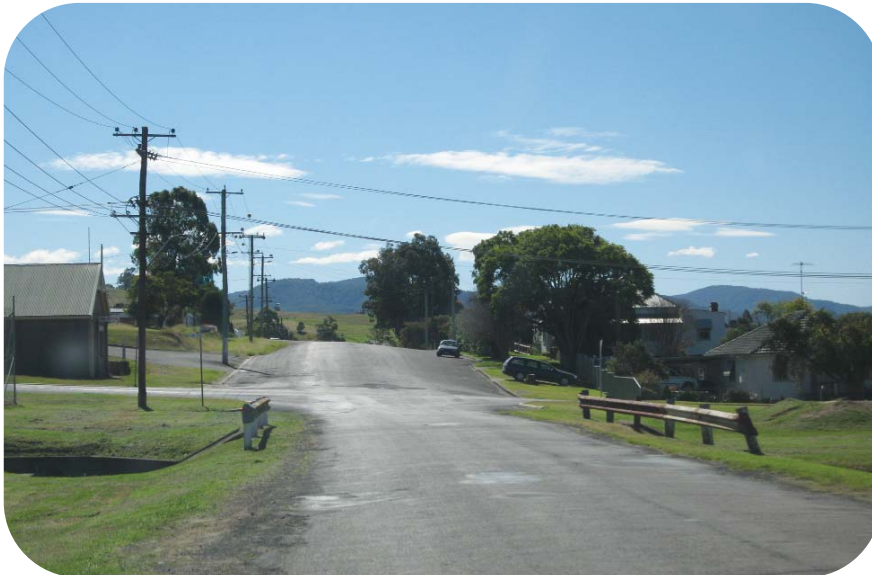
PHOTO C20

- south of Mackay Street there are old and damaged crash barriers for a culvert (Photo C20).

Old and damaged guard rails south of Mackay Street on Lord Street, Dungog.

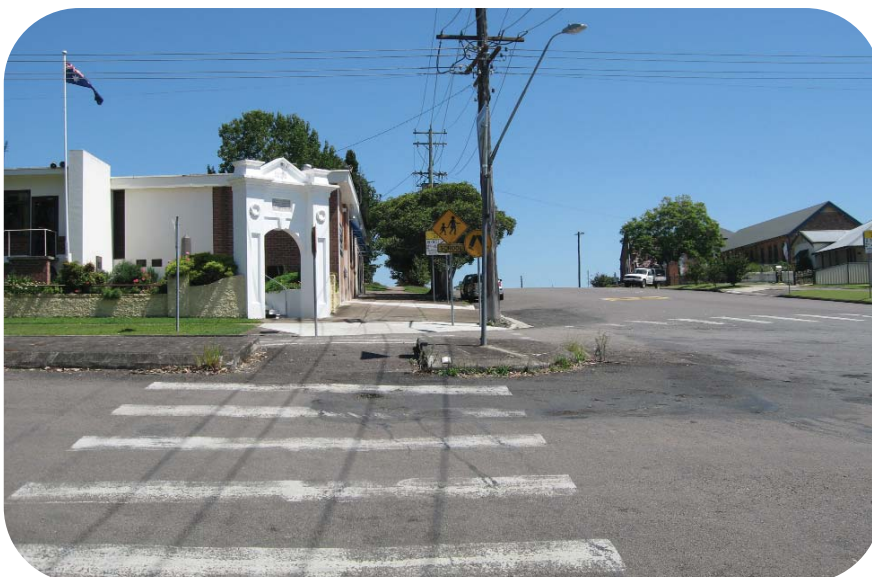
- faded pedestrian crossing marking observed at the southern and western leg of this intersection (Photo C21)
- adverse cross fall was observed at the departure side of the southern leg of this intersection (Photo C22).

PHOTO C21

Faded pedestrian crossing markings, intersection of Lord Street/Brown Street, Dungog.

PHOTO C22

Adverse crossfall on Lord Street, looking south from intersection with Brown Street, Dungog.

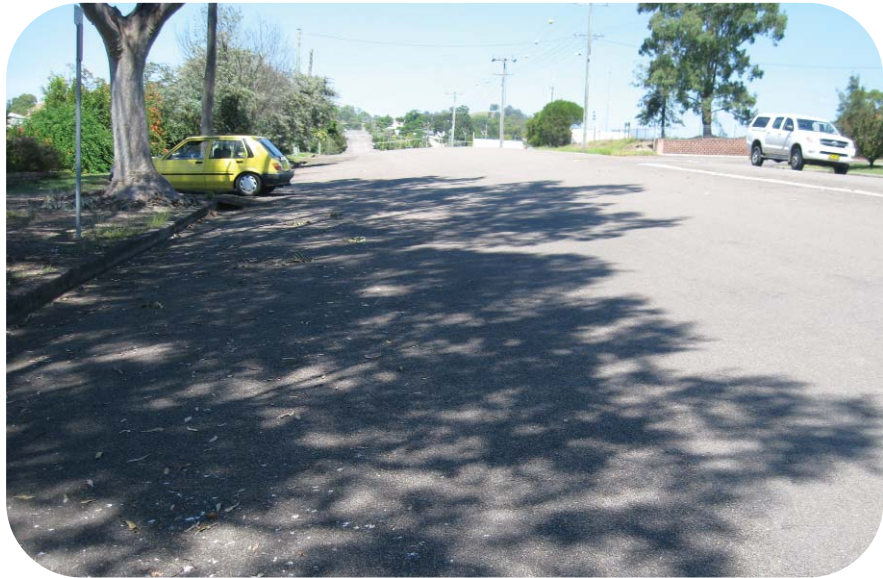
PHOTO C23

- faded pedestrian crossing pavement marking observed at the eastern leg of this intersection (Photo C23).

Faded pedestrian crossing markings, looking west on Hook Street, Dungog.

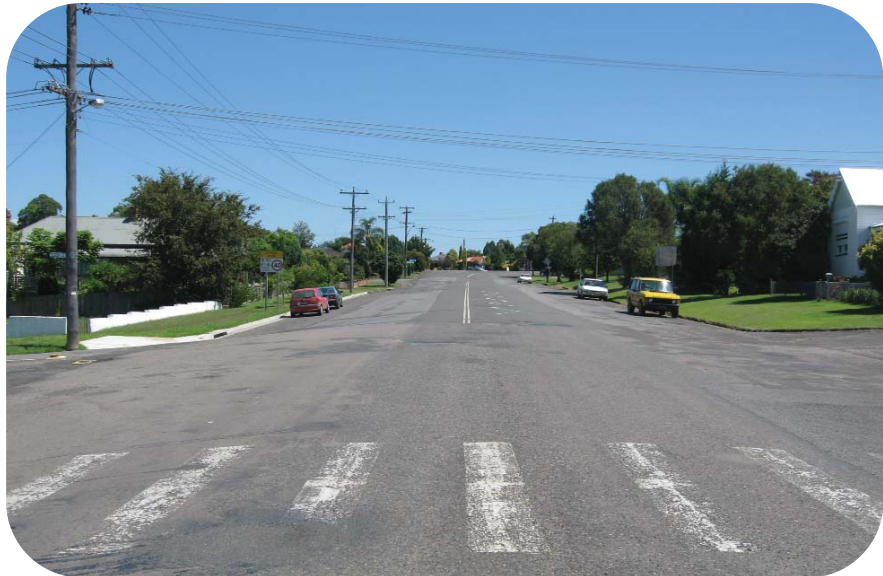
PHOTO C24

Crest with no centreline markings.

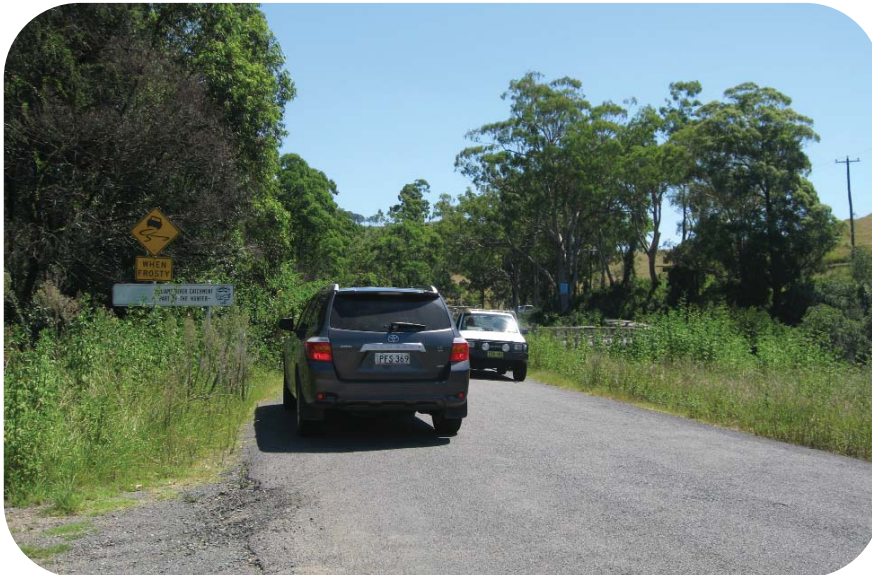
PHOTO C26

Missing single lane bridge warning sign for existing bridge over Williams River.
