Hunter Water Corporation

TILLEGRA DAM DESIGN - CONSULTANCY 361802

Storage Rim Stability and Seepage Potential
Engineering Geotechnical Report

Report No. 08-GN31A-R2, Final Report V 4.1
February 2009

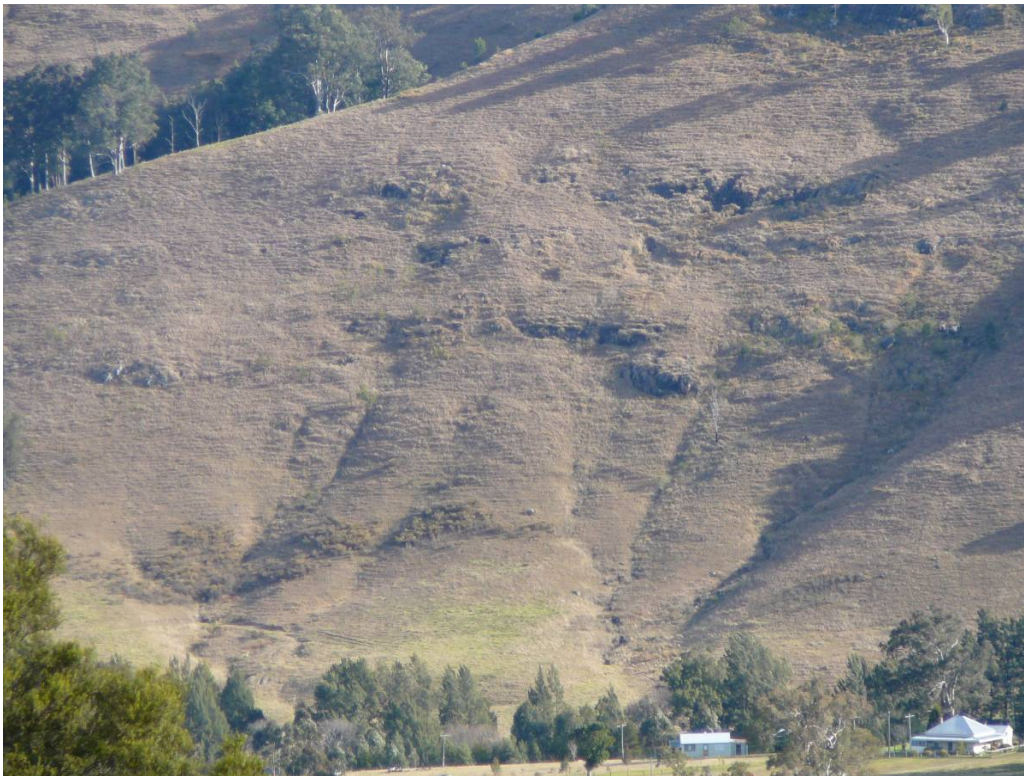
Plate 6-1 - View of Area 8A Feature

Plate 6-1 below shows a small scale pre-existing feature designated Area 8A located on the east facing slope of Elwari Mountain. This feature has been included in the risk assessment.

Geomorphologic mapping (**Figure 12**) of Area 8A has shown significant rock outcrop with only minor areas of soil creep over tuffaceous sandstone. Soil cover is thinly developed up to 1m thickness. Bedding dips into the slope. A major joint set cross-cutting bedding has formed the steep slope (refer Section 4.3.8).

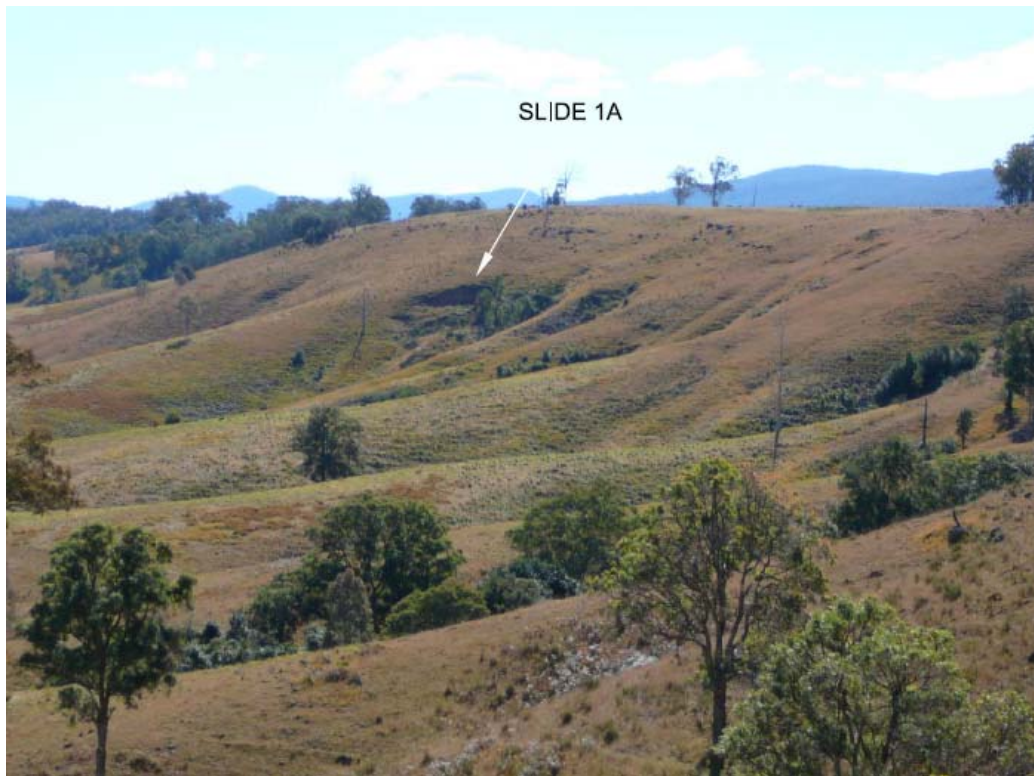
Plate 6-2 - Domain 1 and Slide 1A

Plate 6-2 below shows Slide 1A, located in Domain 1, where bedding dips at a relatively shallow angle (8 to 10 degrees) to the south-east/ east; i.e. out of the reservoir.

Slide 1A is a minor landslip of estimated volume 4,000m³ that has occurred on the western side of the Chichester Range in the extremely/ highly weathered conglomerates underlying a relatively thick cap of horizontally bedded tuffaceous sandstone. The failure is typically shallow in nature and the toe of the slide is located above the storage full supply level (RL152.3).

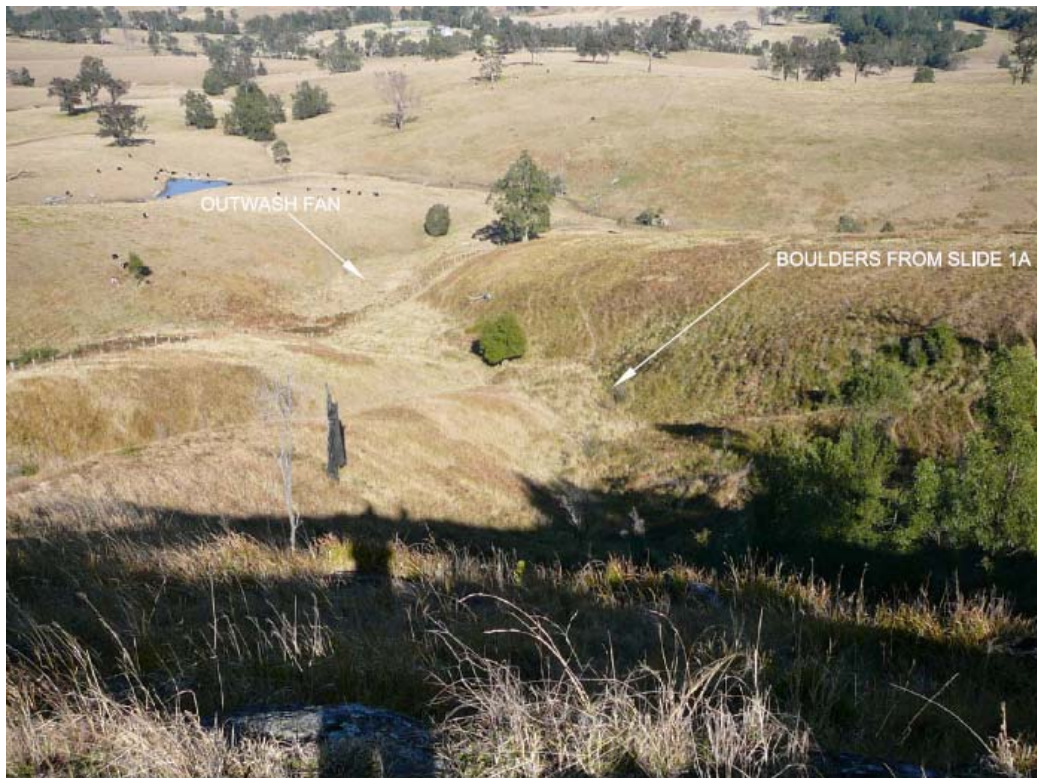
Plate 6-3 - View Looking Down-slope of Slide 1A

The slide is located at the head of a steeply incised creek and has only travelled a short distance down-slope. Plate 6-3 shows a view of the outwash fan, which is assumed to have been formed over a long period from landslide debris and erosion of earlier slides (PSM 2009).

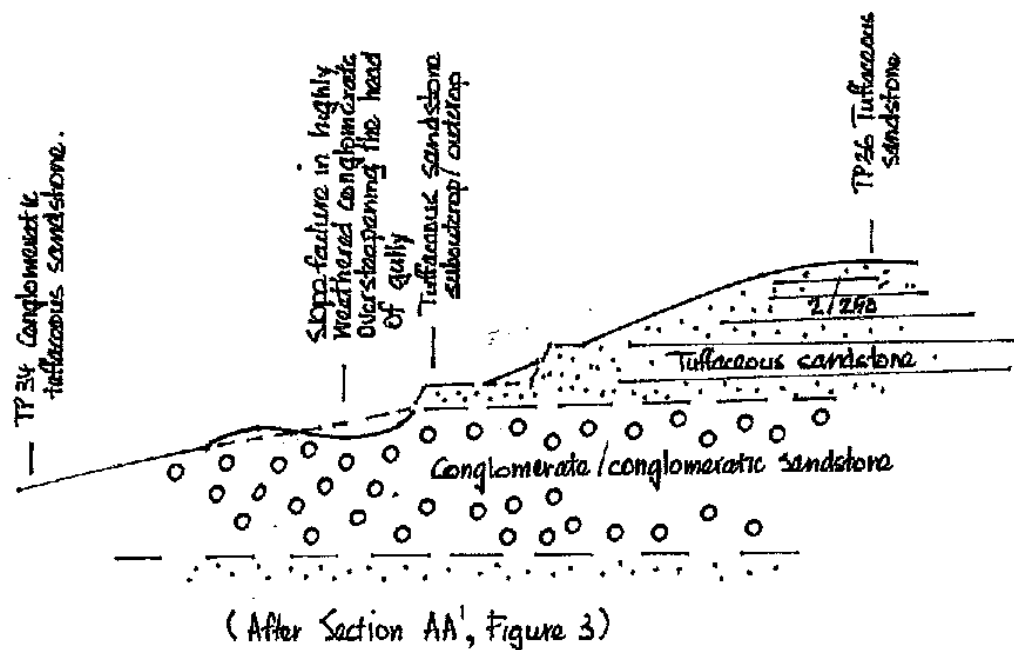
Plate 6-4 - Geological Profile through Slide 1A

Plate 6-4 below shows an indicative geological sectional profile indicating the mechanism causing the localised landslips in Domain 1A.

Minor block type failures of the tuffaceous sandstone may occur on the upper slopes of the ridge well above the influence of the dam storage (Section 4.3.1). However, the frequency of such failures is expected to be very low.

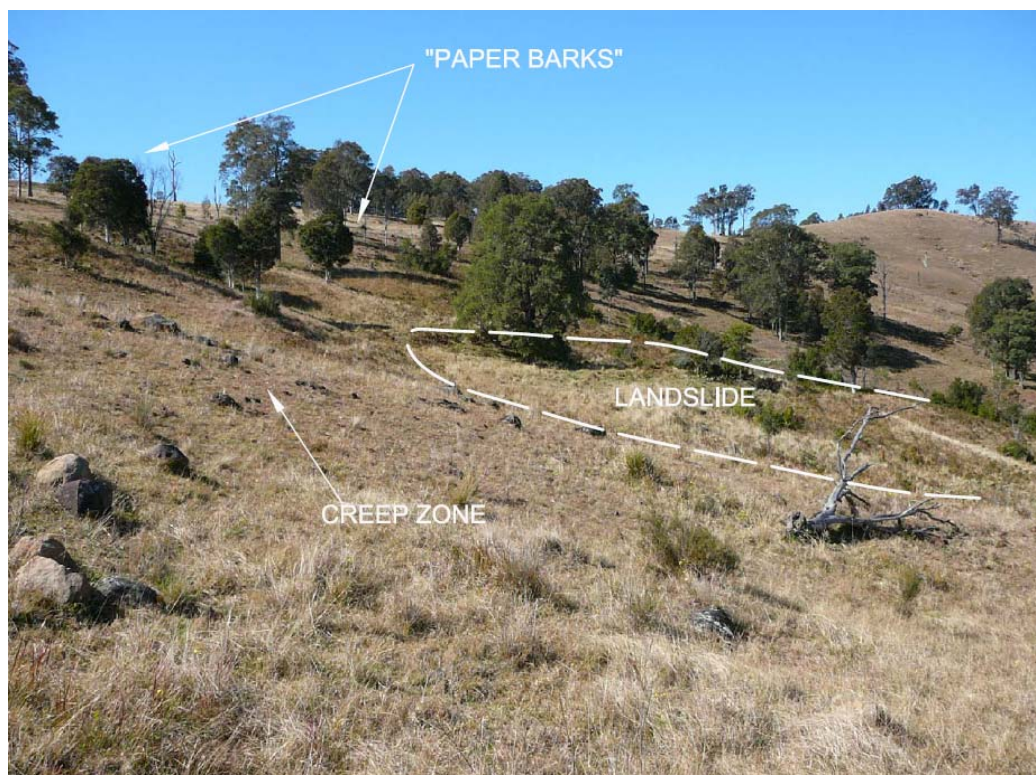
Plate 6-5 - View of Landslide 2A Upper Section

The main active area has approximate plan dimensions 350m long by 160m wide. The landslide is a relatively shallow feature, 5 to 8m in depth. It has an approximate volume 370,000m³. The creep zone above the slide is estimated to be in the order of 200,000m³.

The landslide shows signs of recent re-activation and from the condition of the active scarp this is interpreted to have occurred in June 2007 during a relatively heavy rainfall event (250mm recorded at Dungog from 7th to 9th June). Note that historical records indicate that many larger rainfall events have occurred (refer Volume IV, Figure 20).

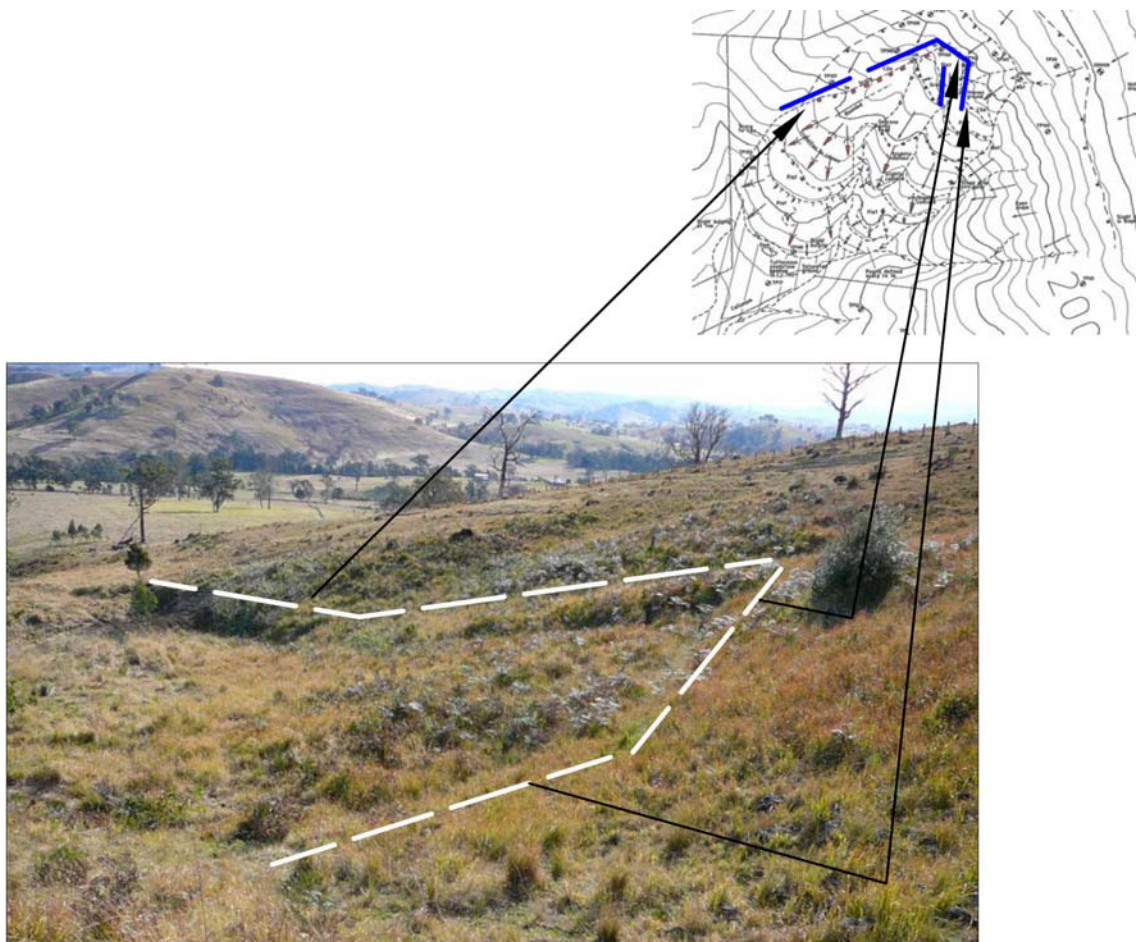
Plate 6-6 - Landslide Controls (PSM 2009)

A particular feature of the recent scarps is their linearity. Plate 6-6 illustrates this linear control in a number of directions on the recently reactivated landslide scarps.

Kinematic analysis of structural mapping data for the landslide (PSM 2009) shows that the alignment of the landslide scarps approximately matches the joint set data. This infers a bedrock-controlled sliding event. Plate 6-7 shows structural mapping data for the landslide presented as a lower hemisphere equal area stereographic projection of the poles to all planes.

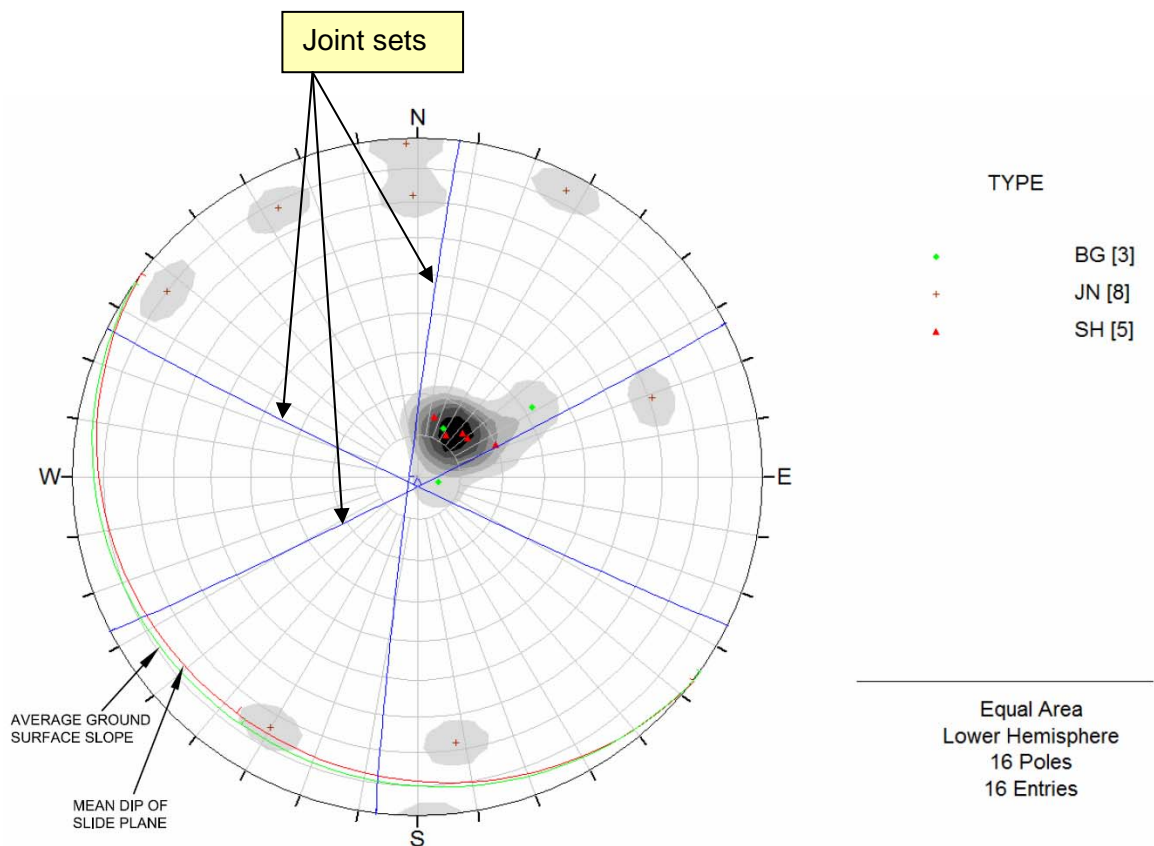
Plate 6-7 - Kinematic Analysis of Slide 2A (PSM 2009)

The analysis also indicates that the average dip of the slide plane is 14° towards 216° (southwest), which is steeper than the ground surface slope of 11½°.

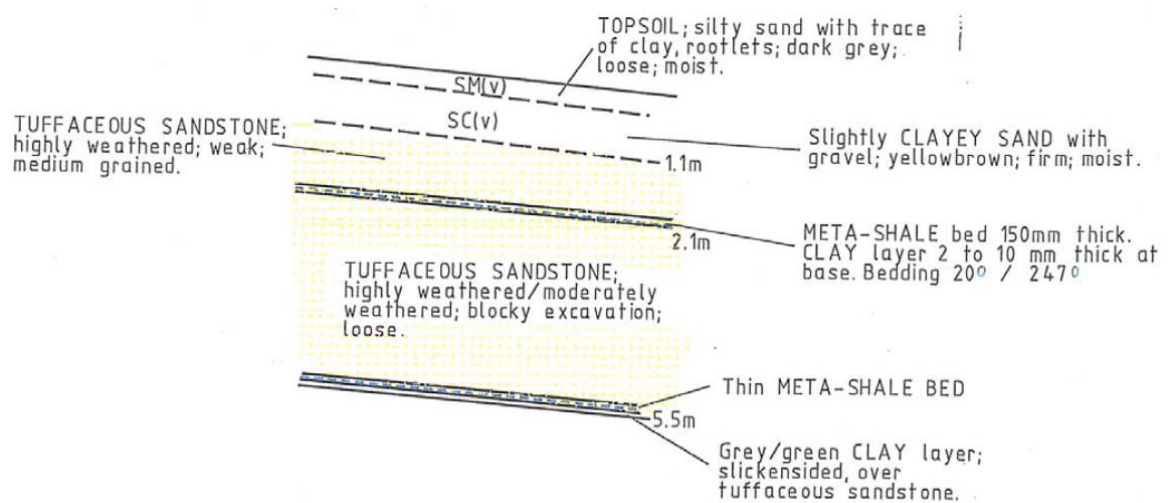
Plate 6-8 - Test Pit 142 Interpretation (2 Slide Planes)

Test Pit TP142, is located immediately above the recently active scarp in the main lobe of the landslide. Plate 6-8 shows an indicative geological section based on field assessment of Test Pit TP142.

- Two slide planes, at 2.1 and 5.5m depth were identified in TP142 immediately above the recently active scarp in the main lobe of the landslide.
- The lower slide plane is an extremely thin (<1mm thick) pale green coloured irregular slickensided clay layer (Plate 6-9).
- The upper slide plane is a meta-shale layer that is still rock-like but shows significant aperture on joints (TP142 and TP143),
- The upper slide plane has been folded by the recent reactivation (TP143).
- Test Pits at the toe of the landslide did not intersect any slide plane (TP149, TP150 and TP151).
- TP149 located at the toe of the main landslide lobe immediately above the outcrop in the farm dam showed brecciated rock with no distinct bedding or layering. This is indicative of a non daylighting toe “shove zone”.

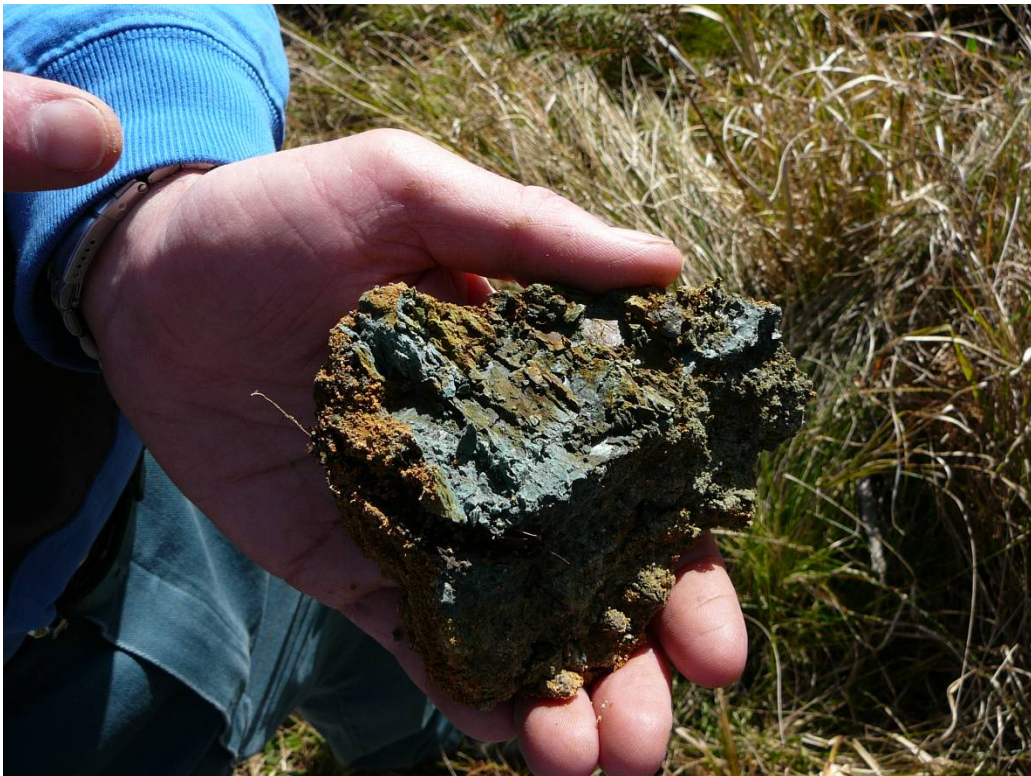
Plate 6-9 - TP142 Lower Slide Plane

Based on the mapping data, the outcrop in the farm dam and test pitting at the toe of the slide, it is clear that the landslide failure plane does not daylight.

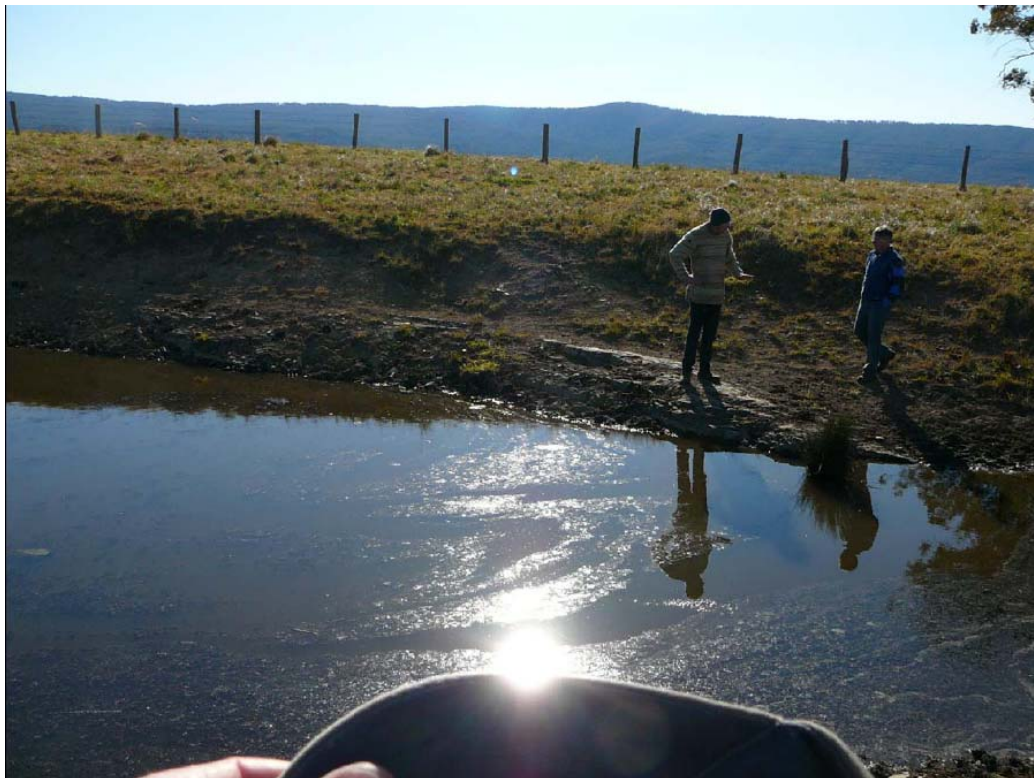
Plate 6-12 - Small Farm Dam in Domain 1A

The test pits and natural exposures in farm dams along the top of the ridge confirm the shallow depth to rock and the low permeability of the rock mass. Plate 6-12 shows one of these dams located near to the Slide 1A area.

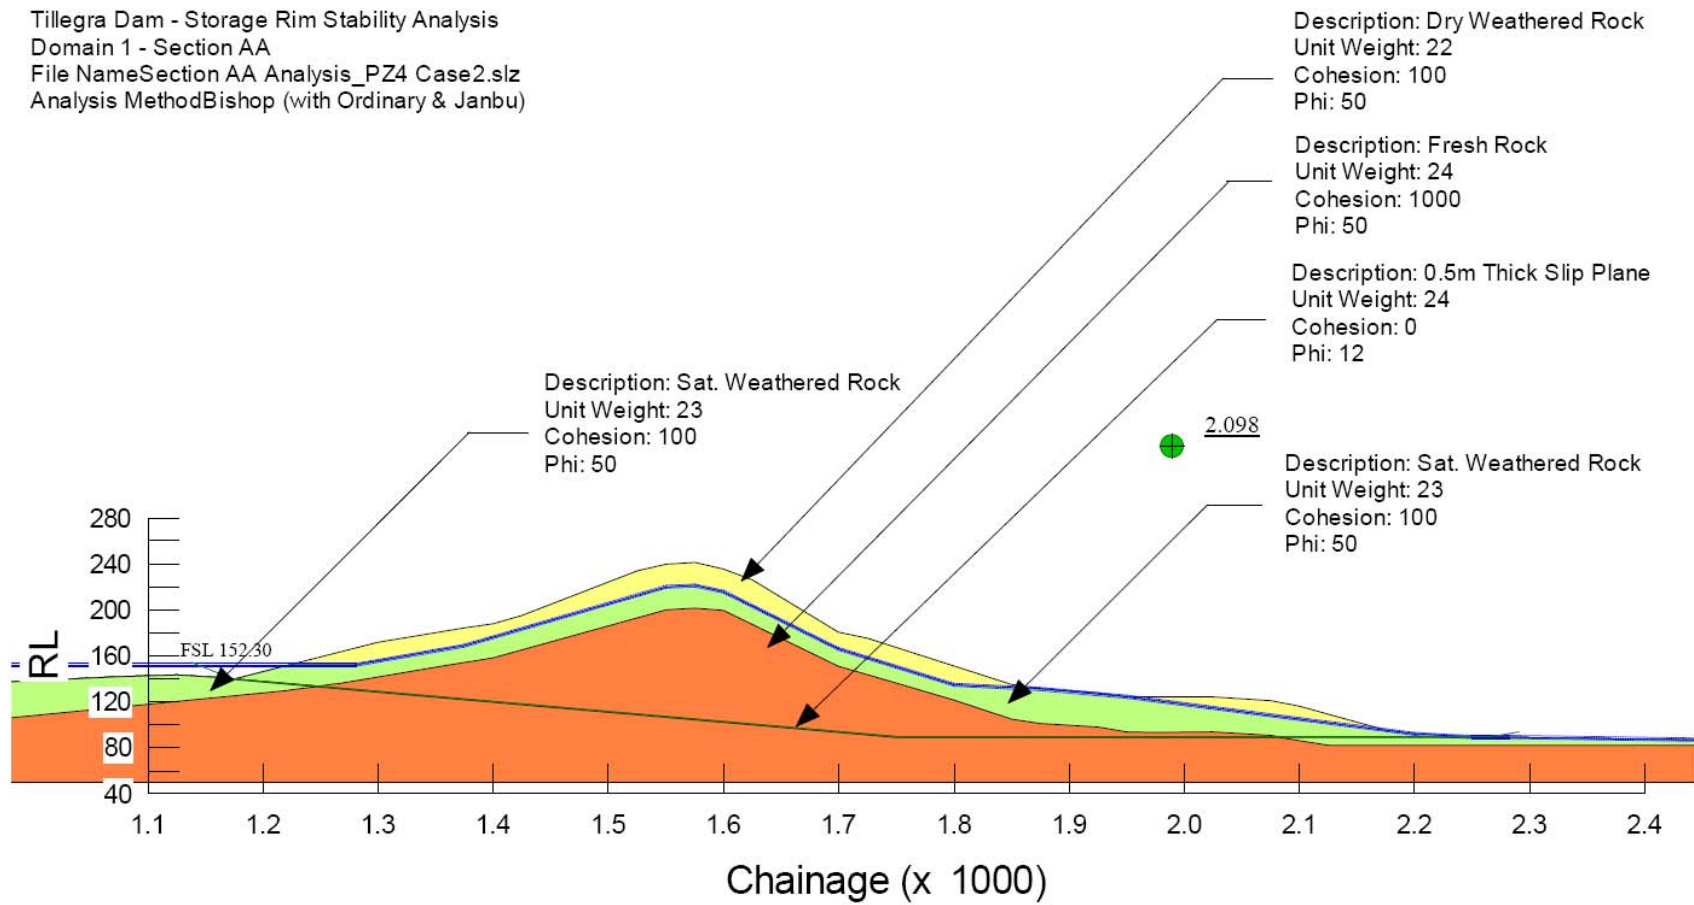
Plate 6-13 - 2-D Stability Analysis in Domain 1

Even with these very conservative assumptions, the results indicated a factor of safety greater than 2.0 for slide planes that could potentially take out the entire rim and release the storage. These analyses do not take account of the effects of side restraint, so the actual factors of safety would be greater than this.

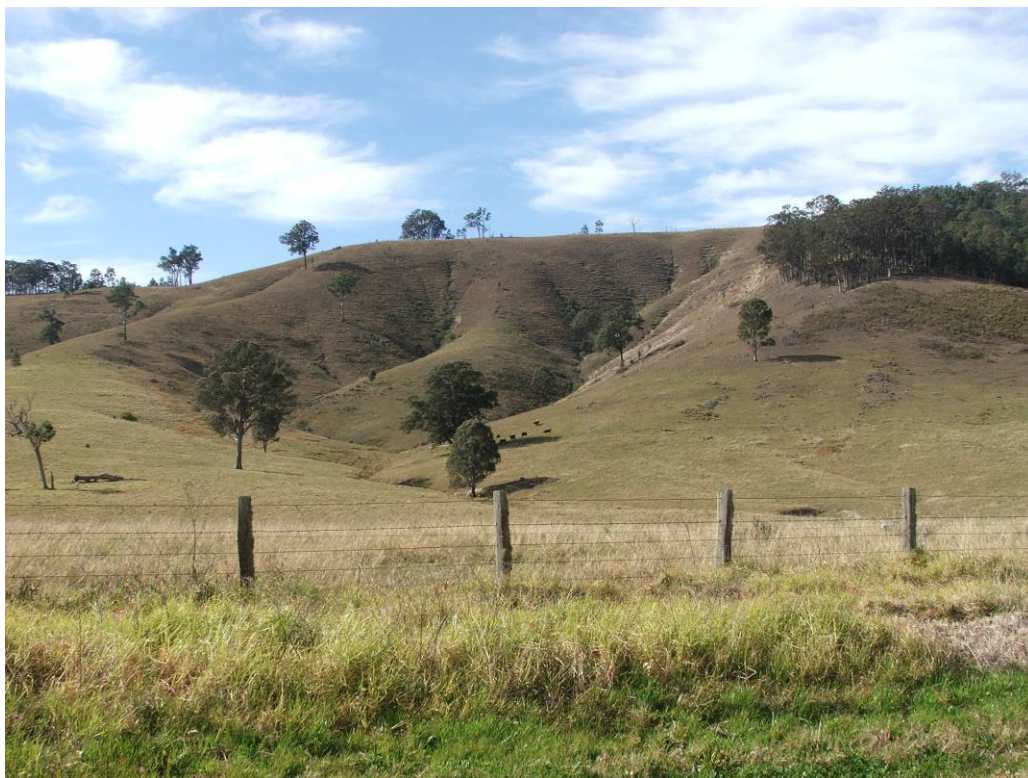
Plate 6-14 - View of Erosion Feature in Domain 4

In Domain 4, there is no evidence of creep movements or land sliding. The folded nature of the bedding and dip direction to the southwest generally precludes any mechanisms for first time sliding in this domain.
