TILLEGRA DAM DESIGN - CONSULTANCY 361802

Storage Rim Stability and Seepage Potential
Engineering Geotechnical Report

**STORAGE RIM LANDSLIDE
GEOTECHNICAL ASSESSMENT**

Report PSM1271.R1

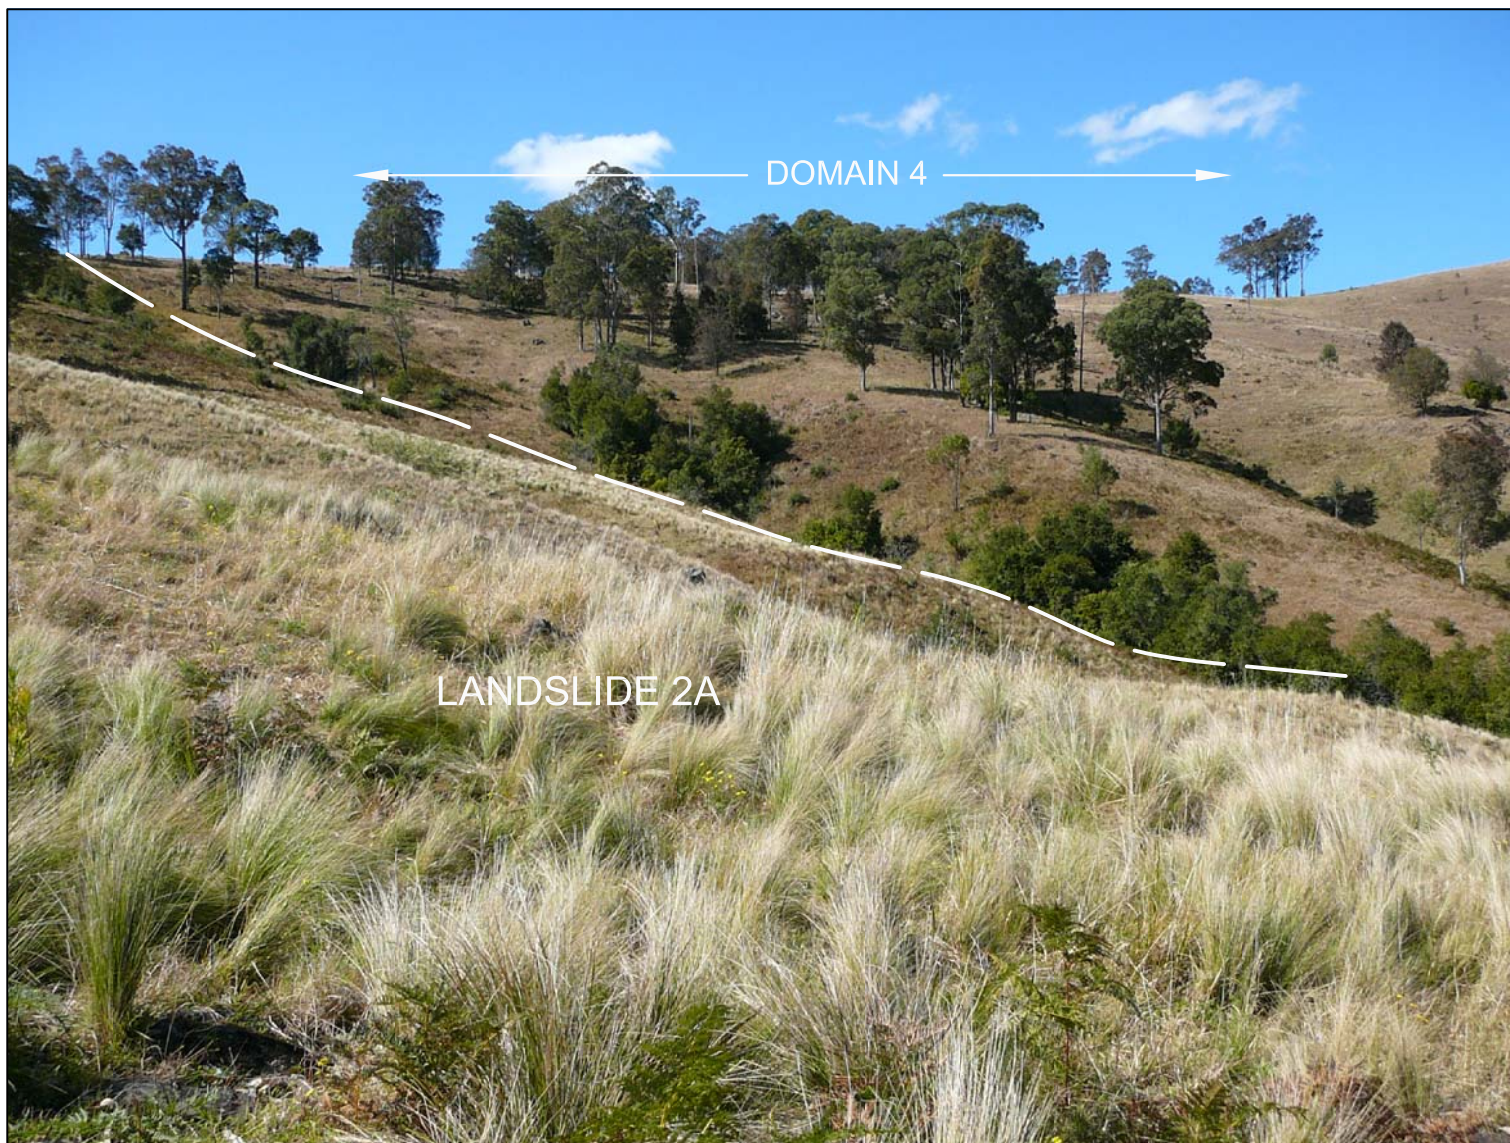
Figure 24

NSW Department of Commerce
Tillegra Dam
Storage Rim Landslide Assessment
VIEW TO SOUTHEAST
ACROSS LANDSLIDE TO DOMAIN 4

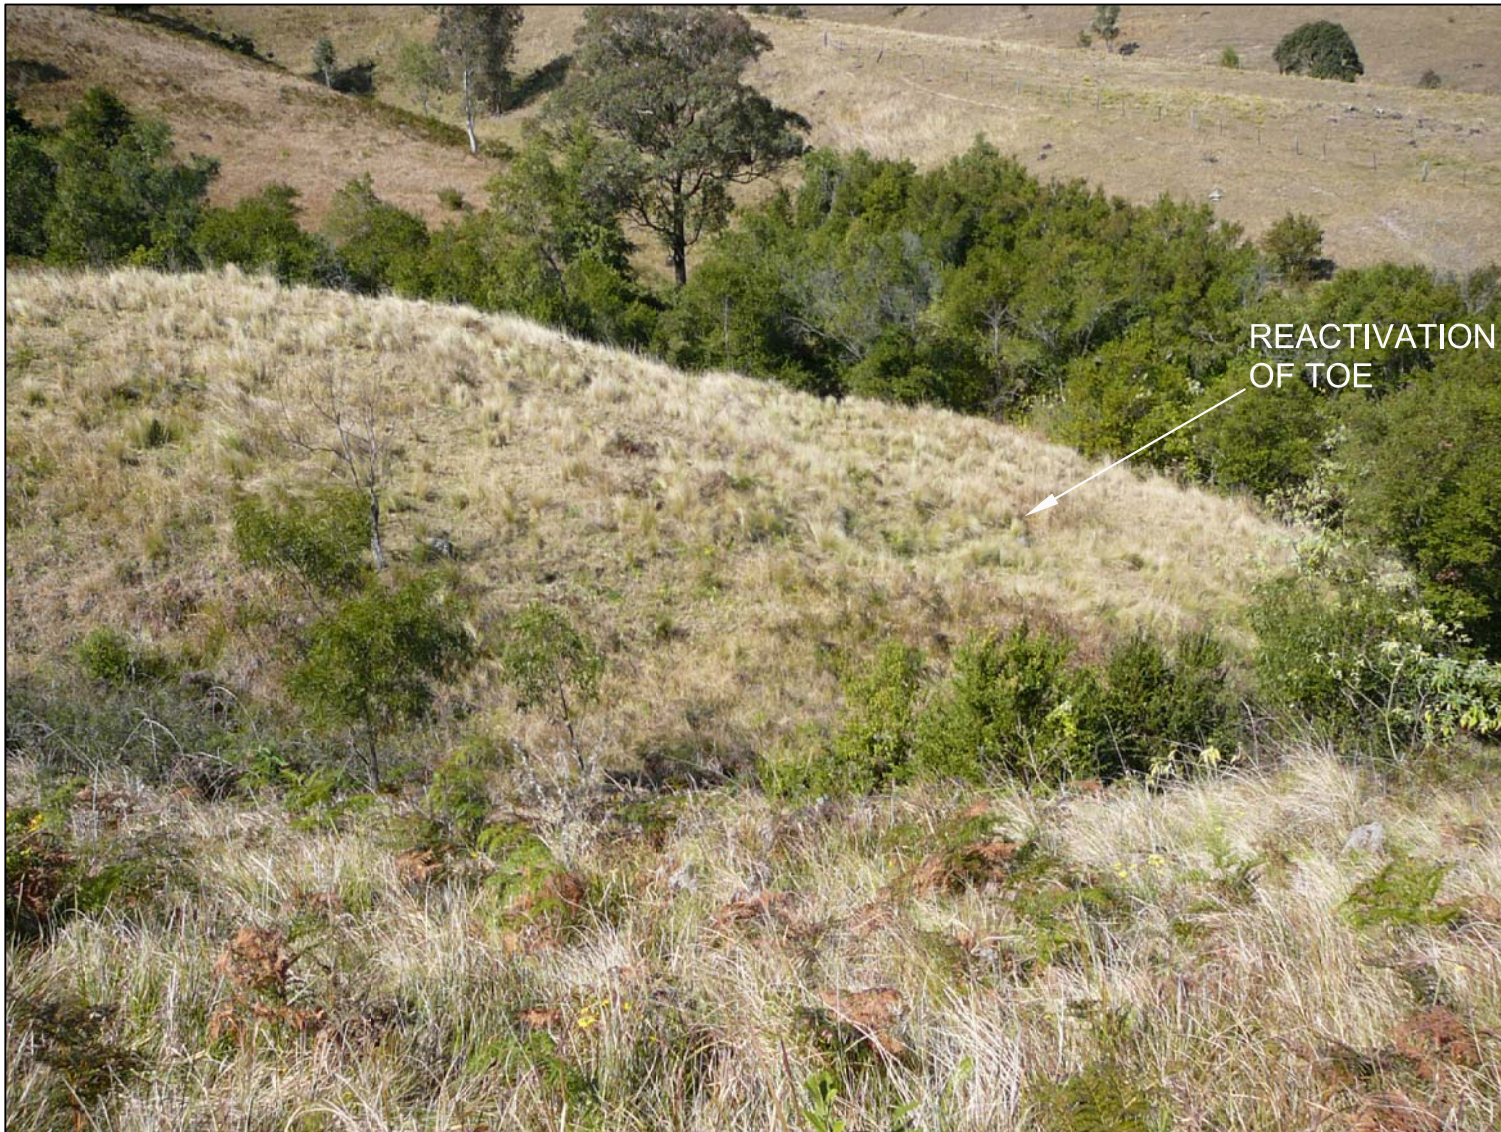
Figure 25

REACTIVATION
OF TOE

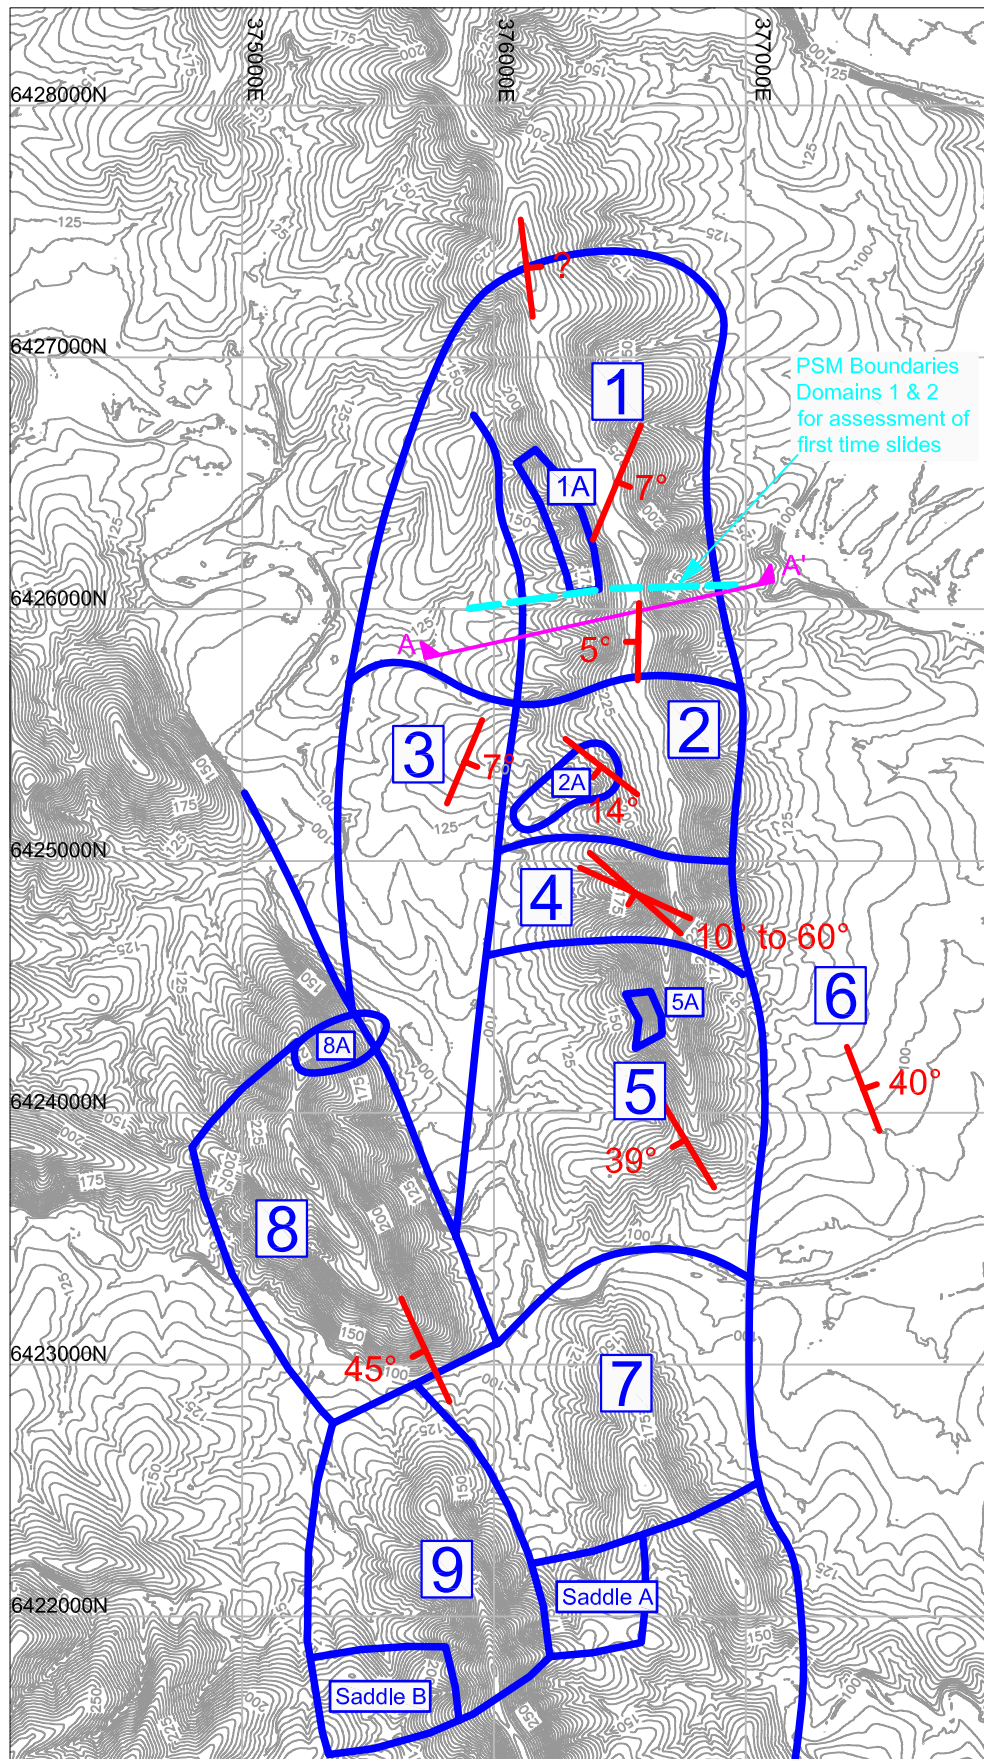
Figure 41

NSW Department of Commerce
 Tillegra Dam
 Storage Rim Landslide Assessment
 SUMMARY MODEL FOR FIRST TIME
 SLIDE & RIM STABILITY

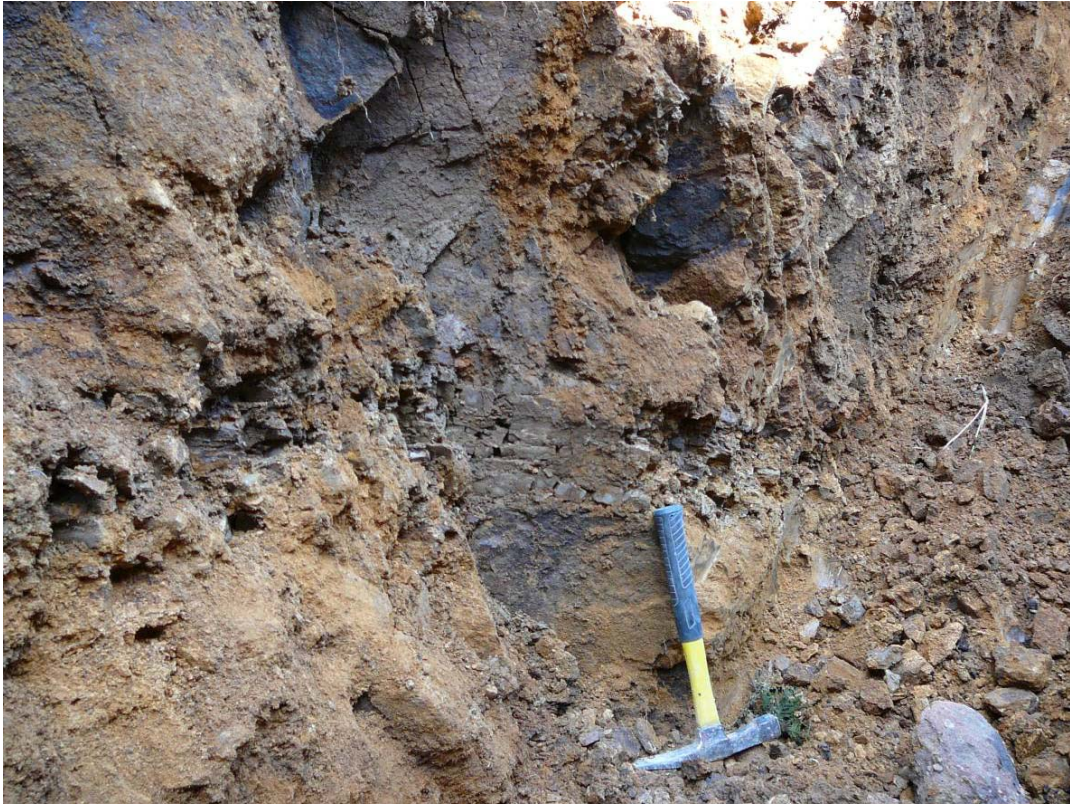
Photo 10: TP140 Note loosened rock mass in creep zone
