3.2 Bank Stability and Erosion Potential

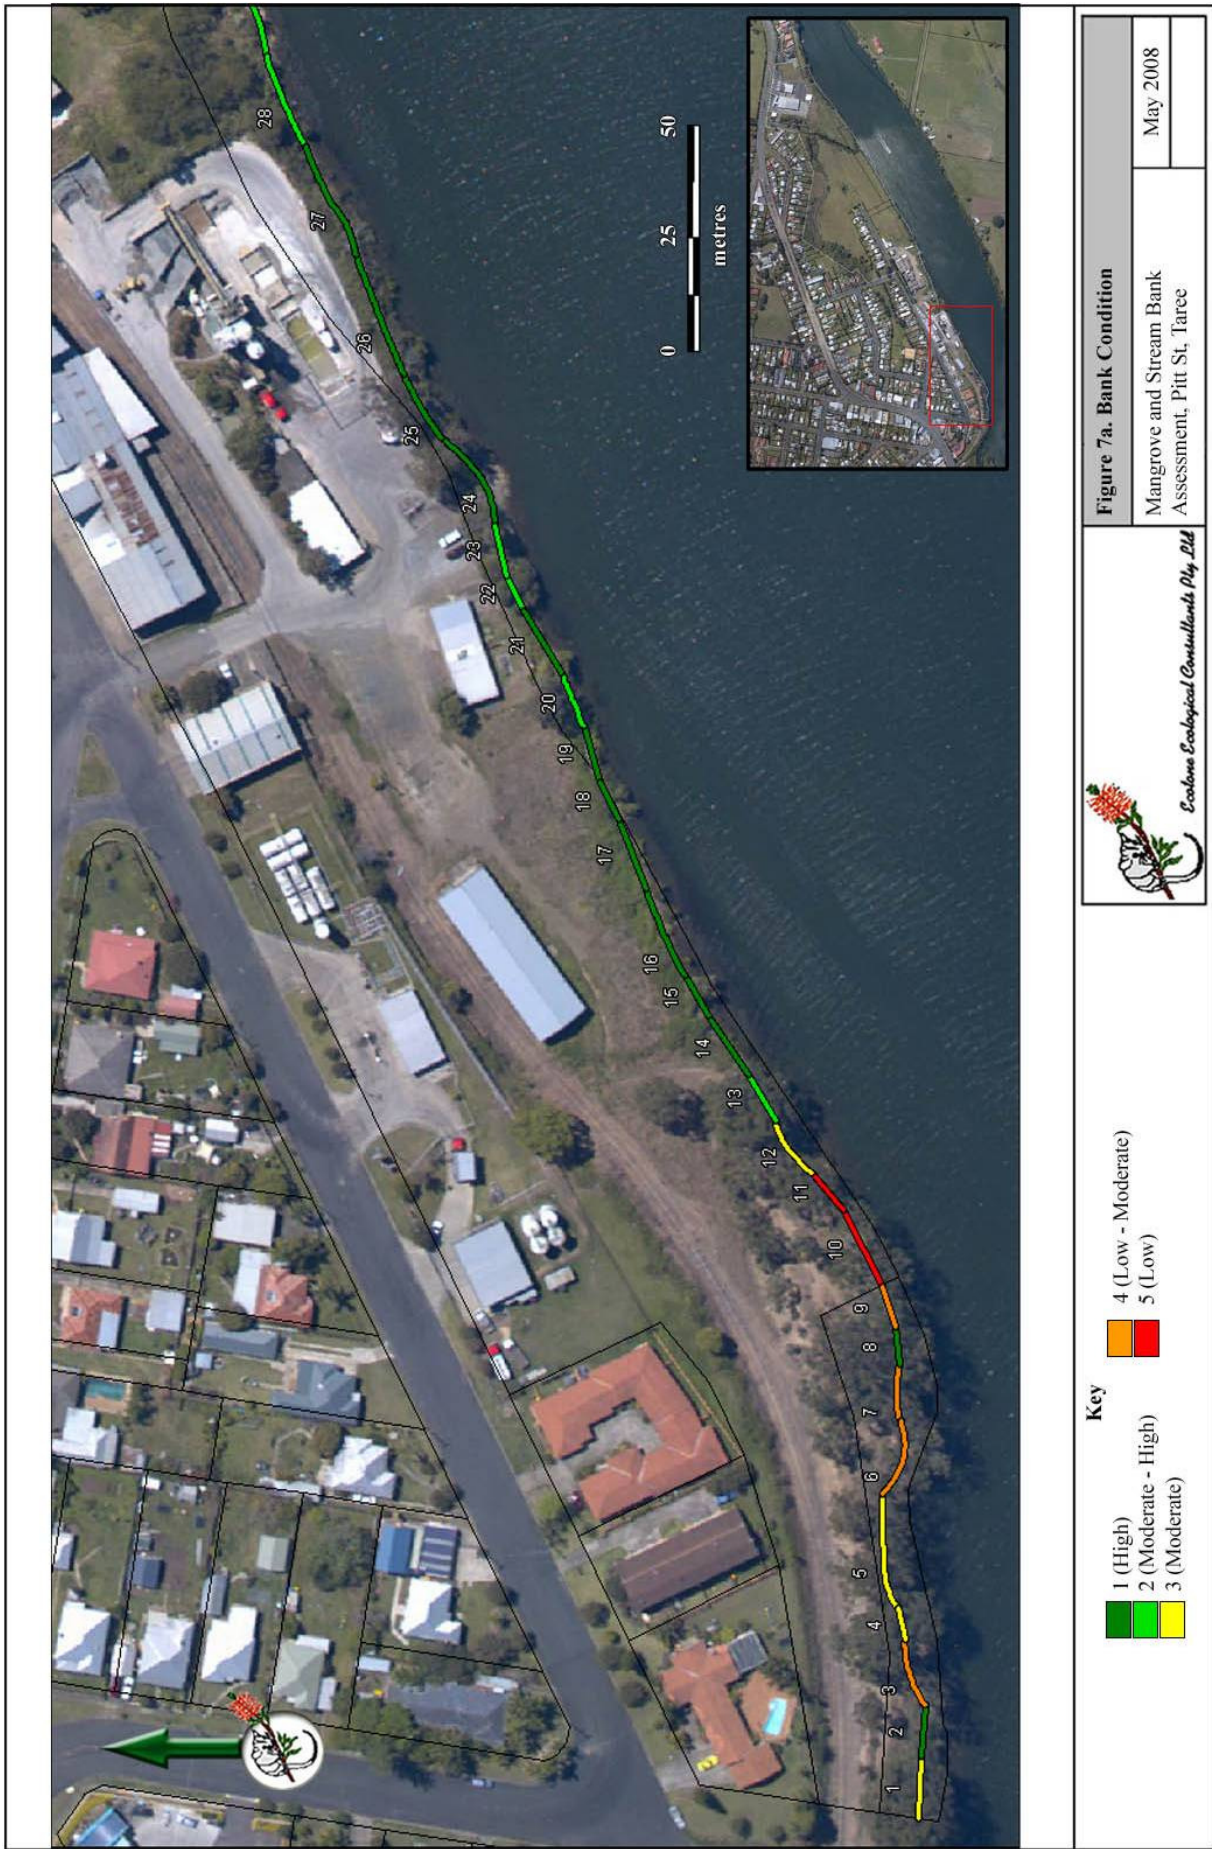
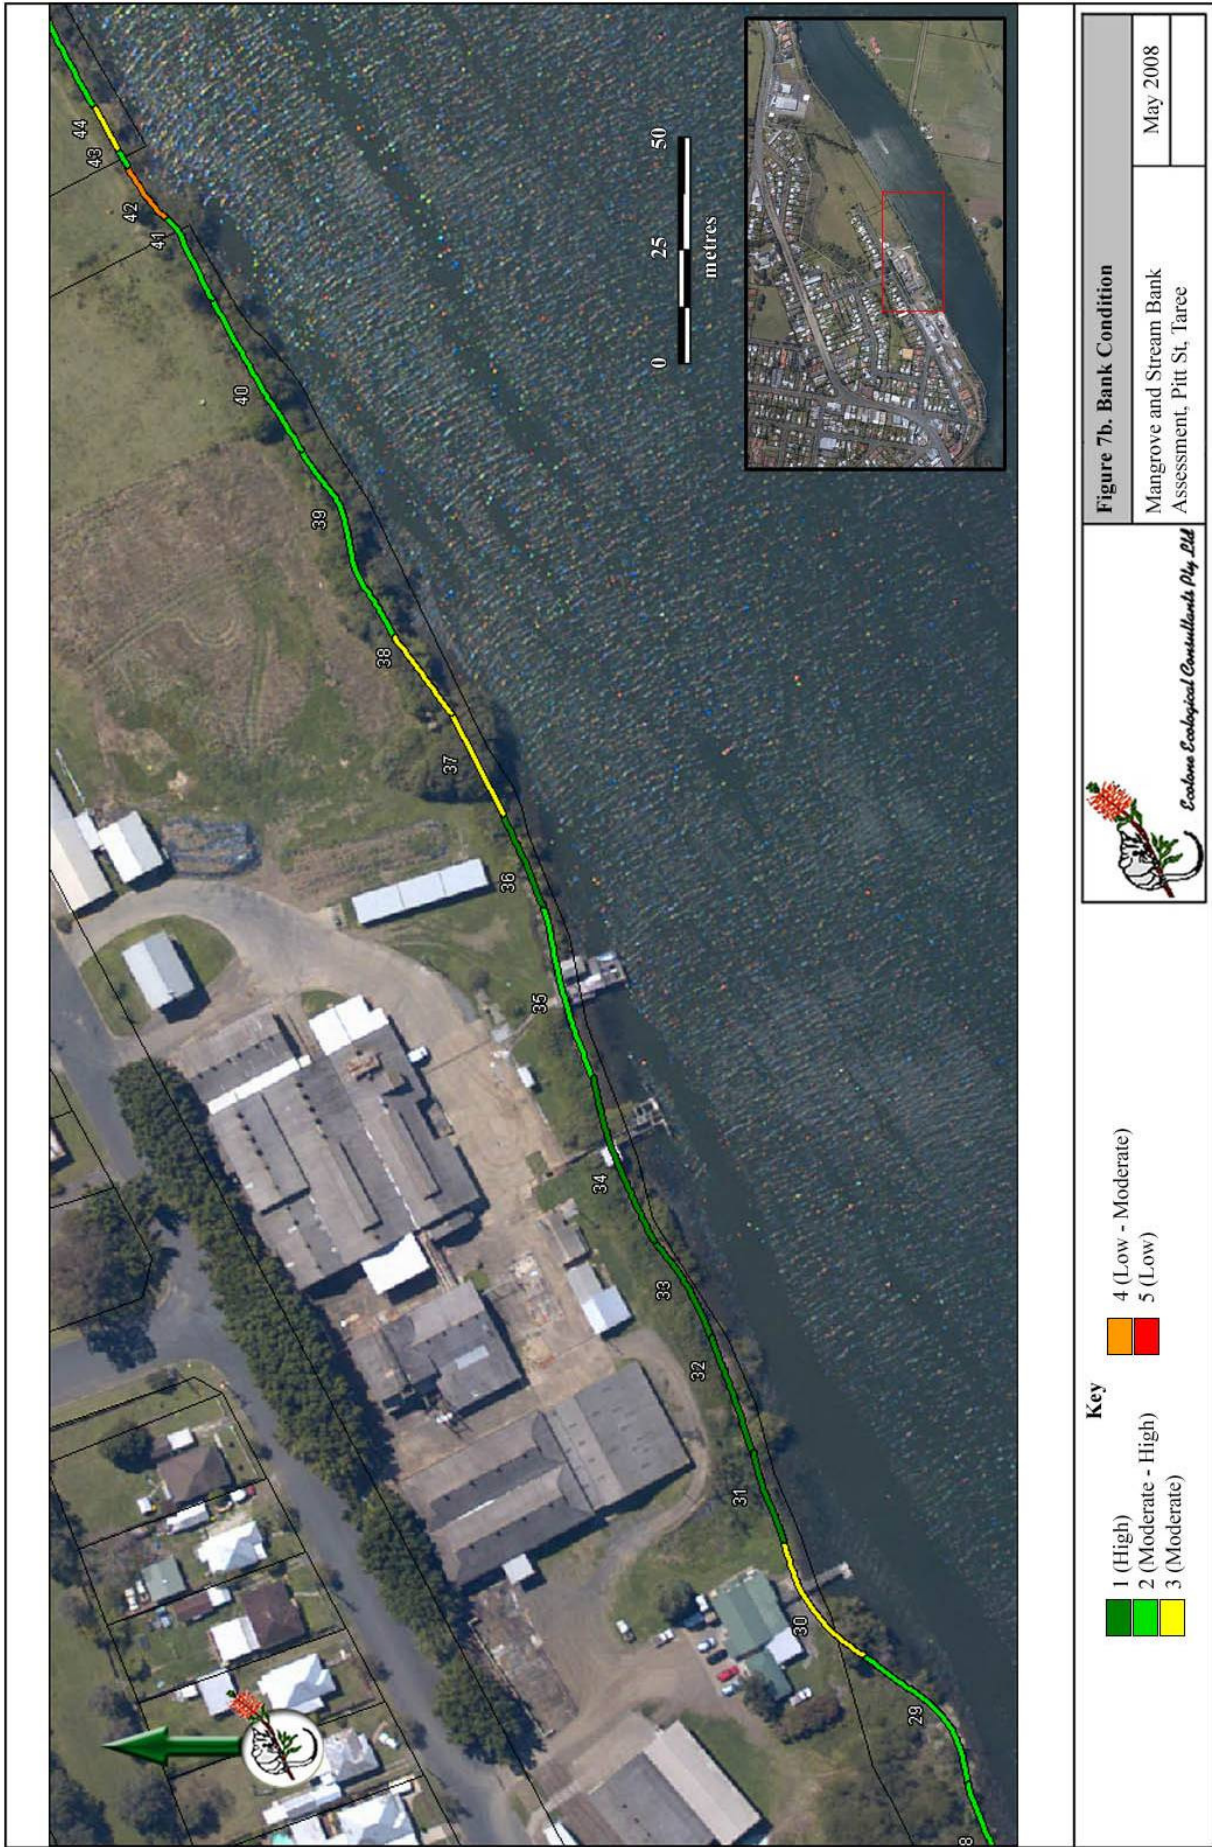
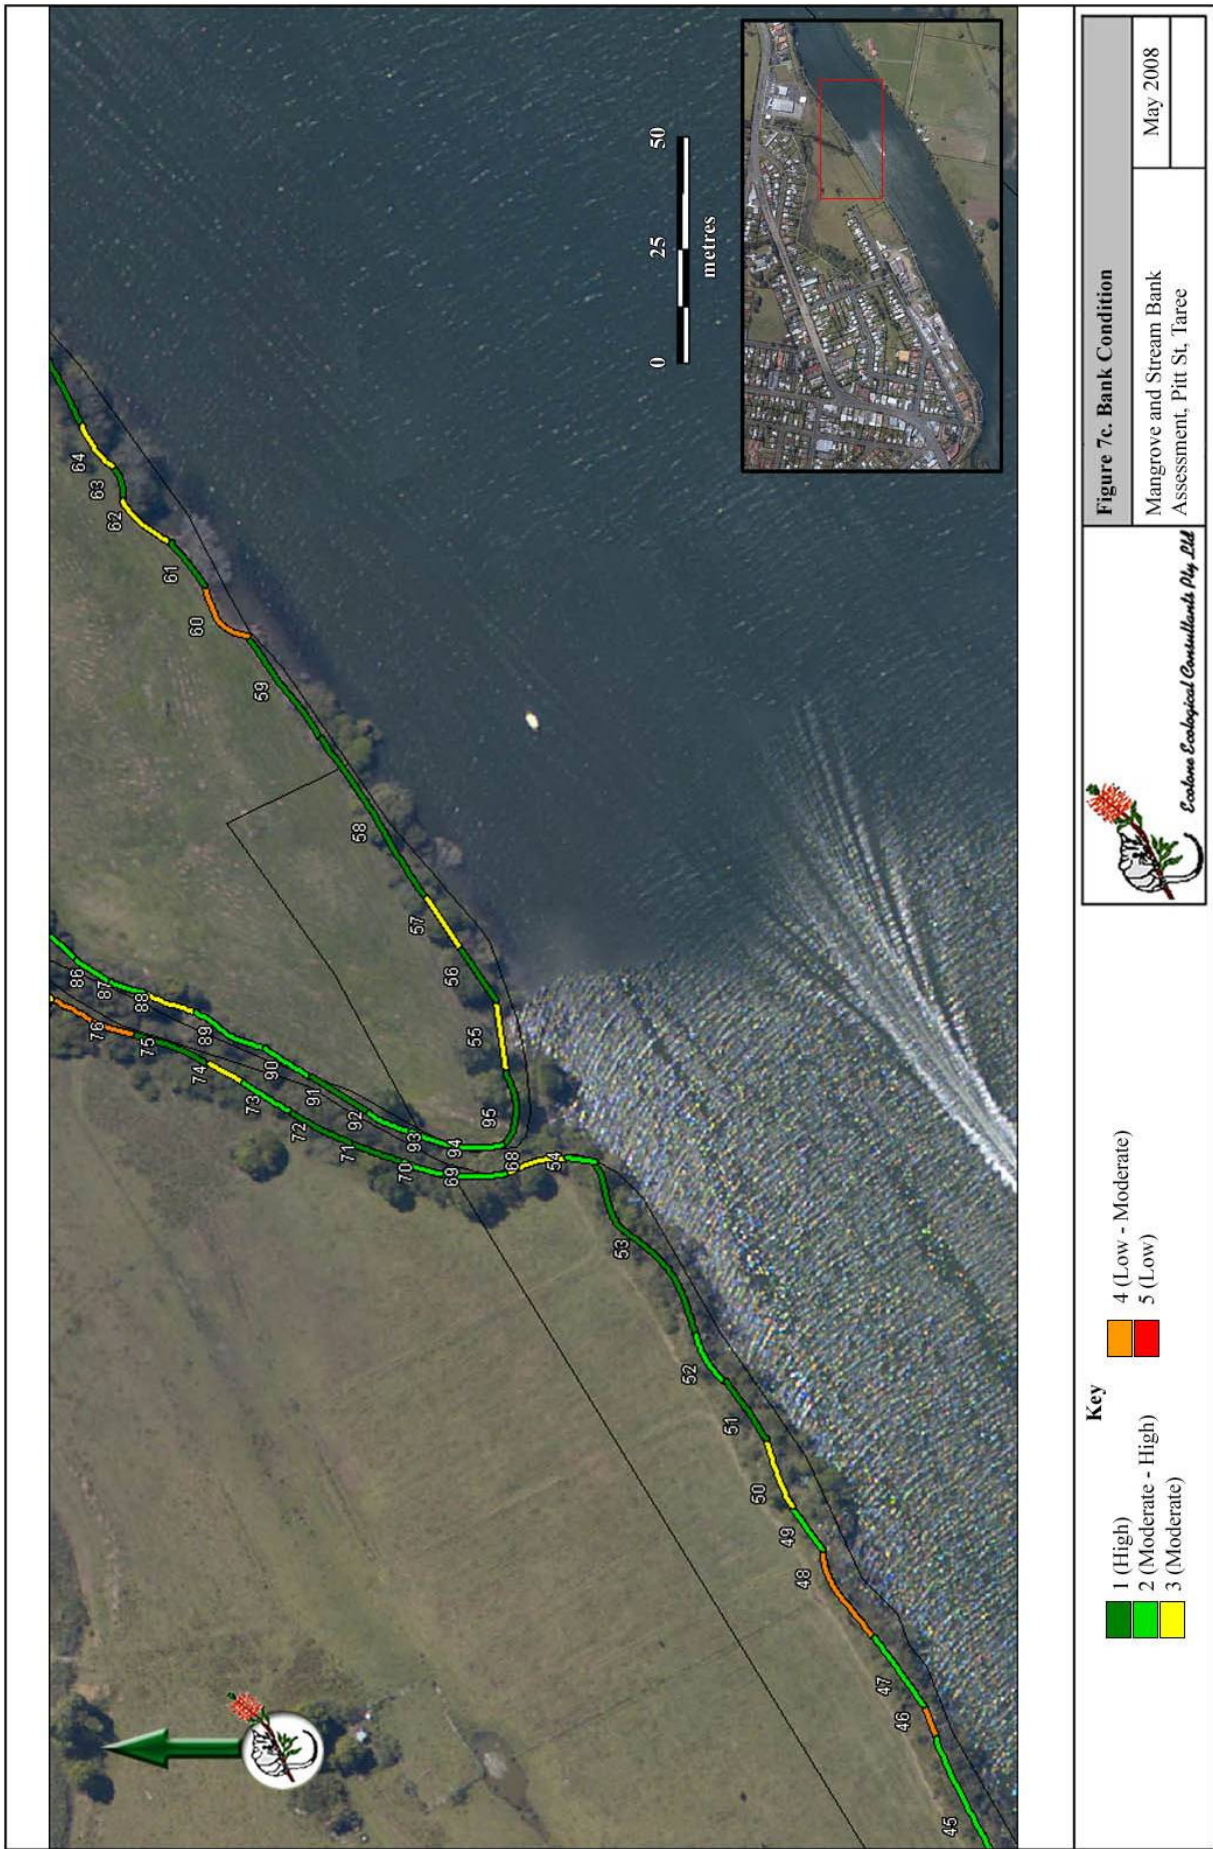
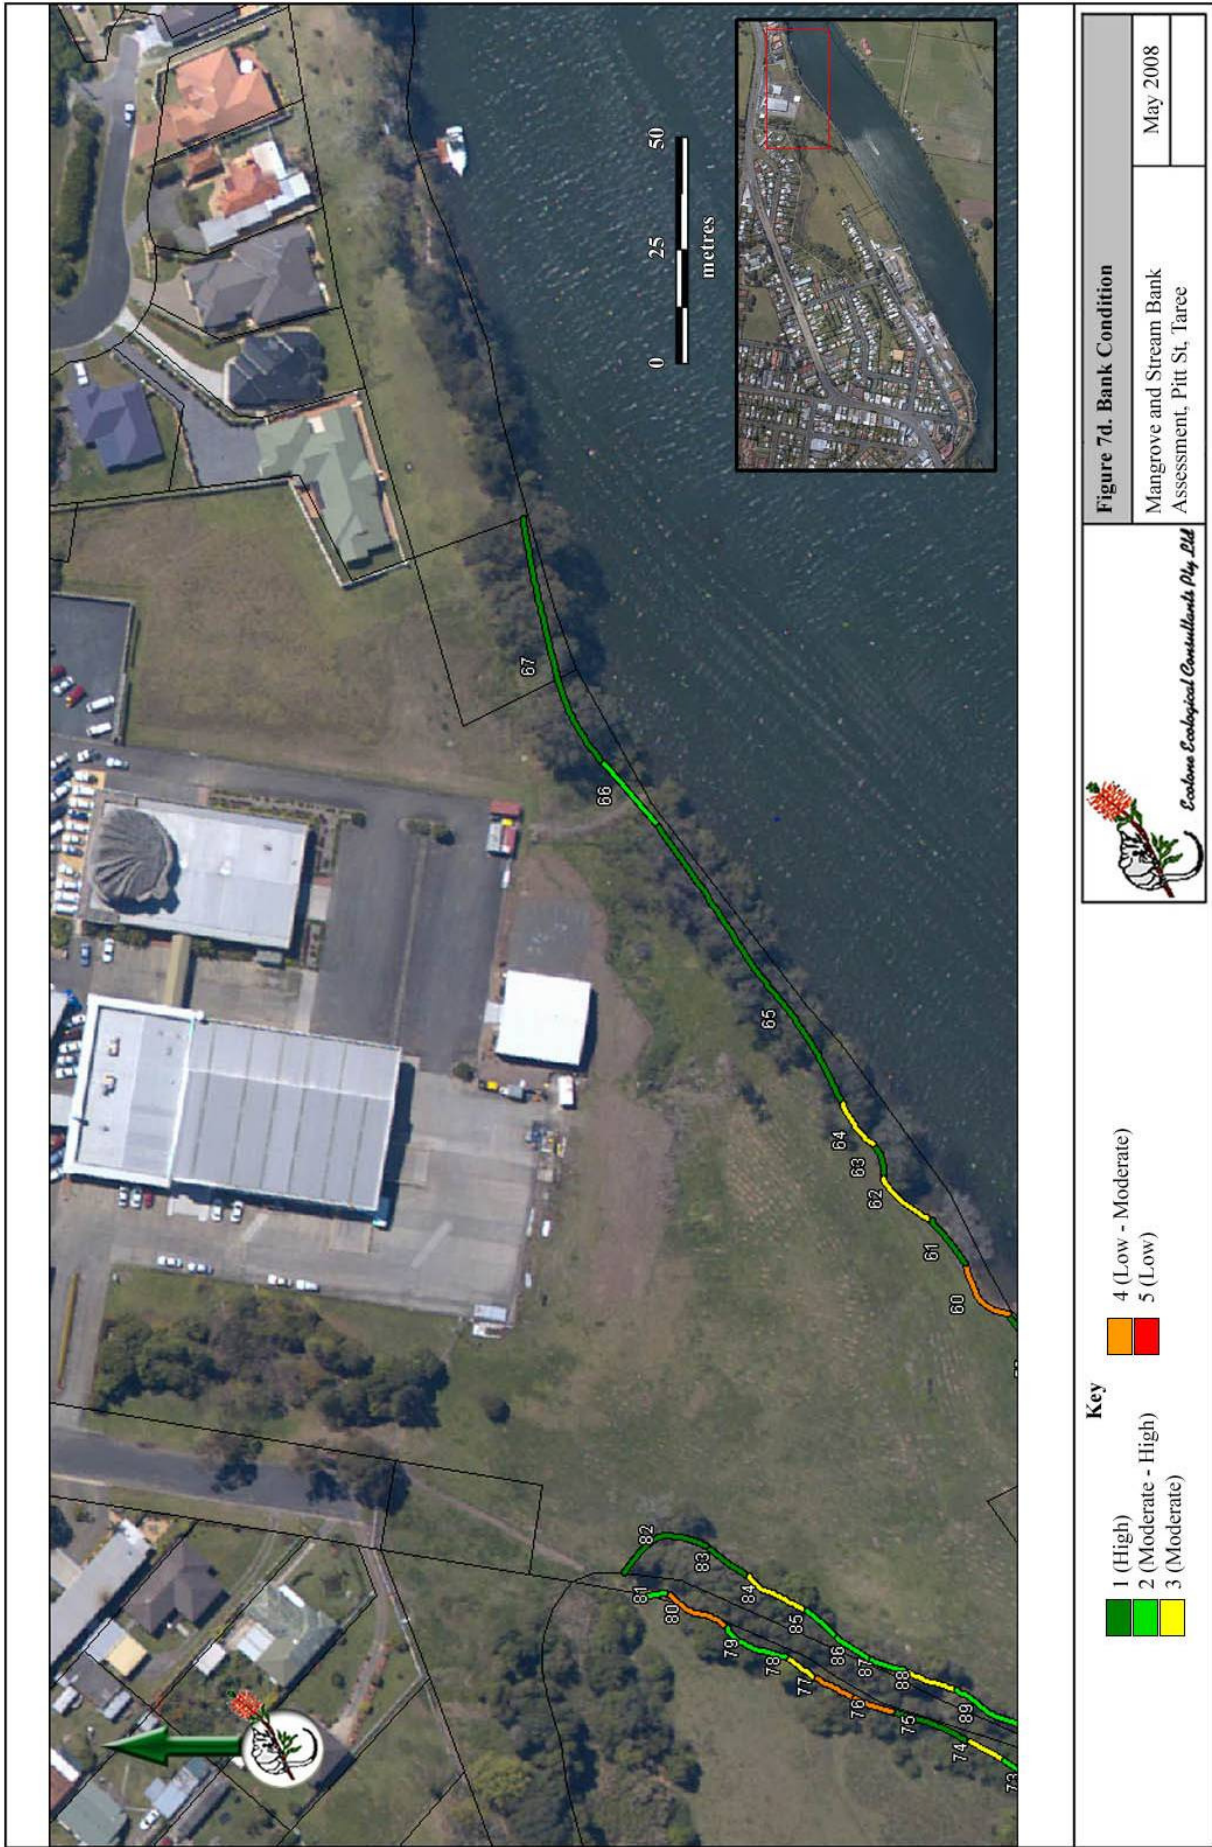
Figures 7a to 7d provide a visual representation of the overall state of bank stability in linear sections along the Manning River and the unnamed tributary. Details of the bank condition along each section are included in **Appendix 4**.

The areas exhibiting the worst bank condition occur towards the western end of the study area (Figure 7a) where the bank was highest and where a rope swing was present. Use of the swing and regular human access has denuded the bank of most ground vegetation and initiated severe erosion, resulting in exposure of tree roots and compromising the stability of trees along this section of the bank. Because of the steepness of the bank, mangroves were relatively sparse in this area.

Other areas of poor bank stability occurred in more limited areas along the shoreline, and were usually related to access by horses, often combined with wave action due to passing power boats along the main river. Poor stability also occurred where a section of mangroves had died.

The most stable sections of bank occurred mainly at the eastern end along the Manning River, plus stretches in the central area where mangroves were dense and the bank was heavily vegetated. The sections of bank where the bank height was lower and less steep were also generally more stable. One section directly behind the concrete plant had been artificially stabilised by the pouring of large quantities of concrete on and at the base of the bank. This section had a higher stability rating for this reason plus the high level of plant cover. Many parts of the unnamed tributary also had a high stability rating where vegetation cover was high and access by horses too difficult.

Erosion: This occurred at greatest intensity at the western end of the river (sections 3, 9, 10 and 11). Other major areas of erosion also occurred along short stretches in the unnamed tributary, due to access by horses (sections 68, 76-78, 80 and 84).

Slumping: This was relatively minor throughout the study area, and only appeared to occur west of the tributary mouth where the bank was lower and less rocky (e.g., sections 62 and 64 where mangroves had died).

- Following removal of horses and stock from the site, eroded areas along sections of the bank that will be retained should be stabilised and revegetated. A weed management plan should be prepared for weedy sections of the bank that will be retained. The plan should aim to progressively control weeds and promote native plant regeneration without creating bare soil and initiating further erosion.
