**GREATER TAREE CITY COUNCIL
REZONING OF PITT ST WATERFRONT
CHATHAM**

Acid Sulphate Soil and Contamination Assessment
and Review

GEOTTUNC01736AA-AD
7 November 2007

**RE: Acid Sulphate Soils and Contamination Assessment
Pitt Street Waterfront, Chatham (Taree)**

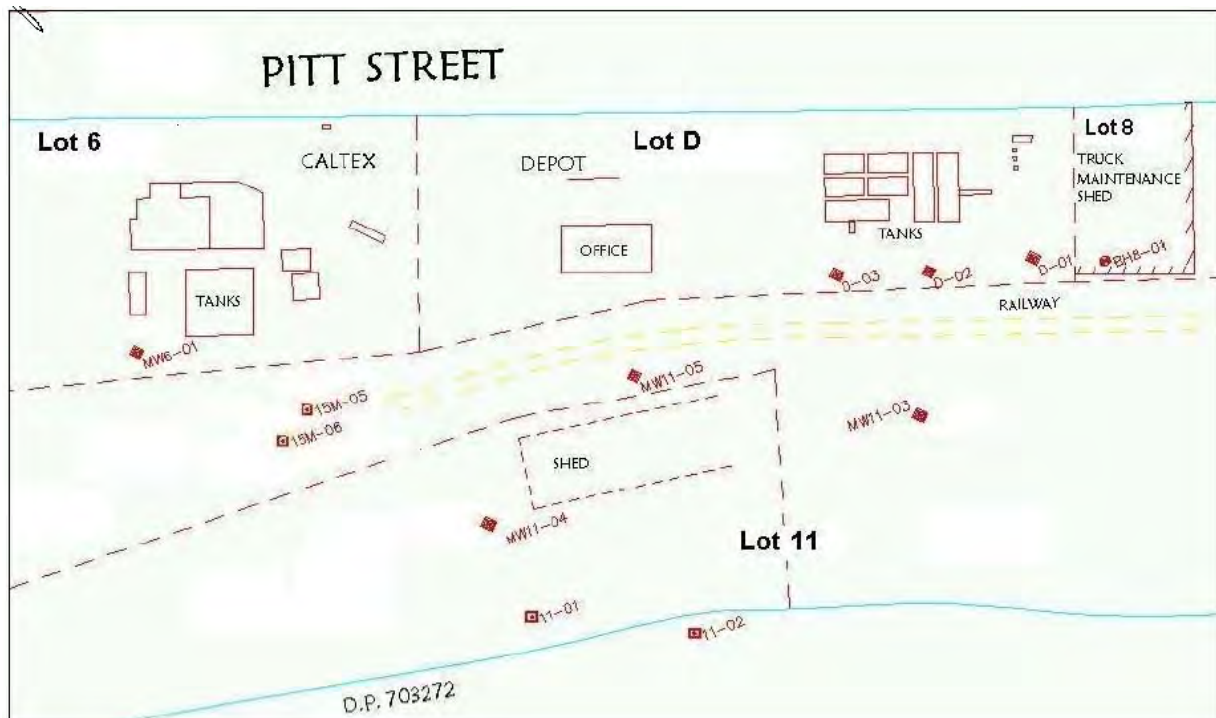
Figure 3: Extract from Envirosafe 2004 report showing sample locations on Lot 6, Lot D, the southwestern end of Rail Siding, and Vacant Lot 11.

Samples taken from this area were analysed for petroleum hydrocarbons and lead. Sampling included a borehole to 10.2m deep at location MW6-01. Soil samples taken at approximately 1m intervals in this location revealed no concentrations of hydrocarbons above guideline criteria. Sample locations D-01 to D-03 involved surface sampling and sampling to a maximum depth of 2.9m. Analysis revealed no concentrations of hydrocarbons or lead exceeding guideline criteria for residential development.

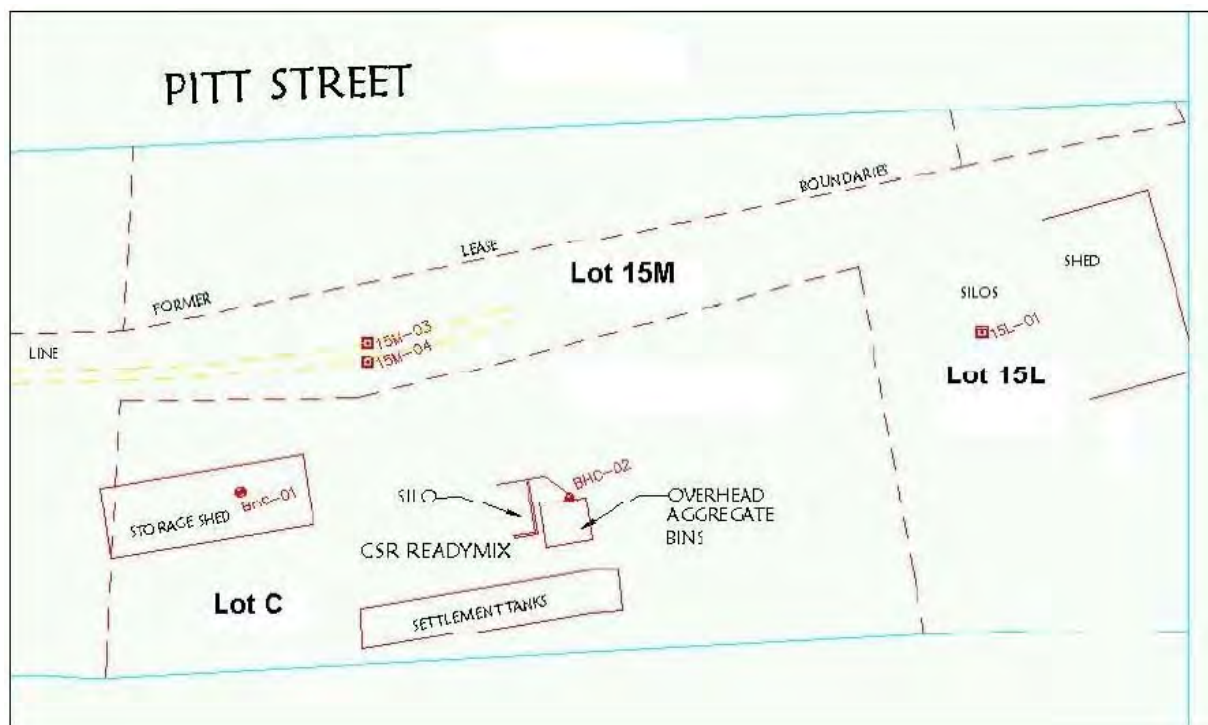
Figure 4: Extract from Envirosafe 2004 report showing sample locations within the existing Concrete Plant, part rail siding, and storage shed on vacant lot adjacent.

Sample Locations within the concrete plant area are shown in Figure 3 and Figure 4. These soil samples were taken from the ground surface and to maximum depths of 0.48m and were tested for petroleum hydrocarbons, heavy metals and PAH, which commonly accompany the presence of heavy oils and greases or partially combusted coal ash. Concentrations were below guideline values for residential development in all samples analysed.

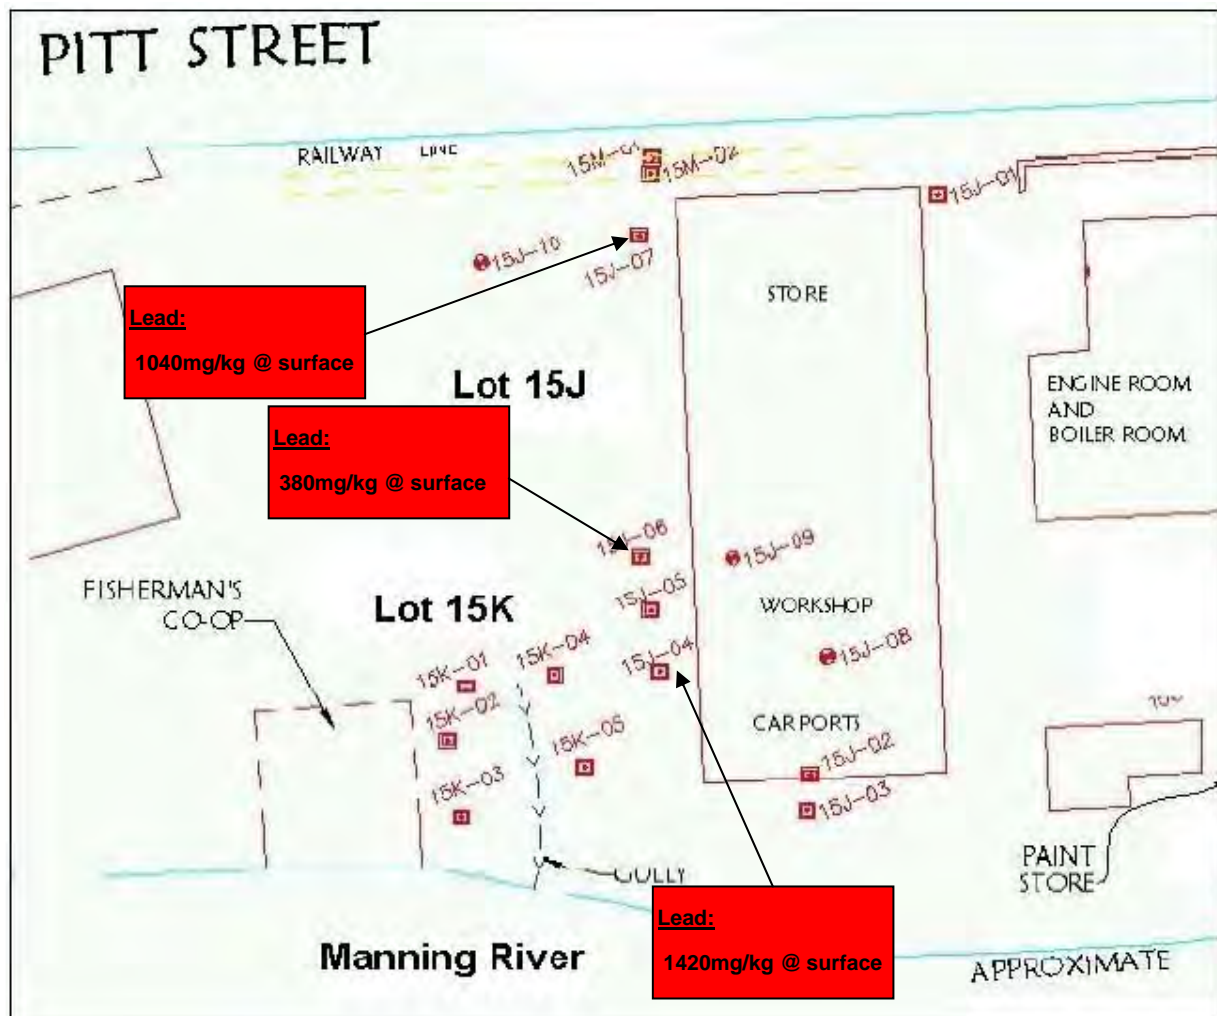
Figure 5: Extract from Envirosafe 2004 report showing sample locations in the filled gully adjacent to the Fishermans Co-operative building.

Although the Fishermans Co-operative building itself was not an area of concern in relation to contamination, it was noted that the land in the adjacent gully had formerly contained a boat repair slipway and also contained fill believed to have consisted largely of ash from the coal fired boiler in the dairy factory. This area was therefore targeted by the sampling program at the locations shown in Figure 5. Samples were analysed for petroleum hydrocarbons and heavy metals. Concentrations of

these analytes were below guideline concentrations for residential development in all locations, with the exception of a cadmium concentration of 24mg/kg in location BH15K-03 that exceeded the guideline value of 20mg/kg for residential development, and lead concentration in location 15J-04 that exceeded concentrations for residential and recreational landuse but was within guidelines for commercial/industrial landuse.

In relation to the investigations undertaken in this area it is notable that the analysis undertaken did not include contaminants commonly associated with the past landuses. In areas of former boat repair slipways it is good practice to analyse for polycyclic aromatic hydrocarbons (PAH) and Polychlorinated Biphenyls (PCB), that are often associated with engine oils, marine oils, refrigeration oils, and antifouling agents such as tar pitch often used on older timber boats. Testing for PAH should also be undertaken in soils containing coal ash. Tributyl-tin is also a common contaminant associated with former marine antifouling agents used up until the 1980's and should be tested for around older boat repair facilities.

It is therefore recommended that further sampling and analysis of surface soils around the former slipway and fill soils in the gully be undertaken and these soils should be tested for:

- Heavy Metals
- PAH
- TRH
- PCB's
- Tributyl-tin (near slipway/repair area)

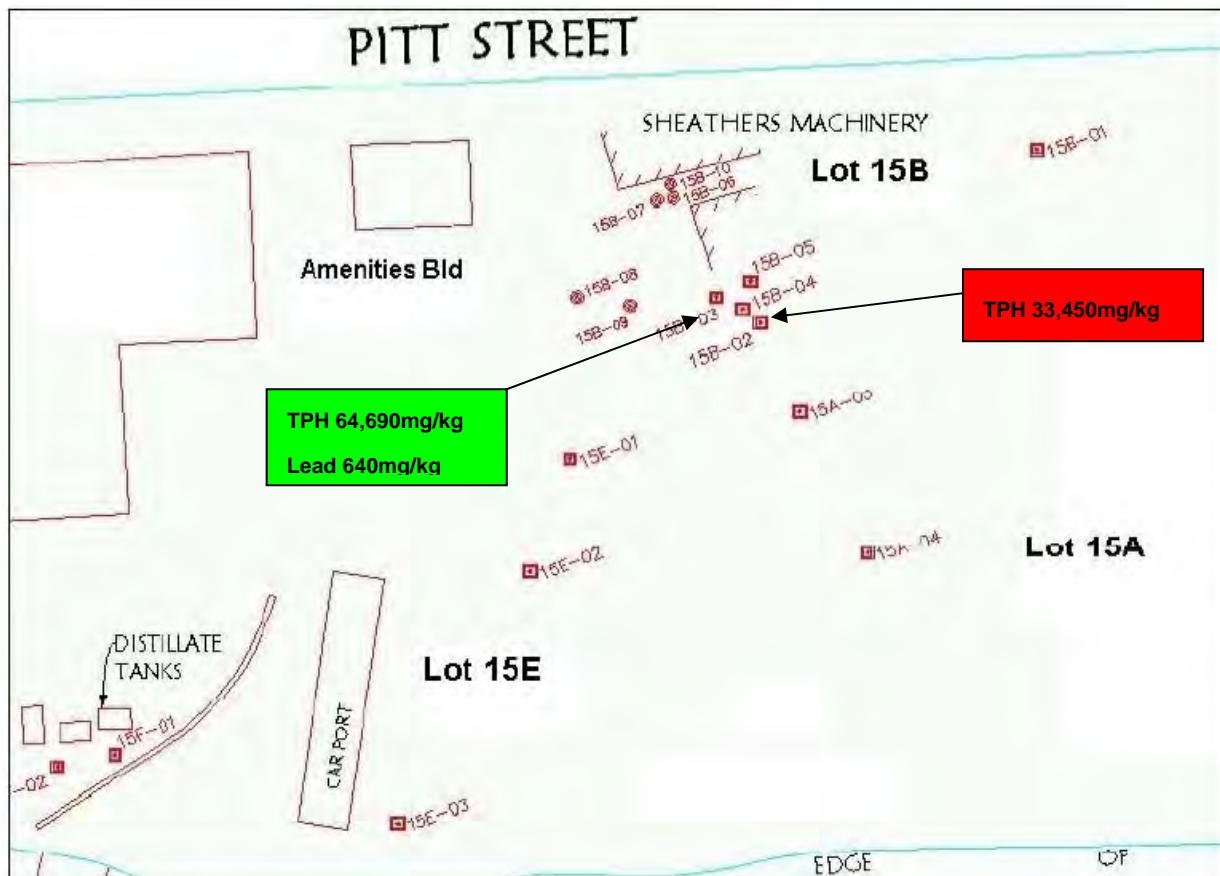
Figure 7: Extract from EnviroSafe 2004 report showing sample locations behind the Sheathers building.

The previous investigations identified visible oil staining behind the Sheathers farm machinery building and also noted that this area was used to bury machinery parts in the past. Deposits of partially combusted ash were also noted. This area was sampled in the locations shown on Figure 7 and samples were tested for petroleum hydrocarbons, heavy metals and asbestos.

- Petroleum hydrocarbon concentrations in surface samples at locations 15B-02 (33,450mg/kg) and 15B-03 (64,690mg/kg) exceed the guidelines in the C₁₀-C₃₆ range for residential, recreational/open space, and commercial/industrial site usage. These locations are highlighted on Figure 7.
- Lead exceeded the concentration for residential land use in the surface sample at location 15B-03. The concentration of 640mg/kg also exceeded the guideline for parks and open spaces but was within guidelines for commercial/industrial land use.
- All other contaminants encountered were within guideline concentrations for residential development.

It is notable that the sampling and analysis did not include PAH which should be tested for in any area containing oil staining, disposed machinery, or ash fill.

This area was previously investigated and remediated, however, the appeared to be insufficient testing for the presence of PAH's. Considering the use of the area to bury and burn machinery it is recommended that a grid of sampling points be established to further sample for the presence of PAH in the remaining soils.

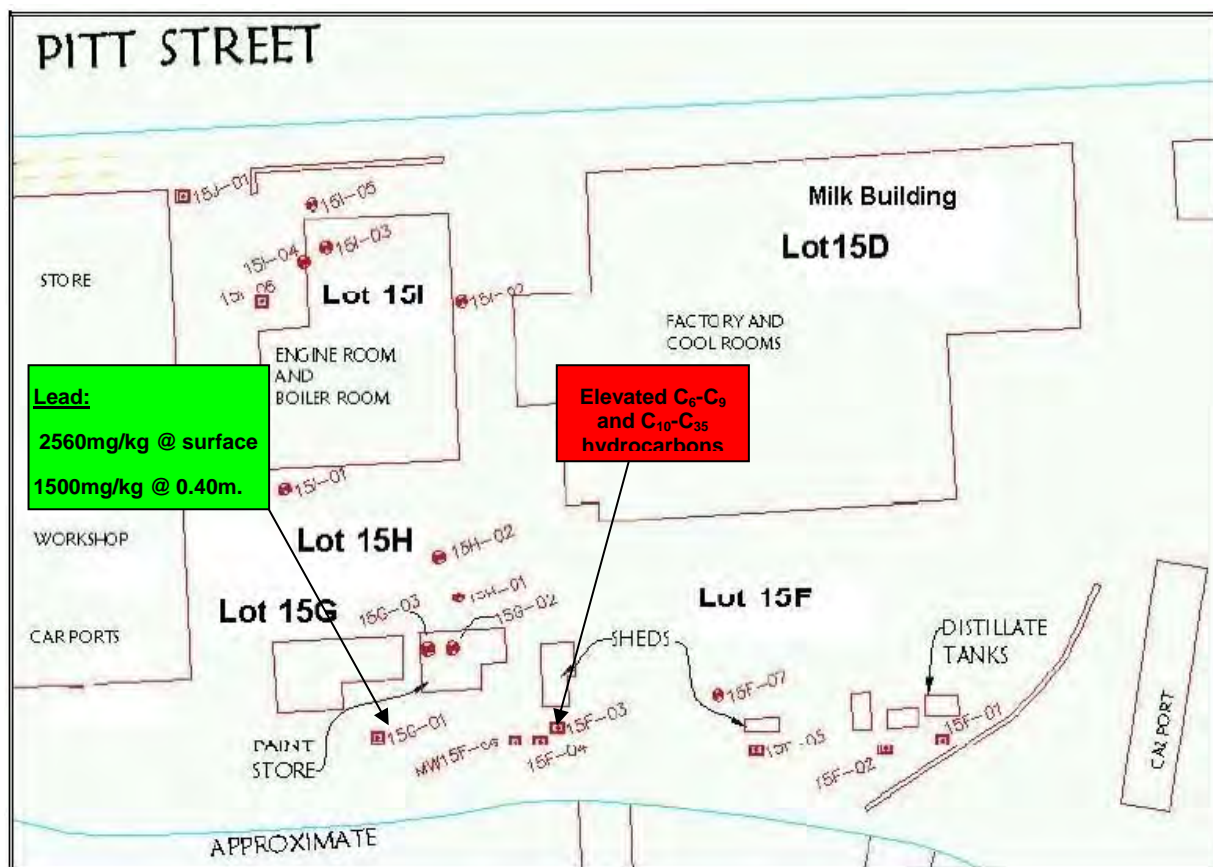
Figure 8: Extract from Envirosafe 2004 report showing sample locations over the remainder of the dairy factory.

Sample locations over the remainder of the dairy factory area are shown in Figures 7 and 8. The following points are noted in relation to this sampling and analysis:

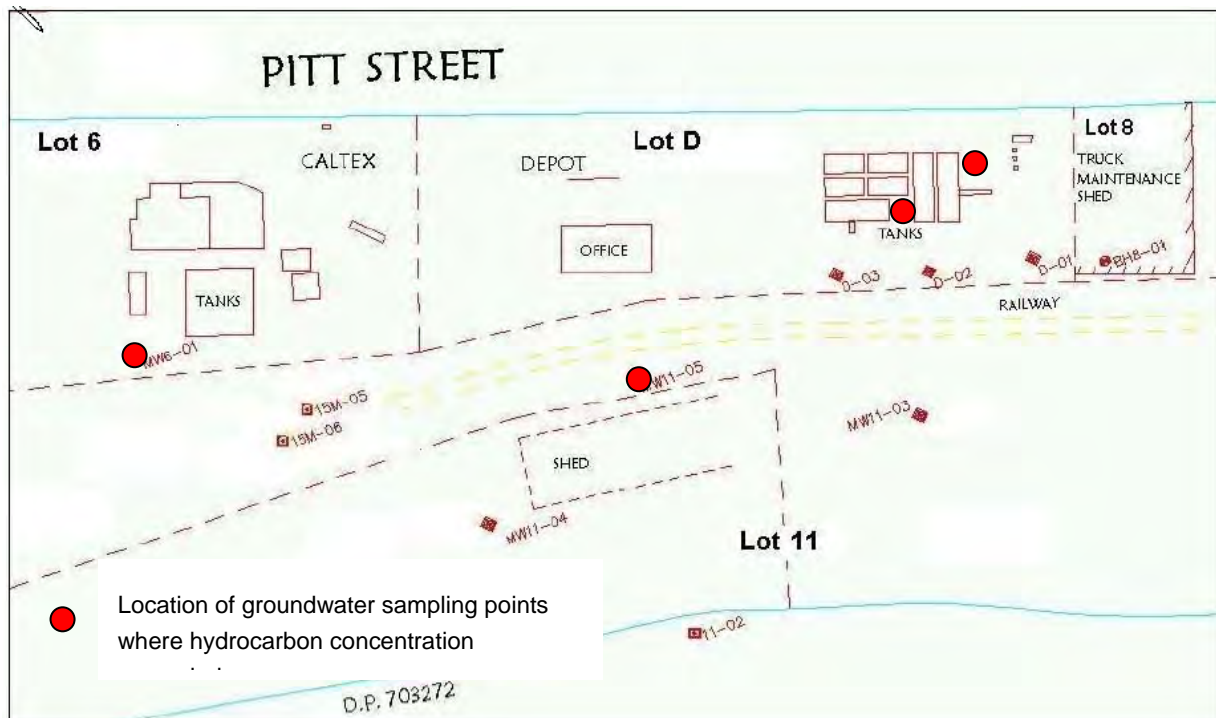
Figure 9: Groundwater sampling locations where hydrocarbon concentrations exceeded guidelines.

Results of groundwater analysis indicated the concentrations of TRH exceed guideline values in samples from the bores found on the Caltex fuel depot site, in bore MW6-01 installed on the downslope gradient of the site and in bore MW11-05 located beyond the down-gradient boundary. Laboratory analysis undertaken to identify the type of hydrocarbons present indicated the product encountered is likely to be diesel. Benzene concentrations and heavy metals concentrations in MW06 also exceeded adopted guideline values for recreational water usage or stock watering. The locations of groundwater bores in which contamination was encountered are shown in Figure 9.

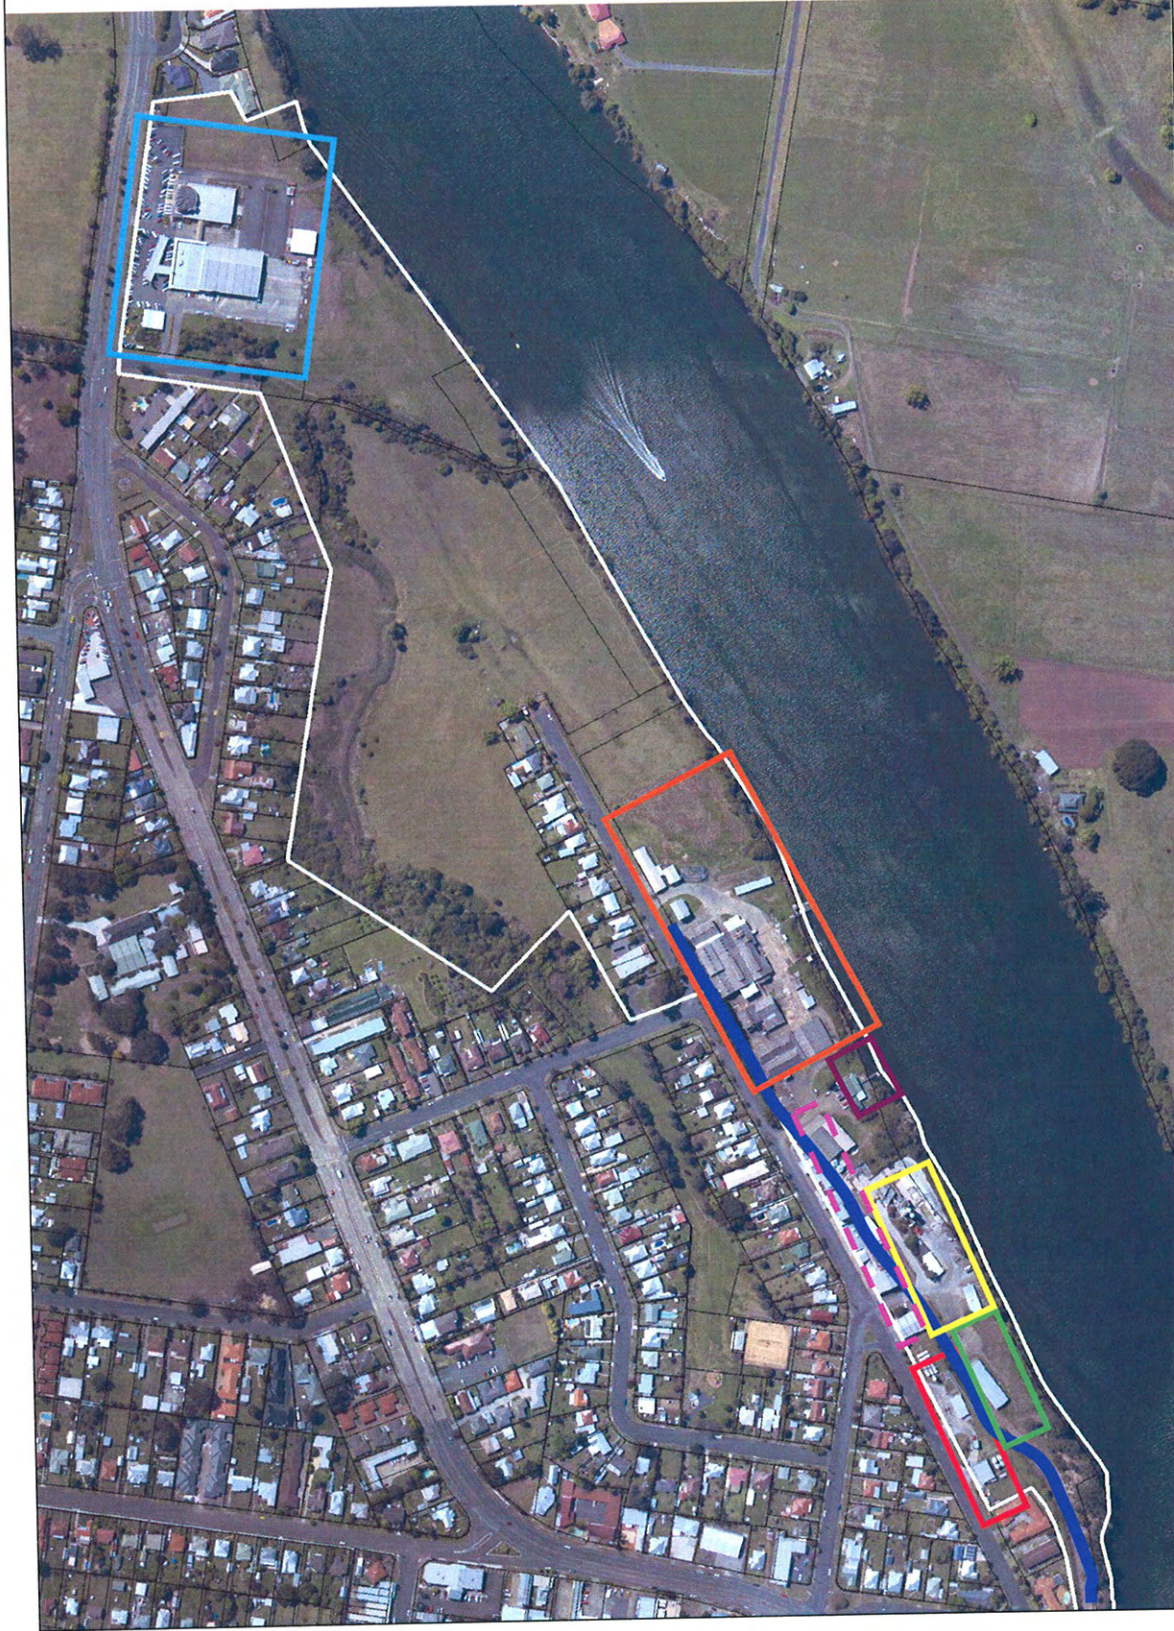
client:	SINCLAIR KNIGHT MERZ
project:	PITT STREET WATERFRONT, CHATHAM ACID SULPHATE SOILS AND CONTAMINATION ASSESSMENT
title:	AREAS OF ENVIRONMENTAL CONCERN
project no:	GEOTTUNC01736AA-AD
	figure no: FIGURE 2

The extent of the former rail siding is illustrated on Figure 2. Where the rail line passes into the former dairy factory the lines and sleepers have been removed. Over the remainder of the site the lines are still in place. Ballast and sleepers contain some oil staining. Most of the railway line easement is largely unvegetated, which might reflect the past common practice of using herbicide sprays in railway easements for the purposes of weed control.

At the western end of the site the rail line passes adjacent to the rear boundary of the fuel depot and a remnant concrete structure might indicate past usage of the rail line to either supply the depot or load rail tankers from the depot. There is visible oil staining in this area.

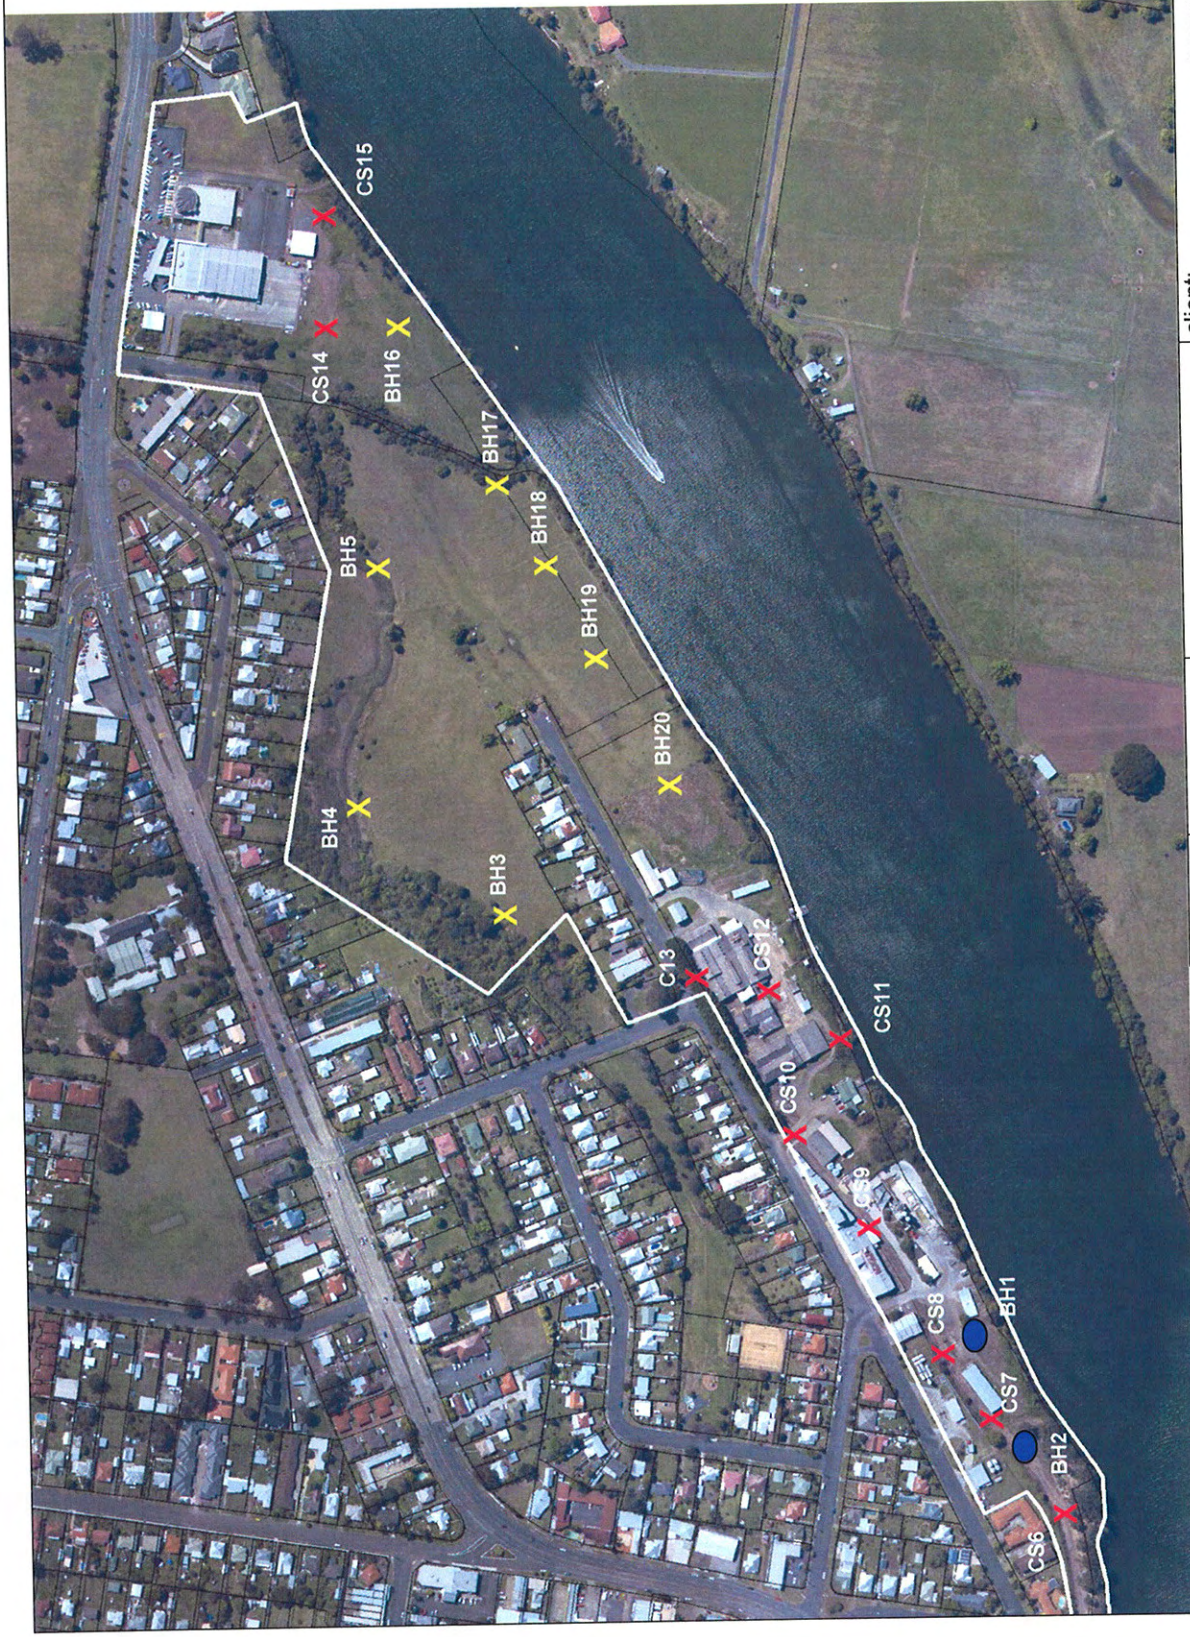
client: GREATER TAREE CITY COUNCIL		  SPECIALISTS MANAGING THE EARTH			
project: PITT STREET MARINA PRECINCT TAREE		drawn		SRM	
title: SAMPLE LOCATIONS		approved		14/9/07	
project no: GEOTTUNC01736AA-AD		date		nts	
figure no: FIGURE 10		scale		A4	
		original size

Near surface soil samples were then taken from the remainder of the locations marked on Figure 10. These samples were obtained using a stainless steel trowel and were placed in laboratory supplied sample jars and placed on ice in cooler boxes on site for transport to the testing laboratory under Chain of Custody conditions.

Groundwater samples from BH1 revealed no contaminants within detectable limits. In location BH2A concentrations of petroleum hydrocarbons were encountered up to 690 micrograms per litre for petroleum hydrocarbons, which exceed the Dutch (1994) Intervention Value of 325ug/L normally used for evaluation of hydrocarbons in groundwater in NSW. These are likely to be a result of fuel spillages at the former fuel depot rail loading facility and/or leakages from the fuel depot itself. The extent of this groundwater plume should be further investigated.
