Preliminary Environmental Site Assessment Kanangra Drive Gwandalan, NSW

10 September 2007

HLA Ref: N4080801_RPT_10Sep07

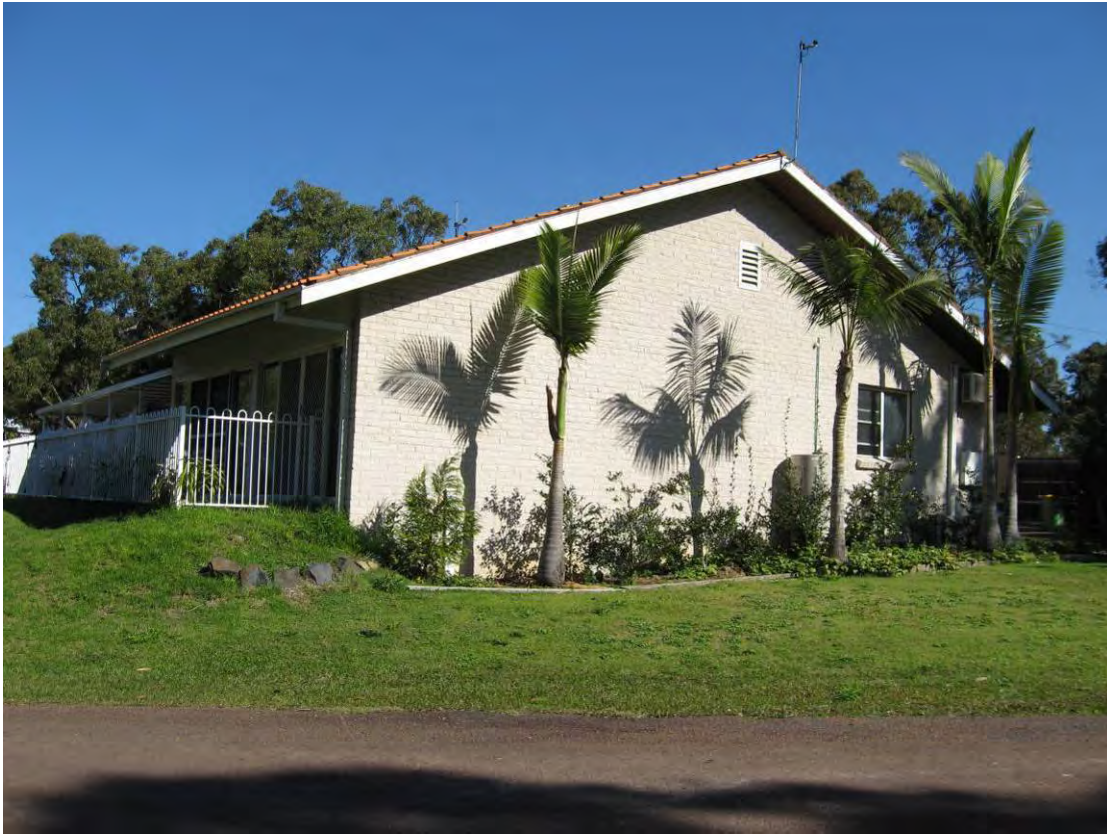
Plate P1: Residence located on Kanangra Drive, near main gates. Currently occupied

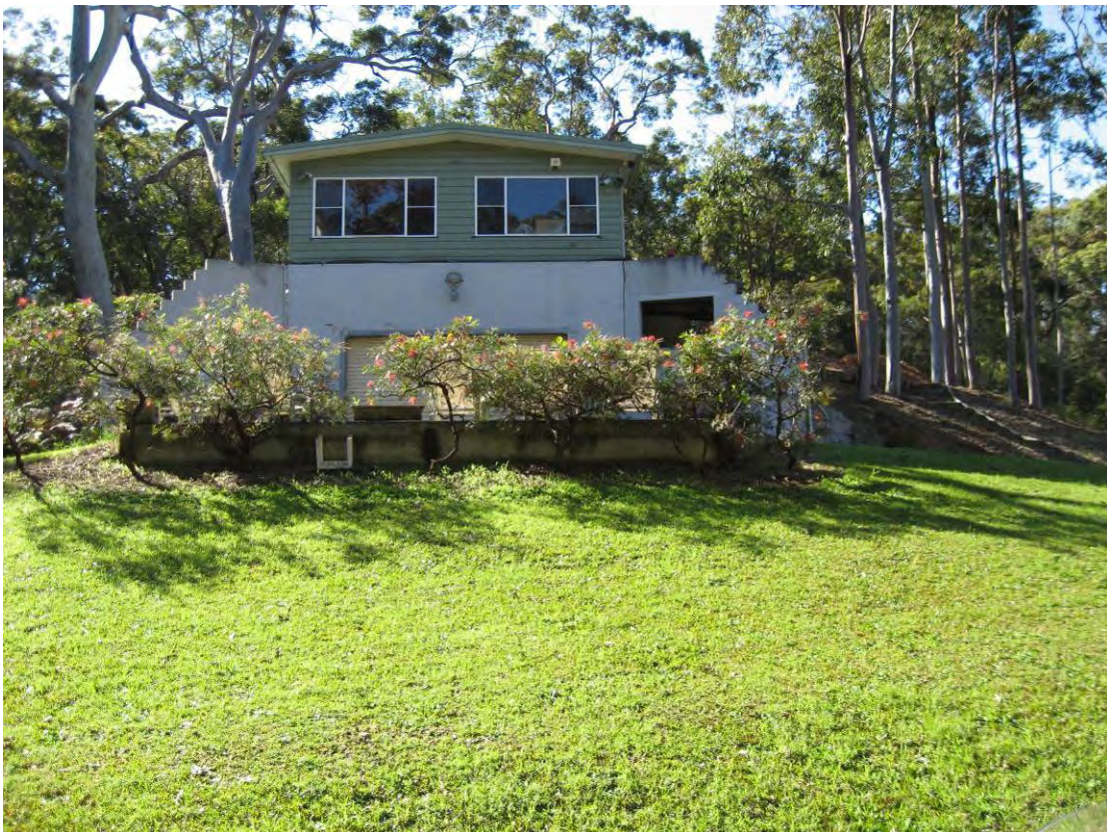
Plate P2: Bunker located in North East corner of site, currently vacant

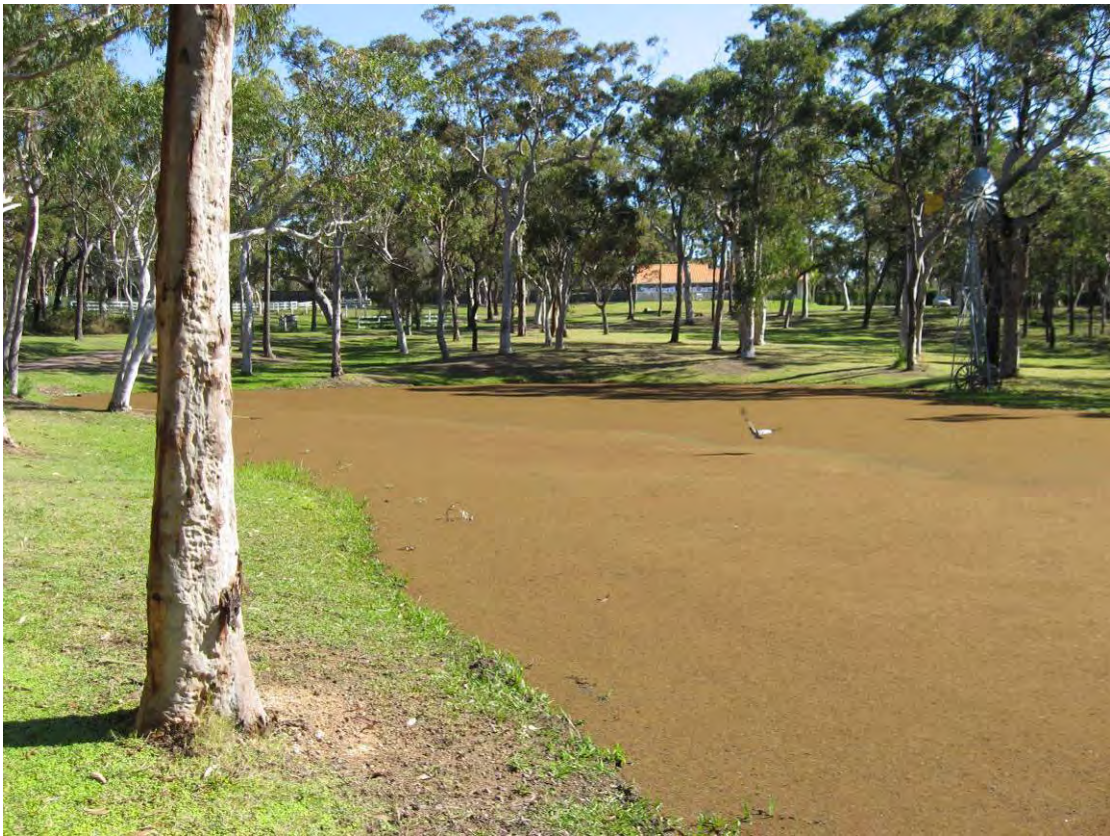
Plate P3: Dam located in Southern portion of the Site, residence can be seen in the background

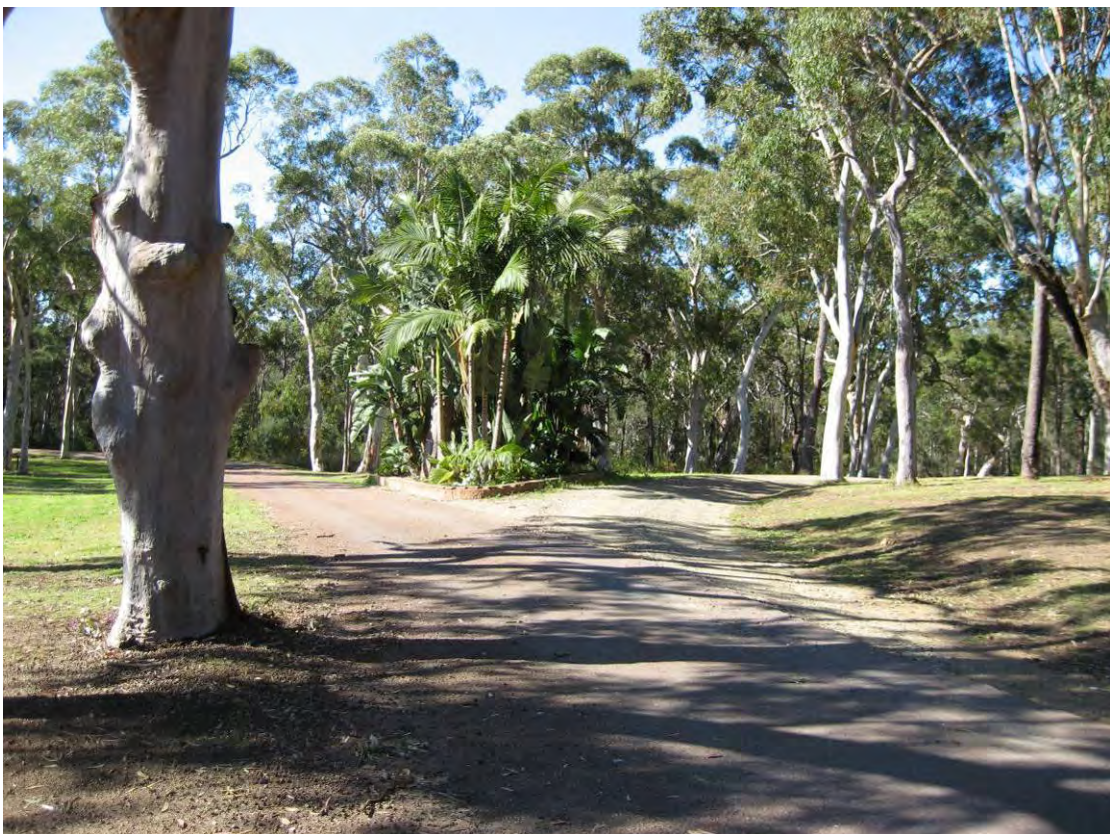
Plate P4: Driveway leading from main entrance on Kanangra Drive to Eastern side of Site

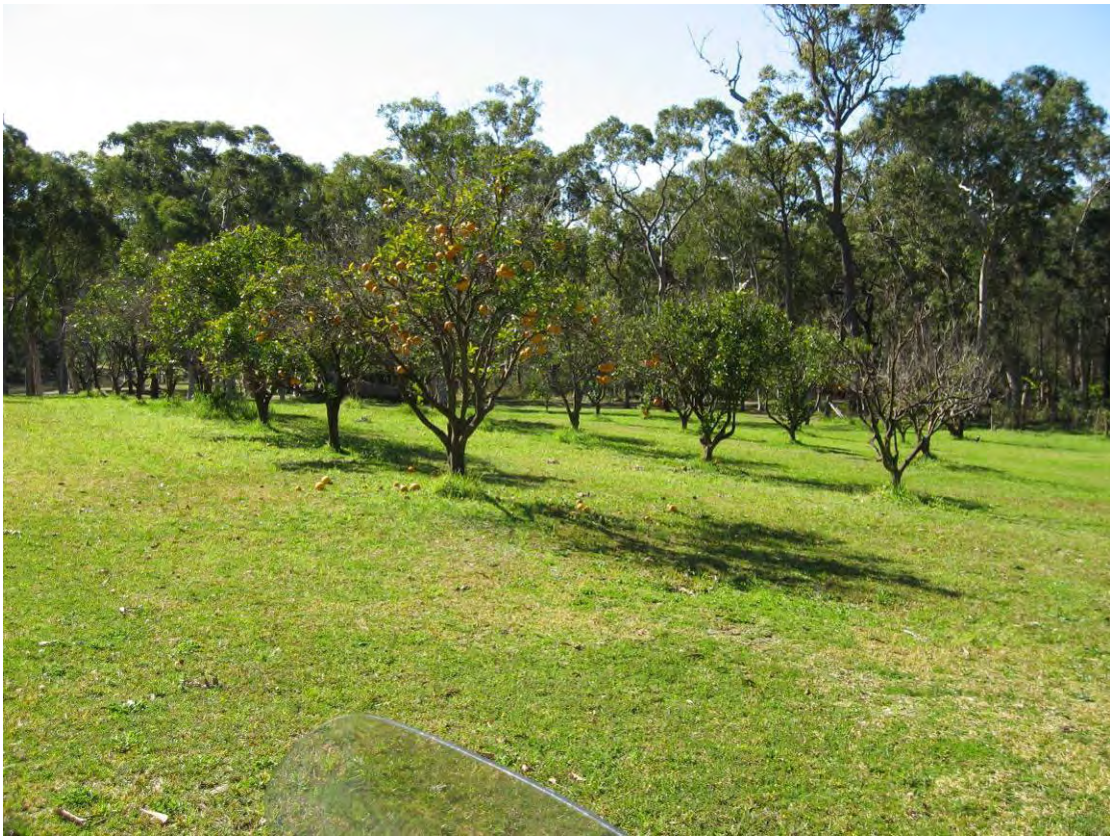
The Site is predominantly covered with native vegetation. The vegetation was observed to be in good condition with some trees having fallen in a recent storm event. Some areas of the Site contained non-native plantings of palm trees (**Plate 4**) and kikuyu grass along with turfed areas around dams and a fruit orchard. It is understood the orchard (**Plate 5**) contains orange, lemon, mandarin and mango trees.

Plate P5: Small Orchard located in south East portion of Site

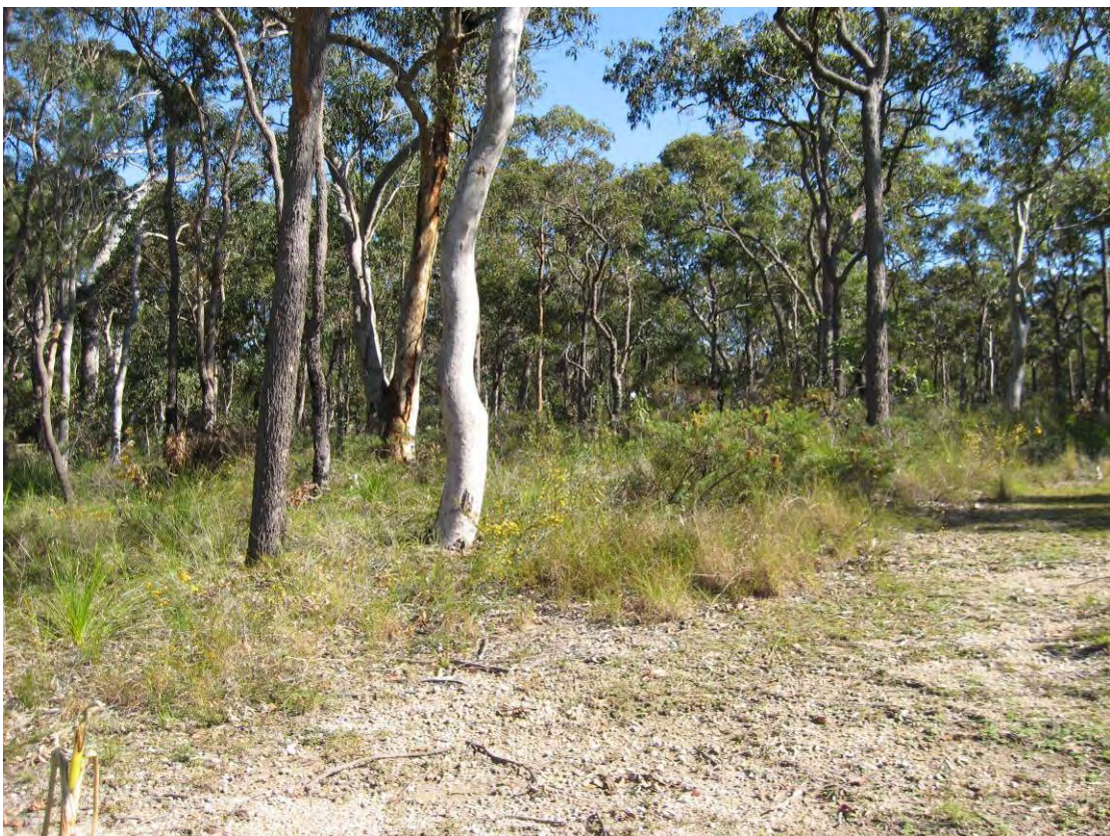
There was no stressed vegetation observed during the inspection (**Plate 6**). Non-native vegetation covered some areas of the Site and there were a number of fallen trees across the Site which it is understood are the result of a recent storm event in the area.

Plate P6: Bushland in central portion of Site

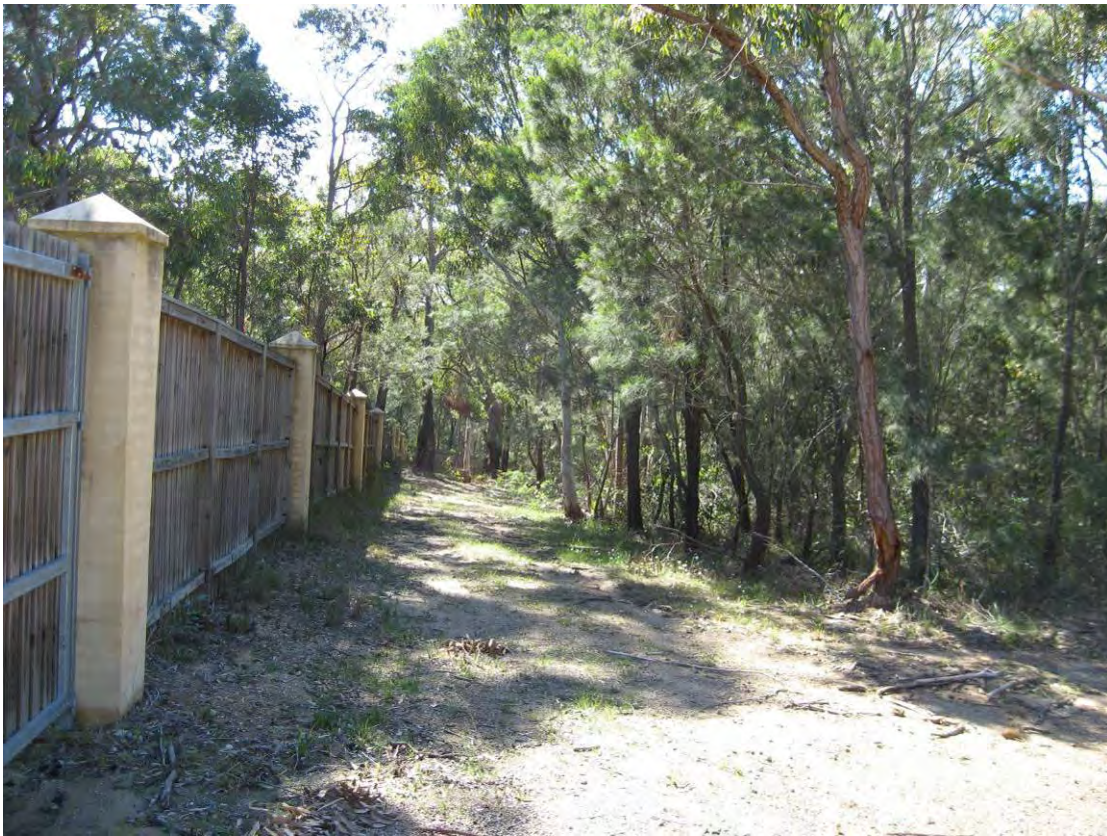
The Northern boundary of the Site is bounded by a barbed wire fence. The remainder of the Site's boundary is fenced by timber wall in excess of two metres high with locked gates at the two entrances to the property off Kanangra Drive (**Plate 7**).

Plate P7: Timber fencing along Kanangra Drive

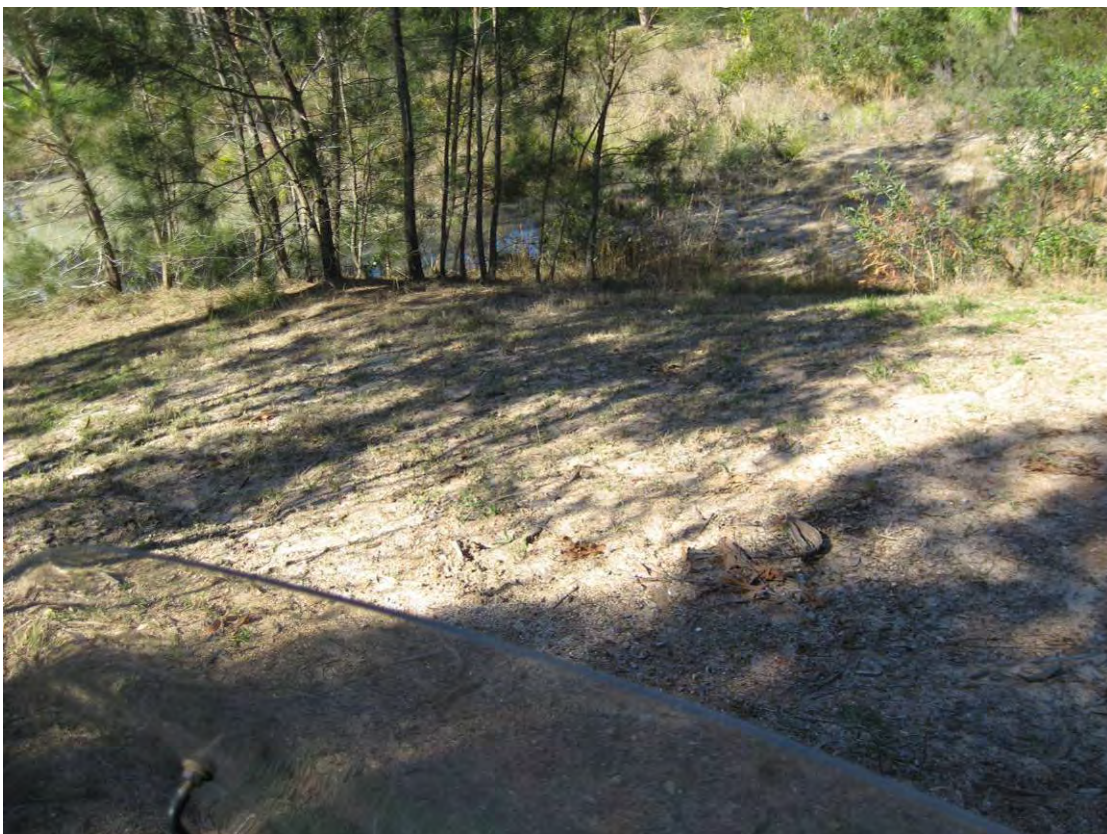
There was no evidence of recent excavation or stockpiled soil on the Site. An area in the North West of the Site could have potentially been used for extractive purposes in the past. The area appeared to have been dug out and is now poorly vegetated (**Plate 8 & 9**).

Plate P8: Poorly vegetated portion of Site located in the North West corner where possible quarry or other extractive activities may have previously taken place

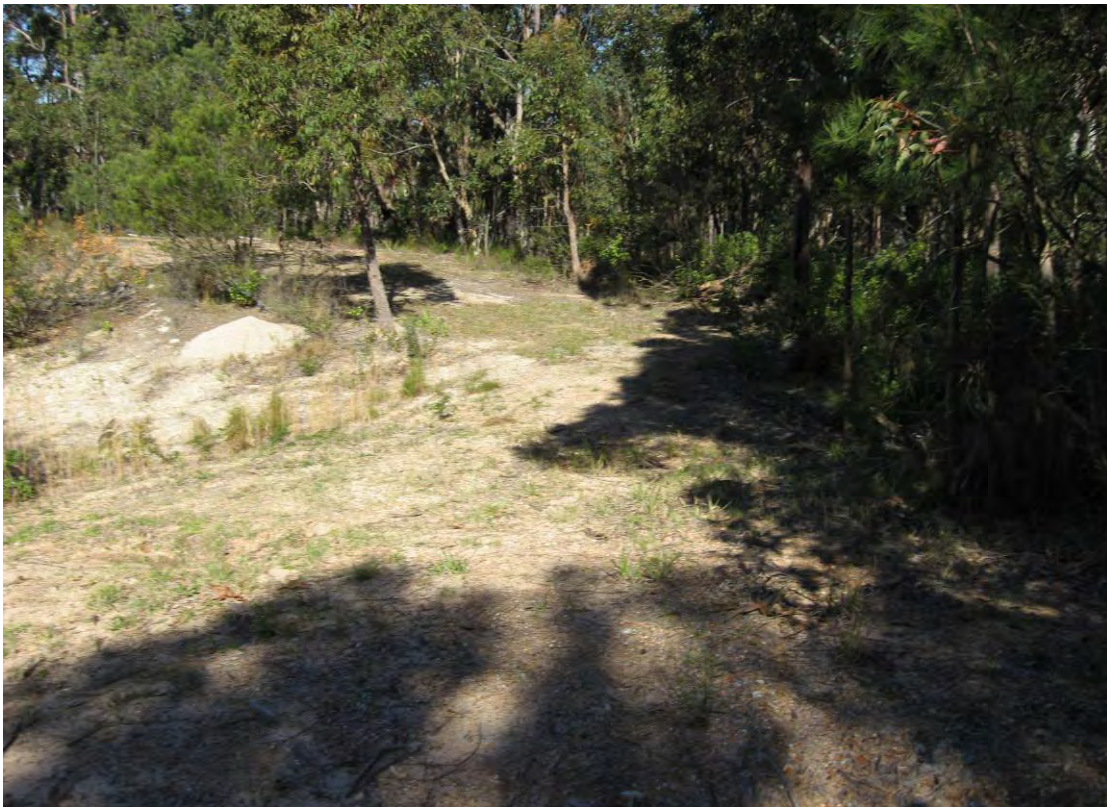
Plate P9: Part of poorly vegetated portion of Site located in the North West corner where possible quarry or other extractive activities may have previously taken place

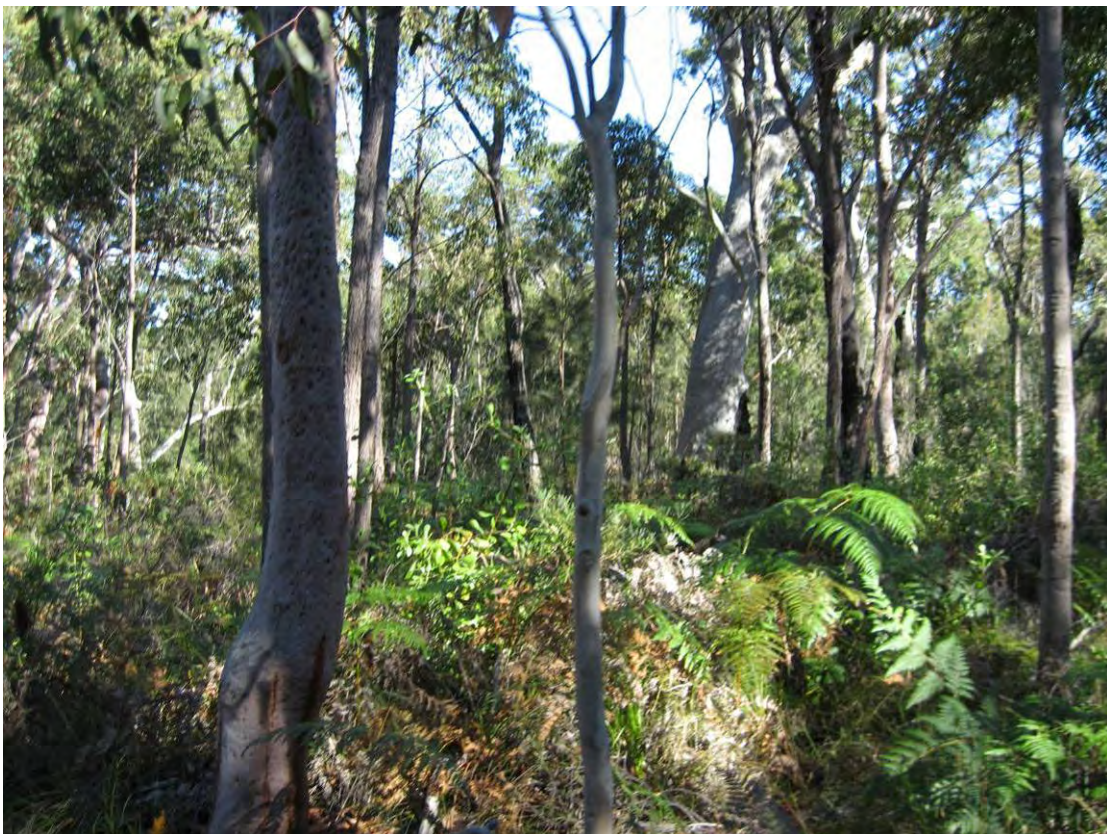
Plate P10: Vegetation in Northern portion of the Site

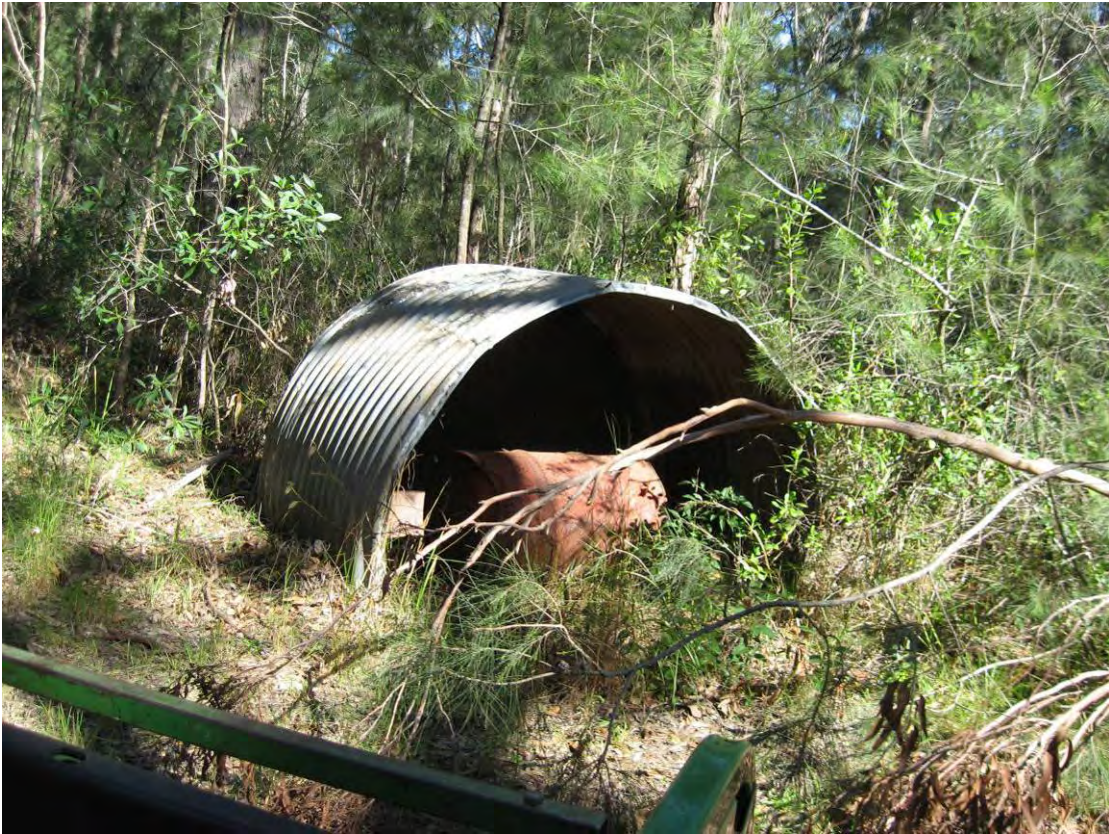
HLA ENSR is not currently aware of any equipment abandonment, removal, replacement or repair. A small amount of rubbish was observed near the Northern boundary of the Site (**Plate 11**) consisting of half a large metal tank and an empty, rusted drum. This was the only rubbish observed during the inspection.

Plate P11: Only sign of rubbish on Site, located close to Northern boundary of the Site consisting of half a large metal tank with a rusted empty drum.

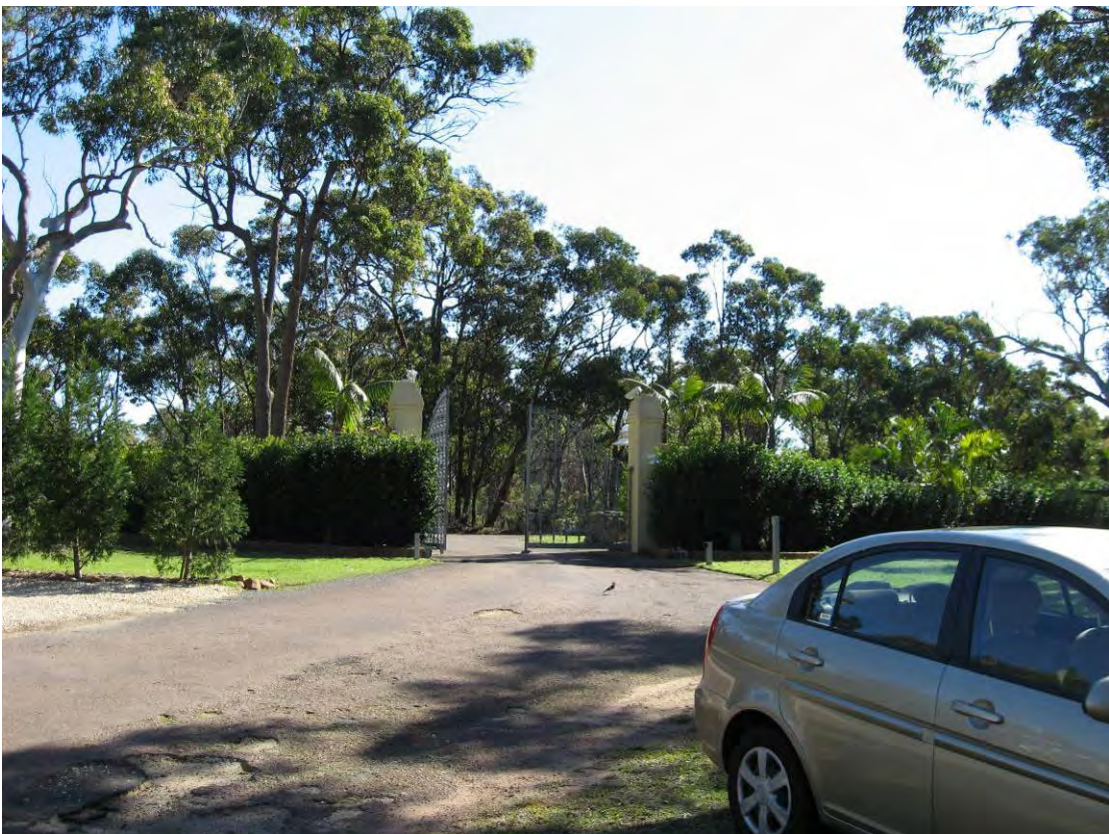
Plate P12: Main entrance to Site

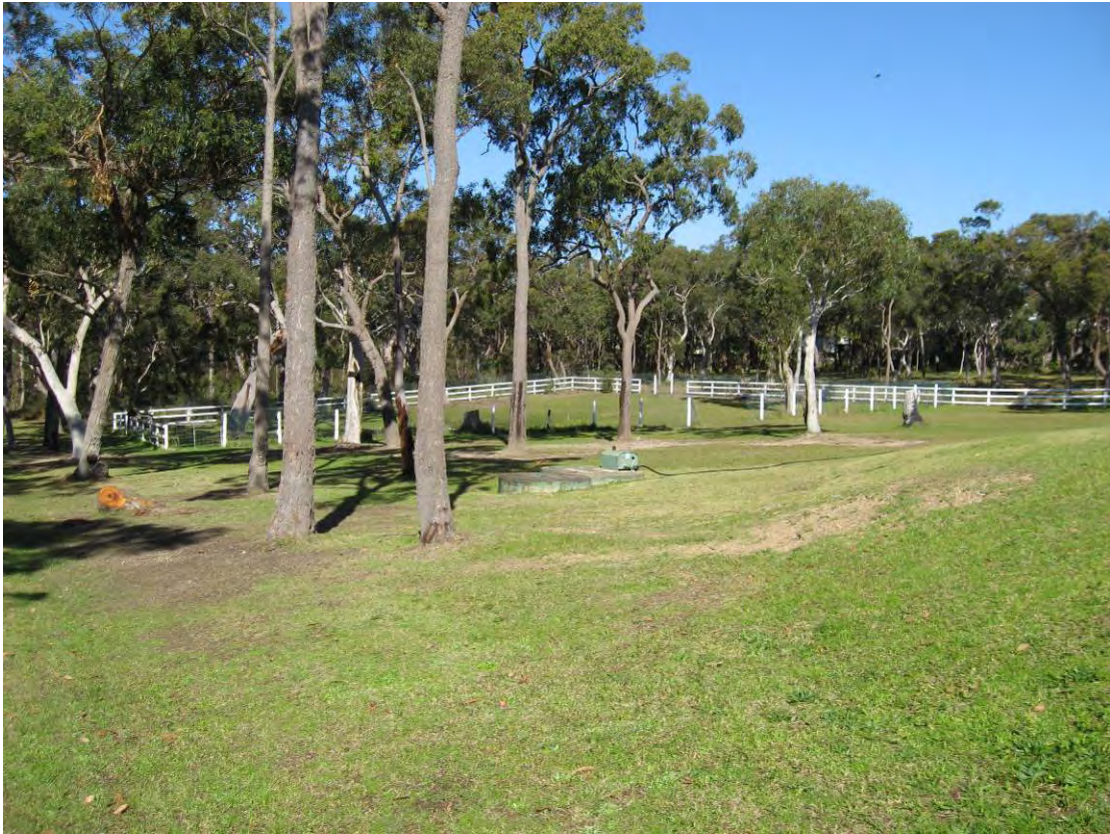
Plate P13: On-site biological sewage treatment system
