Arborist Assessment West Ryde Redevelopment

Compiled by
George Palmer
Botanics, Tree Wise People Pty Ltd

Dated
June 2009

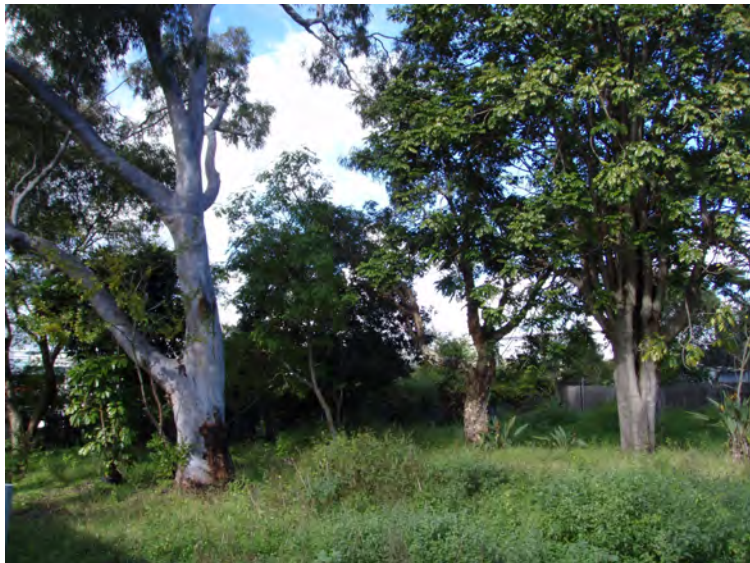
1.3.7 The majority of the trees detailed are located centrally within the site and will require removal to allow for the construction process to occur. The most significant of these is a fully mature Lemon Scented Gum documented as Tree 12. It can be estimated to be over 50 years of age and is a prominent feature. The tree has a trunk diameter of over 1.2 meters and will have a large critical root zone. This will limit construction within approximately 10+ meters of its base.

1.3.8 This Lemon Scented Gum tree also has a large wound on the northern side of its base and its structural integrity would be questioned if it was to be retained in an urban environment. The mature age of the tree will also limit its ability to compartmentalize wounds and reduce the spread of decay as well as adapt to an altered environment. These are important issues when considering its long term viability within the context of the proposed development.

Figure 1 Shows Trees 10, 11 and 12 located within the vacant block.

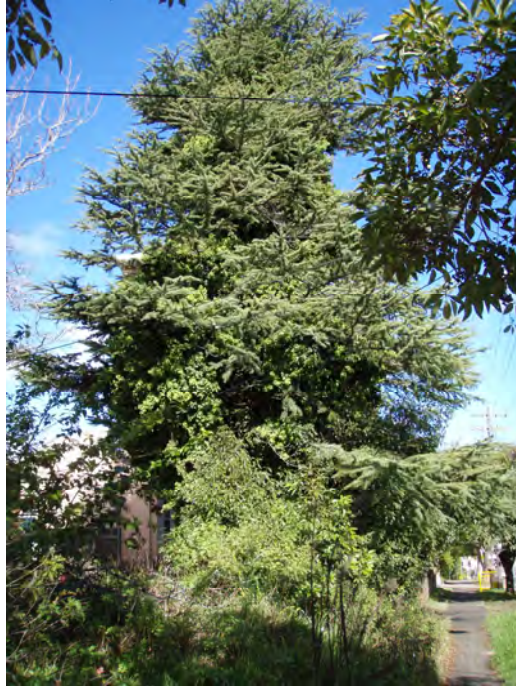
Figure 2 Shows Tree 1 with its lower trunk covered in Ivy.
