CARDINAL FREEMAN VILLAGE

Structural & Geotechnical Assessment

APP CORPORATION PTY LTD
GEOTECHNICAL INVESTIGATION
ADDITIONAL SELF CARE UNITS
8-10 Clissold Street, Ashfield

**RE: GEOTECHNICAL INVESTIGATION
ADDITIONAL SELF CARE UNITS
8-10 CLISSOLD STREET, ASHFIELD**

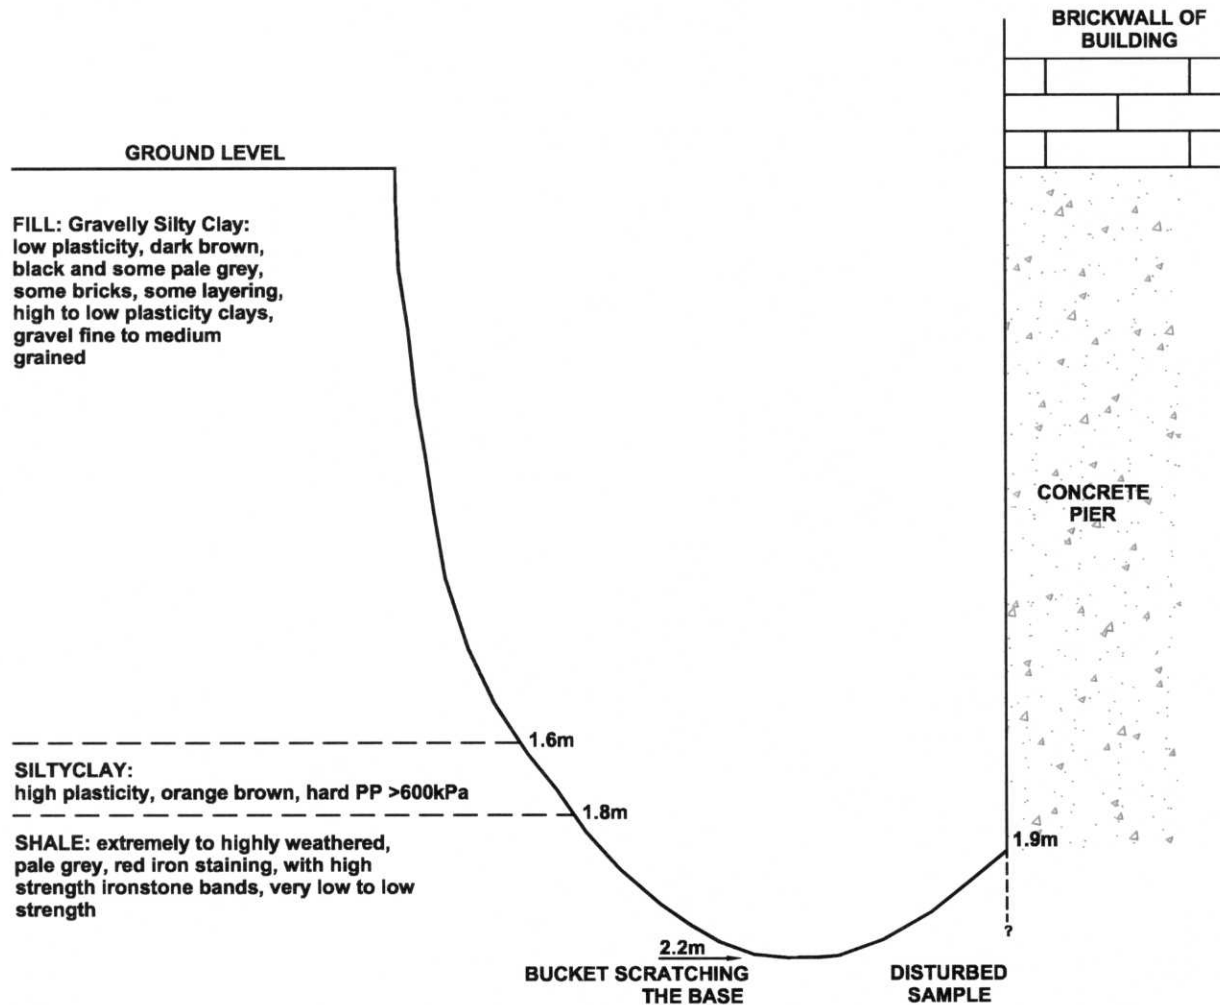
In TP1 located on the south east of the building, the excavation revealed a concrete footing extending down to 1.9m below ground level. However, the base of the footing was not observed. The test pit revealed extremely to highly weathered shale, very low to low strength, with high strength ironstone bands from 1.8m depth to the base of excavation at 2.2m depth. This material is consistent with Class V Shale, in accordance with the Pells classification (see earlier reference).

NOTE: BASE OF PIER NOT OBSERVED

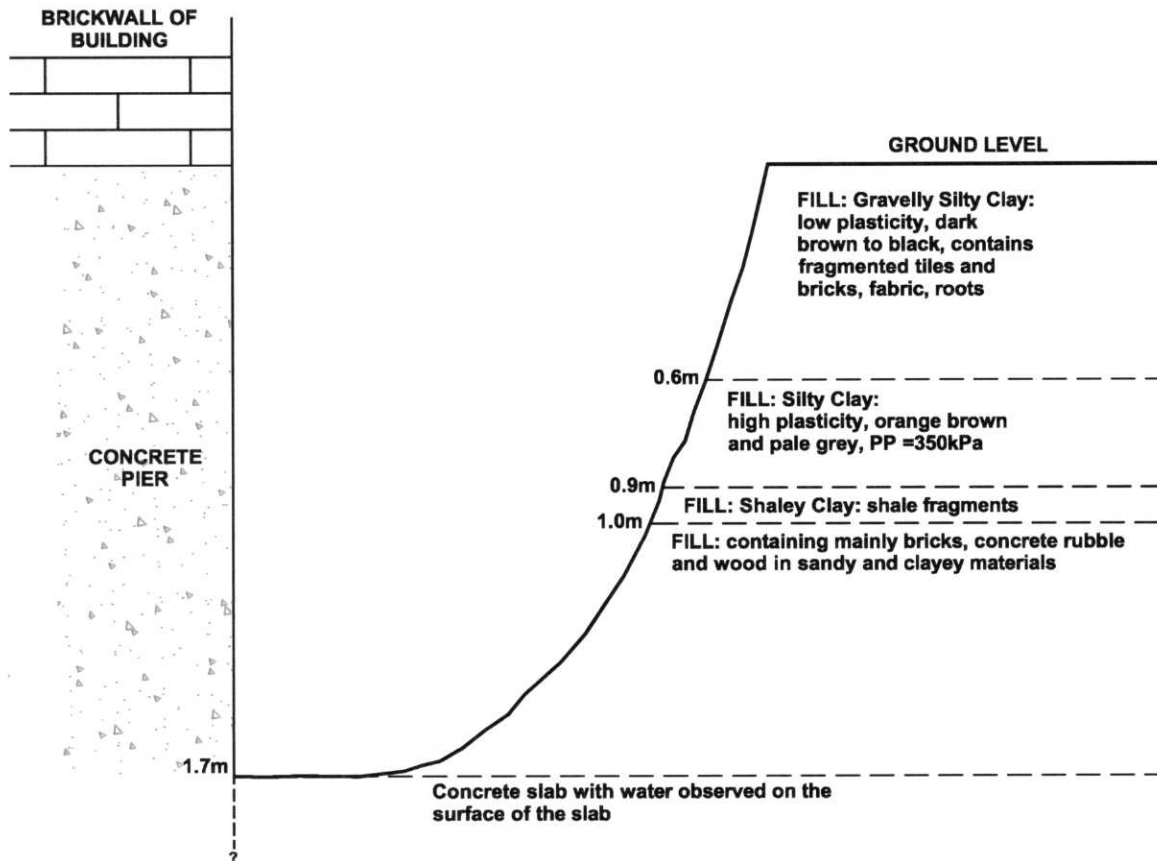
TP2

Groundwater was observed at the base of TP2. The groundwater observed may be trapped water on the surface of the concrete slab. Previous investigations indicated that no groundwater was observed. It should be noted that groundwater levels may vary seasonally with rainfall and other factors and seepage could be expected at the soil bedrock interface.

NOTE: TEST PIT TERMINATED AT 1.7m DUE TO CONCRETE SLAB ENCOUNTERED AT THE BASE

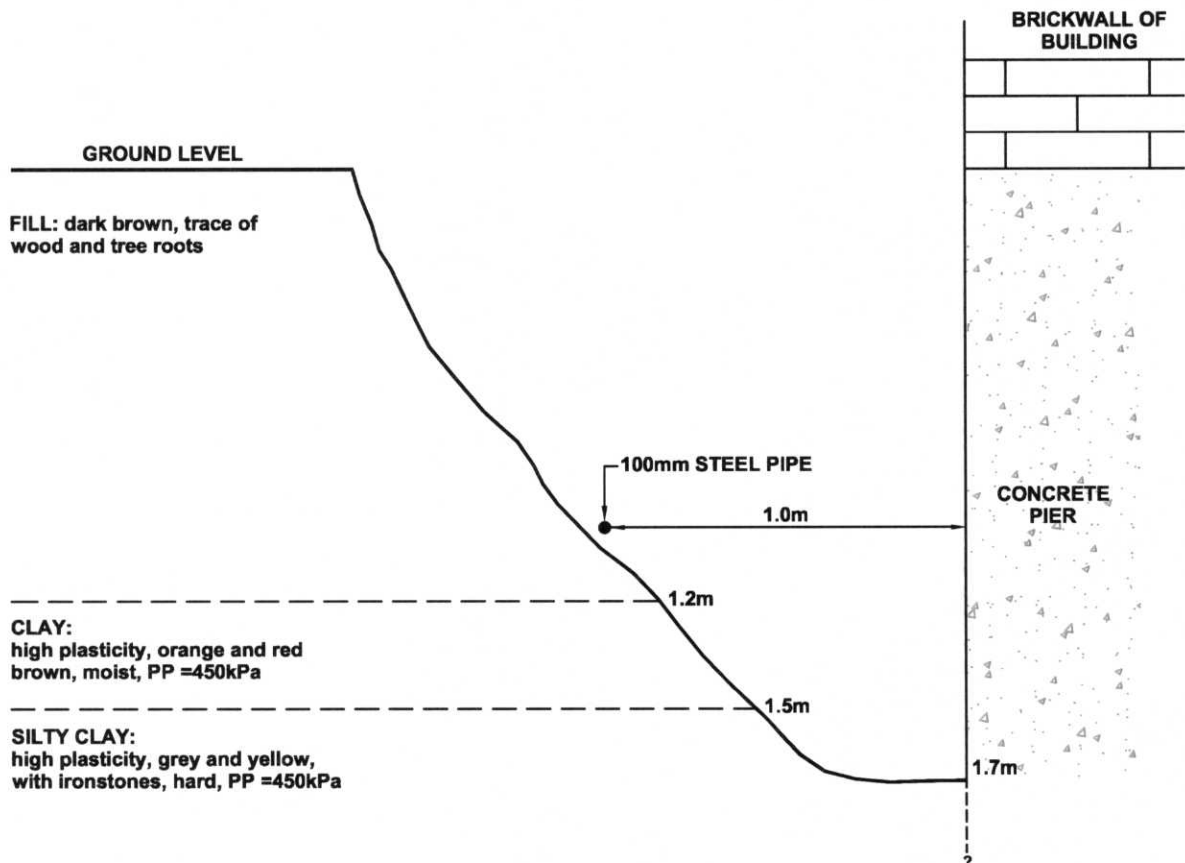
TP3

NOTE: BASE OF PIER NOT OBSERVED, TEST PIT TERMINATED AT 1.7m DUE TO STEEL PILE ENCOUNTERED IN THE PIT

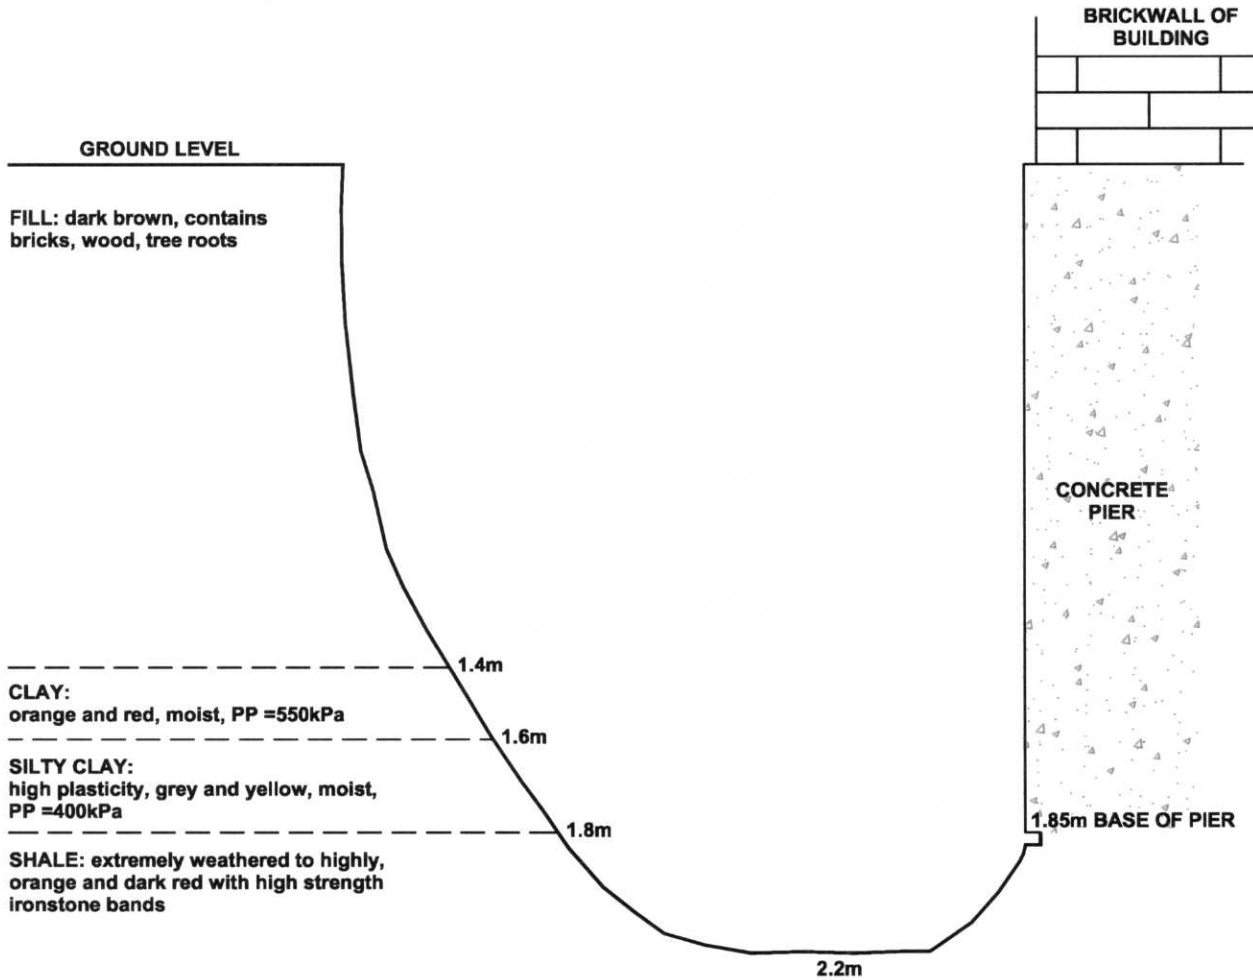
TP4

The existing building footings were observed as consisting of a concrete footing. In TP4, the base of footing was observed to be at 1.85m below the existing ground level. Due to the plan size limitations of the test pits it is unknown whether the footings exposed are individual mass concrete piers or strip footings. However, the client's supplied drawings indicated that the footings are bored piers.
