Hazardous Building Materials Survey

HAZARDOUS BUILDING MATERIALS SURVEY CARDINAL FREEMAN RETIREMENT VILLAGE, VICTORIA STREET, ASHFIELD, NSW 2131

REFERENCE NO. S5738A FINAL REV 1

JUNE 2009

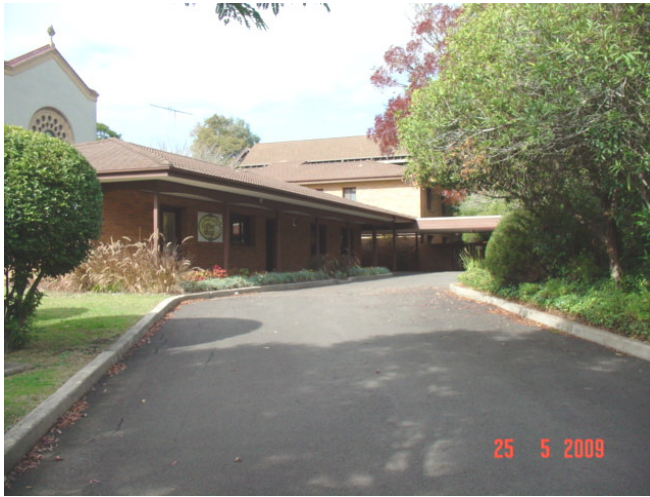
Photograph 1

Convent and Village Café (western side) – View of single storey Café in foreground and two-storey Convent in background. Note the carport in the right hand side of the photograph. The awning ceiling of the carport and the eaves of both the buildings are made of fibre cement sheeting that did not contain asbestos.

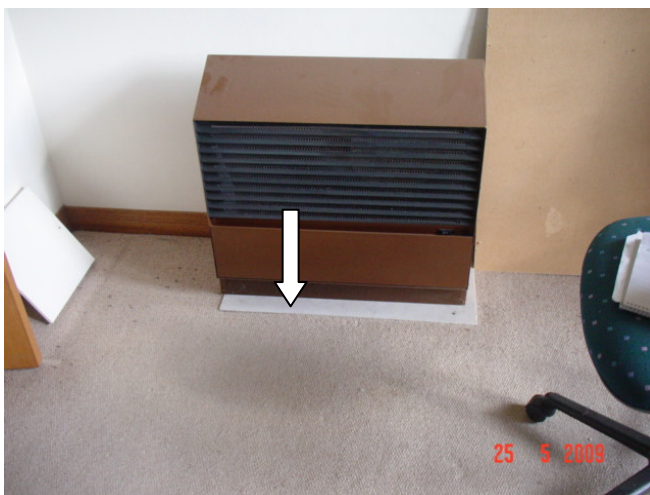
Photograph 3

Convent, Ground floor – The fibre cement sheeting underneath the heater unit does not contain asbestos.

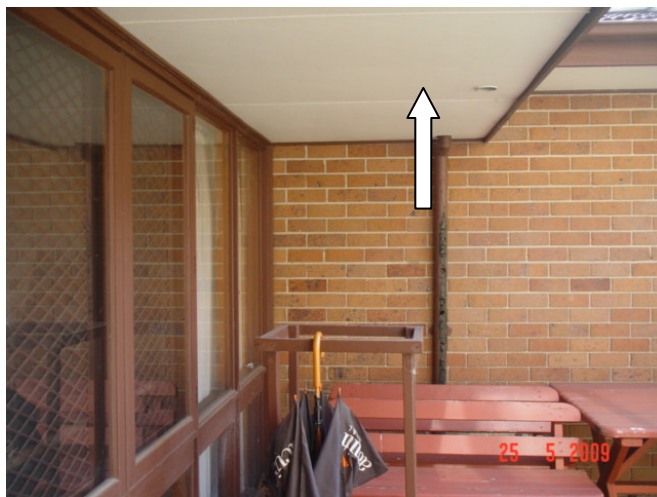
Photograph 5

Convent, External - View of the eastern entry and fibre cement sheet awning that did not contain asbestos.

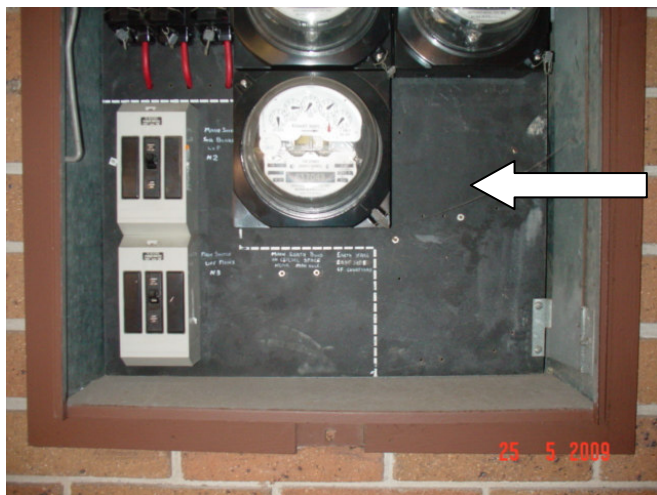
Photograph 6

Convent, External – Arrow points to the black backing board that may contain asbestos. The metal cabinet that house the electrical backing board is located on the wall adjacent to the west or main entry to the Convent.

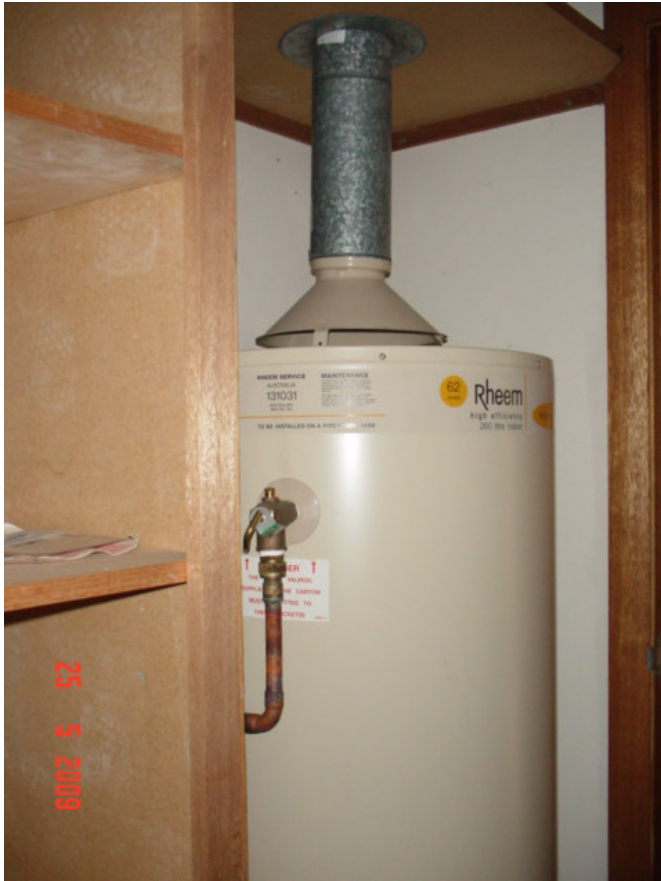
- (i) Convent, Ground floor – The 'Rheem' hot water boiler unit located in the store room is insulated with SMF underneath the metal sheathing. Refer to Photograph 7 in Appendix 3. The flue of the boiler is metal.
- (ii) Convent - The ceiling / roof cavity of the building is insulated with SMF (synthetic mineral fibre) insulation batts which are located on the set plasterboard ceiling. The insulation batts are generally in good condition. Access was via manhole in passage of the upper floor at the western end. Refer to Photograph 8 in Appendix 3.
- (iii) Village Café - The ceiling / roof cavity is insulated with SMF (synthetic mineral fibre) insulation batts which are located on the set plasterboard ceiling. The insulation batts are generally in good condition. Access to the roof cavity was via manhole in store room.

Convent, Ground floor – View of 'Rheem' hot water unit which is insulated with SMF.

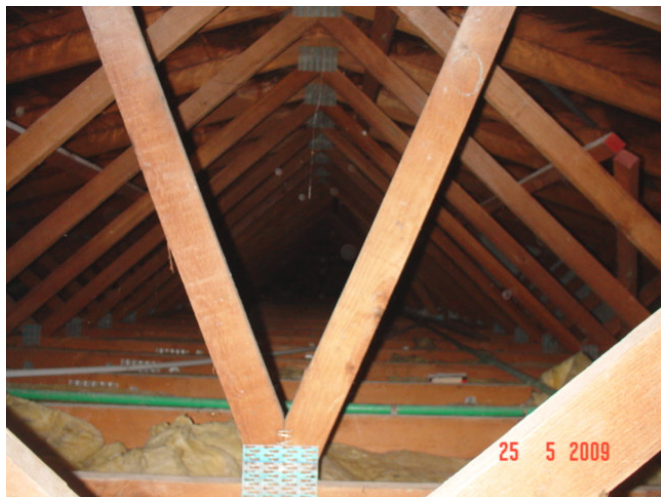
Photograph 8

Convent, Upper floor - View of roof / ceiling cavity and SMF insulation batts on set plasterboard ceiling.

The tiled roof is lined with sarking underneath.

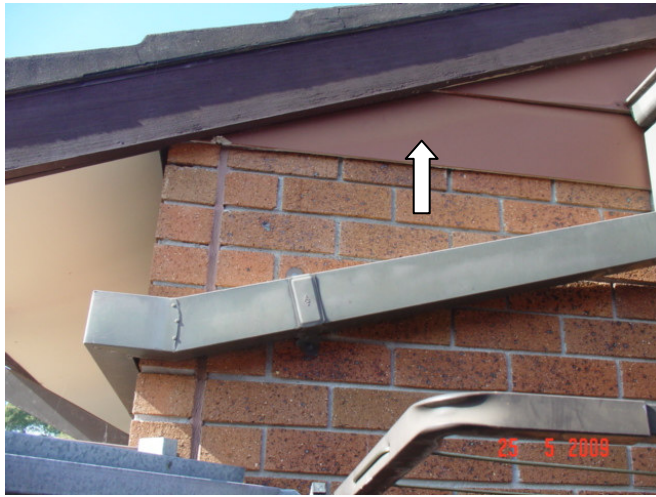
Photograph 11

Serviced Apartments, eastern side of first floor Laundry balcony – arrow points to fibre cement cladding on eastern side that did not contain asbestos.

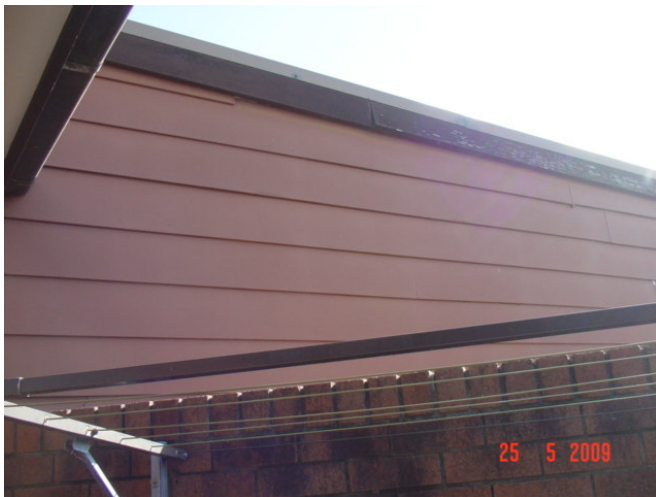
Photograph 12

Serviced Apartments, western side of first floor Laundry balcony – the cladding here is similar to the eastern side of balcony as shown in above Photograph 11.

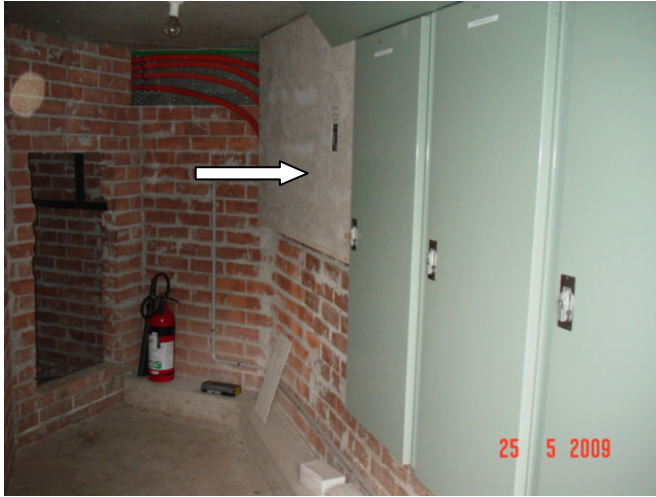
Photograph 14

Switch room – arrow points to fibre cement sheeting that did not contain asbestos.

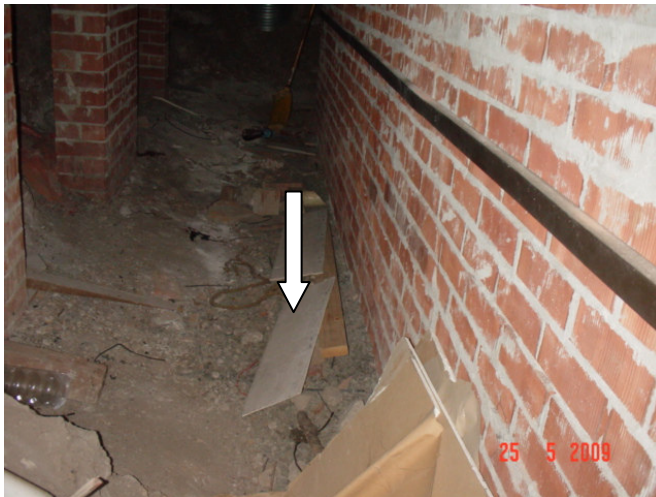
Photograph 15

Sub-floor adjacent Switch Room – arrow points to fibre cement sheeting which is stencilled 'Hardies Villaboard' and 'manufactured without asbestos'.

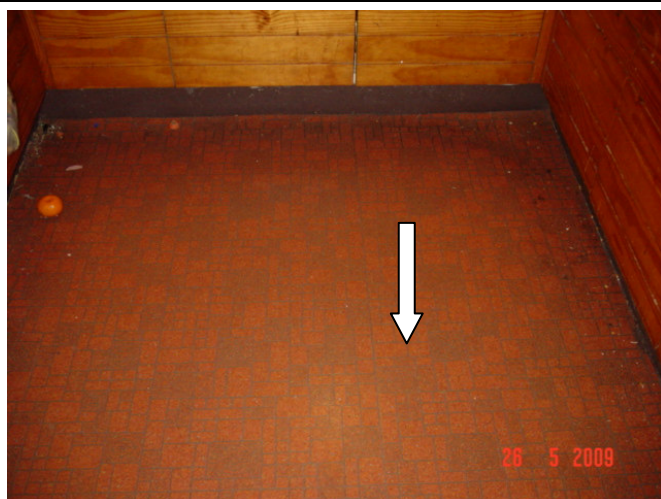
Photograph 18

102 Queen Street, Kitchen – The vinyl floor sheeting did not contain asbestos, however, the backing underneath contains asbestos.

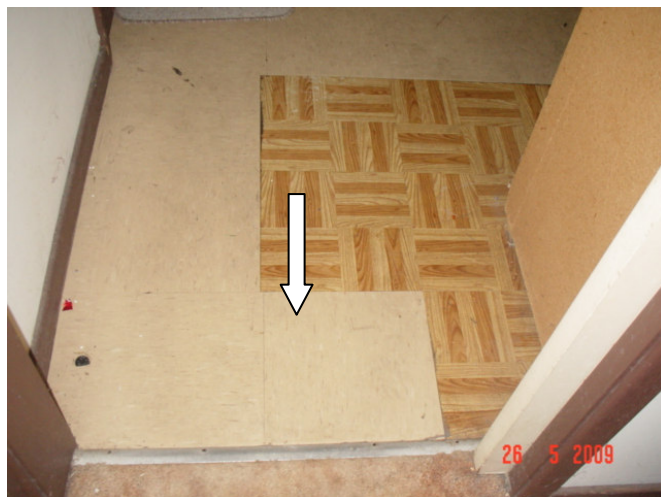
Photograph 19

102 Queen Street, Laundry – The vinyl floor tiles did not contain asbestos.

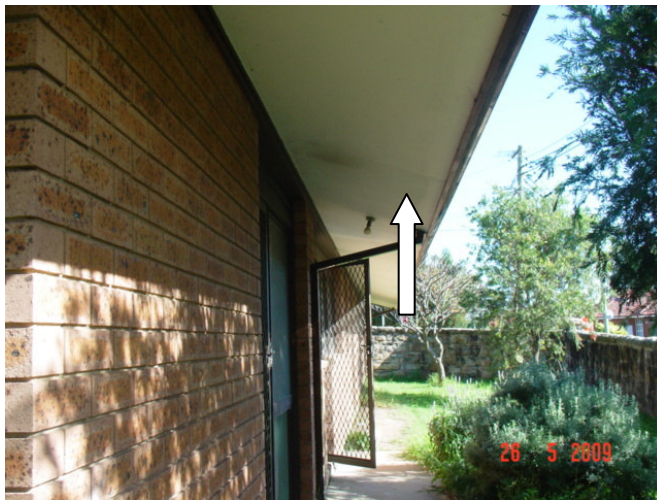
Photograph 20

100 Queen Street – Arrow points to building eaves that contain asbestos.

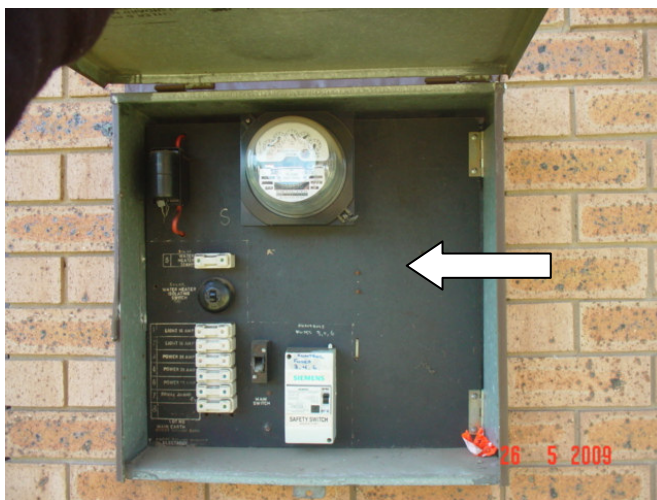
- (viii) 100 Queen Street, External – The black backing board in the electrical cabinet is assumed to contain asbestos. No sample was collected because of the inherent electrical hazard. Refer to Photograph 21 in Appendix 3.

100 Queen Street – The black electrical backing board inside cabinet is assumed to contain asbestos.

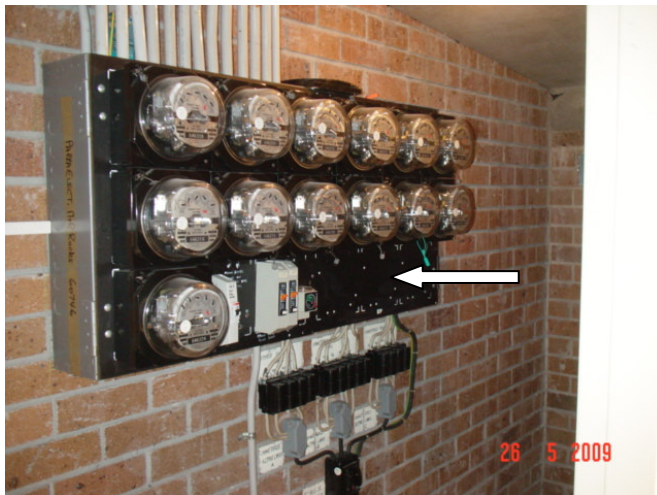
- (i) Switch room - The electrical backing board may contain asbestos. Refer to Photograph 22 in Appendix 3. It was not possible to examine or sample this material due to the inherent electrical hazard. No remedial action is required at this stage.
- (ii) Common area - The underside of the rear stairs landing is insulated with vermiculite insulation material that did not contain asbestos. Refer to Sample S5738A/16 in Appendix 1 and Photograph 23 in Appendix 3.
- (iii) Common area - The fibre cement ceiling above the stairs on the first floor did not contain asbestos. Refer to Sample S5738A/18 and Photograph 24 in Appendix 3.
- (iv) External (Unit 96) – The eaves of the building did not contain asbestos. Refer to Sample S5738A/17 in Appendix 1 and Photograph 25 in Appendix 3.
- (v) Unit 96, First floor – No asbestos materials were identified.

Building E, Switch room – Electrical backing board may contain asbestos.

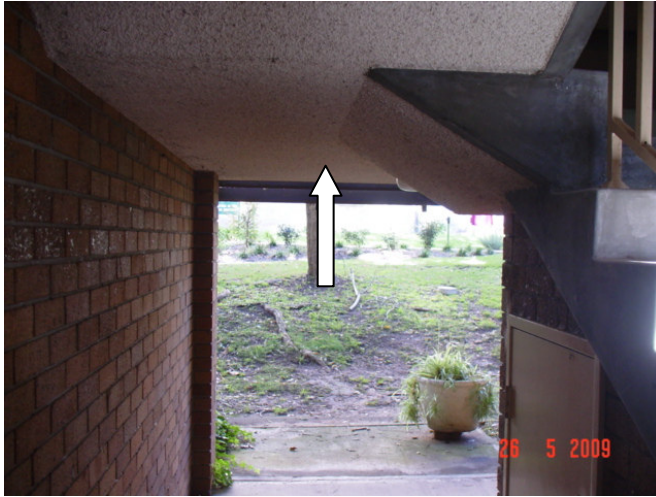
Photograph 23

Building E – Arrow points to vermiculite insulation material that did not contain asbestos.

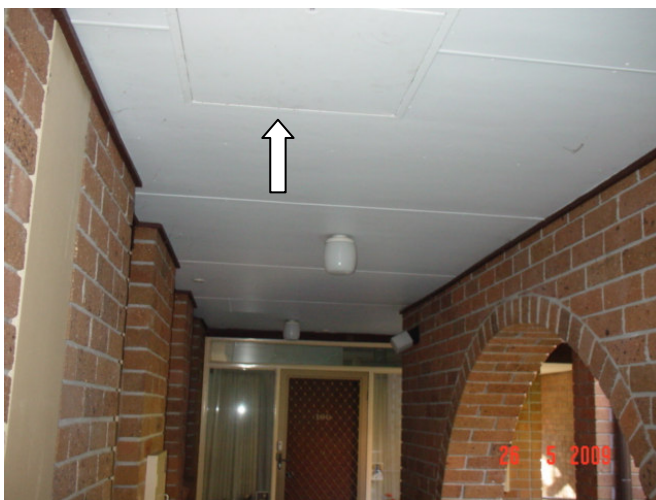
Photograph 24

Building E – arrow points to fibre cement ceiling that did not contain asbestos.

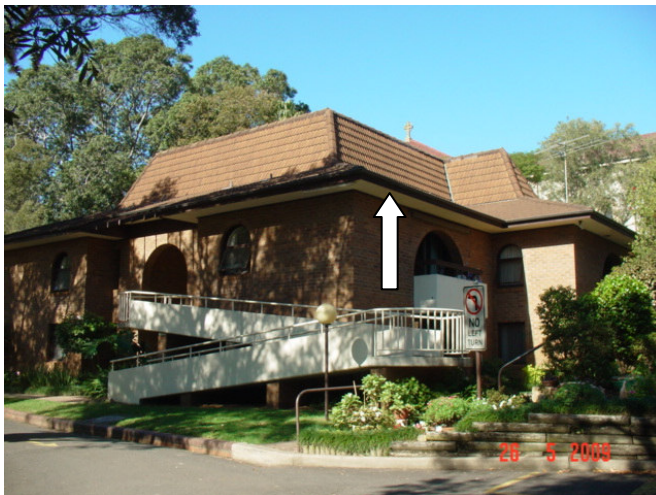
Photograph 25

Building E – Arrow points to eaves that did not contain asbestos.
