2.6.5 The 1937 Infirmary and Sewing Wing

2.6.6 The 1935 Reception Parlours Annex

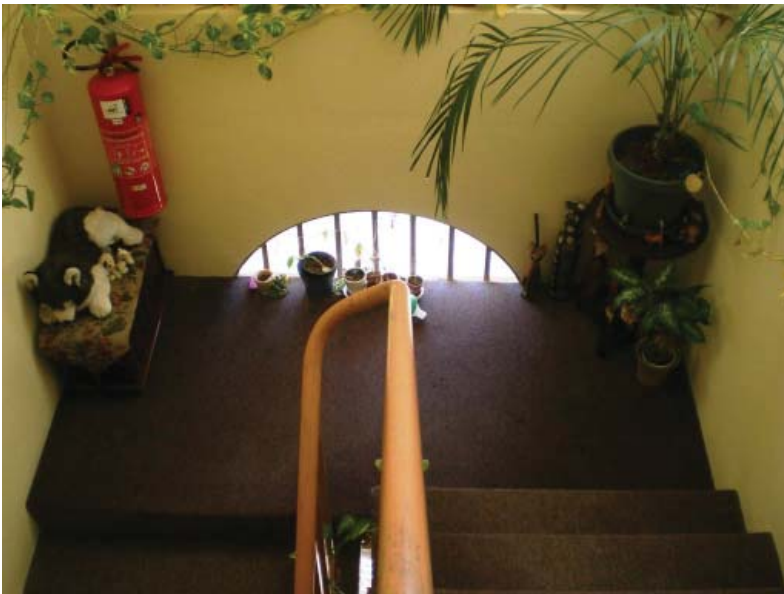
Figure 2.6.34
The current entry foyer was in its original presentation only a ground floor room. The original ceiling has been removed and this flight of stairs added later, disrupting original integrity

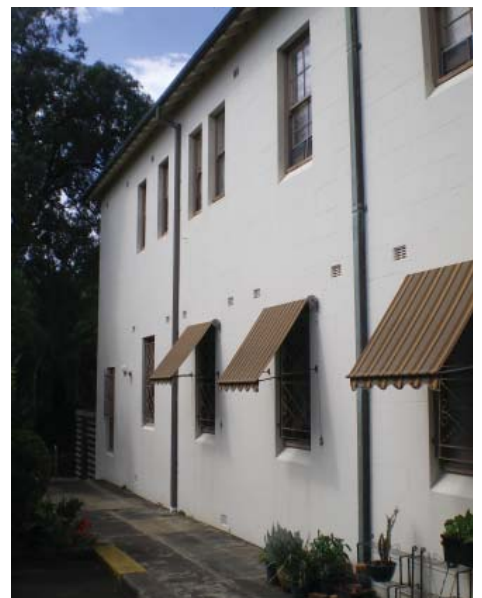
Figure 2.6.35
The west wall of the 1935 wing, which is situated north-south. The far window at the ground floor level, appears to have been a doorway. There are various other changes

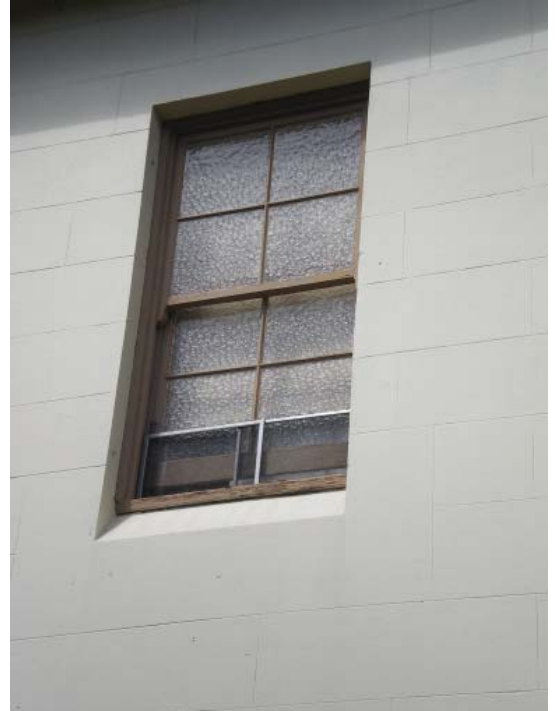
Figure 2.6.40
Typical fenestration in the 1935 wing, shows some original but various glazing and joinery features, much of which is in poor condition under detailed examination.

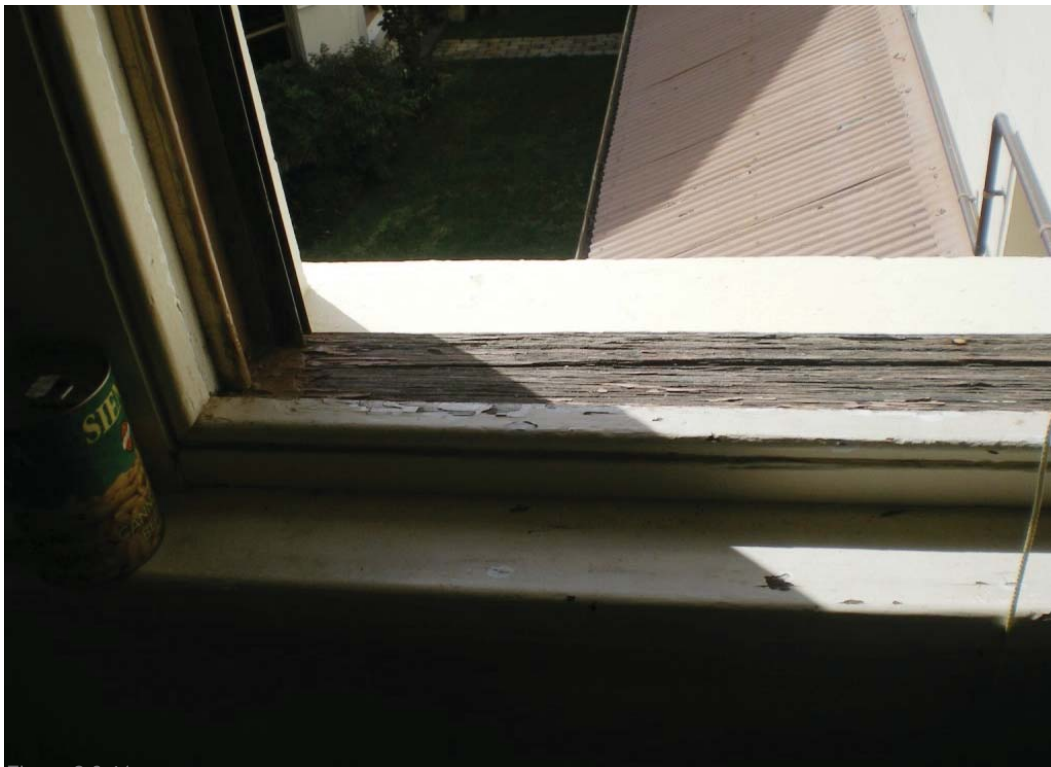
Figure 2.6.41
The windows in the 1935 reception parlours buildings are generally in a poor state of repair under close examination and in some cases have been replaced unsympathetically with fixed glazing arrangements

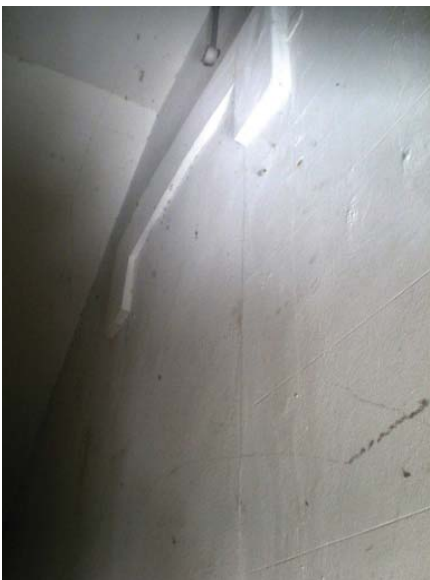
Figure 2.6.45
The storage area under the stairway between the two buildings indicates window infill - 1935 reception parlours building.

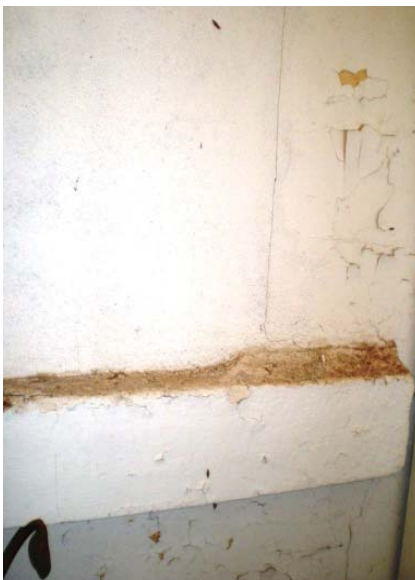
Figure 2.6.46
The storage area under the stairway between the two buildings indicates window infill - *Glentworth House*, probably the original laundry

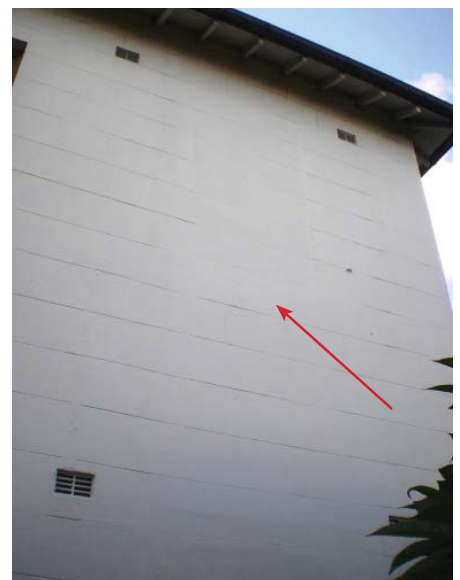
Figure 2.6.47
The south west corner of the reception parlours building indicates window infill. Much of the fenestration has been disrupted and evidences maintenance problems

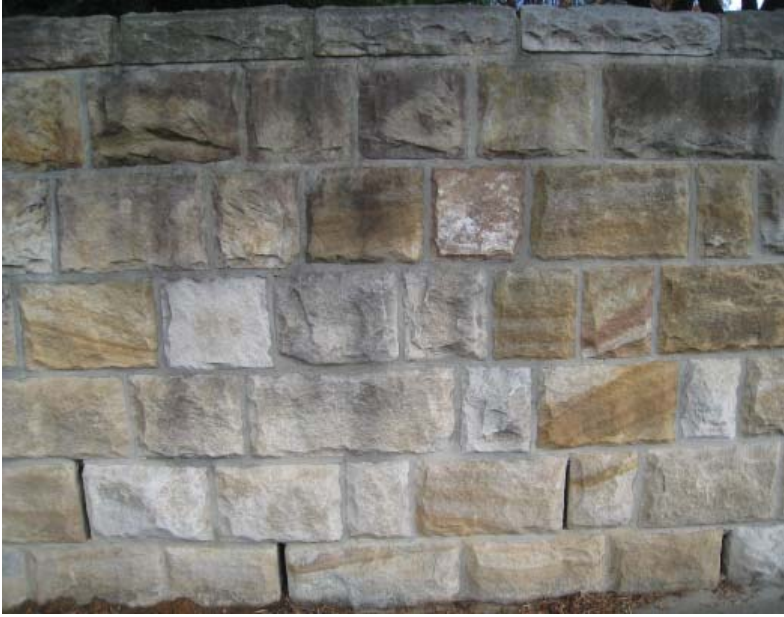
Figure 2.7.17
The stones around the entire perimeter of the complex evidence a single source in their general qualities of colouration etc. Various areas have been re-pointed at different times and with different mortar types

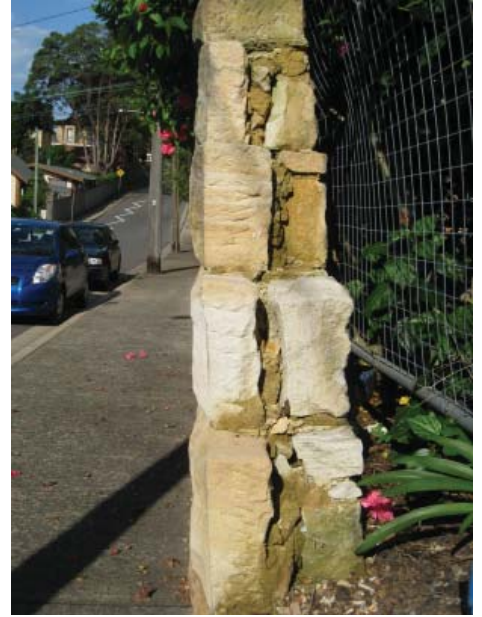
Figure 2.7.18
The general mode of construction consists of double skin with capping stones. If the wall were purpose sourced, the stones would be of single width. The manner of construction typically indicates the stones have been sourced from a previous structure which likely had a similar double skin construction

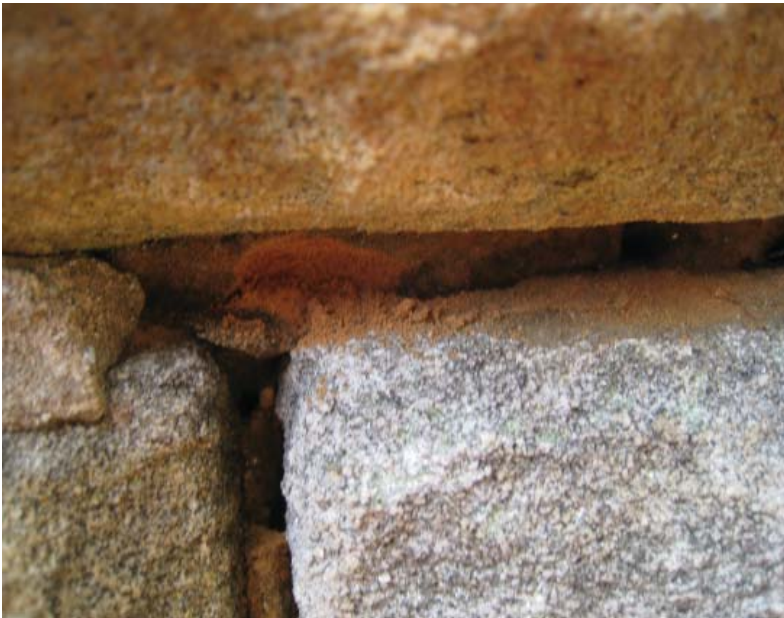
Figure 2.7.19
The re-pointing is variable in mortar type and the areas undertaken. The original mortar is very soft.

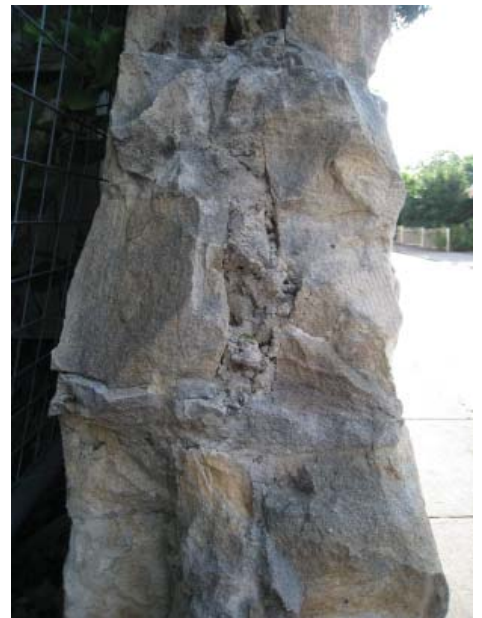
Figure 2.7.20
The stones are quite irregular at various places and constructed with some unusual variation of horizontal and vertical positioning. The original mortar is very soft.
