Report No: MA/ME/AARTPS/C

ARBORICULTURAL ASSESSMENT REPORT & TREE PROTECTION SPECIFICATION

Marrickville Metro

23rd May 2010

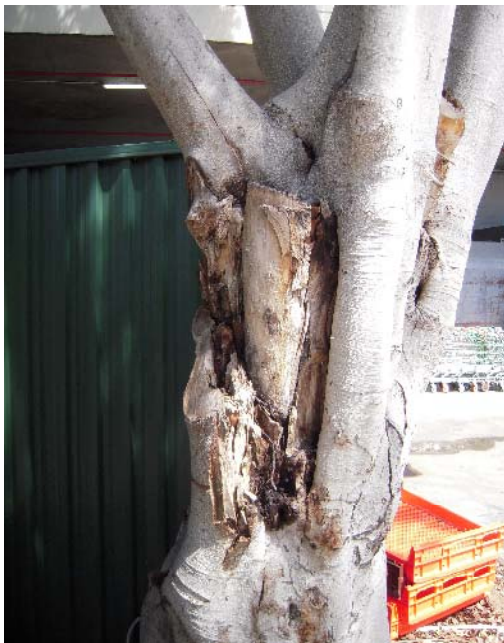
The structure of these trees has been assessed as being fair to poor due to the majority of first order branches being mature epicormic growth resultant from lopping. Wounds with possible decay were also noted at branch attachments on the main stem of several of these trees.

Figure 3: Showing mature epicormic growth, a split branch and wounds with decay on Tree 48

The supplied plans indicate these trees will need to be removed to accommodate the proposed landscape treatment. These works include the installation of rain gardens along the road reserve which capture stormwater from the street. Replacement tree planting (*Syncarpia glomulifera*) is also proposed as part of these works.

4.8 Trees 48 and 57 have structural defects which require their immediate removal.

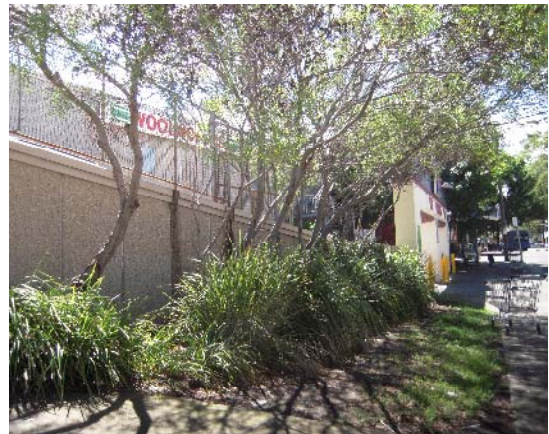
Figure 4: Showing Trees 68

These trees have low Landscape Significance, a Remaining Life Expectance Range of less than 5 years and have been allocated a Retention Value of *Priority for Removal*.

The supplied plans indicate these trees will need to be removed to accommodate the proposed building extension.

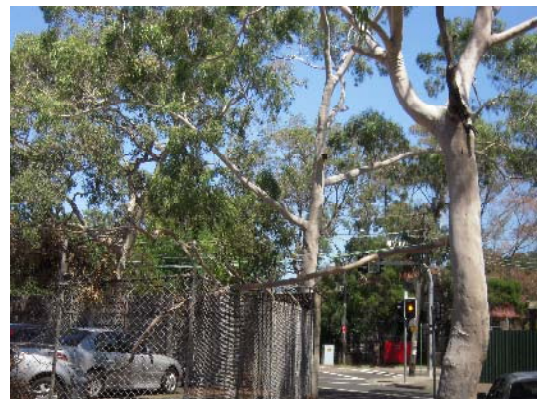
These trees have been assessed as being in good to fair health and good structure. However, recent storm damage was also noted in Tree 77.

Figure 5: Showing *Corymbia citriodora*

The supplied plans indicate that a retail shopping building is to be positioned in the land at 13-55 Edinburgh Road which is located to the south of Smidmore Street. Vehicular access from Smidmore Street is to be constructed in the southern and northern parts of the development. Trees 77-81 will need to be removed to accommodate the proposed vehicular access.

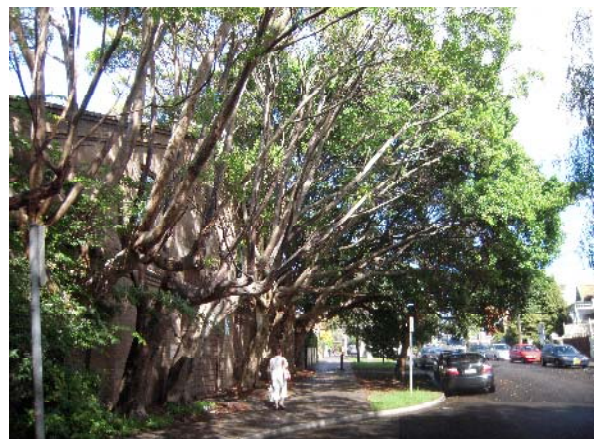
Figure 6: Showing Hills Weeping Figs along Victoria Road

These trees have been planted within close proximity to the masonry walls surrounding the site. The root spread of these trees is likely to be limited due to the adjacent walls, concrete kerbing and planter boxes. The majority of the canopies of these trees extend over pedestrian paths and the adjacent road.

These trees have been assessed as being in fair health due to the small diameter deadwood throughout the canopies and a reduced canopy cover of approximately 60-70% (comparative to the same species growing in ideal site and environmental conditions).

The structure of these trees has been assessed as fair to poor due to the majority of first order branches being mature epicormic growth resultant from lopping. Wounds with possible decay were also noted at branch attachments on the main stem of several of these trees.

Some branches from these trees are in contact with or are in close proximity to the adjacent wall and roof. These branches should be removed by Selective Pruning. Canopy pruning may also be required to provide building clearance and for access during construction. All pruning work should be undertaken in accordance with AS4373: *Pruning of Amenity Trees* (2007) and the *Workcover Code of Practice for the Amenity Tree Industry* (1998).

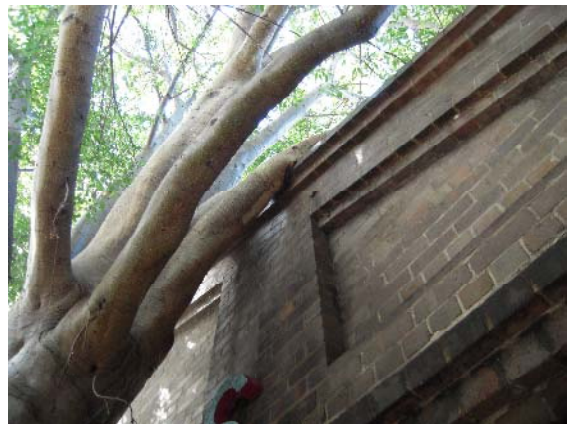
Figure 7: Showing contact of branch on wall

All pruning should be carried out by an experienced and qualified Arborist. The Arborist should hold a minimum qualification equivalent (using the Australian Qualifications Framework) of NSW TAFE Certificate Level 3 or above, in Arboriculture and a NSW TAFE Tree Surgery Certificate or its recognised equivalent.

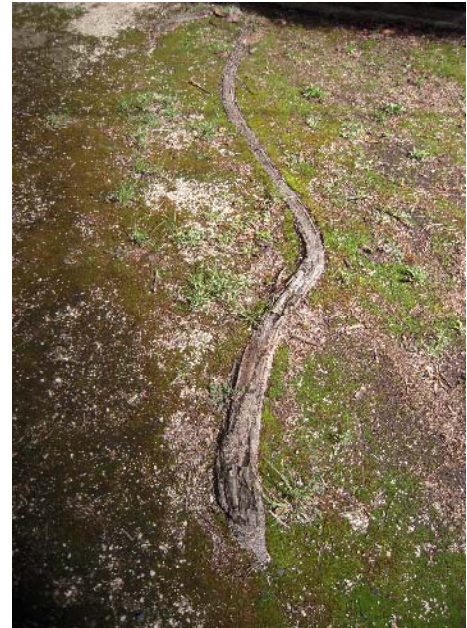
Tree 20 has been identified as *Ficus macrophylla* (Moreton Bay Fig). This tree has been assessed as being in fair health due to the canopy being comprised predominately of epicormic growth and the presence of small and large diameter deadwood throughout its canopy. The structure of this tree has also been assessed as being poor evidenced by the wounds with possible decay on the main stem and first order branches. Mechanical damage likely the result of lawn mower equipment was also noted on several surface roots.

Figure 9: Showing damage to exposed roots of Tree 20

This tree has high Landscape Significance, a Remaining Life Expectancy Range of 5-15 years and has been allocated a Retention Value of *Consider for Retention*. It is understood that this is a heritage-listed tree. If this tree is to be retained, internal diagnostic testing should be undertaken to determine the presence and extent of decay (refer to Section 3.3.4).

The supplied plans indicate that the works adjacent to this tree include the re-alignment of the pedestrian path to the east of the tree as soft landscaping works. To minimize the impact on this tree, a semi-permeable pavement should be used within the TPZ of Tree 20. The pavement should also be placed above grade to minimize the need for excavation and the strength of the pavement should be selected to reduce the reliance on sub-base for strength. The sub-base material should be gap-graded and coarser than the existing soil texture. The sub-base material should not contain a high percentage of fines.

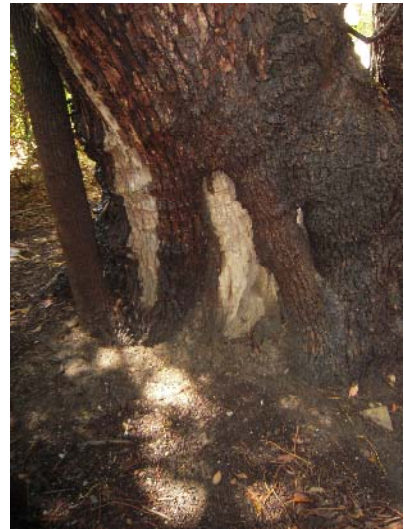
Tree 25: This tree has been identified as *Cinnamomum camphora* (Camphor Laurel). This tree has fair health evidenced by the small and large diameter deadwood throughout its canopy and a reduced canopy cover of approximately 70% (comparative to the same species growing in ideal site and environmental conditions). The structure of this tree has been assessed as poor due to wounds with decay at the base of the stem and throughout the tree.

This tree has high Landscape Significance, a Remaining Life Expectancy Range of less than 5 years and has been allocated a Retention Value of *Consider for Removal*. If this tree is to be retained, internal diagnostic testing should be undertaken to determine the presence and extent of decay (refer to Section 3.3.4).

Figure 10: Showing Tree 25

4.7 Wounds with possible decay were noted on Trees 20, 25, 29. If these trees are to be retained, internal diagnostic testing should be undertaken to determine the presence and extent of decay.

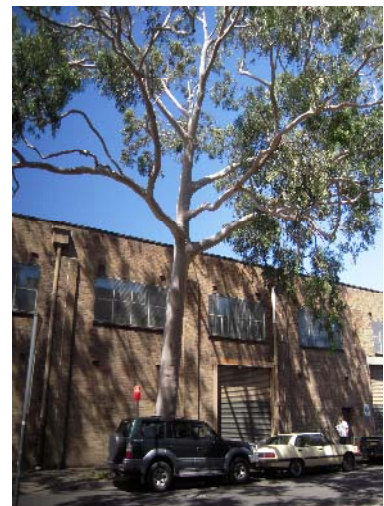
Trees 75-76 and 82-84 have been identified as *Corymbia citriodora* (Lemon-scented Gum) and *Eucalyptus* spp. (Gum Tree) which are Council-managed trees positioned on the road reserve on the southern side of Smidmore Street. These trees have been assessed as being in good to fair health and good structure. The extent of root spread of these trees is difficult to predict due to the existing structures such as kerbing, paths and buildings.

Figure 11: Showing *Corymbia citriodora*

Trees 75 and 76: The supplied plans indicate that vehicular access is proposed within the TPZ of these trees.
