**GEOTECHNICAL INVESTIGATION
AND REPORT FOR SAN HOSPITAL,
WAHROONGA**

GEOTLCOV23462AA-AD
29 April 2008

RE: Geotechnical Investigation and Report for SAN Hospital, Wahroonga

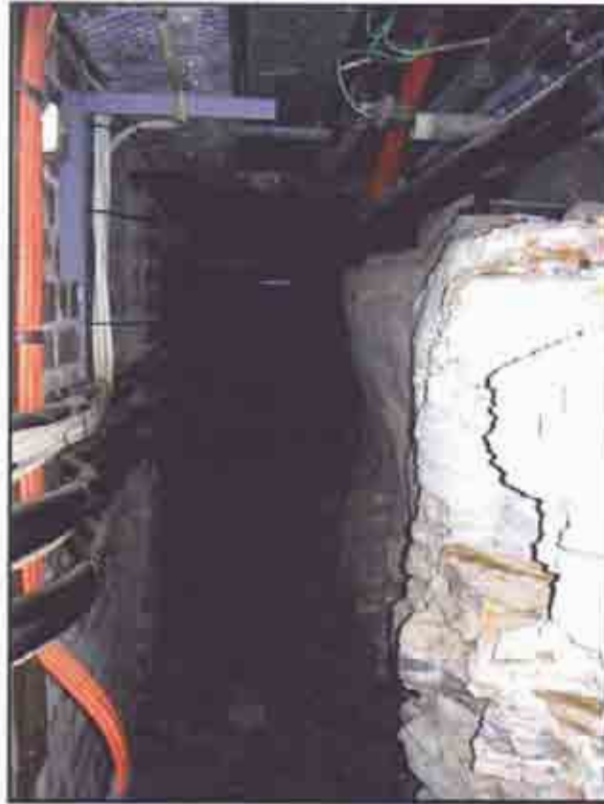
A stairway leads to the basement from within the building. Within the basement in rooms titled "South Wing Switch Room" and the "Electrical Store Room", brick strip footings supporting a concrete slab associated with the ground floor were visible. The footings were bearing on shale which was clearly visible in the cut which forms the basement as shown in photo 1 below.

Photo 1: Basement wall to the left and shale bedrock exposure to the right

The existing basement in the eastern corner of the building was cut into the shale creating a near vertical unsupported rock cutting up to approximately 2m high in places. New footings for load bearing walls will need to be placed a distance of at least 2 footing widths from the edge of any rock cutting. If this is not feasible, our preference would be to excavate the shale to the base of the existing cut and extend the footing. Alternatively, a reduction in the allowable bearing pressure to 600kPa and an inspection by a geotechnical engineer to observe the condition of the near vertical rock face will be

We recommend an allowable bearing pressure for the shale exposed beneath Building 4 of 1000kPa. Footings should be embedded at least 0.3m into the rock and the base cleaned of debris.

required. Following the inspection, further recommendations such as the removal of any loose rock, placement of rock dowels or shotcreting of exposed face may be required.

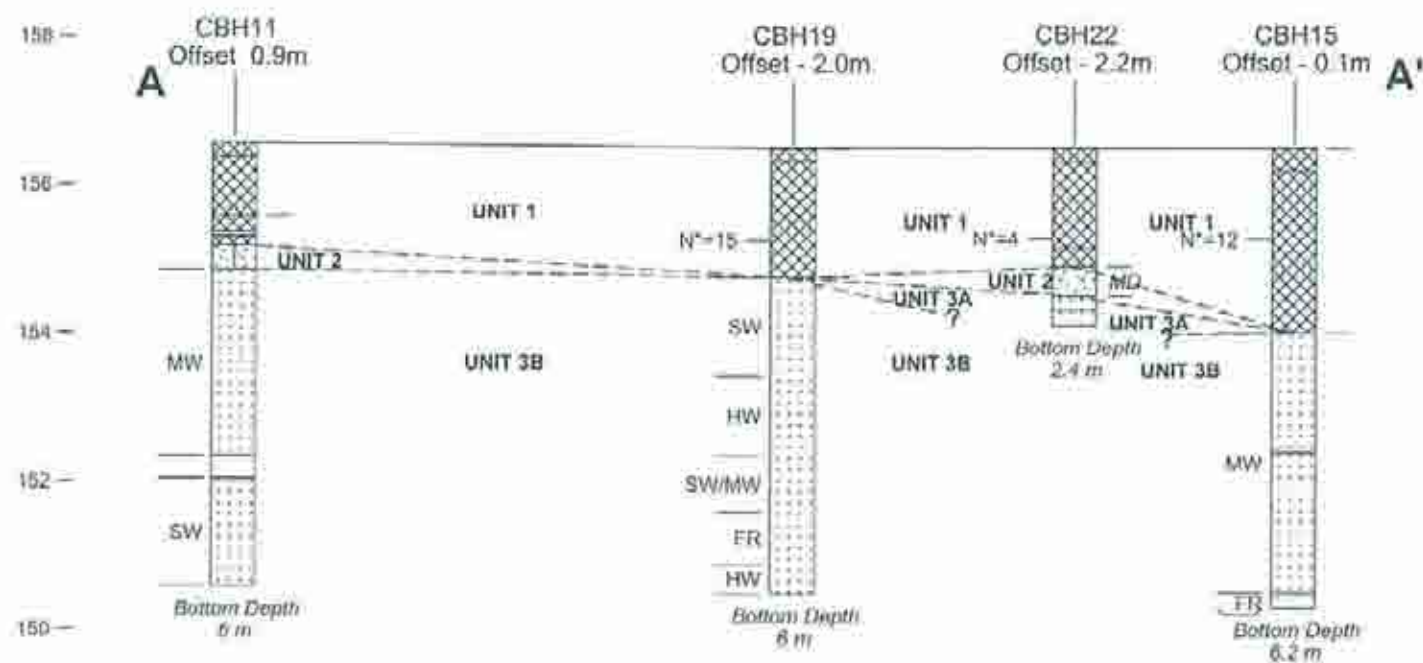
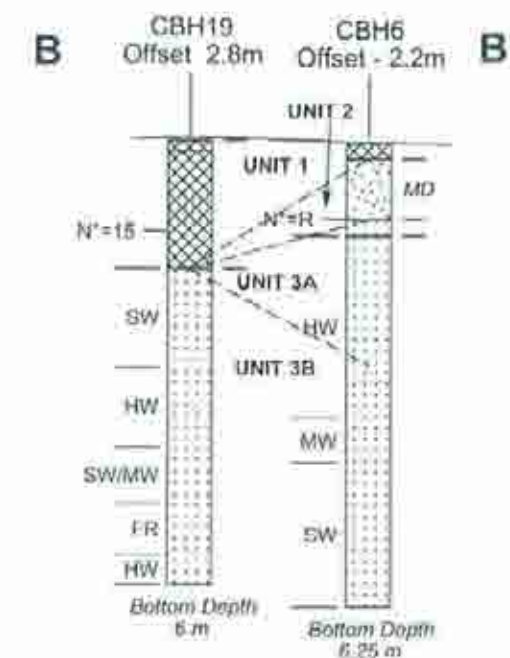
client	TAYLOR THOMSON WHITTING
project	GEOTECHNICAL INVESTIGATION AND REPORT FOR SAN HOSPITAL FOX VALLEY ROAD, WAHROONGA, NSW
title	GEOTECHNICAL LONG SECTIONS A-A' AND B-B'
project no.	GEO1LCOV23462AA
drawing no.	FIGURE 4

Preliminary sketches of the proposed car park show the base level to be at 154.6m AHD. With the depth to sandstone varying from 0.9m to 2.5m below current surface levels, it is likely that rock will be exposed or at relatively shallow depth below the proposed car park structure. With foundations spanning rock and soil there is a greater potential for differential settlements, compared to rock foundations. To avoid possible problems with differential settlement we recommend that building loads such as basement retaining walls and column loads be supported on rock. Strip, pad footings or bored piers could be adopted, depending on the bulk excavation levels and the depth to bedrock. Figure 4 shows cross sections through the site with inferred rock levels.

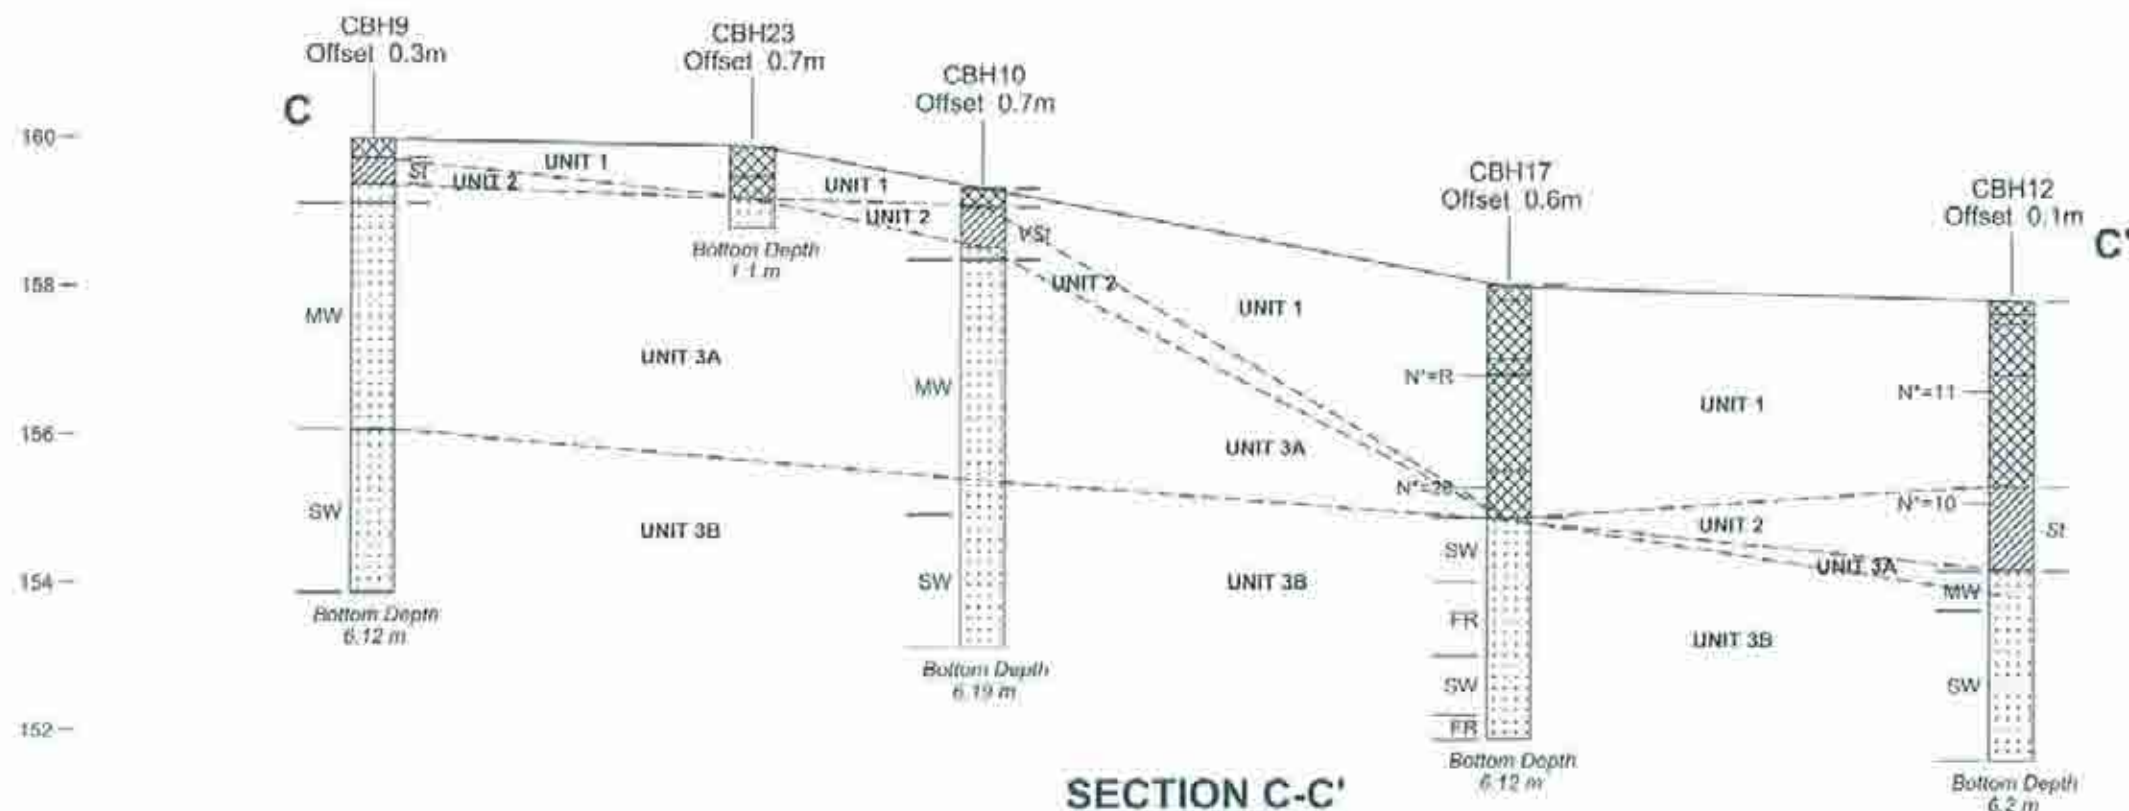
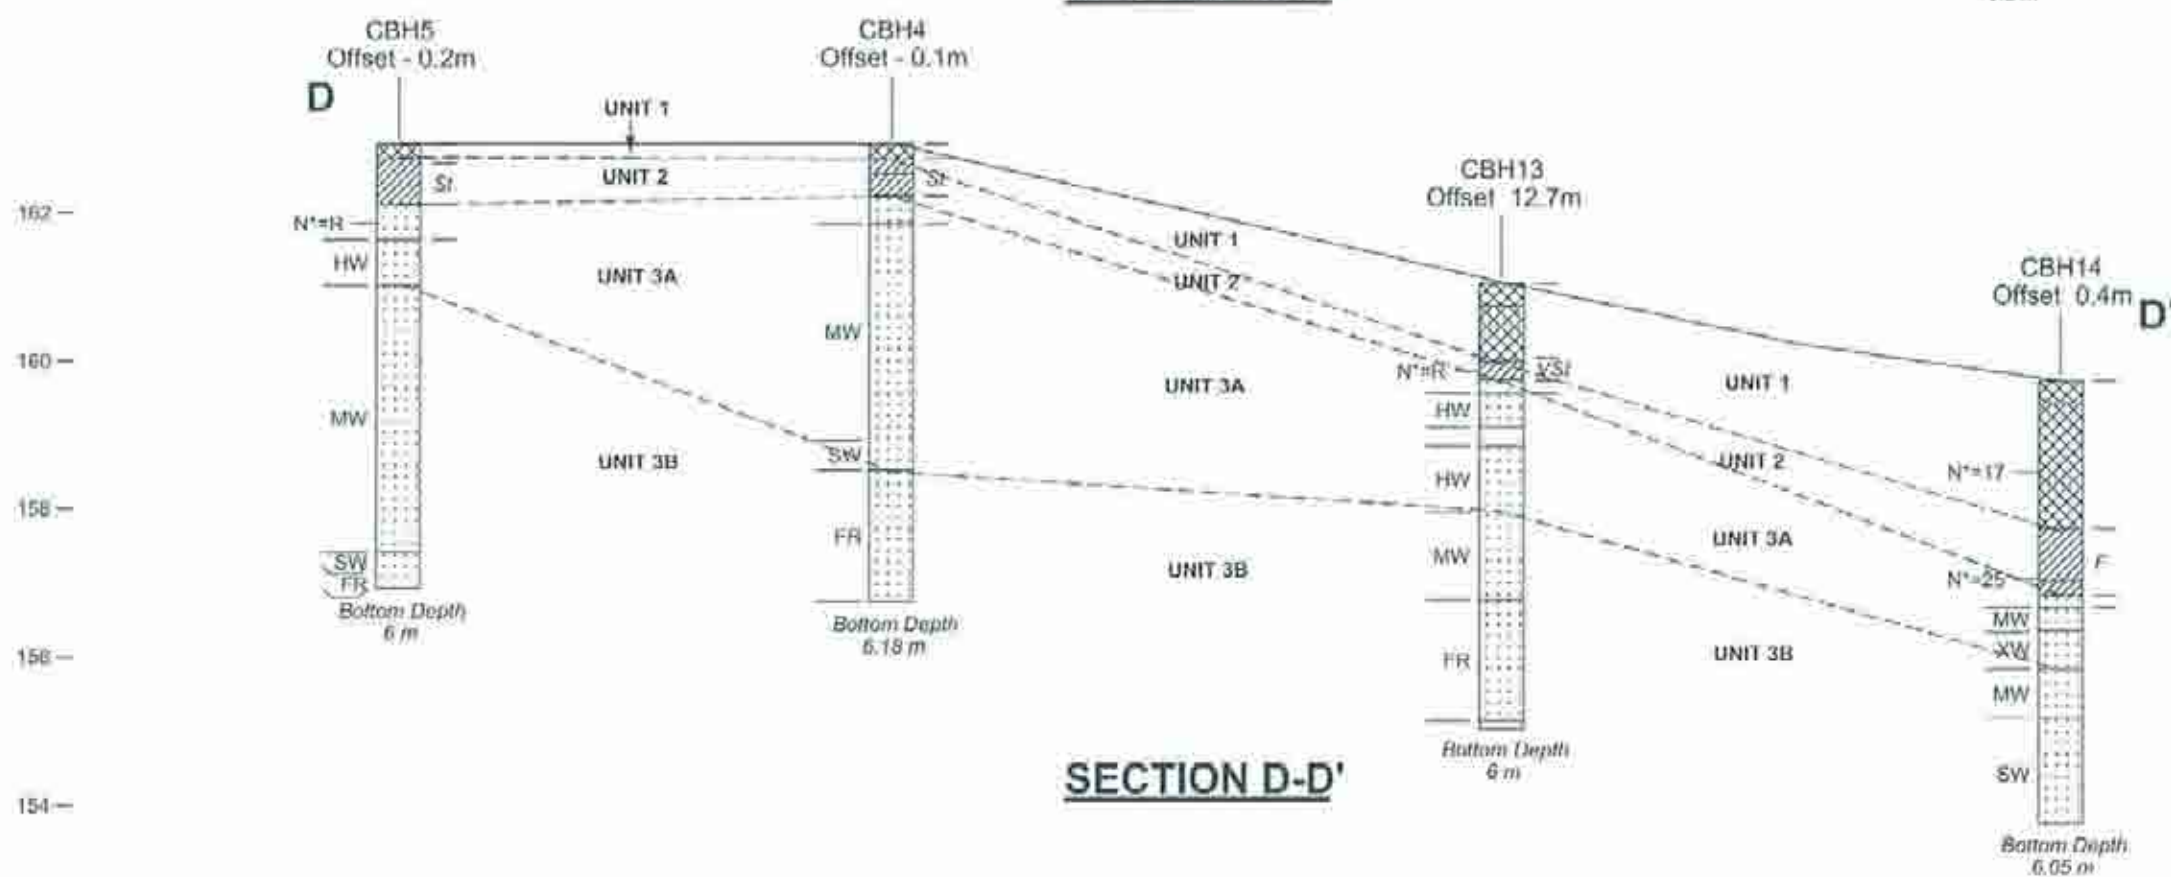
client: TAYLOR THOMSON WHITTING
 project: GEOTECHNICAL INVESTIGATION AND REPORT FOR SAN HOSPITAL
 FOX VALLEY ROAD, WAHROONGA, NSW
 title: GEOTECHNICAL LONG SECTIONS C-C' AND D-D'
 project no: GEOTLCOV23462AA
 drawing no: FIGURE 5

The level of the base of proposed Building 2 was not defined at the time this report was compiled. With the depth to sandstone varying from 0.6m to 3.6m below current surface levels, the base level of the proposed structure may lie within both soil and rock. With foundations spanning rock and soil there is a greater potential for differential settlements, compared to rock foundations. To avoid possible problems with differential settlement we recommend that building loads such as basement retaining walls and column loads be supported on rock. Strip, pad footings or bored piers could be adopted, depending on the bulk excavation levels and the depth to bedrock. Figure 5 shows cross sections through the site with inferred rock levels.

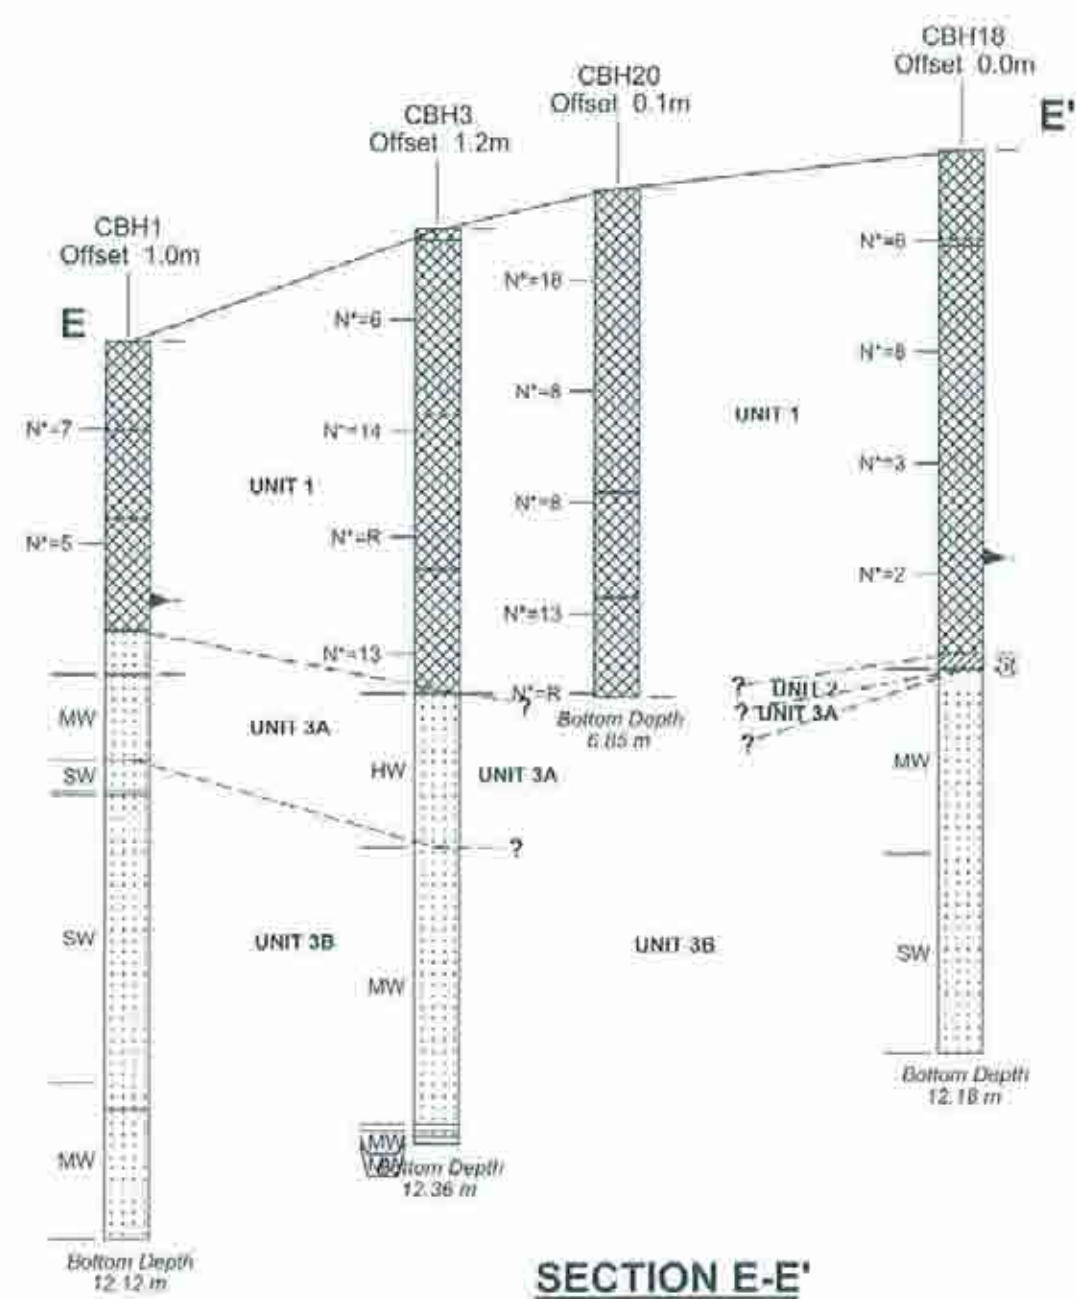
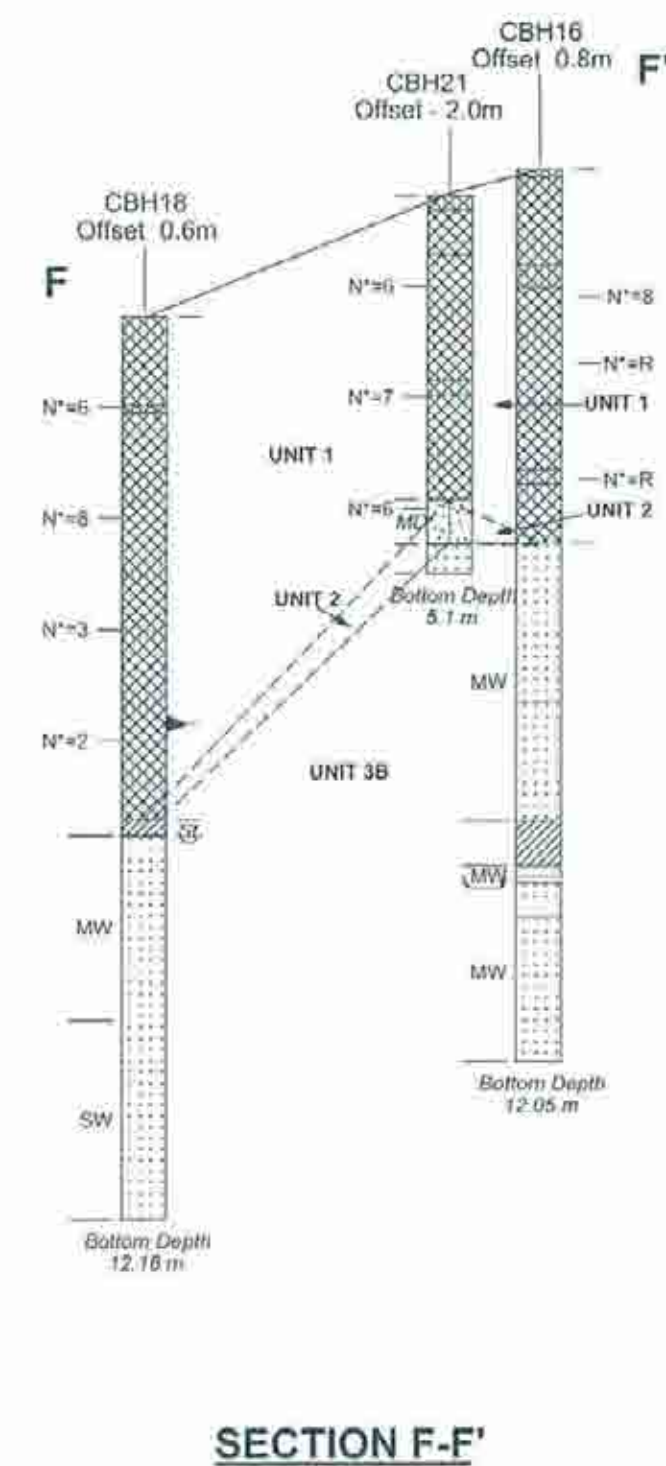
The subsurface conditions across the Building 3 site consist of a relatively thick layer of fill overlying either a thin layer of residual soil or bearing directly on sandstone. Fill thickness varies from 2.7m (within CBH7) at the north eastern area of the proposed structure to 6.8m (within CBH18) at the south western end. The fill consists of Clay, Sandy Clay, Sand, Silty Sand and Clayey Sand. In the absence of fill placement records and compaction control test results, the fill should be considered to be uncontrolled.

Uncontrolled fill is not suitable for supporting building loads and as such, we recommend building loads be supported on rock using either piled footings or a shallow footing system. Strip, pad footings or bored piers could be adopted, depending on the bulk excavation levels and the depth to bedrock. Figure 6 shows cross sections through the site with inferred rock levels.
