SITE CONDITION REPORT
FOR
14-18 BOONDAH ROAD
WARRIEWOOD VALLEY NSW

Prepared for: Tracy Davey, Meriton Apartments
Murray Donaldson, Architectus Sydney

Report No: 110148_Rep_Rev1
August 2010
(Released: 24 August 2010)

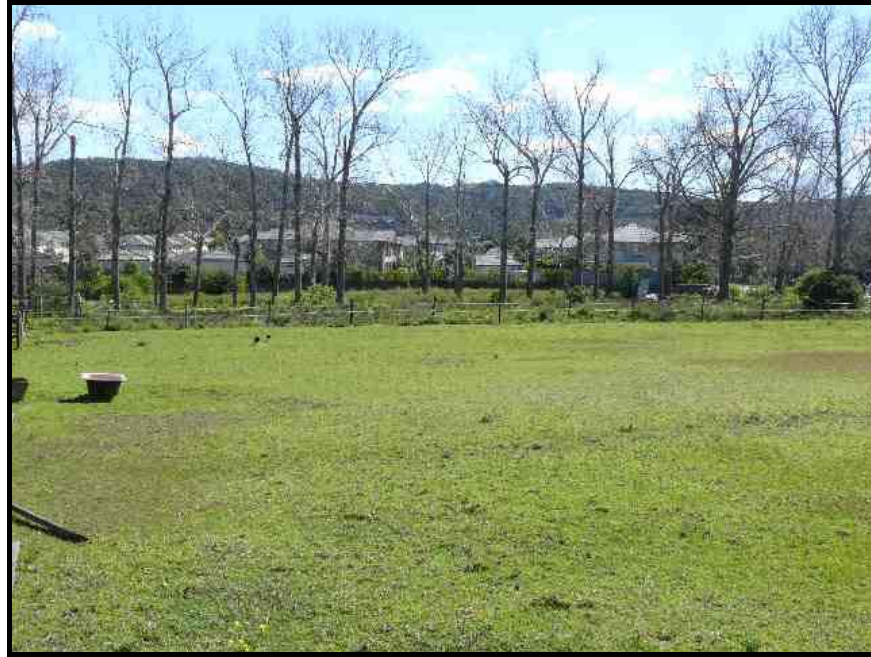
Photograph 1A: Land along MacPherson Street has continued to be used for grazing of livestock.

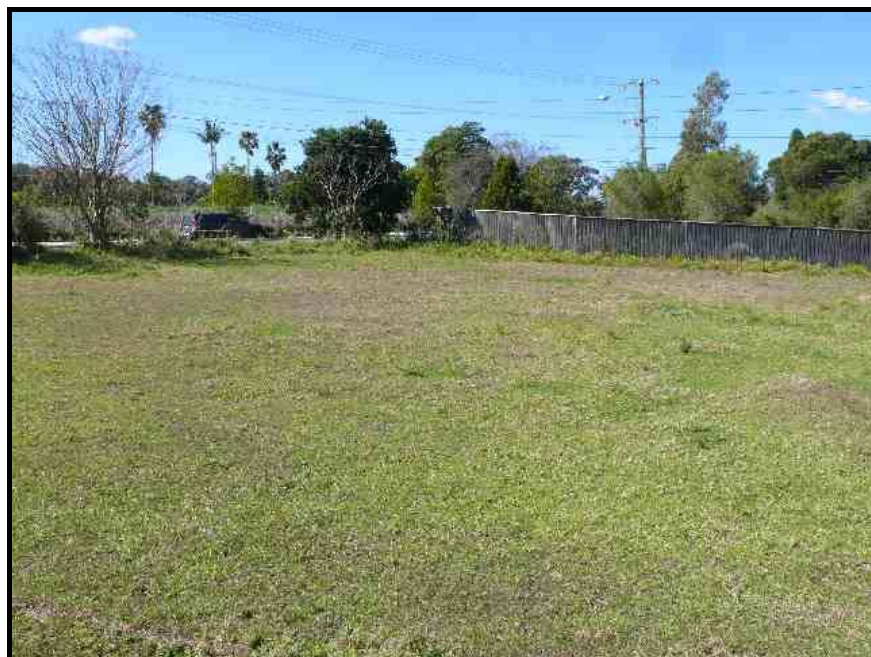
Photograph 1B: There have been no soil disturbing activities.

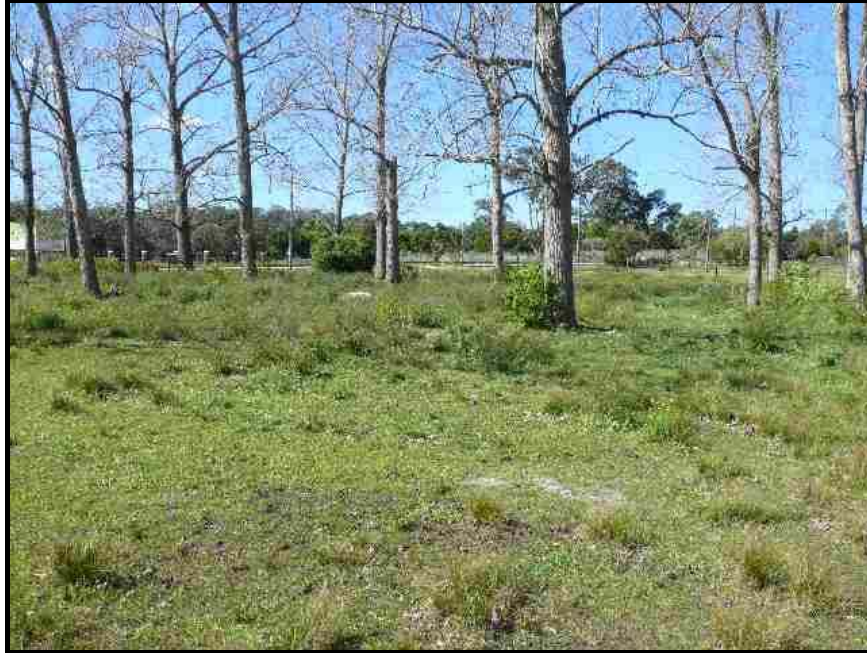
Photograph 1E: Uses remain as were witnessed during 2003.

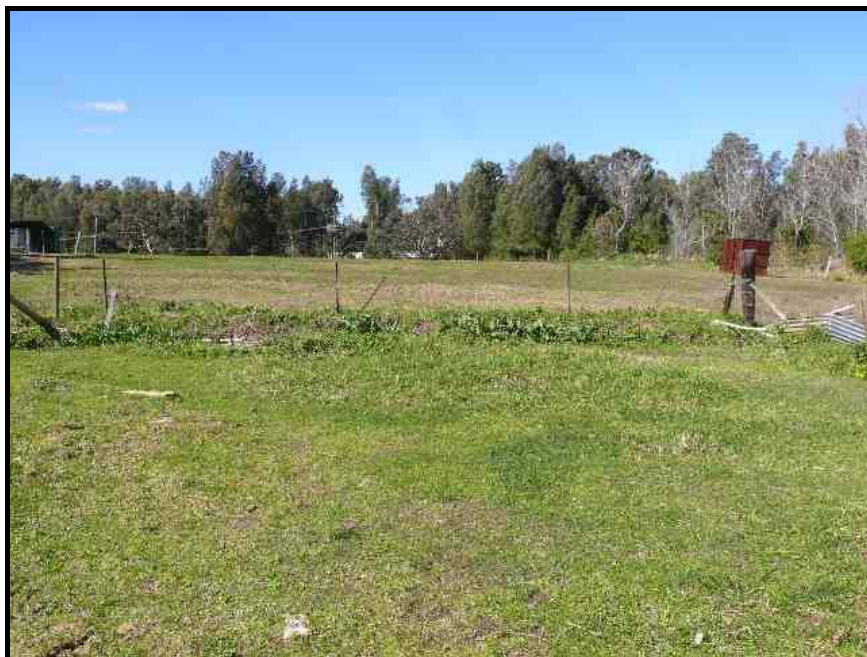
Photograph 1F: There was no visual evidence of soil contaminants (such as oil and fuel) being stored in these areas.

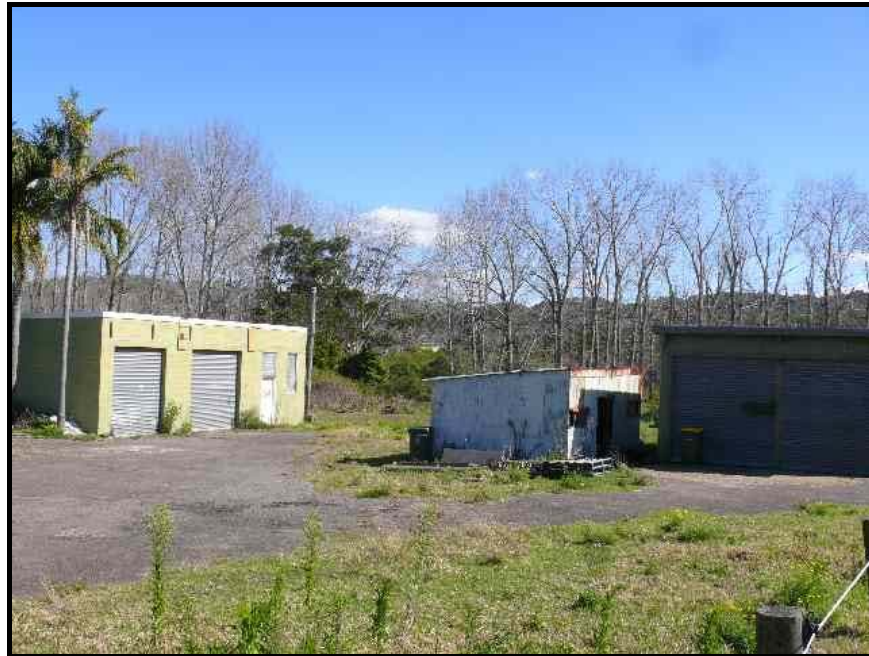
Photograph 2: The sheds on site have not been altered and there was no visual evidence of contamination having occurred from spillages of fuels/oils.

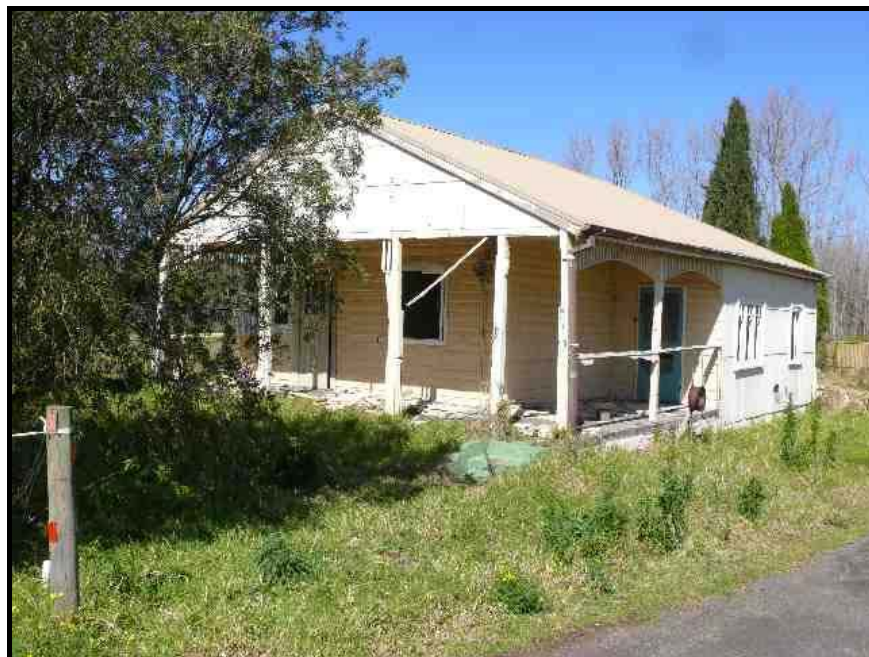
Photograph 3A: The residence is derelict and vandalism of the ceiling cladding of the veranda has occurred.

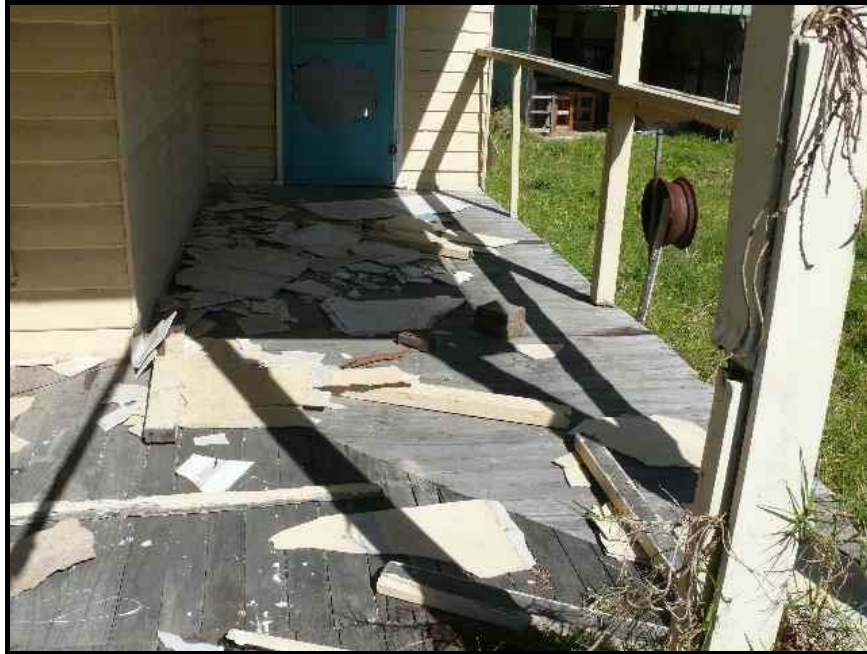
Photograph 3B: Scattered pieces of asbestos cement will need to be removed and the usual work practice required by WorkCover before a building containing bonded asbestos is demolished be implemented. A clearance certificate will be needed from an Occupational Hygienist before any of the sheds, garages or residences are demolished.

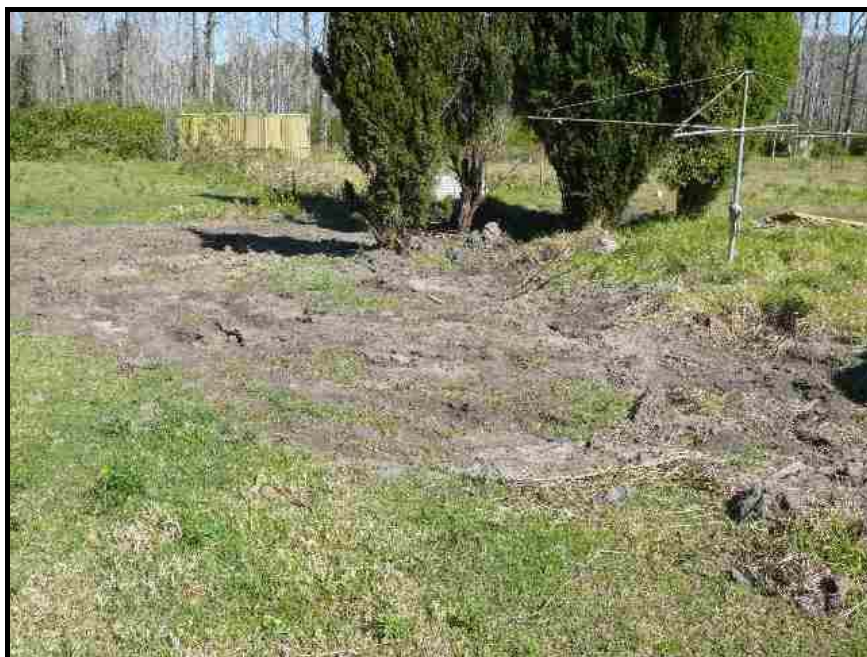
An examination of aerial photographs did not reveal any activity or shed at this location. When construction equipment is on site an inspection of this area is warranted by digging pits to establish if any material has been buried.

Photograph 4A: From the south east corner of this residence and approximately 20m away the soil/grass has recently been disturbed and evidence of the tyre marks of a light truck are present. The reason needs to be known and when construction equipment is on site pits excavated to ensure no waste materials have been buried.

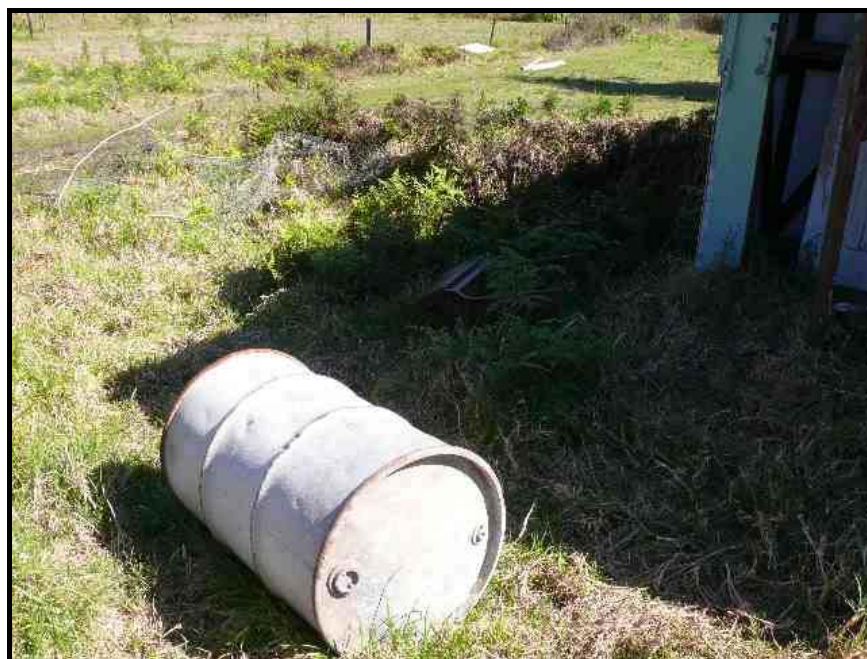
- Drums on site were empty.
- A disused 12V car battery sits near a drum and will need to be removed before construction equipment is on site.
- One of the sheds contains paint containers. There were no spillages at the time of the August 2010 inspection. These will need to be removed before demolition.
- The residence shown in the Photographs (refer to Photograph 3A and 3B) has asbestos cement fragments on the veranda. These had not been thrown onto the ground and therefore prior to demolition would be able to be removed without requiring soil to be decontaminated.
- At the south east corner of this residence, the surface of the soil had been disturbed (refer to Photograph 4). The reason could not be established. There was no visual evidence of trucks having travelled to this location or of the soil being excavated.

Photograph 5: There are few drums on site, those there at the time of the August audit were empty or being used to water the horses on the land holdings.

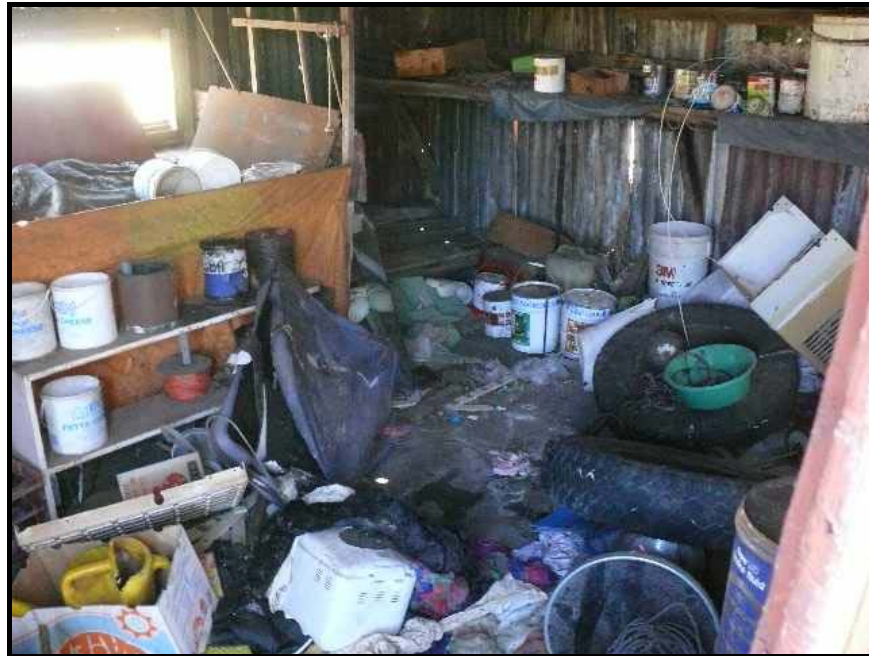
Photograph 6: Within one of the sheds is this accumulation of materials that will need removal prior to demolition.

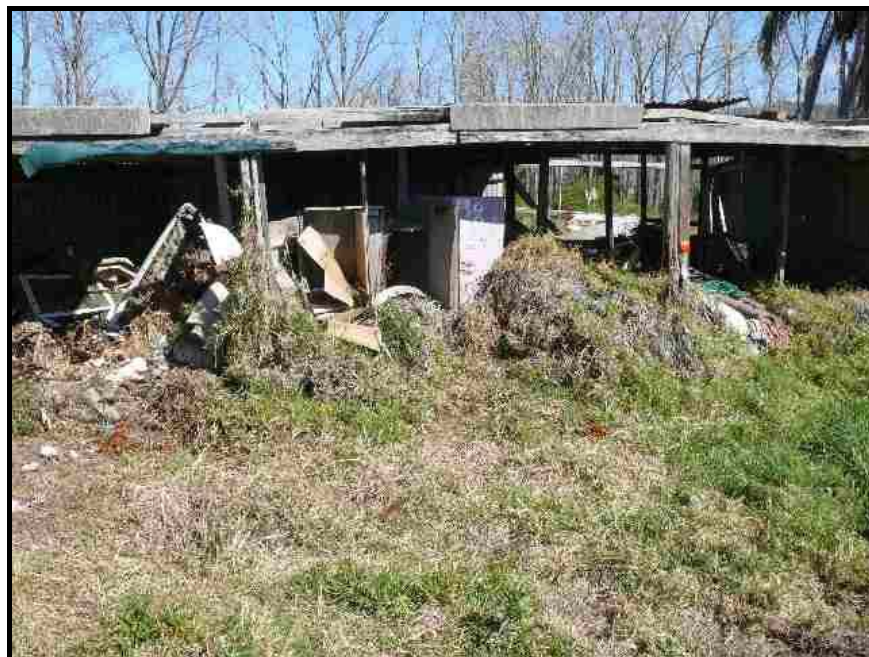
- An inspection of the scrap materials will be needed before these are removed to ensure there are no asbestos containing materials present.
- Similarly waste oils/fuels belonging to tenants who have trucks and machinery will need to be removed.

Photograph 7: There is an accumulation of waste/scrap materials at several locations across the site.

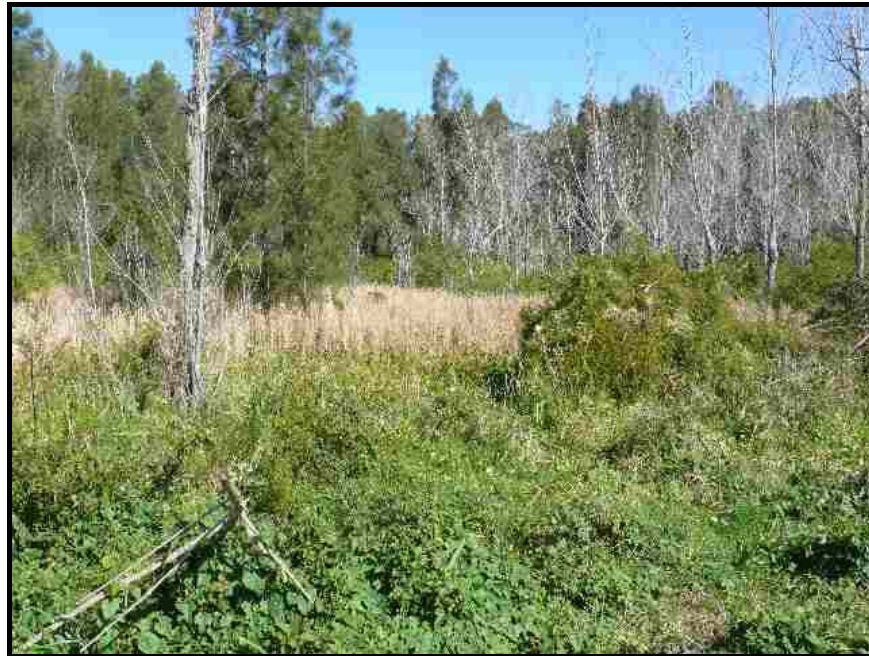
Photograph 8A: The wooded land was inspected and no visual evidence of soil being disturbed or waste materials being dumped were evident.

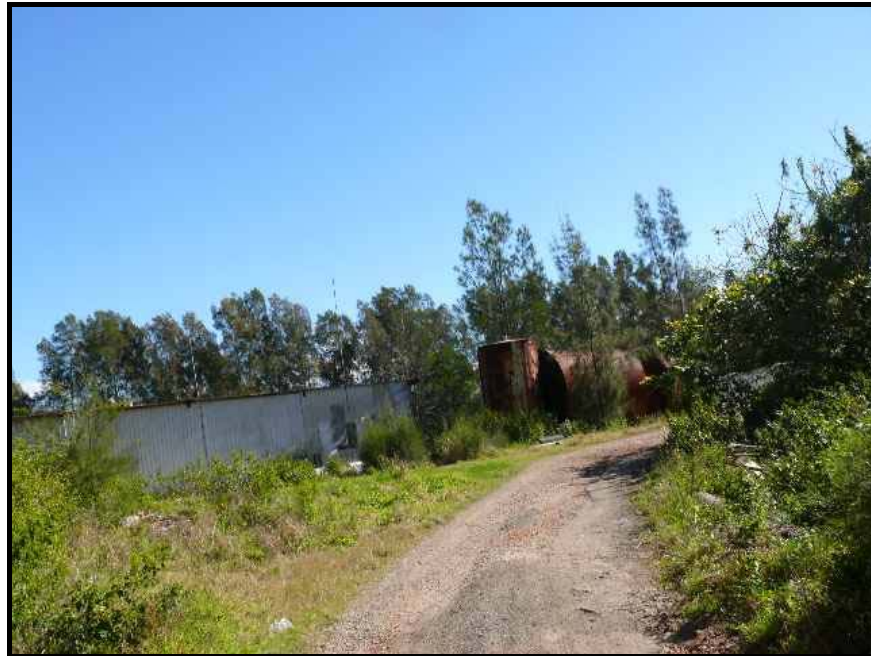
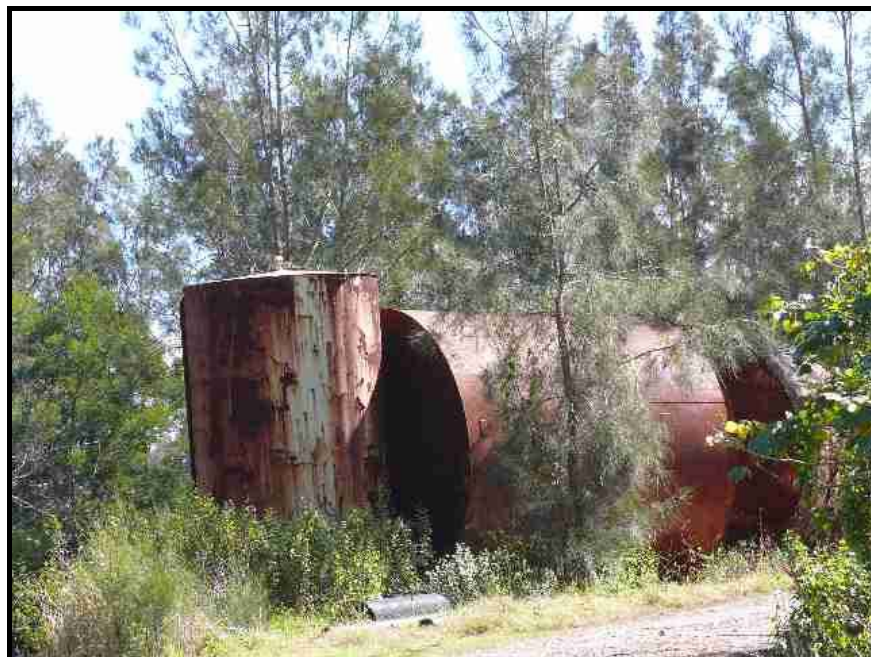
- The properties were not accessible as all gates were locked.
- From the vantage points available and an examination of aerial photographs there was no visual evidence of the uses having changes. These landholdings will require extensive removal of waste materials.
- The three disused aboveground storage tanks will require particular attention to presence of remnant flammable vapour if these are to be cut up on site.

Photograph 9A: These aboveground tanks were present during the November 2003 site Assessment. Advice on matters to check during disposal, are included in Section 3 of the report.

Once these tanks are removed the soil beneath these will need inspection for presence of any odour of petroleum products. Advice will need to be sought if odour of petroleum products is present.
