**REGISTER OF HAZARDOUS
MATERIALS REPORT
SALAMANDER SHORES HOTEL
147 SOLDIERS POINT ROAD
SOLDIERS POINT NSW 2317**

Report Date: 2 March 2009
Project Ref: ENVIRHOD00565AA

**Hazardous Materials Report
Salamander Shores Hotel
Soldiers Point NSW**

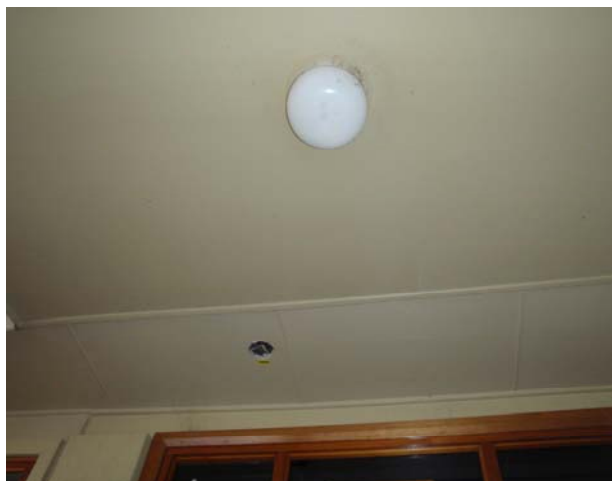
Photograph 2: Asbestos cement sheeting eaves and canopy lining - External: all faces.

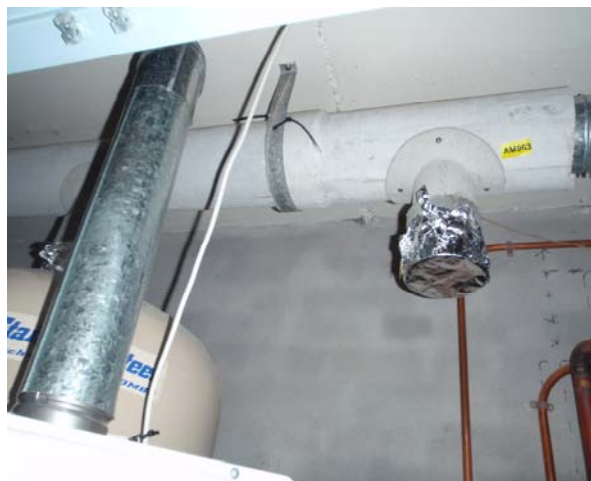
Photograph 3: Formed asbestos cement flue - Internal: boiler cupboard within bathroom.

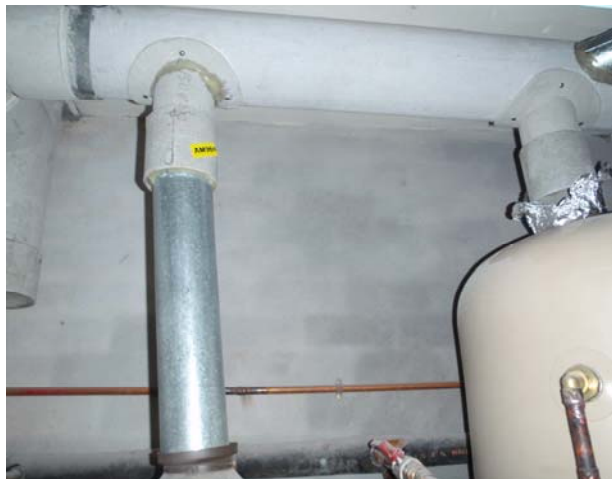
Photograph 4: Formed asbestos cement caps on flue - Internal: boiler cupboard within bathroom.

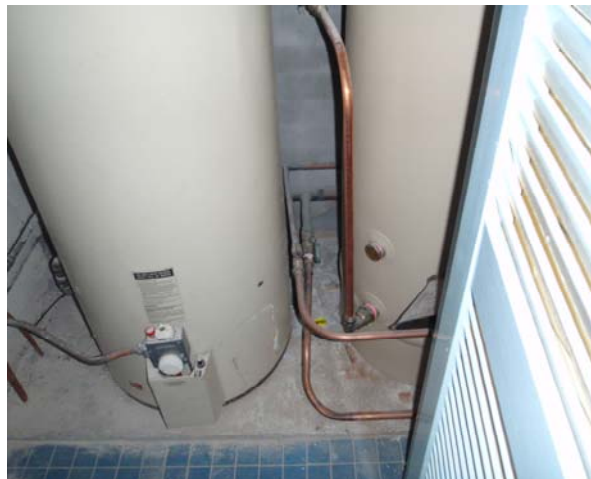
Photograph 5: Asbestos cement debris - Internal: boiler cupboard within bathroom.
