Geotechnical Site Investigation
At
North Byron Parklands
Site 1
Gatehouse & Office Development
Yelgun NSW 2483

Reference Number: 1758-001
31st May 2010

Geotechnical Site Investigation
At
North Byron Parklands
Site 2
Cultural Centre & Administration Development
Yelgun NSW 2483

**At
North Byron Parklands
Site 3
Conference Centre Development
Yelgun NSW 2483**

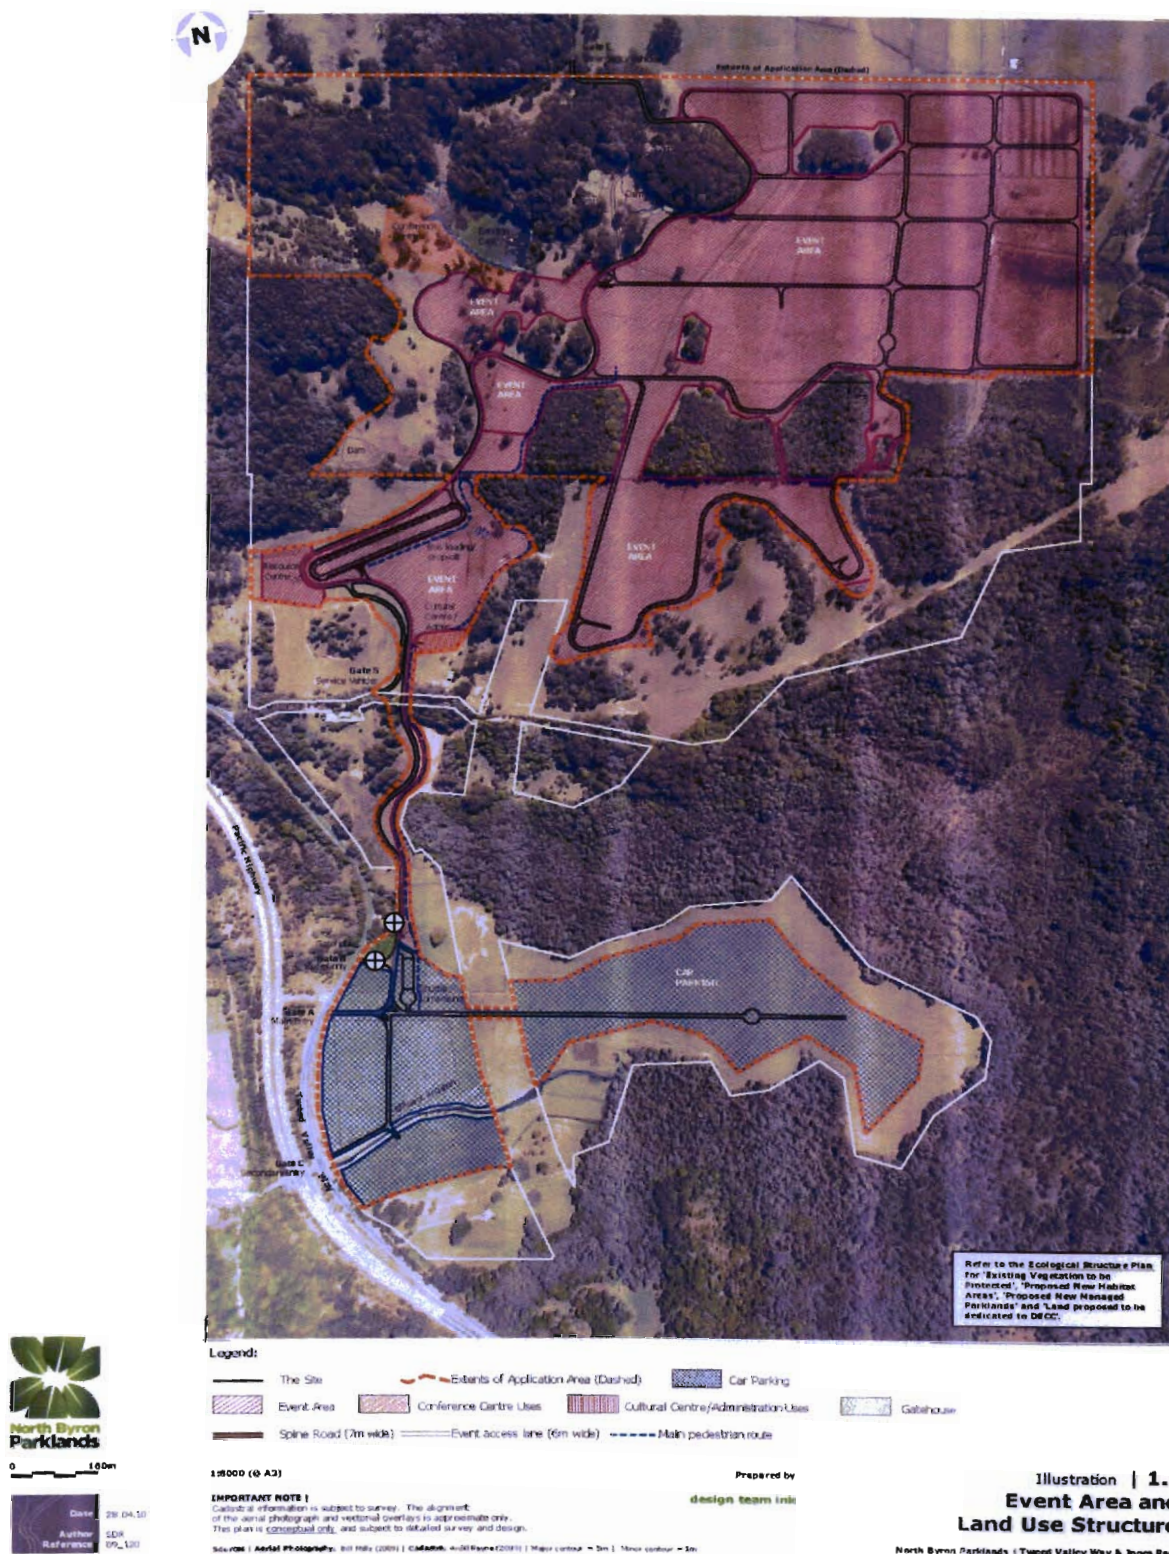
Figure 1: Plan of the proposed gatehouse and office development site 1 at North Byron Parklands, Yeilgun showing the borehole and dynamic cone penetrometer test locations.

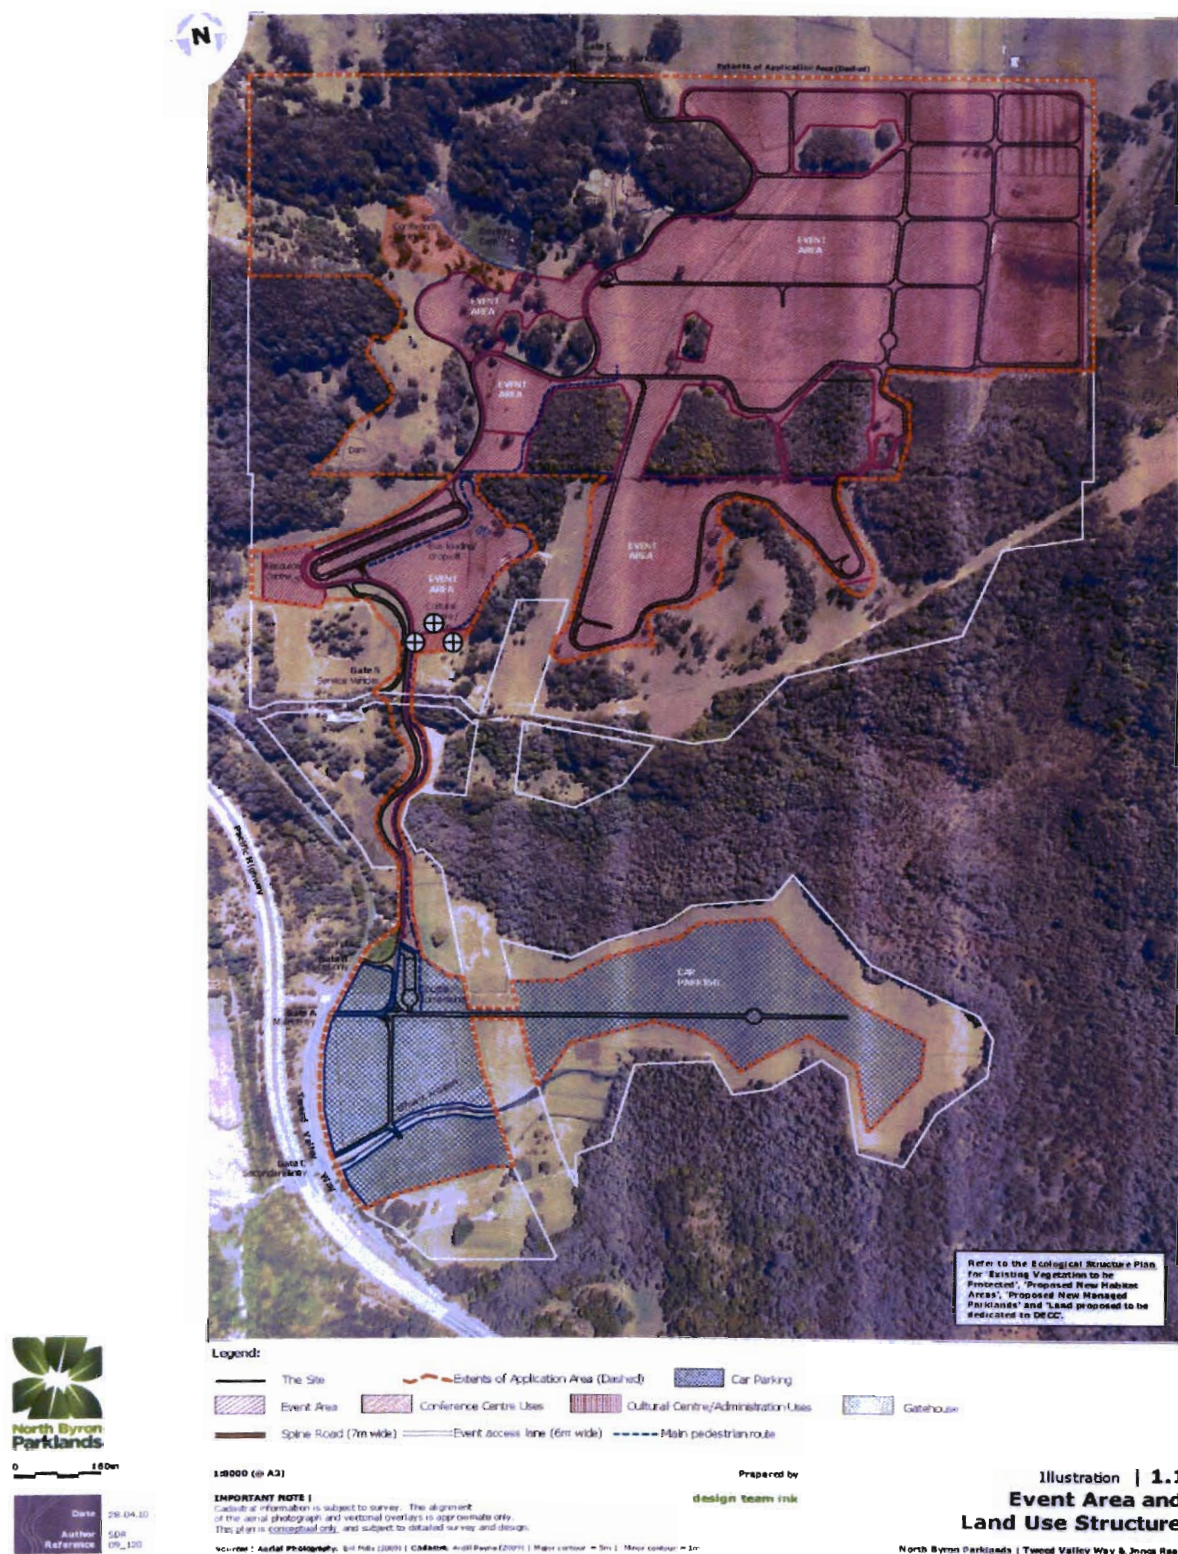
Figure 1: Plan of the proposed cultural centre and administration development site 2 at North Byron Parklands, Yelgun showing the borehole and dynamic cone penetrometer test locations.

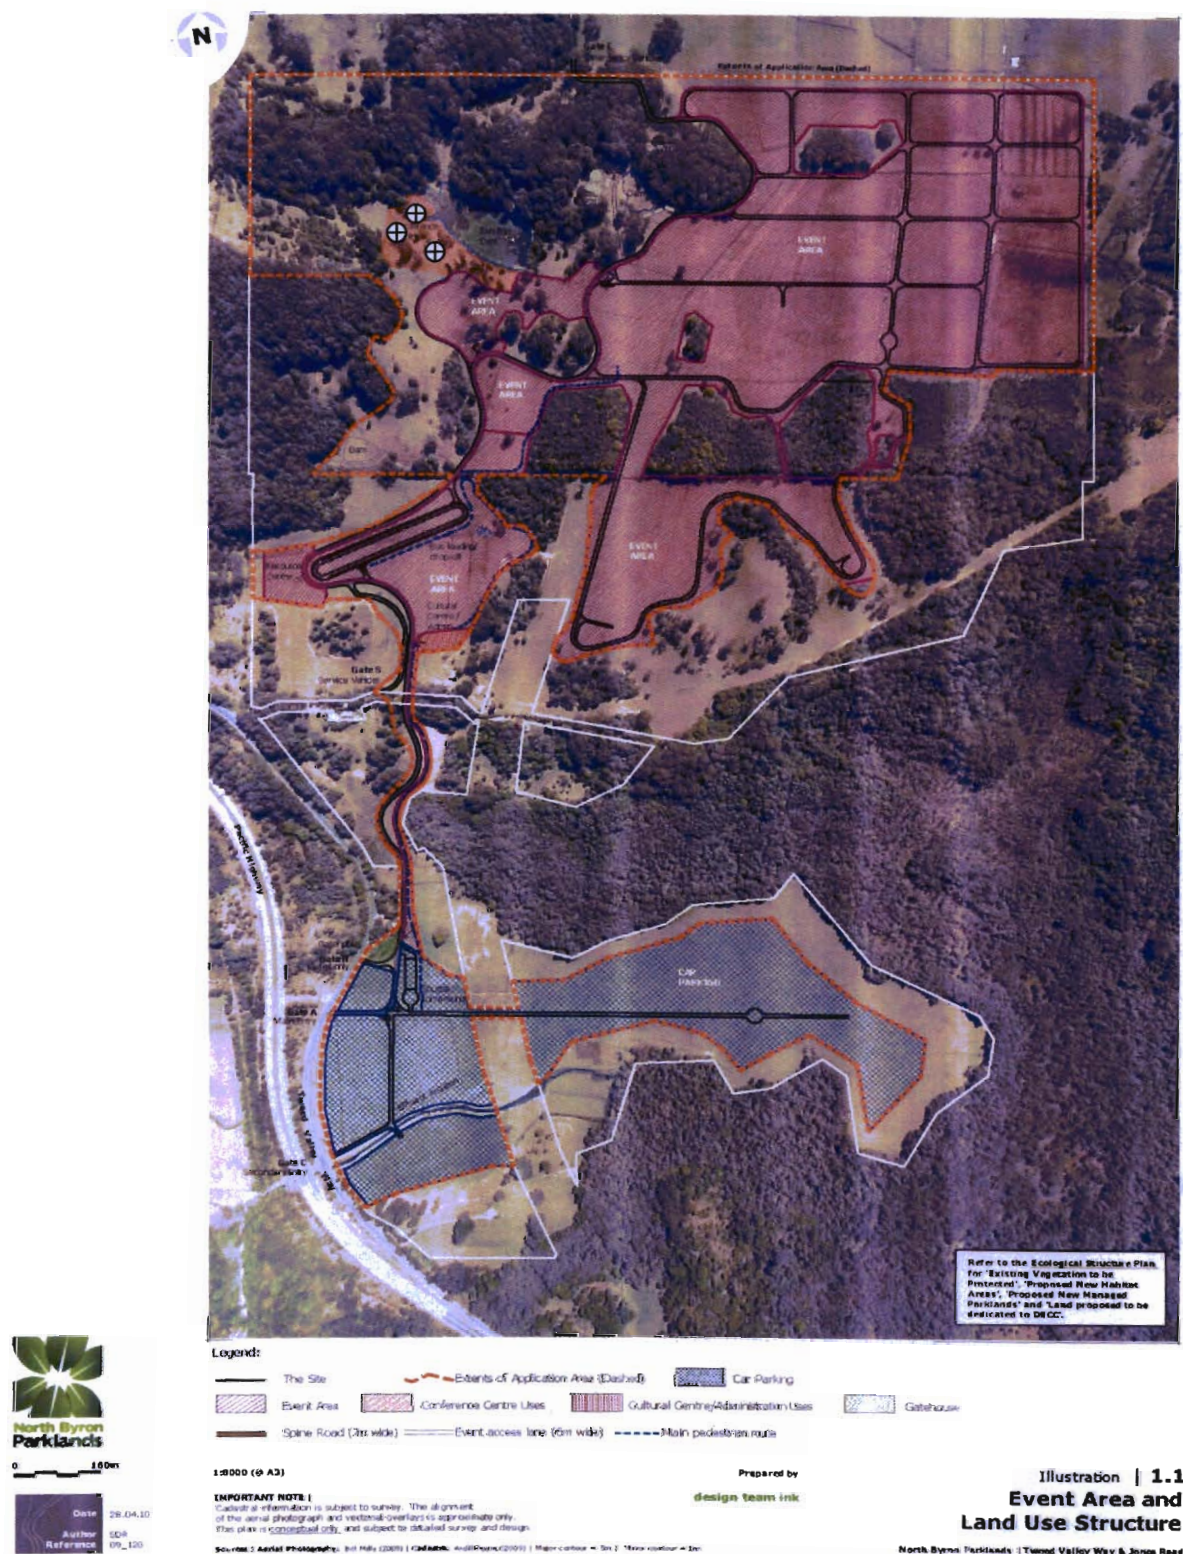
Figure 1: Plan of the proposed conference centre development site 3 at North Byron Parklands, Yelgun showing the borehole and dynamic cone penetrometer test locations.
