Submission- Re Edmondson Park South

HAZARDOUS MATERIALS SURVEY – BAMBI KINDERGARTEN

Hazardous Materials Survey, Bambi Kindergarten, Ingleburn Defence Site, NSW

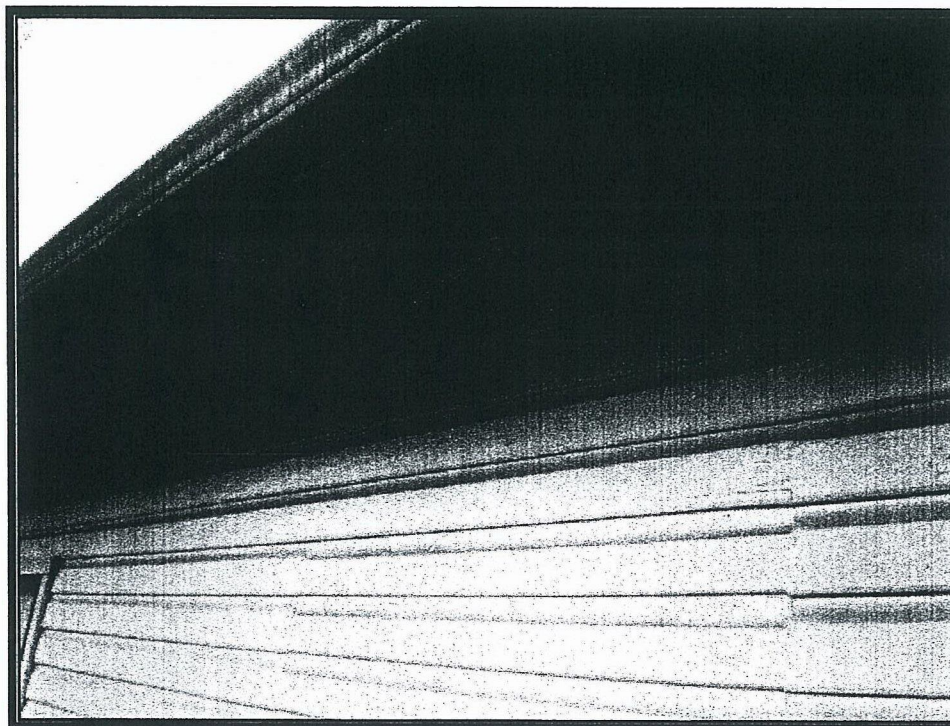
- The library, Blue Gum and Lilli Pilli roof spaces were found to contain SMF insulation.
- The south elevation had an asbestos cement infill panel at the top of the wall, between it and the roof sheets. Refer to Appendix A, sample Bam/07 and Appendix B photograph 2.

Photograph 2: Bambi Kindergarten, South elevation – asbestos cement infill panel between weather board wall and corrugated iron roof (Refer sample Bam/07)

The ACMs identified to the Bambi Kindergarten buildings were all in a good condition at the time of the survey. They should be regularly inspected, at least annually, and managed as detailed below to ensure they remain in a good condition. If work is proposed that could damage the materials then they should be removed in advance. If their condition deteriorates or they suffer some damage then they should be repaired or replaced.

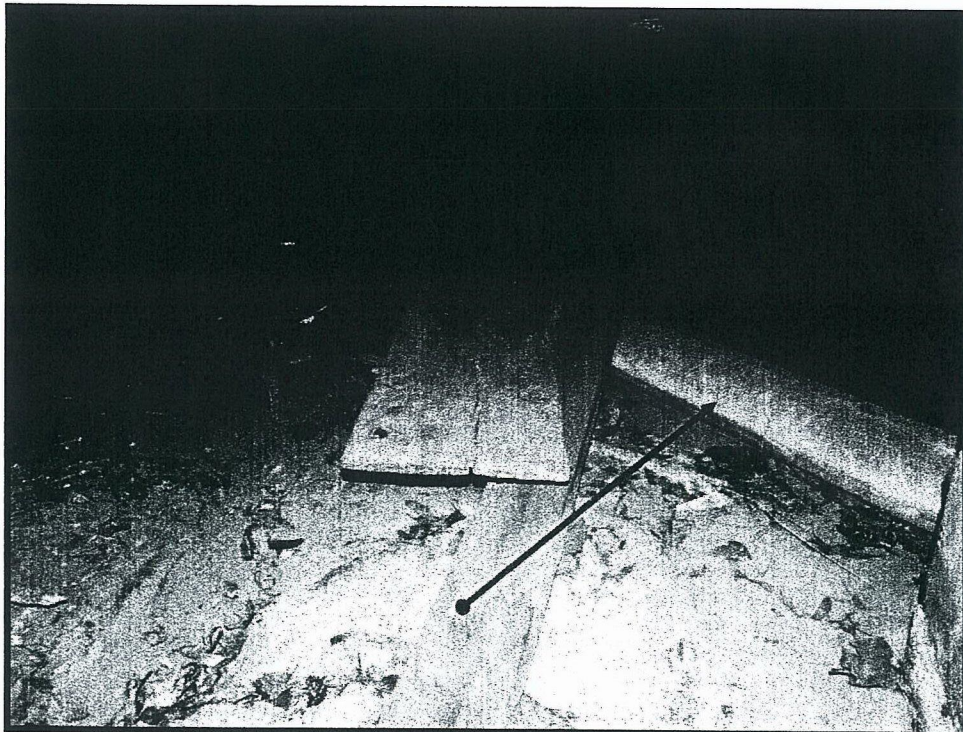
The under-croft area was found to contain a significant amount of asbestos cement debris in a poor condition. Access to this area should remain restricted until this material is removed and the area decontaminated. This work should be carried out prior to any demolition or any other works that will require entry to the area.

26	Under croft	Loose cement debris	AC debris	10/257m ²	Refer to Bam/09	5,6	CH	Poor	Low	Continue to restrict access until area is decontaminated	Oct-09				
27	Throughout buildings	Capacitors to Fluorescent light fittings	N/A	All units	Inspected	N/A	N/A	N/A	N/A	The type of capacitors present are not listed as containing PCBs.	N/A				
28	Building K2	N/A	N/A	N/A	N/A	N/A	N/A	N/A	N/A	No visible, accessible hazardous materials were identified at the time of the inspection	N/A				
29	Building K3	N/A	N/A	N/A	N/A	N/A	N/A	N/A	N/A	No visible, accessible hazardous materials were identified at the time of the inspection	N/A

**Photograph 5: Bambi Kindergarten, under-croft – asbestos cement debris
(Refer to sample Bam/08)**

Removal Information	
Name of Contractor	VB Carpentry
Specific Areas of Work	Void under main building – undercroft.
Asbestos Material (type)	Asbestos cement fragments to ground and packing materials to some support pillars.
Remediation works completed	VB Carpentry removed and replaced the pieces of cement at the tops of those columns where it was present. They then removed visible asbestos cement fragments and other items of cement from the undercroft.

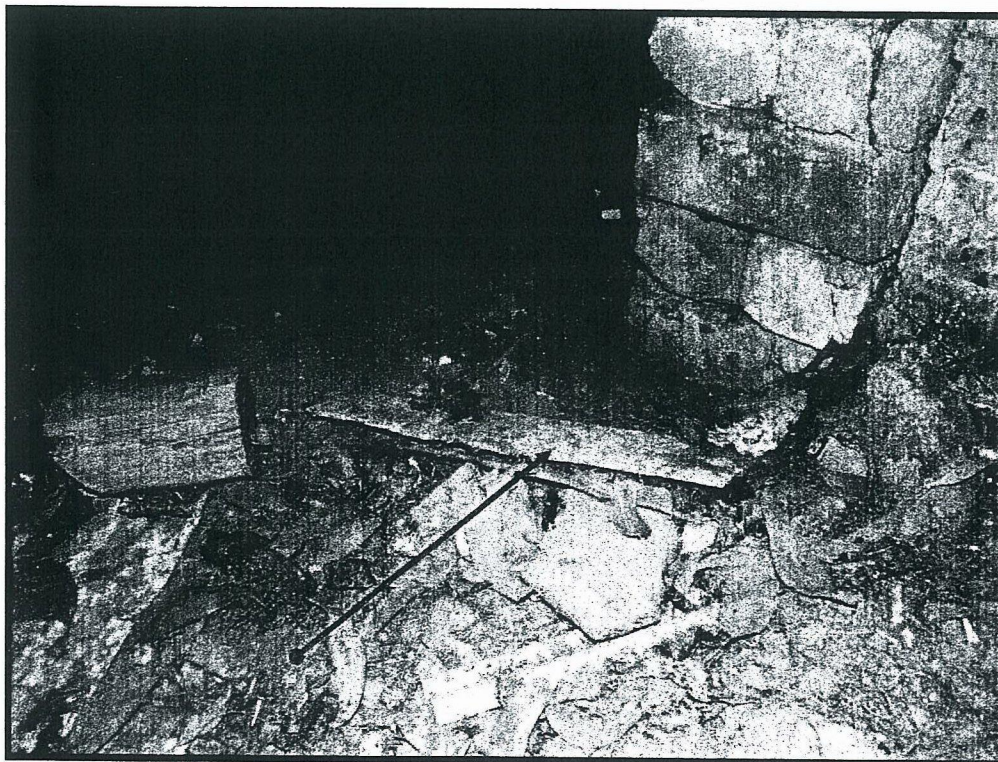
**Photograph 6: Bambi Kindergarten, under-croft – asbestos cement debris
(Refer to sample Bam/08)**
