APPENDIX C
Table C1 – Observations of Sandstone Outcrops
Drawing 6 – Location of Sandstone Outcrops

Site Walkover Photographs

Preliminary Geotechnical Assessment

Proposed Shepherds Bay Urban Renewal

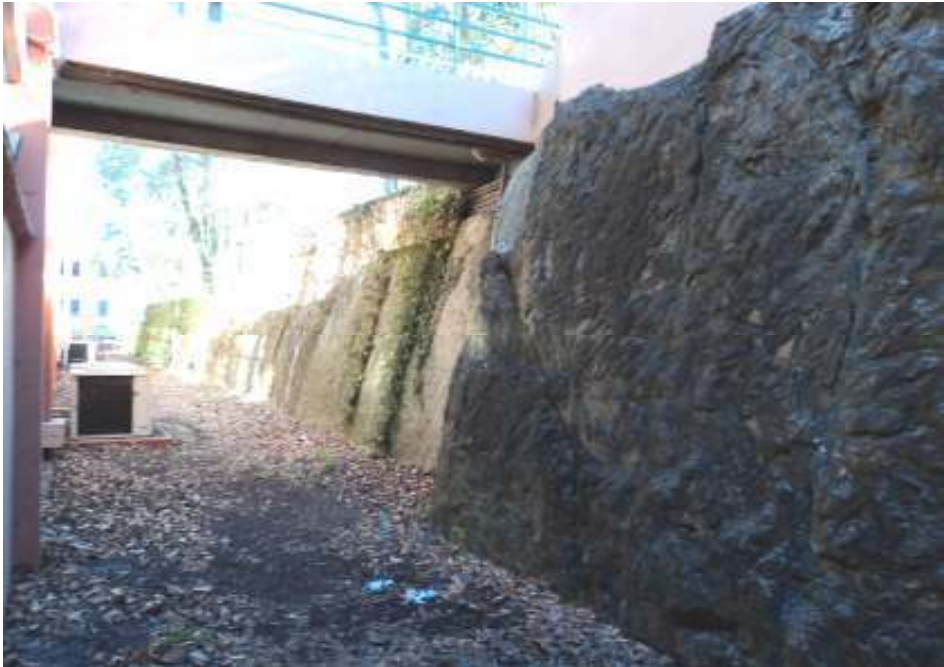
Photo A - Cut at eastern corner of Property 8 - north-eastern wall, facing north

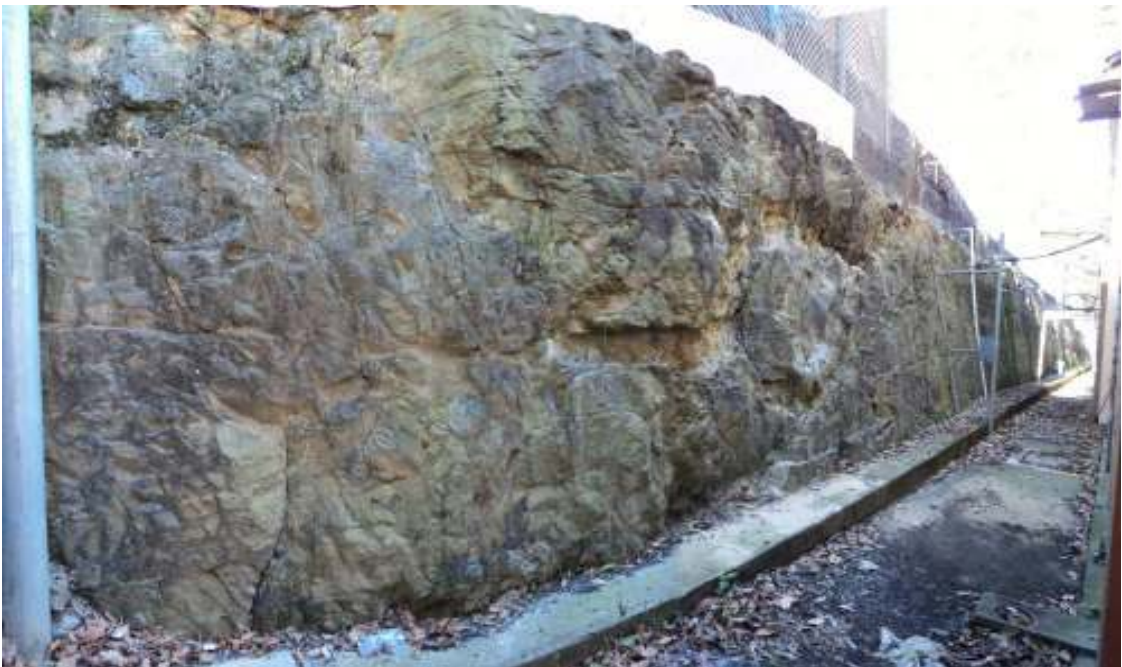
Photo B - Cut at eastern corner of Property 8, south-east wall, facing south

Note: Deeply weathered defects

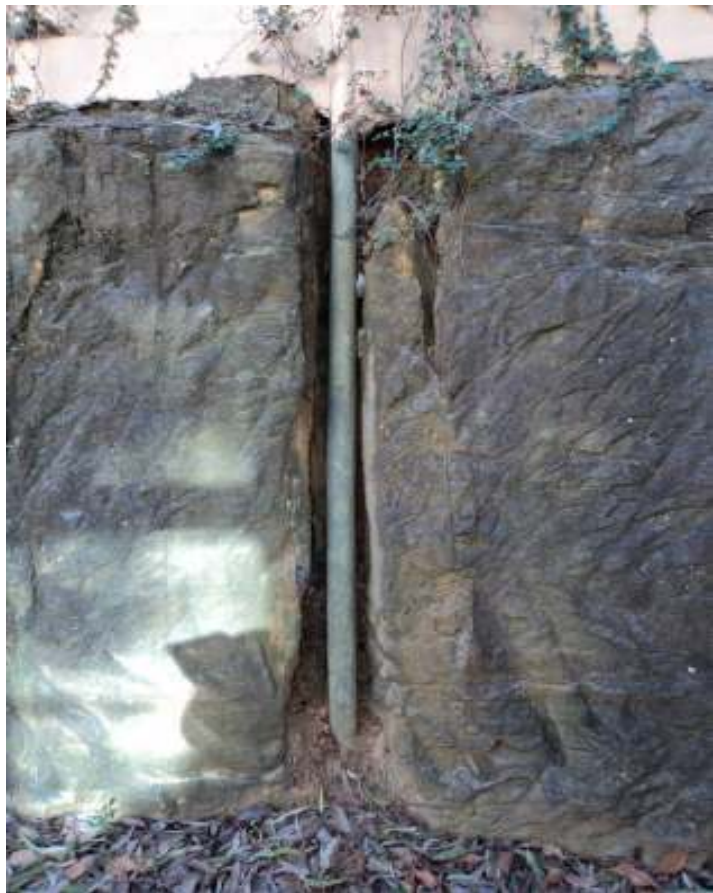
Photo C - Cut at north-eastern side of Property 8, facing north-east

Note: deeply weathered vertical joint

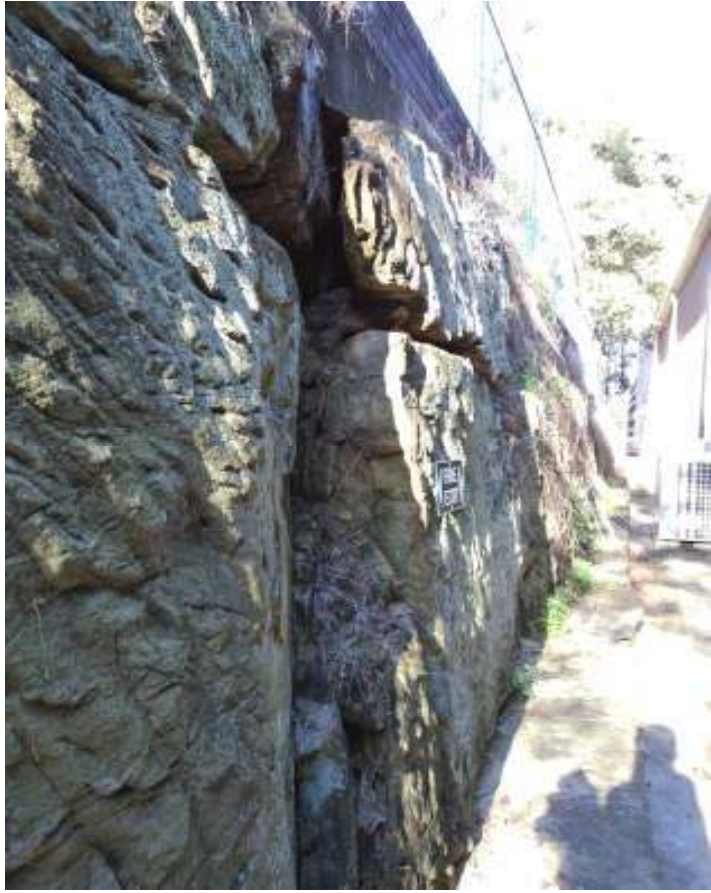
Photo D - Cut at south-eastern side of Property 8, facing south-east

Note: Open subvertical joints and bedding plans, possible instability

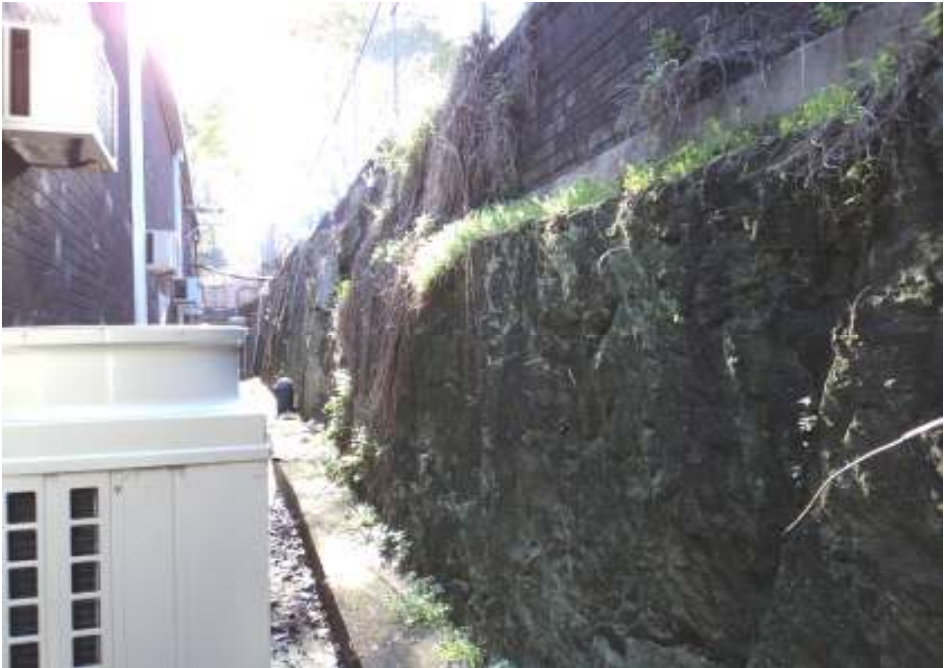
Photo E - Property 8 - Cut at south-eastern side of property, facing north-east

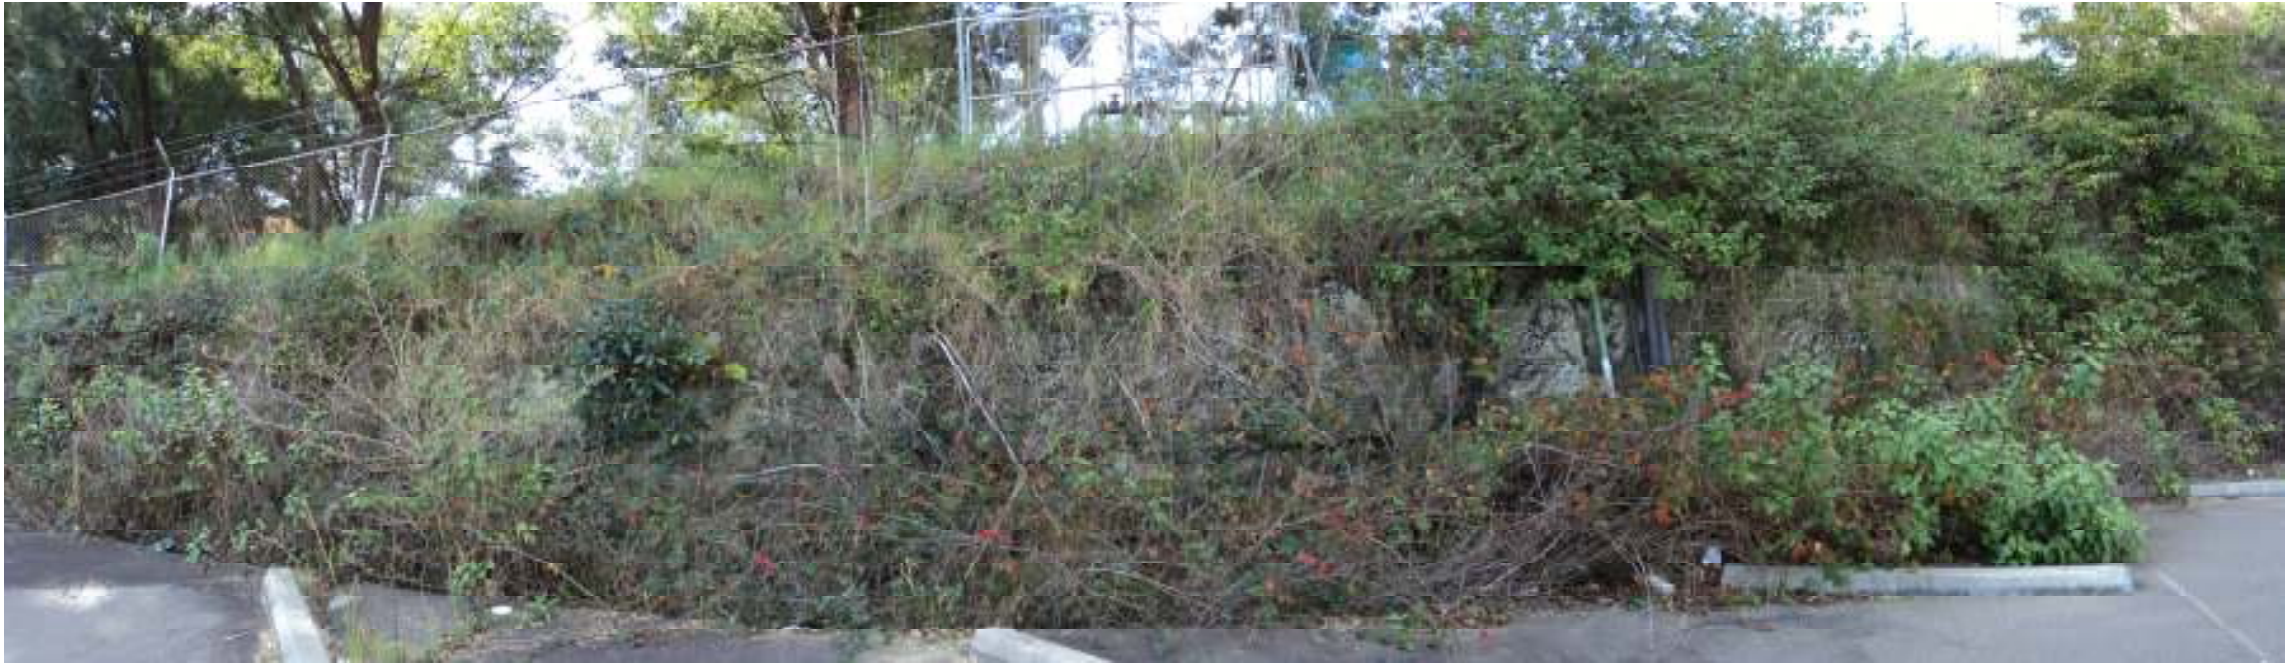
Photo A - Cut at north-eastern boundary of Property 9, adjacent to Constitution Road, facing north-east

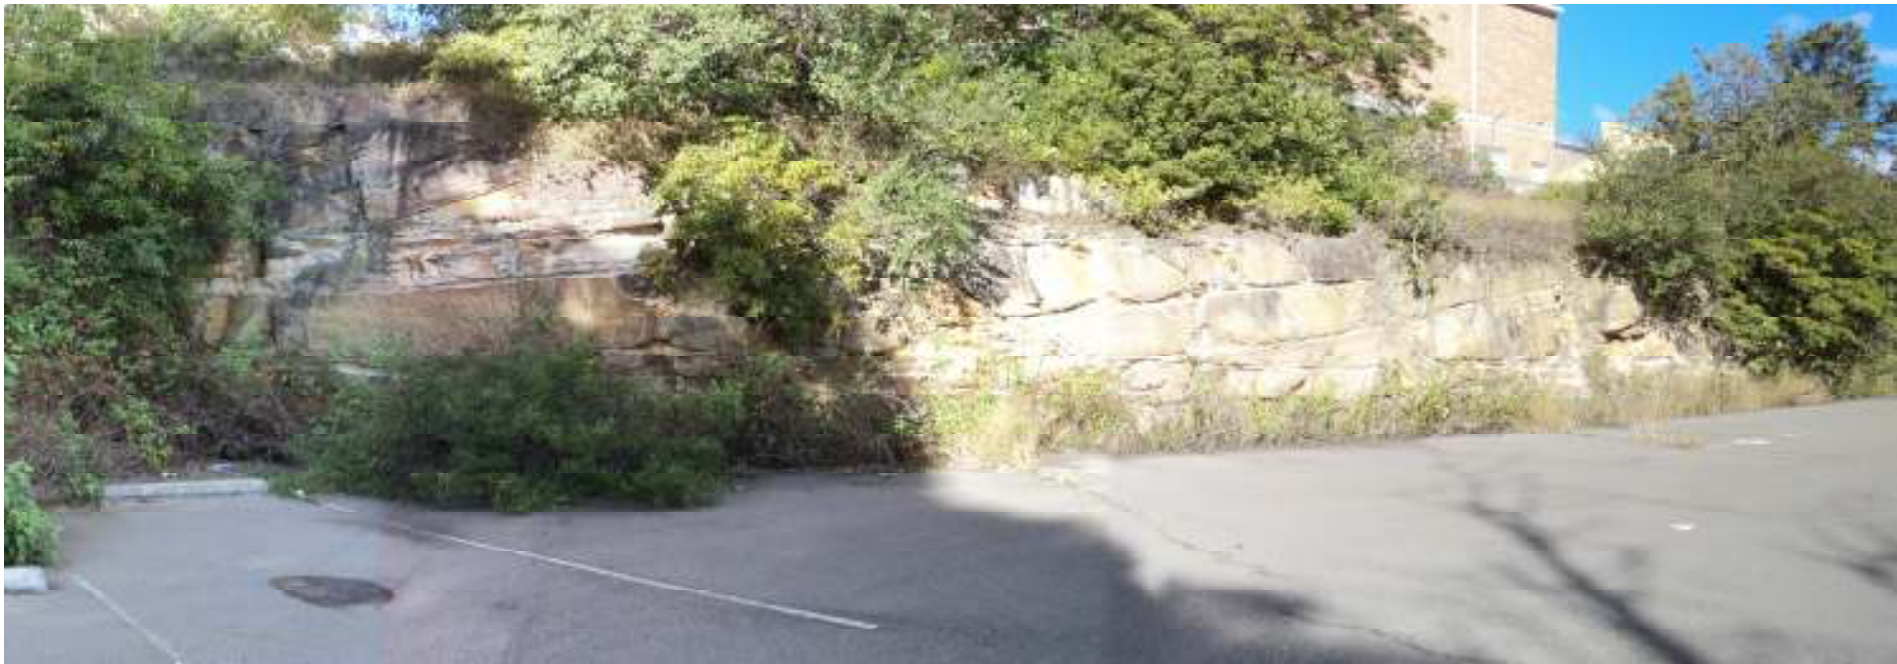
Photo B - Cut at south-eastern boundary of Property 9, adjacent to Property 30, facing south-east

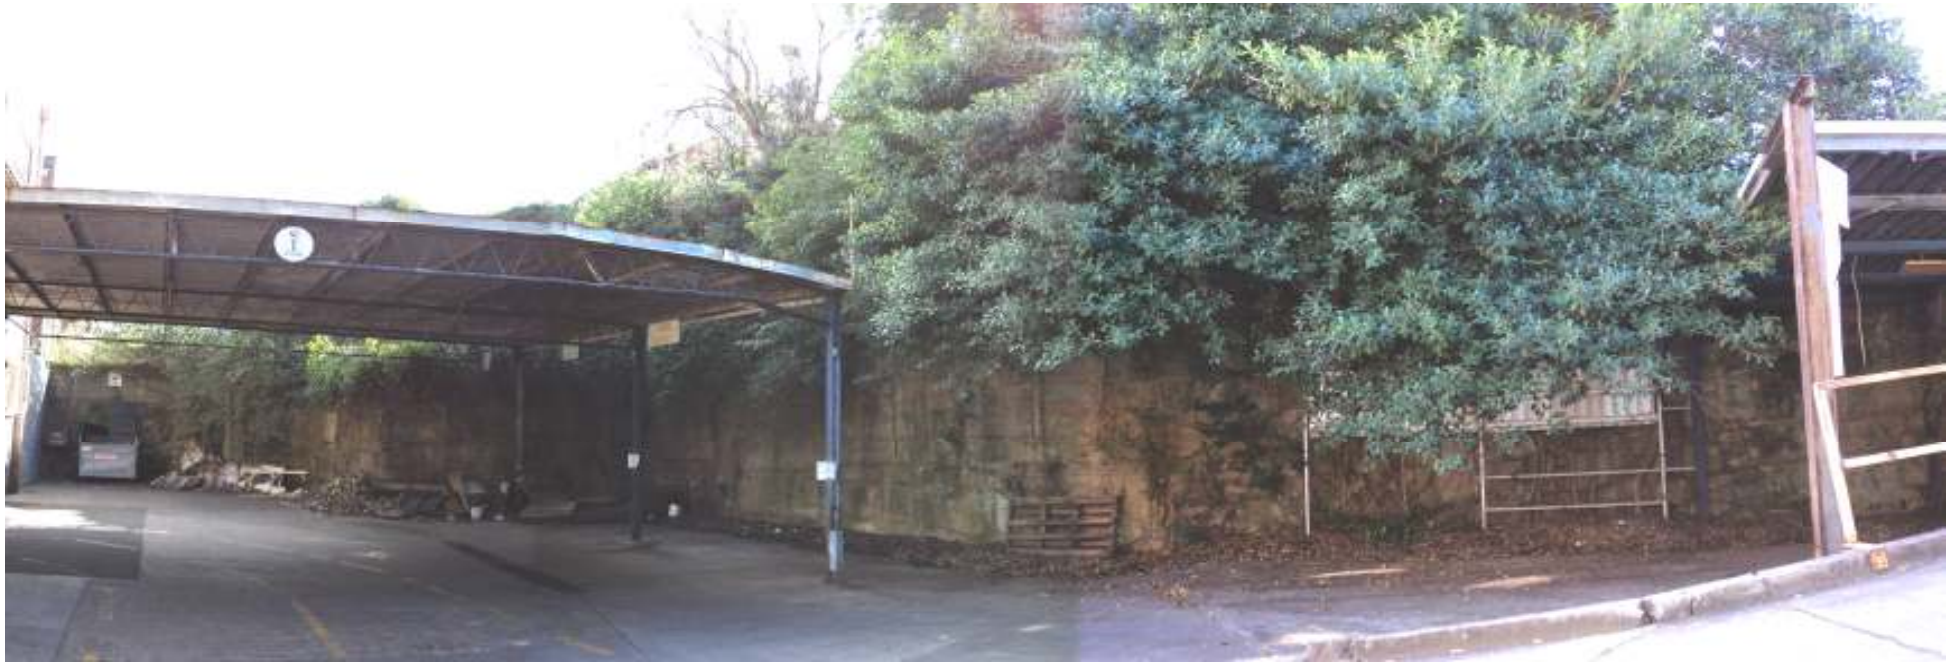
Photo A - Sandstone cliff at north-eastern side of Property 32, adjacent to Hamilton Crescent and Nancarrow Ave, facing north

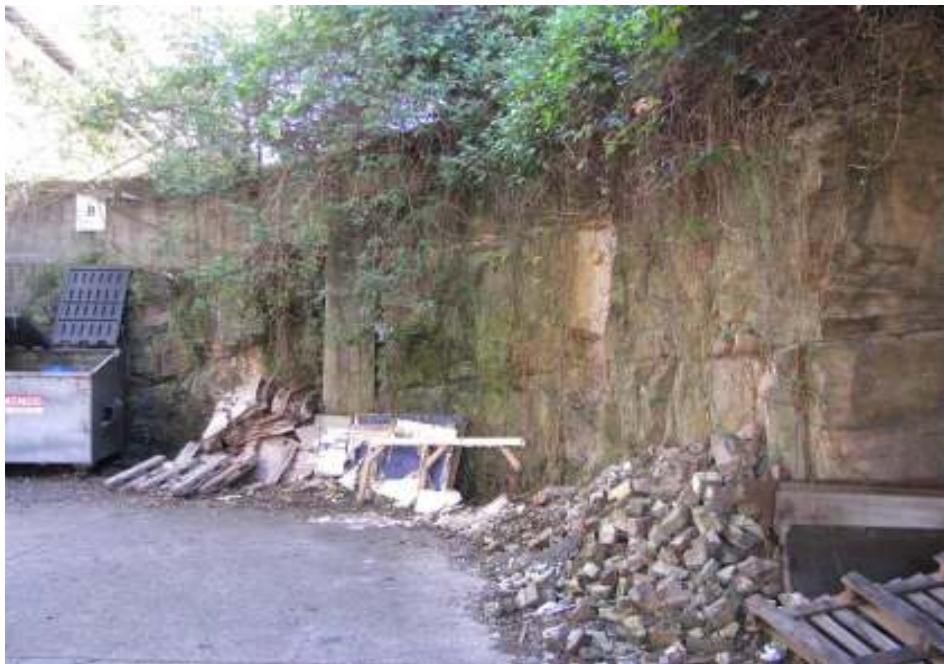
Photo B - Sandstone cliff on Property 32, below Nancarrow Ave, facing north-west

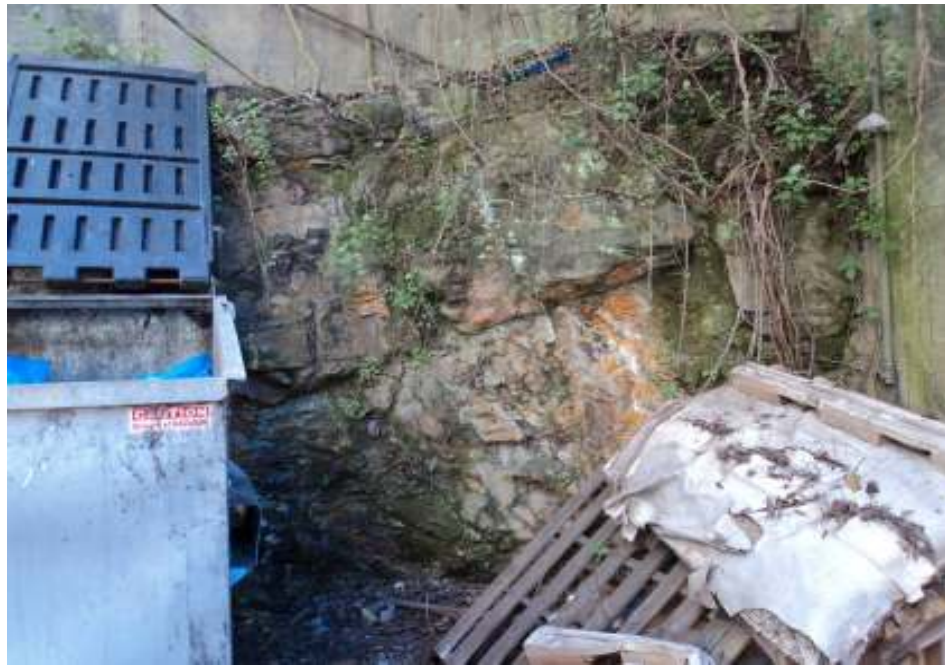
Photo C - Sandstone cliff on property 32, below Nancarrow Ave, facing north-west

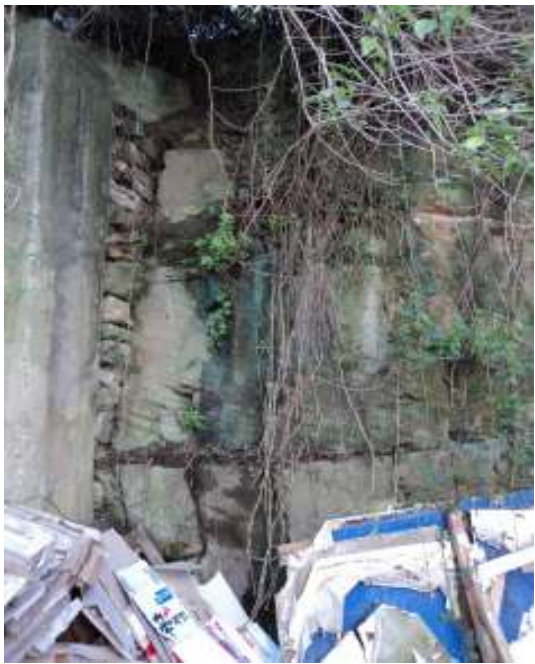
Photo D - Sandstone cliff, facing north, below Nancarrow Ave

Note: extremely low and very low strength sandstone, possible sheared zone

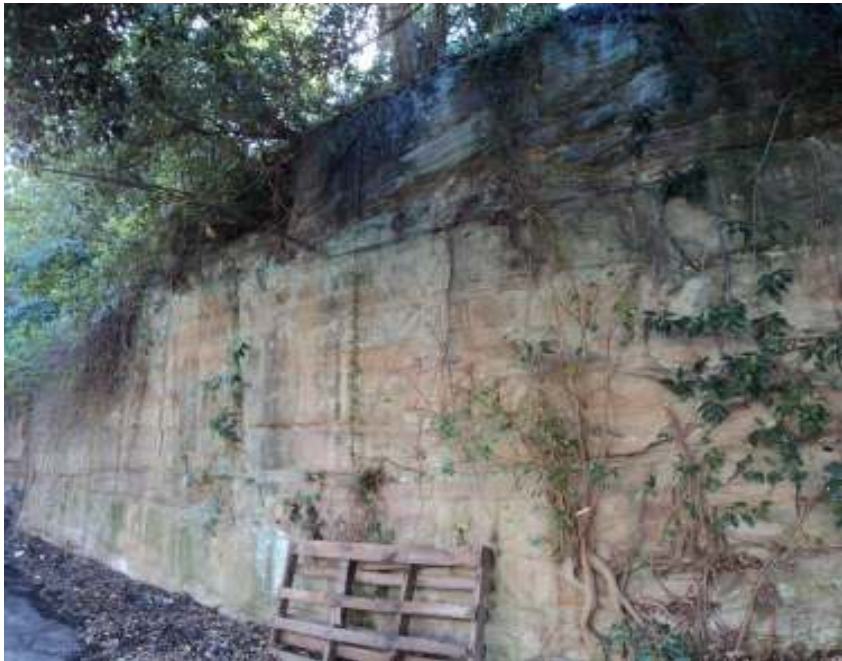
Photo A - sandstone cliff at north-eastern side of Property 32 below Hamilton Crescent, facing north

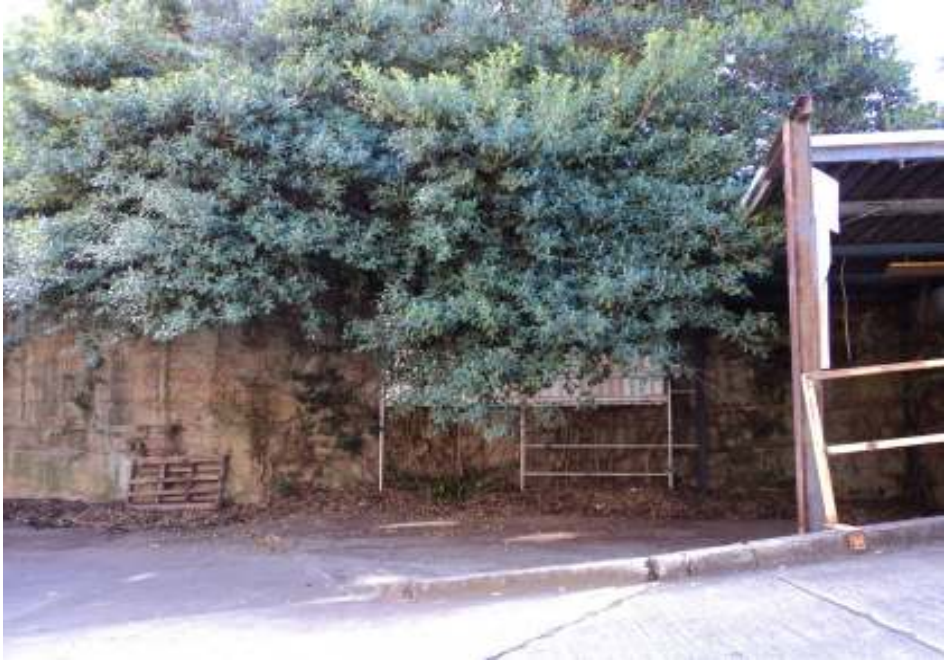
Photo B - sandstone cliff at north-eastern side of Property 32 below Hamilton Crescent, facing north-east

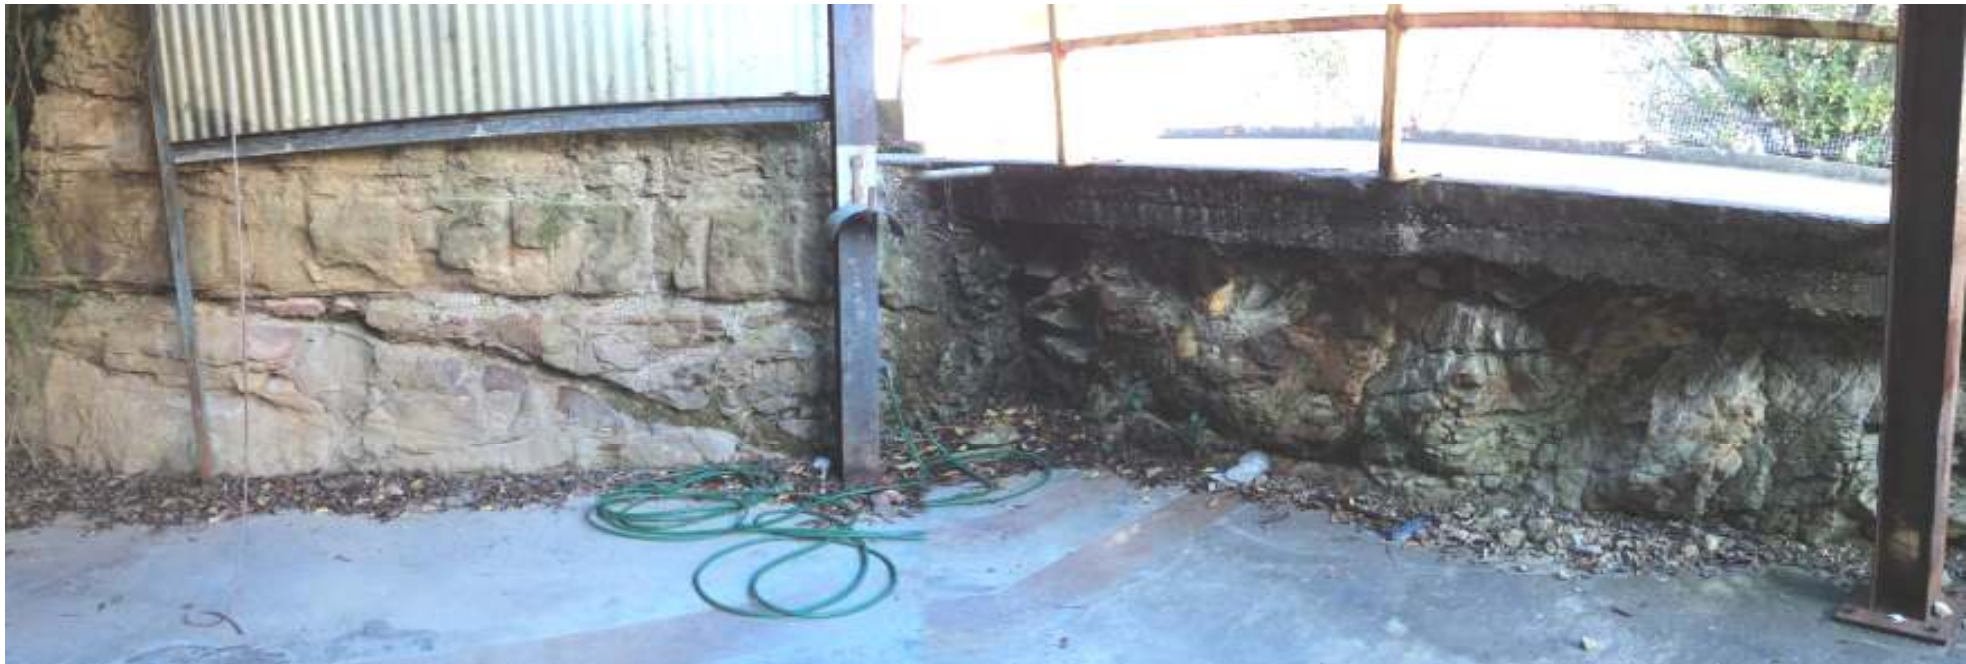
Photo C - cut in sandstone at north-eastern side of Property 32, facing east

Note: Thrust fault dipping south, fragmented, sheared rock above fault

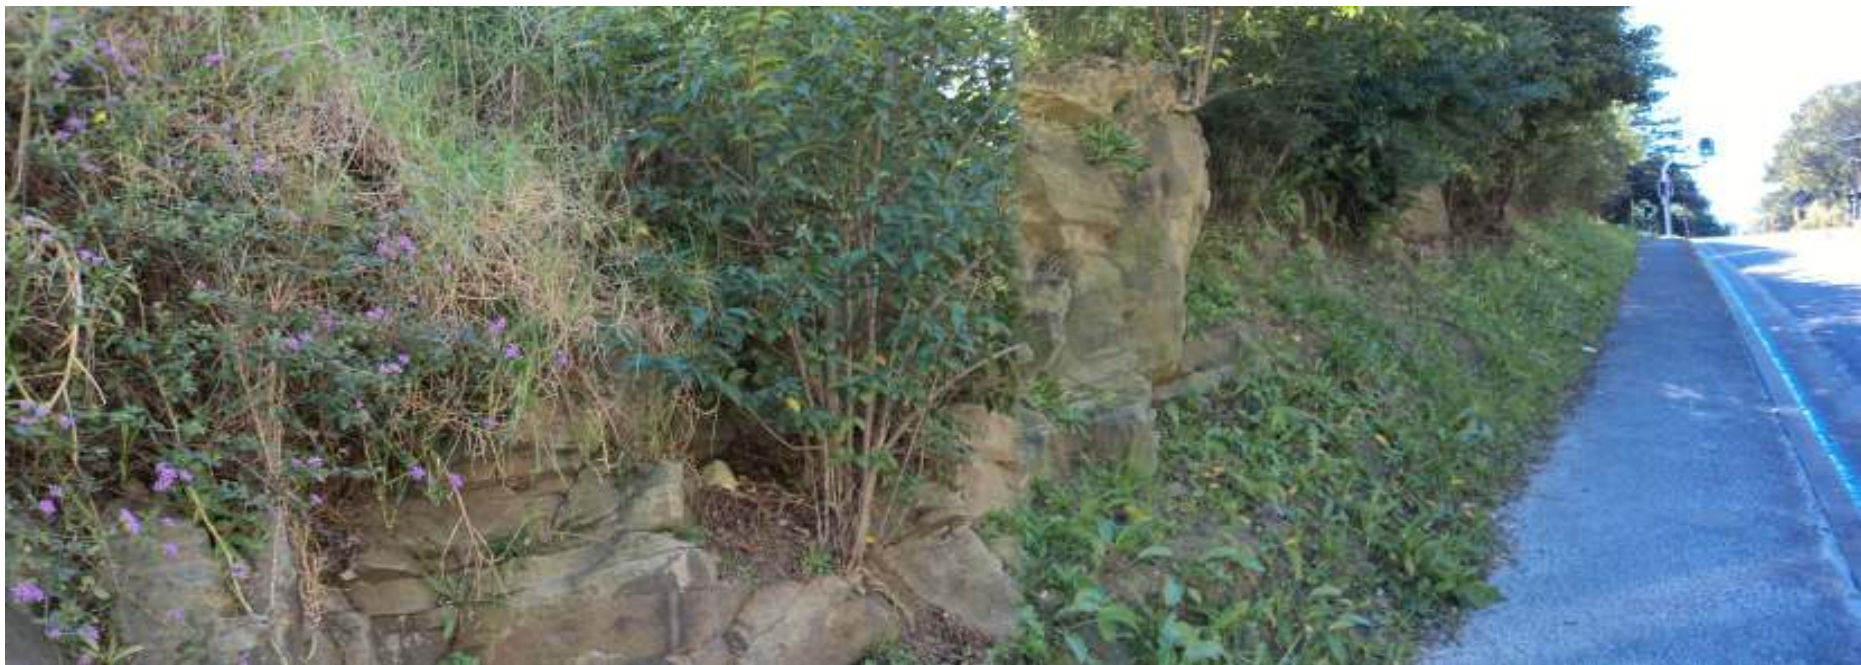
Photo A - Sandstone outcrop below Property 40, adjacent to Belmore Road, facing north

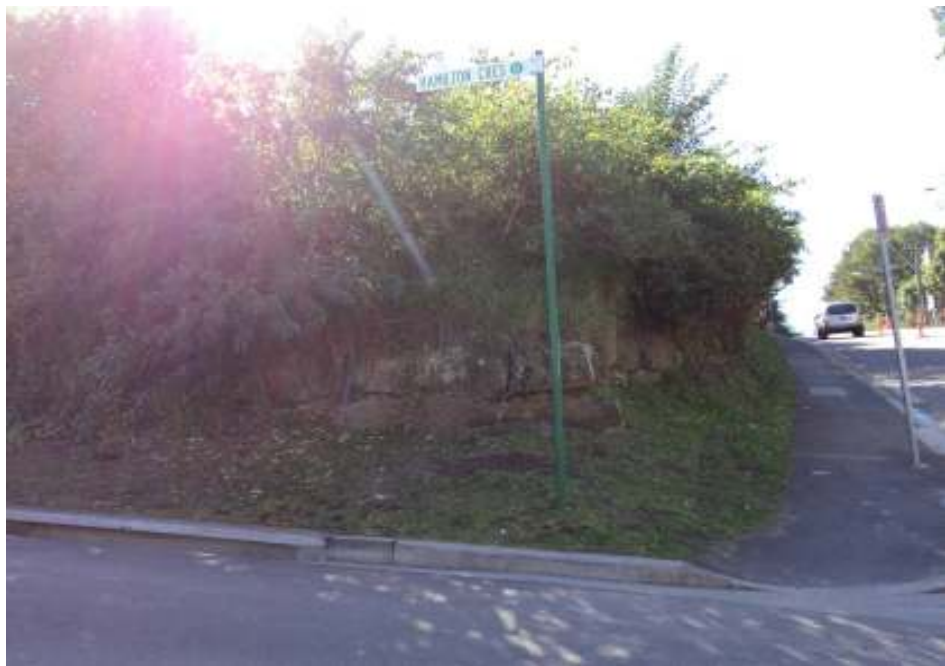
Photo B - Sandstone outcrop at northern corner of intersection between Hamilton Crescent and Belmore Road

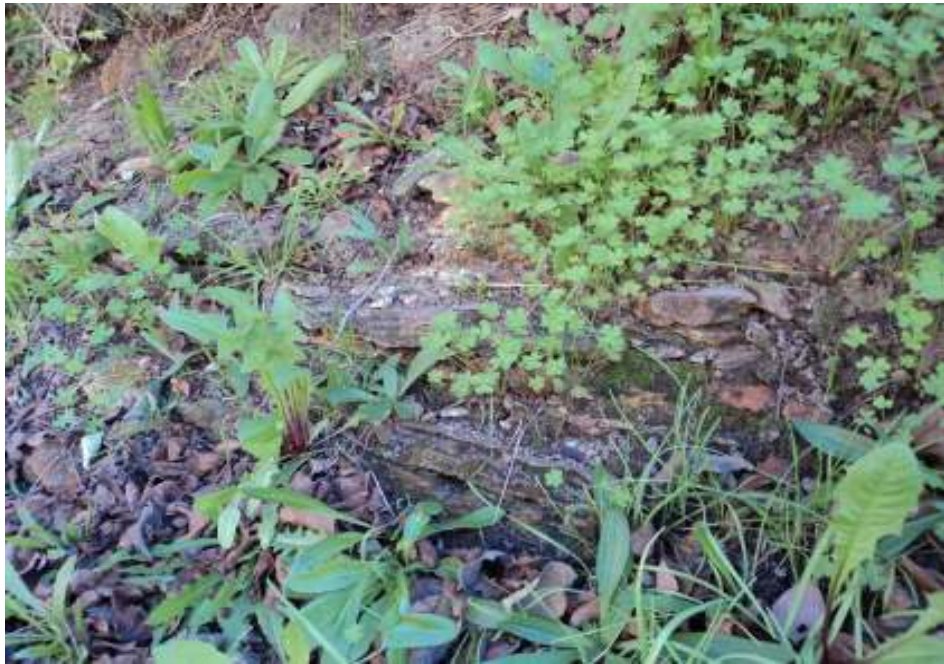
Photo B - Weathered, finely bedded sandstone below Property 40, adjacent to Belmore Road, facing north

Note: deeply weathered, possible Mittagong Formation

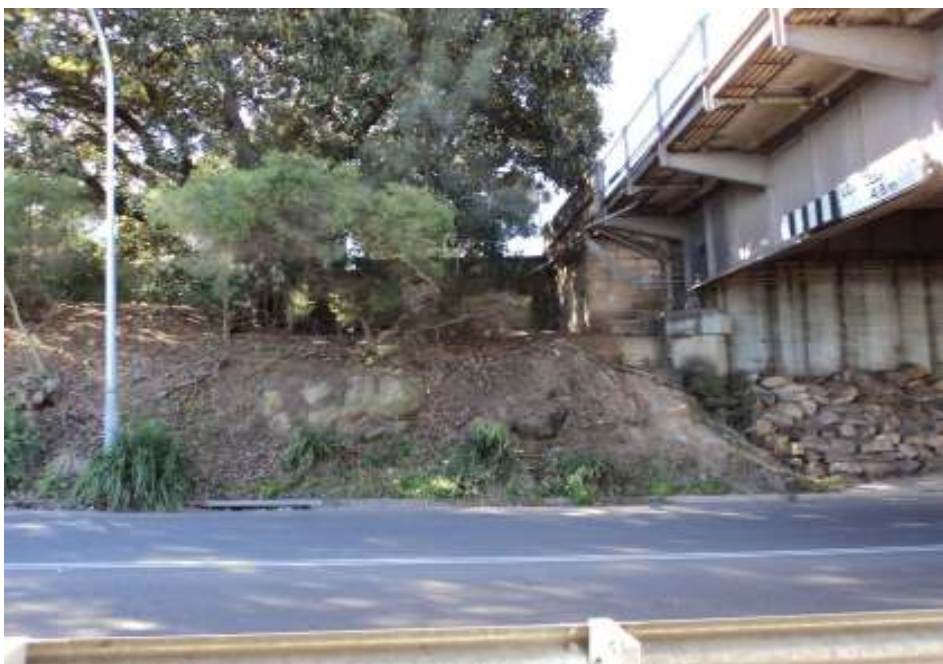
Photo B - Sandstone outcrop below Parsonage Street site, viewed from Loop Road, facing North

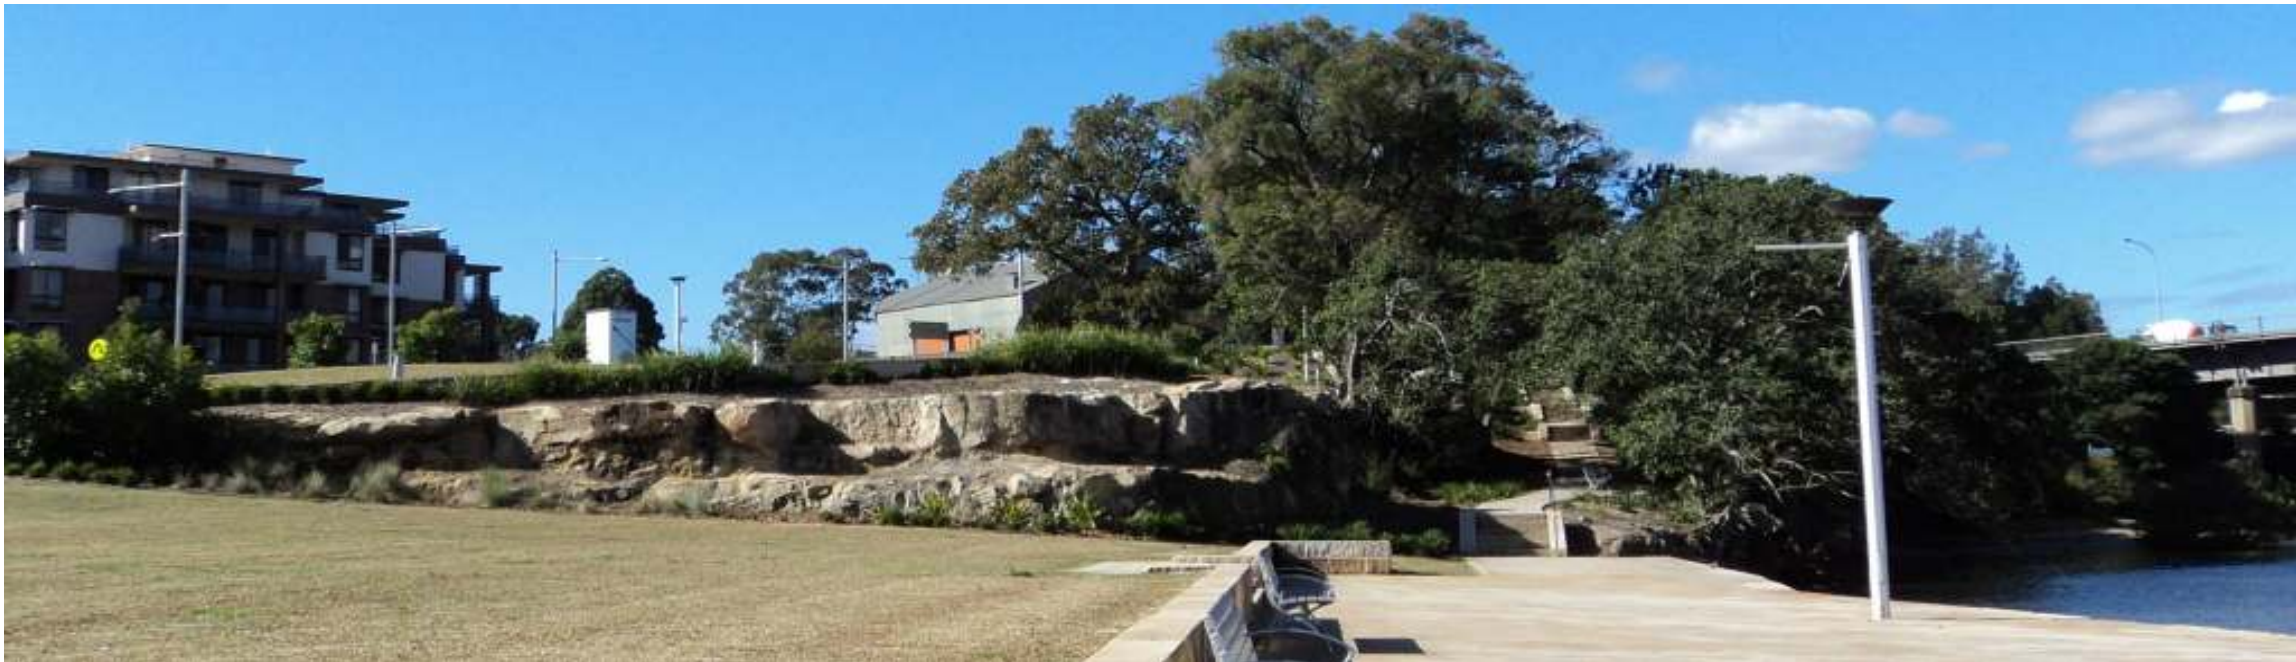
Photo C - Parsonage Street site, viewed from Anderson Park, facing east

Note: Sandstone outcrop in foreground, existing buildings at Parsonage Street site in background

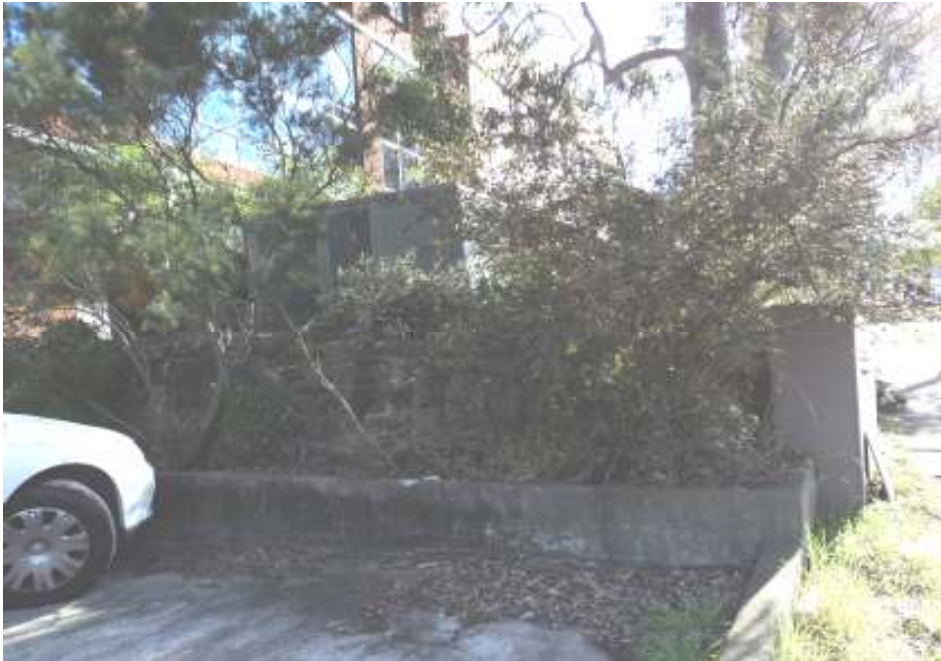
Photo A - Cut into sandstone at nearby sites on Belmore Road, opposite Property 2

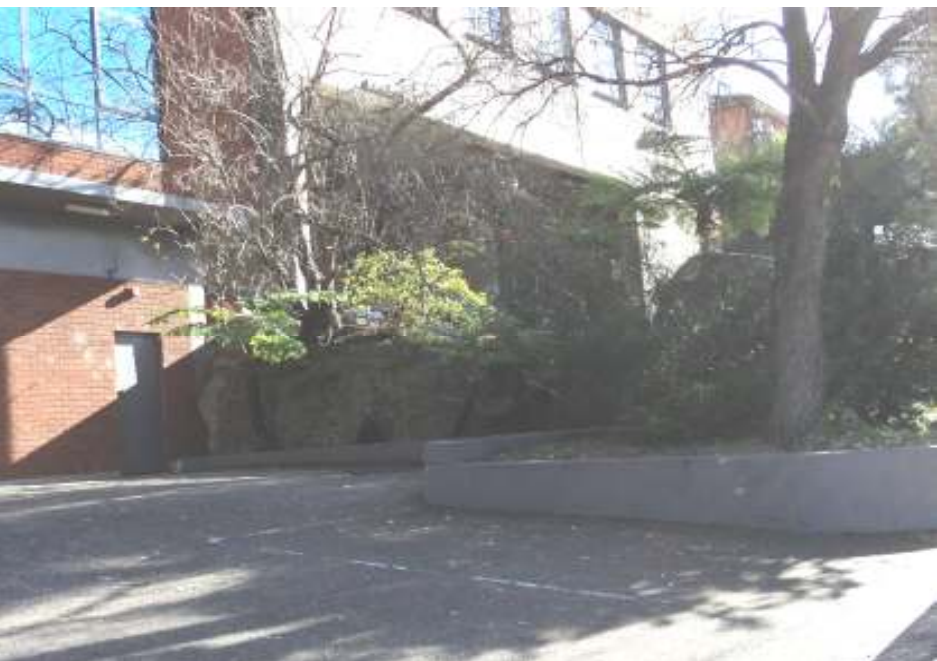
Photo B - Cut into sandstone at nearby sites on Belmore Road, opposite Property 2

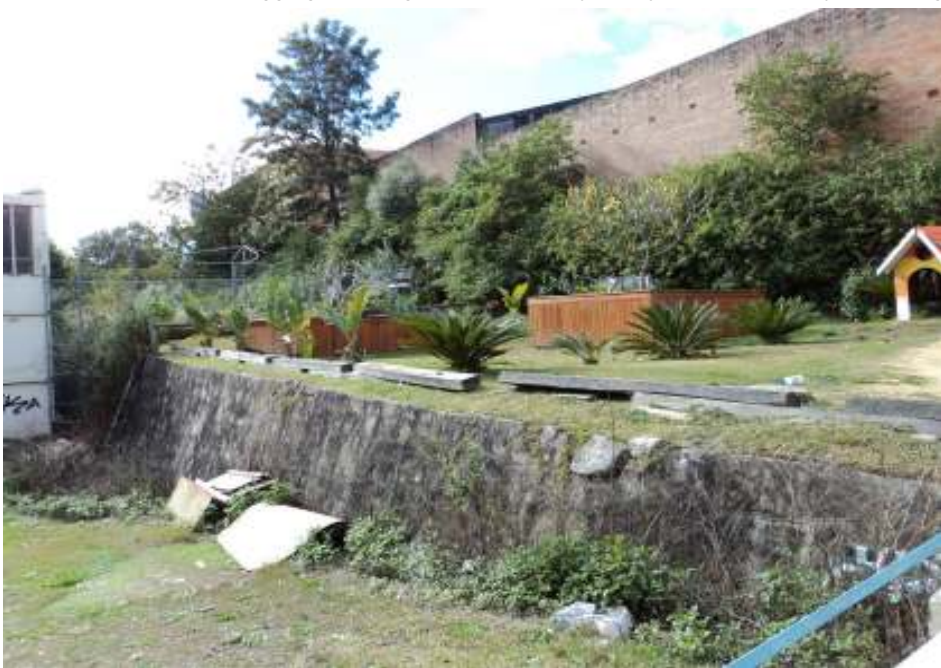
Photo C - Sandstone flagging retaining wall on Property 9, adjacent to Property 10, facing east

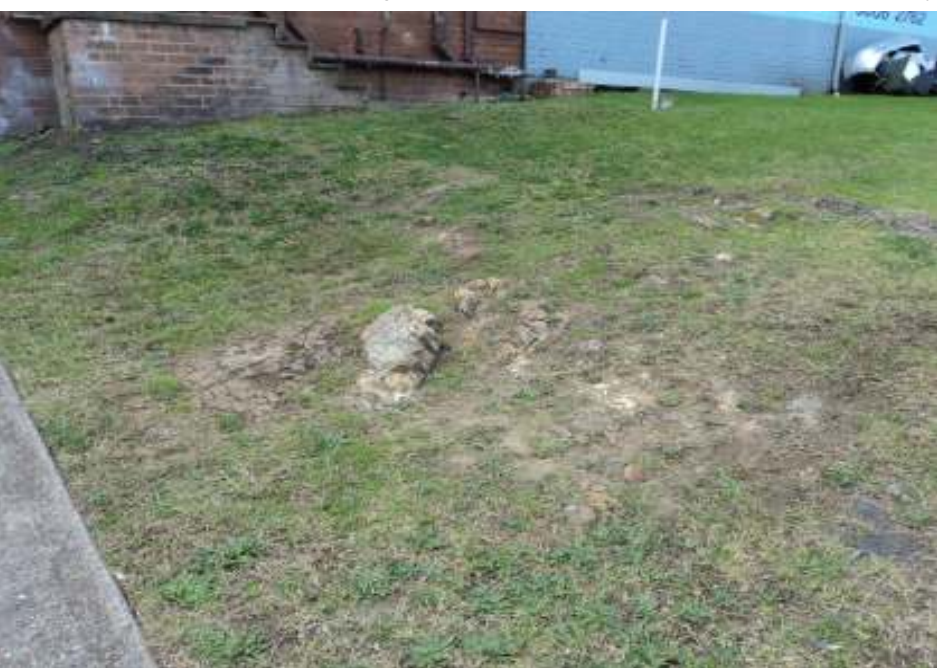
Photo D - Sandstone boulder in filling in Nancarrow Avenue nature strip, outside Property 13

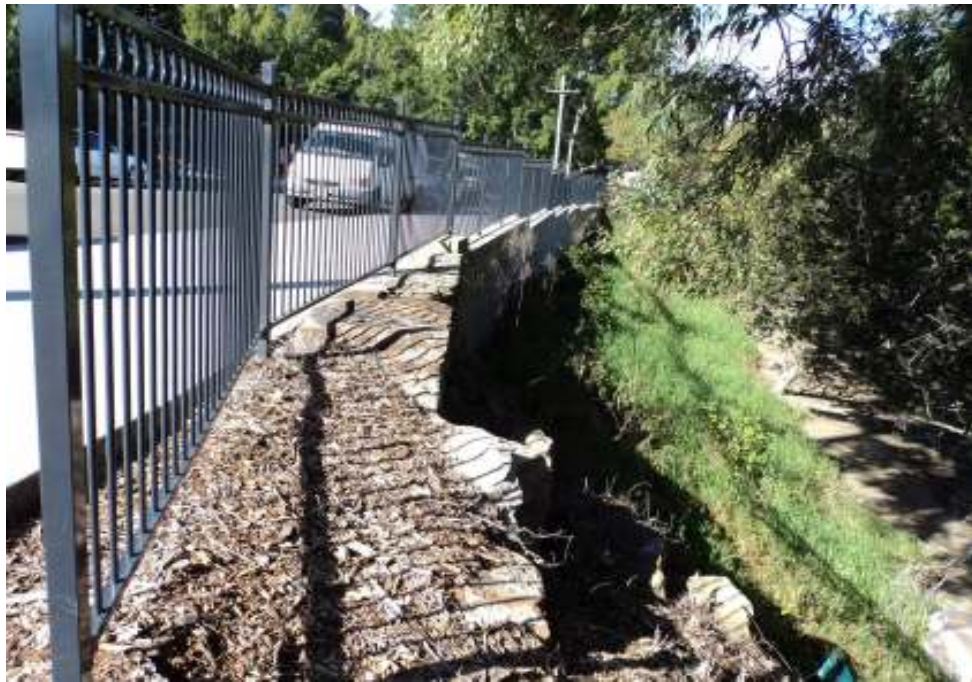
Photo B - Foreshore retaining wall, in front of property 32, facing south-east

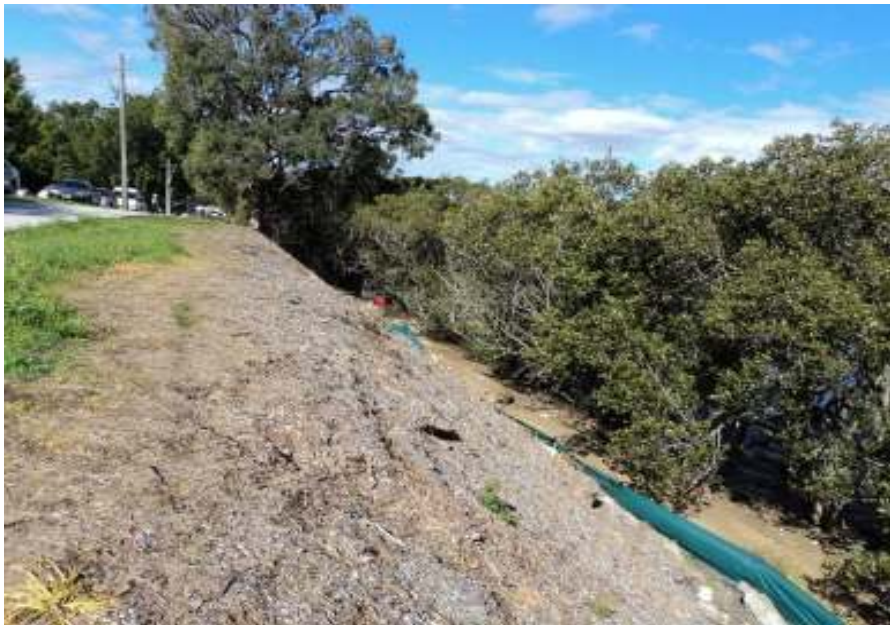
Photo C - Foreshore batter - in front of property 34, facing south-east

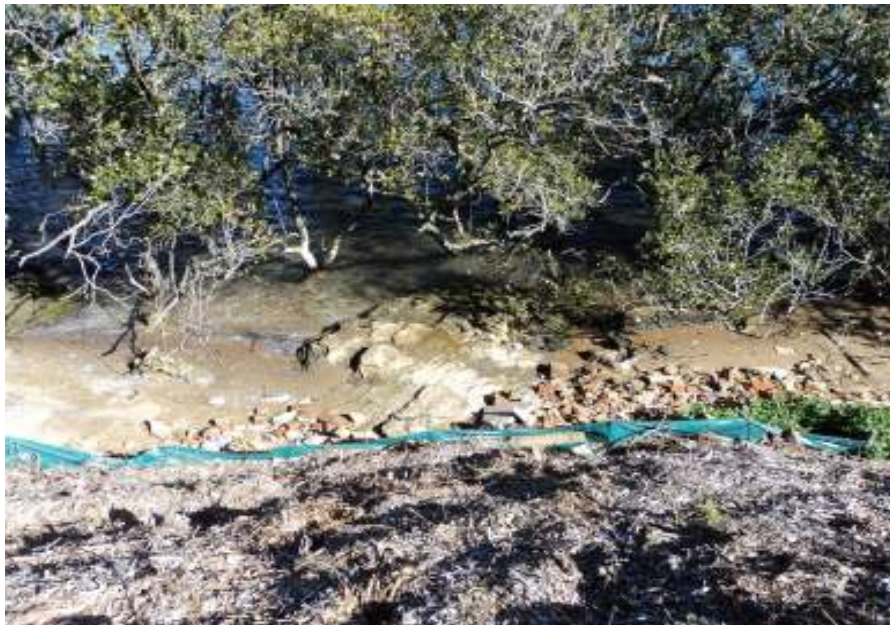
Photo D - Batter toe - in front of property 34, facing ssouth-west

Note possible sandstone boulder at toe

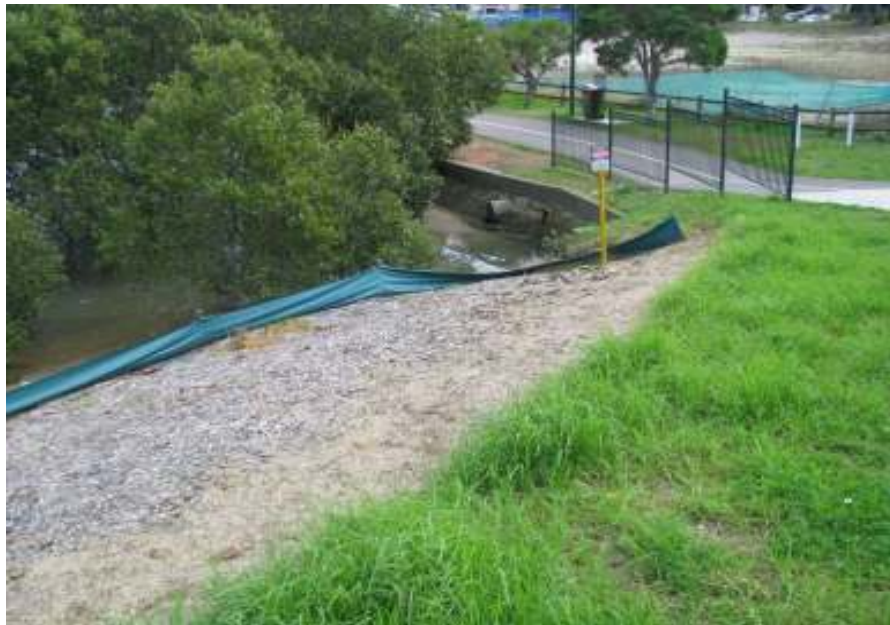
Photo D - Foreshore batter - in front of property 34, facing north-west

Note existing stormwater drain at sandstone seawall
