HAZARDOUS SUBSTANCE AUDIT

15 WATCHHOUSE ROAD PROSPECT NSW

RCA ref 7062-405Haz1/2

**HAZARDOUS SUBSTANCE AUDIT AND MANAGEMENT PLAN
PROPOSED WET 'N' WILD WATER THEME PARK
15 WATCHHOUSE ROAD, PROSPECT**

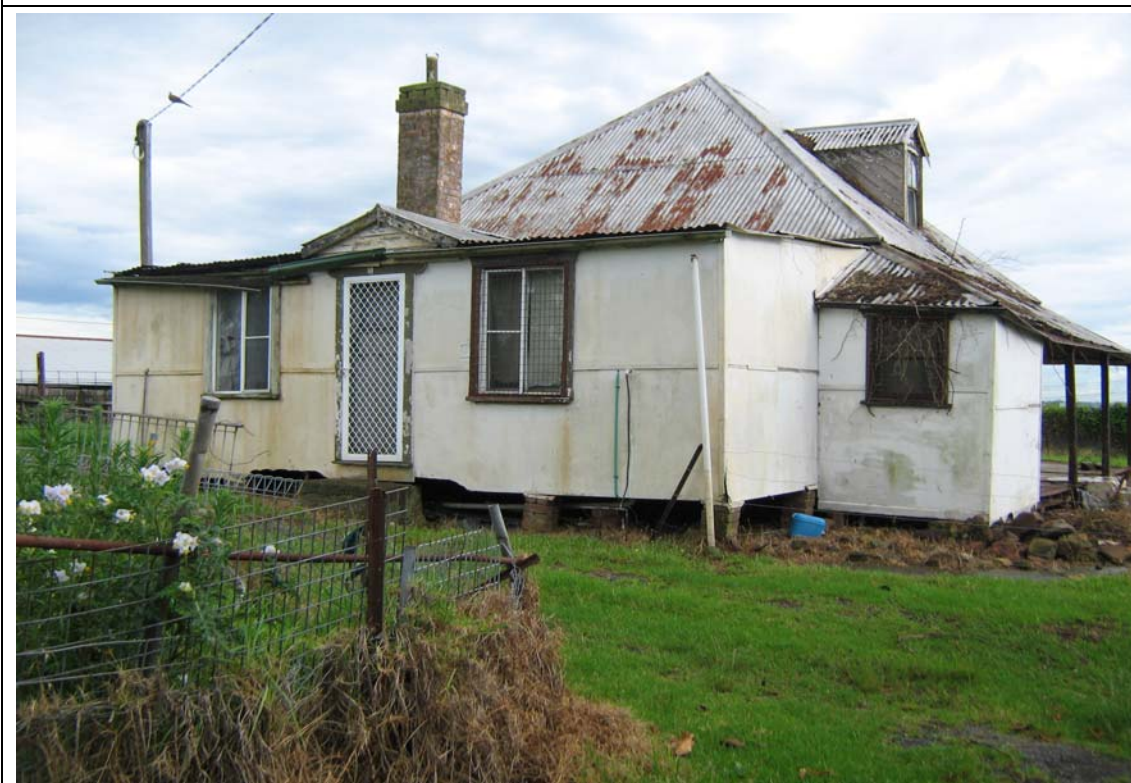
PHOTOGRAPH 2 *Extension of police cottage with AC sheeting on exterior walls*

Prior to demolition, the sheeting at the above locations is to be treated as asbestos and removed by a licensed asbestos removal contractor in accordance with the requirements of WorkCover NSW and the National Occupational Health and Safety Commission Code of Practice for the Safe Removal of Asbestos 2nd Edition [NOHSC: 2002 (2005)], the Guide to the Control of Asbestos Hazard in Buildings and Structures [NOHSC: 3002 (1988)] and AS 2601-2001 The Demolition of Structures.

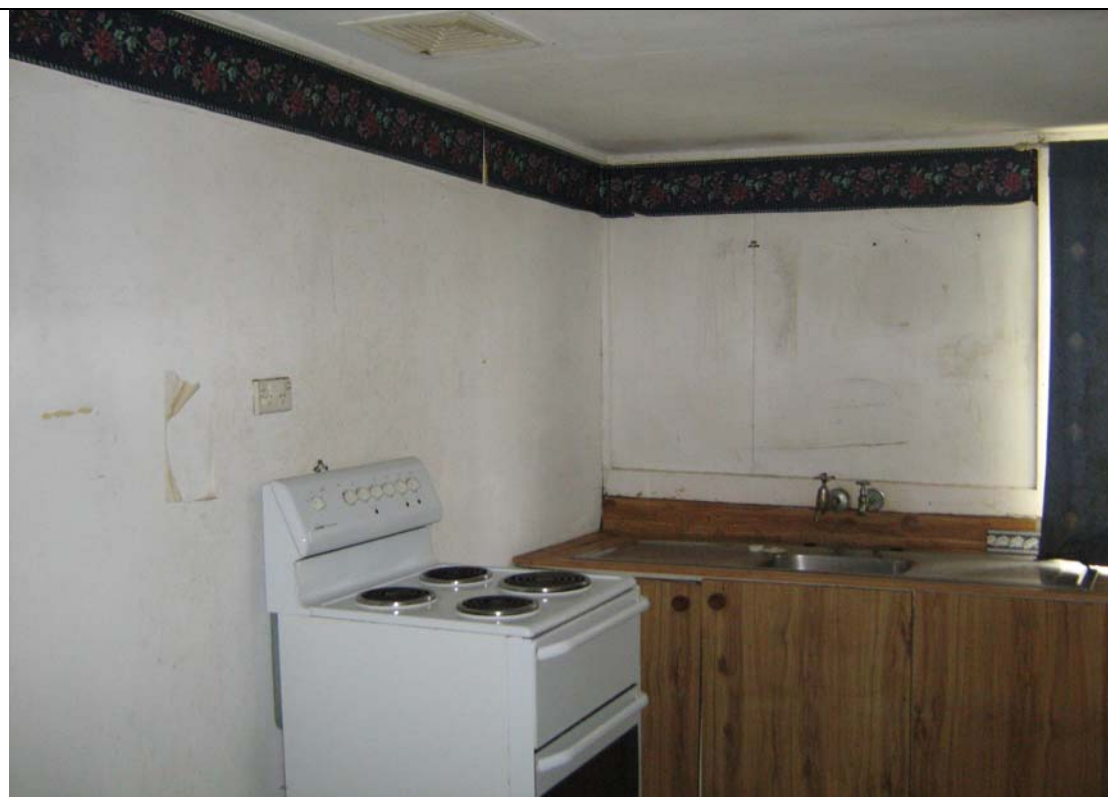
PHOTOGRAPH 4 *AC sheeting on interior walls of kitchen*

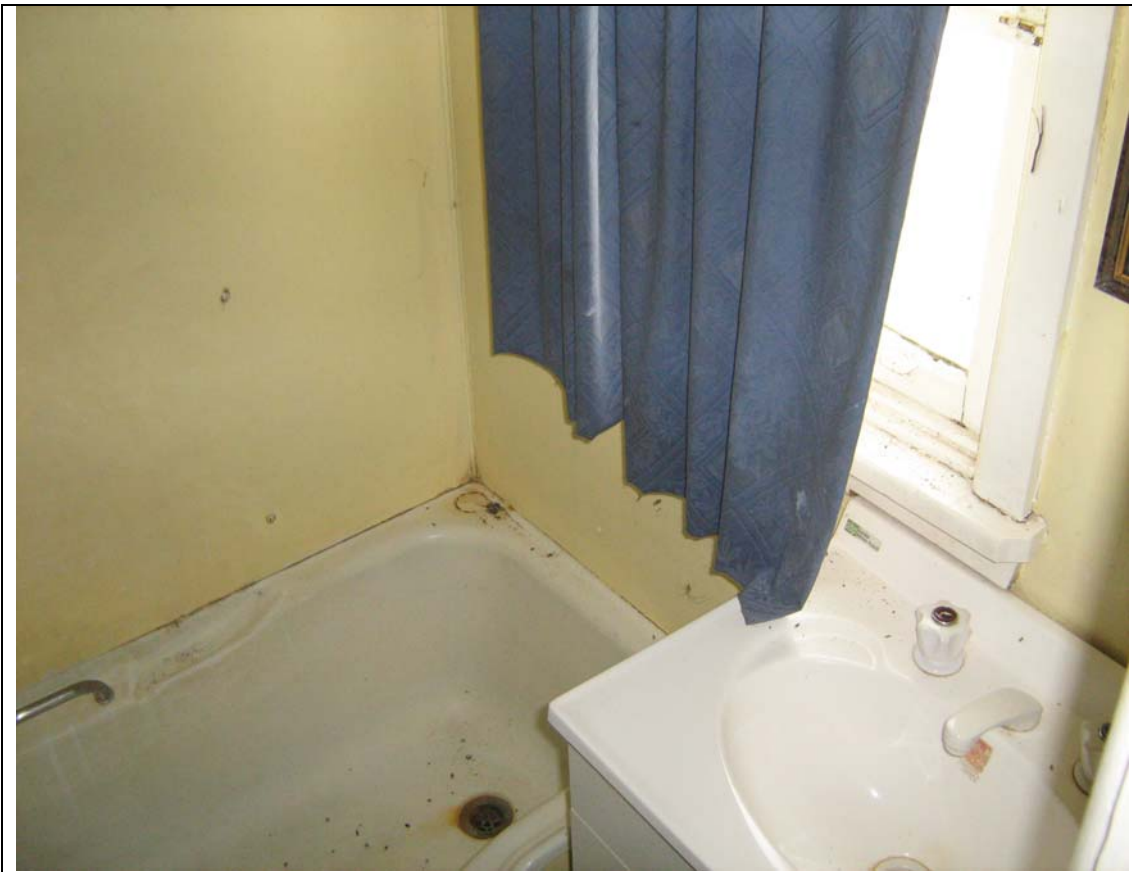
- Flat AC sheeting on the walls in the bathroom.

PHOTOGRAPH 5 *AC sheeting on interior walls of bathroom*

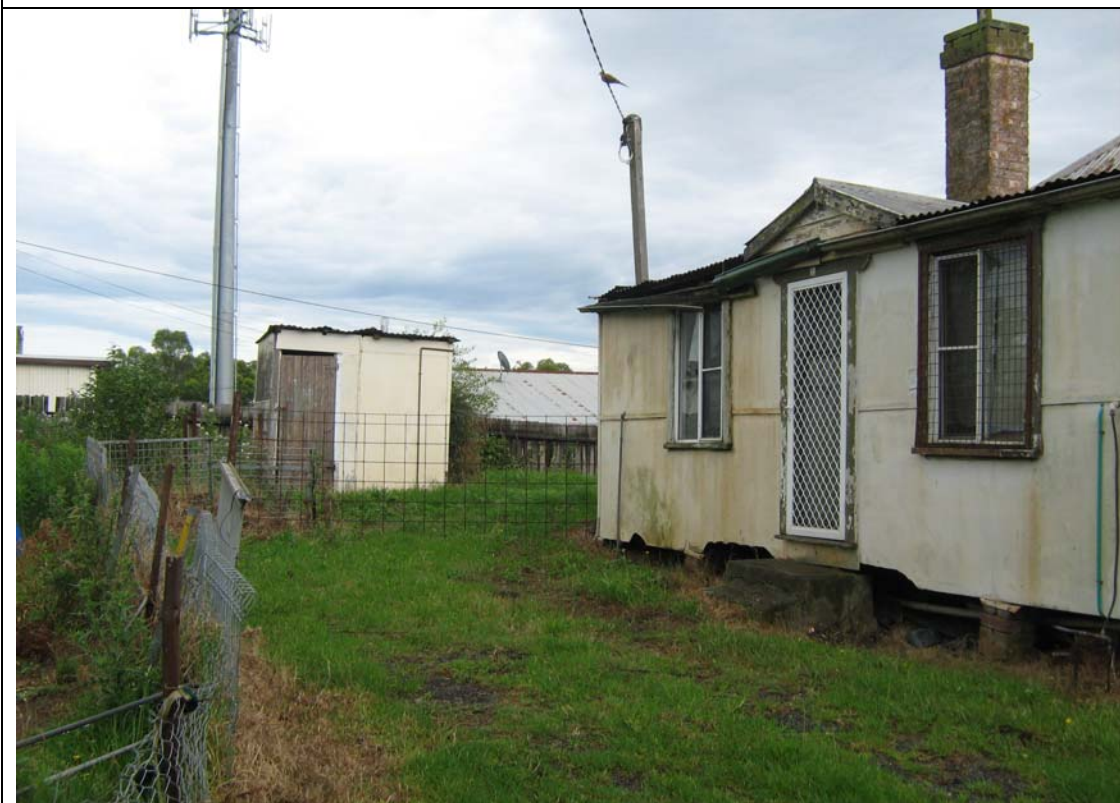
PHOTOGRAPH 6 *Exterior AC sheeting walls of cottage extension and detached WC*

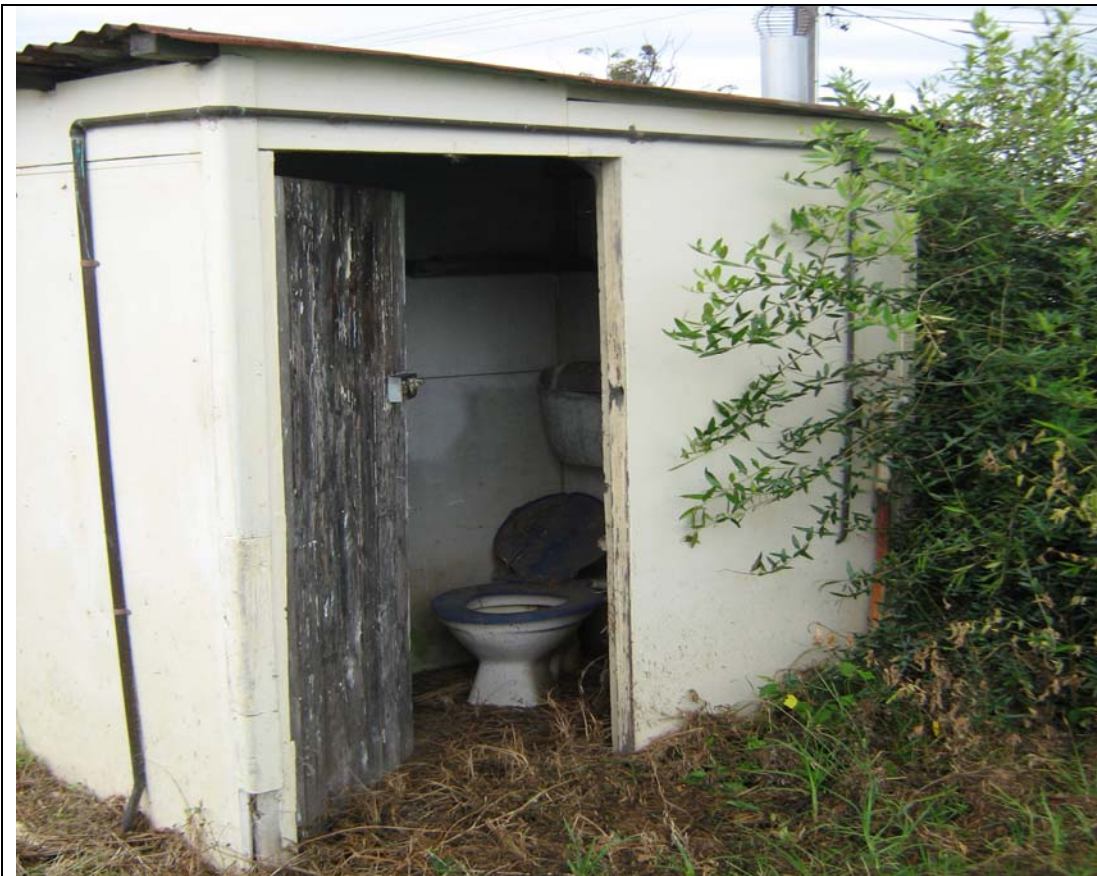
PHOTOGRAPH 7 *AC sheeting on exterior and interior walls of WC*

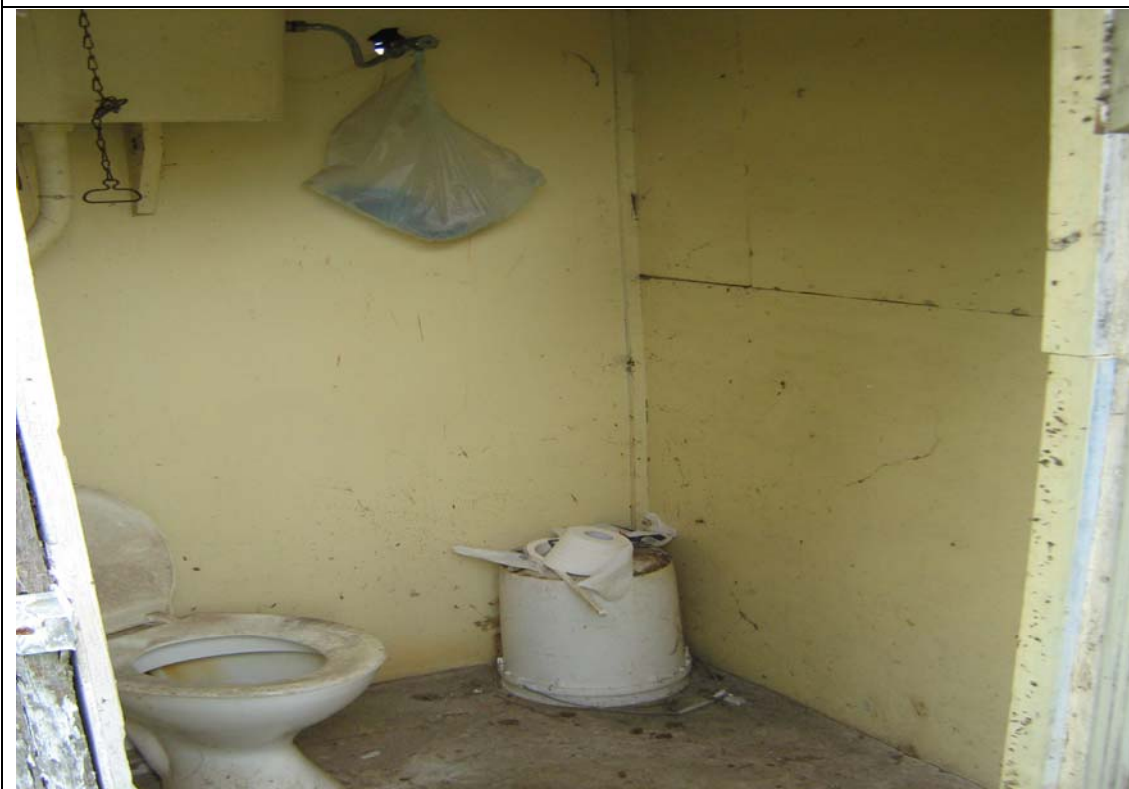
PHOTOGRAPH 8 *AC sheeting on interior walls of WC*

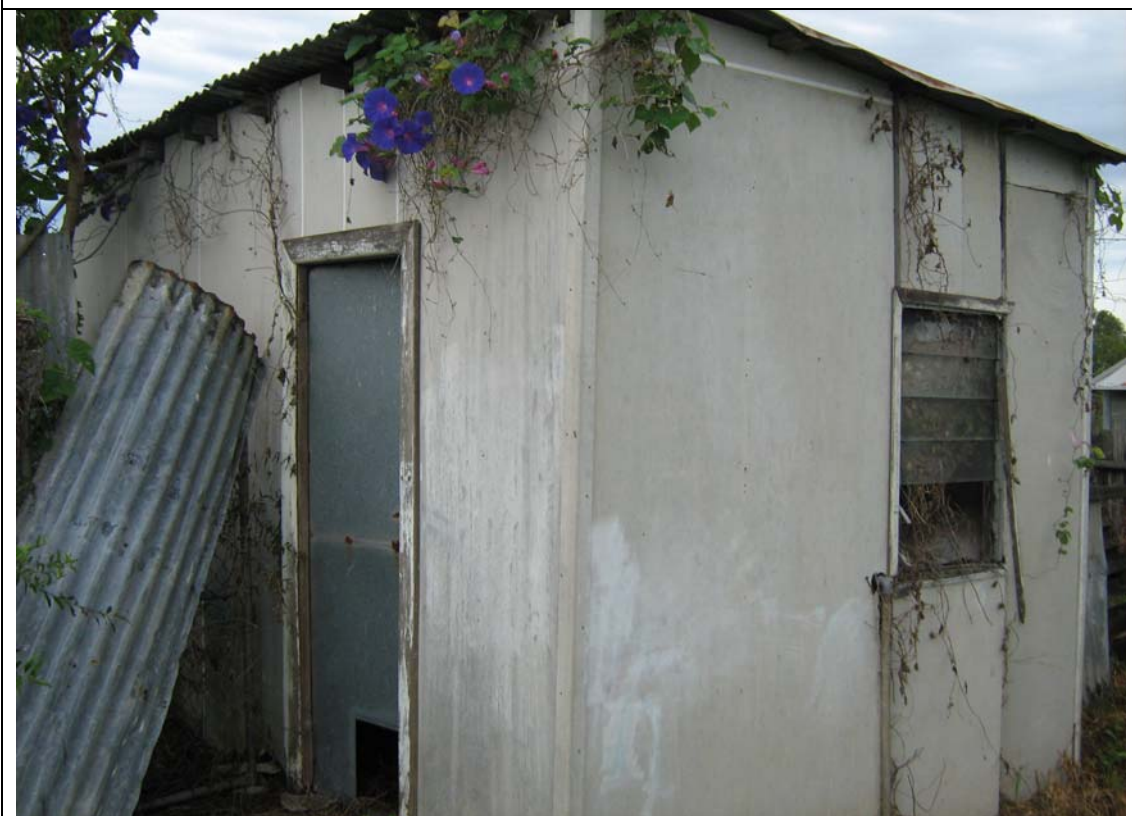
- Flat AC sheeting on the walls.

PHOTOGRAPH 10 *AC sheeting exterior walls and iron roof of detached laundry*

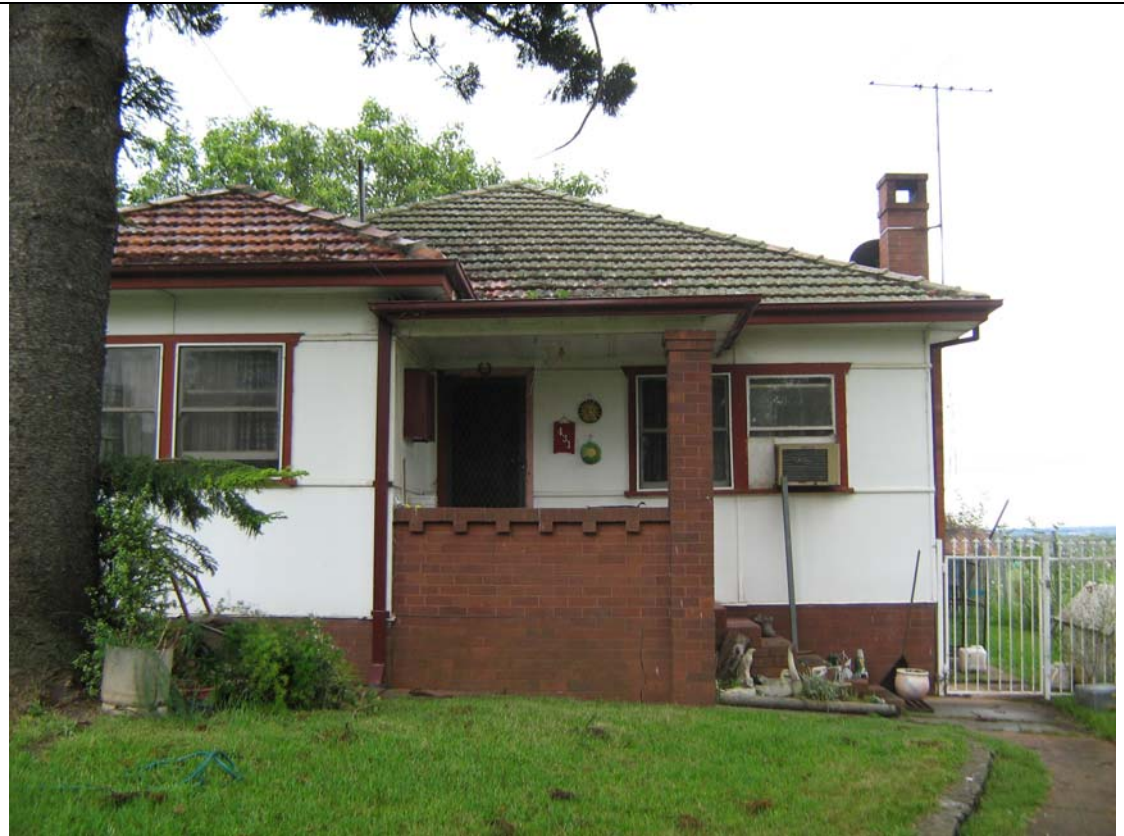
- Flat AC sheeting under the eaves.
- Flat AC sheeting on the walls.

PHOTOGRAPH 1 *Front of house showing AC sheeting on exterior walls*

Prior to demolition, the sheeting at the above locations is to be treated as asbestos and removed by a licensed asbestos removal contractor in accordance with the requirements of WorkCover NSW and the National Occupational Health and Safety Commission Code of Practice for the Safe Removal of Asbestos 2nd Edition [NOHSC: 2002 (2005)], the Guide to the Control of Asbestos Hazard in Buildings and Structures [NOHSC: 3002 (1988)] and AS 2601-2001 The Demolition of Structures.

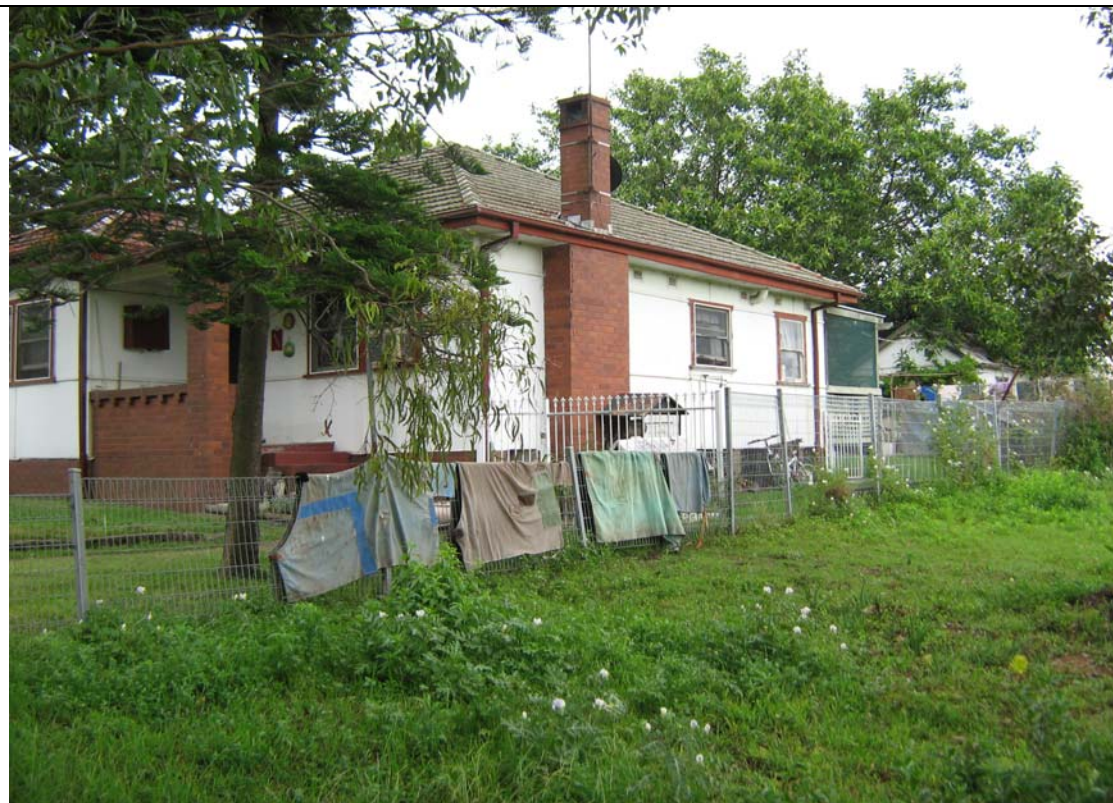
PHOTOGRAPH 2 *AC sheeting on exterior walls at front and side of house and laundry at the rear*

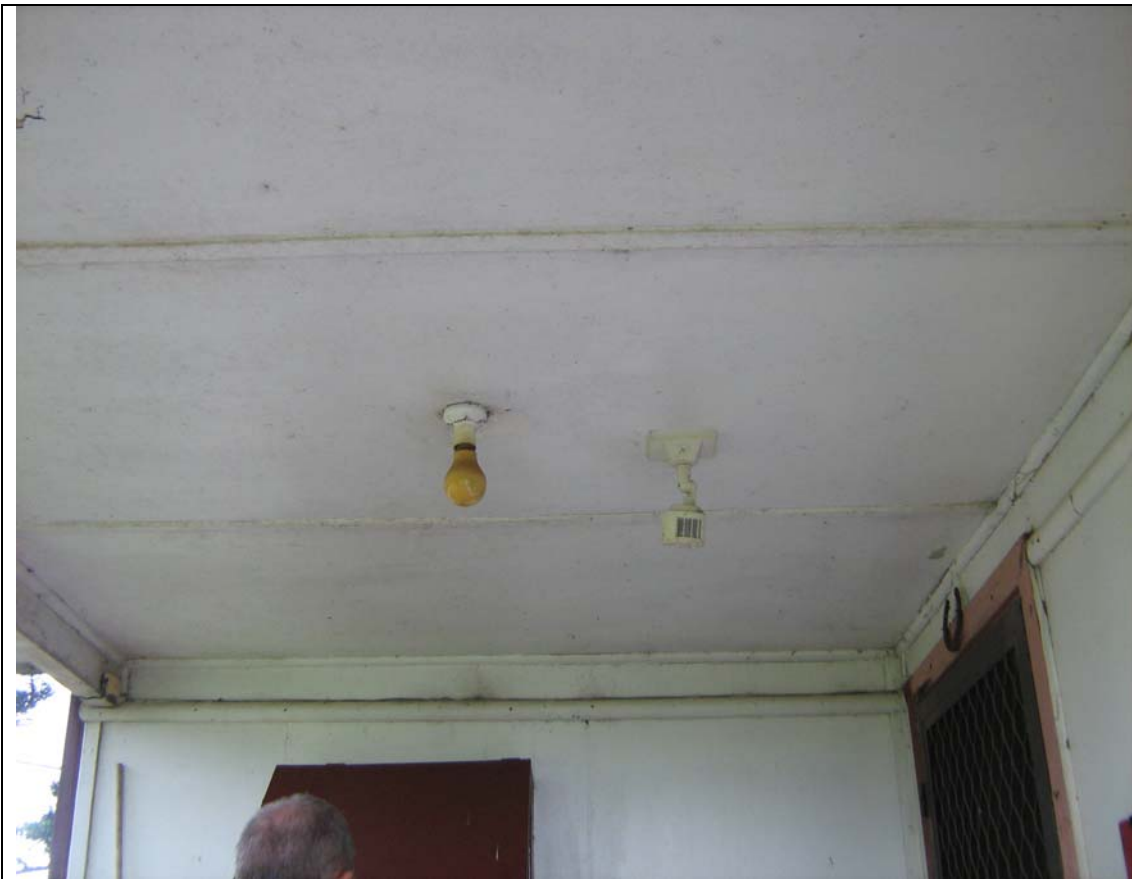
PHOTOGRAPH 3 *AC sheeting on ceiling of front verandah of house*

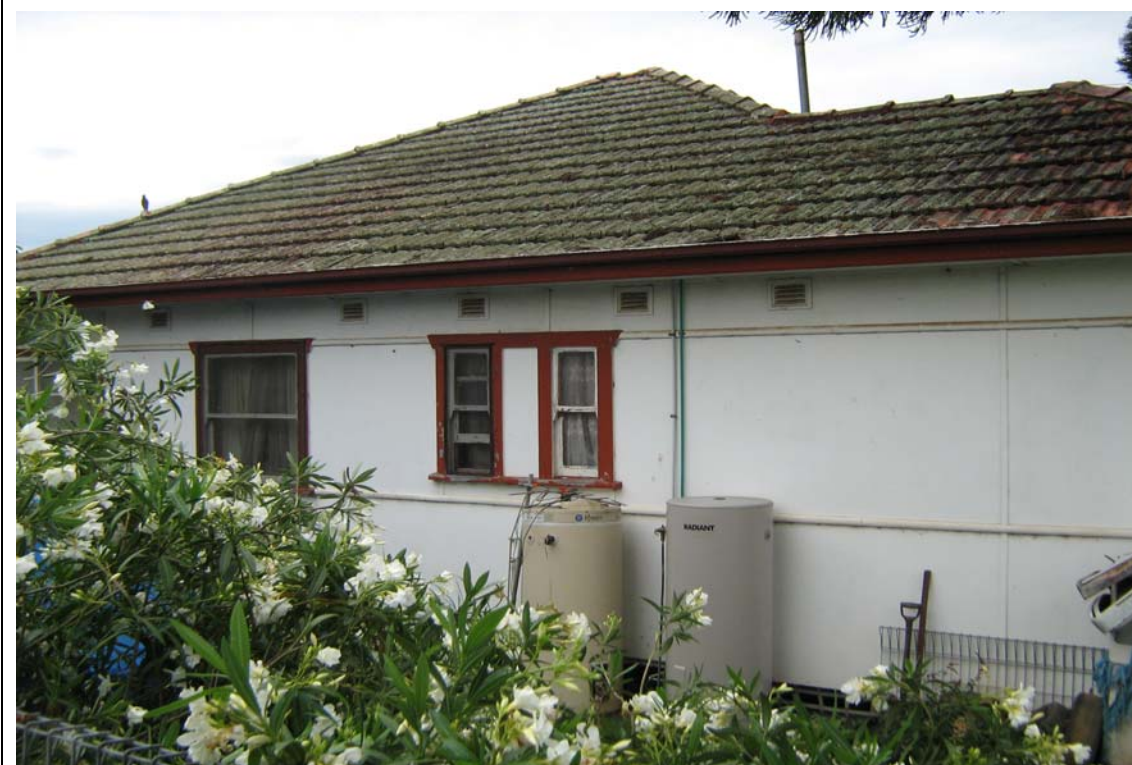
PHOTOGRAPH 4 *AC sheeting on exterior walls at side of house*

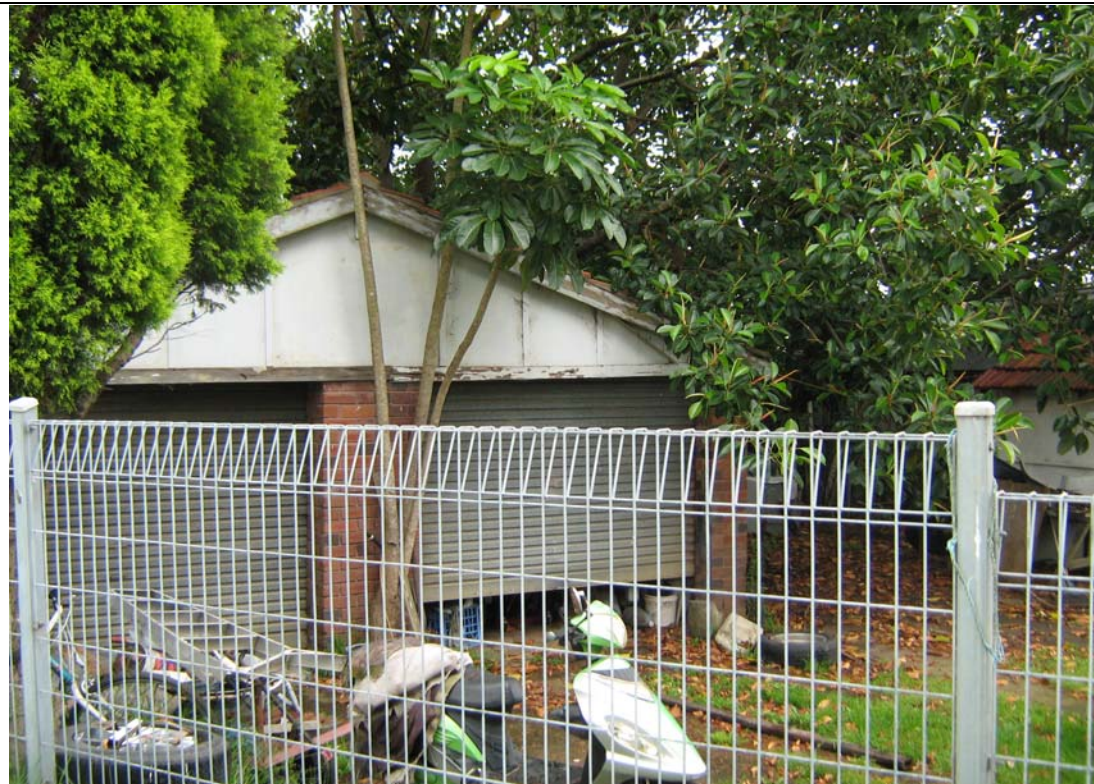
- AC Gable at both ends of garage.

PHOTOGRAPH 6 *Front of Double garage showing front gable end*

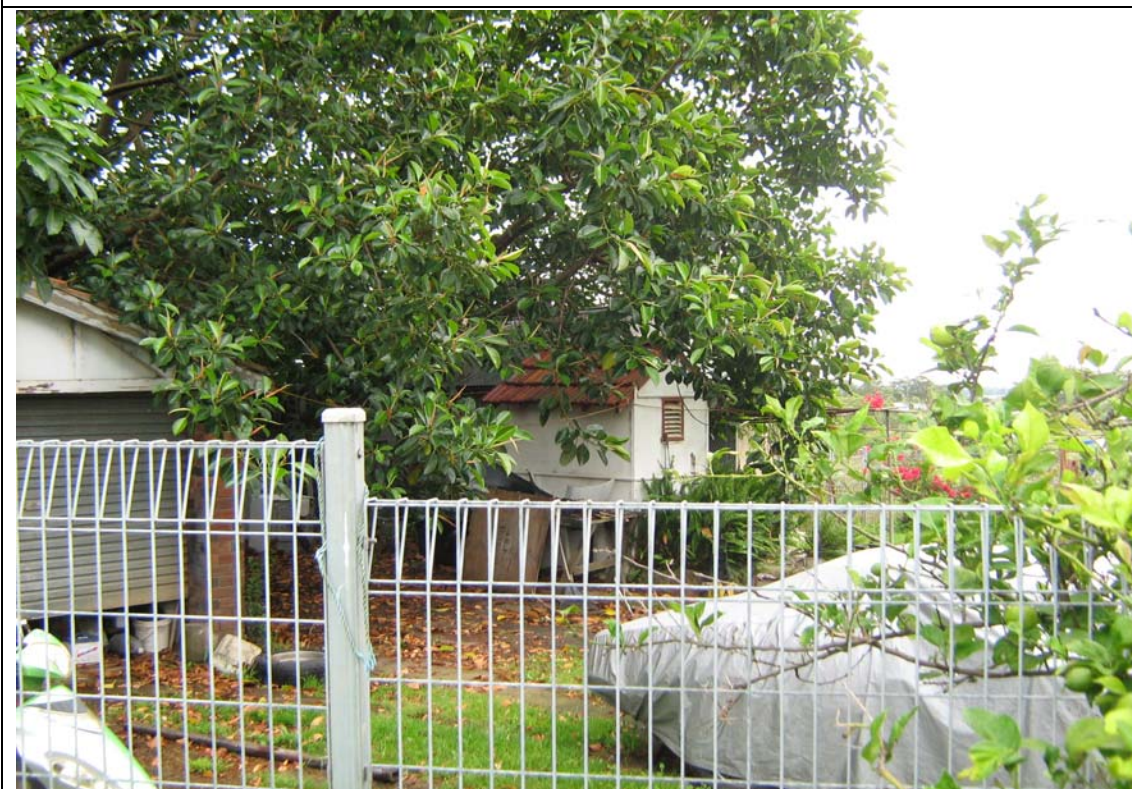
- AC sheeting on the exterior walls.

PHOTOGRAPH 8 *AC sheeting on exterior of W.C (right building)*

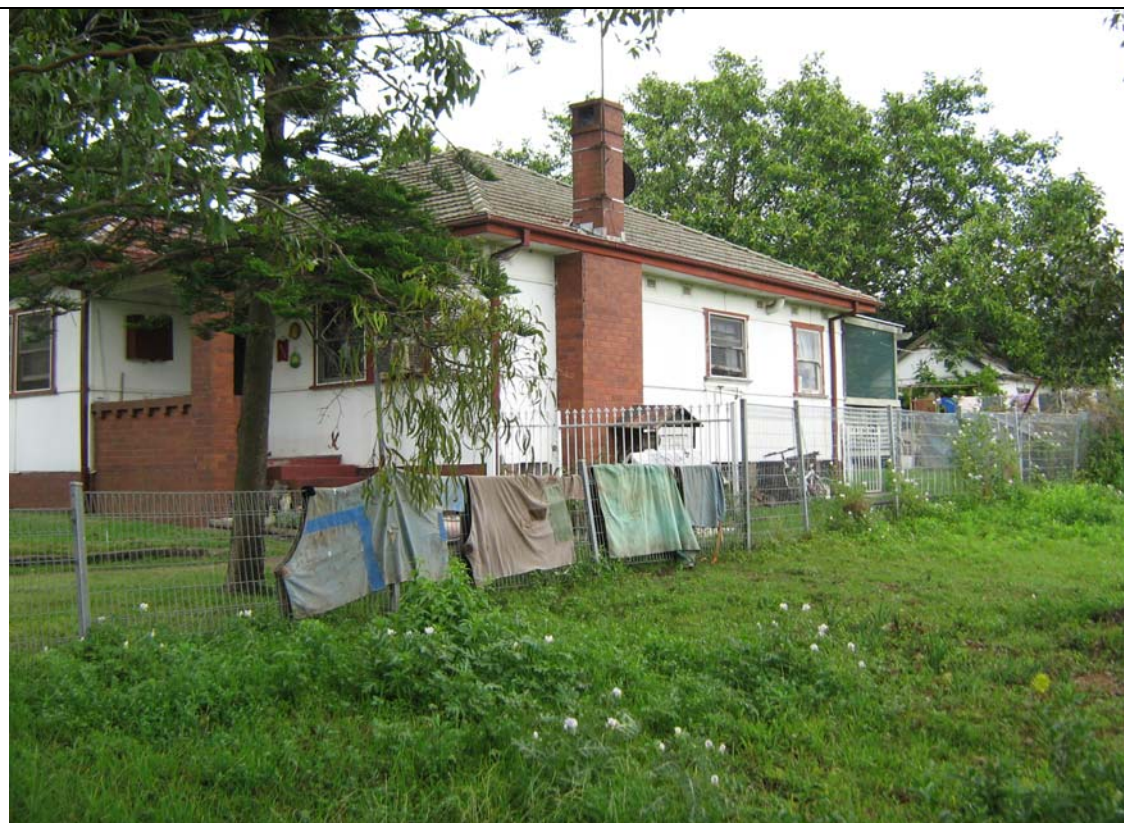
PHOTOGRAPH 9 *AC sheeting on side of house and laundry*

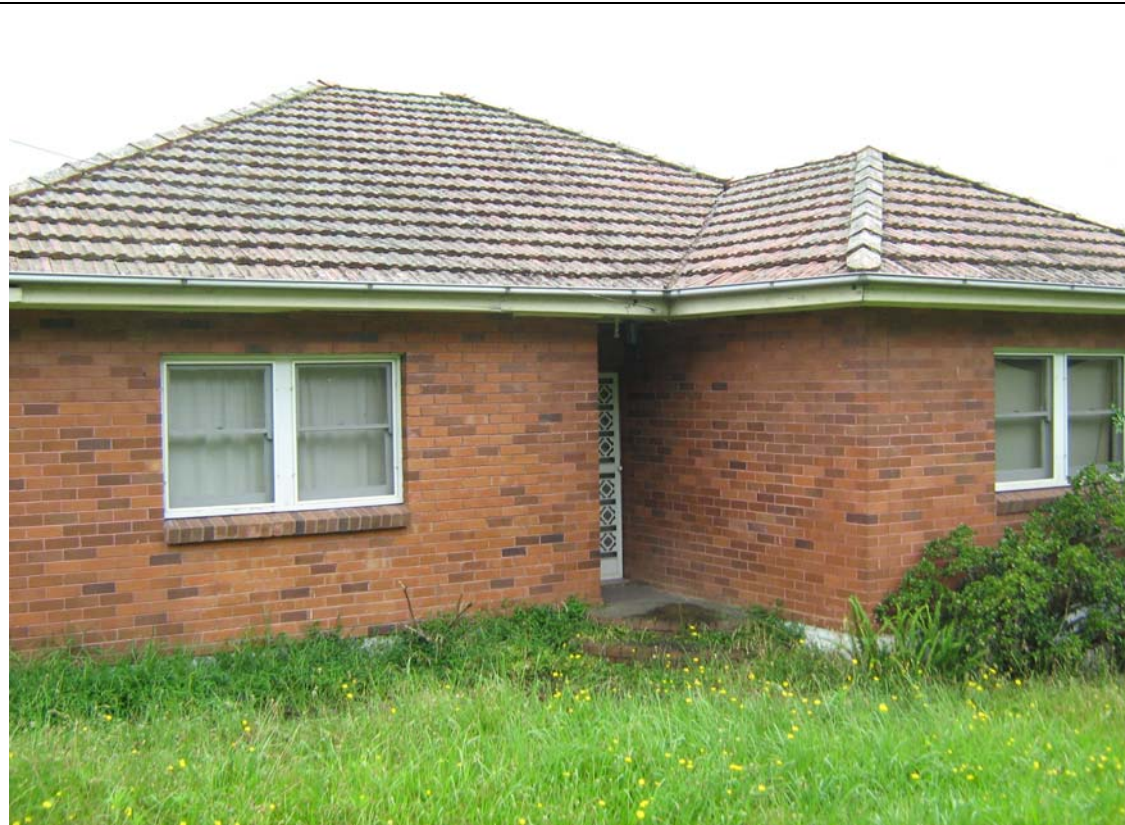
PHOTOGRAPH 3 *Exterior of house and porch with AC ceiling*

Prior to demolition, the sheeting at the above locations is to be treated as asbestos and removed by a licensed asbestos removal contractor in accordance with the requirements of WorkCover NSW and the National Occupational Health and Safety Commission Code of Practice for the Safe Removal of Asbestos 2nd Edition [NOHSC: 2002 (2005)], the Guide to the Control of Asbestos Hazard in Buildings and Structures [NOHSC: 3002 (1988)] and AS 2601-2001 The Demolition of Structures.

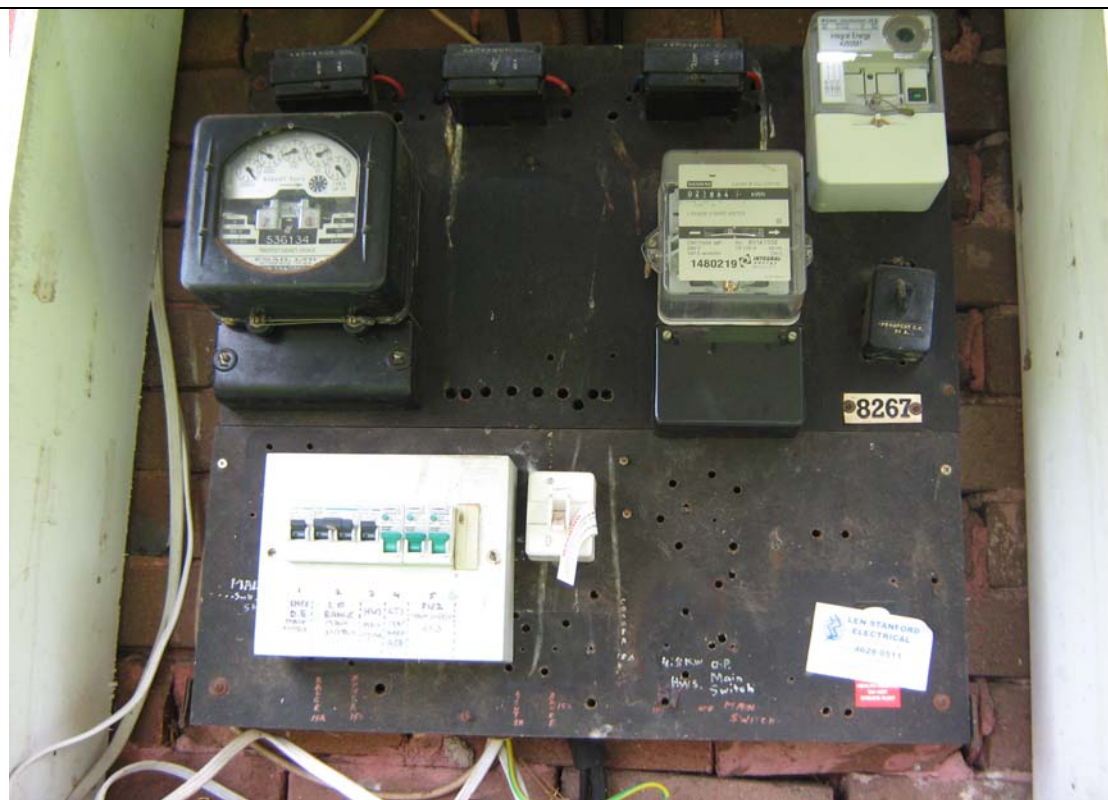
PHOTOGRAPH 4 *Asbestos meter box backboard*

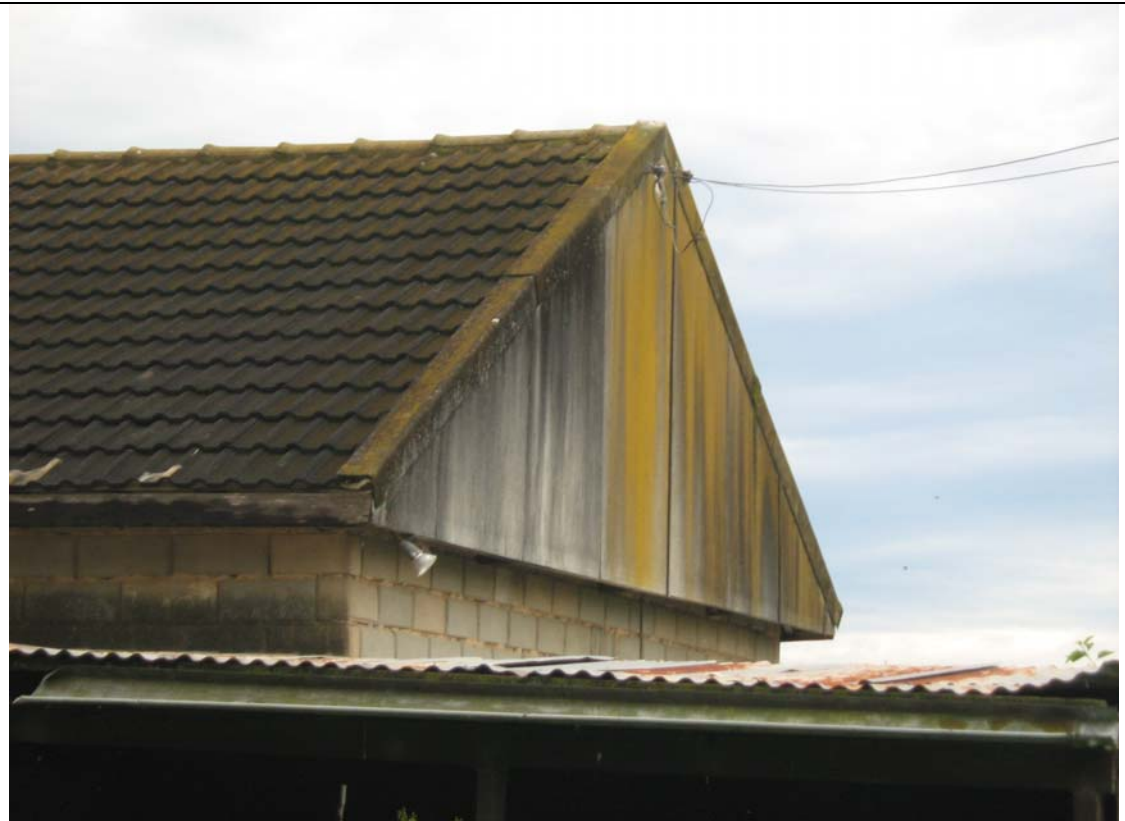
PHOTOGRAPH 7 *Gable ends of detached double garage*

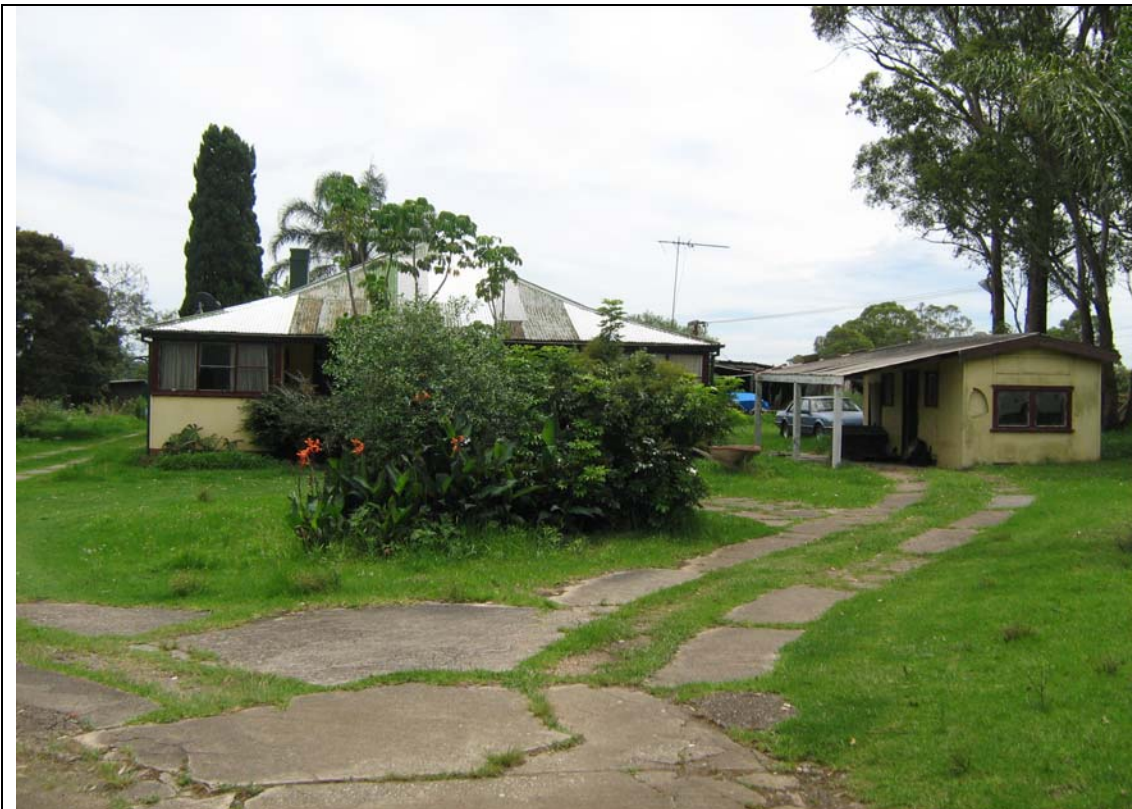
PHOTOGRAPH 1 *Front exterior of main house with detached garage and carport with iron roof and AC sheeting walls*

Prior to demolition, the sheeting at the above locations is to be treated as asbestos and removed by a licensed asbestos removal contractor in accordance with the requirements of WorkCover NSW and the National Occupational Health and Safety Commission Code of Practice for the Safe Removal of Asbestos 2nd Edition [NOHSC: 2002 (2005)], the Guide to the Control of Asbestos Hazard in Buildings and Structures [NOHSC: 3002 (1988)] and AS 2601-2001 The Demolition of Structures.

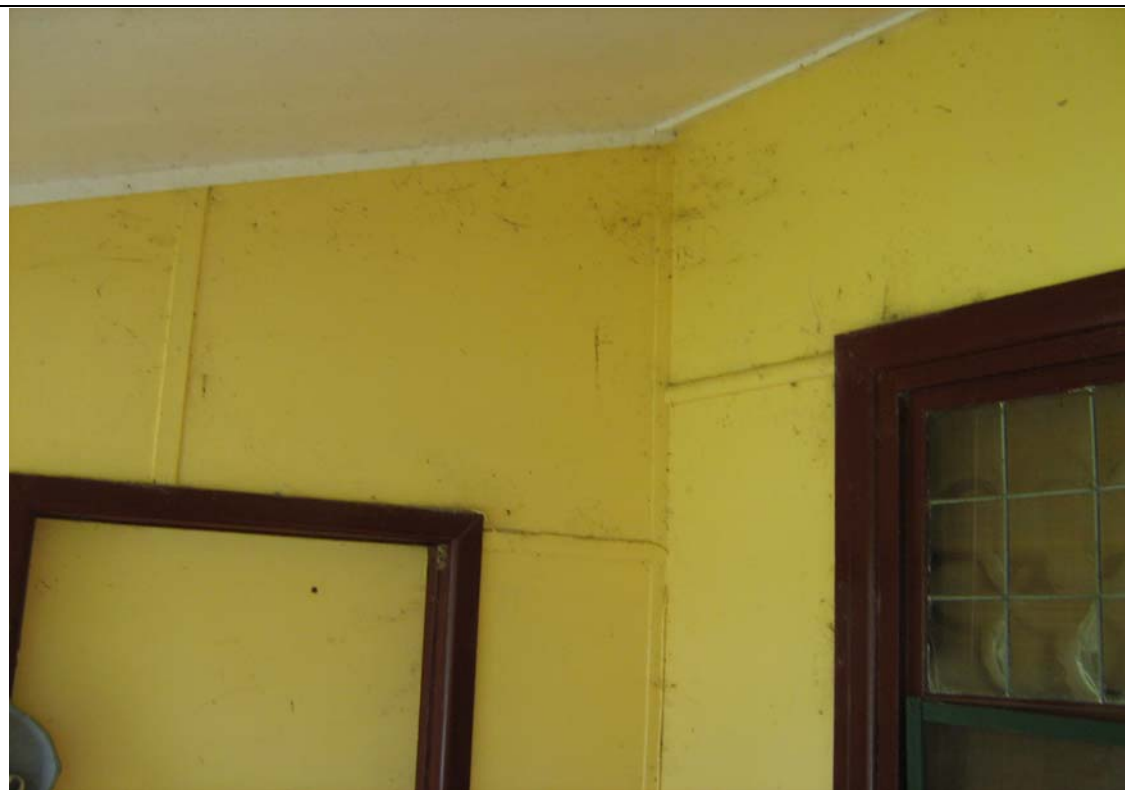
PHOTOGRAPH 2 *AC sheeting exterior walls of house*

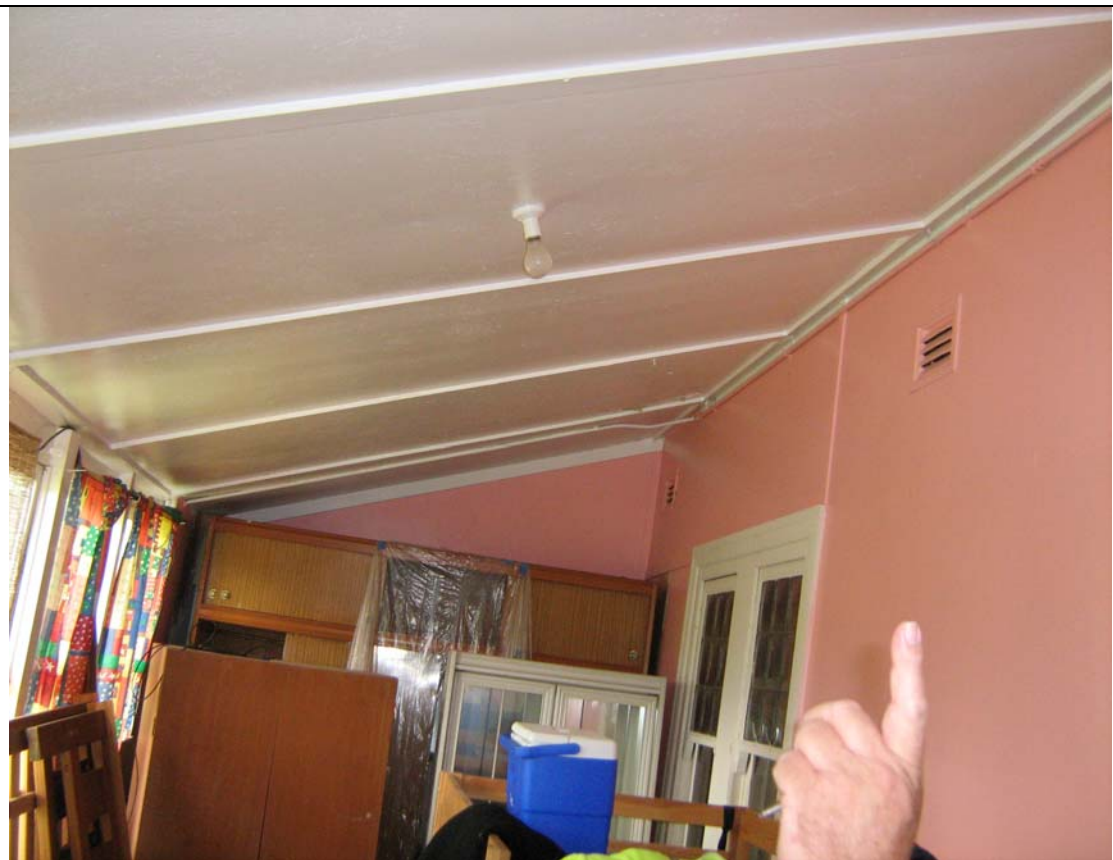
PHOTOGRAPH 4 *AC walls and ceiling of closed in verandah off bedroom*

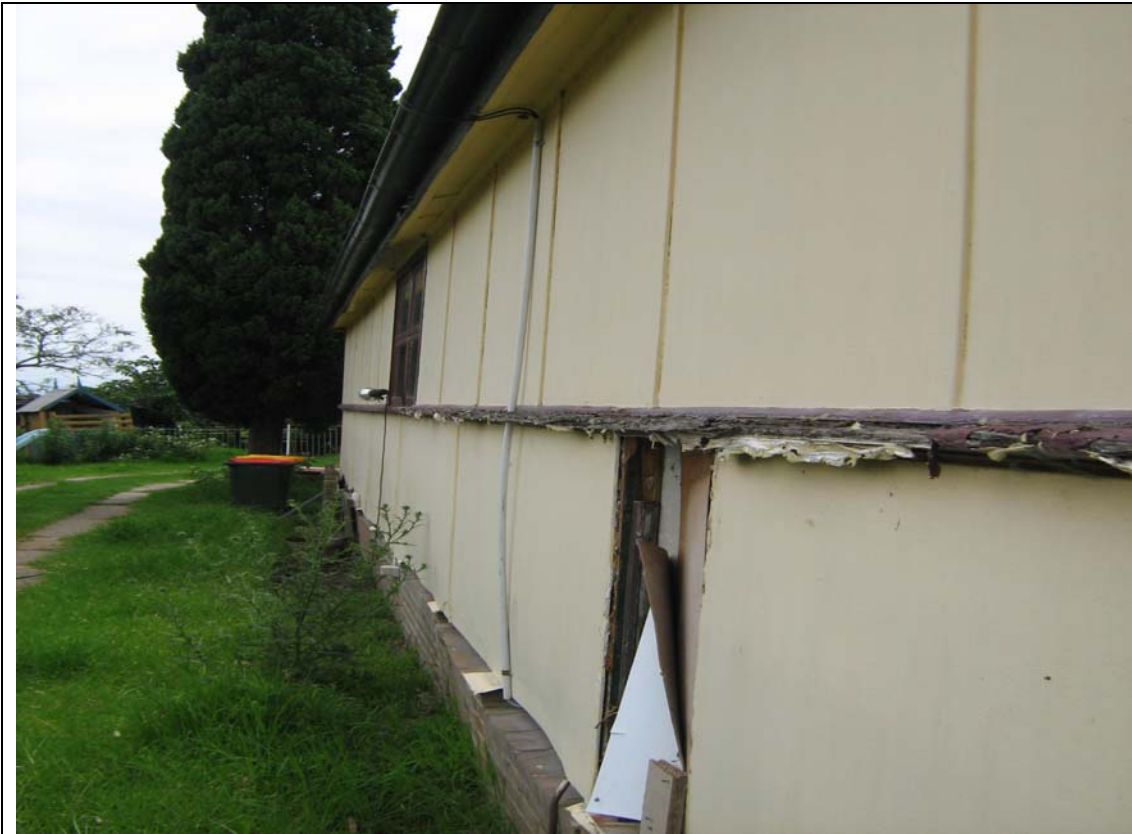
PHOTOGRAPH 5 *AC sheeting on side exterior of house*

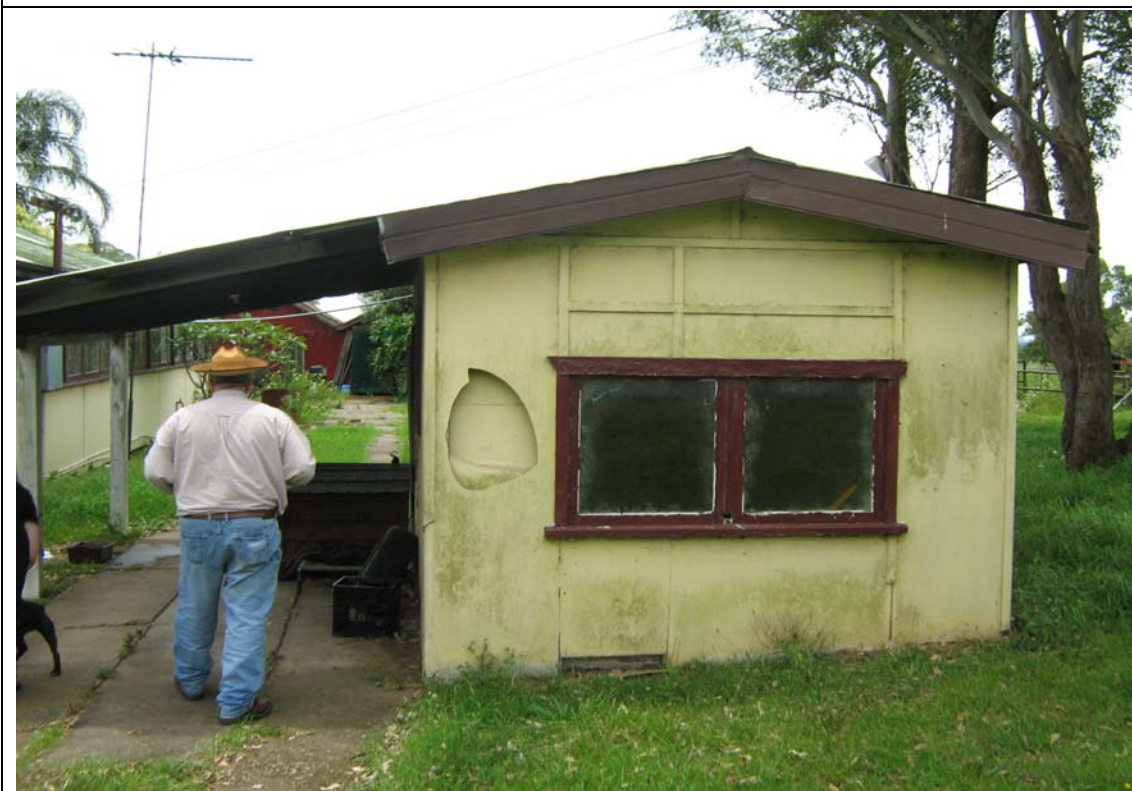
PHOTOGRAPH 6 *AC sheeting on exterior of garage*

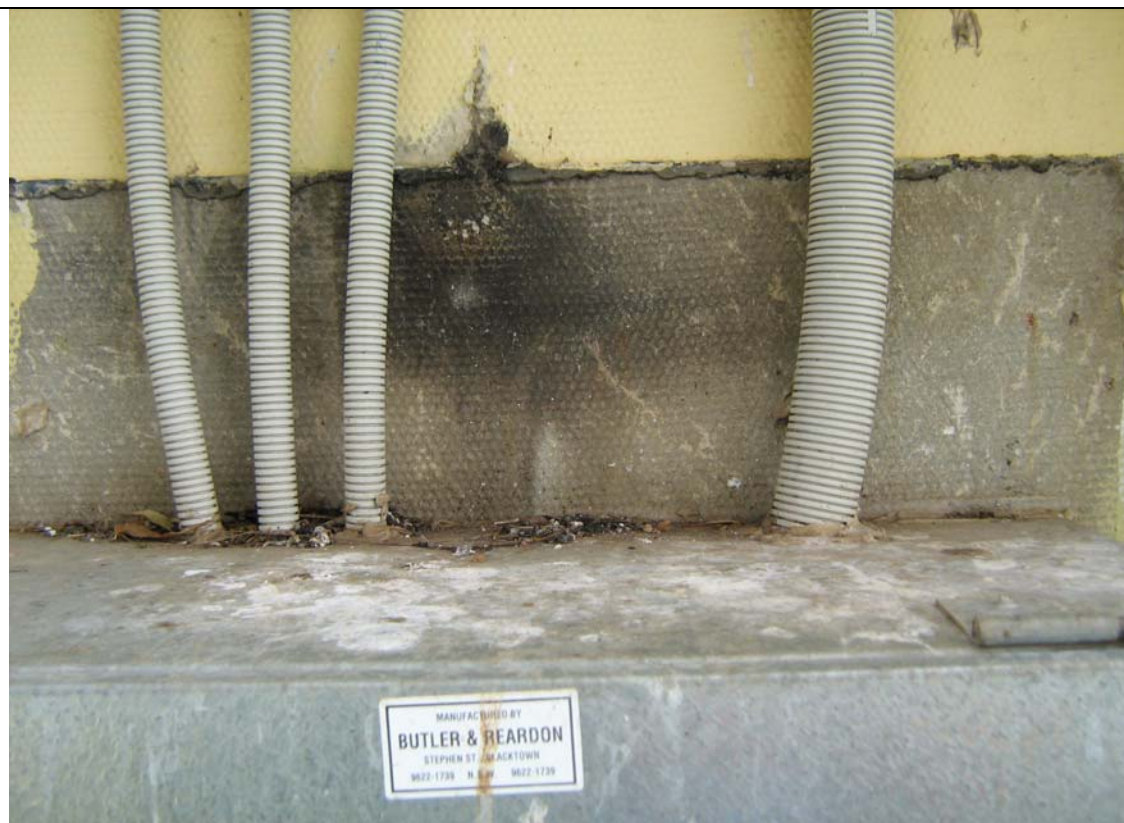
PHOTOGRAPH 7 *Close up of asbestos sheeting above the meter box*

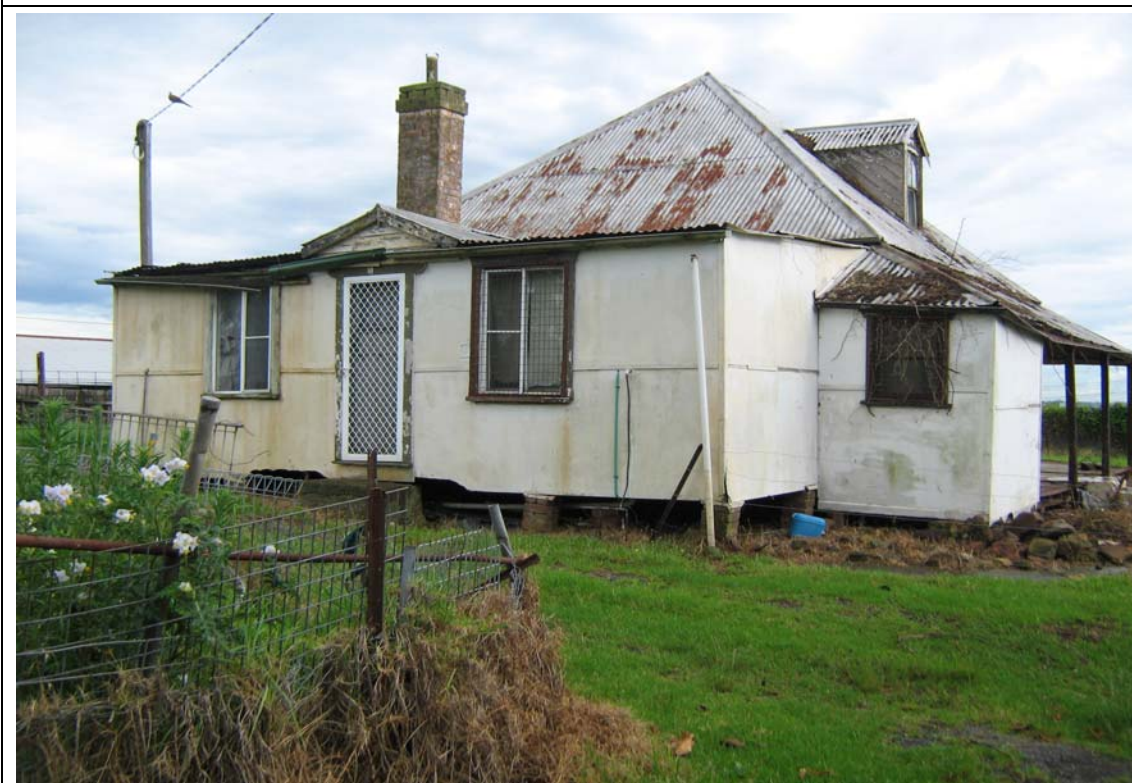
PHOTOGRAPH 2 *Extension of police cottage with AC sheeting on exterior walls*

Prior to demolition, the sheeting at the above locations is to be treated as asbestos and removed by a licensed asbestos removal contractor in accordance with the requirements of WorkCover NSW and the National Occupational Health and Safety Commission Code of Practice for the Safe Removal of Asbestos 2nd Edition [NOHSC: 2002 (2005)], the Guide to the Control of Asbestos Hazard in Buildings and Structures [NOHSC: 3002 (1988)] and AS 2601-2001 The Demolition of Structures.
