HAZARDOUS SUBSTANCE AUDIT

15 WATCHHOUSE ROAD PROSPECT NSW

RCA ref 7062-405Haz1/2

**HAZARDOUS SUBSTANCE AUDIT AND MANAGEMENT PLAN
PROPOSED WET 'N' WILD WATER THEME PARK
15 WATCHHOUSE ROAD, PROSPECT**

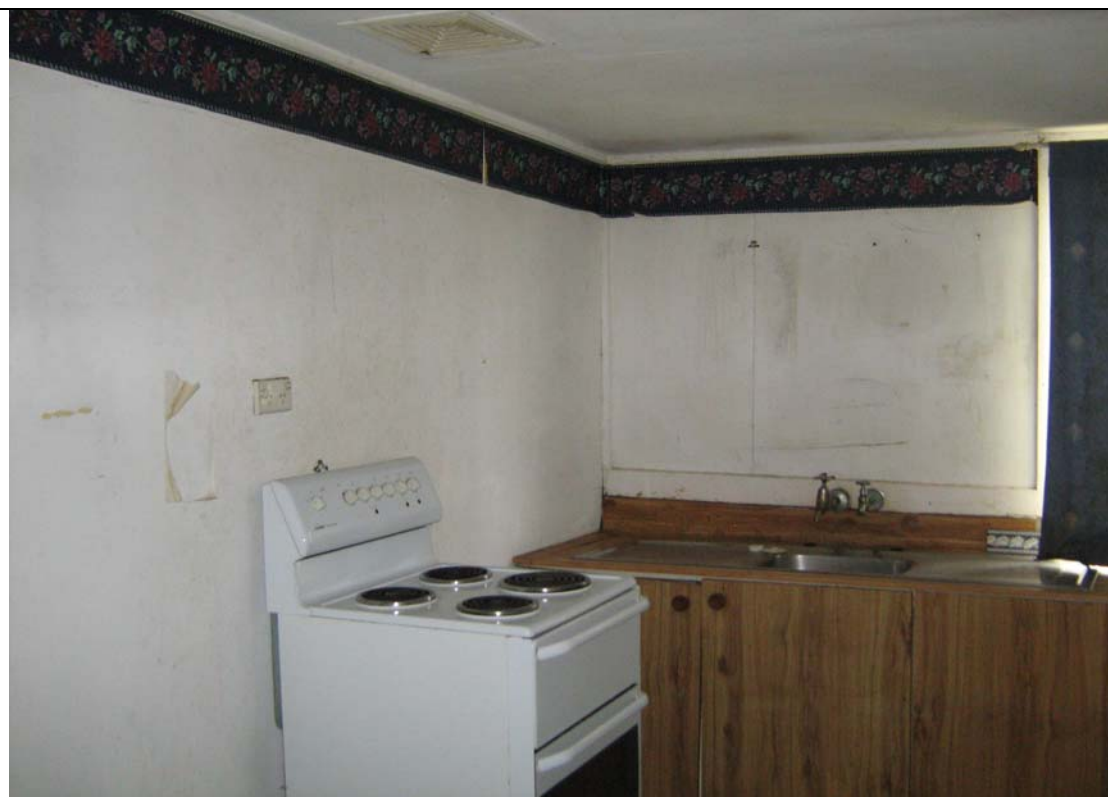
PHOTOGRAPH 4 *AC sheeting on interior walls of kitchen*

Prior to demolition, the sheeting at the above locations is to be treated as asbestos and removed by a licensed asbestos removal contractor in accordance with the requirements of WorkCover NSW and the National Occupational Health and Safety Commission Code of Practice for the Safe Removal of Asbestos 2nd Edition [NOHSC: 2002 (2005)], the Guide to the Control of Asbestos Hazard in Buildings and Structures [NOHSC: 3002 (1988)] and AS 2601-2001 The Demolition of Structures.

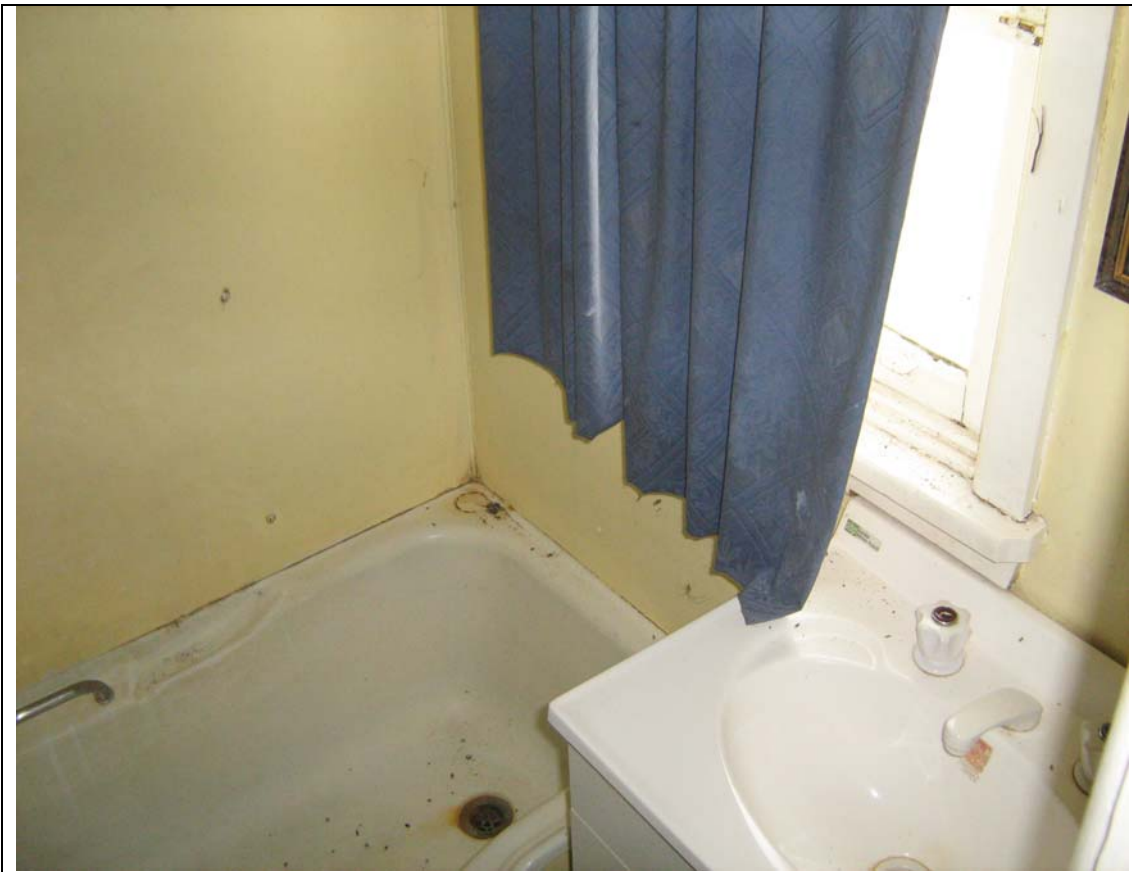
PHOTOGRAPH 5 *AC sheeting on interior walls of bathroom*

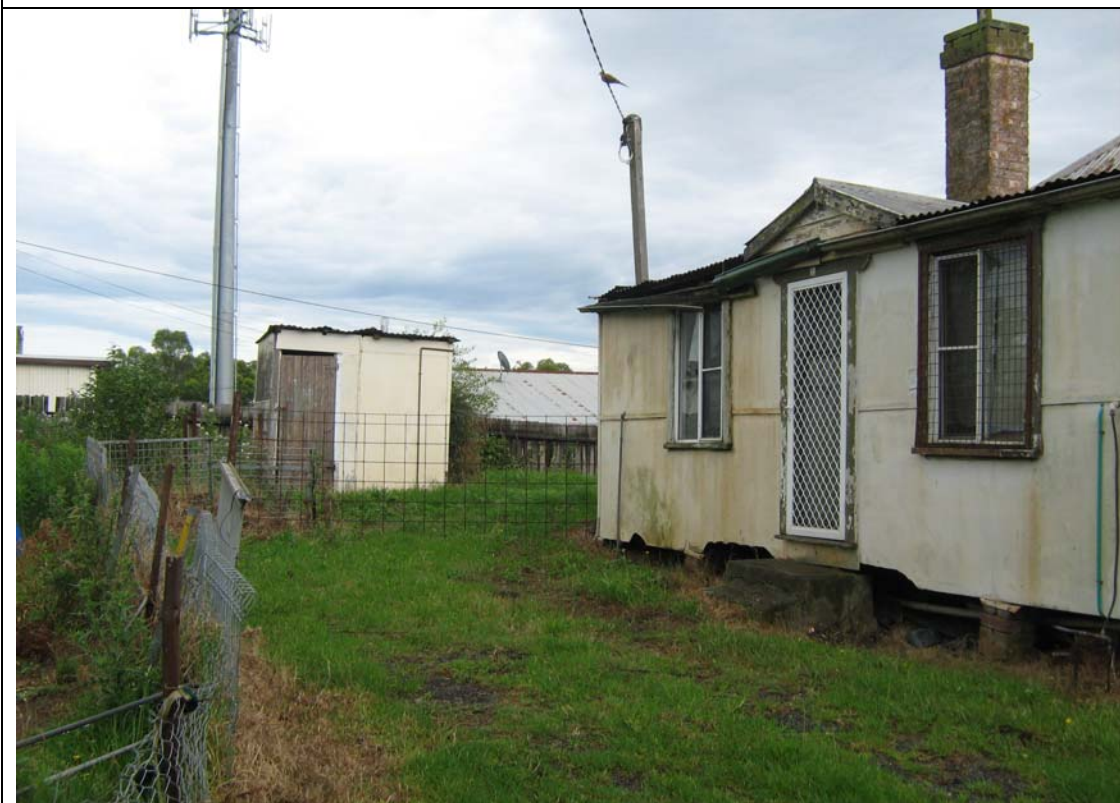
PHOTOGRAPH 6 *Exterior AC sheeting walls of cottage extension and detached WC*

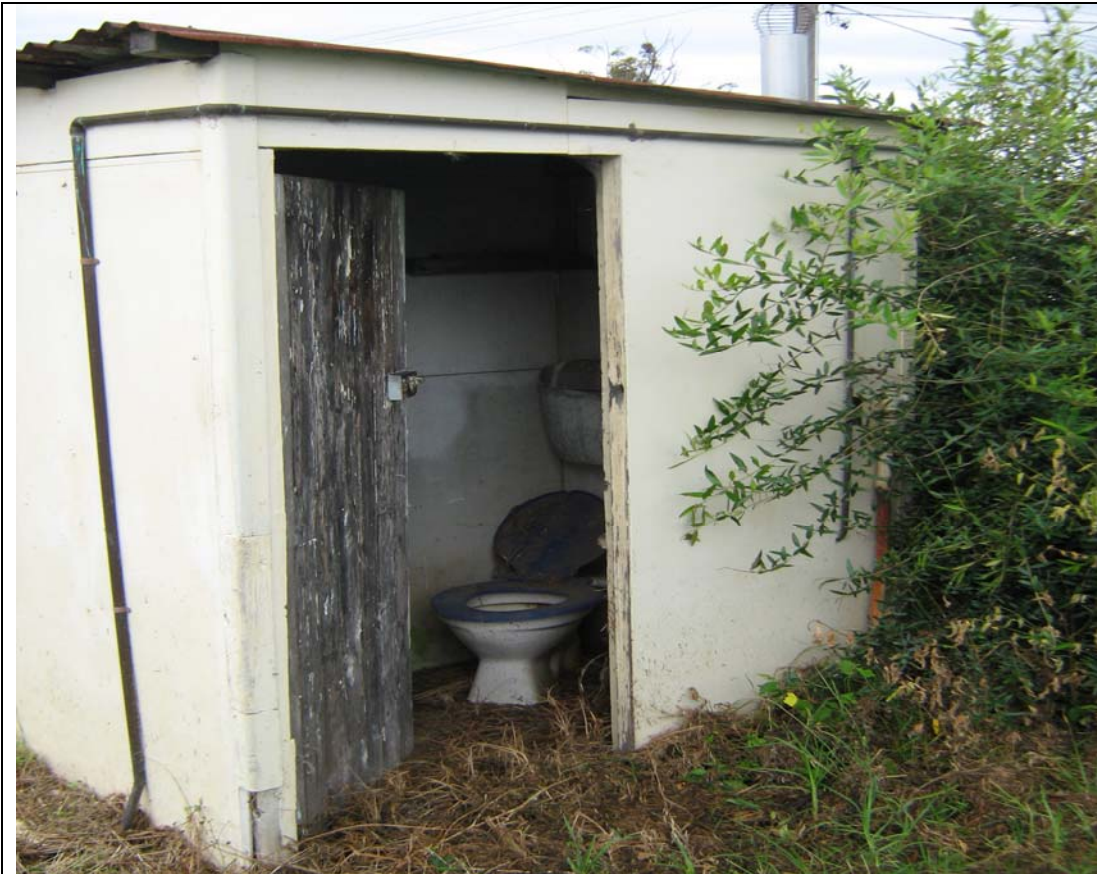
PHOTOGRAPH 7 *AC sheeting on exterior and interior walls of WC*

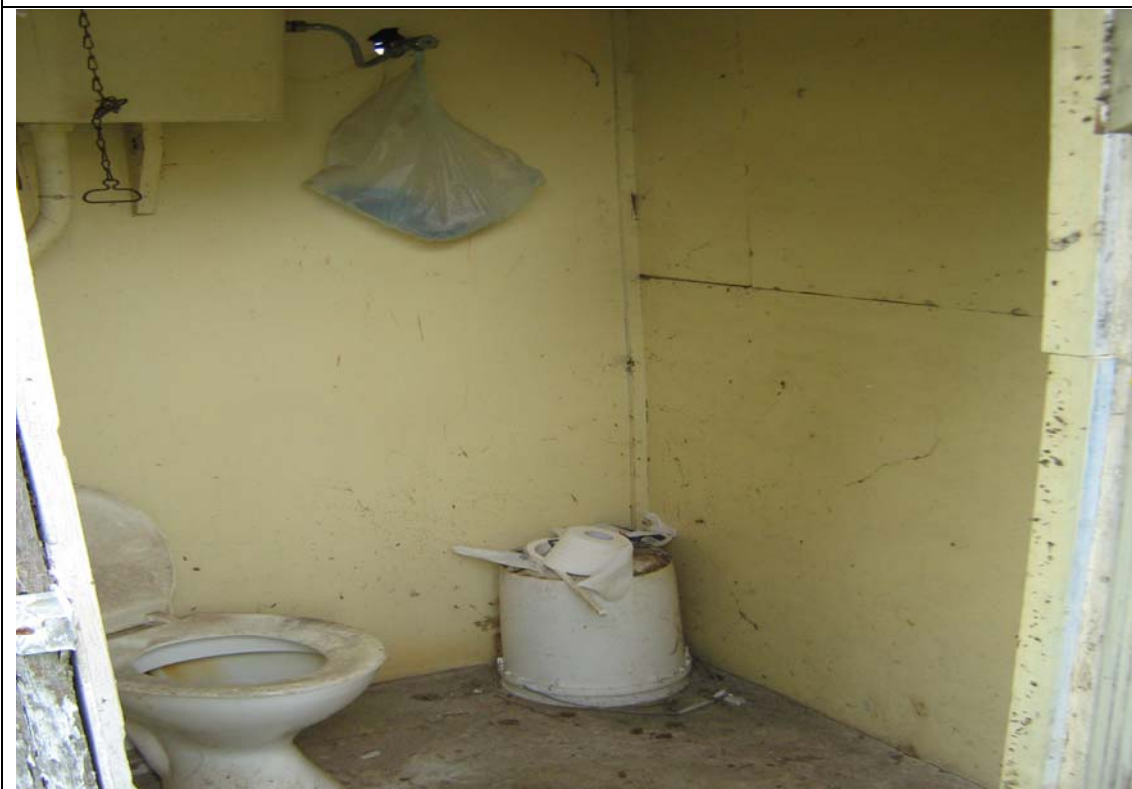
PHOTOGRAPH 8 *AC sheeting on interior walls of WC*

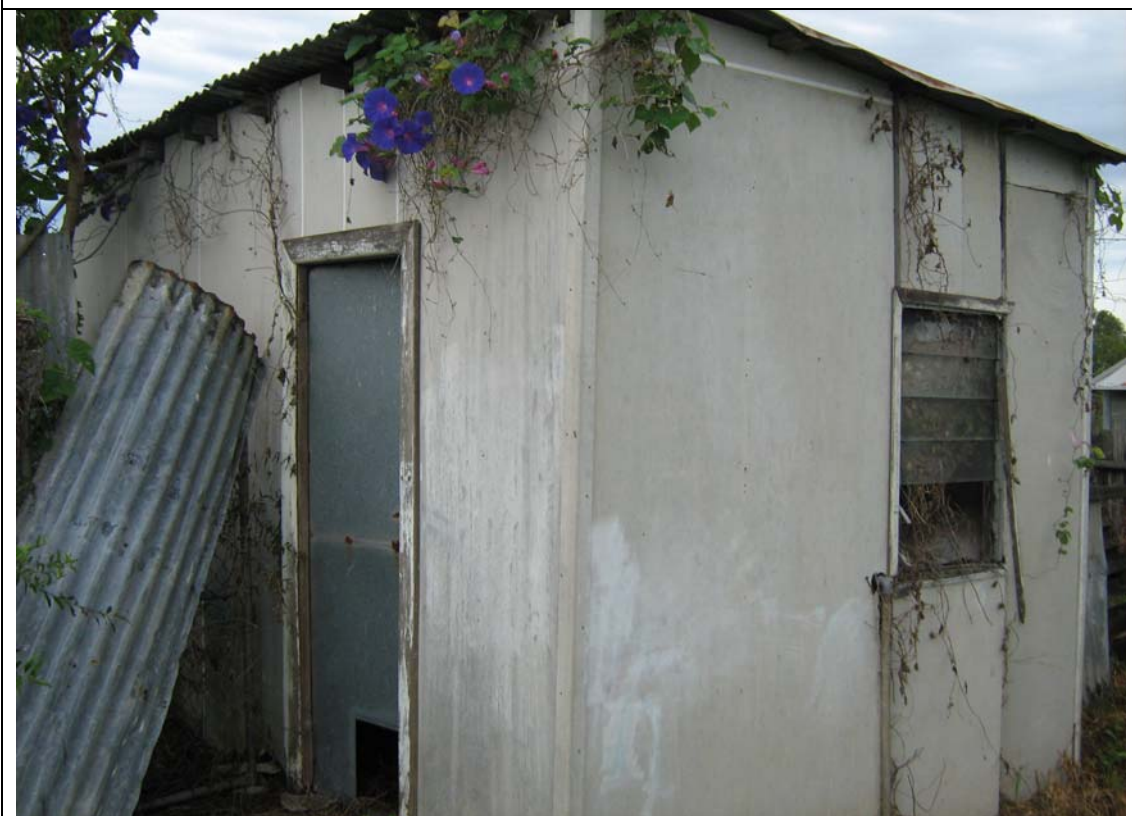
PHOTOGRAPH 10 *AC sheeting exterior walls and iron roof of detached laundry*
