**MINE SUBSIDENCE RISK ASSESSMENT**

**PROPOSED RESIDENTIAL DEVELOPMENT**

**MINMI AND LINK ROAD**

**Project 39663.07**

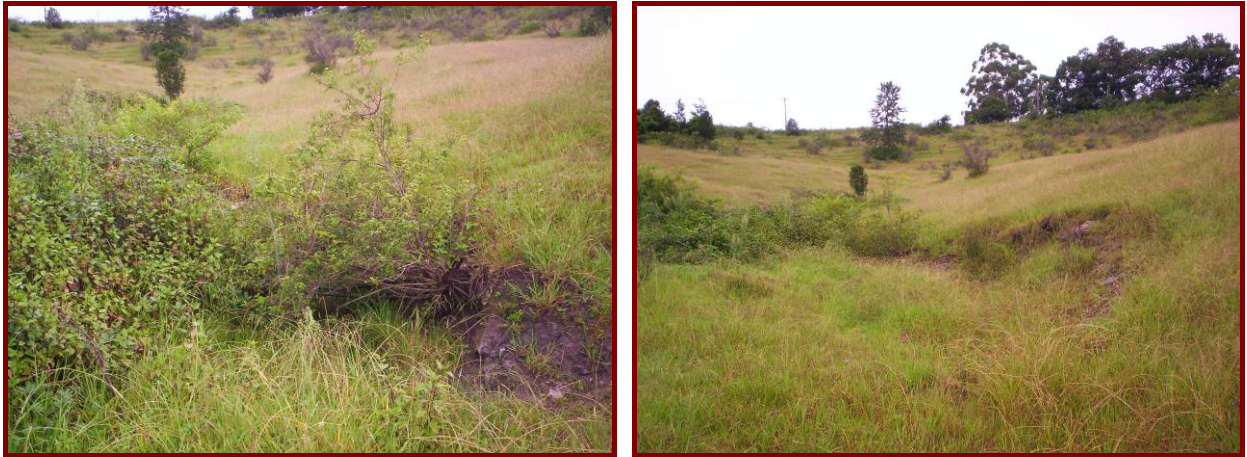
Number	Description	Comments
P1	Located in gully in Minmi West. Area had been clearly filled for a diameter of about 20 m. Small pothole about 2 m diameter was observed to be reforming near centre	Mapping indicates that the pothole is located over an intersection of the Wallsend Borehole Colliery workings in the Young Wallsend Seam at about 16 m depth
P2	Formed in creek bed shortly after June 2007 floods. Water from creek flowed into workings. Was repaired with concrete plug	Borehole Seam workings at shallow depth < 10 m present
P3	Probable pothole in gully, filled with waste material	Underlain by Pit A, B, C workings at about 10 m depth
P4	Possible pothole located on side of road in area of channelled runoff	Underlain by Brown Colliery Borehole Seam workings at about 18 m depth
P5	Reported pothole by Lenny Grant. No evidence of pothole at surface	Underlain by Young Wallsend Seam at about 10 m depth. No workings are mapped. Extensive line drilling at 1 m centres around reported pothole locations indicated no voids. Unlikely to be workings present apart from possible very localised tunnel

**Pothole P1**

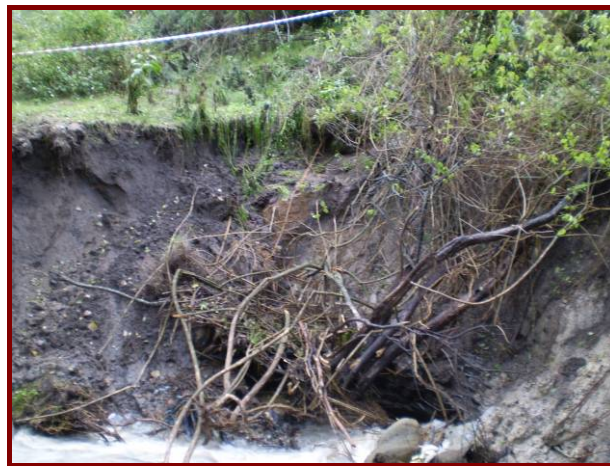
**Pothole P2**

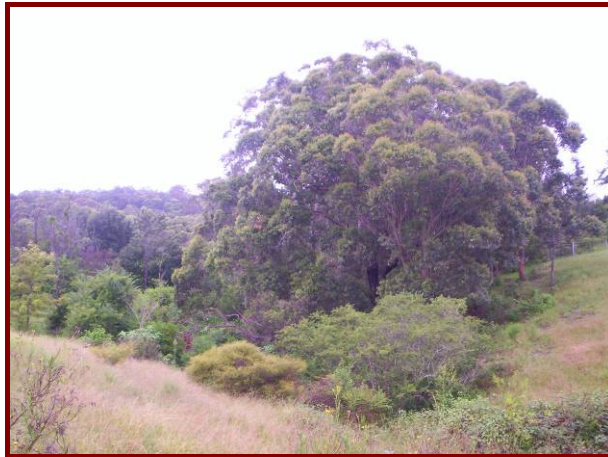
**Pothole P3**

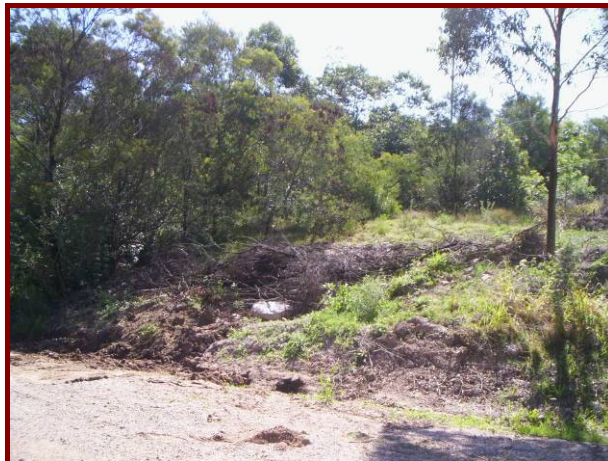
**Pothole P4**

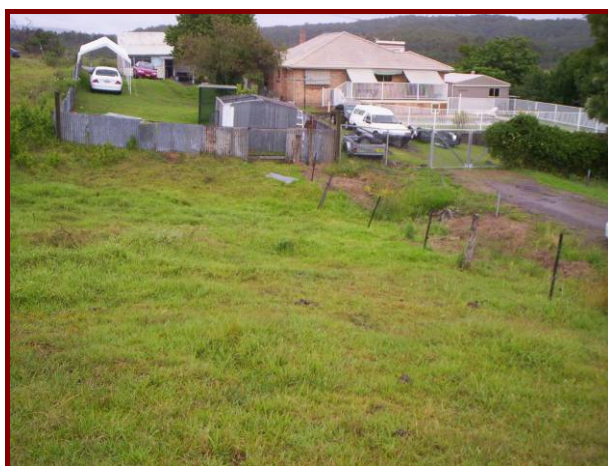
**Reported Location of Pothole P5 - No Void Found**

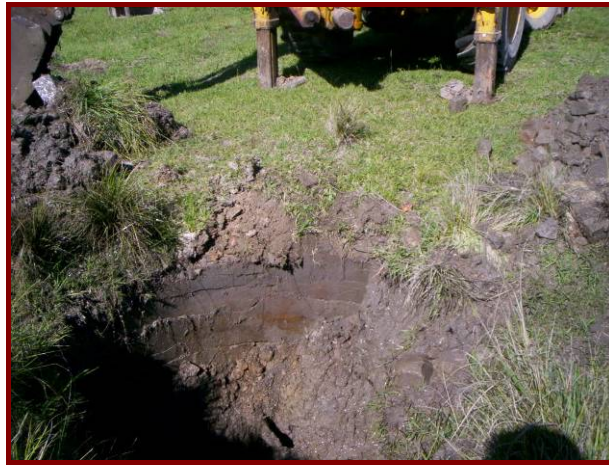
**Brick Cistern at Reported Location of Pothole P7**

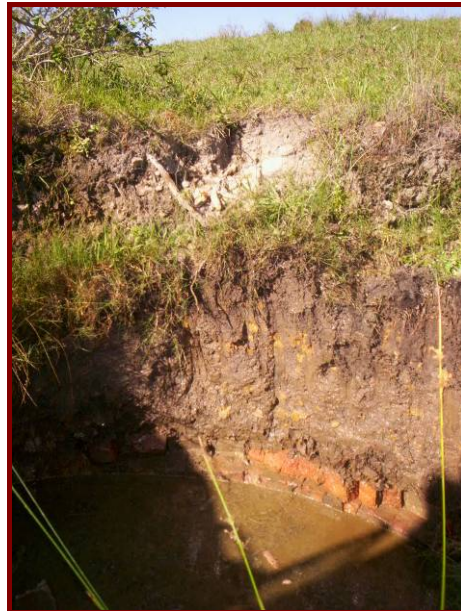
**Brick Cistern at Reported Location of Pothole P6**

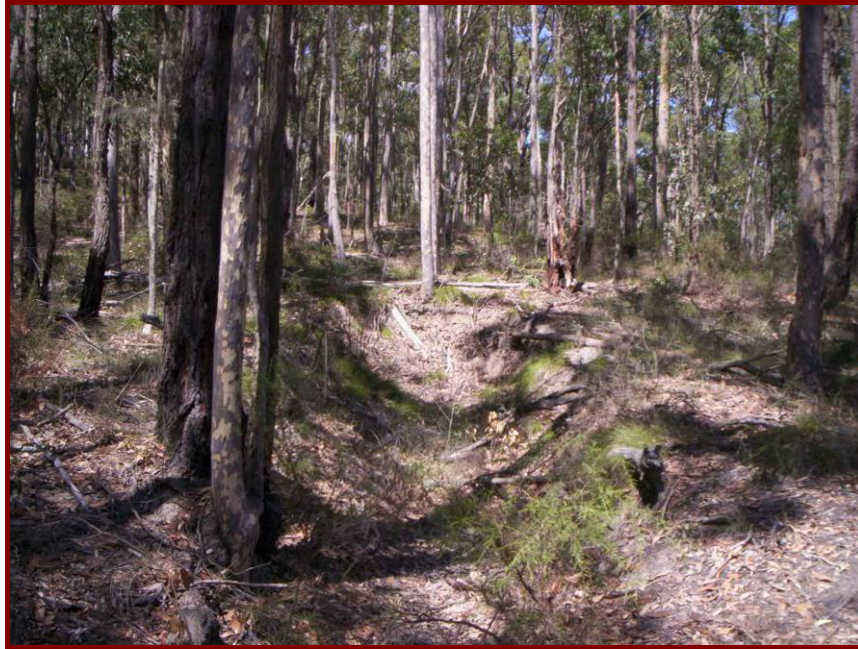
Individual potholes P8 are not shown on Drawing 3; they are numerous and extensive throughout area PR4 in Minmi East (Drawing 3).

**Extensive Potholing in Far Eastern Area P8**

Extensive pothole subsidence was also observed at shallow workings of the Cooperative Colliery on a parcel of land on the far eastern part of the site near Fletcher, Area PR 4 in Minmi East. The depth of cover where potholes are occurring is probably less than about 10 m depth, although this has not been confirmed by drilling.

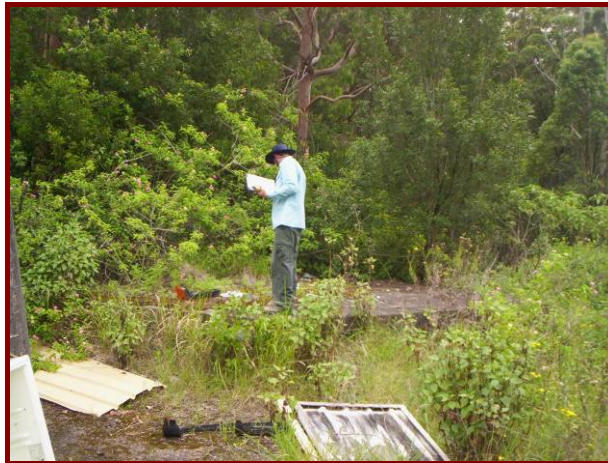
**Concrete Capping on Shaft Near Dam**

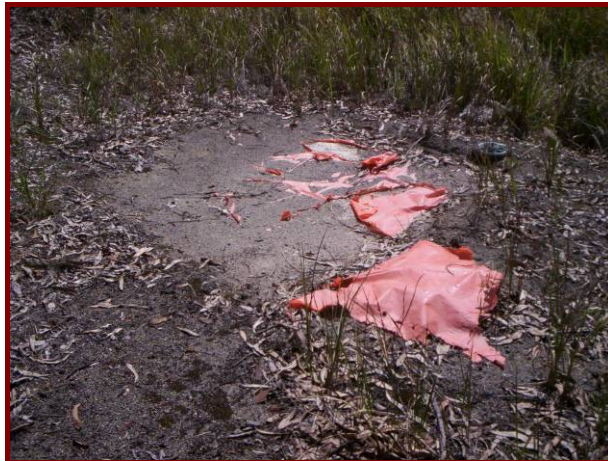
**Capped Shaft No 4**

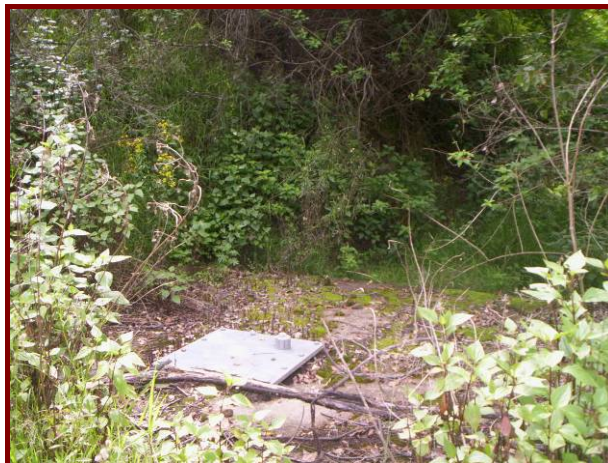
**Capping on Shaft No 12**

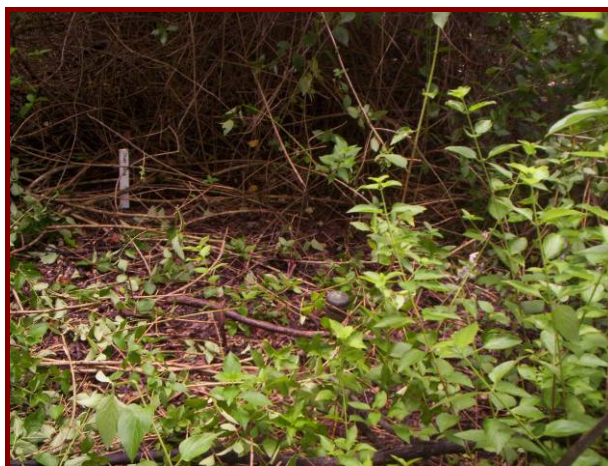
**Capping on Shaft No 14**
