PROPOSED WHITESIDE DEVELOPMENT NORTH RYDE

Arboricultural Assessment

December 2010

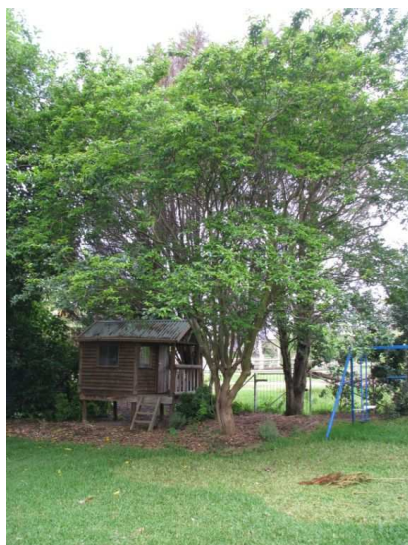
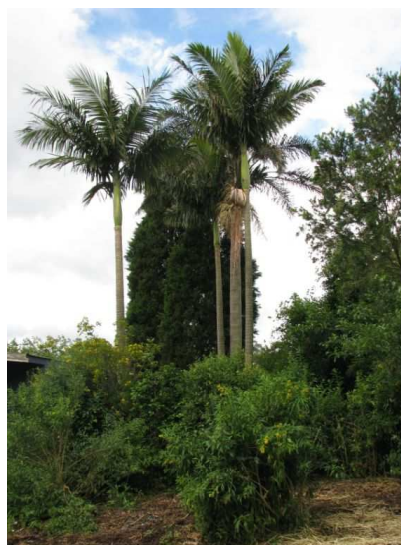
- 5.3 There are several smaller Crepe Myrtles and several mature palms that would be suitable for transplanting if they can be used in appropriate locations within the finished landscape. These trees should be reassessed to determine if they could be retained elsewhere on site.

Figure 2: Trees suitable for transplanting

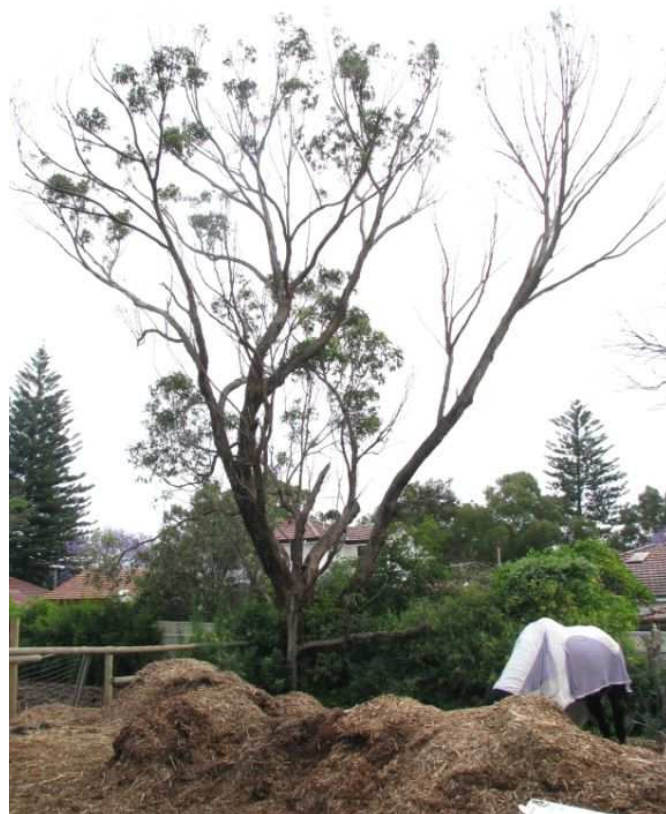
Figure 3: Silver Top Ash, tree 38, is typical of the large trees that have undergone rapid decline across the site over the last 2 to 3 years.

38.	<i>Eucalyptus seiberi</i>	Silvertop Ash	18	15 10	800 250	Poor	Very Poor	Over-mature	H5	Z3	Assess in context of final design	9.6	Large specimen exhibiting poor health and vigour. It is likely that this is the only remnant of the original native vegetation on the site. The tree is located within an existing horse paddock and has been severely damaged by horse browsing. The tree has extensive twig and branch dieback, limited leaf cover and numerous epicormic shoots. Aerial photos show that tree has declined rapidly over last 2 years. The prognosis for this tree is poor. The current design would not impact on this tree.	325788.601	6259912.404

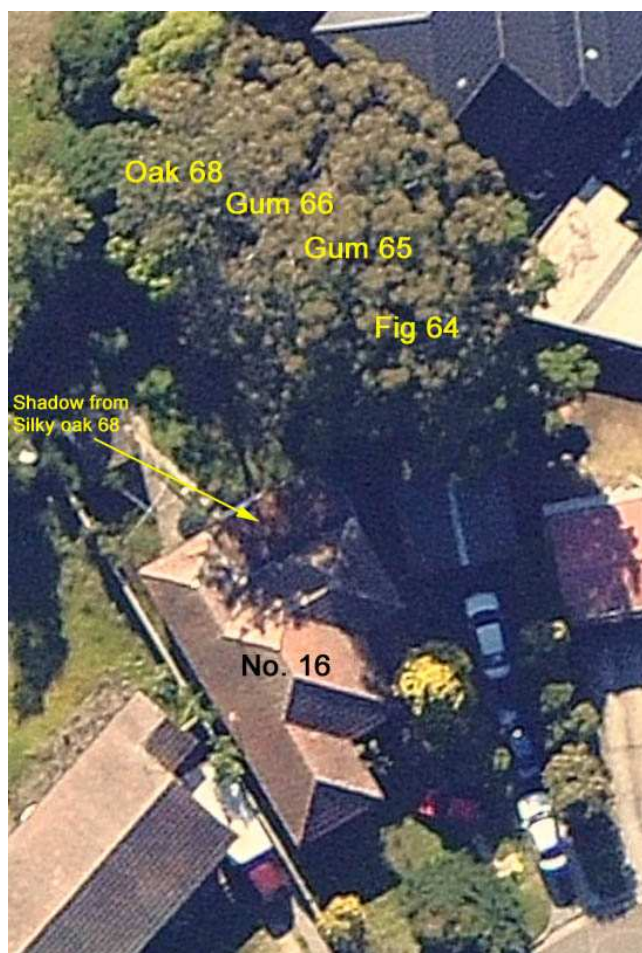
The impact of this group of trees in terms of shade on the proposed dwellings will also be affected by the form of the trees. The dense leaf cover of the Fig will cause the densest shade at ground level in winter. However the location of this tree to the north east of the proposed structure means that the longest shade will be restricted to the morning. Shade will continue to be cast up to midday but with the shade gradually moving towards the unit closest to David St. At 20 metres tall, the two Lemon Scented Gums will also cast long shadows in winter, but this will be a more broken, scattered shade due to the lack of low branches and the open branch arrangement of the tree crowns. By midday, the shadows of the Gums should be combined with the shadow of the Fig and concentrated along the eastern boundary. Similarly, the Silky Oak will cast shadows onto the proposed dwelling until early afternoon. However the narrow crown form and sparse leaf cover will result in broken shade. Refer to Figure 2 for actual shadows cast on the existing property in June.

Figure 4: Shadows at approx. 12.30pm 15/06/2010 by trees located boundary of 16 David St
