HAZARDOUS MATERIALS SURVEY GRAYTHWAITE NURSING HOME 14 EDWARD STREET NORTH SYDNEY NSW 2060

FINAL REPORT
for
HAZARDOUS MATERIALS SURVEY
GRAYTHWAITE NURSING HOME
14 EDWARD STREET
NORTH SYDNEY NSW 2060

Our Reference: S5749
June 2009

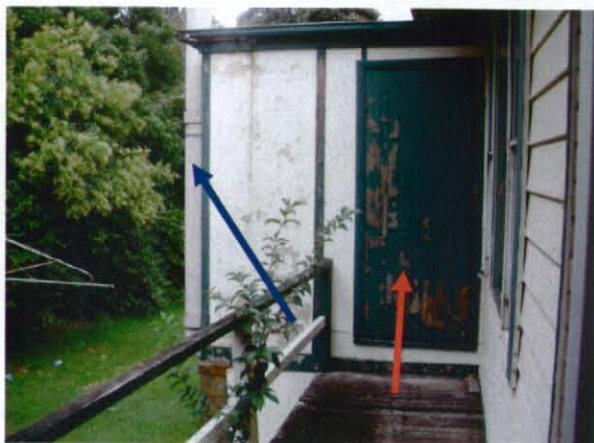
Photograph 1

Location: Nursing home - external south/east corner

Description: The blue arrow points to an asbestos cement flue

It should be noted there was no access behind this door.

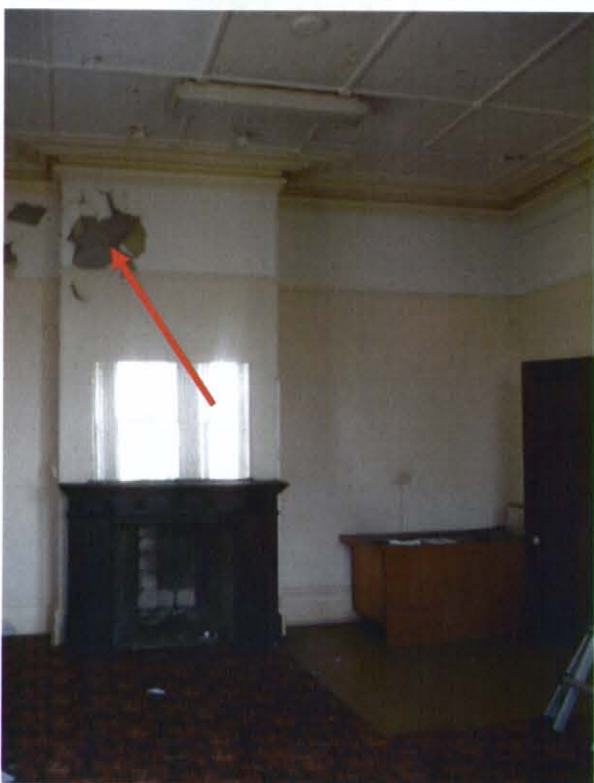
- The white coloured paint system on the ceiling in the south/west room tested positive for lead. Refer to Sample No S5749/P36 in Appendix 2 and Photograph 2 in Appendix 3. This paint system is deteriorated.

Location: The main house, ground floor - south/west room

Description: The red arrow points to peeling lead based paint. The upper walls are peeling and parts of the ceiling are flaking

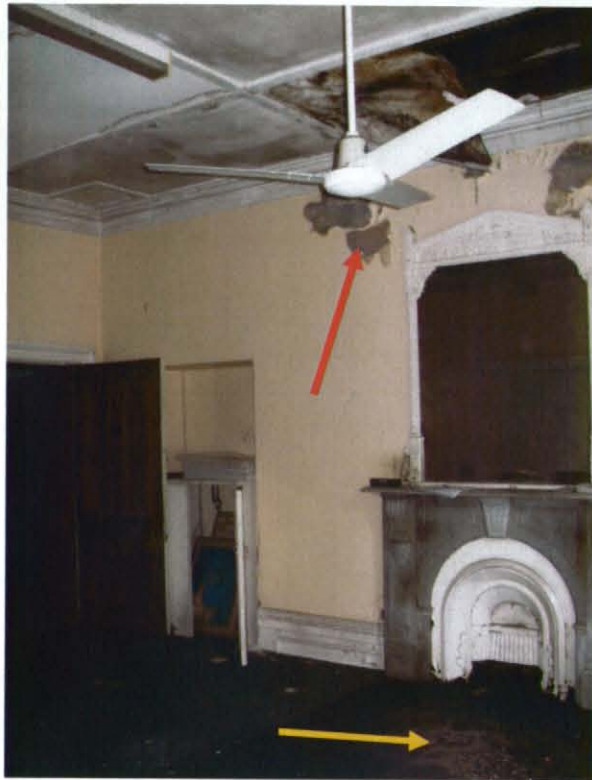
- The white coloured paint system on the ceiling in the third room tested positive for lead. Refer to Sample No S5749/P47 in Appendix 2.
 - The peach coloured paint system on the south wall in the fourth room tested positive for lead. Refer to Sample No S5749/P48 in Appendix 2 and Photograph 3 in Appendix 3. This paint system has heavily deteriorated.

Location: Main house, ground floor - fourth room north along the western side

Description: The red arrow points to peeling lead based paint, the yellow arrow points to rubble from the ceiling space spread over the floor

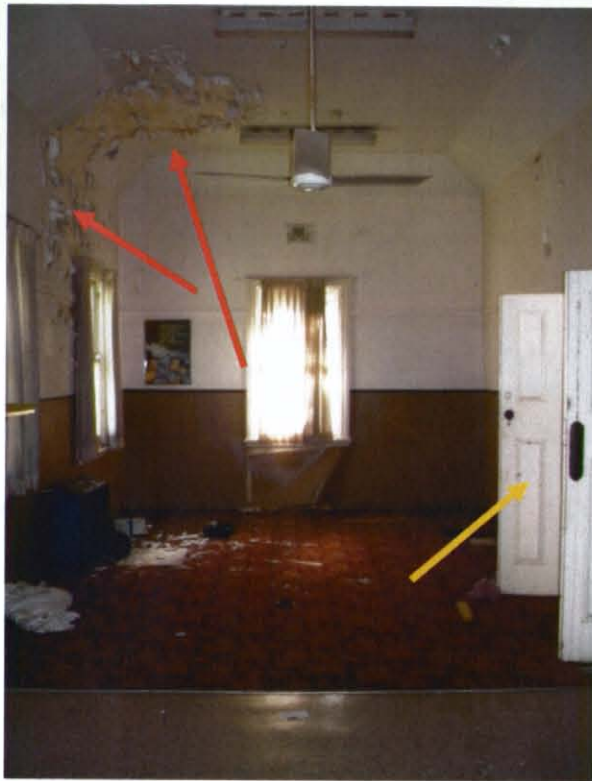
-
- The white coloured paint system on the west wall of the most north/west room tested positive for lead. Refer to Sample No S5749/P53 in Appendix 2 and Photograph 4 in Appendix 3. This paint system has heavily deteriorated.

- The white coloured paint system on the ceiling of the north/west room tested positive for lead. Refer to Sample No S5749/P164 in Appendix 2 and Photograph 4 in Appendix 3. This paint system has heavily deteriorated.

Location: Main house, ground floor – north/west room with work bench

Description: The red arrows point to lead based paint which is peeling and flaking from the walls and ceiling. The yellow arrow points to the white doors which is the entrance for the side storage room which also has peeling and flaking lead based paint walls and ceilings

Lead based paint debris presents a health risk and has the potential to spread contamination to other areas.

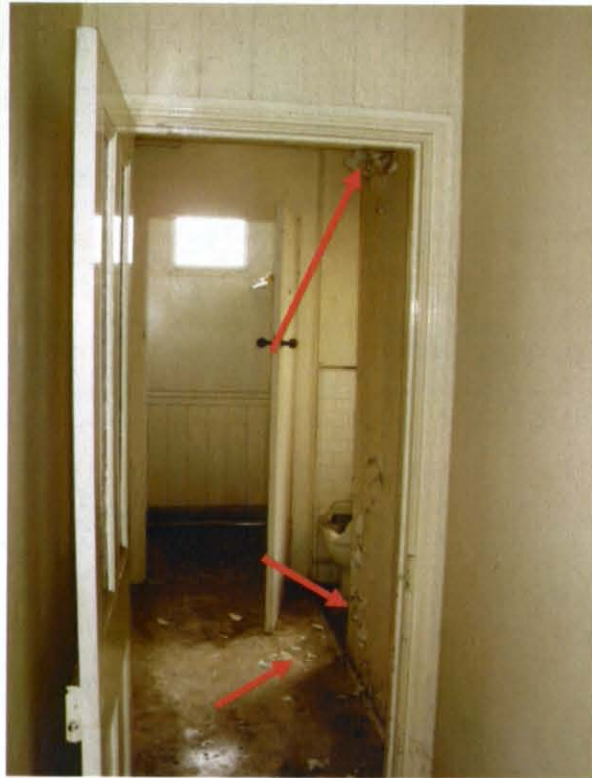
- The white coloured paint system on the wall of the hallway leading to the western toilets tested positive for lead. Refer to Sample No S5749/P74 in Appendix 2 and Photograph 5 in Appendix 3. This paint system has heavily deteriorated.

- The white coloured paint system on the ceiling in the hallway leading to the western toilets tested positive for lead. Refer to Sample No S5749/P168 in Appendix 2 and Photograph 5 in Appendix 3. This paint system has heavily deteriorated.

Location: Main house, level 1 –
Hallway to bathroom on western side.

Description: The red arrows point to peeling and flaking lead based paint from the ceiling and walls and debris on the floor.

Lead based paint debris presents a health risk and has the potential to spread contamination to other areas.

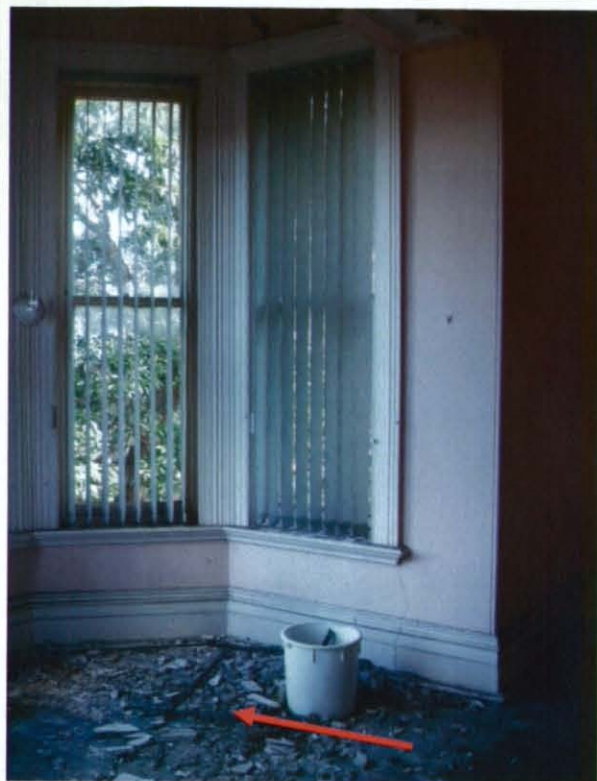
- The white coloured paint system on the ceiling in the bay window section of the south/west room tested positive for lead. Refer to Sample No S5749/P171 in Appendix 2 and Photograph 6 in Appendix 3. This paint system has heavily deteriorated and there are fragments of ceiling plaster on the floor.

Location: Main house, level 2 – south/west room.

Description: The red arrow points to lead based paint debris with fragments of wood and plasterboard which have fallen from the ceiling.

Lead based paint debris presents a health risk and has the potential to spread contamination to other areas.

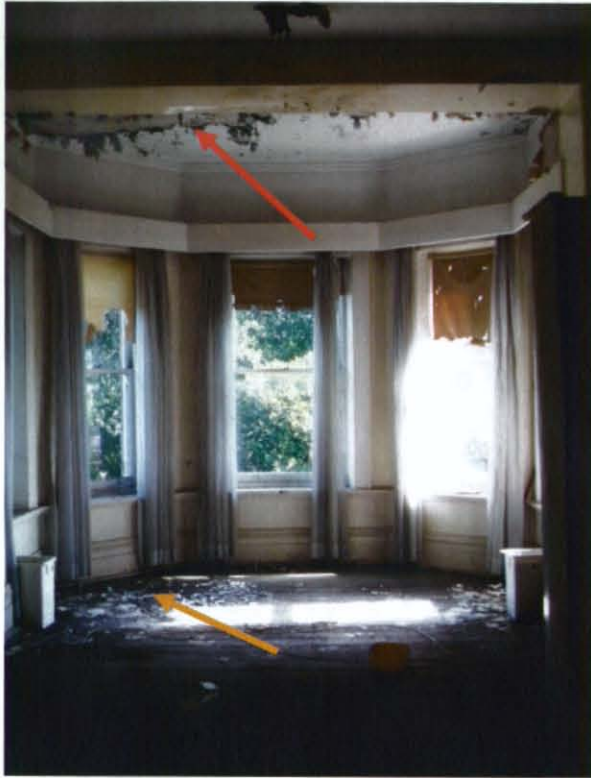
- The white coloured paint system on the ceiling of the bay window section of the third room tested positive for lead. Refer to Sample No S5749/P172 in Appendix 2 and Photograph 7 in Appendix 3. This paint system has heavily deteriorated and there are fragments of ceiling plaster on the floor.

Location: Main house, level 2 – third room north along the western side.

Description: The red arrow points to lead based paint which has severely deteriorated on the ceiling.

Lead based paint debris presents a health risk and has the potential to spread contamination to other areas.

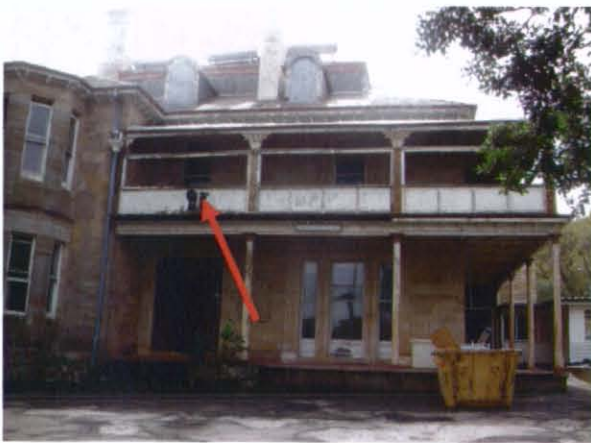
- Asbestos is present in the veranda panels. Some of these panels are damaged and it is recommended to remove any loose fragments of asbestos cement sheet. Refer to Sample No S5749/25 in Appendix 1 and Photograph 8 in Appendix 3.

Location: Main house, level 2 – veranda.

Description: The red arrow points asbestos cement sheet panels which are broken. There are loose fragments which it is recommended to have removed.

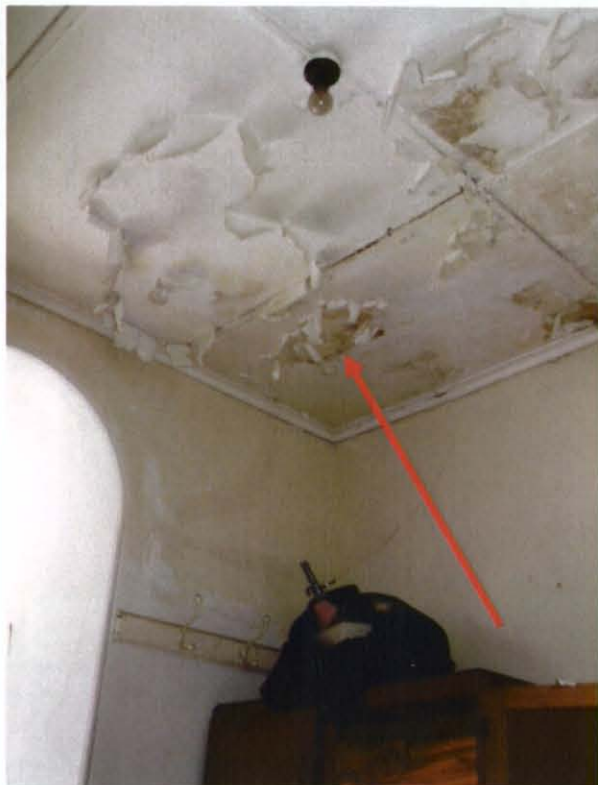
- The white coloured paint system on the ceiling in the west room tested positive for lead. Refer to Sample No S5749/P176 in Appendix 2 and Photograph 9 in Appendix 3. This paint system has heavily deteriorated.

Location: Main house, attic – west room ceiling.

Description: The red arrow points to asbestos cement sheet lined ceiling with peeling lead based paint.

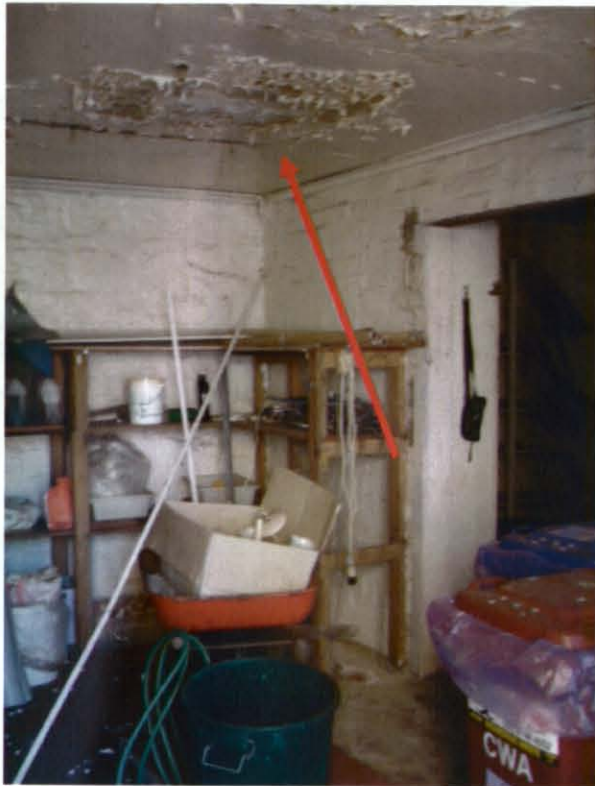
- The white coloured paint system on the storage area ceiling (old stables) tested positive for lead. Refer to Sample No S5749/P177 in Appendix 2 and Photograph 10 in Appendix 3. This paint system has heavily deteriorated.
- The white coloured paint system on the walls in the storage area (old stables) tested positive for lead. Refer to Sample No S5749/P178 in Appendix 2.

Location: Main house, stables – storage area.

Description: The red arrow points to flaking lead based paint on the ceiling of the stables.
