**GRAYTHWAITE HOUSE**

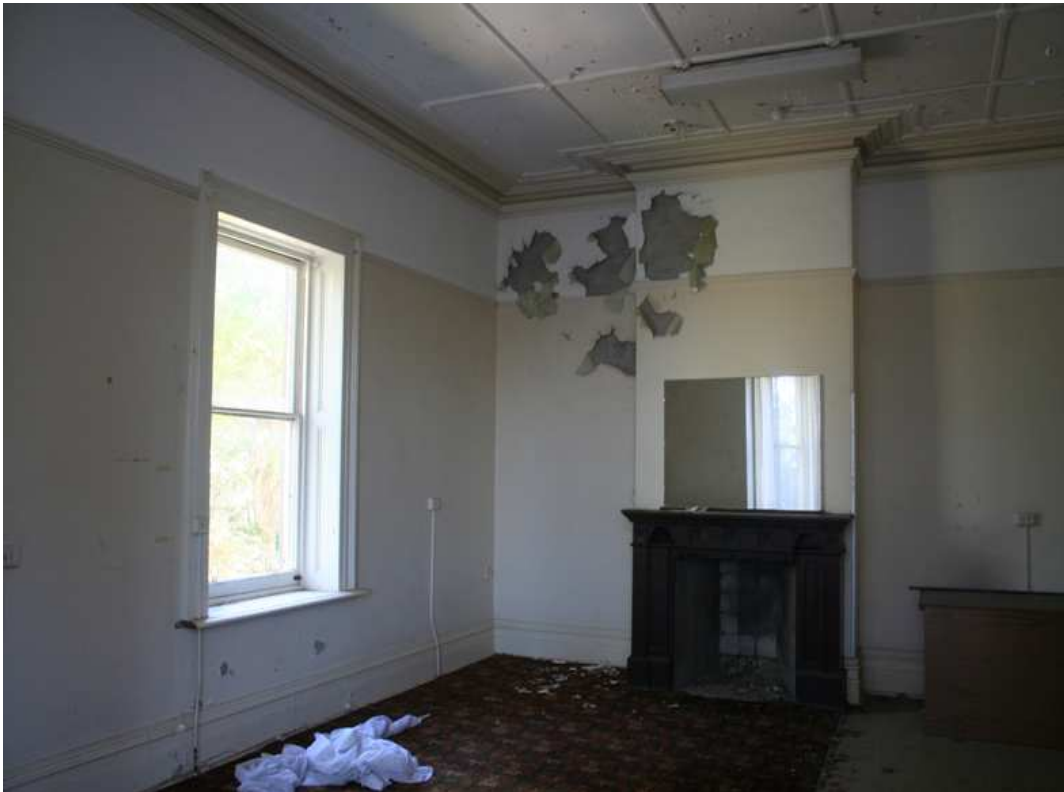
Room G1 looking north

Room	G1	Original function	Not known: possibly the sitting room
Historical notes			
Constructed c.1850s for Edwin Sayers, as part of the double-storey extension to the original single-storey Euroka stone cottage. Bay window rebuilt for GR Dibbs c.1874. Possibly was the sitting room described in the 1880 sale notice. Converted to a hospital ward by the Red Cross in 1916. The room is shown as a hospital ward in a drawing dated 1943.			
Integrity			
Generally good: the plan form is original. Alterations include installation of the strapped plaster ceiling (early twentieth century); ornate carved timber fireplace (late nineteenth century); picture rail (early twentieth century) and modern finishes (c1980s or 1990s).			
Schedule of fabric			
Element	Description		
Floor	Fitted vinyl flooring and carpet over timber.		
Skirtings	330mm moulded timber skirting boards with timber strips at wall/floor junction.

Walls	Hard plaster. Moulded timber picture rail. Chimney breast on north wall with timber staff moulds. Decorative timber fireplace surround on north wall. Decorative tiles removed except for small insitu sample with a floral pattern. Hearth stone is concealed. Evidence for overmantel now removed. Power points mid way up wall with surface mounted conduits. Evidence of painted decoration on south wall.		
Ceiling	Plaster with decorative plaster battens and decorative plaster cornice		
Doors	DG1.1: Four panel door stained facing G5 and painted facing G1. Porcelain knob to G5 and crystal knob with brass rose facing G1. Timber sign with “Royal Sydney Yacht Squadron 1915” Decorative moulded timber architrave. Yale night latch.		
Windows	G1/W1: Double hung two pane sash windows without horns. Evidence for glazing bars being cut out and the sashes originally were six pane. Reveal with sunk mould. Fittings for blinds. G1/W2-W6: Double hung two pane sash windows with window locks and pulls. Decorative moulded timber architrave. Fittings for blinds and curtains.

Conservation policies			
Retain original plan form.			
Investigate original floor finish.			
Conserve and restore early and original fabric.			
Retain hospital era room names. Consider retention of bed blocks.			
Remove modern finishes and fittings. Remove surface-mounted services and repair original finishes.			
Ensure that the addition of services is undertaken in a manner which complements the overall design of the room and minimises loss of significant fabric.

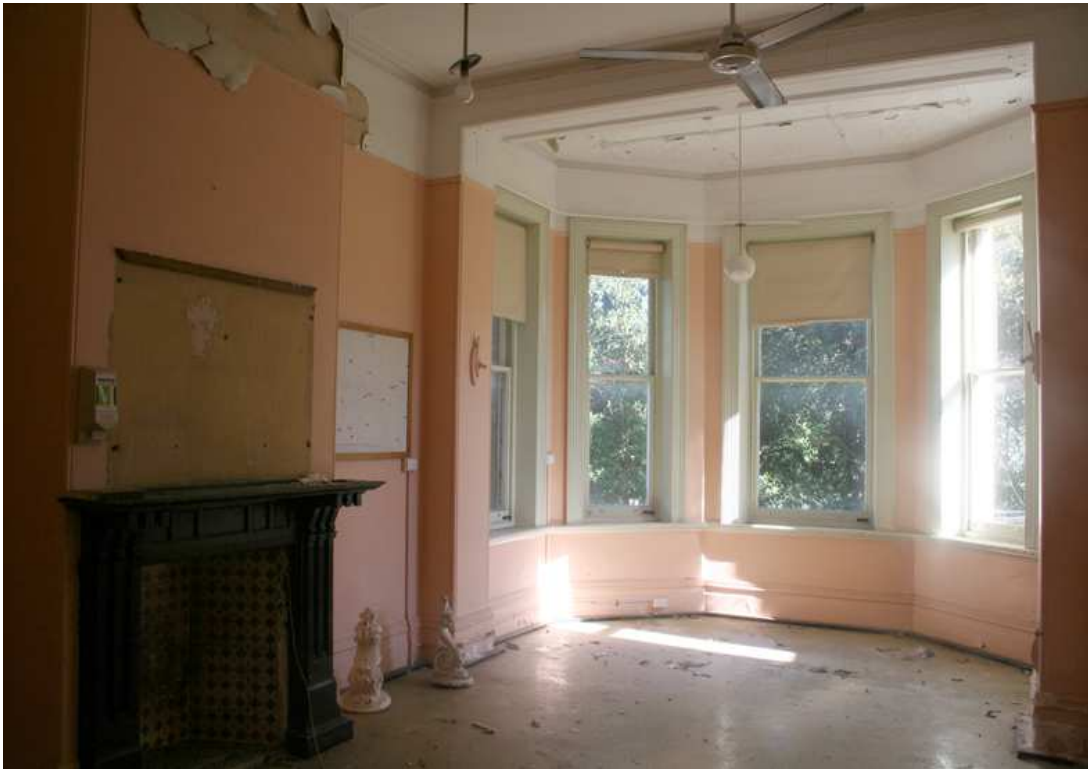
Space G2. Looking west

Room	G2	Original function	Not known: possibly dining room
Historical notes			
Constructed c1850s for Edwin Sayers, as part of the double-storey extension to the original single-storey Euroka stone cottage. The bay window was added c1874 for GR Dibbs. Possibly was the ‘immense dining-room with folding doors’ (with G3) described in the 1880 sale notice. Converted to a hospital ward by the Australian Red Cross Society in 1916. Room shown as a hospital ward in a 1943 drawing.			
Integrity			
Generally good: the plan form is original. Alterations include the installation of the strapped plaster ceiling (early twentieth century); ornate carved timber fireplace (late nineteenth century); picture rail (early twentieth century) and modern finishes (c1980s or 1990s) inclusive of concertina partitioning.			
Schedule of fabric			
Element	Description		
Floor	Fitted vinyl flooring over timber.		
Skirtings	330mm moulded timber skirting boards with timber strips at wall/floor junction

Walls	Plaster Moulded timber picture rail Chimney breast on south wall with timber staff moulds. Decorative timber fireplace surround on south wall. Decorative tiles with a Gothic style pattern. Heath stone is concealed. Evidence for overmantel now removed North wall originally and arched opening with later plasterboard infill and concertina vinyl door. Wall knib and soffit have timber staff moulds West wall is arched opening and the wall knib and soffit have timber staff moulds. The soffit reveal has a sunk mould		
Ceiling	Decorative plaster cornice with later plasterboard ceiling in body of room and plaster with decorative plaster battens and decorative plaster cornice above the bay window.		
Doors	DG2.1: Four panel door stained facing G5 and painted facing G2. Brass knobs and roses to both sides. Night latch. Decorative moulded timber architrave. Highlight.		
Windows	G2/W1-W5: Double hung two pane sash windows with window locks and pulls. Decorative moulded timber architrave. Holland blinds

Conservation policies			
Reinstate original plan form.			
Investigate original floor finish.			
Conserve and restore early and original fabric.			
Investigate earlier ceiling finish.			
Consider retention of bed blocks.			
Remove modern finishes and fittings.			
Remove surface-mounted services and repair original finishes.			
Ensure that the addition of services is undertaken in a manner which complements the overall design of the room and minimises loss of significant fabric.

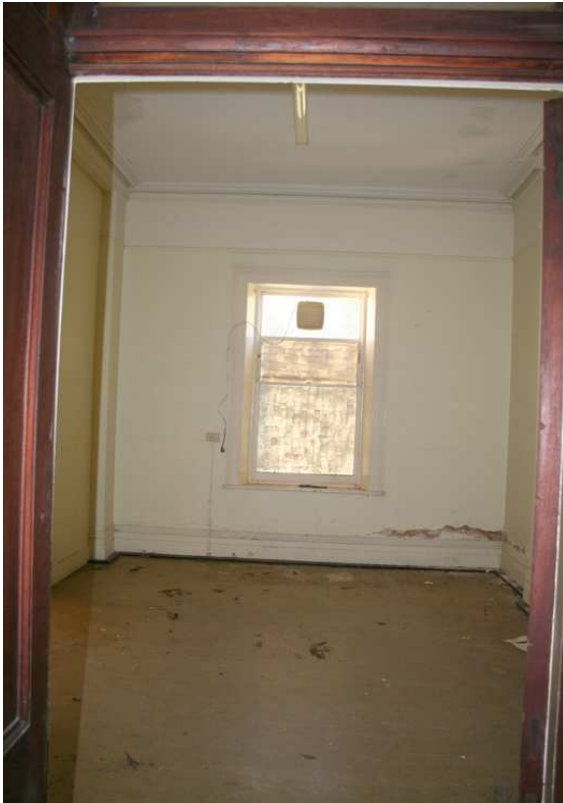
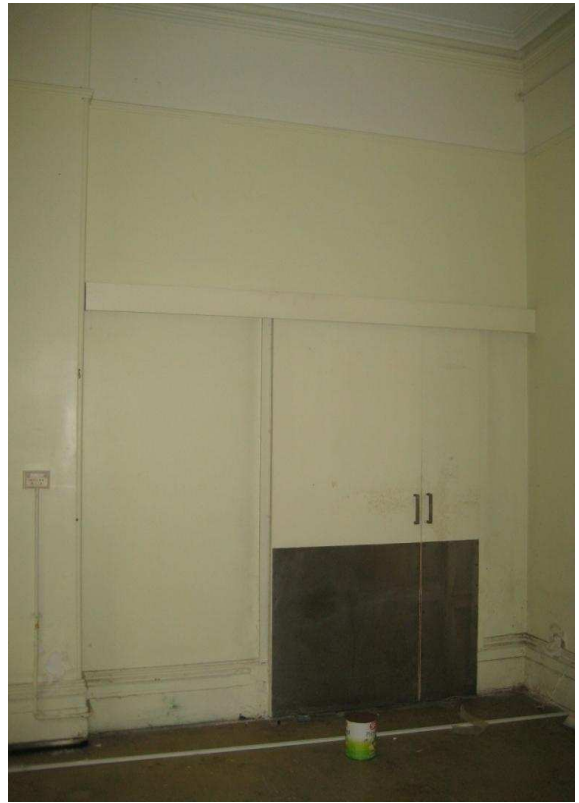
Room	G3	Original function	Not known: possibly dining room
Historical notes			
Constructed c.1850s for Edwin Sayers, as part of the double-storey extension to the original single-storey Euroka stone cottage. Possibly was the 'immense dining-room with folding doors' (with G2) described in the 1880 sale notice. Converted to a hospital ward by the Australian Red Cross Society in 1916. Room shown as a hospital ward in a 1943 drawing.			
Integrity			
Generally good.			
Alterations include the removal of a fireplace (1880s); picture rail (early twentieth century), making of opening DG3.2 and modern finishes (c1980s or 1990s) inclusive of concertina partitioning.			
Schedule of fabric			
Element	Description		
Floor	Fitted vinyl flooring over timber.		
Skirtings	330mm moulded timber skirting boards with timber strips at wall/floor junction		
Walls	Plaster Moulded timber picture rail Shallow chimney breast on south wall with timber staff moulds and without fireplace opening South wall originally and arched opening with later plasterboard infill and concertina vinyl door. Wall knib and soffit have timber staff moulds Power points mid way up wall with surface mounted conduits

Ceiling	Decorative plaster cornice with later plasterboard ceiling		
Doors	DG3.1: Four panel door stained facing G5 and painted facing G2. Reproduction brass knobs both sides. Decorative moulded timber architrave. Highlight. DG3.2: Solid core sliding flush door with stainless panels. Wall mounted		
Windows	G3/W1: Double hung two pane sash windows without horns. Evidence for glazing bars being cut out and the sashes originally were six panes. Upper sash fitted with electric fan. Fittings for blinds and curtains.		
Conservation policies			
Reinstate original plan form and close up DG3.2			
Investigate original floor finish.			
Investigate earlier ceiling finish			
Conserve and restore early and original fabric.			
Remove modern finishes and fittings.			
Remove surface-mounted services and repair original finishes.			
Retain hospital-era room name.			
Consider retention of bed blocks.			
Ensure that the addition of services is undertaken in a manner that complements the overall design of the room and minimises loss of significant fabric.

Room G3 looking north-west to the later doorway.

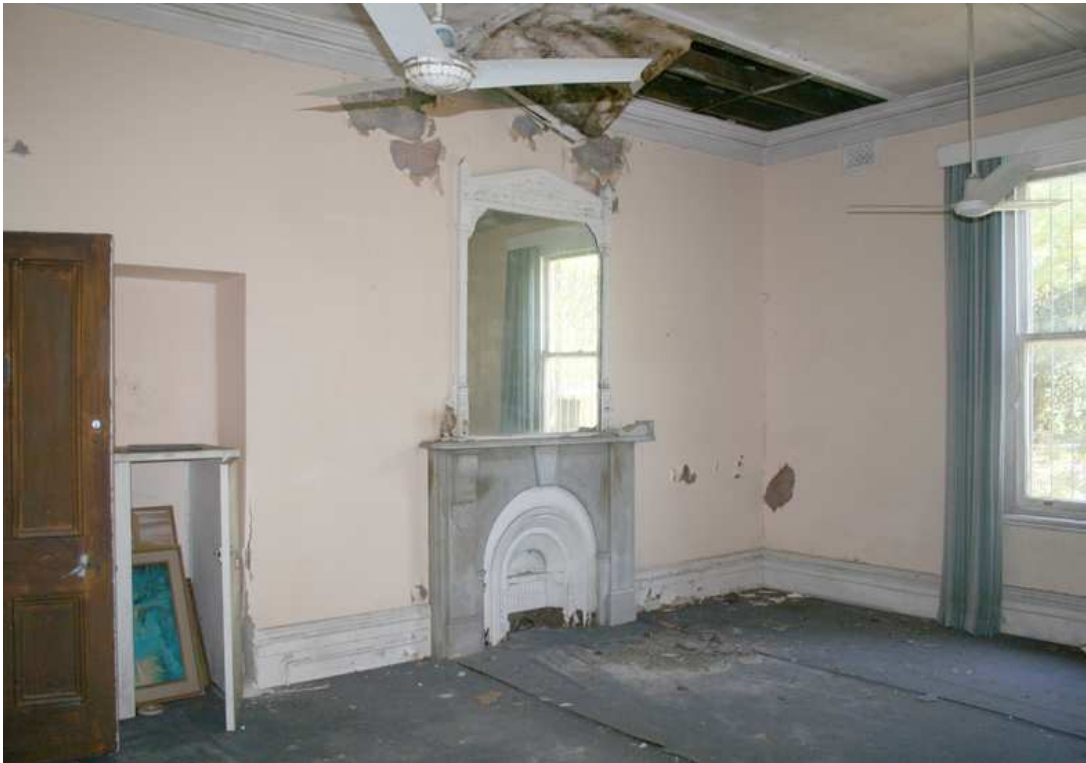
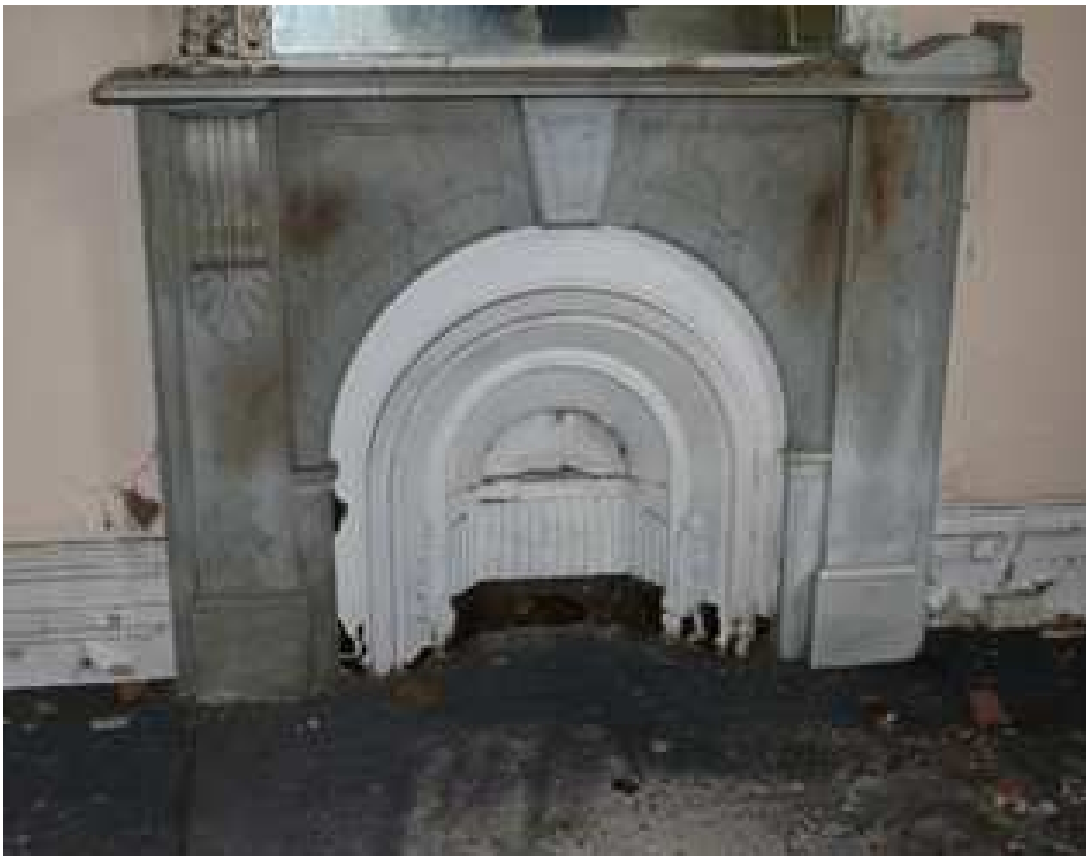
Room	G4	Original function	Not known: possibly Mrs TR Dibb's office
Historical notes			
Probably built for Thomas Dibbs in the 1880s. Converted to Matron's Sitting Room by the Australian Red Cross Society in 1916 with funds provided by North Sydney Superior (High) School. Room shown as the matron's room in a 1943 drawing.			
Integrity			
Generally good: the plan form is original.			
Alterations include installation of the battened ceiling and plaster cornice (mid twentieth century); wall vents and picture rail (early twentieth century), door openings DG3.2 and DG4.2 and modern finishes (c1980s or 1990s).			
Schedule of fabric			
Element	Description		
Floor	Carpet flooring over timber.		
Skirtings	330mm moulded timber skirting boards		
Walls	Plaster Decorative plaster wall vents Moulded timber picture rail Decorative white Carrara marble fireplace surround on south wall. Decorative cast iron grate. Heath stone is concealed. Decorative cast iron with mirror overmantel. Evidence for painted decoration on walls

Ceiling	Masonite sheeting with battened timber cover strips. Shallow decorative plaster cornice with a lower section of undecorated plaster strip.		
Doors	DG4.1: Four panel door painted on both faces. Crystal knob and brass to G4. Timber sign with "Matron's Sitting Room. North Sydney Superior School." Decorative moulded timber architrave. Night latch. DG4.2: Solid core sliding flush door. Opening formerly a window.		
Windows	G4/W1: Double hung two pane sash windows with window locks and pulls. Decorative moulded timber architrave. Fittings for blinds and curtains with pelmet		
Conservation policies			
Retain original plan form.			
Reinstate window at DG4.2			
Close up DG3.2			
Investigate original floor finish.			
Investigate and reinstate original ceiling and cornice finishes.			
Conserve and restore early and original fabric.			
Remove modern finishes and fittings			
Remove surface-mounted services and repair original finishes.

Retain hospital-era room name			
Ensure that the addition of services is undertaken in a manner that complements the overall design of the room and minimises loss of significant fabric

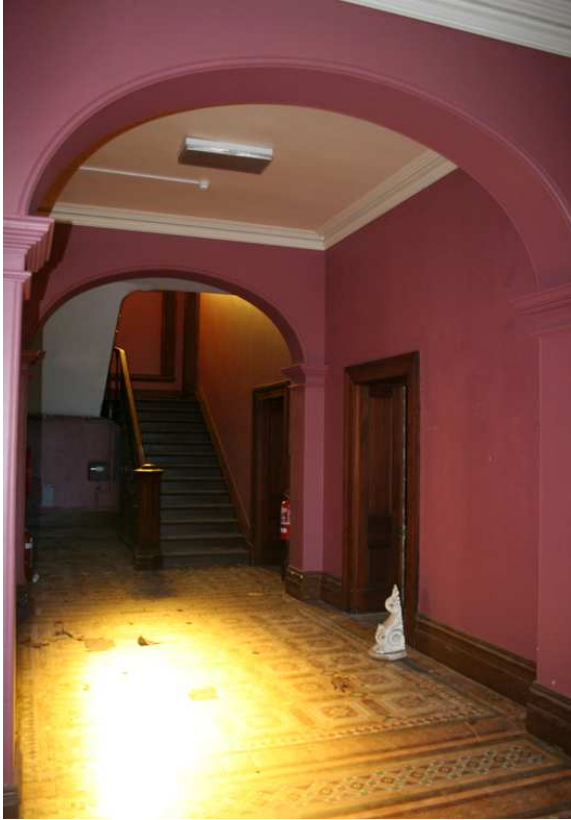
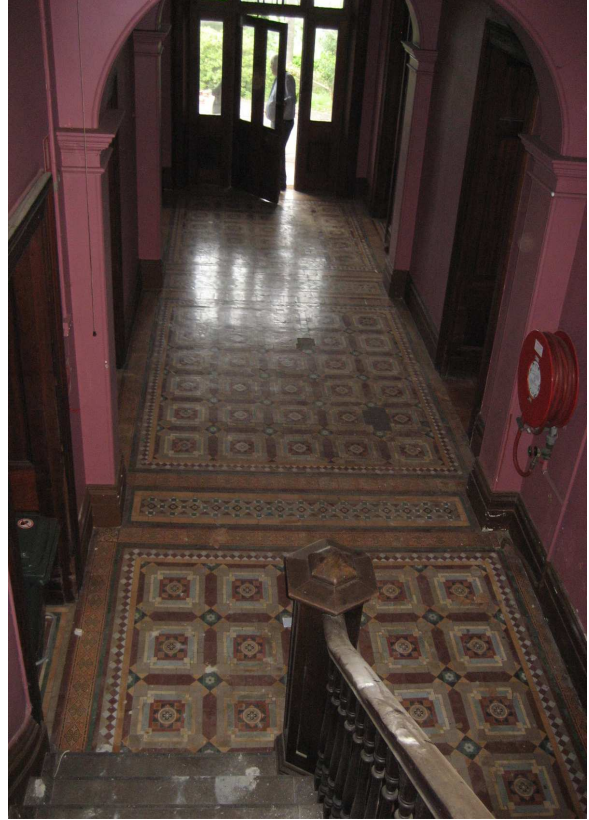
Room	G5	Original function	Hall
Historical notes			
Constructed c1874 for George Dibbs as part of the double-storey extension to Sayers' villa.			
Described in the 1880 sale notice a 'wide hall'. Room shown in a 1916 photograph. Room shown as the hall in a 1943 drawing.			
Integrity			
Good aside from modern finishes (c1980s or 1990s).			
Schedule of fabric			
Element	Description		
Floor	Geometric and encaustic tiles.		
Skirtings	330mm moulded timber skirting boards		
Walls	Plaster Arched openings with staff moulds and plaster capitals on wall knibs Rear hall has a wall mounted employee's timekeeping clock		
Ceiling	Plaster with decorative plaster cornice		
Doors	See entries for adjoining rooms.		
Stair 1	Half-turn staircase with open balustrade of turned balusters, handrail and newel post. Plaster soffit		
Conservation policies			
Retain original plan form.			
Conserve and restore early and original fabric inclusive of the wall brackets stored on-site

Remove modern finishes and fittings.			
Remove surface-mounted services and repair original finishes.			
Ensure that the addition of services is undertaken in a manner that complements the overall design of the room and minimises loss of significant fabric.

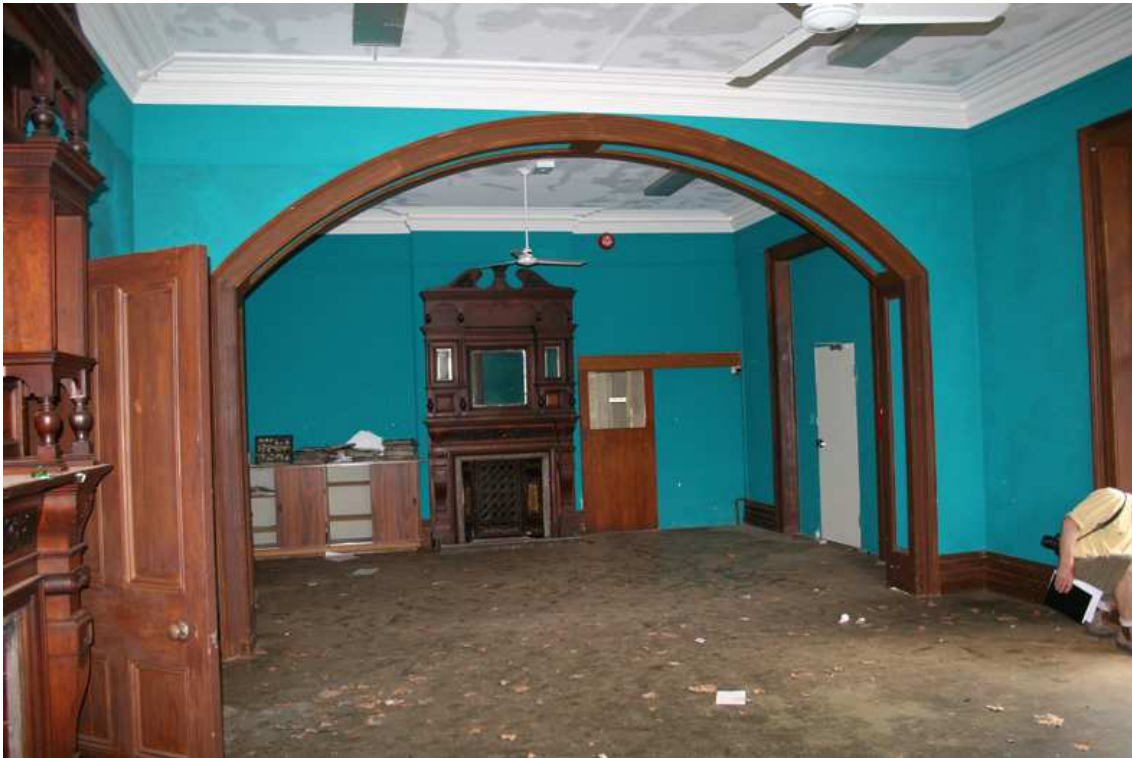
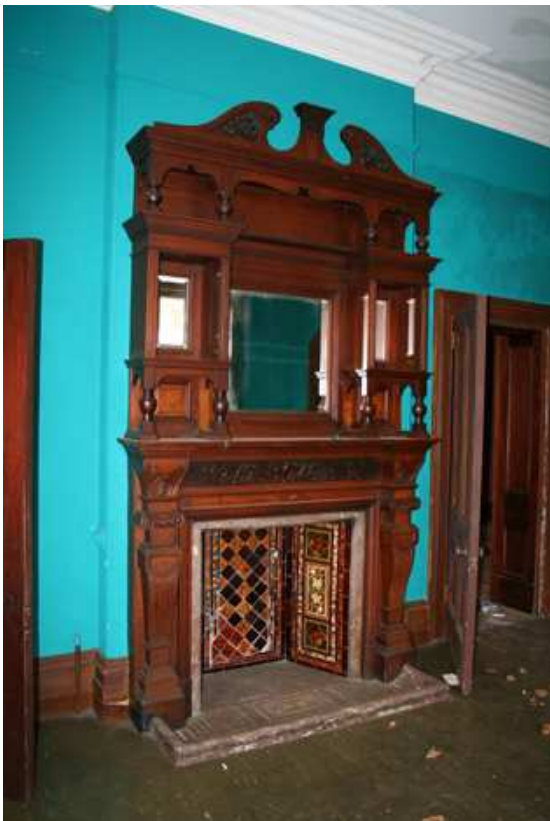
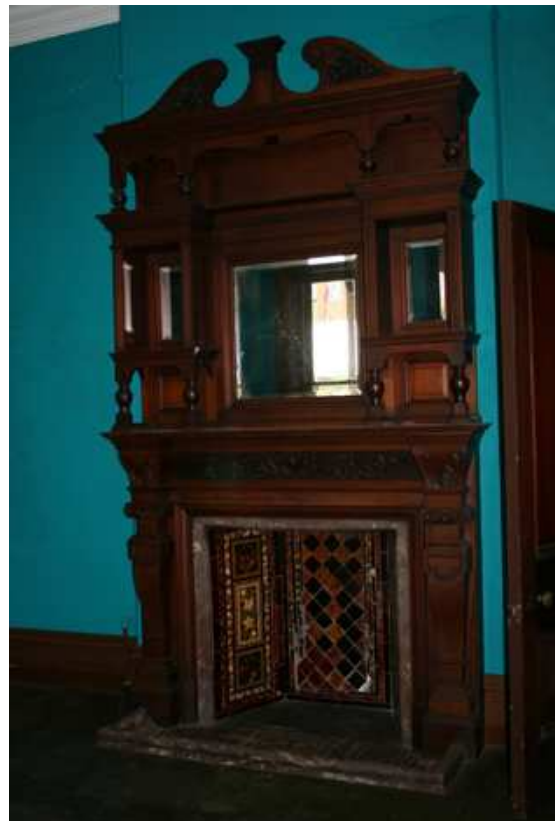
Room	G6	Original function	Not known: possibly the drawing room
Historical notes			
Constructed c1874 for GR Dibbs as part of the double-storey extension to Sayers' villa. Probably the 'drawing room' described in the 1880 sale notice. Room shown in a photograph of c1900 and 1916. Room shown as the patients' dining room in a 1943 drawing.			
Integrity			
Generally good: the plan form is original. Alterations include the installation of the ornate carved timber fireplace (late nineteenth century); picture rail (early twentieth century), insertion of door openings DG6.4 and DG6.5 and modern finishes (c1980s or 1990s).			
Schedule of fabric			
Element	Description		
Floor	Fitted vinyl flooring over timber.		
Skirtings	330mm moulded timber skirting boards		
Walls	Plaster Decorative timber moulded picture rail Chimney breasts on north and west walls with timber staff moulds. Decorative timber fireplace surround on north and west walls with decorative timber overmantel with mirror. Pink marble margin and decorative tiles with floral and geometric patterns. Heath stone is similarly tiled and trimmed. Electric bell push Arched opening with decorative run plaster mouldings

Ceiling	Plaster with decorative plaster cornice		
Doors	DG6.1: Four panel door stained facing G5 and painted facing G6. Timber sign with "Dining and Recreation Room Donated by North Sydney Superior School 1915". Decorative moulded timber architrave DG6.2: Four panel door stained facing G5 and painted facing G6. Decorative moulded timber architrave DG6.3: Four panel door stained facing G5 and painted facing G6. Knob removed. Nigh latch. Decorative moulded timber architrave DG6.4: Solid core, half glazed sliding flush door, wall mounted DG6.5: Solid core fire-rated flush door set within an infilled former window opening. Decorative moulded timber architrave is in situ.		
Windows	G6/W5: Double hung, French windows with lower timber panel with reveal. Window pulls and latch. Fittings for blinds and curtain rod. Decorative moulded timber architrave G6/W6: Double hung, French windows with lower timber panel with reveal. Window pulls and latch. Fittings for blinds and curtain rod. Decorative moulded timber architrave G6/W1-W3: Double hung, French windows with lower timber panel with reveal. Window pulls and latch. Holland blinds and curtain rod. Decorative moulded timber architrave

Conservation policies			
Retain original plan form.			
Investigate original floor finish.			
Conserve and restore early and original fabric.			
Remove modern finishes and fittings.			
Reinstate window at DG6.5			
Close-up DG6.4			
Remove surface-mounted services and repair original finishes.			
Retain hospital-era room name			
Ensure that addition of services is undertaken in a manner that complements the overall design of the room and minimises loss of significant fabric.

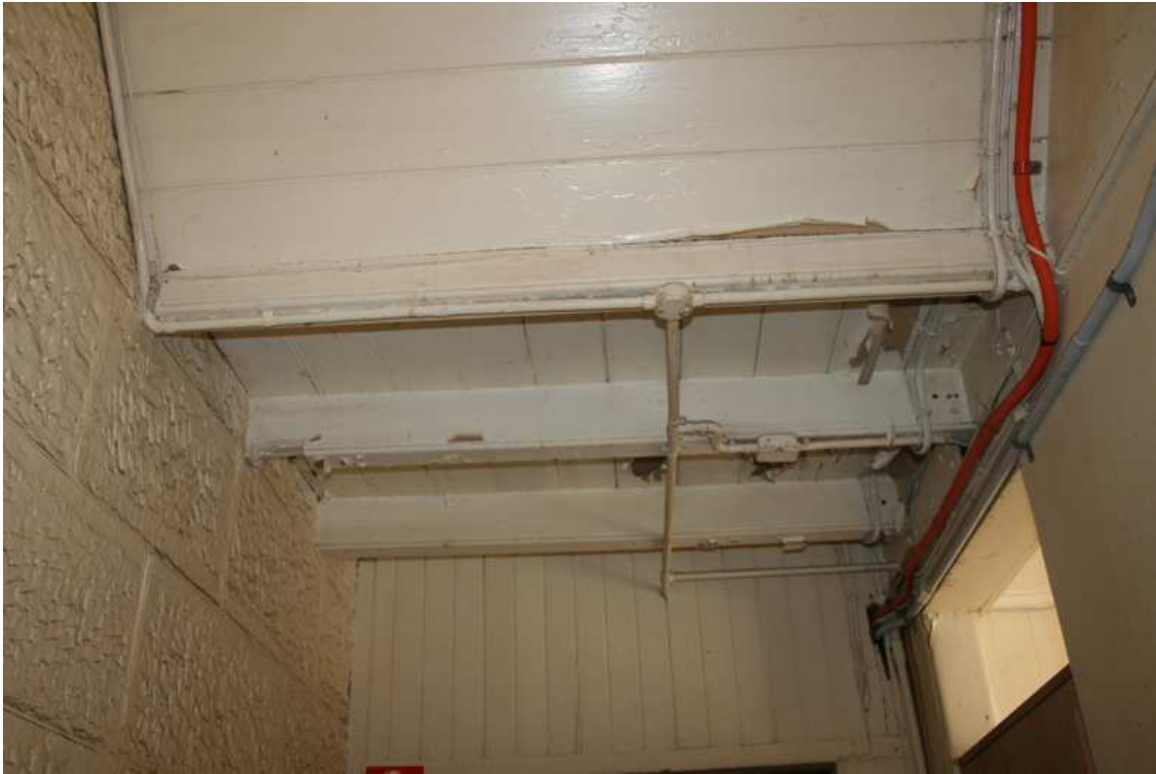
Room G15. Looking at soffit of Stair 3

Room	G14/G15	Original function	Not known: probably rear service verandah
Historical notes			
Constructed c1874 for GR Dibbs as part of the double-storey extension to Sayers' villa. Probably the lower level of a two storey verandah running the length of the north wall to the Kitchen. Originally open and fronted rear service courtyard. Existing configuration dates from addition of lavatory block in 1916.			
Integrity			
Poor: the original plan form is discernible as it the structural framing.			
Alterations include the building of the lavatory block (1916), opening to DG6.4, serviceable concrete floor and other modern finishes (c1980s or 1990s).			
Schedule of fabric			
Element	Description		
Floor	Concrete		
Skirtings	—		
Walls	South: Painted brick and sandstone North: Rendered brick masonry		
Ceiling	Framing and boarding of floor above: 150mm tongue and groove boarding with joists with beaded edge Boarded soffit of Stair 3: 150mm tongue and groove boarding with beaded edge North side has remnants of timber framing of the verandah above

Doors	DG6.4: Solid core, half glazed sliding flush door, wall mounted		
Windows	—		
Conservation policies			
Reinstate original verandah plan form.			
Remove 1916 and later additions			
Investigate original floor finish.			
Conserve and restore early and original fabric.			
Remove modern finishes and fittings.			
Close-up DG6.4			
Remove surface-mounted services and repair original finishes.			
Ensure that the addition of services is undertaken in a manner that complements the overall design of a verandah and minimises loss of significant fabric.

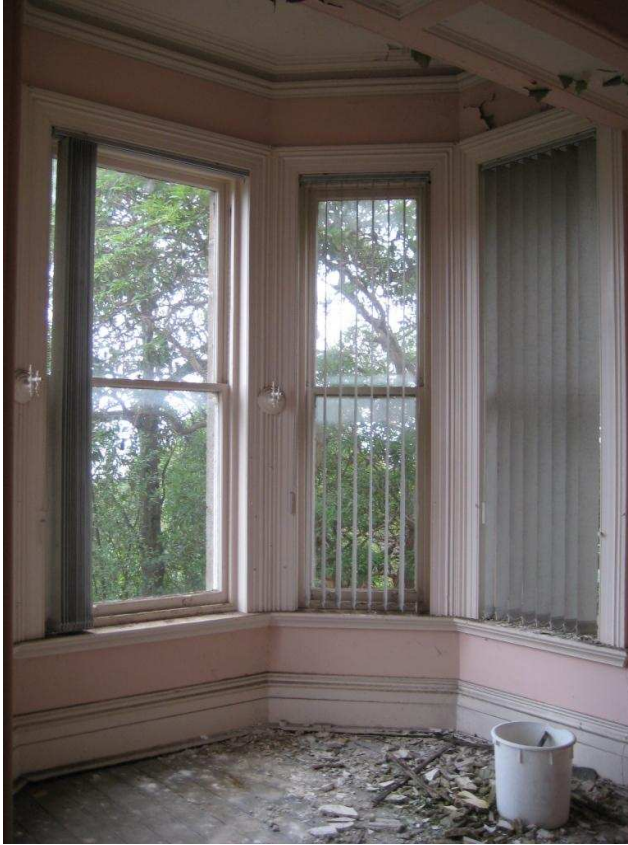
Room F1, bay window.

Room	F1	Original function	Not known: probably a bedroom
Historical notes			
Constructed c.1850s for Edwin Sayers, as part of the double-storey extension to the original single-storey Euroka stone cottage. Probably one of the 'six good bedrooms' (with F2) described in 1880 sale notice. Room partitioned in 1924 and then shown as the Club Room. Room shown as a bedroom in a drawing dated 1943.			
Integrity			
Good to post 1924 alteration. Alterations include the installation of the partitioning (1924), pressed metal ceiling (probably 1916); and modern finishes (c.1980s or 90s).			
Schedule of fabric			
Element	Description		
Floor	150mm wide timber boards without covering		
Skirtings	310mm moulded timber skirting boards with timber strips at wall/floor junction		
Walls	South, west and west: Plaster North: Plasterboard over timber partitioning visible in F2 Wall opening to bay window with staff moulds and reveal

Ceiling	Decorative pressed metal ceiling and decorative plaster cornice		
Doors	DF1.1: Three panel door with brass knob and plate		
Windows	F1/W1-W5: Double hung two pane sash windows with window locks and pulls. Decorative moulded timber architrave. 2 No. gas fittings on architrave. Vertical blinds. Fittings for blinds		
Conservation policies			
Consider retention of post 1924 plan form.			
Conserve and restore pre 1924 fabric.			
Remove modern finishes and fittings.			
Retain hospital era room name			
Remove surface-mounted services and repair original finishes.			
Ensure that the addition of services is undertaken in a manner that complements the overall design of the room and minimises loss of significant fabric.

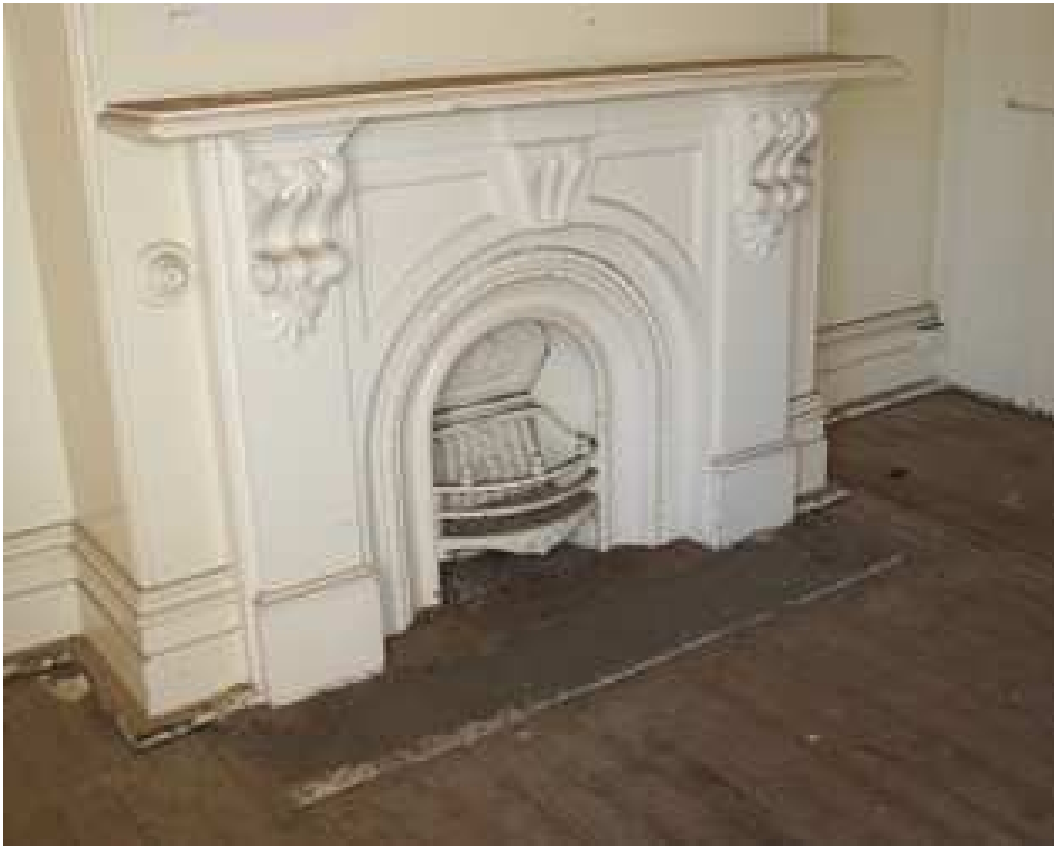
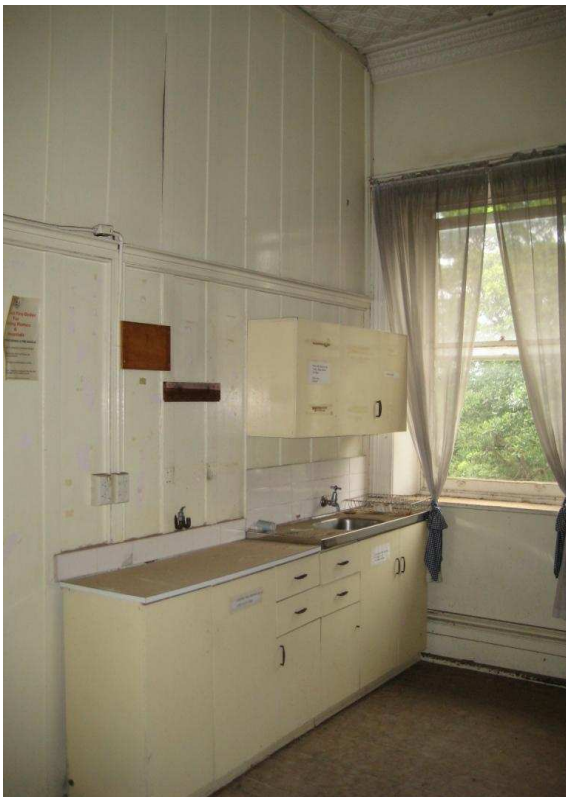
Room	F2	Original function	Not known: probably a room
Historical notes			
Constructed c.1850s for Edwin Sayers, as part of the double-storey extension to the original single-storey Euroka stone cottage. Bay window rebuilt for GR Dibbs c.1874. Probably one of the 'six good bedrooms' (with F1) described in 1880 sale notice. Room partitioned in 1924 and then shown as the Helper's Room. Room shown as a bedroom in a drawing dated 1943.			
Integrity			
Good to post 1924 alteration. Alterations include the installation of the partitioning (1924), pressed metal ceiling (probably 1916); upper partition section (mid (20 <sup>th</sup> ), and modern finishes (c.1980s or 90s).			
Schedule of fabric			
Element	Description		
Floor	150mm wide timber boards without covering		
Skirtings	310mm moulded timber skirting boards with timber strips at wall/floor junction		
Walls	North and west: Plaster East and south: Timber partitioning with later masonite sheeting above Chimney breast on north wall with timber staff moulds. 2 No. electric bell push Decorative timber fireplace surround on north wall. Cast-iron grate. Cement heath. Fitted kitchen cupboards (1990s?) on south wall.

Ceiling	Decorative pressed metal ceiling and decorative metal cornice		
Doors	DF2.1: Three panel door with brass knob and plate		
Windows	GF1/W1: Double hung two pane sash windows without horns. Evidence for glazing bars being cut out and the sashes originally were six pane. Fittings for blinds		
Conservation policies			
Consider retention of post 1924 plan form.			
Conserve and restore pre 1924 fabric.			
Retain hospital era name			
Remove modern finishes and fittings.			
Remove surface-mounted services and repair original finishes.			
Ensure that the addition of services is undertaken in a manner that complements the overall design of the room and minimises loss of significant fabric.

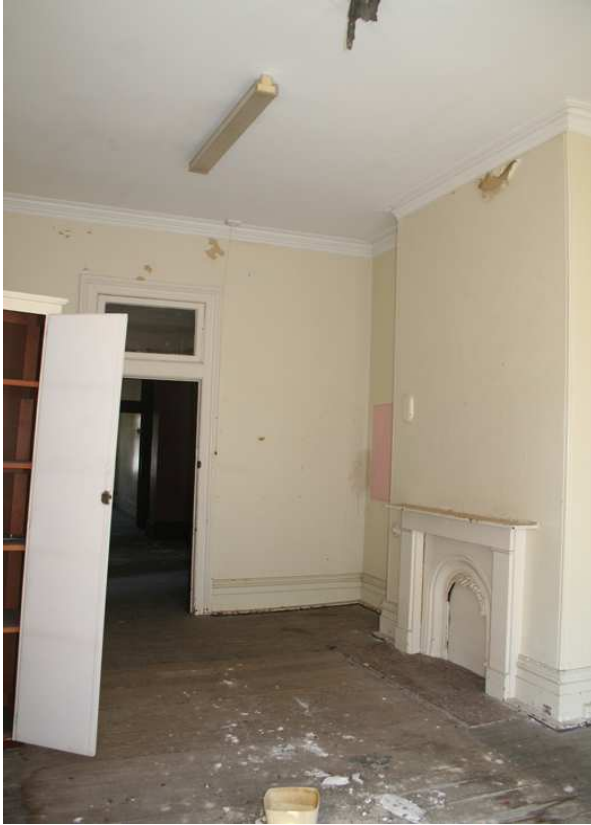
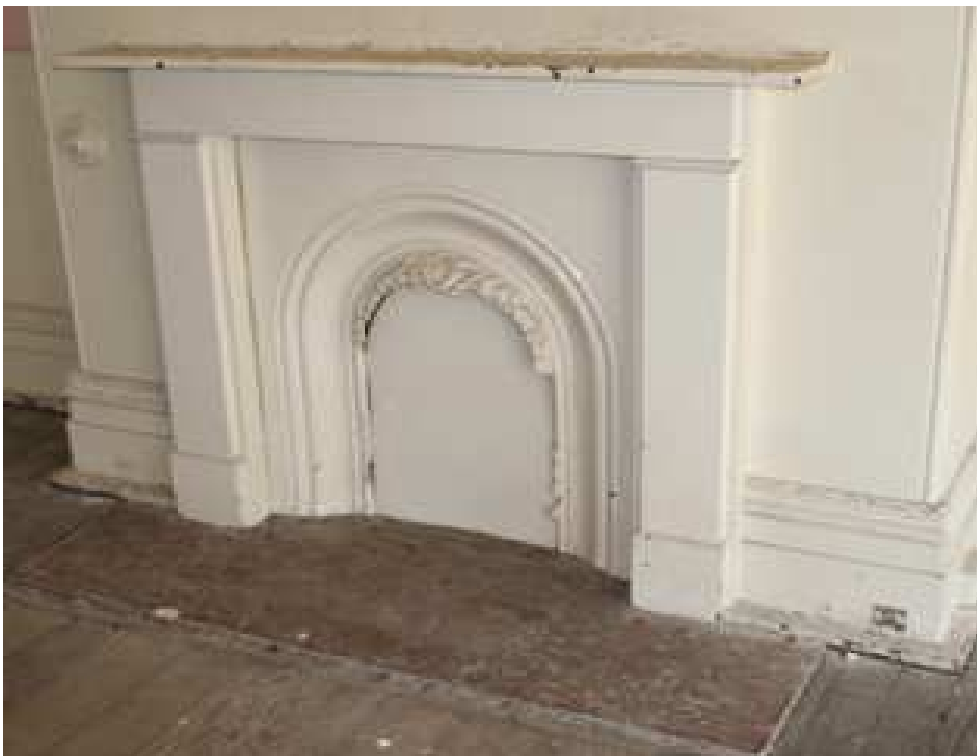
Room	F3	Original function	Not known: probably a bedroom
Historical notes			
Constructed c.1850s for Edwin Sayers, as part of the double-storey extension to the original single-storey Euroka stone cottage. Bay window added for GR Dibbs c.1874. Possibly one of the bedrooms described in the 1880 sale notice. Converted to a hospital ward by the Red Cross in 1916. Room shown as the Neutral Bay Ward in a drawing dated 1924. Room shown as the Sitting Room in a drawing dated 1943.			
Integrity			
Good			
Schedule of fabric			
Element	Description		
Floor	150mm wide timber boards without covering.		
Skirtings	330mm moulded timber skirting boards with timber strips at wall/floor junction		
Walls	North, south and west: Plaster East: Lath and plaster Chimney breast on south wall with timber staff moulds. Electric bell push Timber fireplace surround on south wall. Cast-iron grate (damaged). Cement heath. Wall opening to bay window with staff moulds and 2 No. gas fittings

Ceiling	Plasterboard with decorative plaster cornice		
Doors	DF3.1: Four panel door. Brass knobs with plate. Highlight. Decorative moulded timber architrave. Night latch		
Windows	F3/W1-W5: Double hung two pane sash windows with window locks and pulls. Decorative moulded timber architrave. Holland blinds, and curtains with pelmet		
Conservation policies			
Retain original plan form.			
Conserve and restore early and original fabric.			
Remove modern finishes and fittings.			
Remove surface-mounted services and repair original finishes.			
Retain hospital-era room name.			
Consider retention of bed blocks.			
Ensure that the addition of services is undertaken in a manner that complements the overall design of the room and minimises loss of significant fabric.

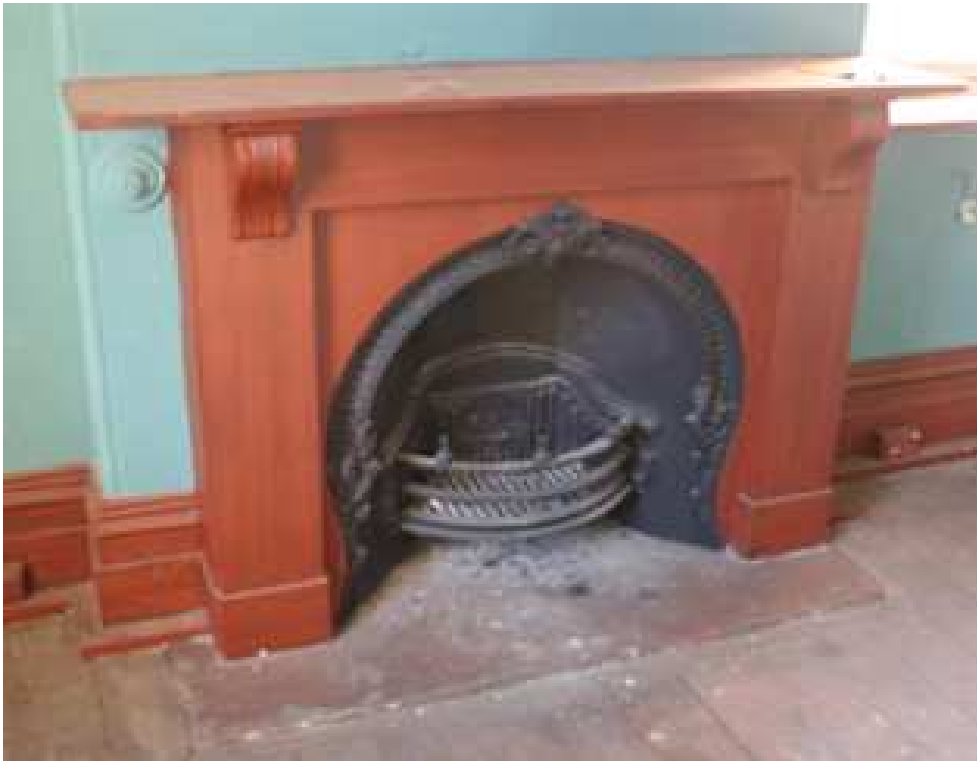
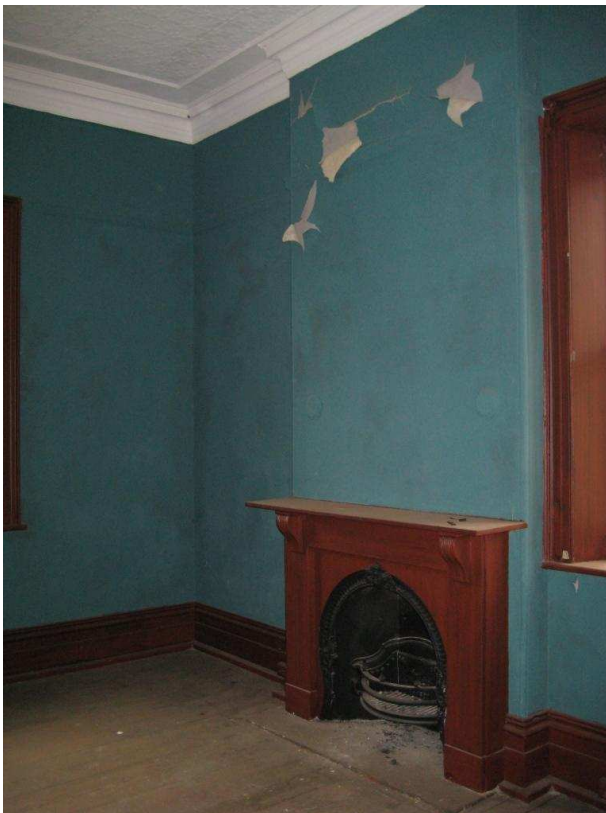
Room	F4	Original function	Not known: probably a bedroom
Historical notes			
Constructed c.1850s for Edwin Sayers, as part of the double-storey extension to the original single-storey Euroka stone cottage. Probably one of the 'six good bedrooms' described in 1880 sale notice. Converted to a hospital ward by the Red Cross in 1916. Room shown as the Northern Suburbs Ward in a drawing dated 1924. Room shown as a bedroom in a drawing dated 1943.			
Integrity			
Good; the plan form is original. Alterations include the installation of the pressed metal ceiling (probably 1916); picture rail (early 20th century; and modern finishes (c.1980s or 90s).			
Schedule of fabric			
Element	Description		
Floor	150mm wide timber boards without covering.		
Skirtings	330mm moulded timber skirting boards with timber strips at wall/floor junction		
Walls	Plaster Timber picture rails Chimney breast on north wall with timber staff moulds. 1 No. electric bell push. 2 No. gas fittings Timber fireplace surround on north wall. Cast-iron grate. Cement heath.

Ceiling	Pressed metal with decorative plaster cornice. Pressed metal ceiling rose		
Doors	DF4.1: Four panel door. Brass knobs with plate. Ceramic finger plate. Decorative moulded timber architrave. Night latch		
Windows	F4/W1: Double hung two pane sash windows without horns. Evidence for glazing bars being cut out and the sashes originally were six panes. Decorative moulded timber architrave. Fittings for blinds		
Conservation policies			
Retain original plan form.			
Conserve and restore early and original fabric.			
Remove modern finishes and fittings.			
Remove surface-mounted services and repair original finishes.			
Retain hospital-era room name.			
Consider retention of bed blocks.			
Ensure that the addition of services is undertaken in a manner that complements the overall design of the room and minimises loss of significant fabric.

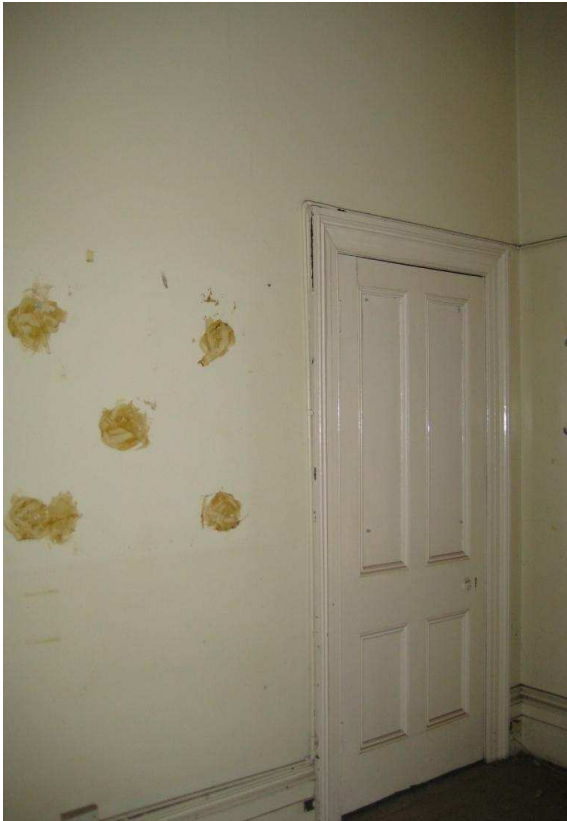
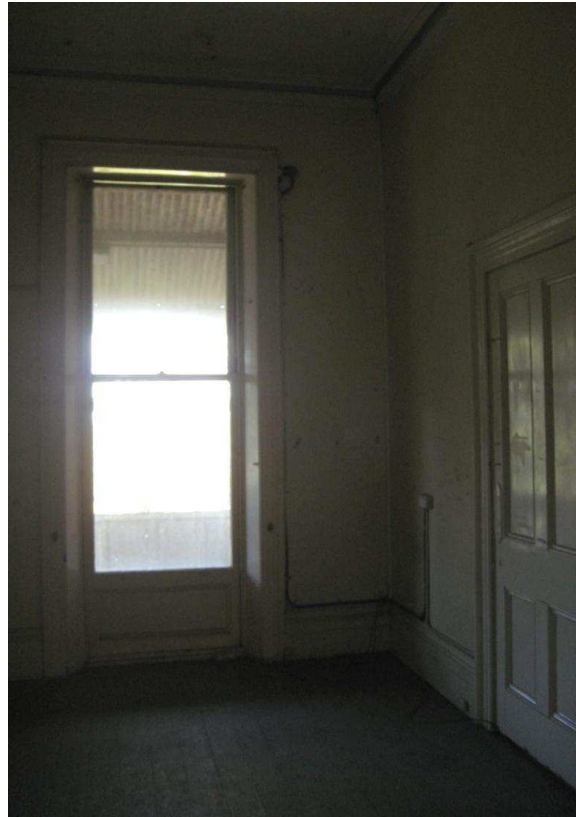
Room	F5	Original function	Not known
Historical notes			
Constructed c.1874 for GR Dibbs as part of the double-storey extension to Sayers' villa. Converted to a hospital ward by the Red Cross in 1916. Room shown as the Cullen Ward in a drawing dated 1924. Room shown as a bedroom in a drawing dated 1943.			
Integrity			
Good			
Schedule of fabric			
Element	Description		
Floor	150mm wide timber boards without covering		
Skirtings	330mm moulded timber skirting boards		
Walls	Plaster		
Ceiling	Plaster with decorative plaster cornice		
Doors	DF5.1: Four panel door. Brass knobs with plate. Ceramic fingerplate. Decorative moulded timber architrave. Night latch and barrel bolt DF5.2: Four panel door. Ceramic fingerplate. Decorative moulded timber architrave. Barrel bolt DF5.3: Four panel door. Brass knob missing. Decorative moulded timber architrave		
Windows	F5/W1: Double hung, French windows with lower timber panel with reveal. Window pulls and latch. Fittings for blinds. Decorative moulded timber architrave

Conservation policies			
Retain original plan form.			
Conserve and restore early and original fabric.			
Remove modern finishes and fittings.			
Remove surface-mounted services and repair original finishes.			
Retain hospital-era room name			
Ensure that the addition of services is undertaken in a manner that complements the overall design of the room and minimises loss of significant fabric.

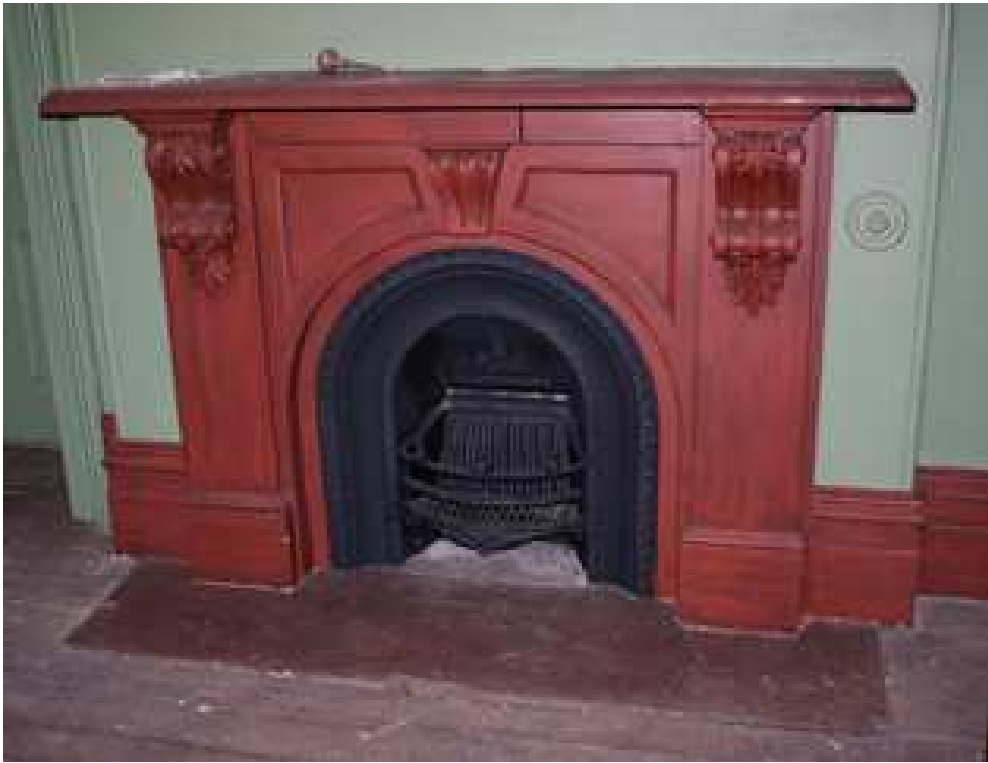
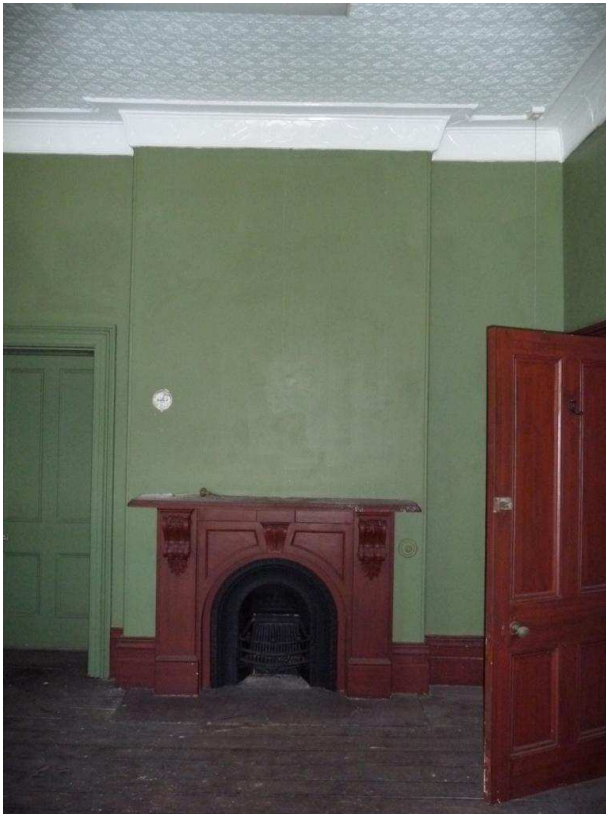
Room	F6	Original function	Not known: probably a bedroom
Historical notes			
Constructed c.1874 for GR Dibbs as part of the double-storey extension to Sayers' villa. Probably one of the 'six good bedrooms' described in 1880 sale notice. Converted to a hospital ward by the Red Cross in 1916. Room shown as the Thurgood Ward in a drawing dated 1924. Room shown as a bedroom in a drawing dated 1943.			
Integrity			
Good. Alterations include the pressed metal ceilings (probably 1916), and modern finishes (c.1980s or 90s).			
Schedule of fabric			
Element	Description		
Floor	150mm wide timber boards without covering		
Skirtings	330mm moulded timber skirting boards with timber strips at wall/floor junction		
Walls	Plaster Chimney breast on west wall with timber staff moulds. 1 No. electric bell push Decorative timber fireplace surround on west wall. Cast-iron grate. Cement heath		
Ceiling	Decorative pressed metal ceiling and decorative metal cornice. Pressed metal ceiling rose.

Doors	DF5.3: Four panel door. Ceramic fingerplate. Decorative moulded timber architrave. Panelled reveal DF6.1: Four panel door. Brass rose and knob. Night latch. Decorative moulded timber architrave		
Windows	F6W1&2: Double hung, French windows with lower timber panel with reveal. Window pulls and latch. Fittings for blinds. Decorative moulded timber architrave		
Conservation policies			
Retain original plan form.			
Conserve and restore early and original fabric.			
Remove modern finishes and fittings.			
Remove surface-mounted services and repair original finishes.			
Retain hospital-era room name.			
Consider retention of bed blocks.			
Ensure that the addition of services is undertaken in a manner that complements the overall design of the room and minimises loss of significant fabric.
