**GRAYTHWAITE HOUSE**

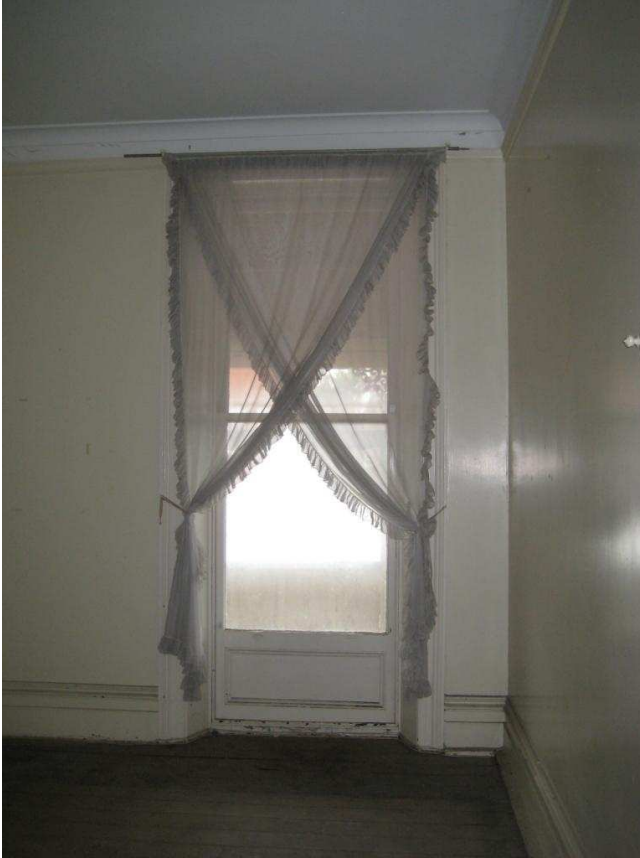
Room F7, looking east.

Room	F7	Original function	Not known: possibly the bathroom
Historical notes			
Constructed c.1874 for GR Dibbs as part of the double-storey extension to Sayers' villa. Converted to a hospital ward by the Red Cross in 1916. Room shown as the Kirribilli Ward in a drawing dated 1924. Room shown as a bedroom in a drawing dated 1943.			
Integrity			
Fair: the plan form is original. Alterations include the installation of the plasterboard ceiling (late 20th century); picture rail (early 20th century) and modern finishes (c.1980s or 90s).			
Schedule of fabric			
Element	Description		
Floor	150mm wide timber boards without covering		
Skirtings	330mm moulded timber skirting boards with timber strips at wall/floor junction		
Walls	Plaster Timber picture rail Gas fitting		
Ceiling	Plasterboard ceiling and coved profile plasterboard cornice		
Doors	DF7.1: Four panel door. Brass rose and knob. Ceramic fingerplate. Decorative moulded timber architrave. Highlight. Night latch

Windows	F7W1: Double hung, French windows with lower timber panel with reveal. Window pulls and latch. Fittings for blinds. Decorative moulded timber architrave		
Conservation policies			
Retain original plan form.			
Conserve and restore early and original fabric.			
Remove modern finishes and fittings.			
Remove surface-mounted services and repair original finishes.			
Retain hospital-era room name.			
Consider retention of bed blocks.			
Ensure that the addition of services is undertaken in a manner that complements the overall design of the room and minimises loss of significant fabric.

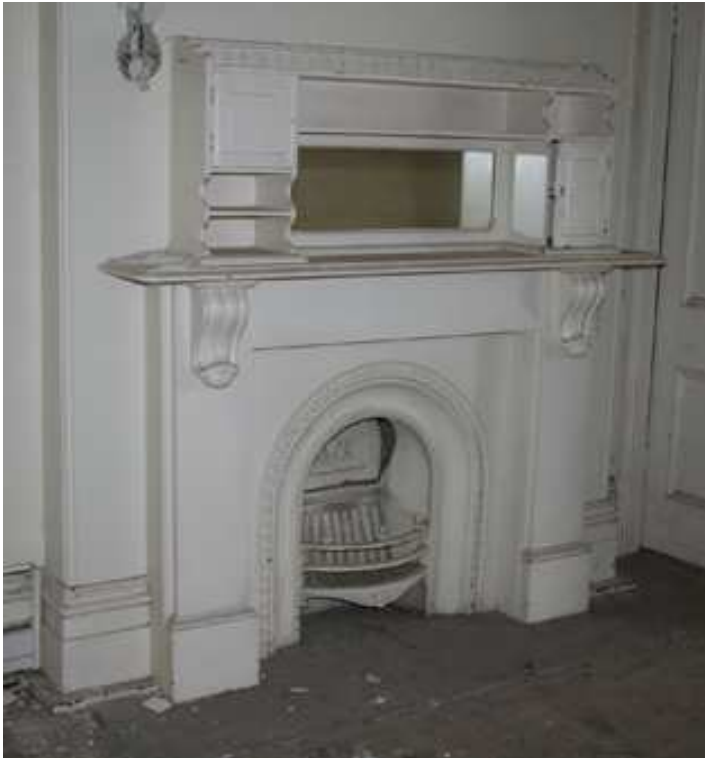
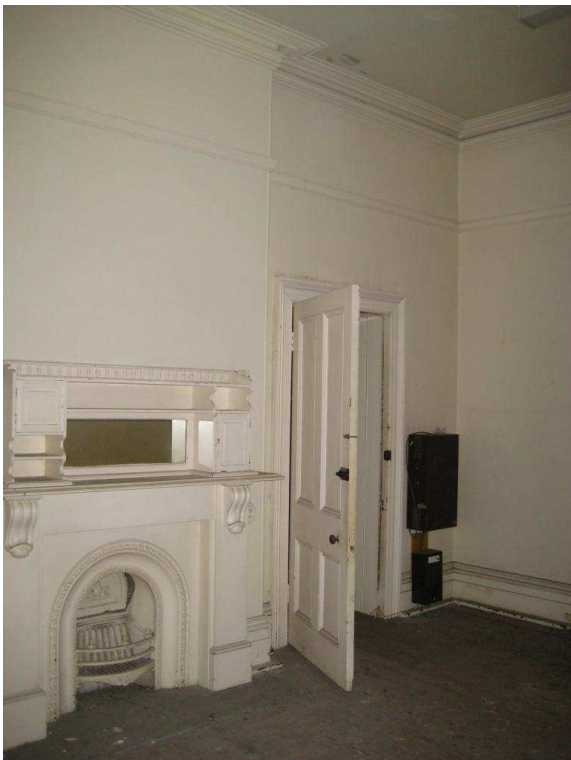
Room	F8	Original function	Not known: possibly a nursery
Historical notes			
Constructed c.1874 for GR Dibbs as part of the double-storey extension to Sayers' villa. Probably one of the 'six good bedrooms' described in 1880 sale notice. Converted to a hospital ward by the Red Cross in 1916. Room shown as the Golden Button Ward in a drawing dated 1924. Room shown as a bedroom in a drawing dated 1943.			
Integrity			
Good and retains original plan form. Alterations include the picture rail (early 20th century) and modern finishes (c.1980s or 90s).			
Schedule of fabric			
Element	Description		
Floor	150mm wide timber boards without covering.		
Skirtings	330mm moulded timber skirting boards with timber strips at wall/floor junction		
Walls	Plaster Timber picture rail Chimney breast on north wall with timber staff moulds. 1 No. electric bell push. Evidence for gas fitting Decorative timber fireplace surround on north wall. Cast-iron grate. Cement heath Decorative timber overmantel with mirror inlay Electricity junction box

Ceiling	Plaster ceiling and decorative plaster cornice		
Doors	DF8.1: Four panel door. Brass rose and knob. Ceramic fingerplate. Night latch. Decorative moulded timber architrave DF8.2: Four panel door. Brass rose and knob. Night latch. Decorative moulded timber architrave		
Windows	F8W1: Double hung, French windows with lower timber panel with reveal and with side lights. Window pulls and latch. Fittings for blinds. Decorative moulded timber architrave		
Conservation policies			
Retain original plan form.			
Conserve and restore early and original fabric.			
Remove modern finishes and fittings.			
Remove surface-mounted services and repair original finishes.			
Retain hospital-era room name			
Retain bed blocks			
Ensure that the addition of services is undertaken in a manner that complements the overall design of the room and minimises loss of significant fabric.

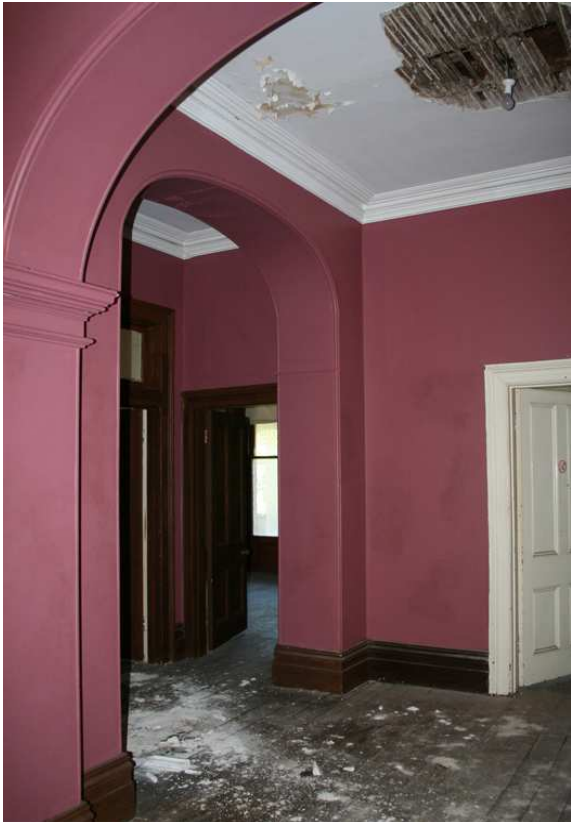
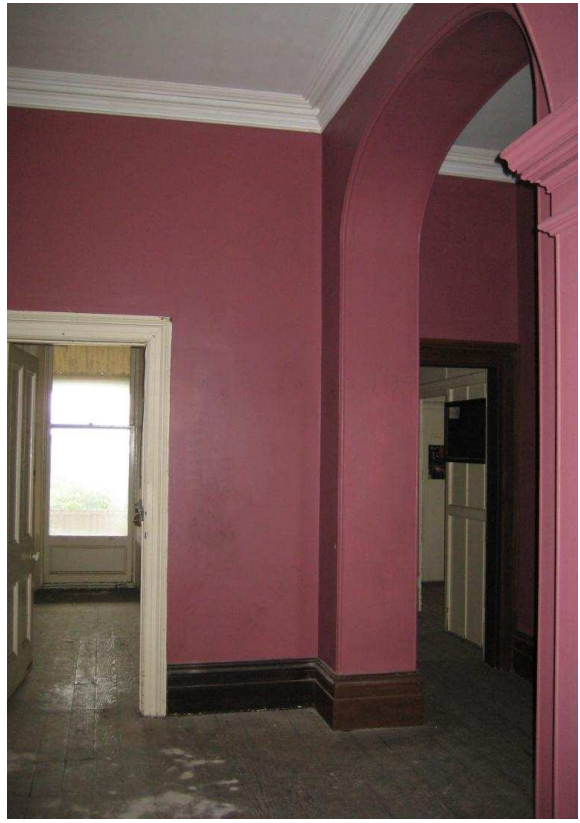
Room	F9	Original function	Landing
Historical notes			
Constructed c.1874 for GR Dibbs as part of the double-storey extension to Sayers' villa. Probably the 'large landing' described in the 1880 sale notice. Room shown as the hall in drawings dated 1924 and 1943.			
Integrity			
Good: the plan form is original. Alterations include the installation of the cast iron balustrading to land (date?) and changes to landing window (1916).			
Schedule of fabric			
Element	Description		
Floor	150mm wide timber boards without covering		
Skirtings	330mm moulded timber skirting boards		
Walls	Plaster Arched openings with staff moulds and plaster capitals on wall nibs		
Ceiling	Plaster with decorative plaster cornice		
Doors	See entries for adjoining rooms		
Windows:	A5/W1 (Landing window): Double hung sash window with lower sash removed and cavity bricked in. Remaining sash glazed in leaded rippled glass. Landing has a cast iron balustrade.

Stair 1	Half-turn staircase with open balustrade of turned balusters, handrail and newel post. Plaster soffit. Moulded timber skirting. Remnant linoleum runner in the risers. Evidence for painted ashlar lined wall decoration		
Conservation policies			
Retain original plan form.			
Conserve and restore early and original fabric.			
Remove modern finishes and fittings.			
Remove surface-mounted services and repair original finishes.			
Investigate and reinstate landing window to pre 1916 configuration			
Ensure that the addition of services is undertaken in a manner that complements the overall design of the room and minimises loss of significant fabric.

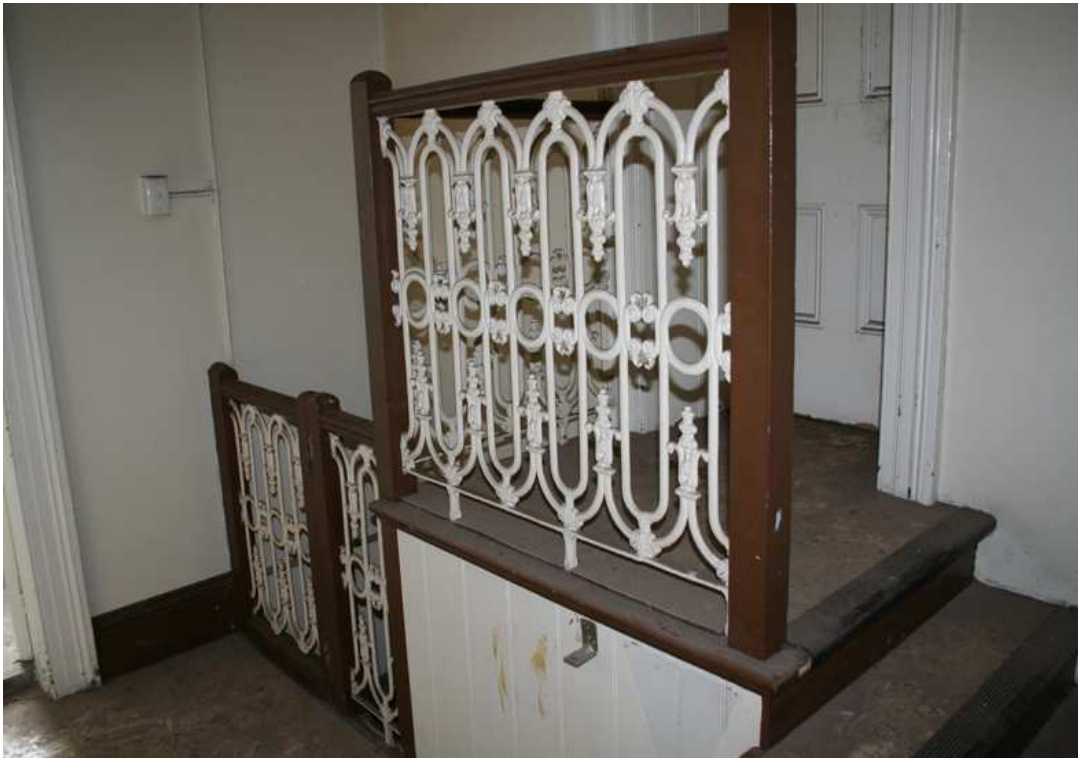
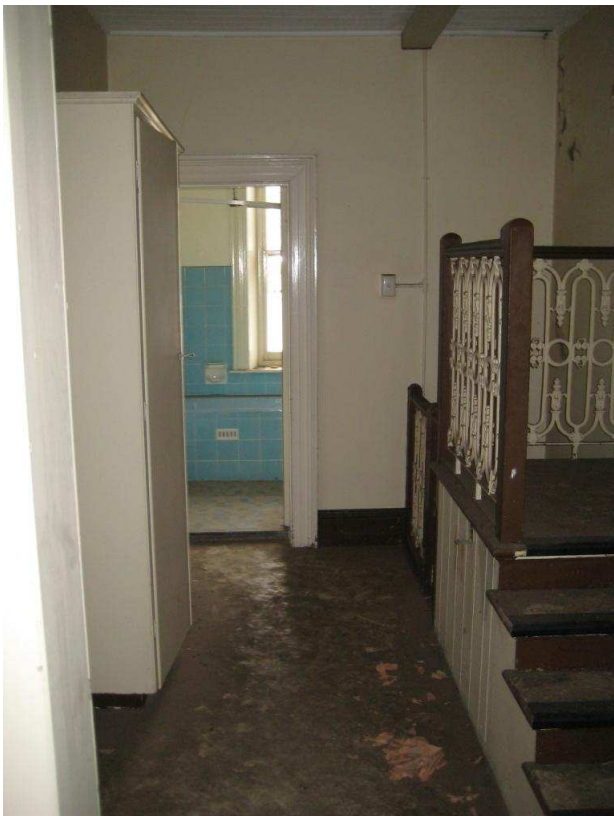
Room	F14	Original function	Not known: probably rear service verandah
Historical notes			
Constructed c.1874 for GR Dibbs as part of the double-storey extension to Sayers' villa. Probably the upper level of a two storey verandah running the length of the north wall to the Kitchen. Originally open and roofed and fronted rear service courtyard. Existing configuration dates from addition of lavatory block in 1916.			
Integrity			
Poor: the original plan form is discernible as it the structural framing and coved roof. Alterations include the building of the lavatory block (1916), modern finishes (c.1980s or 90s).			
Schedule of fabric			
Element	Description		
Floor	Fitted vinyl over timber boards.		
Skirtings	-		
Walls	Painted sandstone and plaster Boarded partitioning		
Ceiling	150mm edge beaded tongue and groove boards Plaster with strip timber cornice Coved corrugated iron soffit of verandah roof and timber framing with stop chamfered members

Doors	DF14.1: Four panel door. Brass knob. Decorative moulded timber architrave DF14.2: Four panel door. Brass knob. Panelled reveal. Decorative moulded timber architrave		
Stairs	STAIR 3: Timber risers and treads STAIR 4: Timber risers and treads. Timber handrail and newel post with decorative cast iron balustrade STAIR 2: Timber risers and treads. Timber handrail and newel post with decorative cast iron balustrade; part operable gate		
Conservation policies			
Reinstate original verandah plan form.			
Remove 1916 and later additions			
Investigate original floor finish.			
Conserve and restore early and original fabric.			
Remove modern finishes and fittings.			
Remove surface-mounted services and repair original finishes.			
Ensure that the addition of services is undertaken in a manner that complements the overall design of a verandah and minimises loss of significant fabric.

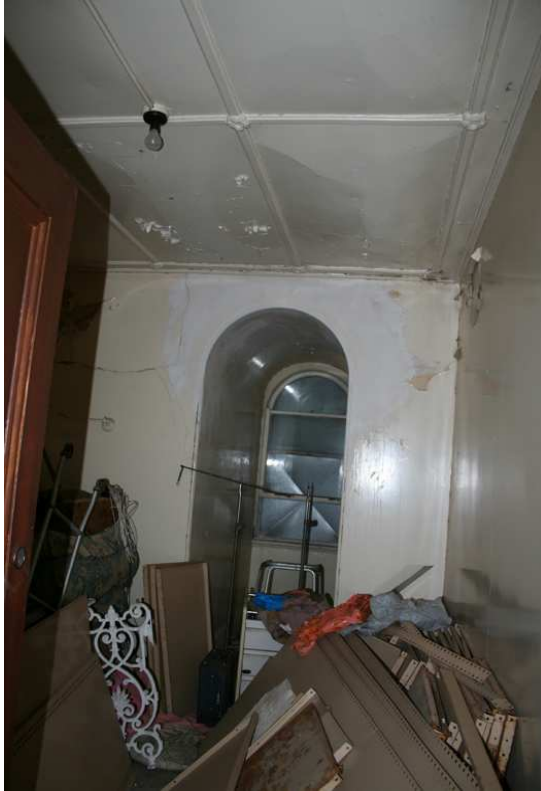
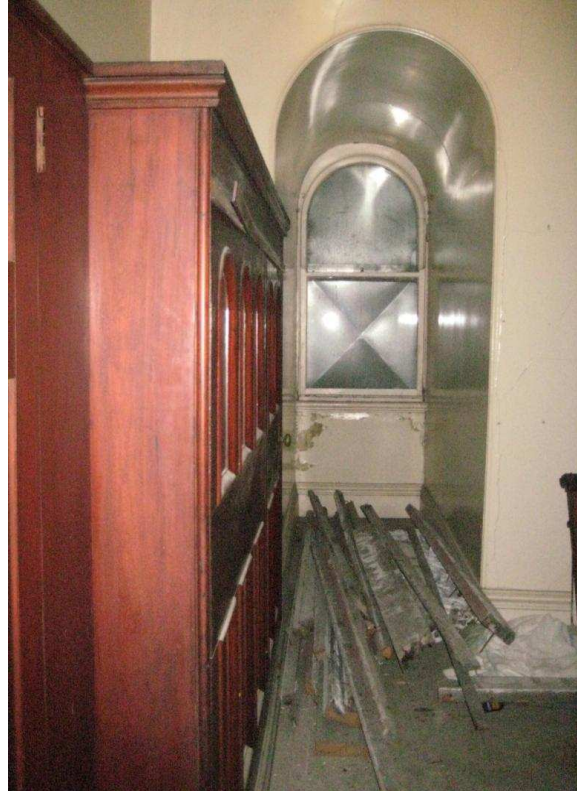
Rooms	A1-A5	Original function	Not known: probably bedrooms
Historical notes			
Constructed c.1874 for GR Dibbs as part of the double-storey extension to Sayers' villa. Rooms described as bedrooms in the 1880 sale notice.			
Integrity			
Generally good: the plan form is original. Alterations include the installation of the strapped plaster ceiling (early 20th century), highlights (mid 20 <sup>th</sup> century) and modern finishes (c.1980s or 90s).			
Schedule of fabric			
Element	Description		
Floor	150mm wide timber boards without covering.		
Skirtings	190 mm moulded timber skirting boards		
Walls	Plaster to stair hall Lath and plaster stud walls		
Ceiling	Battened plaster with decorative rosettes		
Doors	DA2.1-D5.1: Four panel doors. Ceramic knobs. Later highlight		
Windows	A4W1, A3W1-W2, A2W1-W2, A1W1: Double hung sash windows with rounded upper sash head		
Other	Cedar linen cupboard in A2 Stored cast iron railing from the roof observatory in A3

Conservation policies			
Retain original plan form.			
Conserve and restore early and original fabric.			
Remove modern finishes and fittings.			
Remove surface-mounted services and repair original finishes.			
Ensure that the addition of services is undertaken in a manner that complements the overall design of the room and minimises loss of significant fabric.

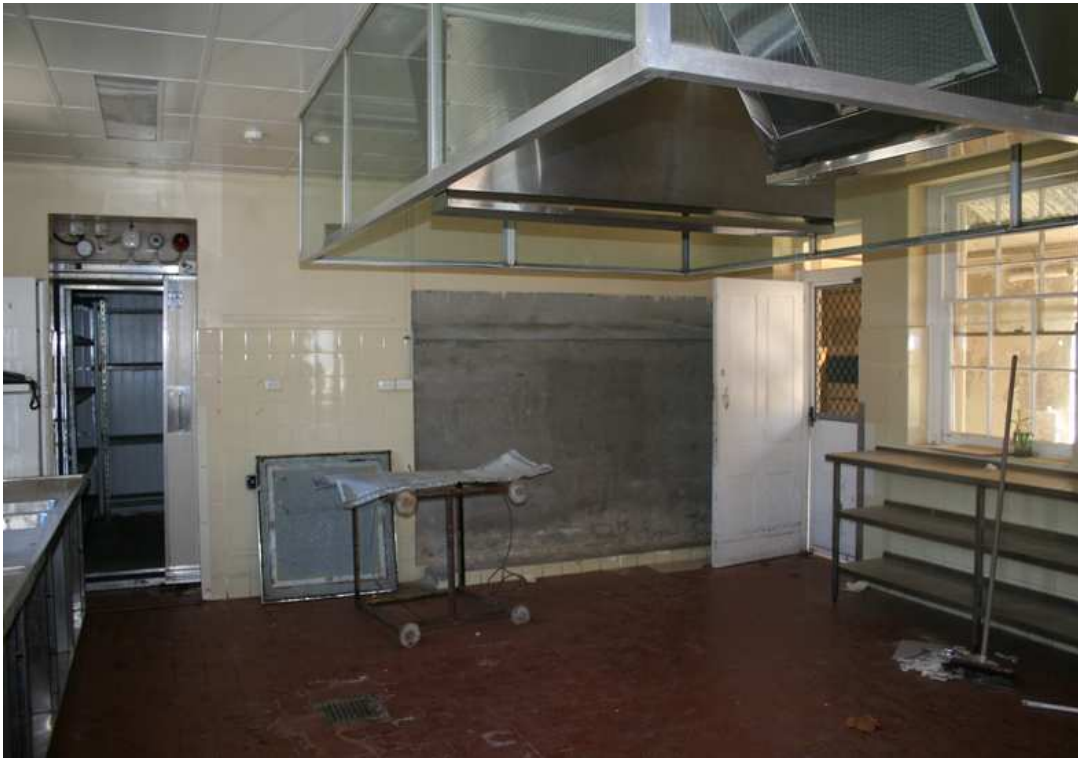
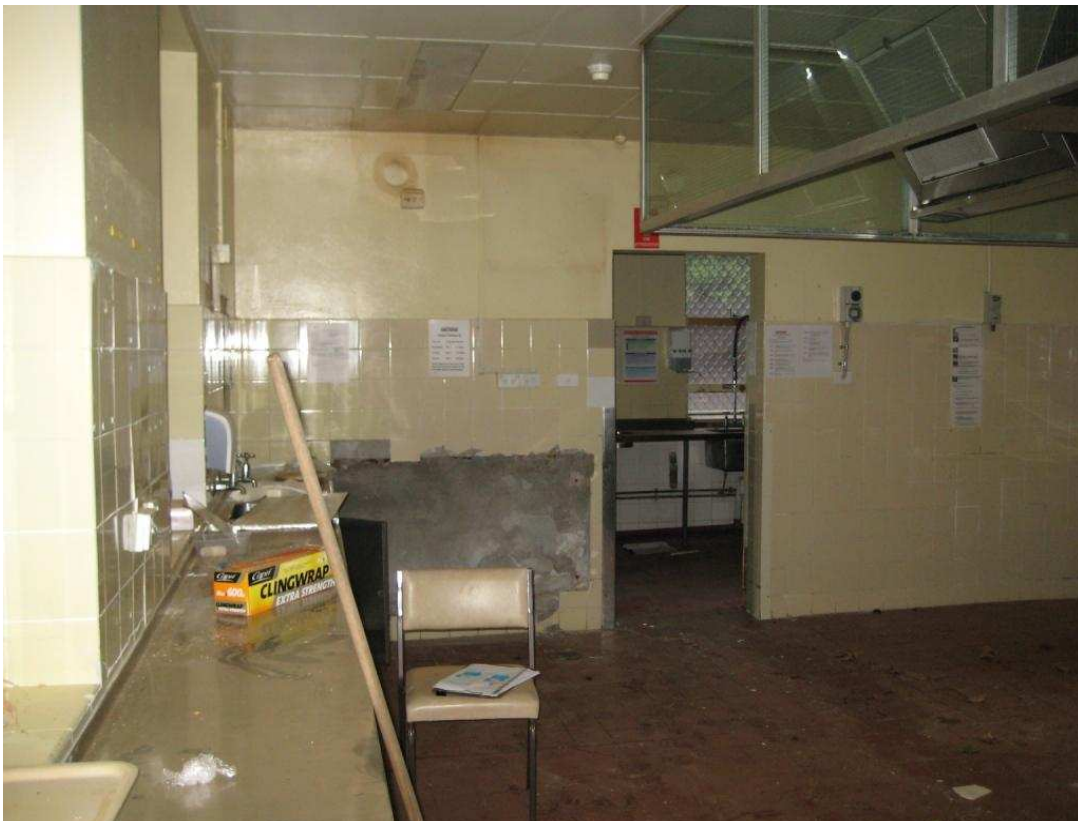
Room	G7	Original function	Kitchen
Historical notes			
<p>The lower level of the Kitchen Wing, including Room G7, was probably constructed c1850s as a one storey building for Edwin Sayers.</p> <p>The lower level of the Kitchen Wing is depicted in a c1874 photograph.</p> <p>Room originally comprised two spaces with the cross wall containing a fireplace. Shown as the kitchen (south) and nurse's room (north) in a drawing dated 1916. The cross wall was removed in the 1980s or 1990s.</p>			
Integrity			
<p>Generally poor as the original plan form is lost.</p> <p>Alterations include the modern (c1890s/1990s) fitout and finishes.</p>			
Schedule of fabric			
Element	Description		
Floor	Quarry tiles over concrete		
Skirtings	—		
Walls	Plaster and glazed tiles		
Ceiling	Battened fibreboard		
Doors	DG7.1: Four panel door with beaded sunk mould on external face. Internal face has no mouldings. Night latch. Highlight. Quad profile architrave DG7.2: Fire rated flush door

Windows	G7/W1& W2: Double hung sash window G7/W5 & W6: Double hung sash window without horns, six panes per sash. Pulls and latch. Sill height raised		
Conservation policies			
<p>Conserve and restore early and original fabric.</p> <p>Reinstate original plan form if warranted.</p> <p>Investigate original floor finish if warranted.</p> <p>Remove modern finishes and fittings if warranted.</p> <p>Remove surface-mounted services and repair original finishes if warranted.</p> <p>Ensure that the addition of services is undertaken in a manner that complements the overall design of the room and minimises loss of significant fabric.</p>

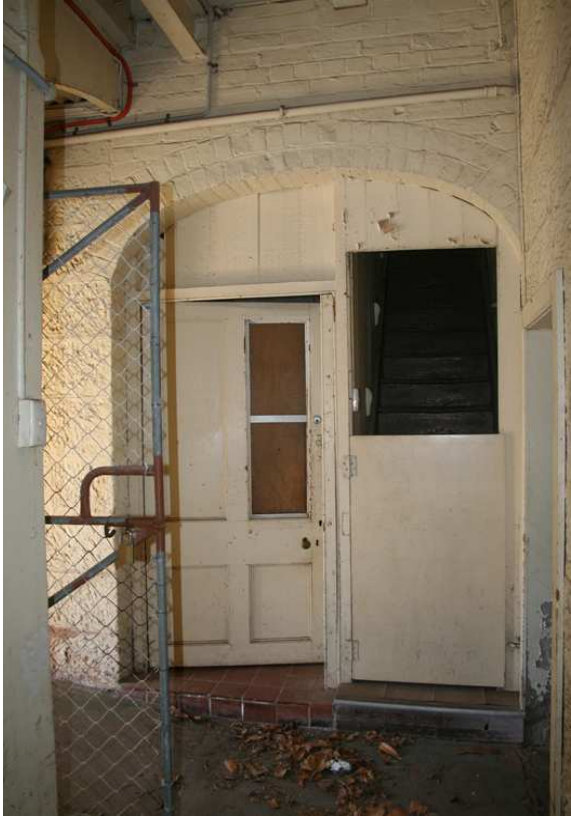
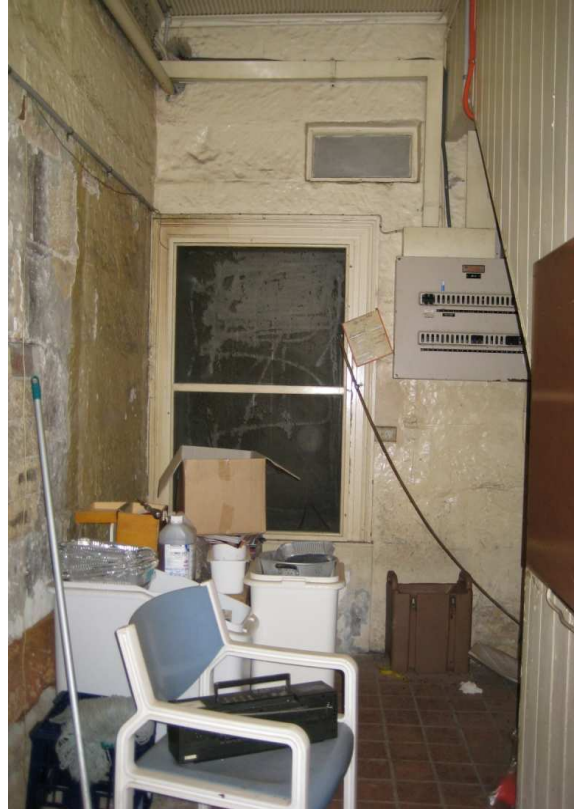
Room	G16	Original function	Not known: Probably open passage
Historical notes			
<p>The lower level of the Kitchen Wing, including Room G16, was probably constructed c1850s as a one storey building for Edwin Sayers.</p> <p>The lower level of the Kitchen Wing is depicted in a c1874 photograph.</p> <p>This space could have originally provided fire separation between the House and the kitchen. The brick arch over DG16.1 seems a later (perhaps George Dibbs) insertion suggesting that the room itself may have been formed c1874.</p> <p>The room is shown as a passage in a drawing dated 1943.</p>			
Integrity			
<p>Generally good: the plan form is original to c1874 and further investigation is likely to reveal more of its early configuration.</p>			
Schedule of fabric			
Element	Description		
Floor	Quarry tiles on concrete		
Skirtings	—		
Walls	<p>West: Timber boarding abutting a brick arched opening</p> <p>North, south and east: Painted sandstone masonry</p> <p>East: Boarded panelling of Stair 2. Tongue and groove with beaded edge</p> <p>Telecommunications switch box.</p> <p>Bricked-in opening on north wall with iron lintel</p> <p>Bricked-in window opening on south wall opening to verandah and partially obscured by Stair 2</p>

Ceiling	Ripple iron with a quad profile cornice		
Doors	DG16.1: Four panel door, one panel metal gauze. Night latch. Frame with beaded margin		
Windows	G7/W7: Sash removed and panel fitted. Decorative moulded timber architrave		
Conservation policies			
<p>Reinstate post 1874 plan form if warranted.</p> <p>Investigate original floor finish if warranted.</p> <p>Conserve and restore early and original fabric.</p> <p>Remove modern finishes and fittings if warranted.</p> <p>Remove surface-mounted services and repair original finishes</p> <p>Ensure that the addition of services is undertaken in a manner that complements the overall design of the room and minimises loss of significant fabric.</p>

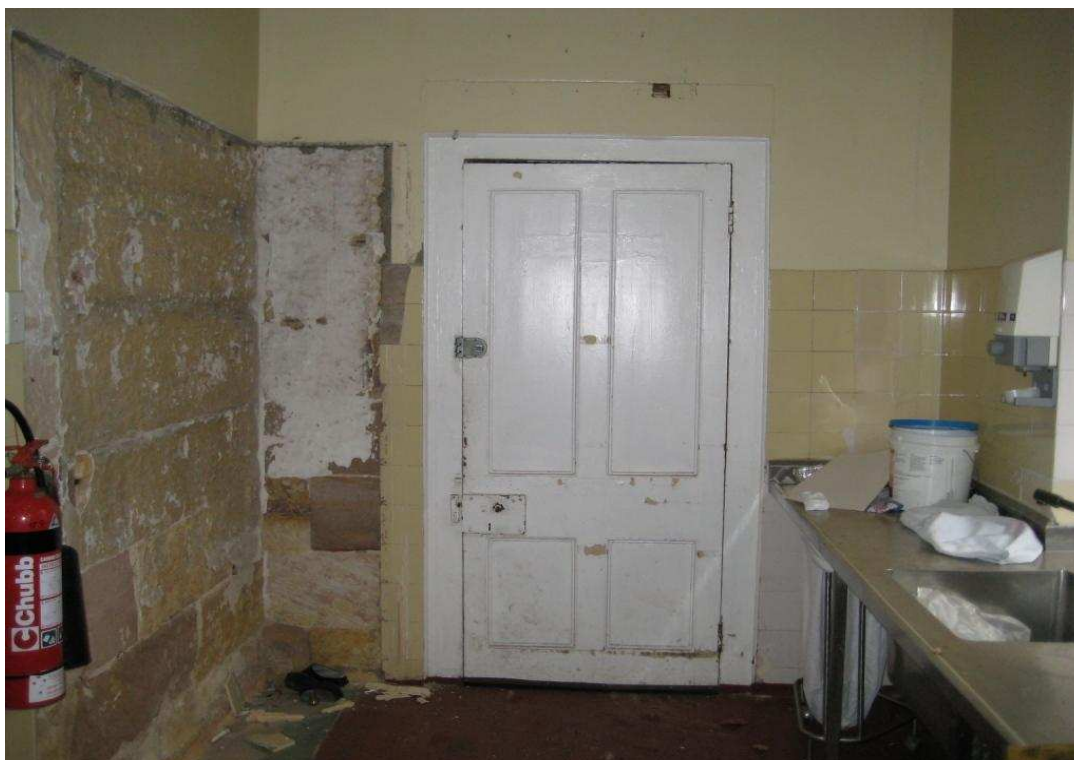
G17, looking east.

Room	G17	Original function	Not known: possibly scullery
Historical notes			
The lower level of the Kitchen Wing, including Room G17, was probably constructed c1850s as a one storey building for Edwin Sayers.			
The lower level of the Kitchen Wing is depicted in a c1874 photograph.			
The room is shown as the laundry in a drawing dated 1916 and as the scullery in a drawing dated 1943.			
Integrity			
Generally good: the plan form is original.			
Alterations include the installations, and modern finishes (c1980s or 1990s).			
Date of door opening to G7 requires further investigation.			
Schedule of fabric			
Element	Description		
Floor	Quarry tiles over concrete		
Skirtings	—		
Walls	Plaster and glazed tiles Chimney flue on east/south wall junction		
Ceiling	Battened fibreboard		
Doors	DG17.1: four panel door with external flyscreen		
Windows	G7/W4 & W5: Double hung sash window. Quad profile architrave. Latch

Conservation policies			
Reinstate original plan form if warranted.			
Investigate original floor finish if warranted.			
Conserve and restore early and original fabric.			
Remove modern finishes and fittings if warranted.			
Remove surface-mounted services and repair original finishes if warranted.			
Ensure that the addition of services is undertaken in a manner that complements the overall design of the room and minimises loss of significant fabric.

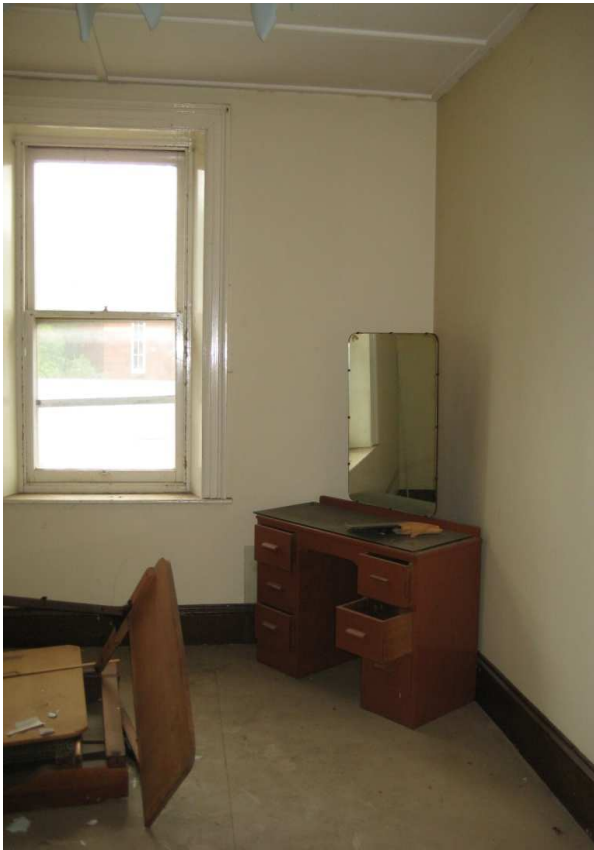
F10, looking east.

Room	F10	Original function	Not known: probably a bedroom
Historical notes			
<p>It is likely that the upper level of the Kitchen Wing, including Room F10, was constructed c1874.</p> <p>The timber partitions were constructed in 1924.</p> <p>The room is shown as a sewing room in a drawing dated 1924 and then was converted to a bedroom for nurses—it is shown as a bedroom on a drawing dated 1943.</p>			
Integrity			
<p>Generally good: the plan form is original.</p> <p>Alterations include the installation of the battened fibreboard ceiling (c1920s); timber partitioning (1924), infilling of space above partitioning (mid twentieth century) and modern finishes (c1980s or 1990s).</p>			
Schedule of fabric			
Element	Description		
Floor	Fitted vinyl over timber boards.		
Skirtings	190mm moulded timber skirting boards		
Walls	North, south and east: Plaster North wall: Chimney flue with timber staff moulds West: Timber partition with later fibreboard upper section.

Ceiling	Timber battened fibreboard		
Doors	DF10.1: Three panel door. Brass knob and plate. Night latch		
Windows	F10/W1: Double hung sash. Pull and latch. Decorative moulded timber architrave		
Conservation policies			
<p>Retain post-1924 plan form.</p> <p>Investigate original floor finish.</p> <p>Conserve and restore early and original fabric.</p> <p>Remove post-1924 finishes and fittings.</p> <p>Remove surface-mounted services and repair original finishes.</p> <p>Ensure that the addition of services is undertaken in a manner that complements the overall design of the room and minimises loss of significant fabric.</p>

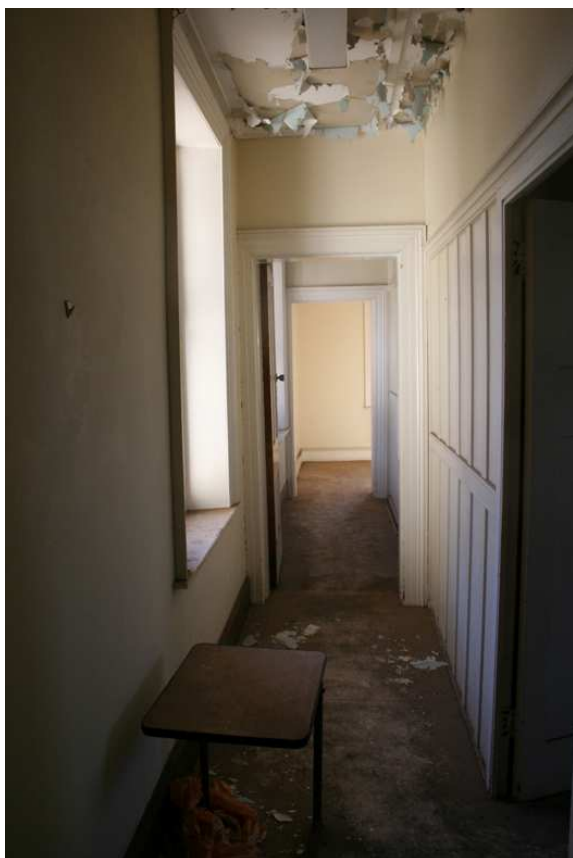
Room	F10A/F11A	Original function	Not known: probably passage
Historical notes			
It is likely that the upper level of the Kitchen Wing, including Room F10A/F11A, was constructed c1874. The timber partitions were constructed in 1924.			
Integrity			
Generally good: the plan form is original.			
Alterations include the installation of the battened fibreboard ceiling (c1920s); timber partitioning (1924), infilling of space above partitioning (mid twentieth century) and modern finishes (c1980s or 1990s).			
Schedule of fabric			
Element	Description		
Floor	Fitted vinyl over timber boards.		
Skirtings	190mm moulded timber skirting boards (west)		
Walls	North, south and west: plaster East: Timber partition with later fibreboard upper section		
Ceiling	Timber battened fibreboard		
Doors	DF11.2: Four panel door		
Window	F11A/W1 & F10A/W1: Double hung sash. Pull and latch. Blind fittings. Decorative moulded timber architrave

Room F10A. Looking north. The 1924 timber partitions and mid-twentieth century upper level infill are at right.

Conservation policies			
Consider retention of post-1924 plan form.			
Investigate original floor finish.			
Conserve and restore early and original fabric.			
Remove post-1924 finishes and fittings.			
Remove surface-mounted services and repair original finishes.			
Ensure that the addition of services is undertaken in a manner that complements the overall design of the room and minimises loss of significant fabric.

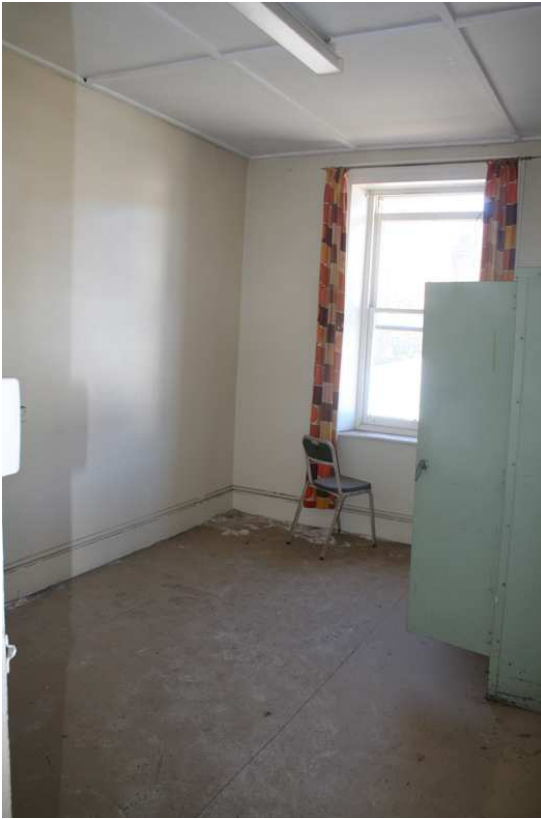
Room F11, looking east.

Room	F11	Original function	Not known: probably bedroom
Historical notes			
It is likely that the upper level of the Kitchen Wing, including Room F11, was constructed c1874.			
The timber partitions were constructed in 1924.			
The room is shown as the Sister's Bedroom on a 1924 drawing and as a bedroom in a 1943 drawing.			
Integrity			
Generally good: the plan form is original.			
Alterations include the installation of the battened fibreboard ceiling (c1920s); timber partitioning (1924), infilling of space above partitioning (mid twentieth century) and modern finishes (c1980s or 1990s).			
Schedule of fabric			
Element	Description		
Floor	Fitted vinyl over timber boards.		
Skirtings	190mm moulded timber skirting boards		
Walls	North, south and east: Plaster North wall: Chimney flue with timber staff moulds West: Timber partition with later fibreboard upper section		
Ceiling	Timber battened fibreboard

Doors	DF11.1: Four panel door. Brass knob		
Windows	F11/W1: Double hung sash. Pull and latch. Blind fittings. Decorative moulded timber architrave		
Conservation policies			
Consider retention of post-1924 plan form.			
Investigate original floor finish.			
Conserve and restore early and original fabric.			
Remove post-1924 finishes and fittings.			
Remove surface-mounted services and repair original finishes.			
Ensure that the addition of services is undertaken in a manner that complements the overall design of the room and minimises loss of significant fabric.

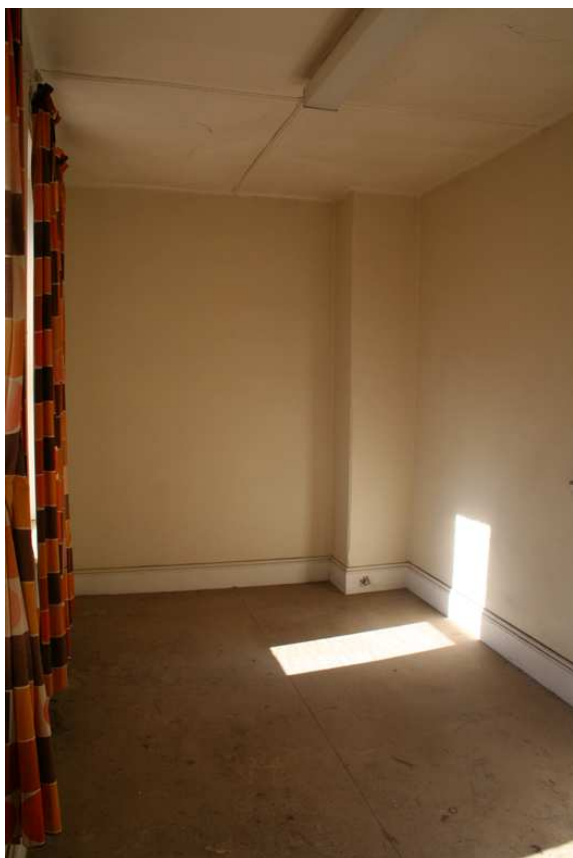
Room F12, looking east

Room	F12	Original function	Not known: probably housekeeper's bedroom
Historical notes			
It is likely that the upper level of the Kitchen Wing, including Room F12, was constructed c1874.			
The room is shown as the Matron's bedroom in a 1924 drawing and as a bedroom in a 1943 drawing.			
Integrity			
Generally good: the plan form is original.			
Alterations include installation of battened fibreboard ceiling (c1920s) and modern finishes (c1980s or 1990s).			
Schedule of fabric			
Element	Description		
Floor	Fitted vinyl over timber boards.		
Skirtings	190mm moulded timber skirting boards		
Walls	Plaster Chimney flue at south-east wall junction		
Ceiling	Timber battened fibreboard		
Doors	DF12.3: Four panel door. Brass knob		
Windows	F12/W1 & W2: Double hung sash. Pull and latch. Blind fittings. Decorative moulded timber architrave		
Conservation policies			
Retain original plan form.			
Investigate original floor finish.

Conserve and restore early and original fabric.			
Remove modern finishes and fittings.			
Remove surface-mounted services and repair original finishes.			
Ensure that the addition of services is undertaken in a manner that complements the overall design of the room and minimises loss of significant fabric.

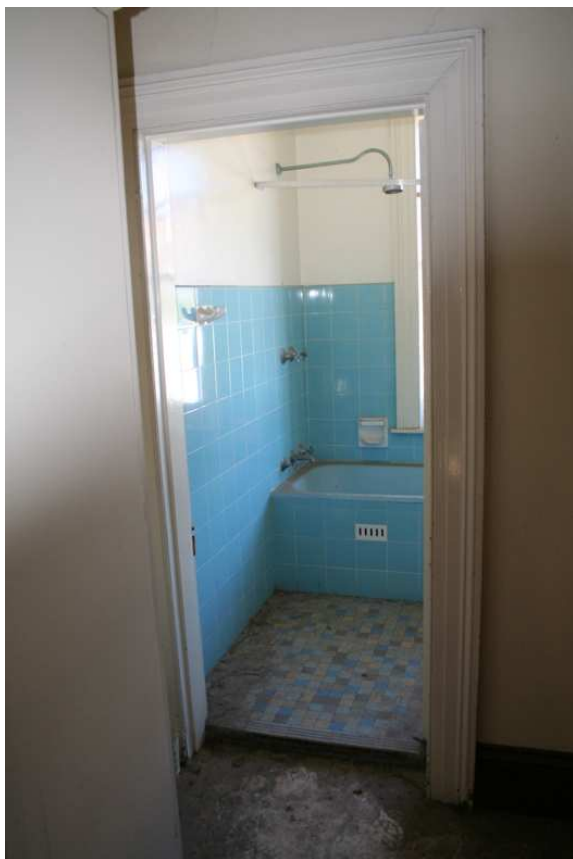
Room	F13	Original function	Not known: probably bathroom
Historical notes			
It is likely that the upper level of the Kitchen Wing, including Room F13, was constructed c1874. The room is shown as a bathroom in a 1924 drawing.			
Integrity			
Generally good: the plan form is original. Alterations include the installation of battened fibreboard ceiling (late twentieth century); and finishes and fittings (mid twentieth century).			
Schedule of fabric			
Element	Description		
Floor	Tessellated tiles		
Skirtings	—		
Walls	Plaster and glazed tiles		
Ceiling	Plasterboard and coved plasterboard cornice		
Doors	DF13.1: Four panel door. Brass knob		
Windows	F13/W1: Double hung sash. Pull and latch. Blind fittings. Decorative moulded timber architrave		
Conservation policies			
Retain original plan form. Retain bathroom use Investigate original floor finish. Conserve and restore early and original fabric. Remove modern finishes and fittings if warranted Remove surface-mounted services and repair original finishes. Ensure that the addition of services is undertaken in a manner that complements the overall design of the room and minimises loss of significant fabric.

Room F13. Looking east into the bathroom.

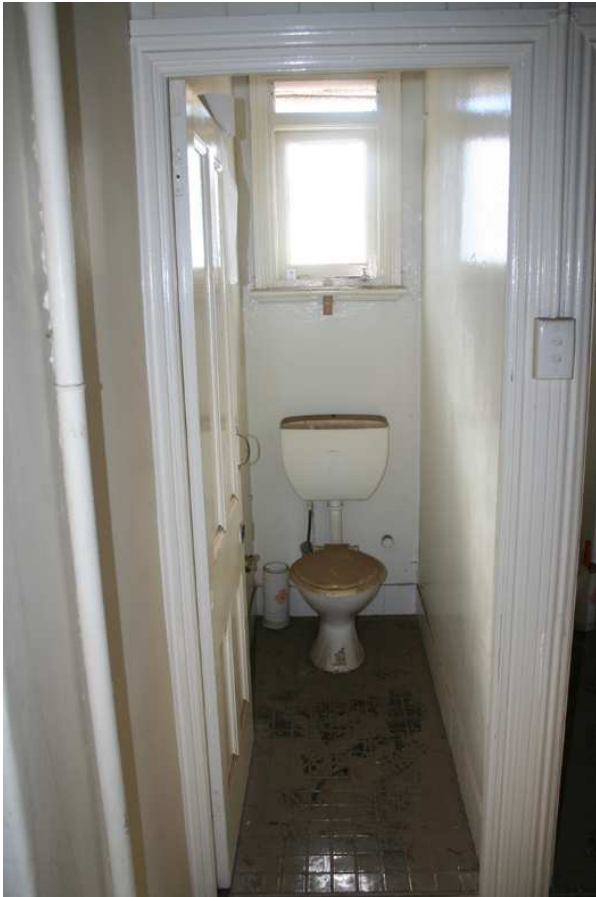
Room F14. Looking north

Room	F14	Original function	Lavatories
Historical notes			
Constructed 1915/16 for the Australian Red Cross Society as part of a two-storey lavatory and bathroom wing.			
Integrity			
High. Retains original plan form and some fittings and most finishes.			
Fittings upgraded in the 1980s or 1990s.			
Schedule of fabric			
Element	Description		
Floor	Tiles over concrete		
Skirtings	Tiles		
Walls	Plaster		
Ceiling	Battened fibrous plaster		
Doors	Un-numbered: Four panel door. Latch and pull		
Windows	F14/W1 & W2: Timber framed casement with rippled glass glazing. Casement stay. Louvred panel above		
Conservation policies			
The structure is of historical interest insofar it demonstrates its role as part of the Red Cross Convalescent Home.			
If proposed to be demolished, a photographic archival recording should be undertaken prior to its removal.

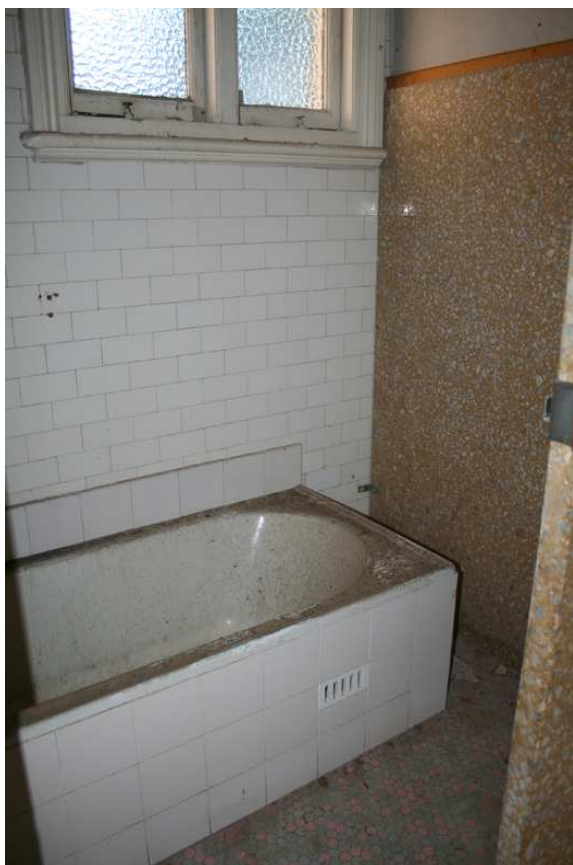
Room F16. Looking west

Room	F16	Original function	Bathroom and Urinals
Historical notes			
Constructed 1915/16 for the Australian Red Cross Society as part of a two-storey lavatory and bathroom wing.			
Integrity			
High. Retains original plan form and some fittings and most finishes.			
The terrazzo partitions were installed in the 1950s or 1960s.			
Fittings upgraded in the 1980s or 1990s.			
Schedule of fabric			
Element	Description		
Floor	Fibreboard and tiles		
Skirtings	—		
Walls	North wall passage: Timber stud frame and battened fibreboard and timber boarded dado. East alcove: Plaster and vitrified tiles. J. Tylor and Sons Ltd. Belmont bed pan sluice Plaster WC & Bath: vitrified tiles Terrazzo cubicle partitions with boarded and braced door		
Ceiling	Timber battened fibreboard		
Doors	DF16.1: Four panel door, brass knob. Splayed timber architrave		
Windows	F16/W1: Timber framed casement. Casement stay F16/W2: Timber framed, fixed glazing F16/W3 & W4: Timber framed casement with rippled glass glazing. Casement stay. Louvred panel above

Conservation policies			
The structure is of historical interest insofar it demonstrates its role as part of the Red Cross Convalescent Home.			
If proposed to be demolished, a photographic archival recording should be undertaken prior to its removal.

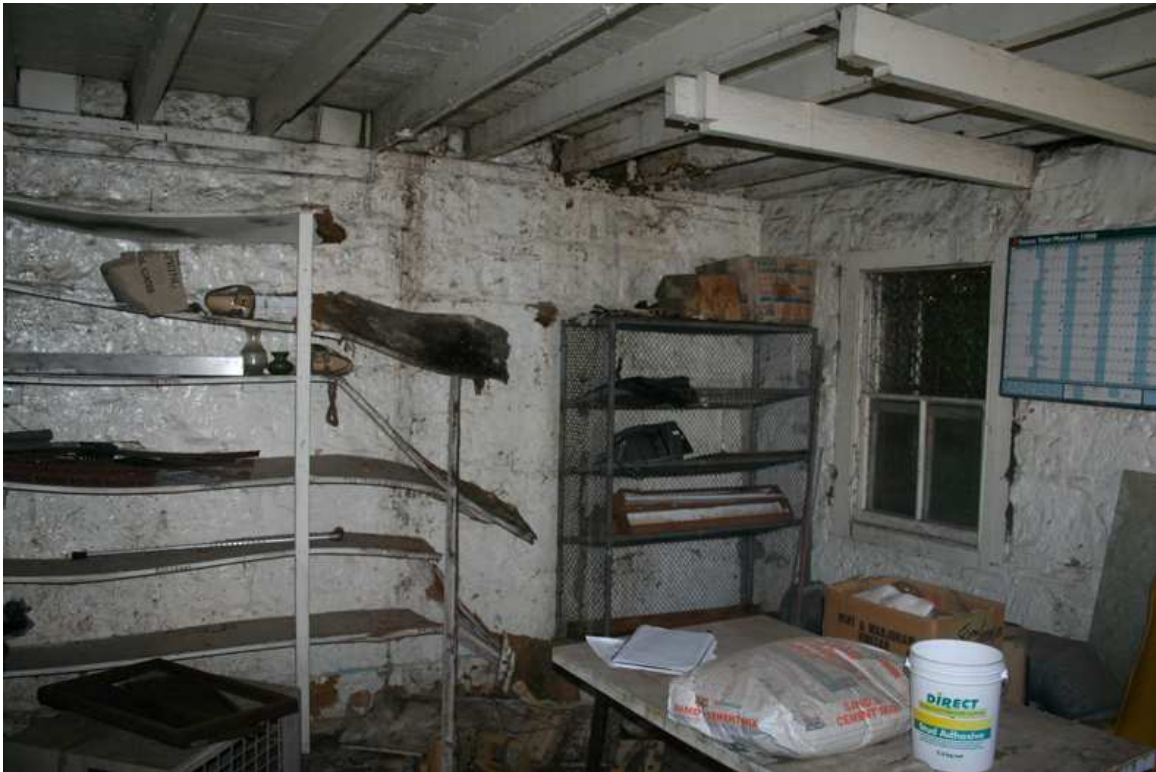
Room 19A, looking north-west

Room	G19A	Original function	Part stable/coach house
Historical notes			
<p>The building was originally constructed c1833 as a stable/coach house for 'Euroka Cottage'.</p> <p>Room G19A is shown in a 1916 drawing with a partitioned bathroom at the north end. The south wall was constructed at this time, the bathroom removed, and the space used as a general store. The bathroom probably dated to the 1880s.</p> <p>The bathroom and fireplace in Room G19b suggests that the co-joined room was a residence from c1882.</p>			
Integrity			
<p>Poor.</p> <p>Alterations include the concrete floor (late twentieth century), reframing the ceiling/floor and changes to the windows (late nineteenth century), removal of the bathroom (for which framing is insitu in the ceiling) and construction of south wall (1916).</p>			
Schedule of fabric			
Element	Description		
Floor	Concrete		
Skirtings	—		
Walls	<p>North, east and west: Painted sandstone masonry</p> <p>South: Painted brick masonry</p> <p>Along west wall ceiling joists are supported on a timber plate set within the wall</p> <p>Shelving along west and south walls with chipboard shelves</p>

Ceiling	<p>Machine cut boards and joists of floor above.</p> <p>Two cross timber members at 90 degrees to end wall with notches cut into south edge</p>		
Doors	<p>DG9.2: Ledged and braced door with beaded edge boarding. Bracing has bevelled edge. Mid-stile is cut in two. 4 No. iron strap hinges. (19<sup>th</sup> rim lock. Night latch</p>		
Windows	<p>G19/W3: Double hung sash window without horns. Vertical sash bar. Strip timber architrave</p> <p>G19/W2: Double hung sash window. Pulls and latch. Decorative moulded architrave</p>		
Conservation policies			
<p>Retain existing plan form as evidence for hospital use.</p> <p>Investigate original floor finish.</p> <p>Conserve and restore early and original fabric.</p> <p>Remove modern finishes and fittings.</p> <p>Remove surface-mounted services and repair original finishes.</p> <p>Ensure that the addition of services is undertaken in a manner that complements the overall design of the room and minimises loss of significant fabric.</p>

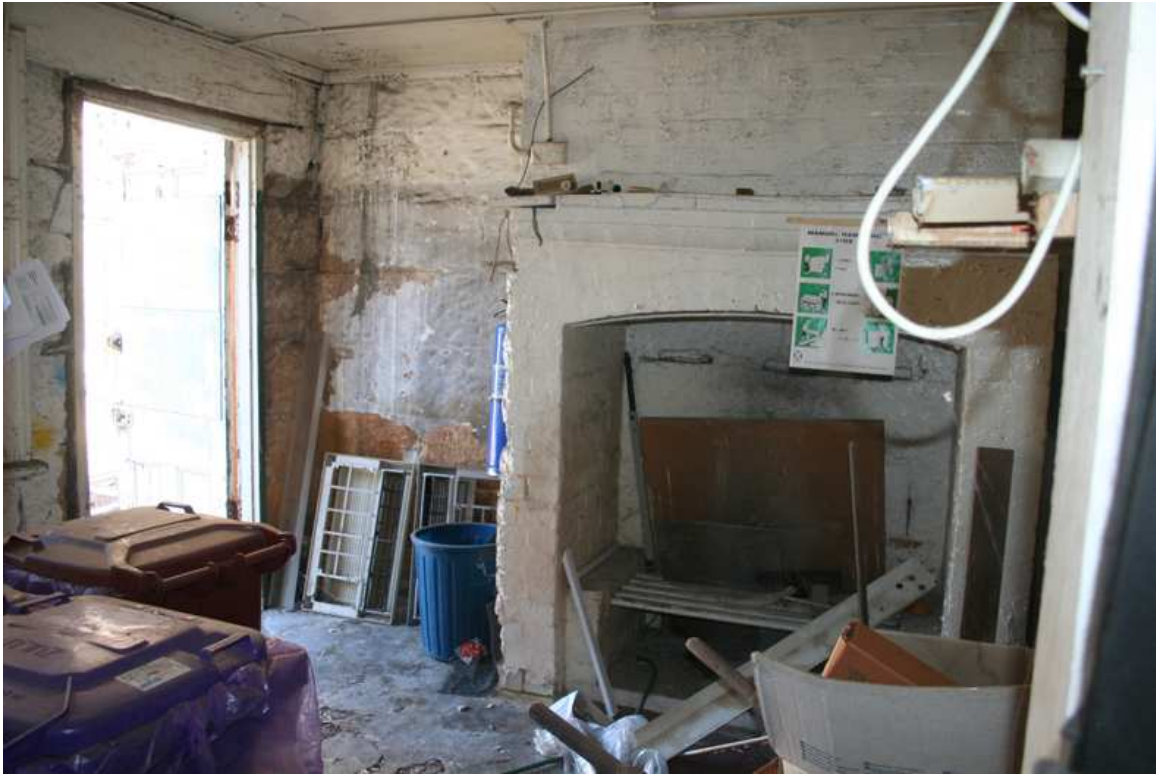
Room 19B, looking south

Room	G19b	Original function	Part stable/coach house
Historical notes			
<p>The building was the original stable/coach house at Euroka and is believed to date to Walker’s c.1833 development.</p> <p>Room G19b is shown in a 1916 drawing. The north wall and door DG19.1 was inserted at this time, and the space used as a meat store. The door opening in the north wall is not shown.</p> <p>The fireplace was constructed in the 1880s.</p> <p>The bathroom and fireplace in Room G19a suggests that the co-joined room was a residence from c1882.</p>			
Integrity			
<p>Poor.</p> <p>Alterations include the concrete floor (late twentieth century), the reframing the ceiling/floor (subject to further investigation), changes to the east wall, and insertion of fireplace (late nineteenth century), and installation of DG19.1 (1916).</p>			
Schedule of fabric			
Element	Description		
Floor	Concrete		
Skirtings	—		
Walls	East and west: Painted sandstone masonry North and south: Painted brick masonry South wall at west end: Painted sandstone masonry South: Brick fireplace with brick hob and mantel East: Section of later infilling below hardwood lintel

Ceiling	Fibreboard with quad profile timber cornice		
Doors	DG19.1: Four panel door and timber frame		
Windows	G19/W1: Double hung sash window. Pulls and latch. Decorative moulded architrave		
Conservation policies			
<p>Retain existing plan form as evidence for Dibbs era use.</p> <p>Investigate original floor finish.</p> <p>Conserve and restore early and original fabric.</p> <p>Remove modern finishes and fittings.</p> <p>Remove surface-mounted services and repair original finishes.</p> <p>Ensure that the addition of services is undertaken in a manner that complements the overall design of the room and minimises loss of significant fabric.</p>

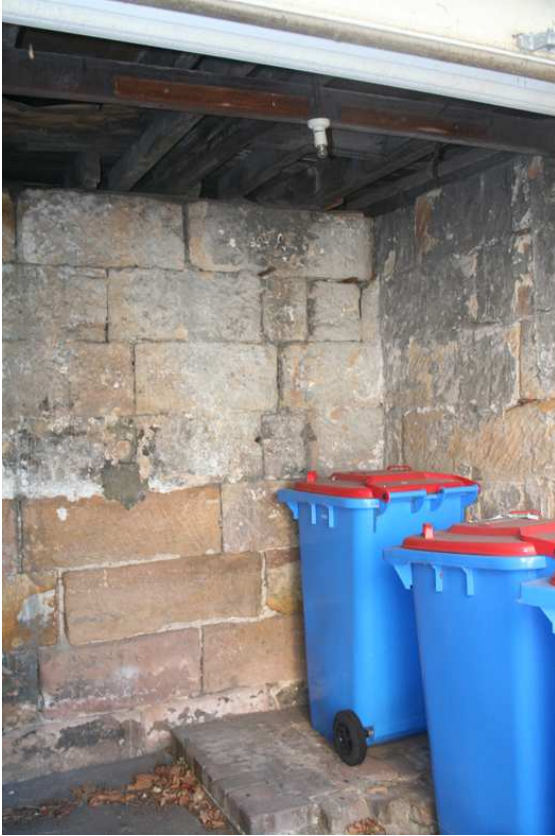
Room 19c, looking north-west.

Room	G19c	Original function	Part stable/coach house
Historical notes			
<p>The building was the original stable/coach house at Euroka and is believed to date to Walker’s c.1833 development.</p> <p>Room G19c is shown in a 1916 drawing as the boiler room. The east wall at this time was infilled and with a door opening. Physical investigation is required to determine if the west cross wall is original or an alteration dating to the 1880s. The division into two spaces is shown in the 1916 drawing. The association of this space with the boiler room could date to the 1880s.</p>			
Integrity			
<p>Poor.</p> <p>Alterations include the concrete floor (late twentieth century), reframing the ceiling/floor and probable rebuilding of west wall and use as boiler house (late nineteenth century), removal of east wall (late twentieth century).</p>			
Schedule of fabric			
Element	Description		
Floor	<p>Concrete</p> <p>North-west corner has a laid brick platform</p>

Skirtings	—		
Walls	<p>Whitewashed sandstone masonry</p> <p>West and south walls have notched housings for timber members</p>		
Ceiling	<p>Machine cut boards and joists of floor above.</p> <p>Framing and housing for a circular flue (now removed)</p>		
Doors	Steel roller door and hardwood lintel		
Windows	—		
Conservation policies			
<p>Retain plan form as evidence of Dibbs era use as boiler house</p> <p>Investigate original floor finish.</p> <p>Investigate earlier east wall details.</p> <p>Conserve and restore early and original fabric.</p> <p>Remove modern finishes and fittings.</p> <p>Remove surface-mounted services and repair original finishes.</p> <p>Ensure that the addition of services is undertaken in a manner that complements the overall design of the room and minimises loss of significant fabric.</p>
