**GRAYTHWAITE HOUSE**

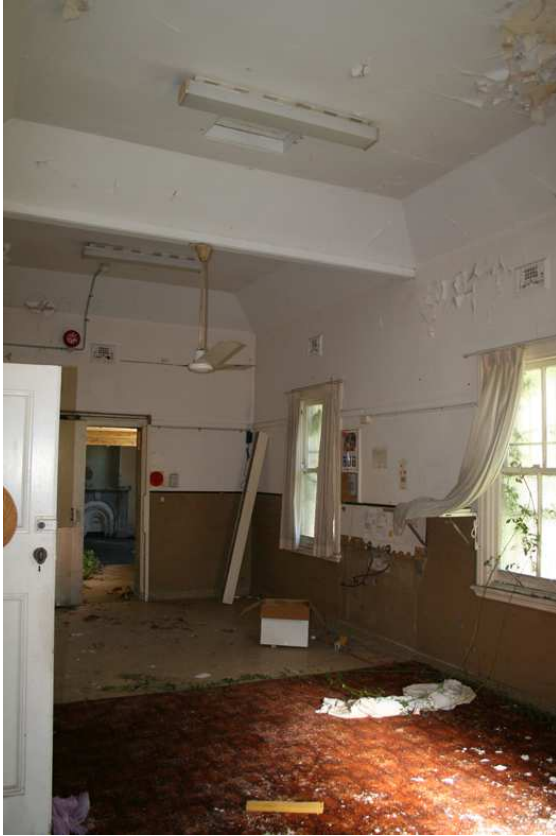
Room G8, looking south.

Room	G8	Original function	North – Massage Room/South – Doctor's Room
Historical notes			
Constructed in 1916 for the Australian Red Cross Society for use as the massage room and doctor's room.			
Integrity			
Generally good: the plan form is discernible and most of the original fabric is intact.			
Alterations include the installation of the terrazzo floor and removal of the cross wall (1950s or 1960s), insertion of DG 8.1 and modern finishes (c1980s or 1990s).			
Schedule of fabric			
Element	Description		
Floor	North: Carpet over terrazzo South: Terrazzo		
Skirtings	Coved terrazzo		
Walls	Plaster Decorative moulded timber picture rails Evidence for early painted finish Decorative plaster vents Evidence in ceiling for a cross wall		
Ceiling	Fibrous plaster, pitched at wall junction.		
Doors	DG8.3: 2 No. four panel doors with deep reveals. Brass knob. Ceramic fingerplate. Barrel bolt. Night latch. Splayed profile timber architrave with skirting block DG8.2: four panel door with deep reveals. Splayed profile timber architrave DG8.1: Fire rated sliding flush door, wall mounted. Located within a former window opening

Windows	G8/W1-W4: Double hung sash window. Pulls and latch. Decorative timber architrave		
Conservation policies			
Reinstate original plan form.			
Investigate original floor finish.			
Conserve and restore early and original fabric.			
Remove modern finishes and fittings.			
Close-up DG8.1 and reconstruct window.			
Remove surface-mounted services and repair original finishes.			
Ensure that the addition of services is undertaken in a manner that complements the overall design of the room and minimises loss of significant fabric.

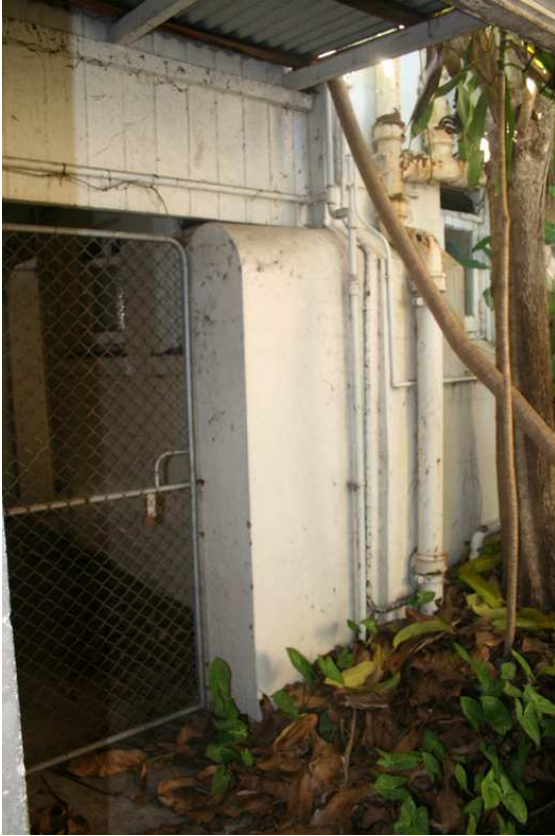
Room	G10	Original function	Covered Way
Historical notes			
Constructed 1980s or 1990s.			
Integrity			
—			
Schedule of fabric			
Element	Description		
Floor	Concrete		
Skirtings	—		
Walls	North: External wall. Rendered brick lined as ashlar and coloured as sandstone East: Rendered stone wall to courtyard with rounded top West: Timber stud frame and fibreboard panelling		
Ceiling	Fibreboard		
Doors	DG8.1: Fire rated sliding flush door, wall mounted. Located within a former window opening DG4.2: Fire rated sliding flush door, wall mounted. Located within a former window opening		
Windows	G9/W4: Timber casement with louvred glass upper section (panes missing)		
Conservation policies			
The covered way is an intrusive element and may be contributing to the physical deterioration of more significant elements and fabric. It should be carefully removed when the opportunity arises and any damage to significant elements or fabric made good.

Room G10, remnant courtyard wall.

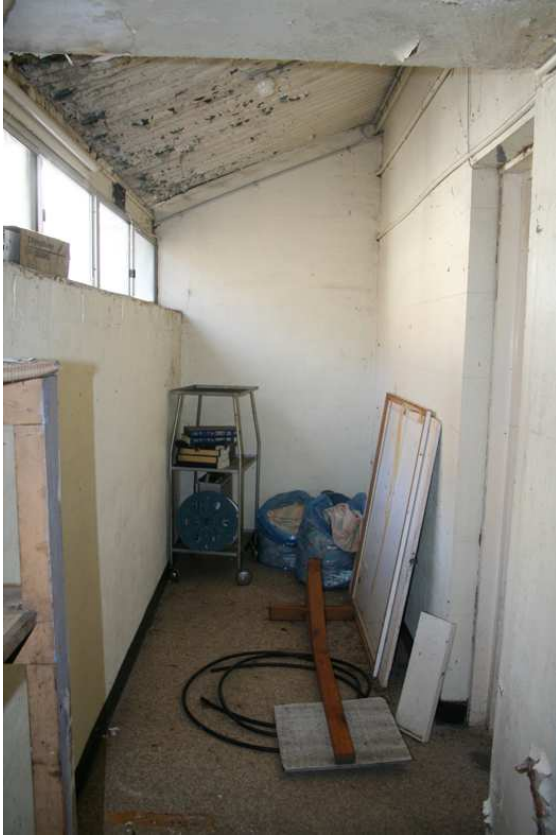
Room	G18	Original function	Covered Way
Historical notes			
Constructed in 1916 for the Australian Red Cross Society to provide access to the massage room and doctor's room (Room G8). This space provided a covered way from the House linking with G9a			
Integrity			
Poor: the sense of a connecting covered way has been removed.			
The changes seem to have been made in the 1980s or 1990s.			
Schedule of fabric			
Element	Description		
Floor	Vinyl over concrete		
Skirtings	—		
Walls	West: Cement rendered and lined out as ashlar masonry East: Rendered bricks with aluminium framed glazed upper section Cross north wall: Cement rendered and lined out as ashlar masonry and upper section of painted sandstone North wall and return: Cement rendered and lined out as ashlar masonry		
Ceiling	Soffit of corrugated iron roof and timber structure		
Doors	DG8.3: 2 No. four panel doors with deep reveals. Brass knob. Ceramic fingerplate. Barrel bolt. Night latch. Lambs tongue profile timber architrave with skirting block DG8.2: Four panel door with deep reveals

Room G18—looking south towards infill wall. Entry to the former massage room is at right.

Windows	—		
Conservation policies			
Investigate original floor finish.			
Conserve and restore early and original fabric.			
Remove modern finishes and fittings.			
Remove surface-mounted services and repair original finishes.			
Ensure that the addition of services is undertaken in a manner that complements the overall design of the room and minimises loss of significant fabric.
